Asbestos Management Survey Report

Cheese Hall, High Street, Chippenham, Wiltshire, SN15 3ER

Date of Survey:	2 Dec 2025 to 7 Dec 2025
Date of Report:	15 Dec 2025
<u>Job No:</u>	<u>J012948</u>
Authorising Surveyor:	Jim Hook
Verified/Signature:

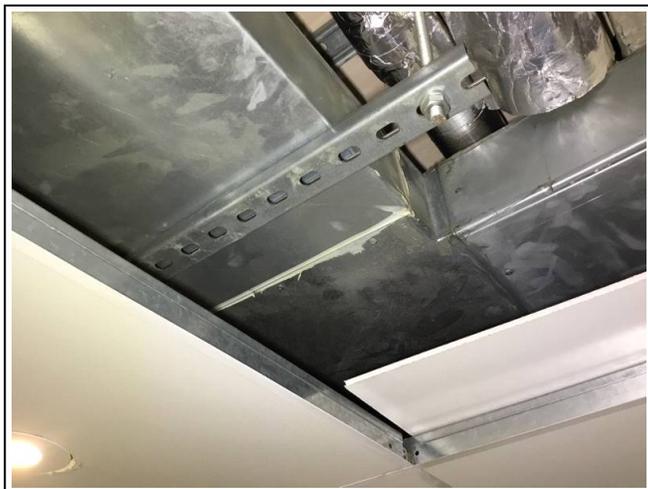
Survey Data Sheet: Conclusions & Recommendations
 Site Location: Cheese Hall, High Street, Chippenham, Wiltshire, SN15 3ER
 Building Designation: Building 01
 Unique item Number: 1

Sample Ref	Fl	Location	Description	Qty	Analysis Result	Total M.A.S	Licensed Material Y/N
CT004821	Ground Floor	G.01 - Corridor	Ducting joints - Mastic sealant - Well Bound Material	1lm	NADIS	0	N/A

Recommendations:
 No asbestos detected in sample

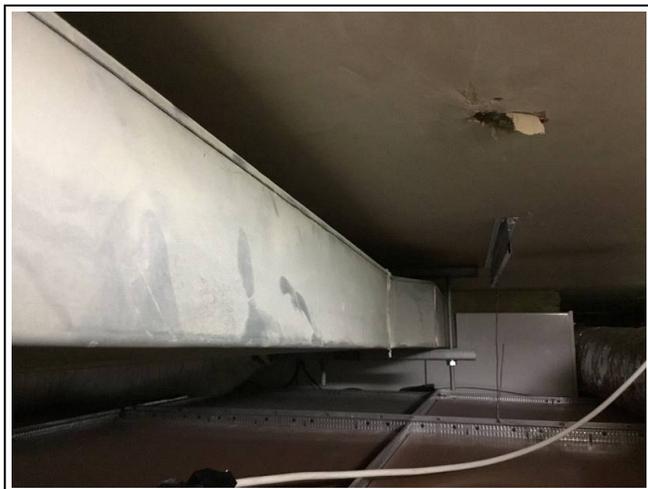
Survey Data Sheet: Conclusions & Recommendations
 Site Location: Cheese Hall, High Street, Chippenham, Wiltshire, SN15 3ER
 Building Designation: Building 01
 Unique item Number: 3

Sample Ref	Fl	Location	Description	Qty	Analysis Result	Total M.A.S	Licensed Material Y/N
REFER (CT004821)	Ground Floor	G.03 - Male Toilets	Ducting joints - Mastic sealant - Well Bound Material	1lm	NADIS	0	N/A

Recommendations:
 No asbestos detected in sample

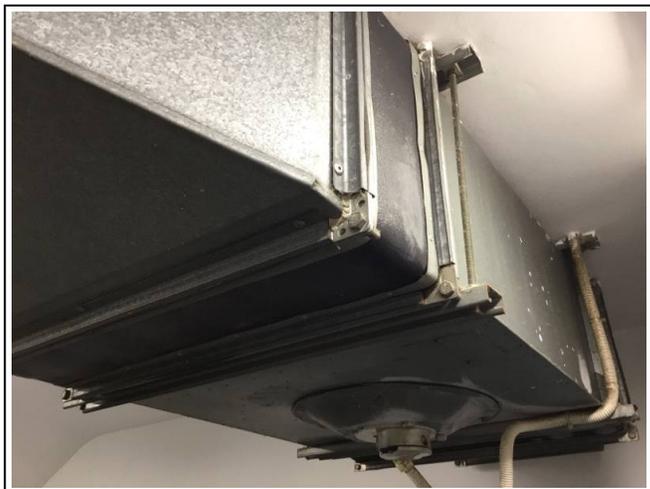
Survey Data Sheet: Conclusions & Recommendations
 Site Location: Cheese Hall, High Street, Chippenham, Wiltshire, SN15 3ER
 Building Designation: Building 01
 Unique item Number: 7

Sample Ref	Fl	Location	Description	Qty	Analysis Result	Total M.A.S	Licensed Material Y/N
CT004822	Ground Floor	G.07 - Kitchen	Ducting joints - Mastic sealant - Well Bound Material	1lm	NADIS	0	N/A

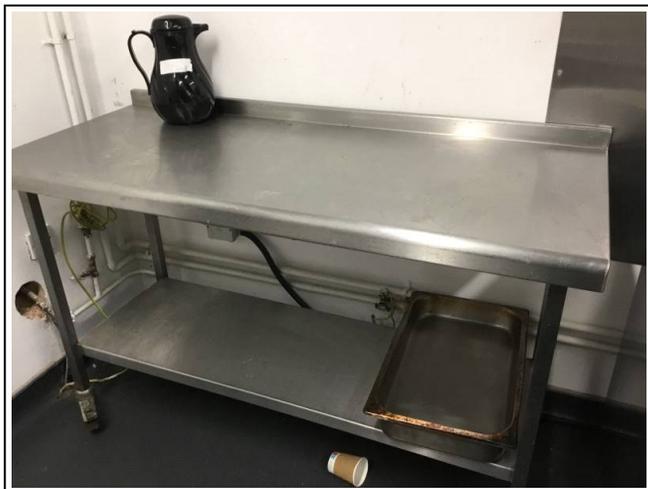
Survey Data Sheet: Conclusions & Recommendations
 Site Location: Cheese Hall, High Street, Chippenham, Wiltshire, SN15 3ER
 Building Designation: Building 01
 Unique item Number: 8

Sample Ref	FI	Location	Description	Qty	Analysis Result	Total M.A.S	Licensed Material Y/N
CT004823	Ground Floor	G.07 - Kitchen	Underside of prep table - Painted coating - Well Bound Material	1no.	NADIS	0	N/A

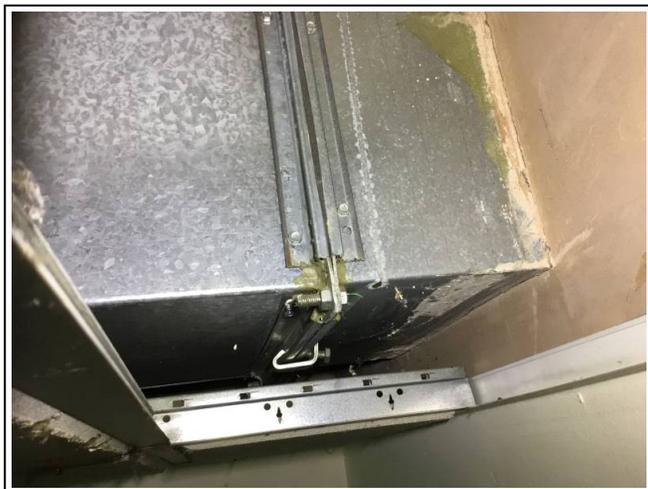
Survey Data Sheet: Conclusions & Recommendations
 Site Location: Cheese Hall, High Street, Chippenham, Wiltshire, SN15 3ER
 Building Designation: Building 01
 Unique item Number: 10

Sample Ref	Fl	Location	Description	Qty	Analysis Result	Total M.A.S	Licensed Material Y/N
REFER (CT004822)	Ground Floor	G.09 - Lobby	Ducting joints - Mastic sealant - Well Bound Material	<0.25lm	NADIS	0	N/A

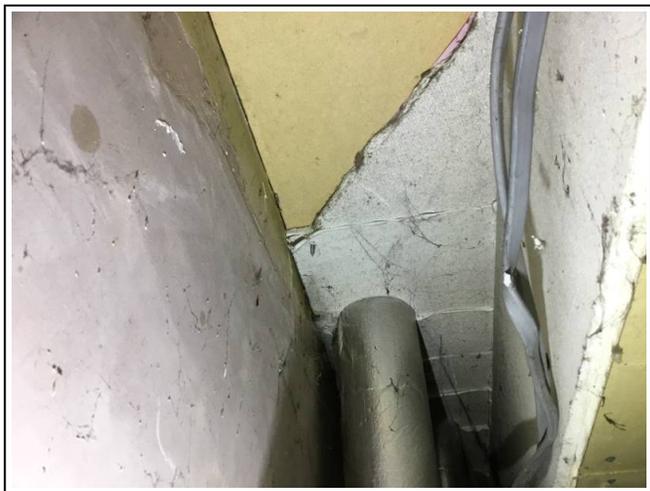
Survey Data Sheet: Conclusions & Recommendations
 Site Location: Cheese Hall, High Street, Chippenham, Wiltshire, SN15 3ER
 Building Designation: Building 01
 Unique item Number: 11

Sample Ref	Fl	Location	Description	Qty	Analysis Result	Total M.A.S	Licensed Material Y/N
CT004824	Ground Floor	G.10 - Electrical Cupboard	Ceiling - Firebreak panelling - Insulating Board	1lm	NADIS	0	N/A

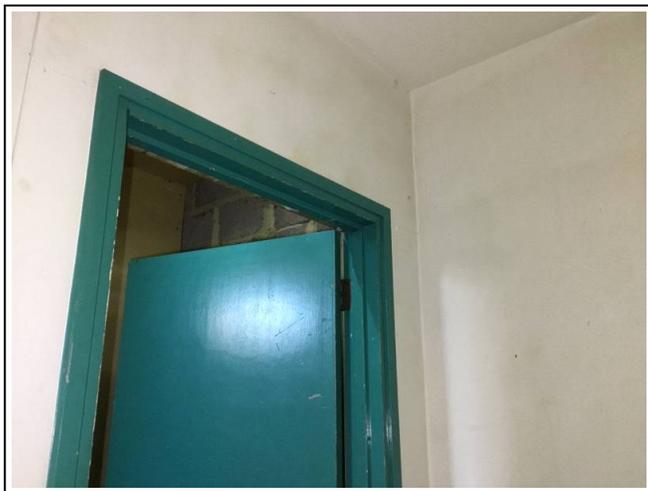
Survey Data Sheet: Conclusions & Recommendations
 Site Location: Cheese Hall, High Street, Chippenham, Wiltshire, SN15 3ER
 Building Designation: Building 01
 Unique item Number: 14

Sample Ref	Fl	Location	Description	Qty	Analysis Result	Total M.A.S	Licensed Material Y/N
CT004825	1st Floor	1.01 - Landing	Door frame surround - Panelling - Insulating Board	1m ²	NADIS	0	N/A

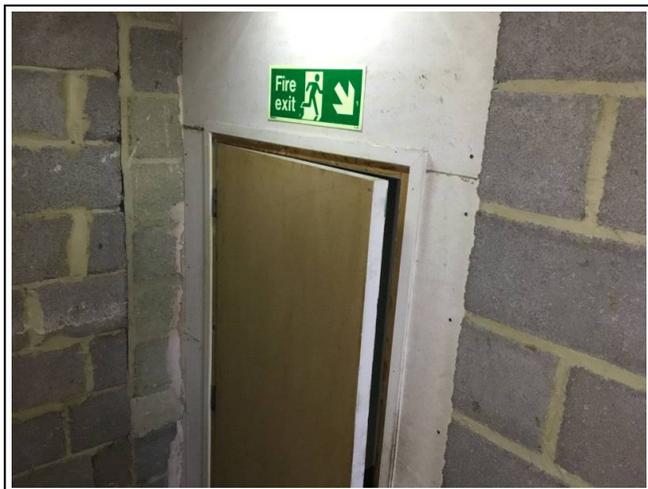
Survey Data Sheet: Conclusions & Recommendations
 Site Location: Cheese Hall, High Street, Chippenham, Wiltshire, SN15 3ER
 Building Designation: Building 01
 Unique item Number: 15

Sample Ref	Fl	Location	Description	Qty	Analysis Result	Total M.A.S	Licensed Material Y/N
REFER (CT004825)	1st Floor	1.02 - Landing	Door frame surround - Panelling - Insulating Board	1m ²	NADIS	0	N/A

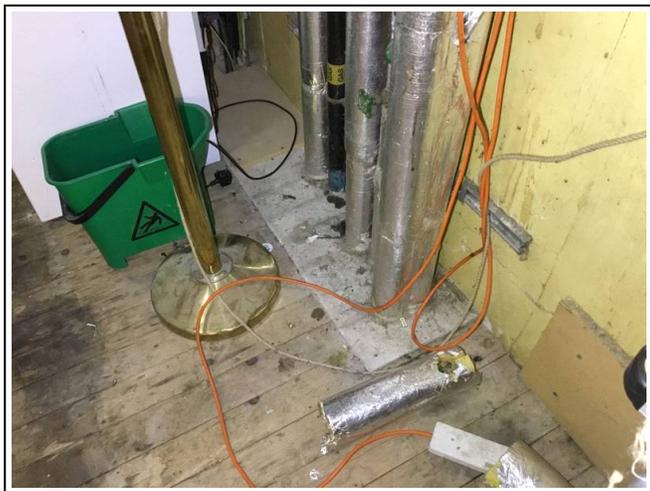
Survey Data Sheet: Conclusions & Recommendations
 Site Location: Cheese Hall, High Street, Chippenham, Wiltshire, SN15 3ER
 Building Designation: Building 01
 Unique item Number: 16

Sample Ref	Fl	Location	Description	Qty	Analysis Result	Total M.A.S	Licensed Material Y/N
REFER (CT004824)	1st Floor	1.03 - Store	Floor - Firebreak panelling - Insulating Board	2lm	NADIS	0	N/A

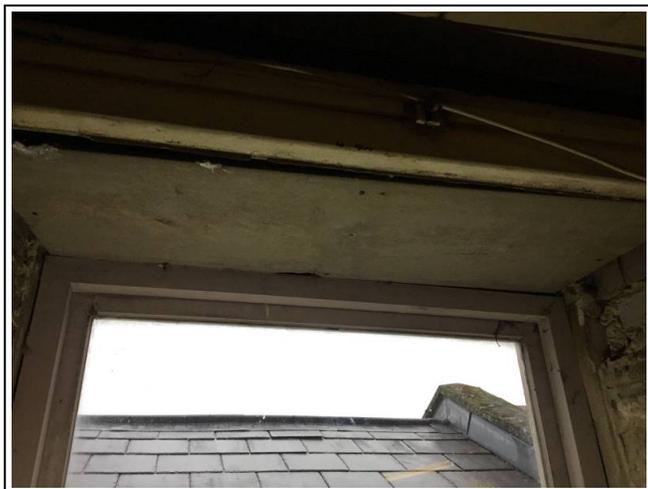
Survey Data Sheet: Conclusions & Recommendations
 Site Location: Cheese Hall, High Street, Chippenham, Wiltshire, SN15 3ER
 Building Designation: Building 01
 Unique item Number: 17

Sample Ref	Fl	Location	Description	Qty	Analysis Result	Total M.A.S	Licensed Material Y/N
CT004826	1st Floor	1.03 - Store	Window lintel - Soffit panel - Asbestos Insulating Board	11m	Chrysotile	6	Y

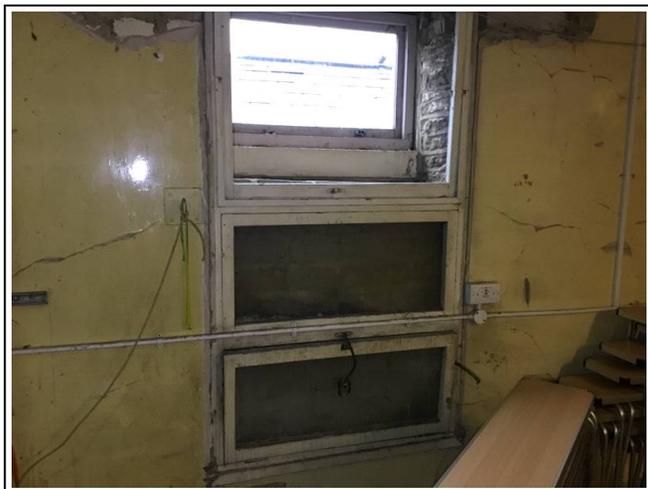
Survey Data Sheet: Conclusions & Recommendations
 Site Location: Cheese Hall, High Street, Chippenham, Wiltshire, SN15 3ER
 Building Designation: Building 01
 Unique item Number: 18

Sample Ref	Fl	Location	Description	Qty	Analysis Result	Total M.A.S	Licensed Material Y/N
CT004827	1st Floor	1.03 - Store	Window - Putty to window frame - Well Bound Material	10lm	NADIS	0	N/A

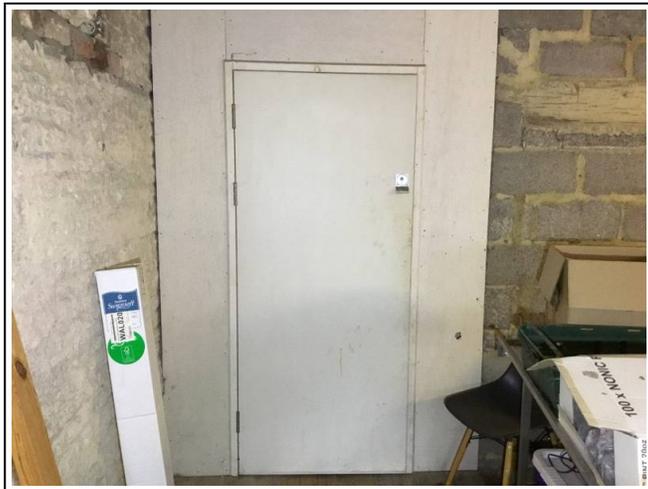
Survey Data Sheet: Conclusions & Recommendations
 Site Location: Cheese Hall, High Street, Chippenham, Wiltshire, SN15 3ER
 Building Designation: Building 01
 Unique item Number: 19

Sample Ref	Fl	Location	Description	Qty	Analysis Result	Total M.A.S	Licensed Material Y/N
CT004828	1st Floor	1.04 - Store	Door frame surround - Panelling - Insulating Board	1.5m ²	NADIS	0	N/A

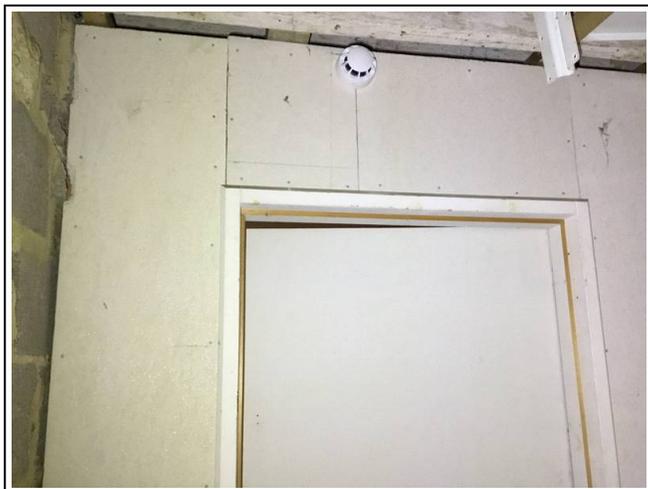
Survey Data Sheet: Conclusions & Recommendations
 Site Location: Cheese Hall, High Street, Chippenham, Wiltshire, SN15 3ER
 Building Designation: Building 01
 Unique item Number: 20

Sample Ref	Fl	Location	Description	Qty	Analysis Result	Total M.A.S	Licensed Material Y/N
REFER (CT004828)	1st Floor	1.05 - Store Cupboard	Door frame surround - Panelling - Insulating Board	1.5m ²	NADIS	0	N/A

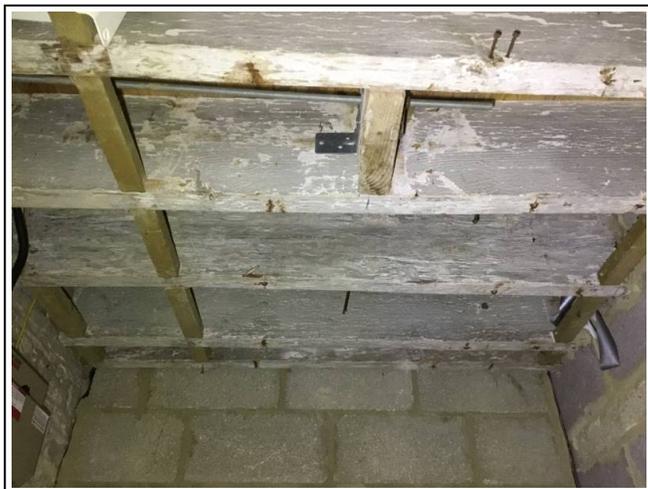
Survey Data Sheet: Conclusions & Recommendations
 Site Location: Cheese Hall, High Street, Chippenham, Wiltshire, SN15 3ER
 Building Designation: Building 01
 Unique item Number: 21

Sample Ref	Fl	Location	Description	Qty	Analysis Result	Total M.A.S	Licensed Material Y/N
CT004829	1st Floor	1.05 - Store Cupboard	Timber joists - Residue - Insulation	8lm	NADIS	0	N/A

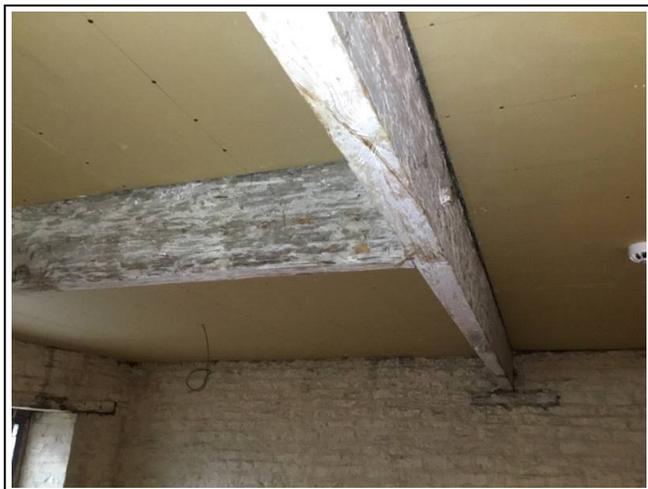
Survey Data Sheet: Conclusions & Recommendations
 Site Location: Cheese Hall, High Street, Chippenham, Wiltshire, SN15 3ER
 Building Designation: Building 01
 Unique item Number: 22

Sample Ref	Fl	Location	Description	Qty	Analysis Result	Total M.A.S	Licensed Material Y/N
CT004830	2nd Floor	2.01 - Store	Timber joists - Residue - Insulation	30lm	NADIS	0	N/A

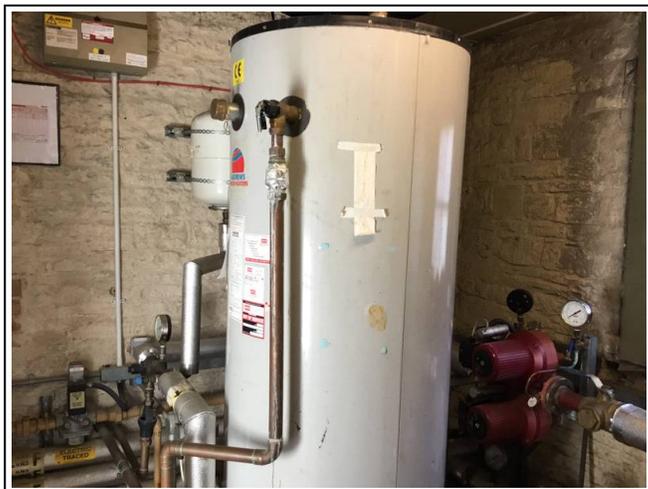
Survey Data Sheet: Conclusions & Recommendations
 Site Location: Cheese Hall, High Street, Chippenham, Wiltshire, SN15 3ER
 Building Designation: Building 01
 Unique item Number: 23

Sample Ref	Fl	Location	Description	Qty	Analysis Result	Total M.A.S	Licensed Material Y/N
Presumed	2nd Floor	2.02 - Plant Room	Within water heater - Gaskets - Asbestos Textiles/Paper	1no.	Chrysotile	4	N

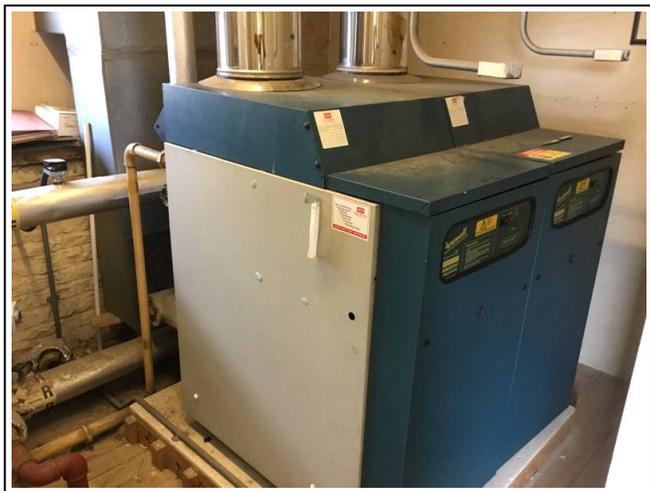
Survey Data Sheet: Conclusions & Recommendations
 Site Location: Cheese Hall, High Street, Chippenham, Wiltshire, SN15 3ER
 Building Designation: Building 01
 Unique item Number: 24

Sample Ref	Fl	Location	Description	Qty	Analysis Result	Total M.A.S	Licensed Material Y/N
Presumed	2nd Floor	2.02 - Plant Room	Within Hamworthy boilers - Gaskets - Asbestos Textiles/Paper	2no.	Chrysotile	4	N

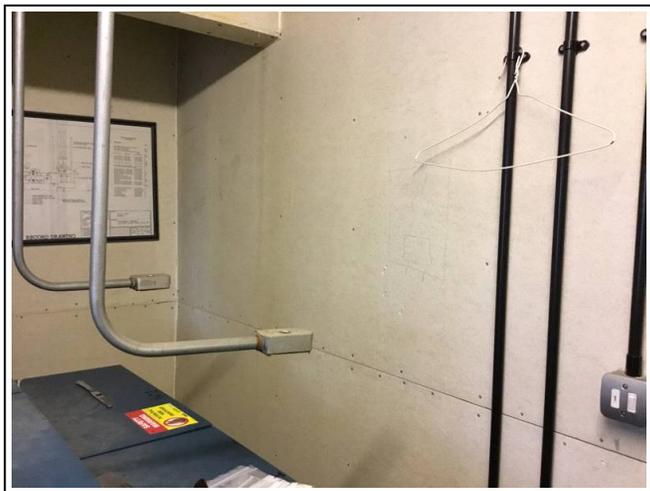
Survey Data Sheet: Conclusions & Recommendations
 Site Location: Cheese Hall, High Street, Chippenham, Wiltshire, SN15 3ER
 Building Designation: Building 01
 Unique item Number: 25

Sample Ref	Fl	Location	Description	Qty	Analysis Result	Total M.A.S	Licensed Material Y/N
CT004831	2nd Floor	2.02 - Plant Room	Walls - Panelling - Insulating Board	12m ²	NADIS	0	N/A

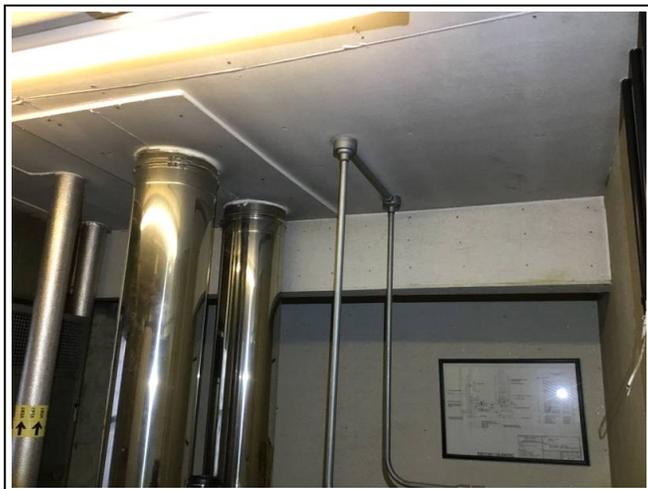
Survey Data Sheet: Conclusions & Recommendations
 Site Location: Cheese Hall, High Street, Chippenham, Wiltshire, SN15 3ER
 Building Designation: Building 01
 Unique item Number: 26

Sample Ref	Fl	Location	Description	Qty	Analysis Result	Total M.A.S	Licensed Material Y/N
REFER (CT004831)	2nd Floor	2.02 - Plant Room	Ceiling and ceiling joist - Panelling - Insulating Board	9m ²	NADIS	0	N/A

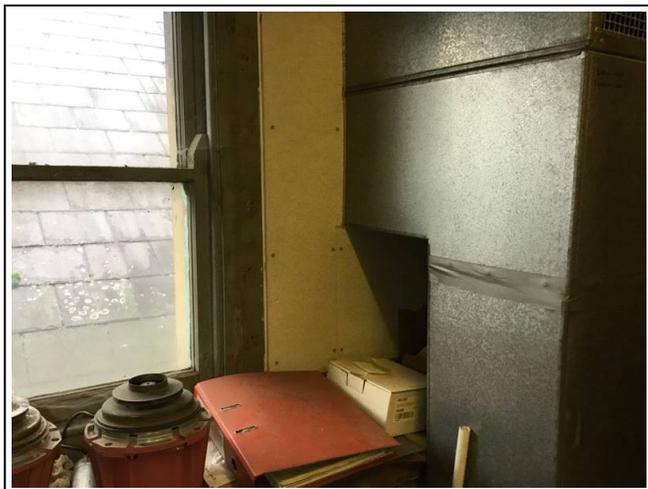
Survey Data Sheet: Conclusions & Recommendations
 Site Location: Cheese Hall, High Street, Chippenham, Wiltshire, SN15 3ER
 Building Designation: Building 01
 Unique item Number: 27

Sample Ref	FI	Location	Description	Qty	Analysis Result	Total M.A.S	Licensed Material Y/N
REFER (CT004831)	2nd Floor	2.02 - Plant Room	Window - Panelling - Insulating Board	0.5m ²	NADIS	0	N/A

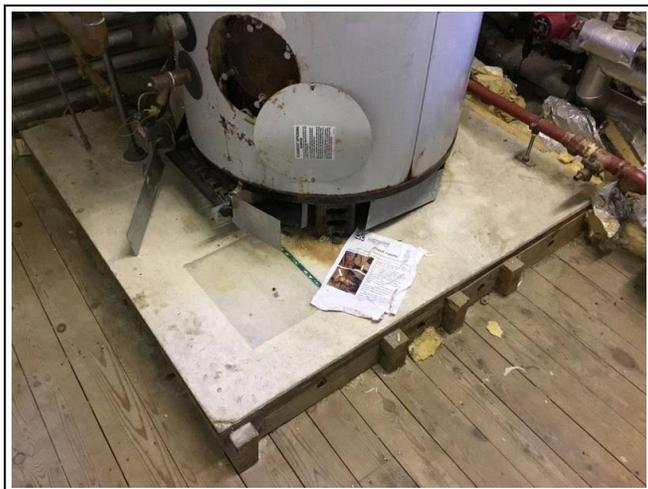
Sample Ref	Fl	Location	Description	Qty	Analysis Result	Total M.A.S	Licensed Material Y/N
CT004832	2nd Floor	2.02 - Plant Room	Timber frame platform - Panel - Insulating Board	1m ²	NADIS	0	N/A

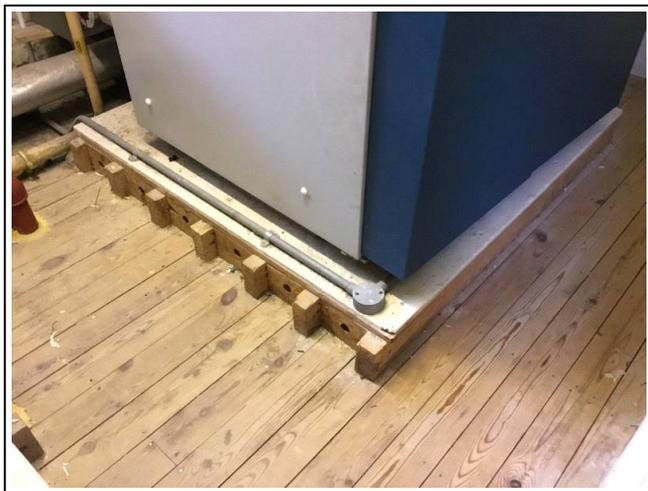
Sample Ref	Fl	Location	Description	Qty	Analysis Result	Total M.A.S	Licensed Material Y/N
REFER (CT004832)	2nd Floor	2.02 - Plant Room	Timber frame platform - Panel - Insulating Board	1.25m ²	NADIS	0	N/A

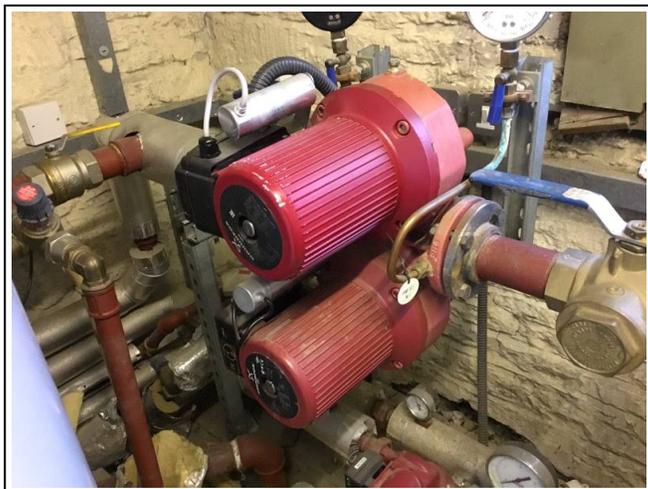
Sample Ref	Fl	Location	Description	Qty	Analysis Result	Total M.A.S	Licensed Material Y/N
CT004833	2nd Floor	2.02 - Plant Room	Pump flanges - Gasket - Textiles/Paper	2no.	NADIS	0	N/A

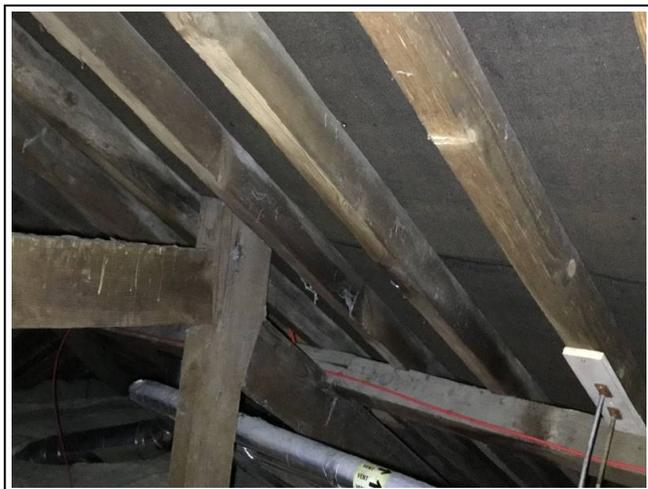
Sample Ref	FI	Location	Description	Qty	Analysis Result	Total M.A.S	Licensed Material Y/N
CT004834	Roof Void	Attic	Inner roof - Underfelt - Well Bound Material	128m ²	NADIS	0	N/A

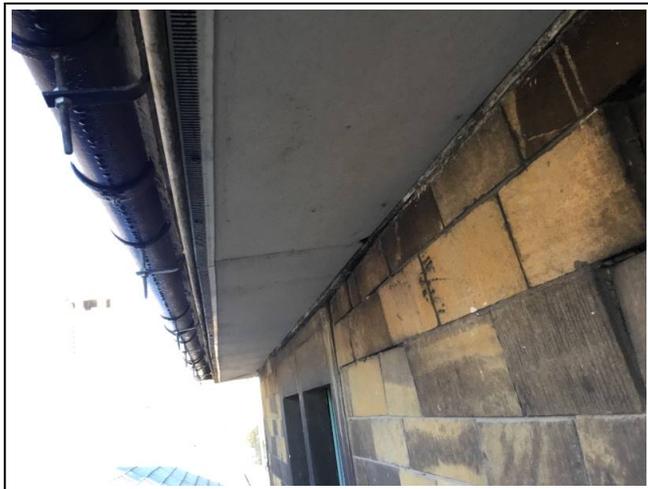
Sample Ref	FI	Location	Description	Qty	Analysis Result	Total M.A.S	Licensed Material Y/N
CT004835	External	External	Roof - Soffit boarding - Insulating Board	48lm	NADIS	0	N/A

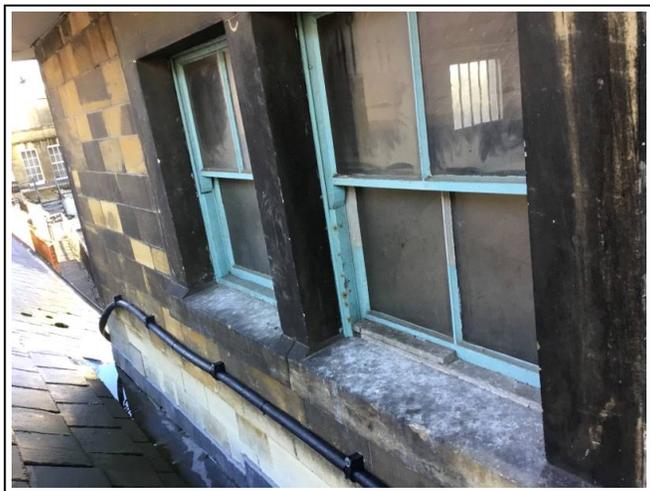
Sample Ref	FI	Location	Description	Qty	Analysis Result	Total M.A.S	Licensed Material Y/N
CT004836	External	External	Windows - Putty to glazing - Well Bound Material	18lm	NADIS	0	N/A
