# Asbestos Management Survey Report

Neeld Hall, High Street, Chippenham, Wiltshire, SN15 3ER

Date of Survey:	18 Nov 2025 to 7 Dec 2025
Date of Report:	15 Dec 2025
<u>Job No:</u>	<u>J012947</u>
Authorising Surveyor:	Jim Hook
Verified/Signature:

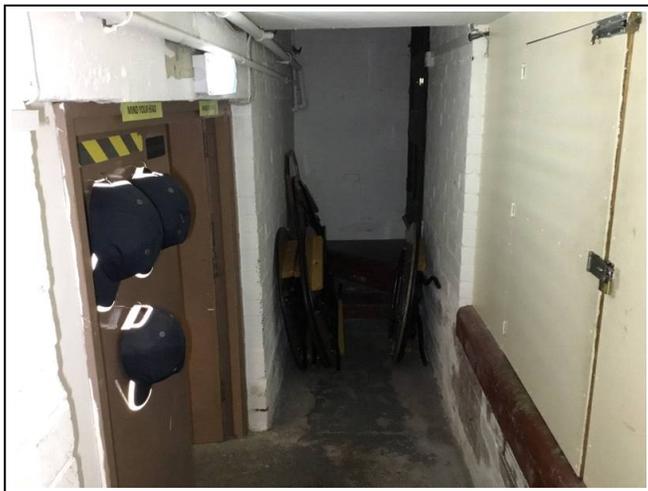
Survey Data Sheet: Conclusions & Recommendations  
 Site Location: Needd Hall, High Street, Chippenham, Wiltshire, SN15 3ER  
 Building Designation: Building 01  
 Unique item Number: 1

Sample Ref	FI	Location	Description	Qty	Analysis Result	Total M.A.S	Licensed Material Y/N
Surveyed	Z-Sub Level 1	B.01 - Lobby	No asbestos detected		N/A	0	N/A

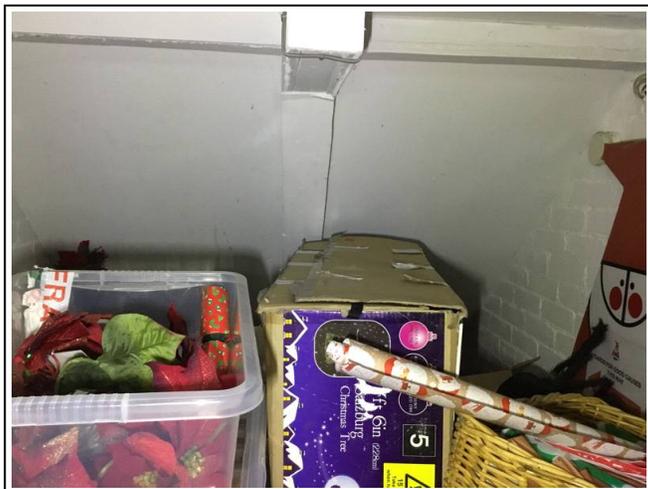
Survey Data Sheet: Conclusions & Recommendations  
 Site Location: Needl Hall, High Street, Chippenham, Wiltshire, SN15 3ER  
 Building Designation: Building 01  
 Unique item Number: 2

Sample Ref	FI	Location	Description	Qty	Analysis Result	Total M.A.S	Licensed Material Y/N
Surveyed	Z-Sub Level 1	B.02 - Store	No asbestos detected		N/A	0	N/A

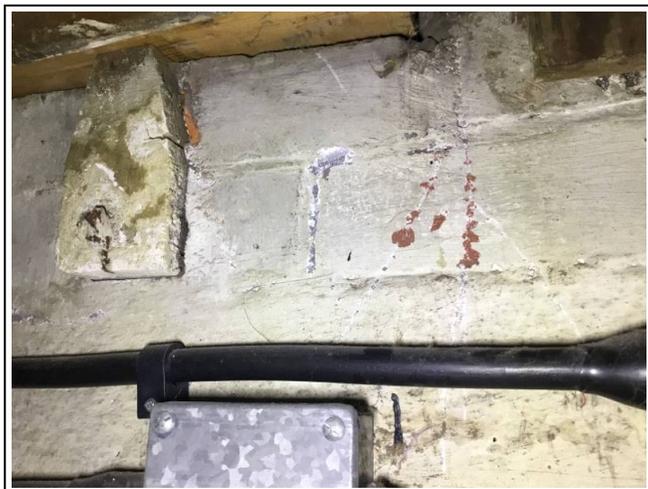
Survey Data Sheet: Conclusions & Recommendations  
 Site Location: Needd Hall, High Street, Chippenham, Wiltshire, SN15 3ER  
 Building Designation: Building 01  
 Unique item Number: 3

Sample Ref	FI	Location	Description	Qty	Analysis Result	Total M.A.S	Licensed Material Y/N
CT004793	Z-Sub Level 1	B.03 - Under Stage Area	Wall presumed throughout - Insulation residue - Insulation		NADIS	0	N/A

Recommendations:  
 No asbestos detected in sample

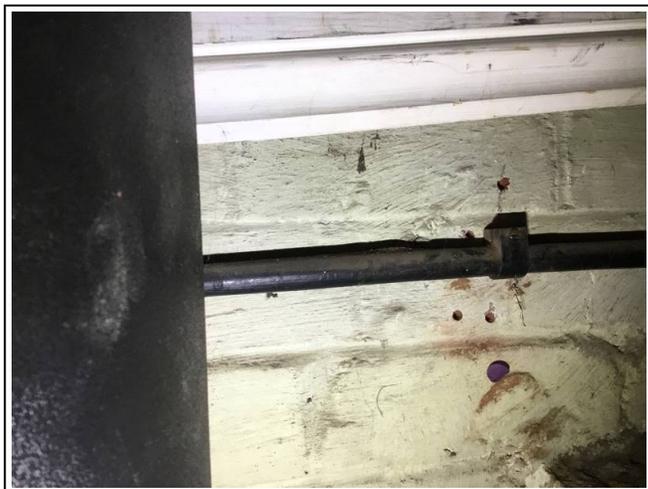
Survey Data Sheet: Conclusions & Recommendations  
 Site Location: Needl Hall, High Street, Chippenham, Wiltshire, SN15 3ER  
 Building Designation: Building 01  
 Unique item Number: 4

Sample Ref	FI	Location	Description	Qty	Analysis Result	Total M.A.S	Licensed Material Y/N
CT004794	Z-Sub Level 1	B.03 - Under Stage Area	Wall presumed throughout - Insulation residue - Asbestos Insulation/Coating	>1m <sup>2</sup>	Chrysotile	6	Y

**Recommended Action:**  
 Leave & Manage

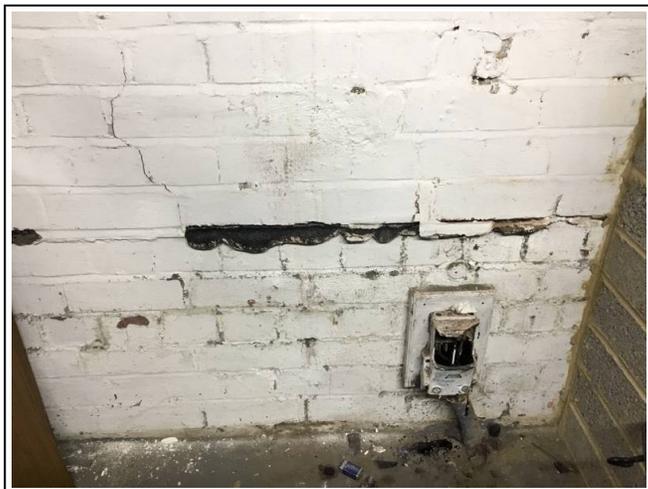
Survey Data Sheet: Conclusions & Recommendations  
 Site Location: Needl Hall, High Street, Chippenham, Wiltshire, SN15 3ER  
 Building Designation: Building 01  
 Unique item Number: 5

Sample Ref	FI	Location	Description	Qty	Analysis Result	Total M.A.S	Licensed Material Y/N
CT004796	Z-Sub Level 1	B.03 - Under Stage Area	Walls - Damp course - Well Bound Material	Throughout	NADIS	0	N/A

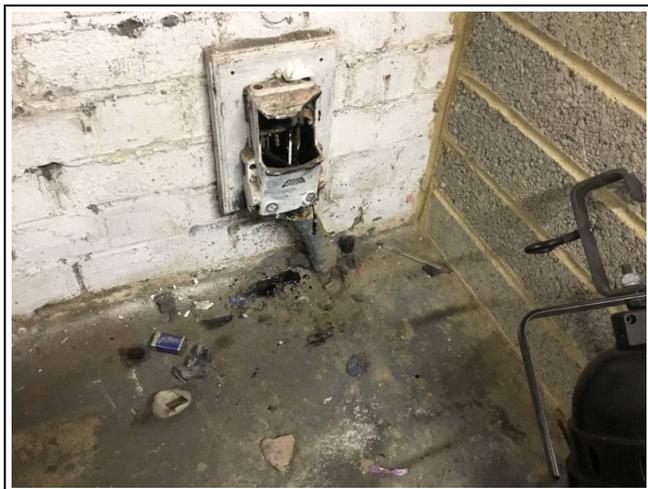
Survey Data Sheet: Conclusions & Recommendations  
 Site Location: Needd Hall, High Street, Chippenham, Wiltshire, SN15 3ER  
 Building Designation: Building 01  
 Unique item Number: 6

Sample Ref	FI	Location	Description	Qty	Analysis Result	Total M.A.S	Licensed Material Y/N
CT004797	Z-Sub Level 1	B.03 - Under Stage Area	Redundant power cable - Bitumen wrap - Well Bound Material	<0.25lm	NADIS	0	N/A

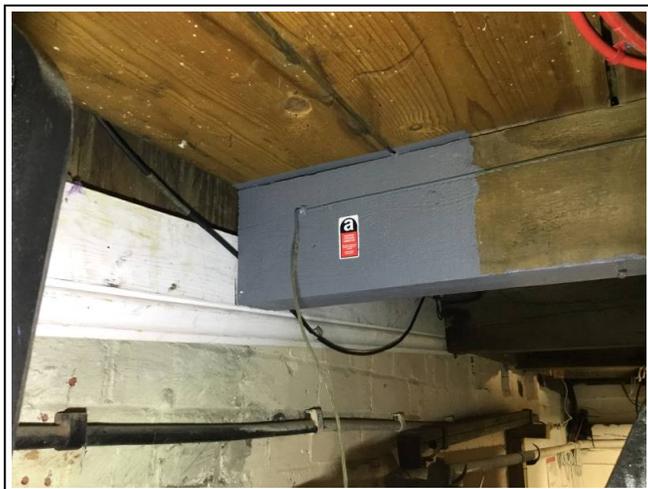
Survey Data Sheet: Conclusions & Recommendations  
 Site Location: Needl Hall, High Street, Chippenham, Wiltshire, SN15 3ER  
 Building Designation: Building 01  
 Unique item Number: 7

Sample Ref	FI	Location	Description	Qty	Analysis Result	Total M.A.S	Licensed Material Y/N
J4955 / AD6176	Z-Sub Level 1	B.03 - Under Stage Area	Timber joist under encapsulation paint and may occur further - Insulation residue - Asbestos Insulation/Coating	>0.25m <sup>2</sup>	Chrysotile + Amosite	7	Y

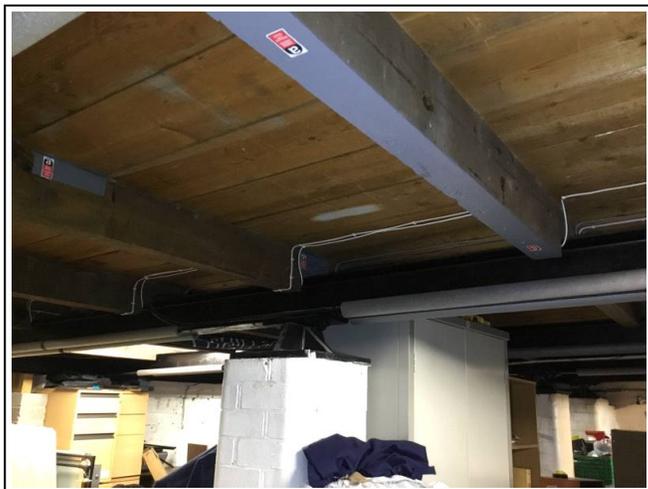
Survey Data Sheet: Conclusions & Recommendations  
 Site Location: Needl Hall, High Street, Chippenham, Wiltshire, SN15 3ER  
 Building Designation: Building 01  
 Unique item Number: 8

Sample Ref	Fl	Location	Description	Qty	Analysis Result	Total M.A.S	Licensed Material Y/N
J4955 / AD6177	Z-Sub Level 1	B.03 - Under Stage Area	Timber joists under encapsulation paint and may occur further - Insulating board residue - Insulating Board	>1lm	Chrysotile	4	Y

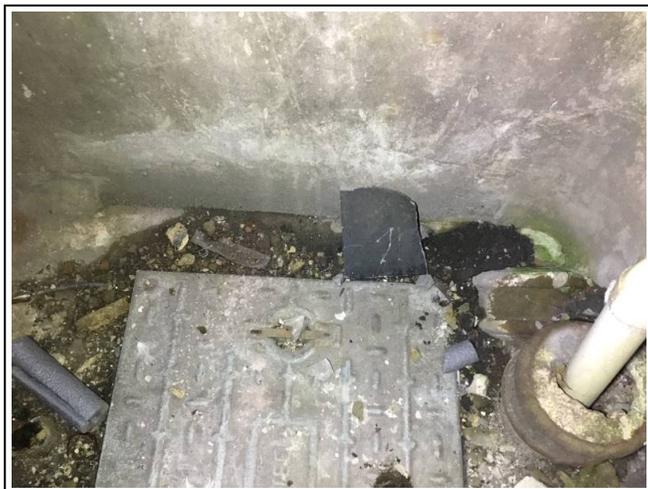
Sample Ref	Fl	Location	Description	Qty	Analysis Result	Total M.A.S	Licensed Material Y/N
CT004791	Ground Floor	G.05 - Service Riser	Floor - Debris - Cement	<0.25m <sup>2</sup>	NADIS	0	N/A

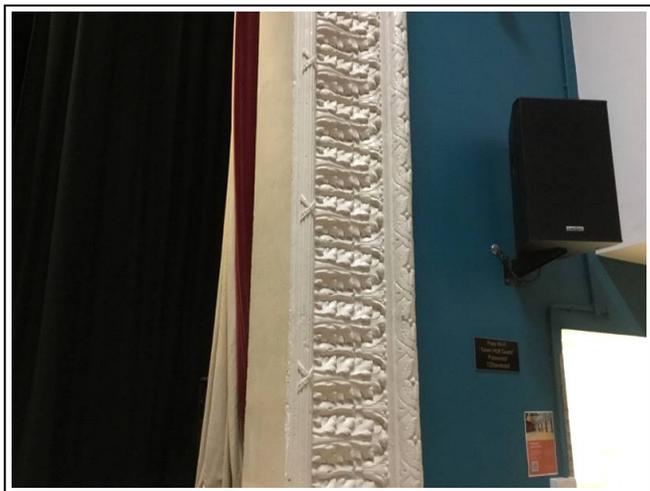
Sample Ref	FI	Location	Description	Qty	Analysis Result	Total M.A.S	Licensed Material Y/N
CT004784	Ground Floor	G.13 - Main Hall	Wall (surrounding stage) - Decorative plaster moulding - Textured Coating	16lm	NADIS	0	N/A

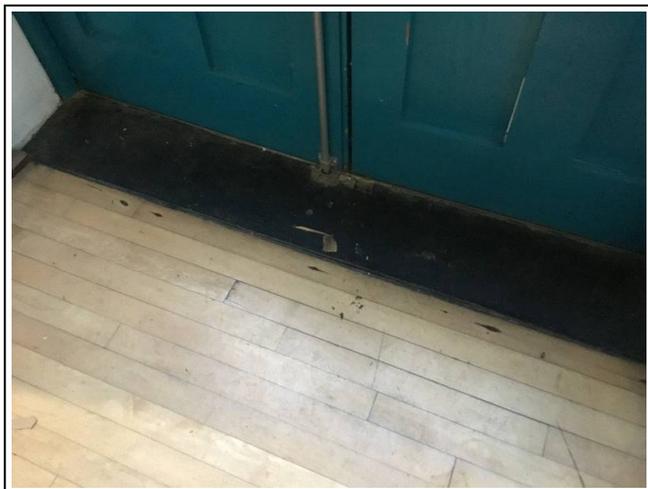
Sample Ref	FI	Location	Description	Qty	Analysis Result	Total M.A.S	Licensed Material Y/N
CT004785	Ground Floor	G.13 - Main Hall	Floor (external door thresholds) - Floor vinyl - Well Bound Material	4lm	NADIS	0	N/A

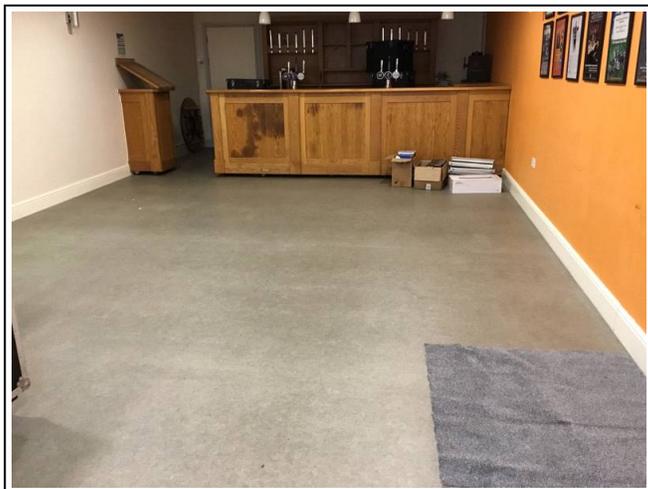
Sample Ref	FI	Location	Description	Qty	Analysis Result	Total M.A.S	Licensed Material Y/N
J4955 / AD6172	Ground Floor	G.18 - The Old Neeld Bar	Base of walls - Damp course - Well Bound Material	40lm	Chrysotile	2	N

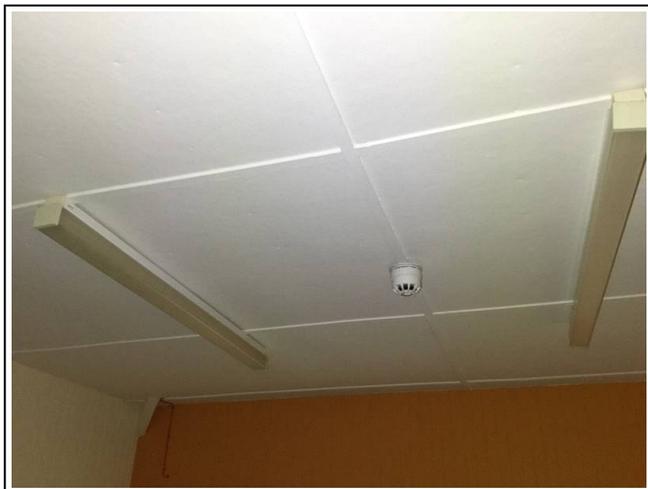
Sample Ref	Fl	Location	Description	Qty	Analysis Result	Total M.A.S	Licensed Material Y/N
CT004786	1st Floor	1.05 - Syndicate Room	Ceiling - Fibreboard panelling - Textiles/Paper	22m <sup>2</sup>	NADIS	0	N/A

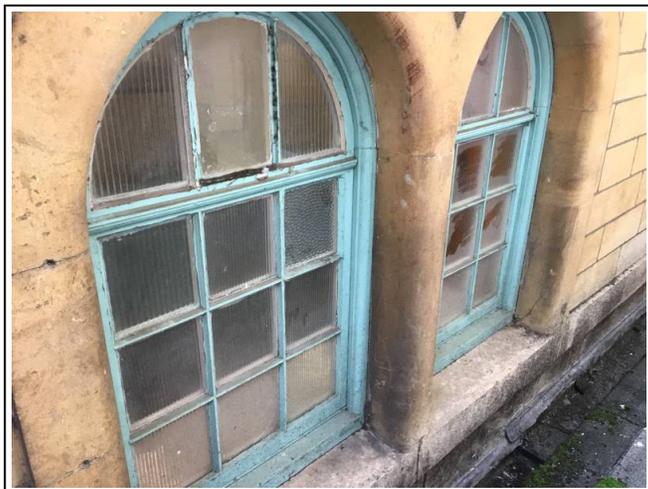
Sample Ref	FI	Location	Description	Qty	Analysis Result	Total M.A.S	Licensed Material Y/N
CT004787	External	External	Windows (rear of building) - Putty to glazing - Well Bound Material	32lm	NADIS	0	N/A

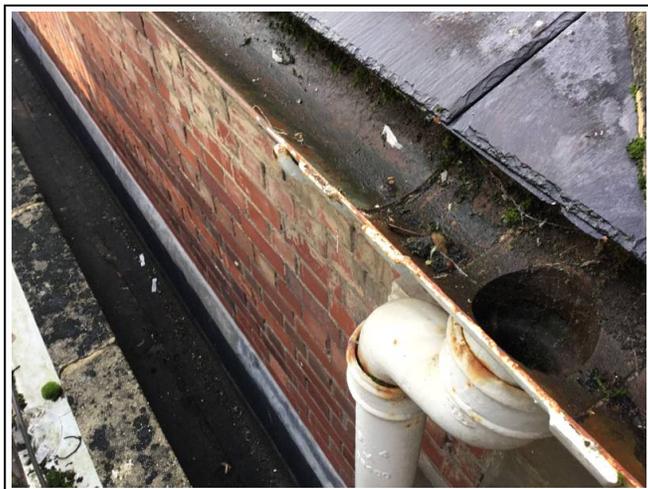
Sample Ref	FI	Location	Description	Qty	Analysis Result	Total M.A.S	Licensed Material Y/N
CT004788	External	External	Gutter joints - Mastic sealant - Well Bound Material	Throughout	NADIS	0	N/A

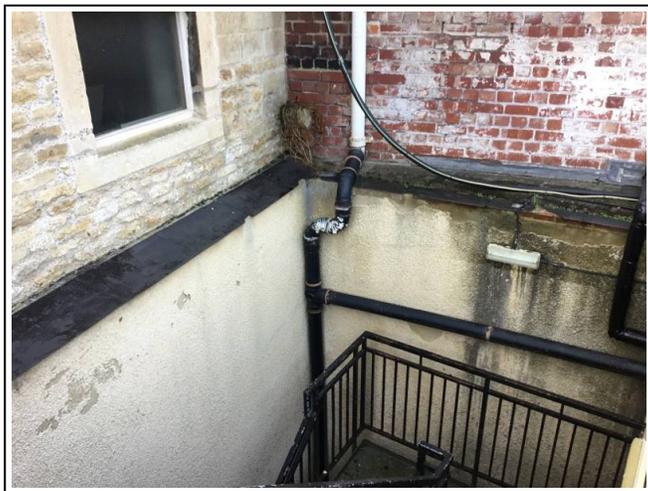
Sample Ref	FI	Location	Description	Qty	Analysis Result	Total M.A.S	Licensed Material Y/N
CT004813	External	External	Wall (courtyard) - Cement slates - Cement	8lm	NADIS	0	N/A

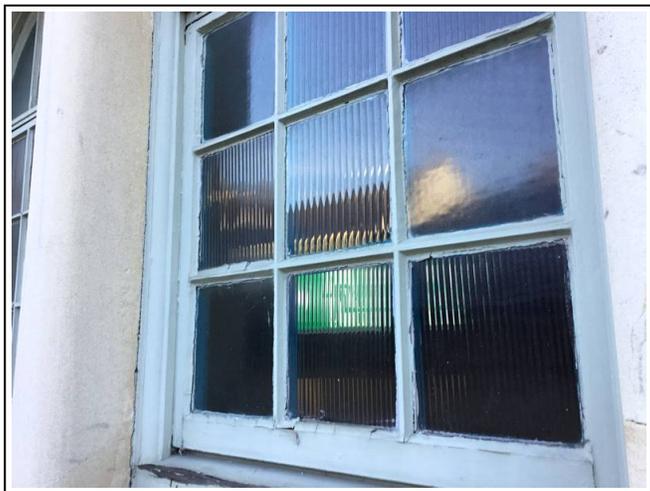
Sample Ref	FI	Location	Description	Qty	Analysis Result	Total M.A.S	Licensed Material Y/N
CT004819	External	External	Windows and doors (side of building) - Putty to glazing - Well Bound Material	60lm	NADIS	0	N/A

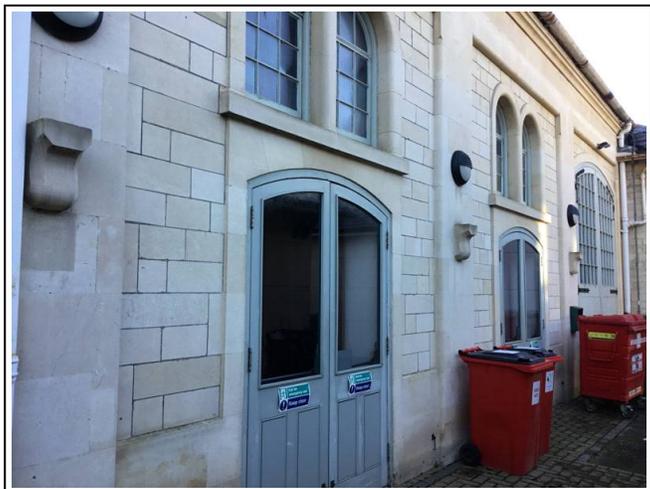
Sample Ref	FI	Location	Description	Qty	Analysis Result	Total M.A.S	Licensed Material Y/N
CT004820	External	External	Window & door frames - Mastic sealant - Well Bound Material	30lm	Chrysotile	2	N

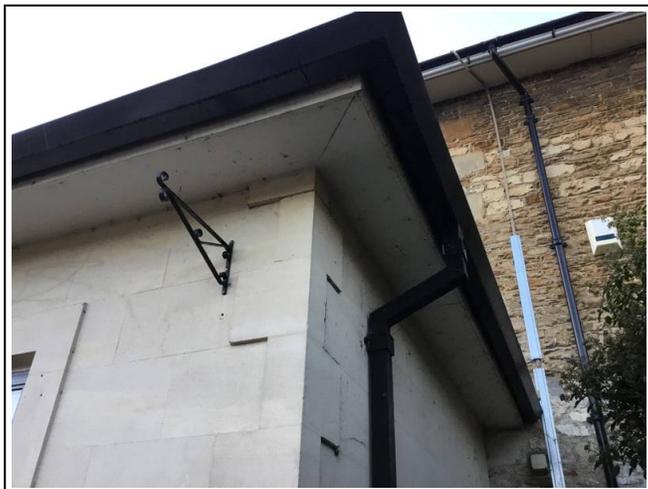
Sample Ref	FI	Location	Description	Qty	Analysis Result	Total M.A.S	Licensed Material Y/N
CT004837	External	External	Roof (Neeld Hall Foyer) - Soffit - Cement	30lm	NADIS	0	N/A
