EXTERNAL WINDOW AND DOOR CONDITION REPORT

SHIRE HALL, WOODBRIDGE, SUFFOLK

Inspecting Architect: Philip Orchard

PEO/Pra/cm/S7303
17th December 2024

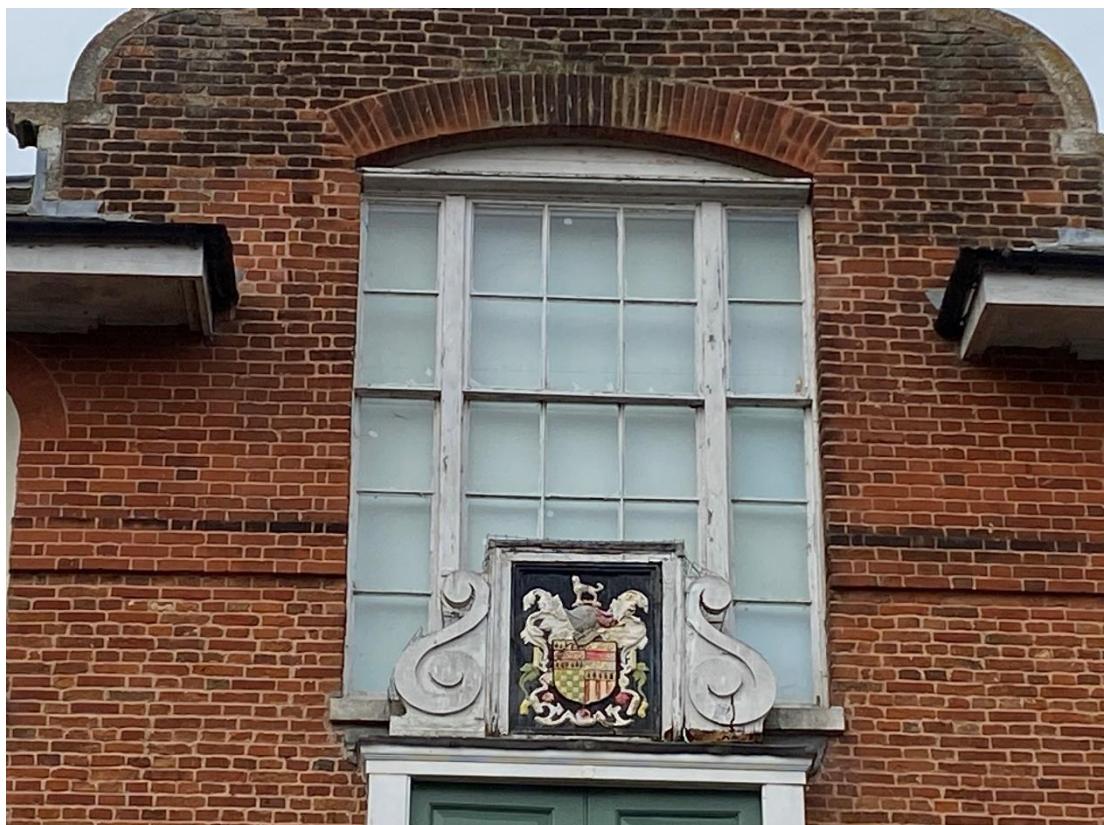
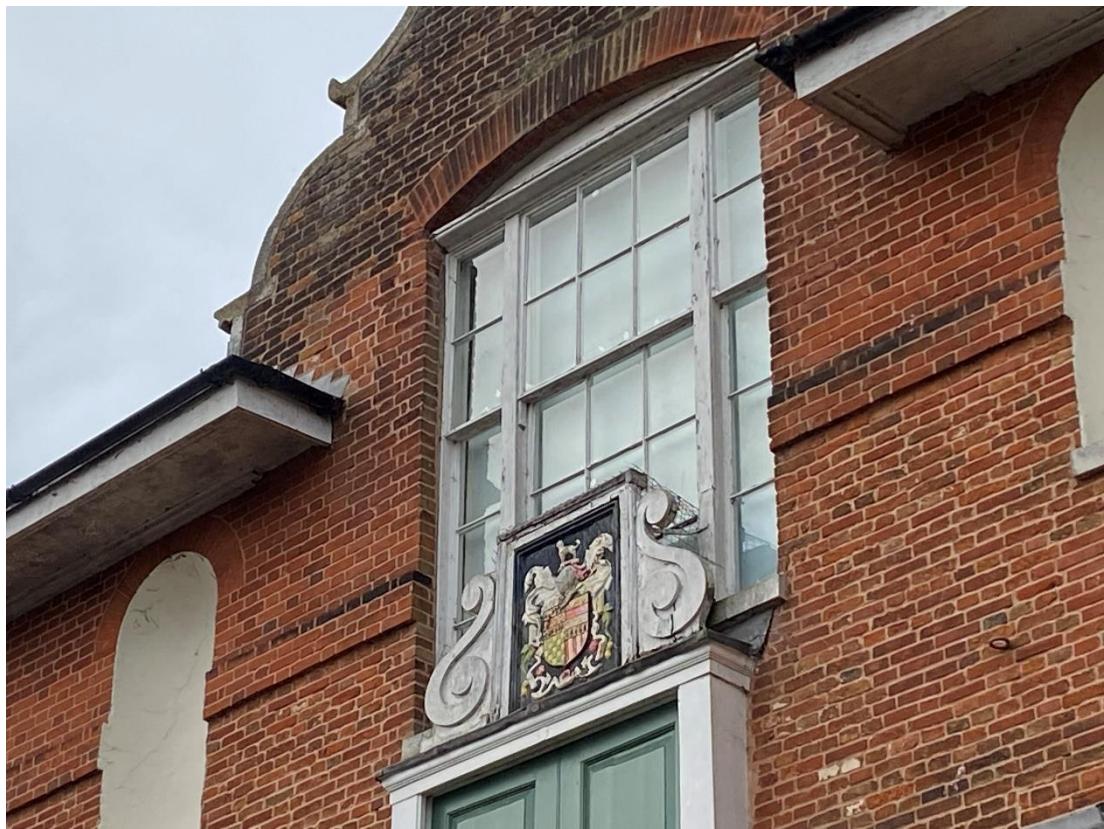
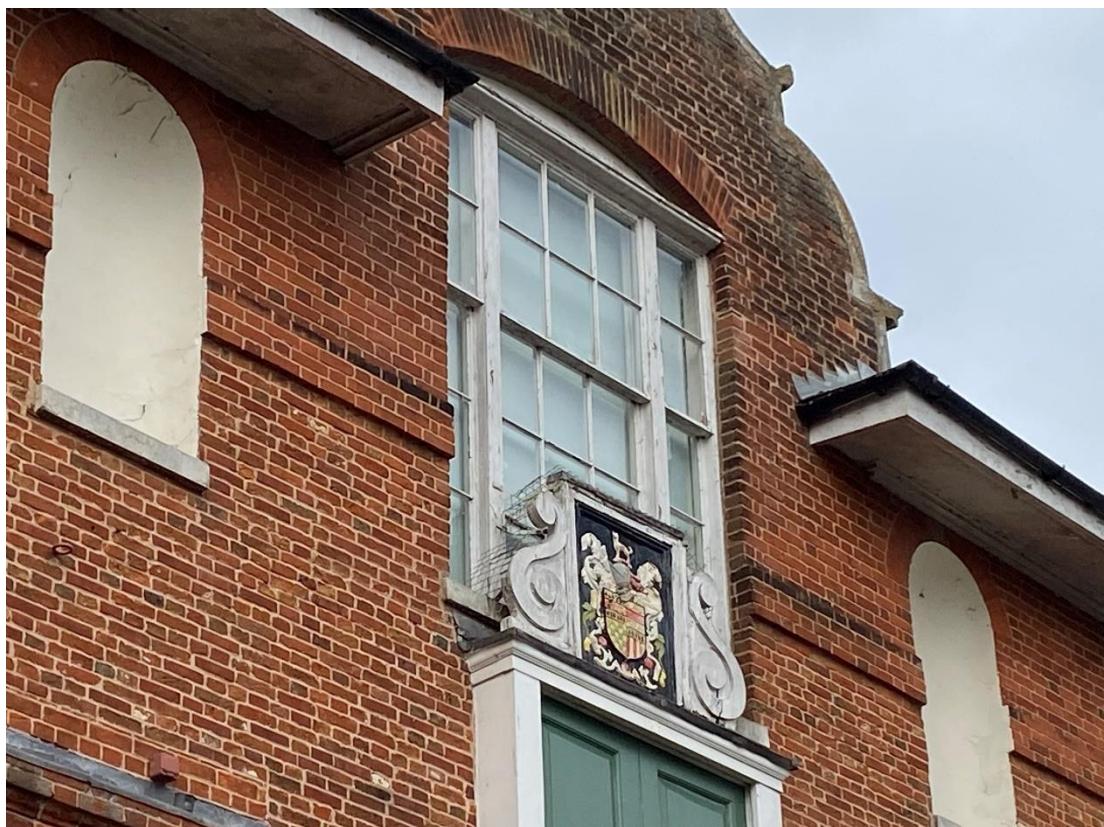
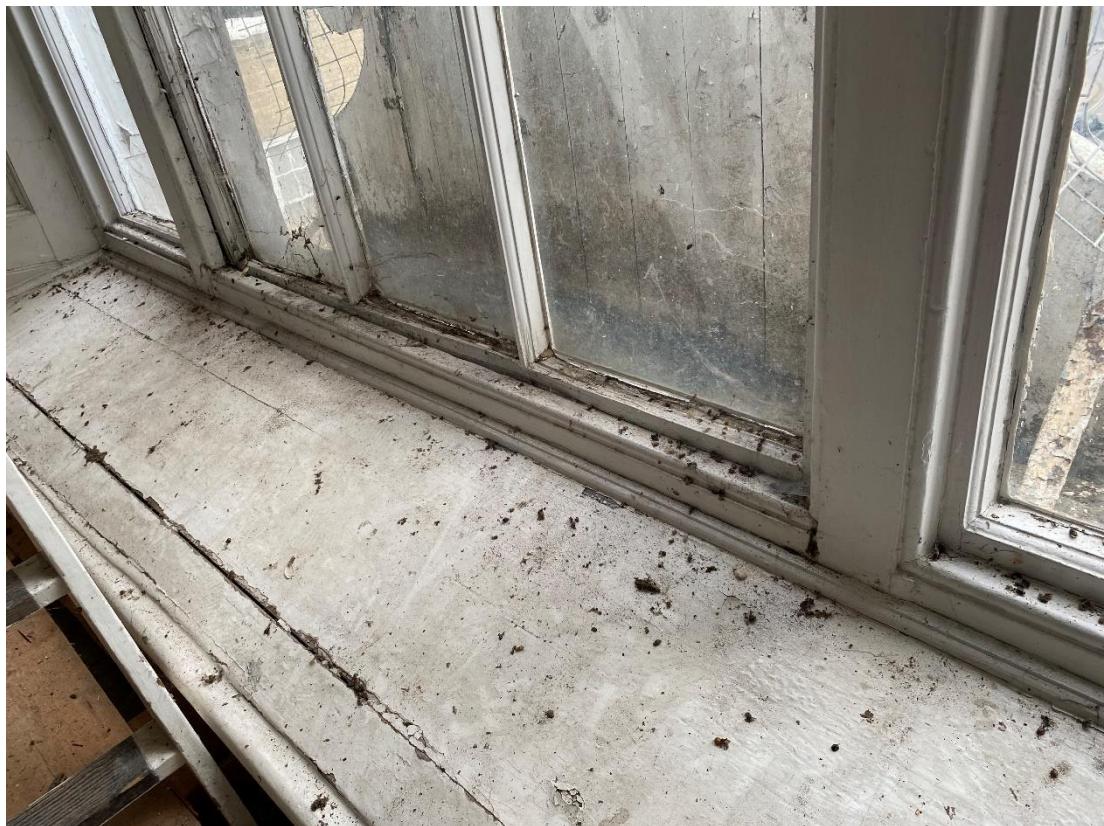
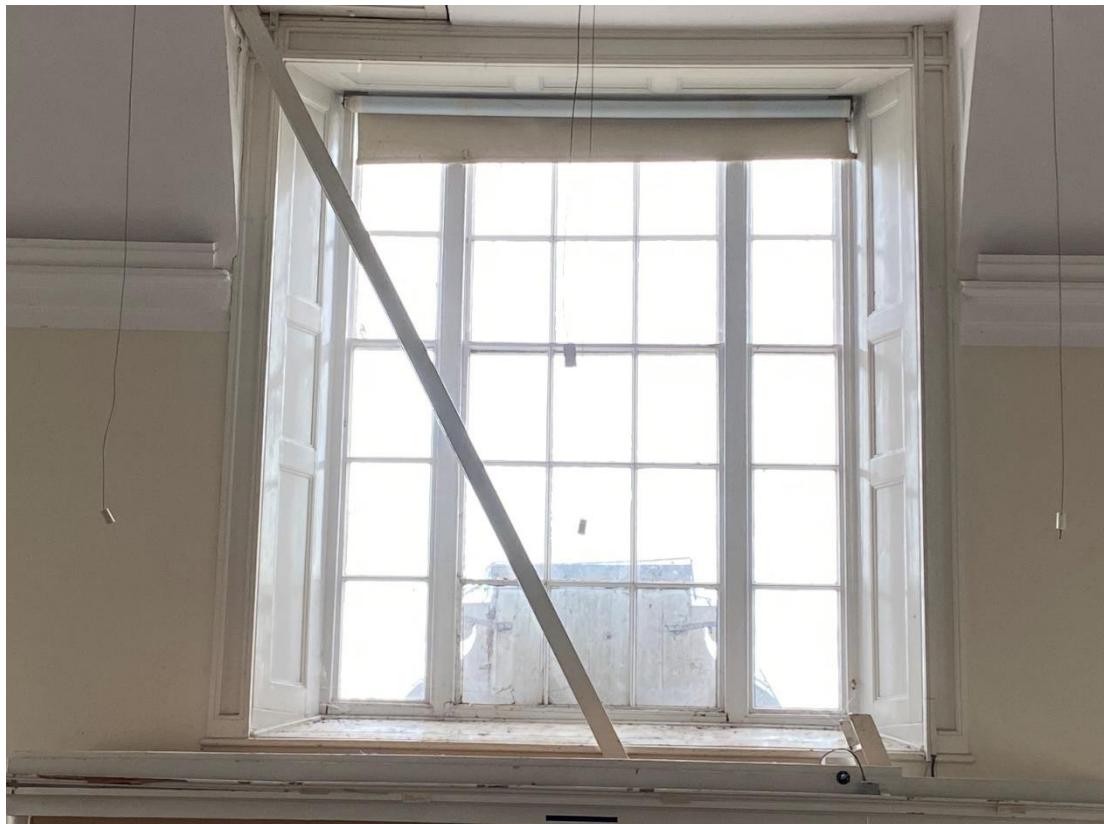
Condition: seen from ground level there is no obvious sign of timber decay, but the putty is in poor order and the finishes generally are in poor condition. General stripping down to bare wood will be needed in view of the degree of paint failure and the exposure of this window. Ideally, the coat of arms should be removed and refixed for access but the condition of the coat of arms, as seen from ground level, suggests that this might bring forward a need for repairs and conservation to that. Internal viewing shows that the central sash lower rail is decayed and needs to be renewed; the bottom rails of the two fixed lights are suspect. The timber sill cannot be clearly seen: provisionally allow for renewal. Allow for additional repairs where joints between glazing bars and the sashes may have decayed higher up. The sash cords should be checked and overhauled. Clean out pigeon guano from the sill behind the coat of arms.

2.1 Window W01 from east

Repairs recommended: repair sashes, strip and repaint, overhaul sash cords, clean out guano.

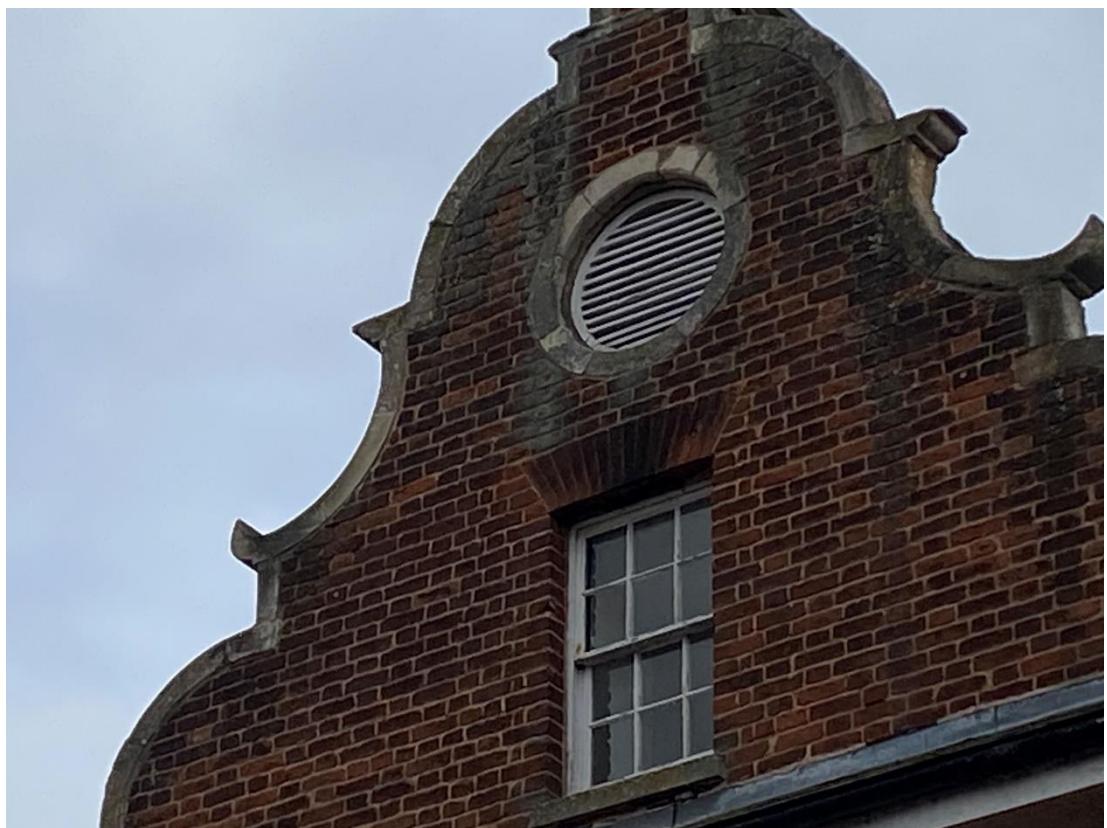
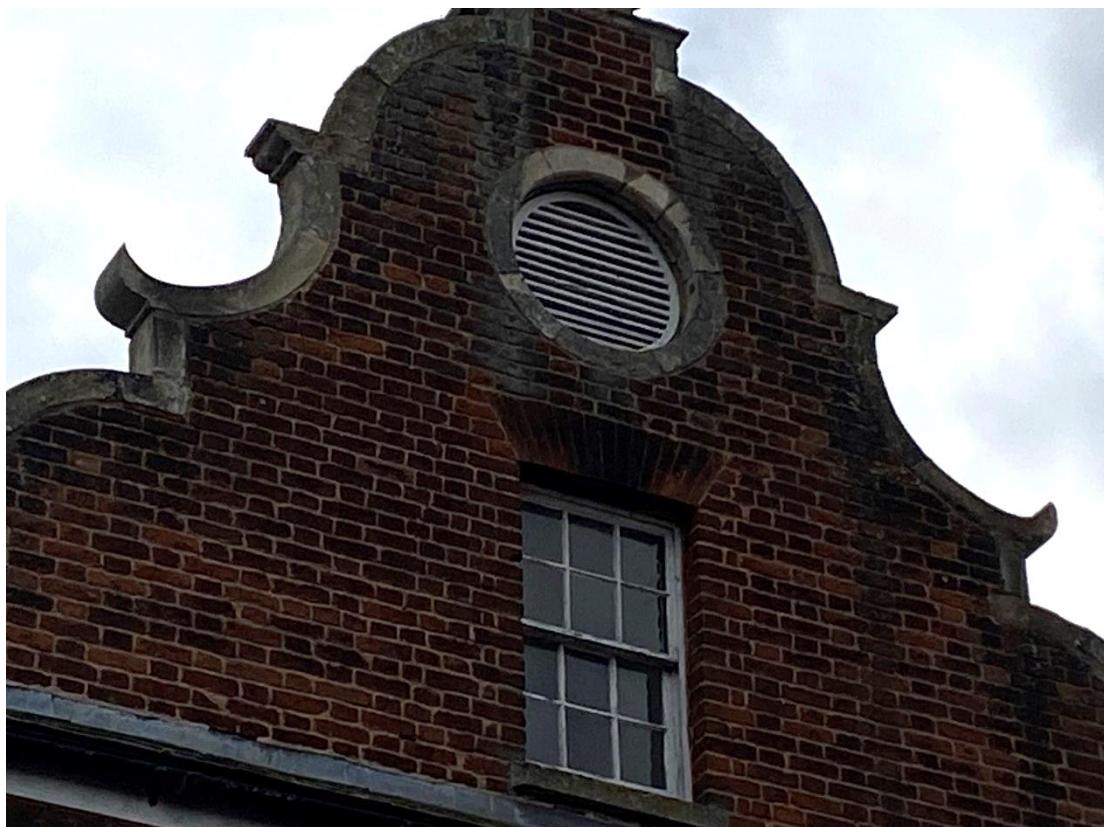
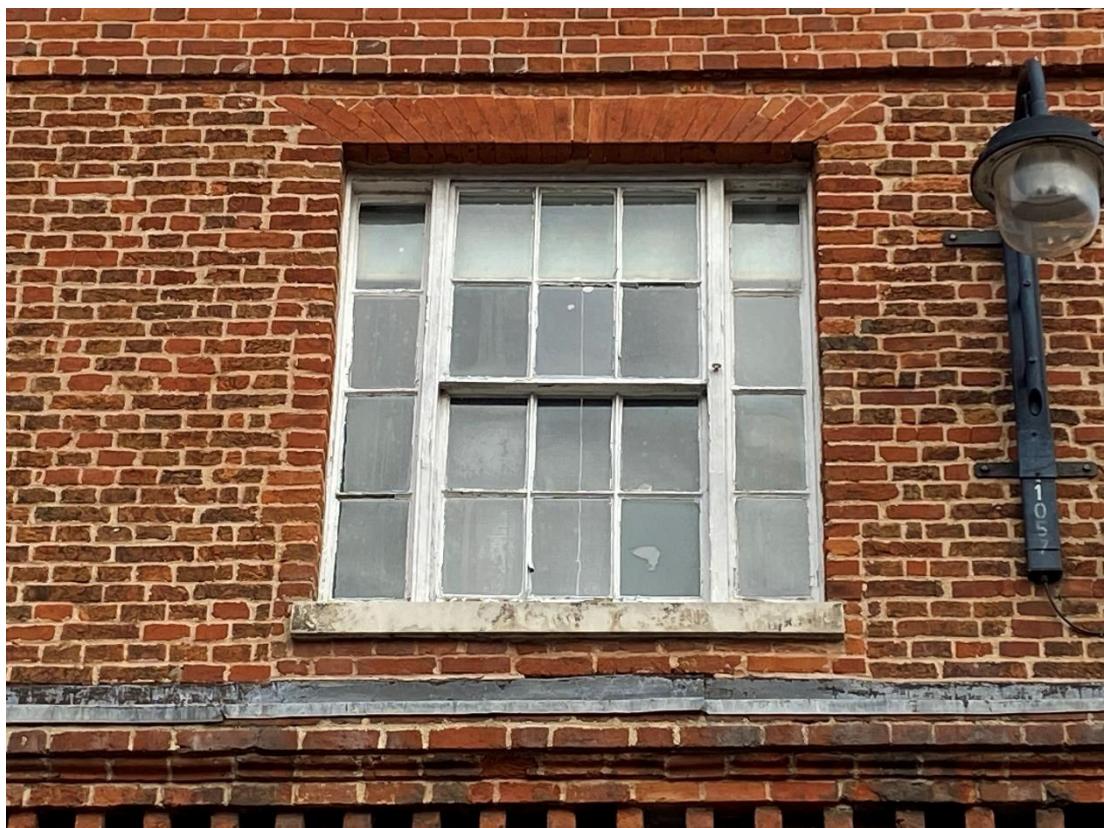
Condition: the lower corners of the upper sash have been reinforced with steel brackets which are now rusting. The bottom rail of the lower sash is badly decayed, particularly at the north end. The timber sill has lost its paint and, as seen from ground level, there appears to be decay at the north end: allow for renewal subject to external access. The paint finishes and approximately 50% of the putty are in poor order: the window needs redecorating and remaking of the putty outside. Junction of lower sash horizontal glazing bar with vertical bars misaligned: stiffen/realign.

Condition: from ground level it is difficult to tell whether the louvres are all in sound order: paint finishes are in poor condition, particularly on the frame in the lower parts. General redecoration will be needed, together with allowances for renewal of defective louvre blades. There were no signs of birds entering or leaving through this opening at the time of the inspection, suggesting that the blades are sufficiently closely spaced or mesh backing is adequate to exclude birds. Include allowance.

2.3, 2.3 Windows W05 and W05A from south west

Repairs recommended: repair, repaint.

Repairs recommended: repaint in association with window W05.

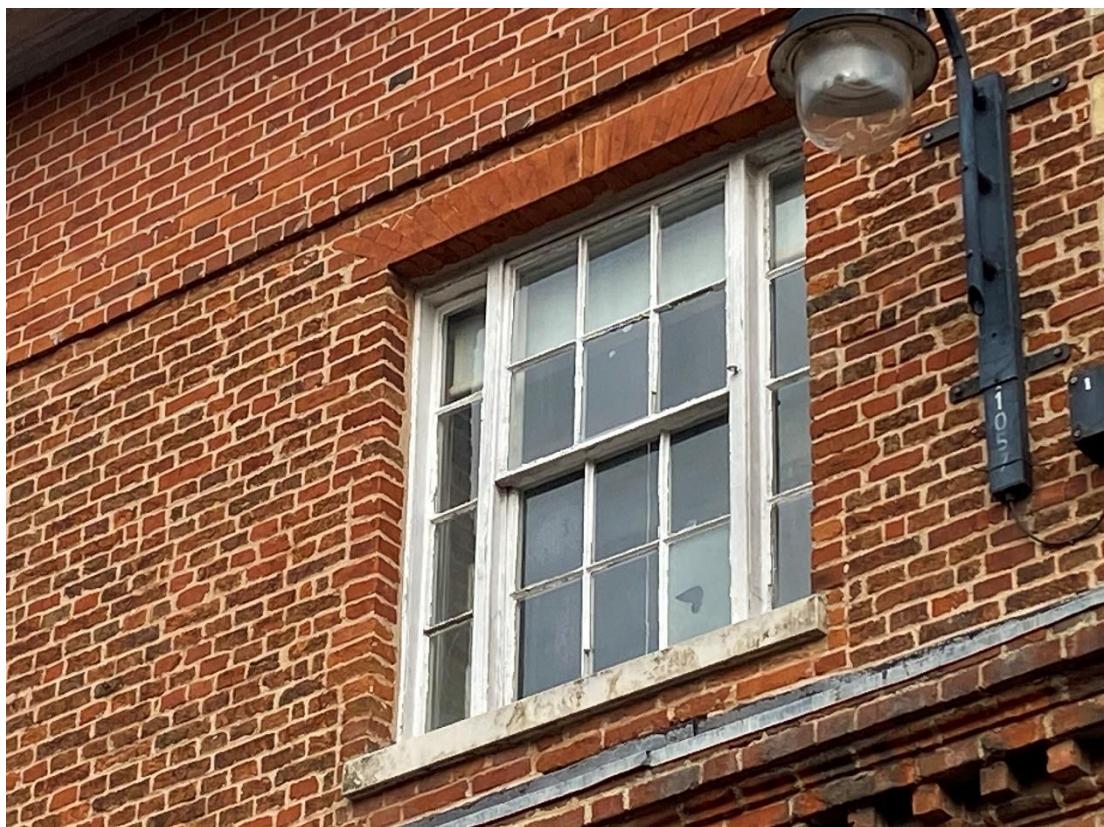
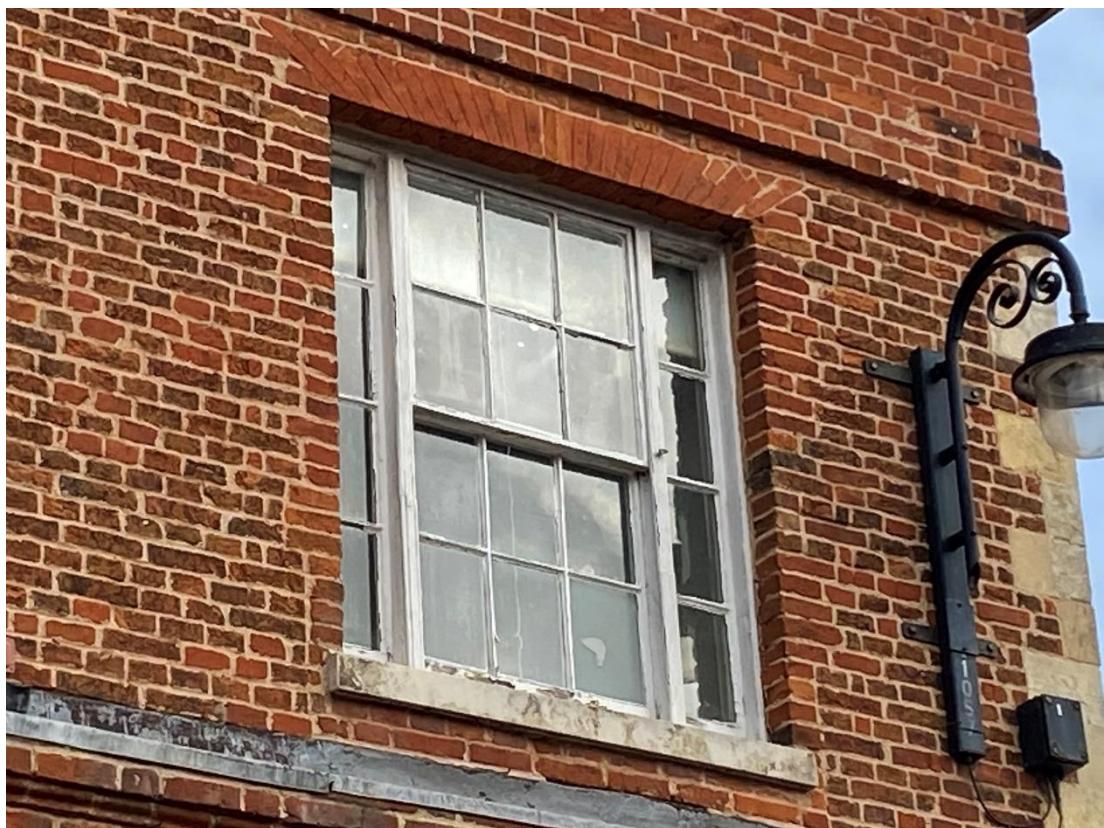
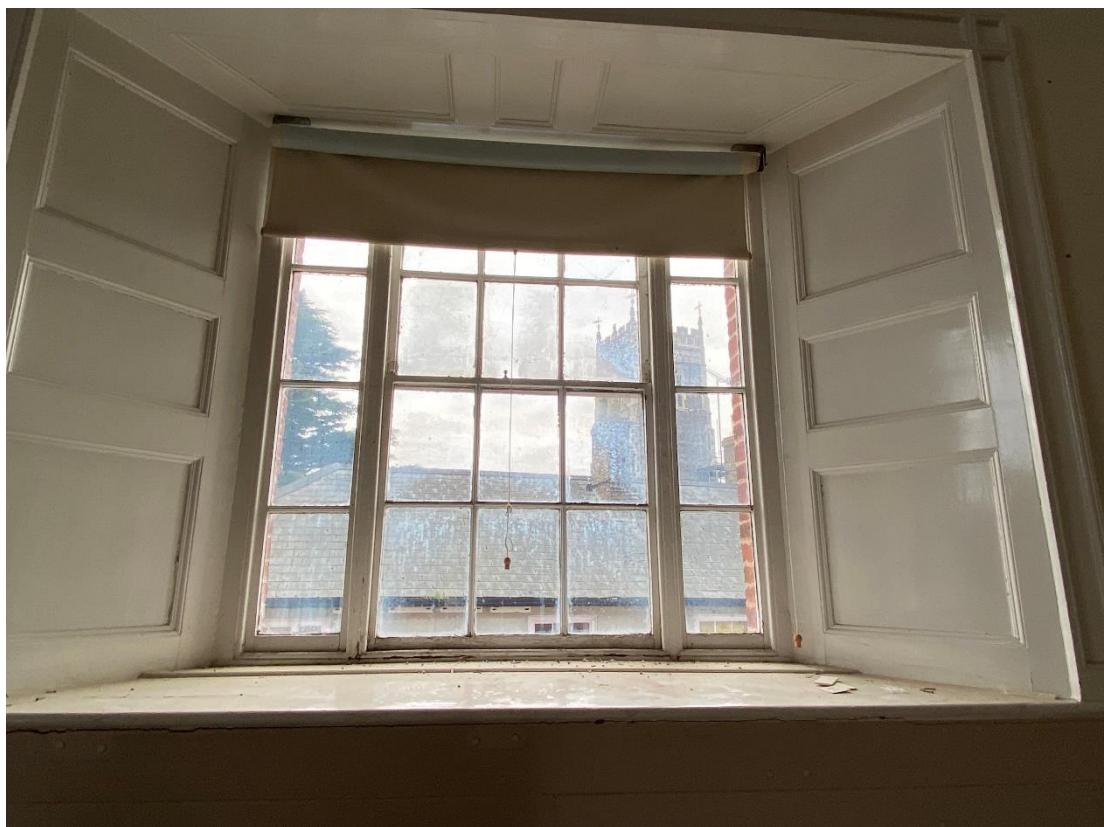
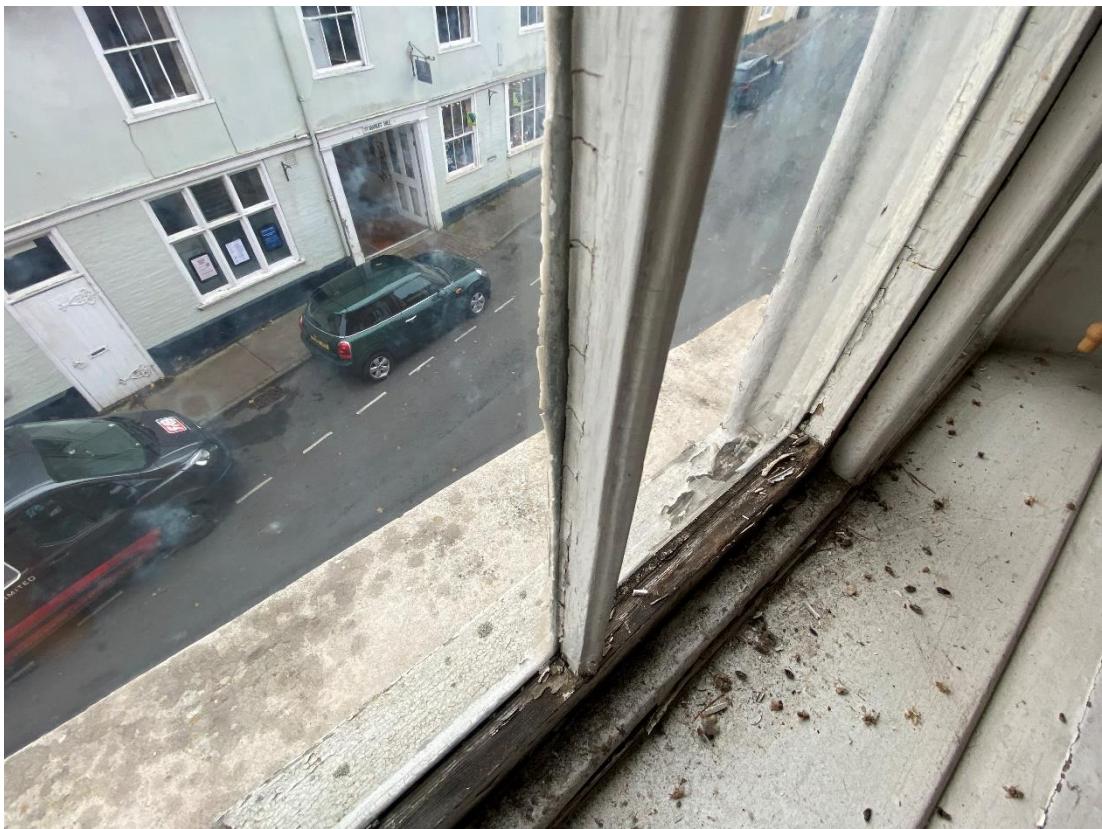
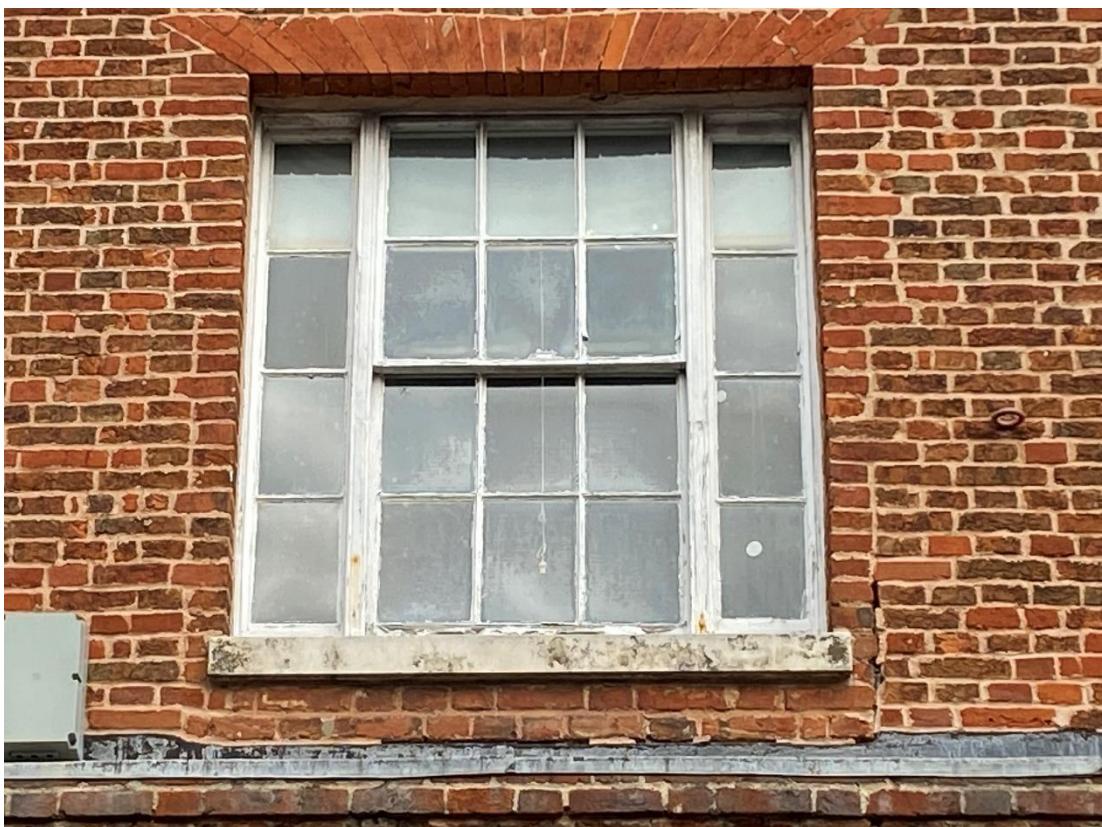
Condition: condition of putty is poor with parts missing and loose. The paint finishes generally are very poor with loss back to the timber in places. General re-puttying and repainting needed outside. Minor decay to mullion bead of central sash, west side at foot inside requires repair. External viewing was restricted but the poor state of the paintwork suggests that the bottom rails of all three sashes may need to be renewed. Allow provisionally to renew the timber sill also.

3.1 Window W02

Repairs recommended: repair timberwork, renew putty, redecorate.

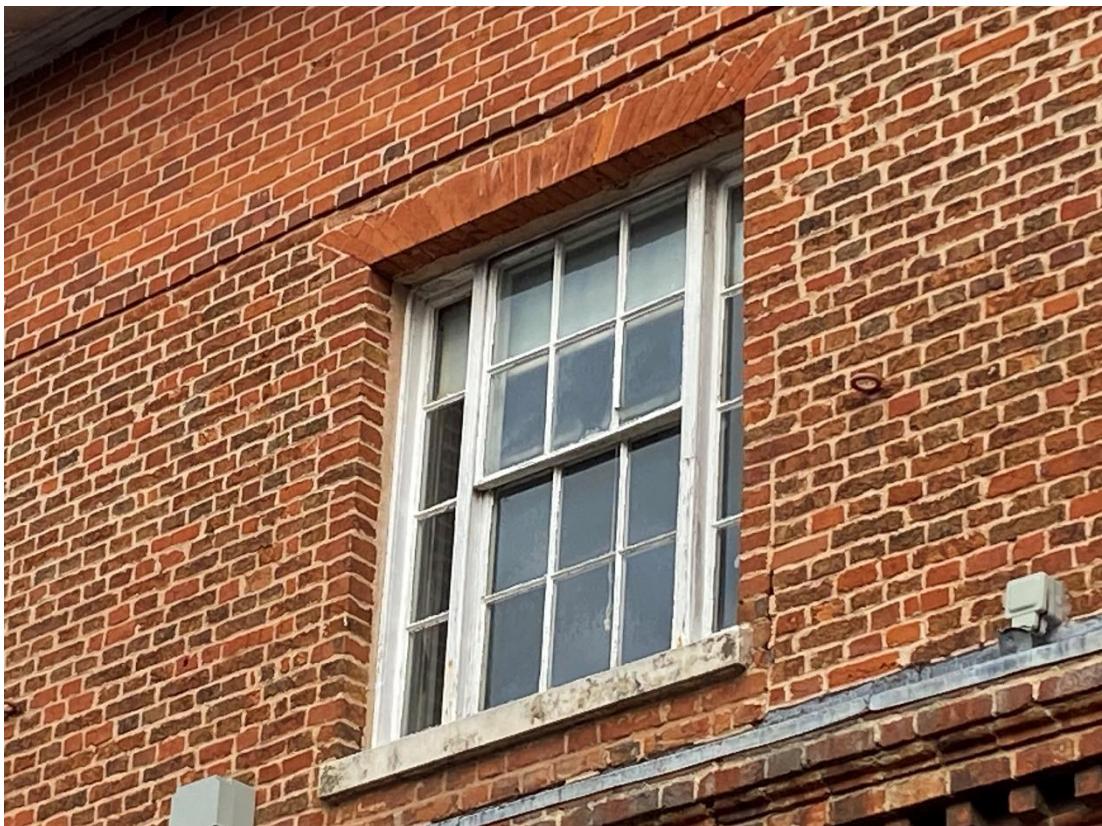
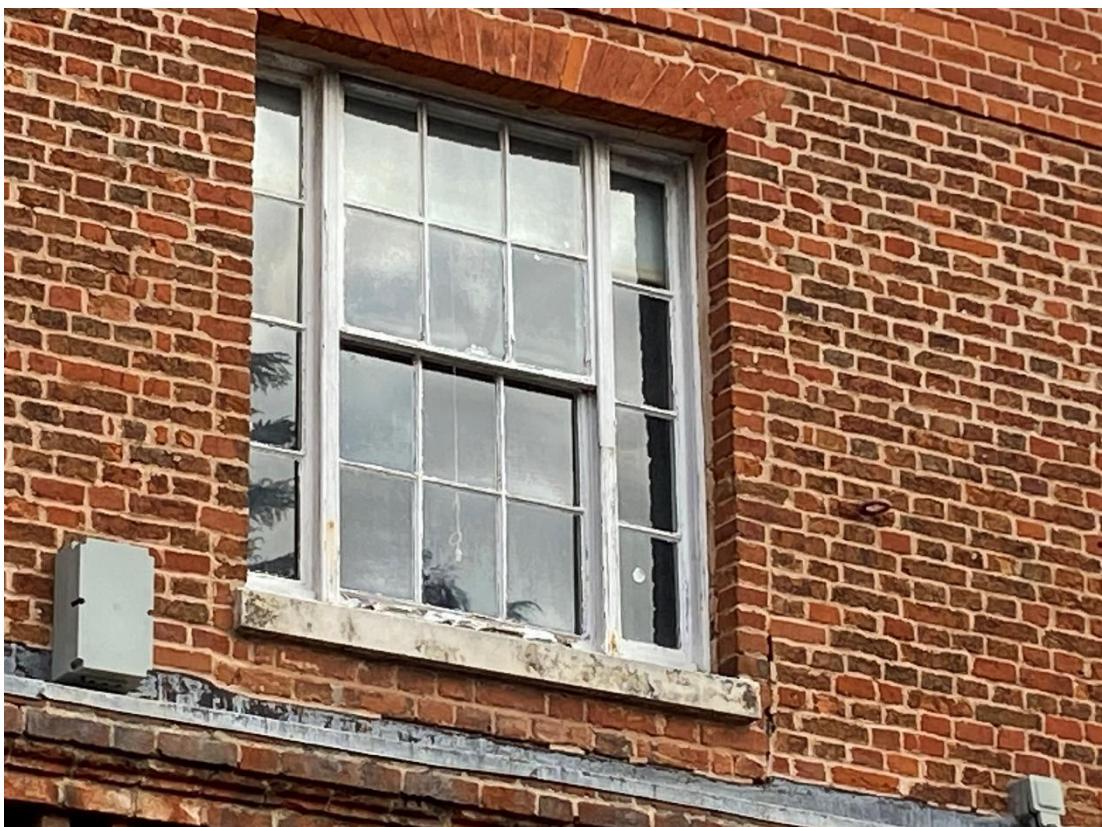
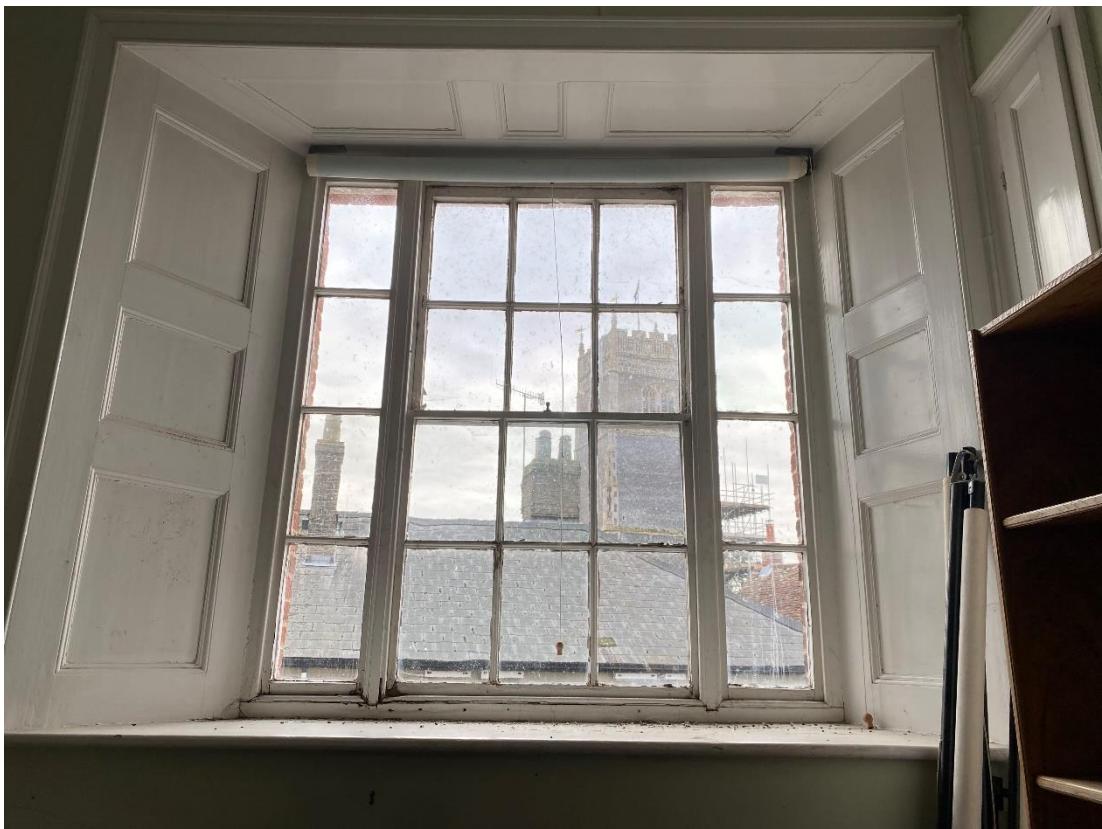
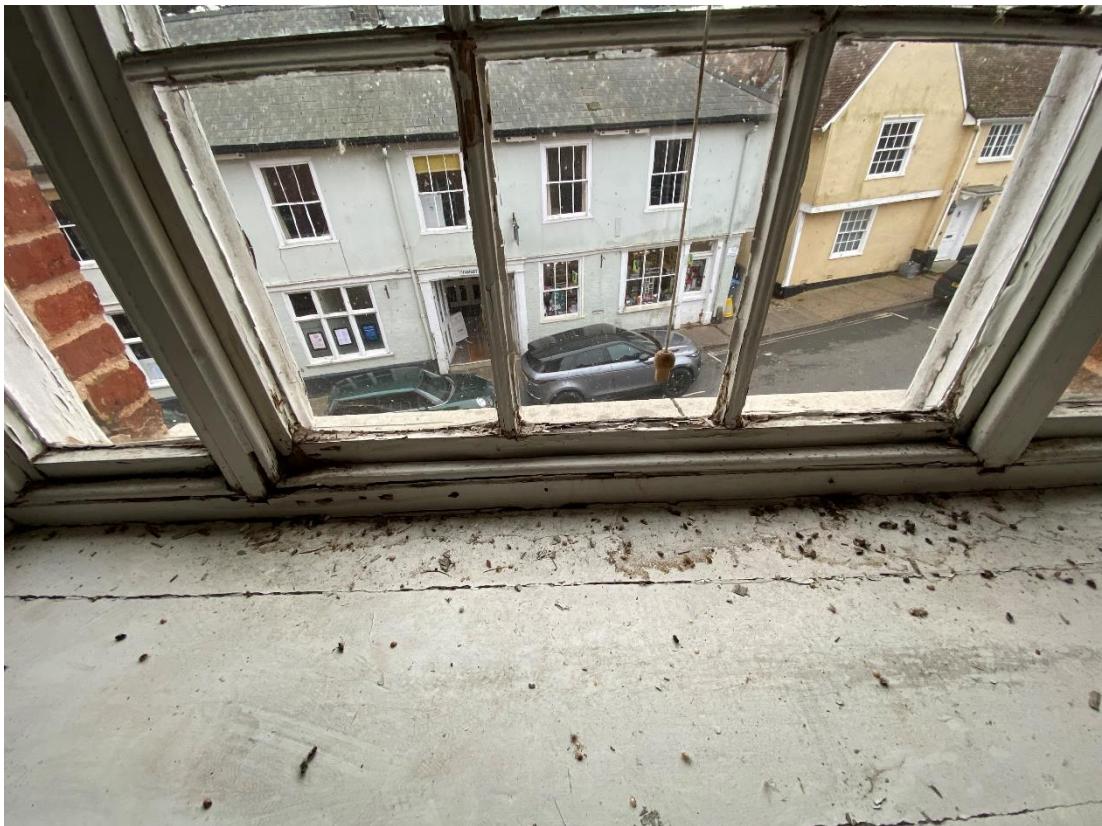
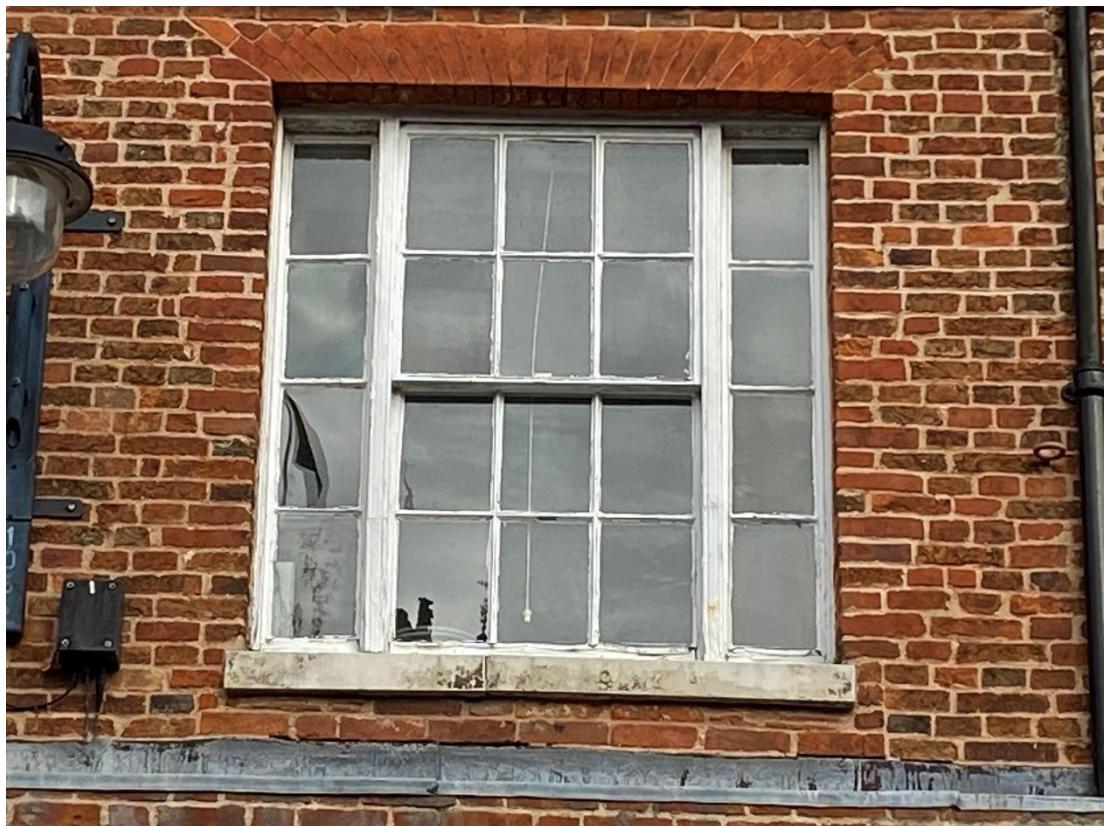
Condition: condition of putty is poor with parts missing and loose. The paint finishes generally are very poor with loss back to the timber in places. General re-puttying and repainting needed outside. Central sash inner sill may need shaving down and planting on of timber where decayed. External viewing was restricted but the poor state of the paintwork suggests that the bottom rails of all three sashes may need to be renewed. Allow provisionally to renew the timber sill also. There is potential decay to both mullions at the foot outside.

3.2 Window W03

Repairs recommended: repair timberwork, redecorate.

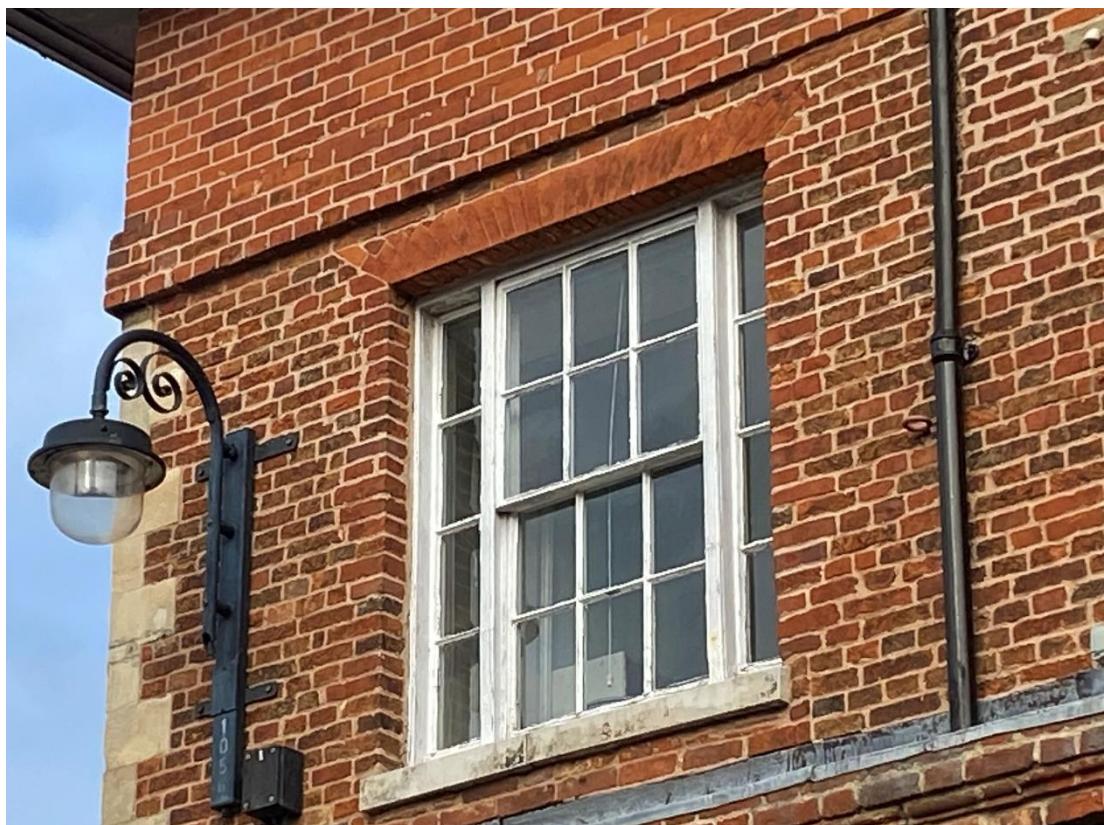
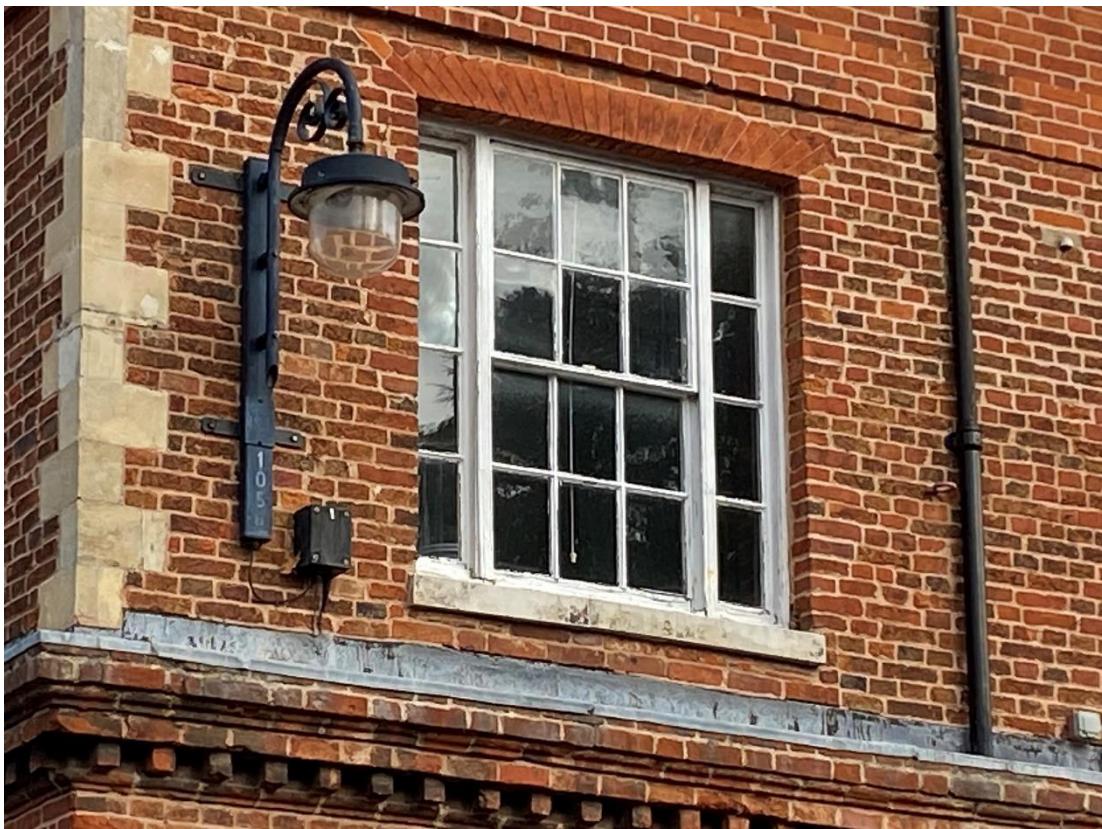
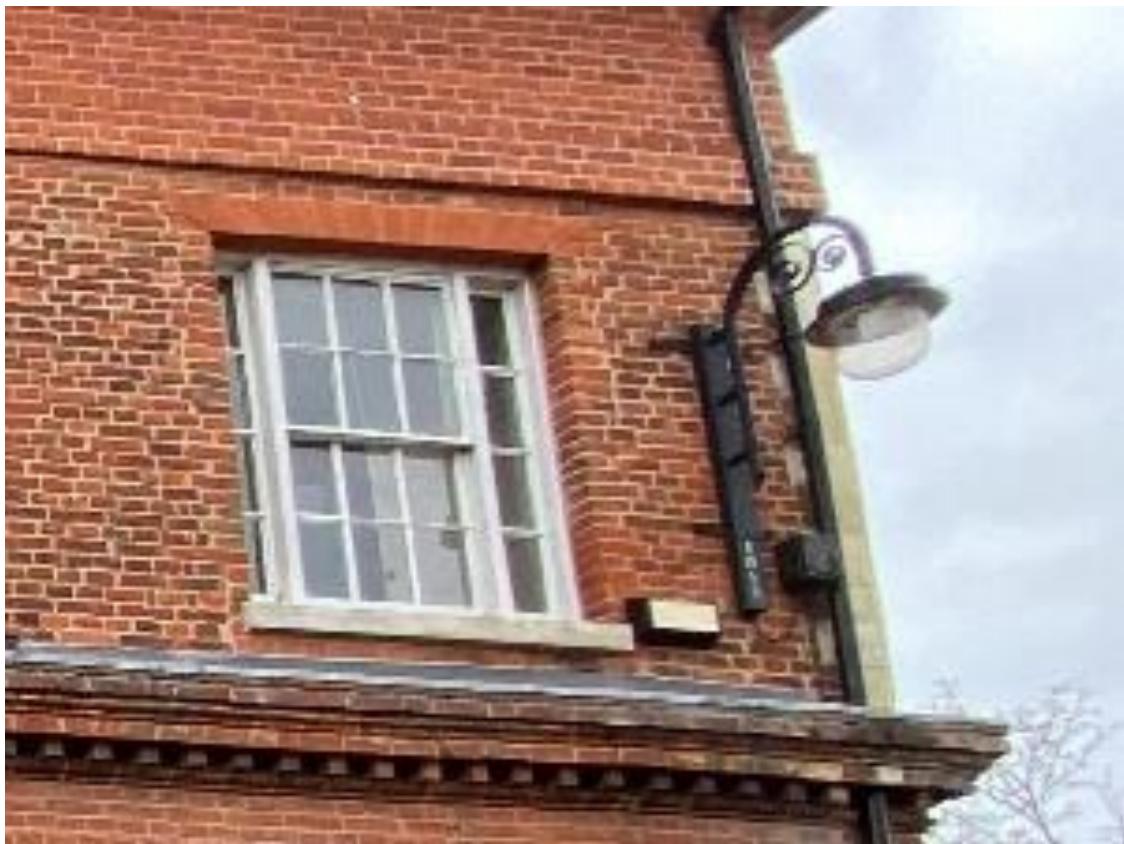
Condition: the sill is badly decayed: renew. Bottom rail of central sash: renew, including feet of stiles and glazing bars. Outer sashes: renew bottom rails and stiles, renew inner glazing beads and feet of mullion beads. Feet of mullions and jambs suspect: scarf on new ends. Condition of putty is poor with parts missing and loose. The paint finishes generally are very poor with loss back to the timber in places. General re-puttying and repainting needed outside. There are no sash cords or sash pulleys.

3.3 Window W04

Repairs recommended: repair timberwork, renew putty, redecorate.

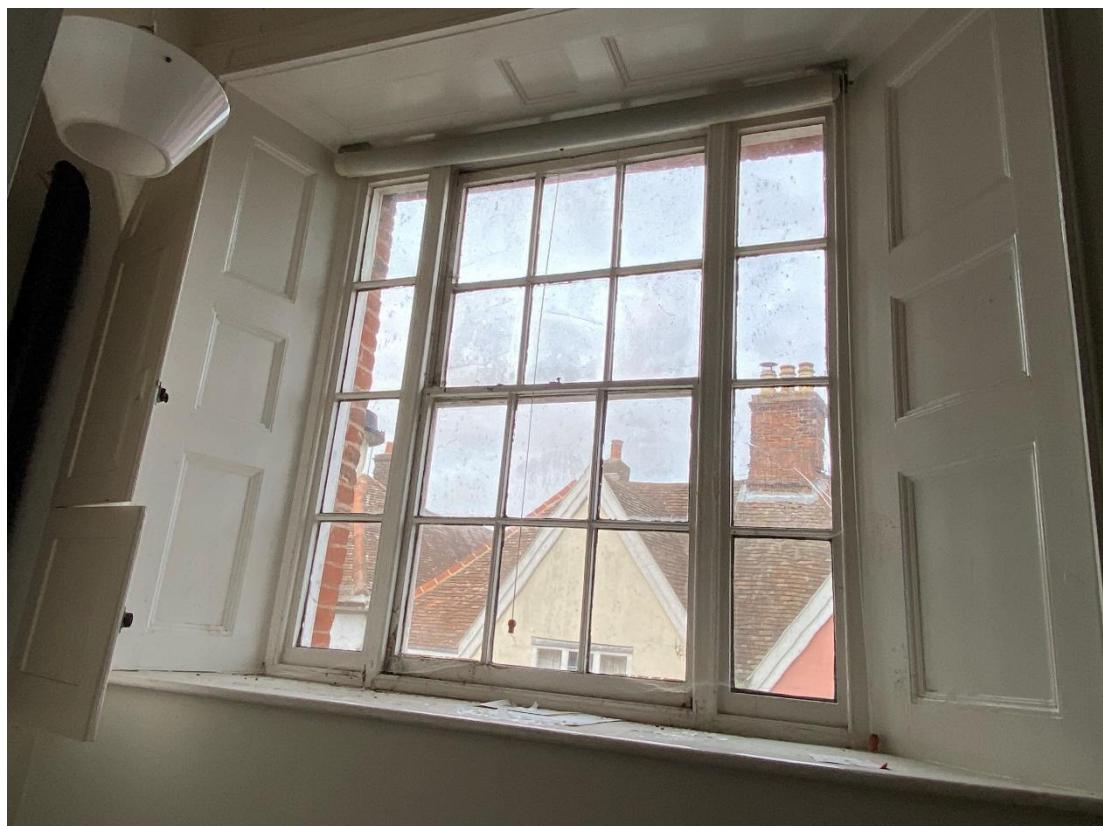
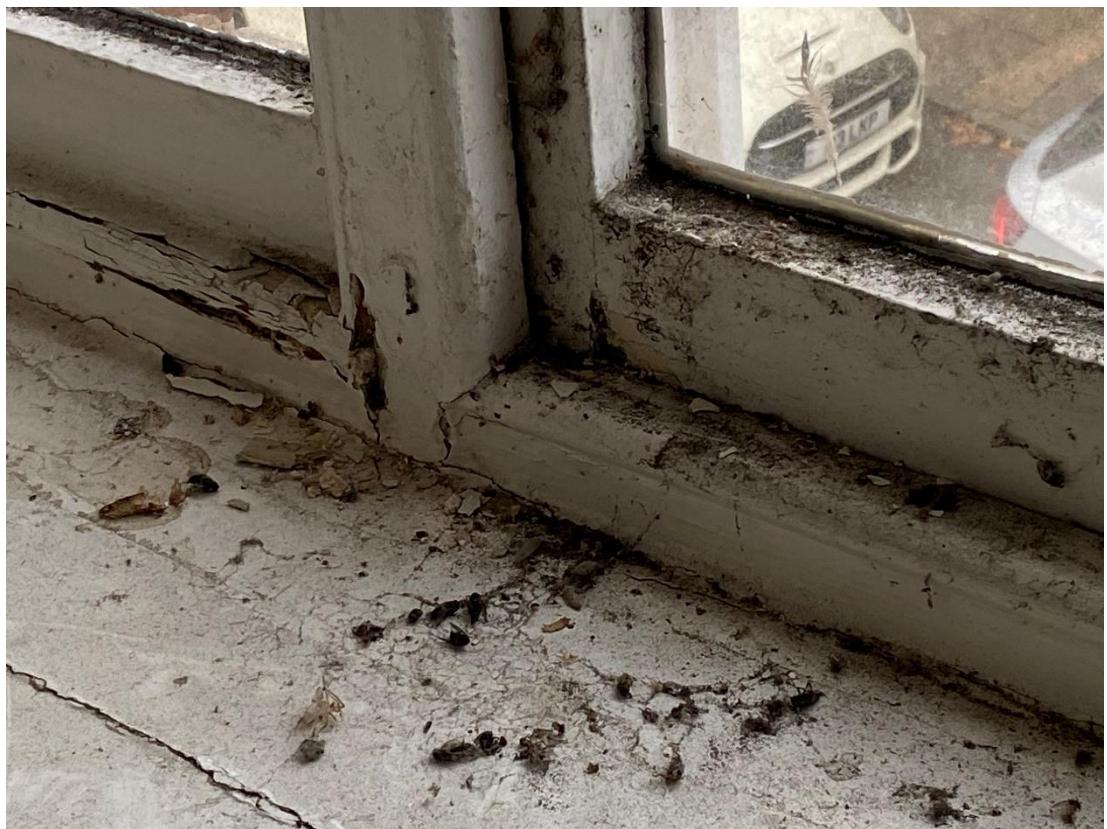
Condition: condition of putty is poor with parts missing and loose. The paint finishes generally are very poor with loss back to the timber in places. General re-puttying and repainting needed. The stone sill is cracked under the west fixed light. The engineer's reports will comment on past movement in this area but if all is stable the joints should be grouted up.

3.4 Window W06

Repairs recommended: reputty, redecorate.
