EXTERNAL WINDOW AND DOOR CONDITION REPORT

SHIRE HALL, WOODBRIDGE, SUFFOLK

Inspecting Architect: Philip Orchard

PEO/Pra/cm/S7303
17th December 2024

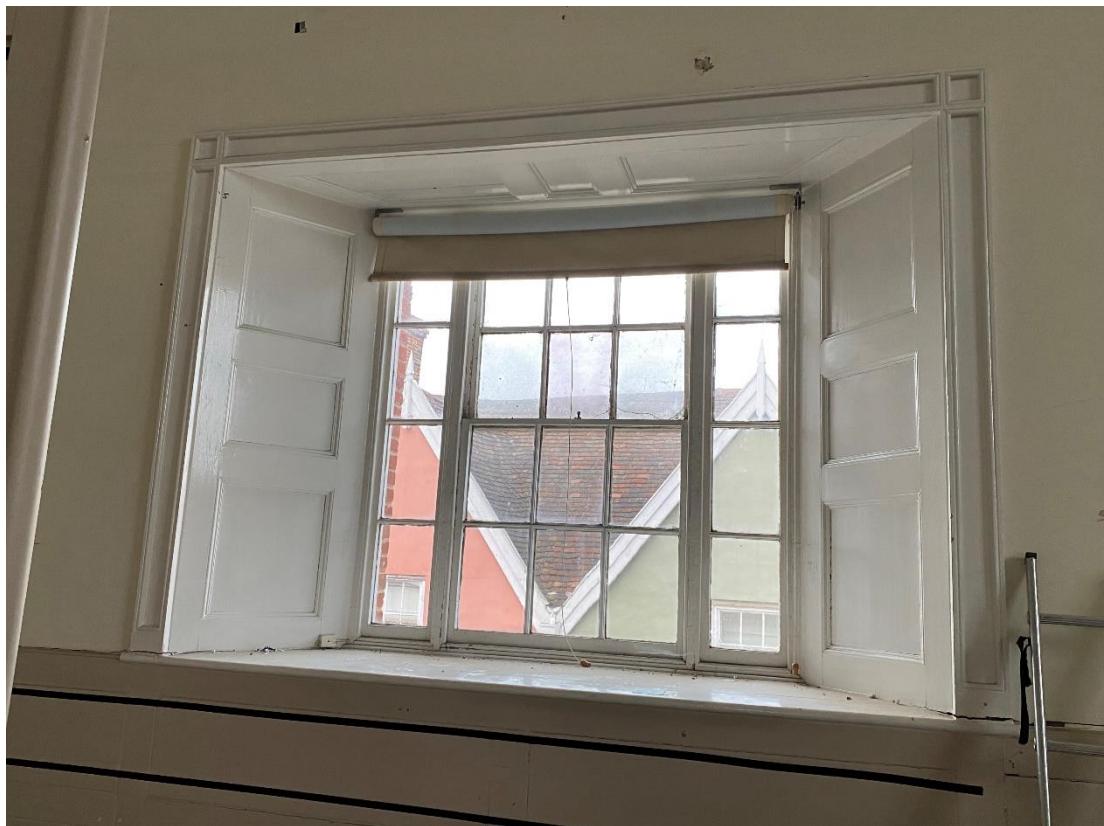
Condition: condition of putty is poor with parts missing and loose. The paint finishes generally are very poor with loss back to the timber in places. General re-puttying and repainting needed. The stone sill is cracked under the west fixed light. The engineer's reports will comment on past movement in this area but if all is stable the joints should be grouted up. Potential decay of the lower sash west jamb foot. Possible decay of sill under the central sash and under the west light. Provisionally renew the sill and the foot of the west mullion.

3.5 Window W07

Repairs recommended: repair timberwork, reputty, redecorate.

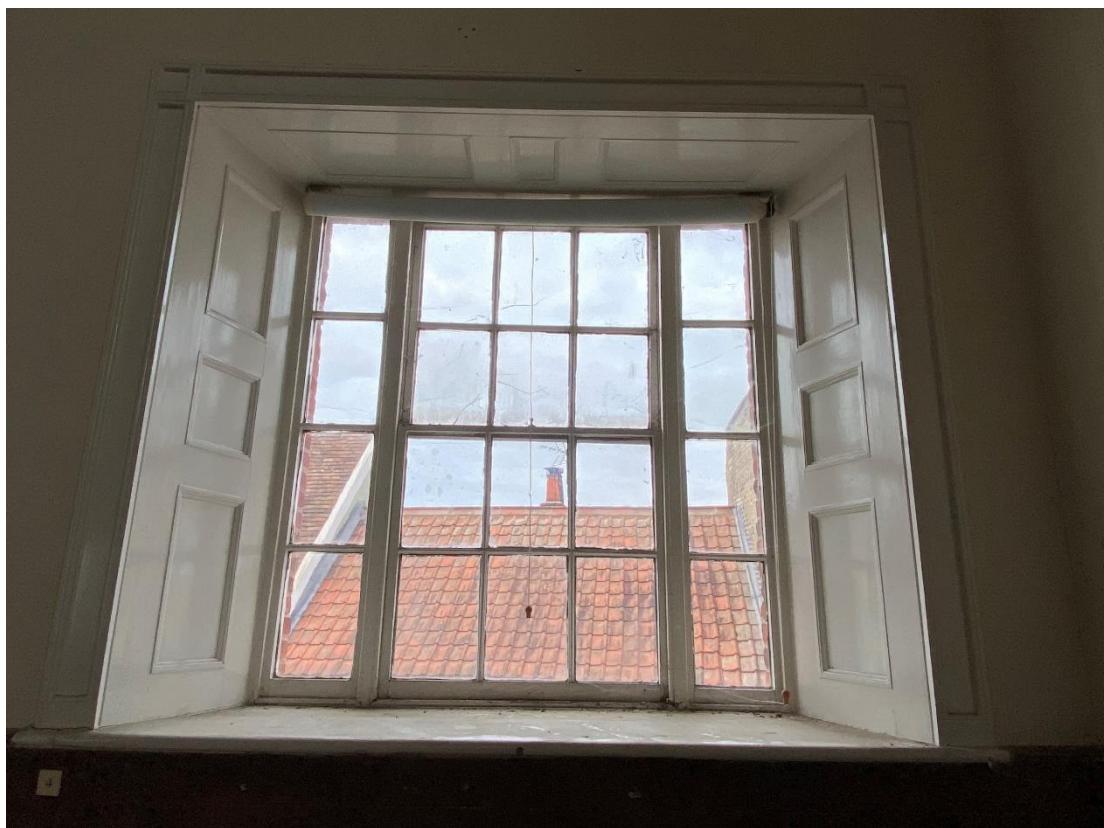
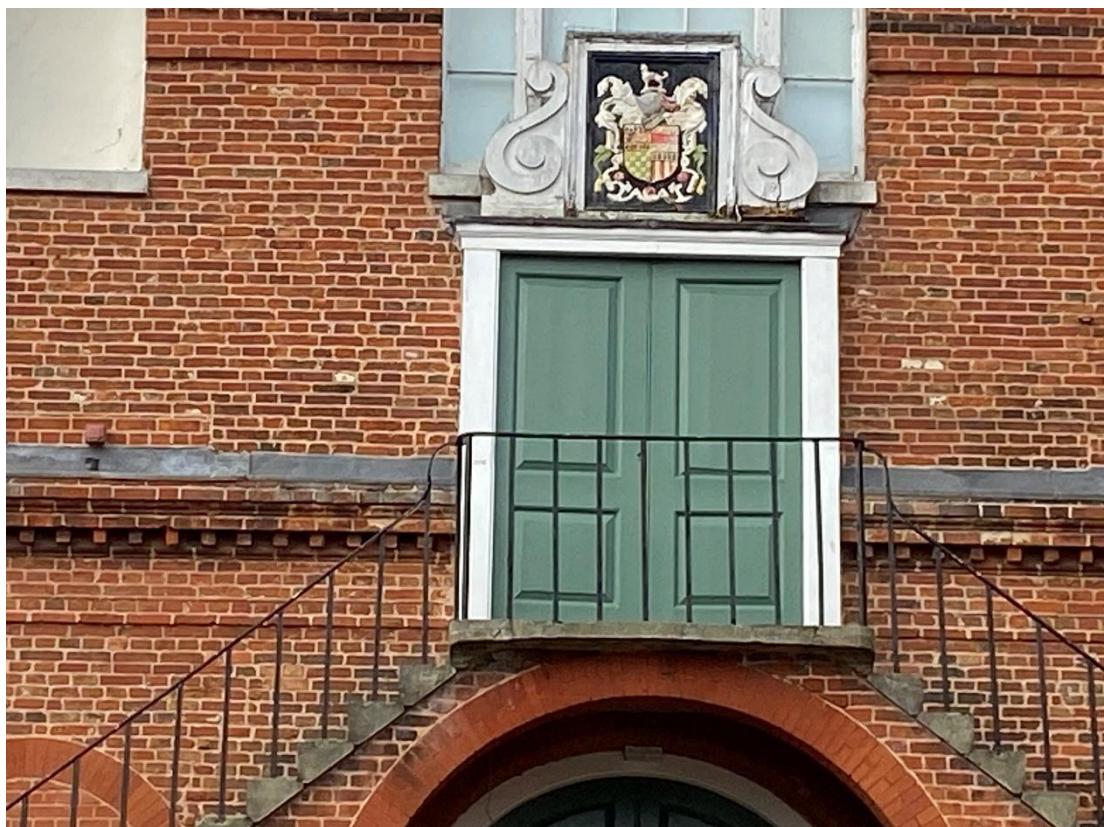
Condition: condition of putty is poor with parts missing and loose. The paint finishes generally are very poor with loss back to the timber in places. General re-puttying and repainting needed. Junction of lower sash horizontal glazing bar with vertical bars misaligned: stiffen/realign. Potential decay of the lower sash west jamb foot. As window W07, there is possible decay of sill under the central sash and under the west light. Provisionally renew the sill and the foot of the west mullion.

3.6 Window W08

Repairs recommended: repair timberwork, reputty, redecorate.

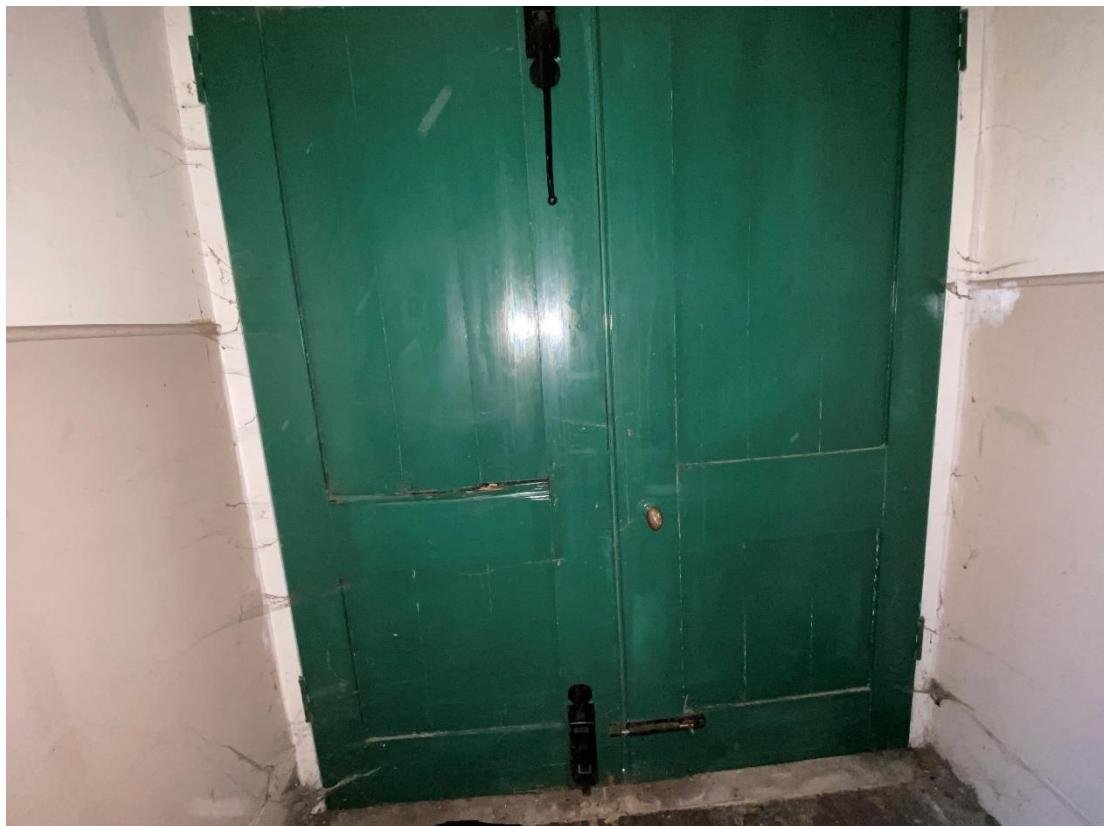
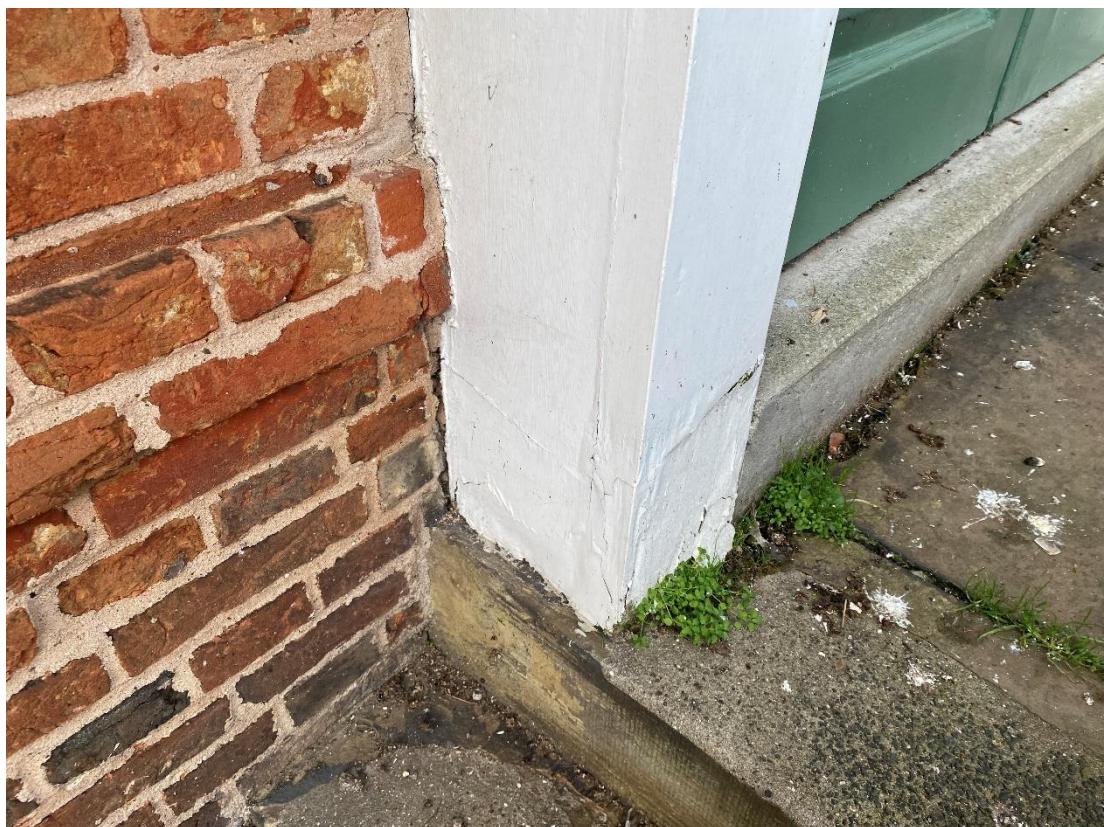
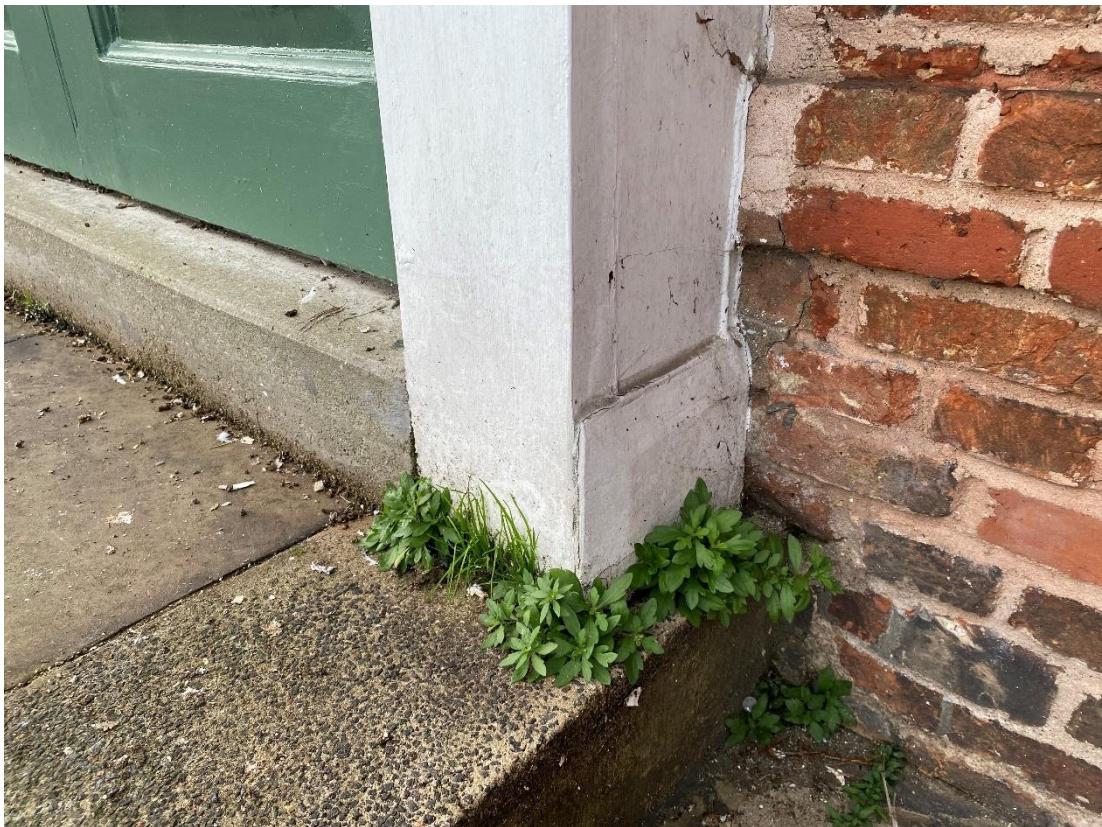
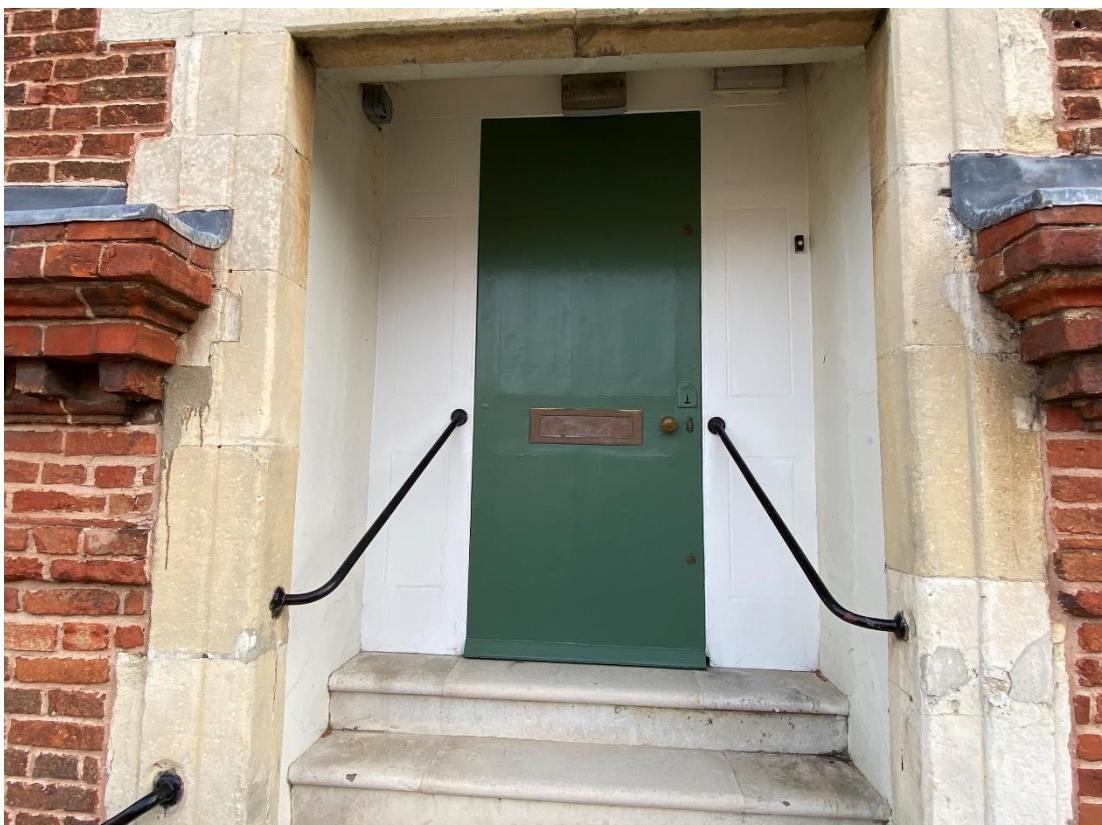
Condition: the doors are in reasonable order, although the escutcheon has previously been bent and could be renewed at the next redecoration for improved appearance. The threshold and head are satisfactory. The north jamb is sound except at the base where timber has decayed and a new section of board will need to be scarfed in. The south jamb boards are decayed at mid-level and at the foot: these will need to be renewed. The frame will need to be redecorated in association with the renewals and the doors should be decorated. The centre rail/upper panel junction has decayed: a later added bead is also decayed. The meeting style has decayed in this area also. Careful timber renewal is needed.

3.7 First floor east door from east

Repairs recommended: repair timberwork, redecorate.

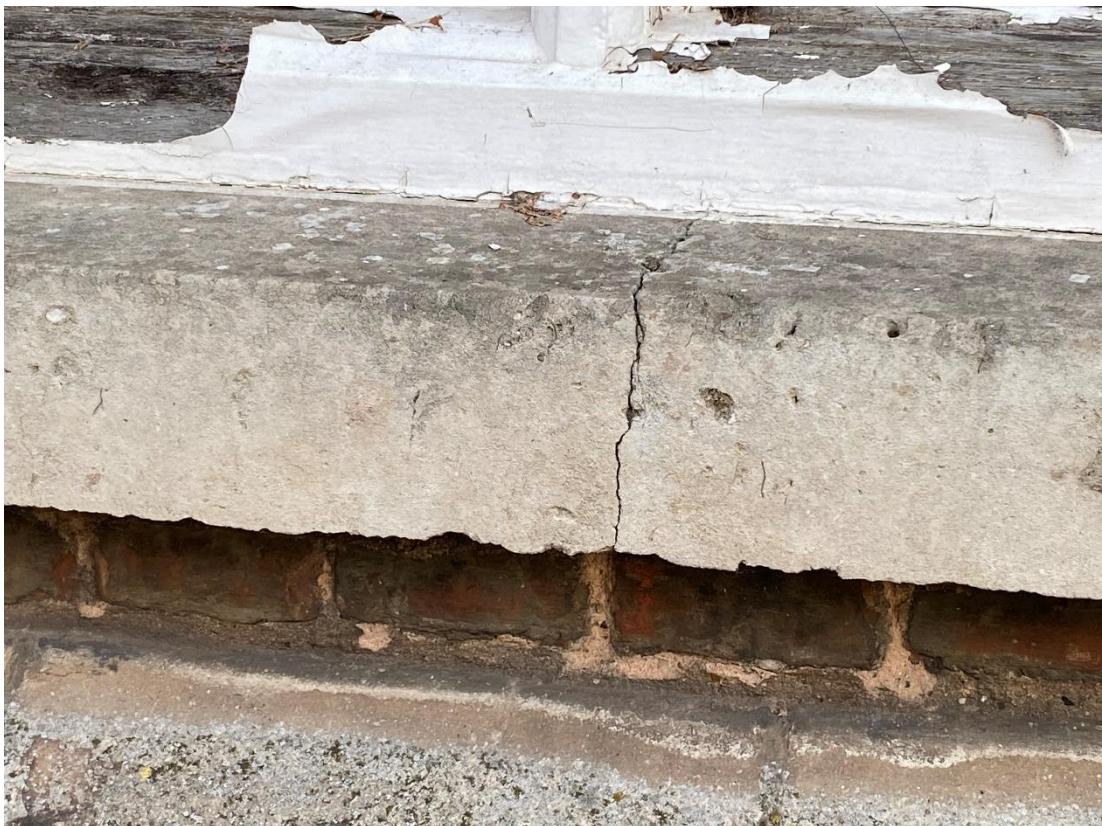
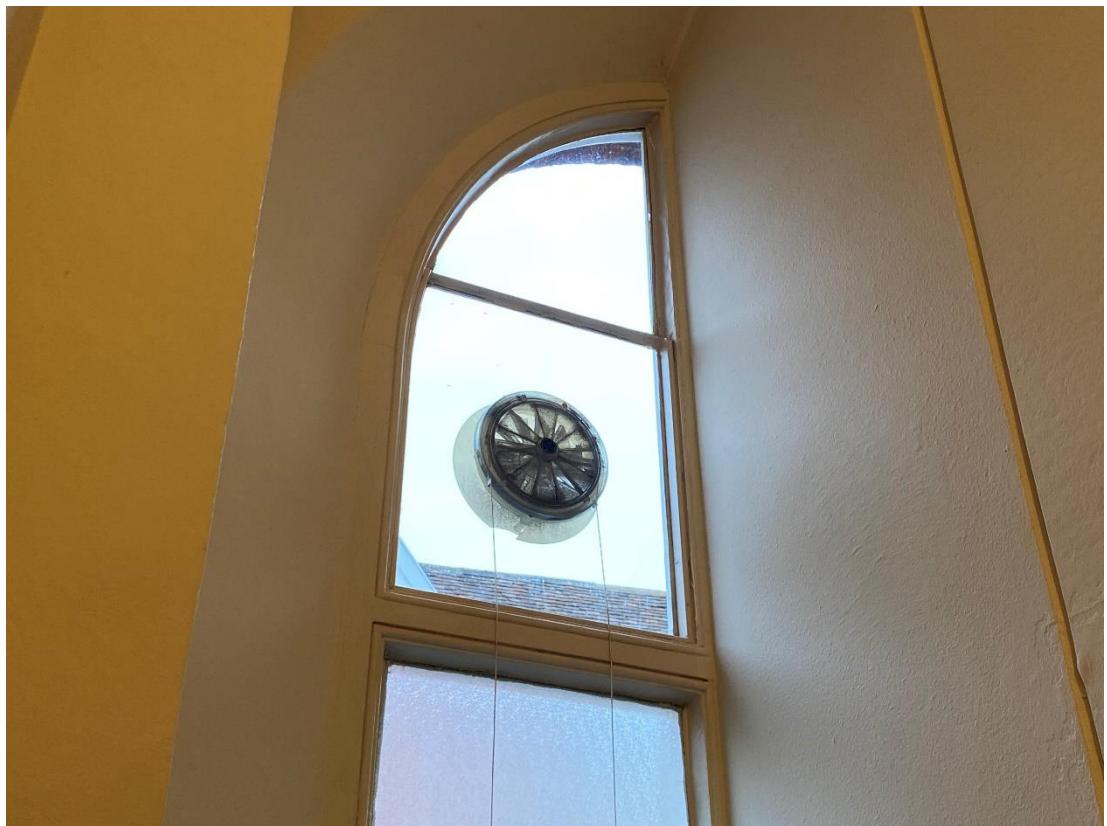
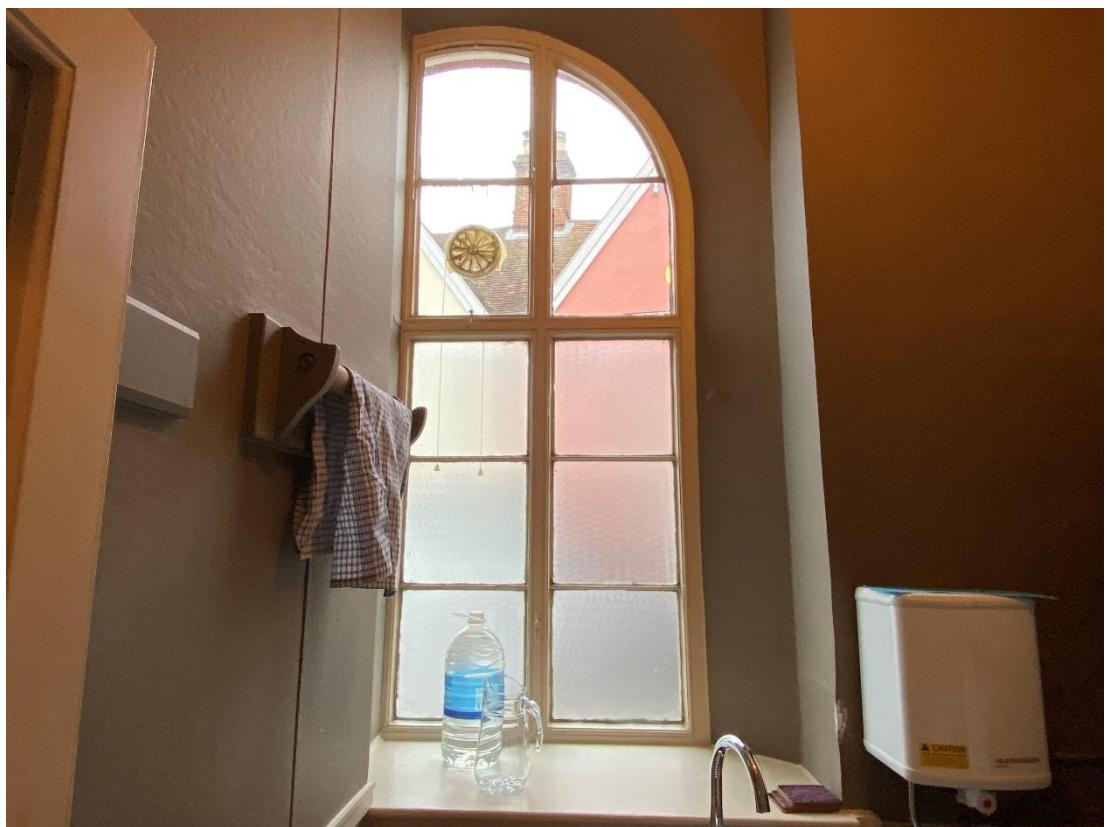
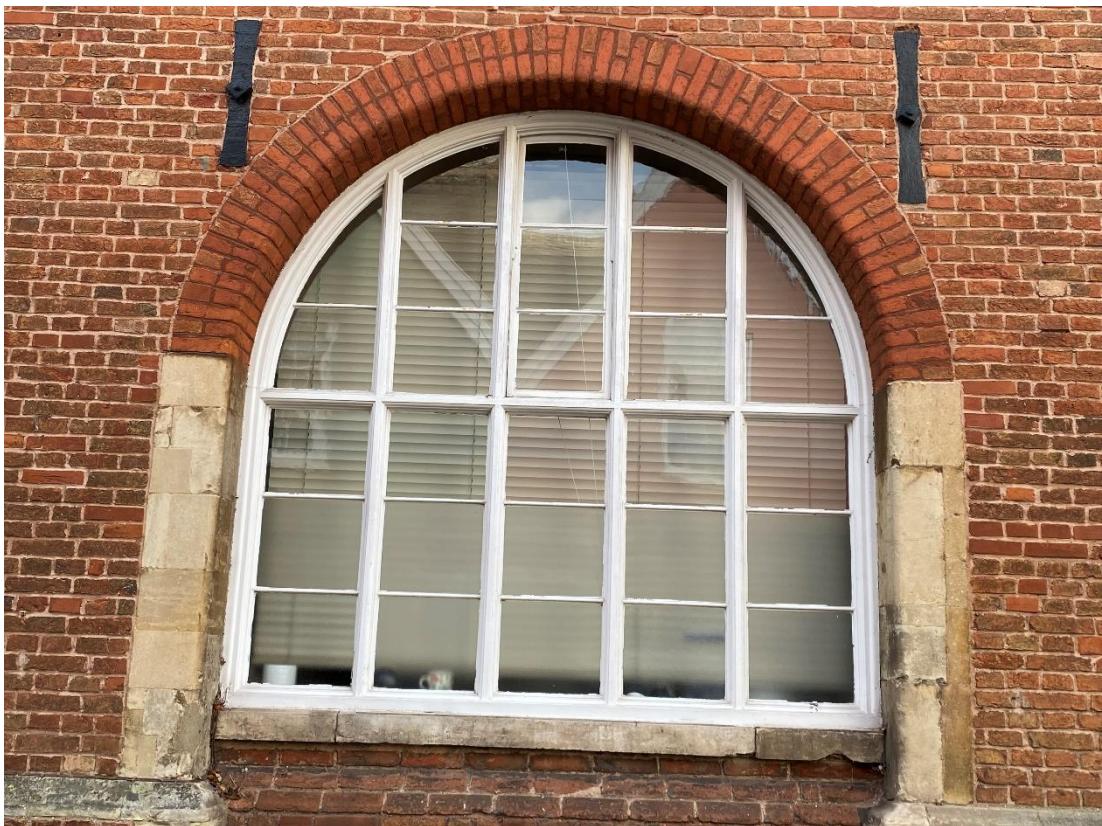
Condition: satisfactory inside; outside the stone sill is cracked and requires grouting. The cowls over the vents in the upper part of the windows are broken, although this is not affecting the general operation at present. If the function of the rooms behind is to change within five years, the vents could be left and removed (with renewal of the glass) at a later date. The timberwork is generally satisfactory except for the east light at sill level, which should be renewed, with the sill beads of the other lights given the loss of paint protection. The applied beading of the west upper light could be removed and this light returned to match the east light if desired, subject to Listed Building Consent. The window generally requires redecoration: putty on the upward-facing surfaces is suspect and should be renewed.

4.1 Window W09

Repairs recommended: reputty, redecorate.

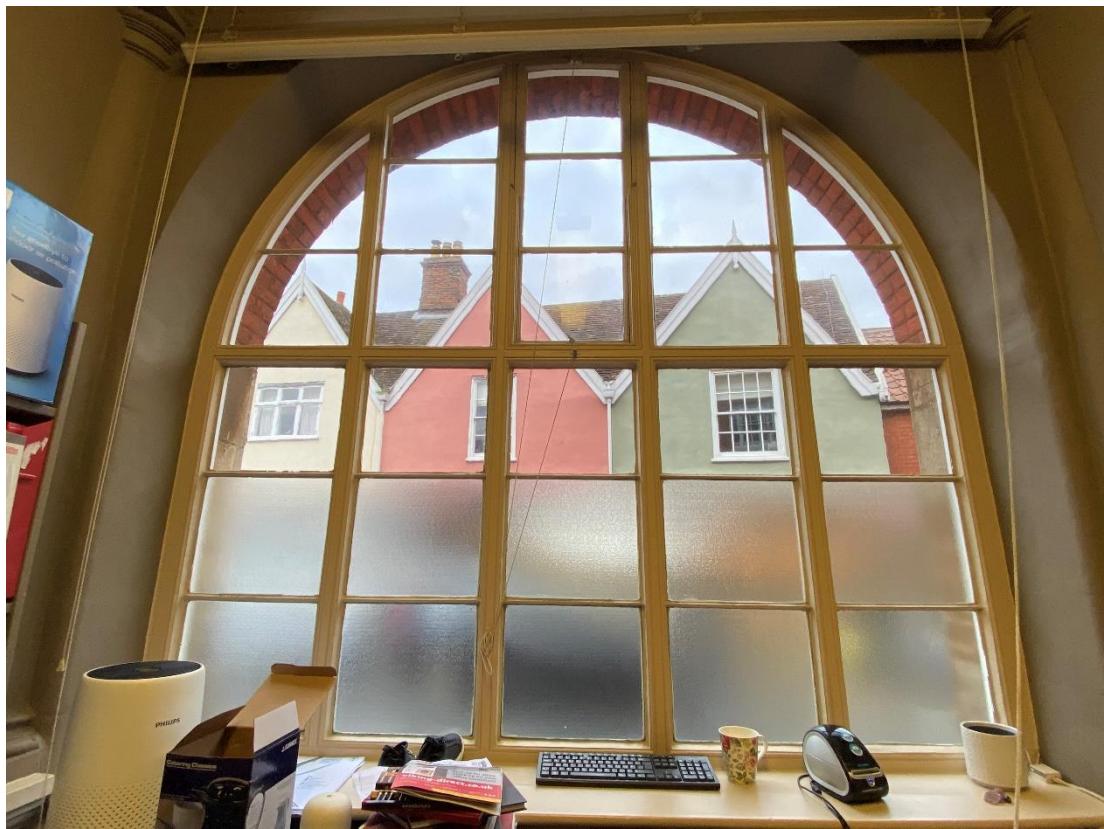
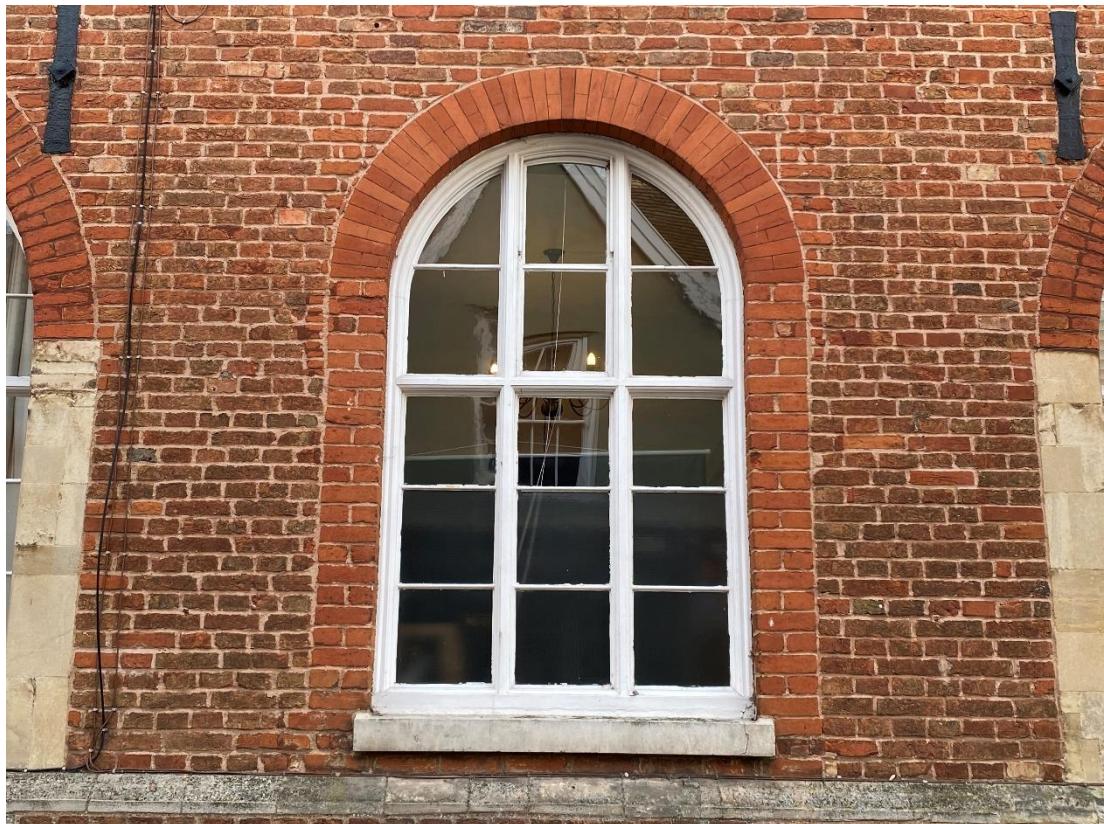
Condition: satisfactory inside, the opening light works, pointing between the sill and the timber sill is suspect in places and will need to be remade. General external redecoration is needed. Putty on upper facing elements is suspect and will need to be remade. The lower east edge of the opening light appears from ground level to be slightly decayed: allow for some piece repairs here.

4.2 Window W10

Repairs recommended: repair timberwork, reputt, redecorate.

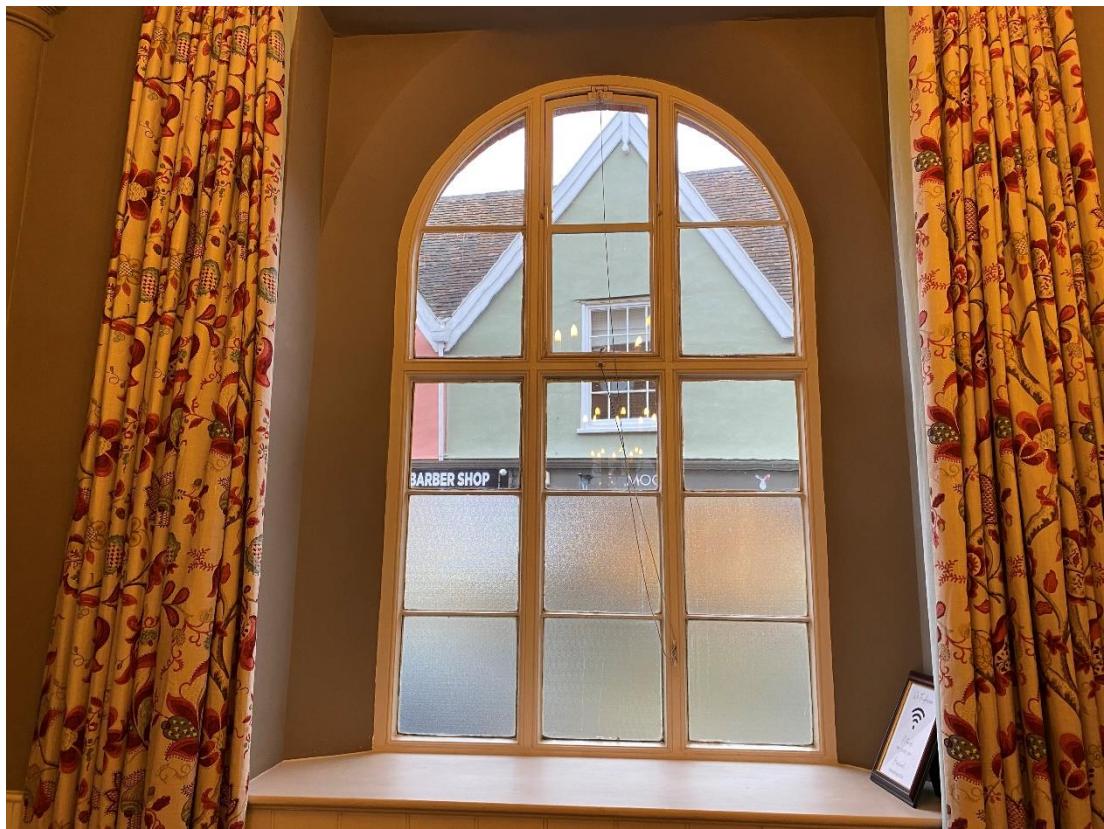
4.3 Window W11

Condition: satisfactory inside: the opening light works, the stone sill is cracked: grout up. The east mullion foot is distorted, suggesting past decay or damage, although the paint finish is not cracked. Allow provisionally for renewal the east sill bead and jamb foot. The timberwork and glazing are otherwise generally satisfactory but need redecoration: remake upward-facing putty.

Repairs recommended: repair timberwork, reputt, redecorate.

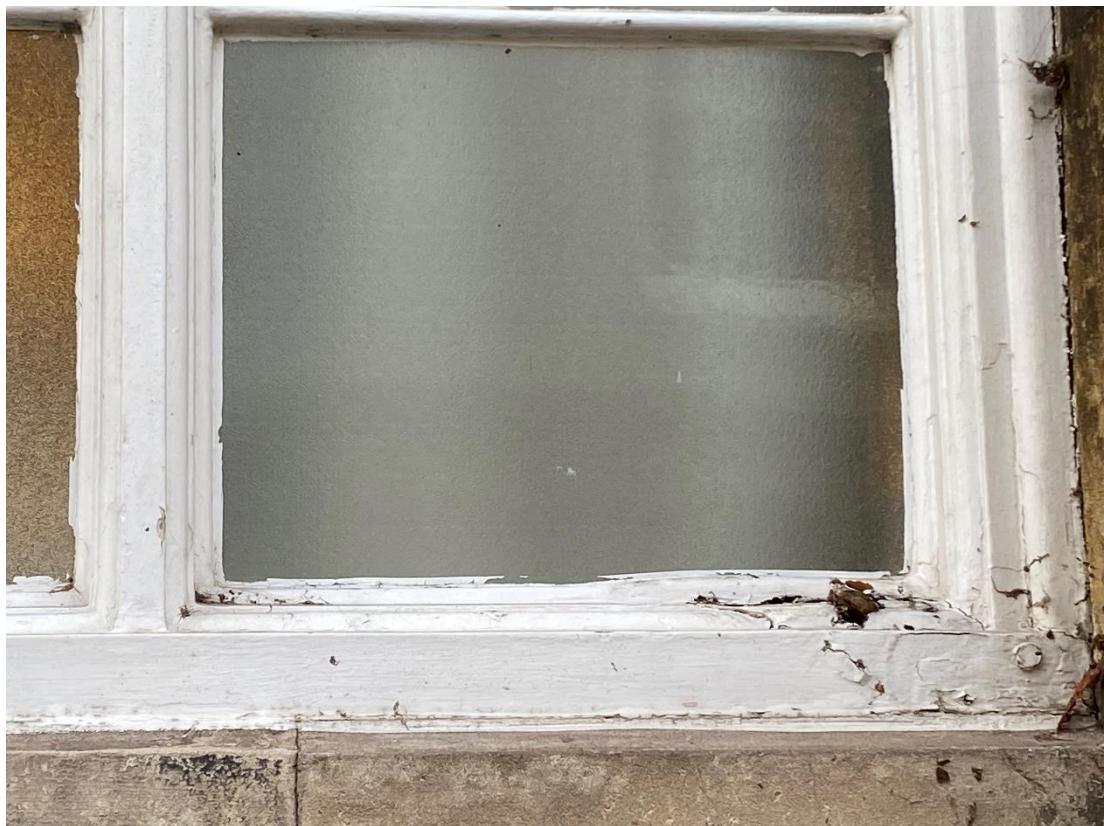
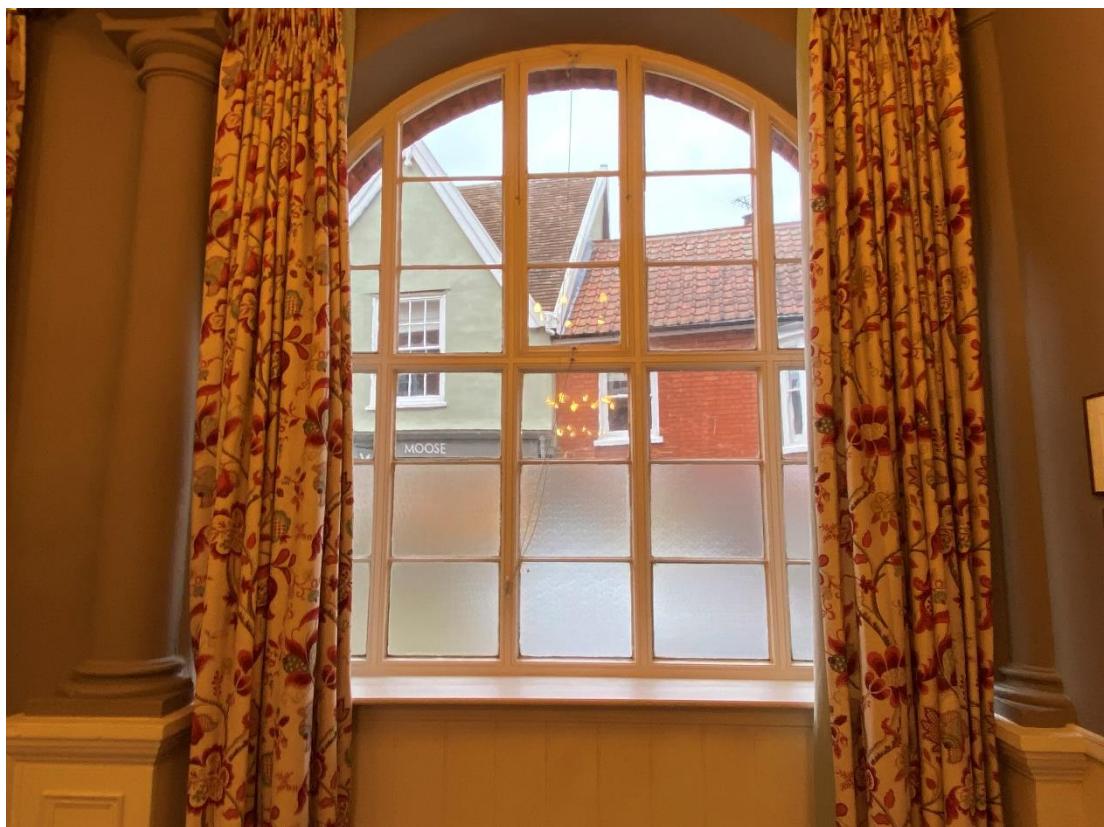
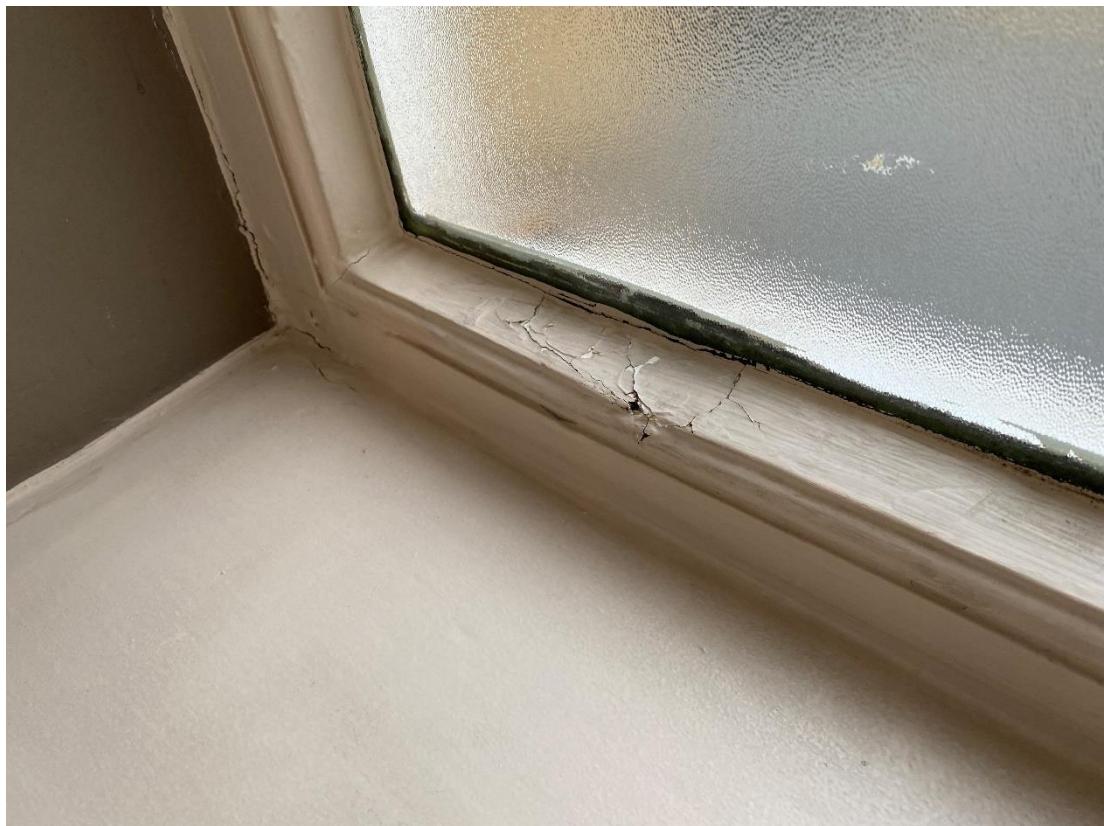
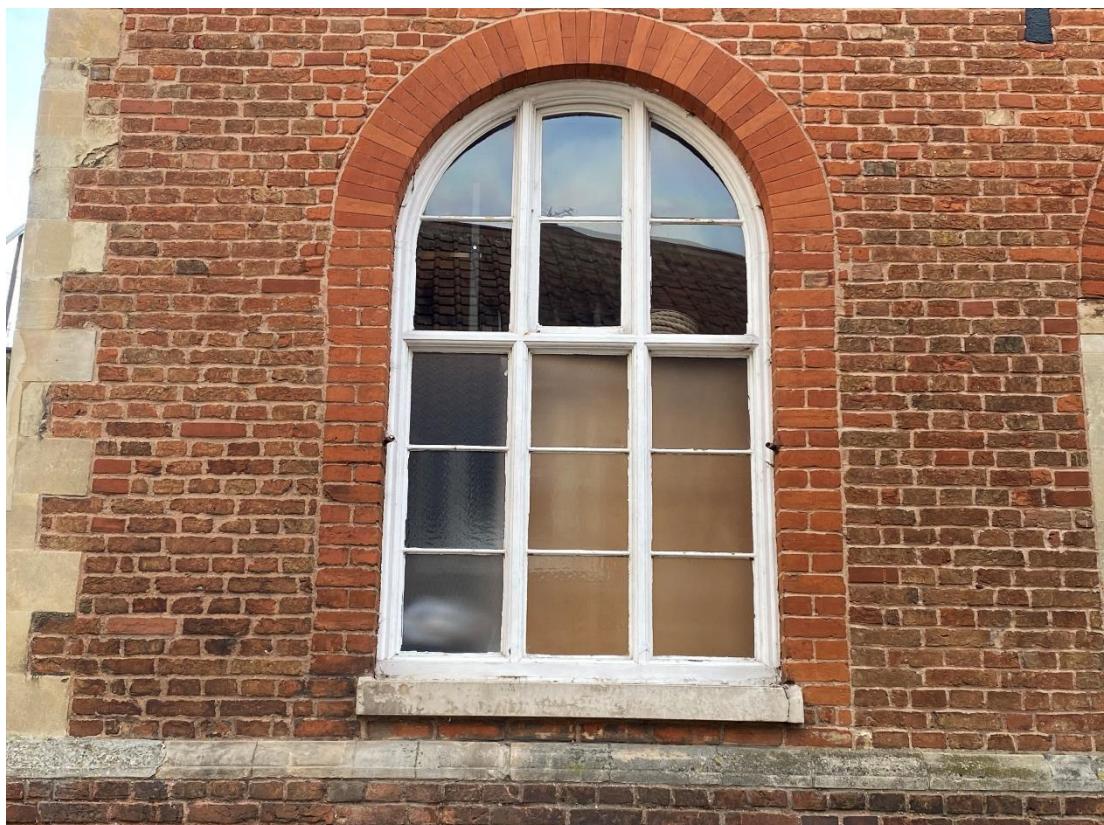
Condition: inside: the opening light works. The westernmost light sill is decayed inside, piece repair with exterior (see below). Outside: generally sound except for the easternmost and westernmost lights where the glazing beads at sill level and the ends of the sill are decayed or suspect: renewals are needed. The second mullion foot from the east is also suspect: allow provisionally for renewal. The window generally requires repainting outside.

4.4 Window W12

Repairs recommended: repair timberwork, reputt, redecorate.

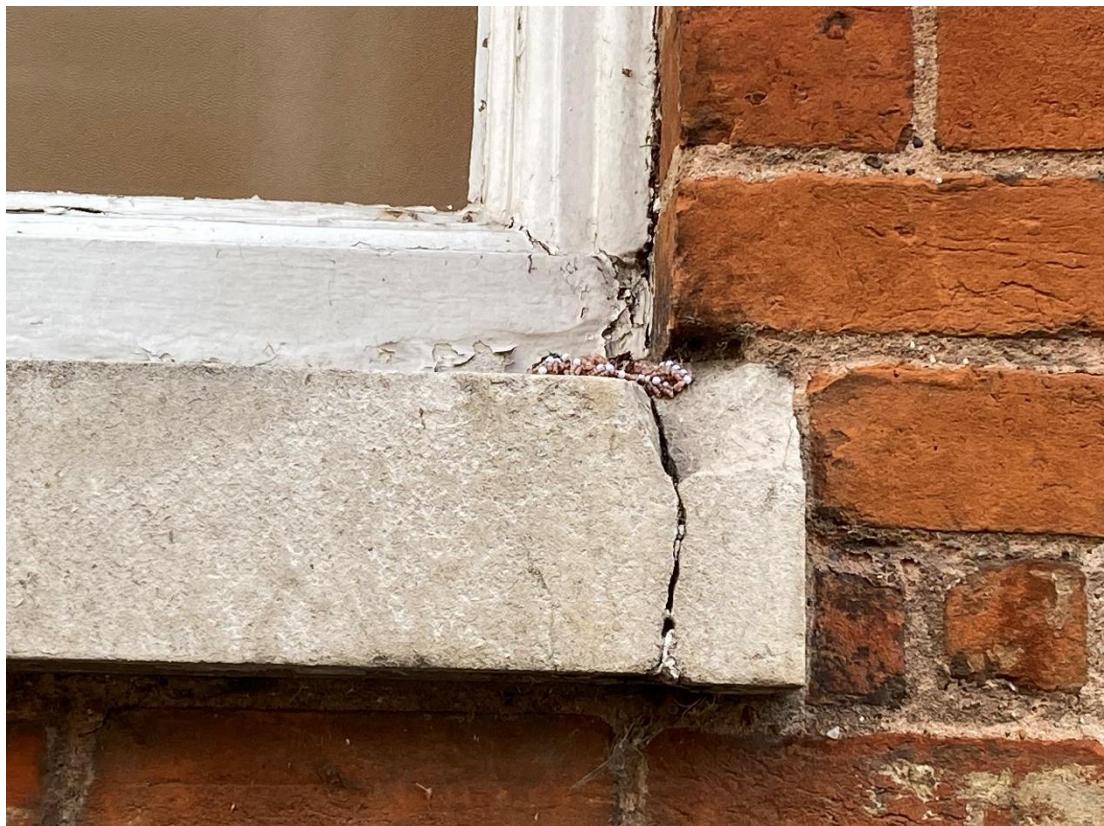
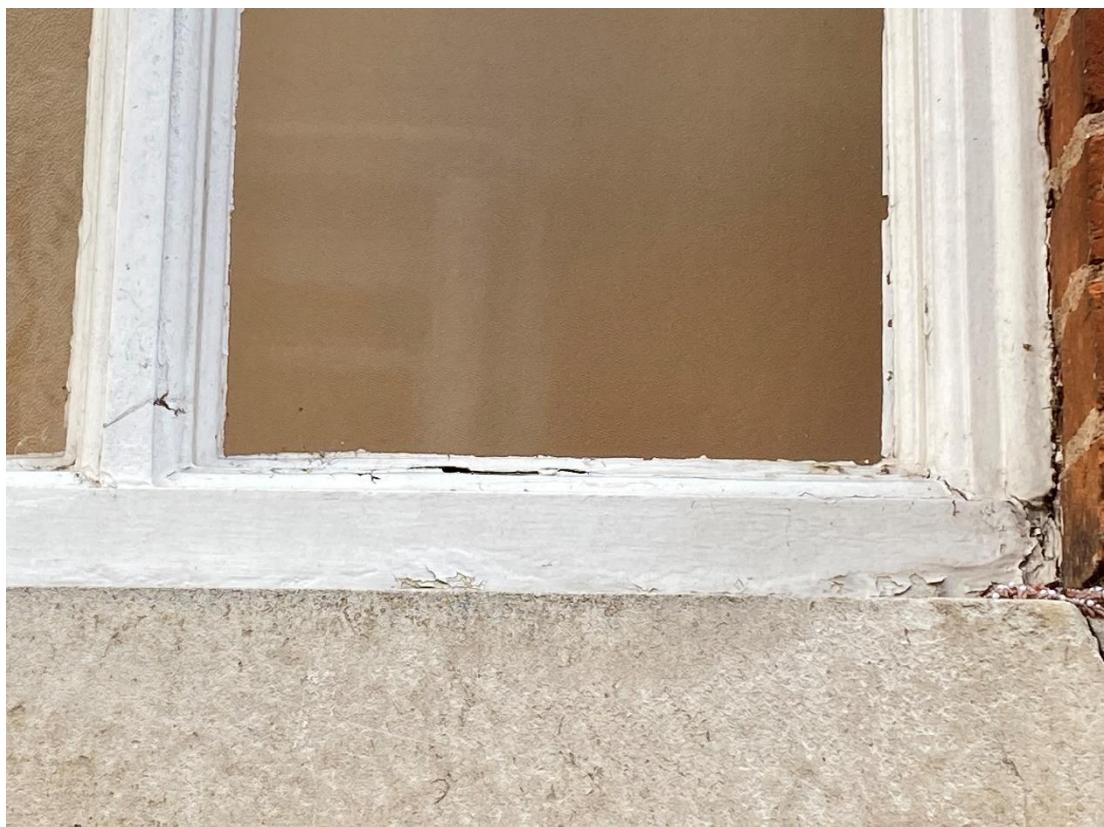
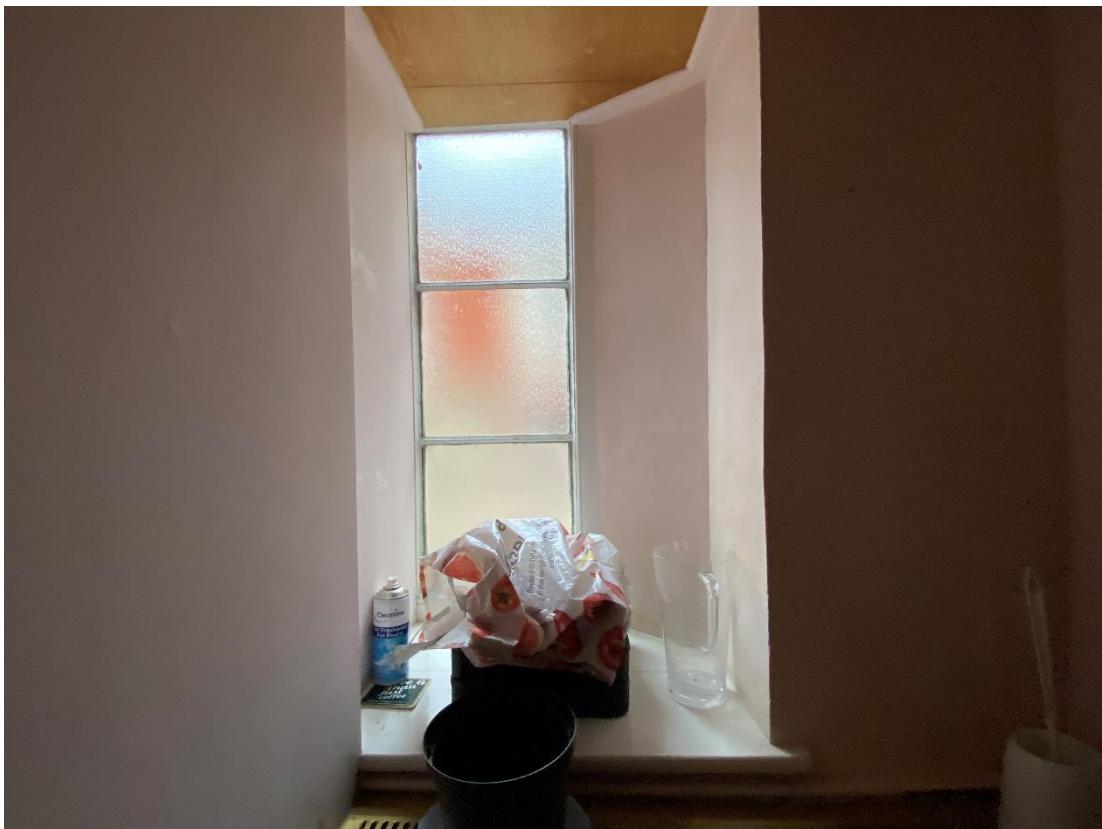
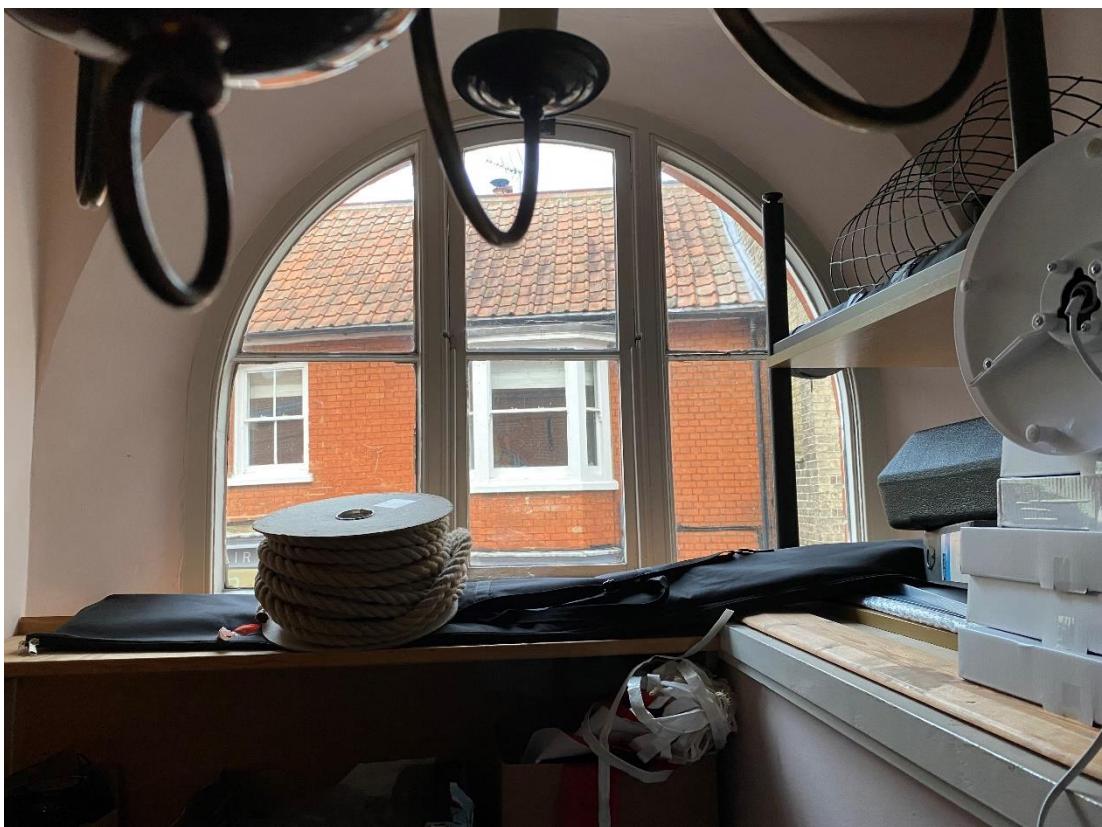
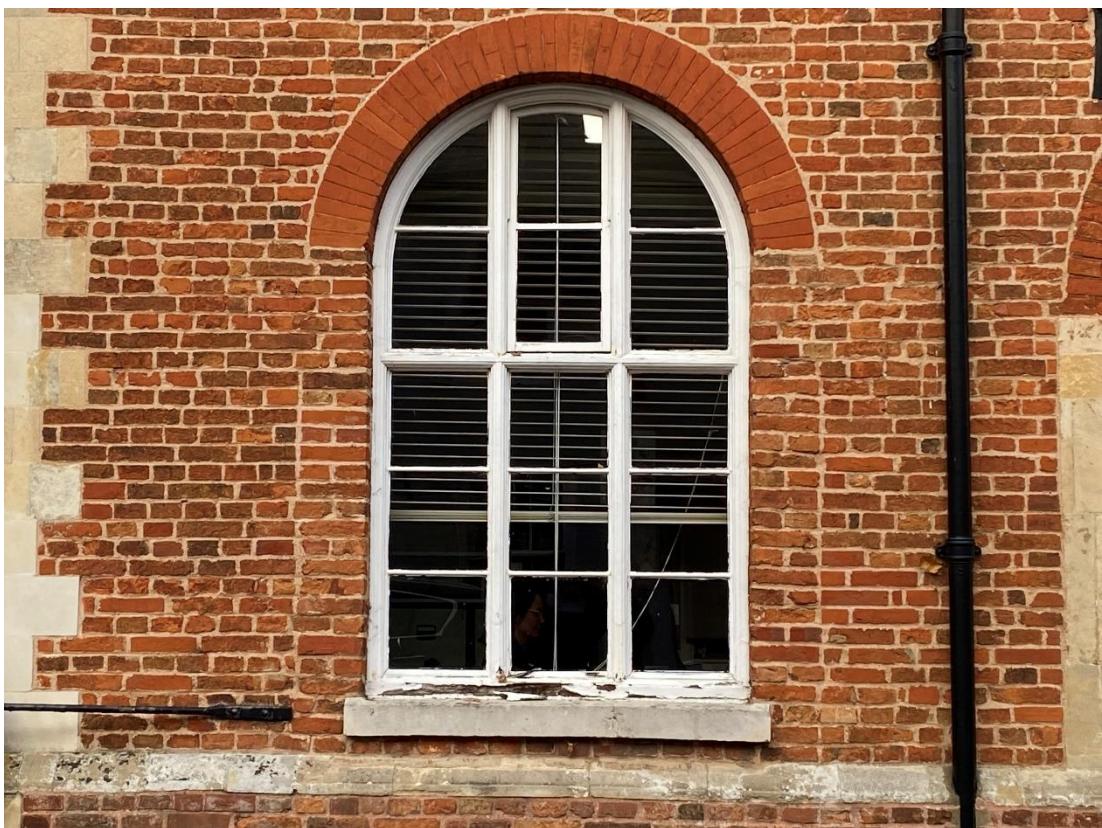
Condition: the west end of the stone sill is cracked and chipped: stone piece repairs or careful mortar 'plastic' repairs are needed. The timber framing is generally satisfactory, but the beads and sill show signs of decay: subject to stripping back paintwork, assume this must be renewed, with the mullion and jamb feet. The window generally requires redecoration. Glass is in sound order.

4.5 Window W13

Repairs recommended: repair timberwork, reputty, redecorate.
