EXTERNAL WINDOW AND DOOR CONDITION REPORT

SHIRE HALL, WOODBRIDGE, SUFFOLK

Inspecting Architect: Philip Orchard

PEO/Pra/cm/S7303
17th December 2024

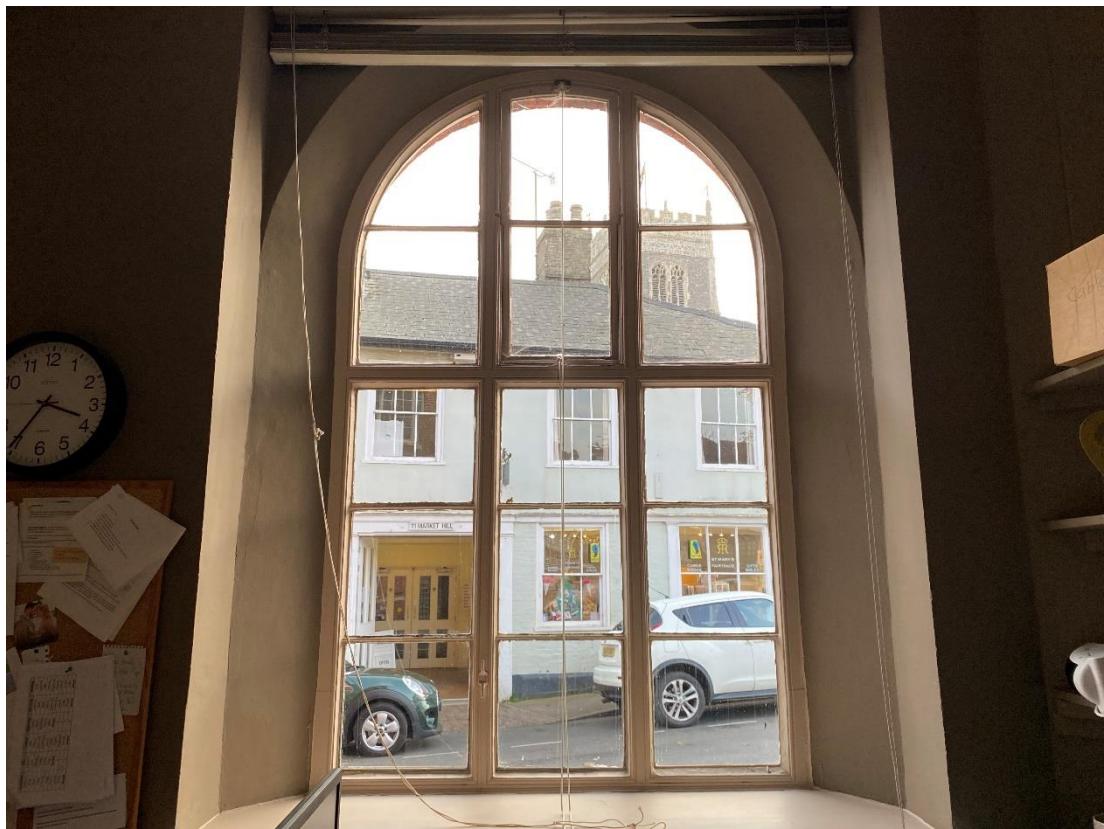
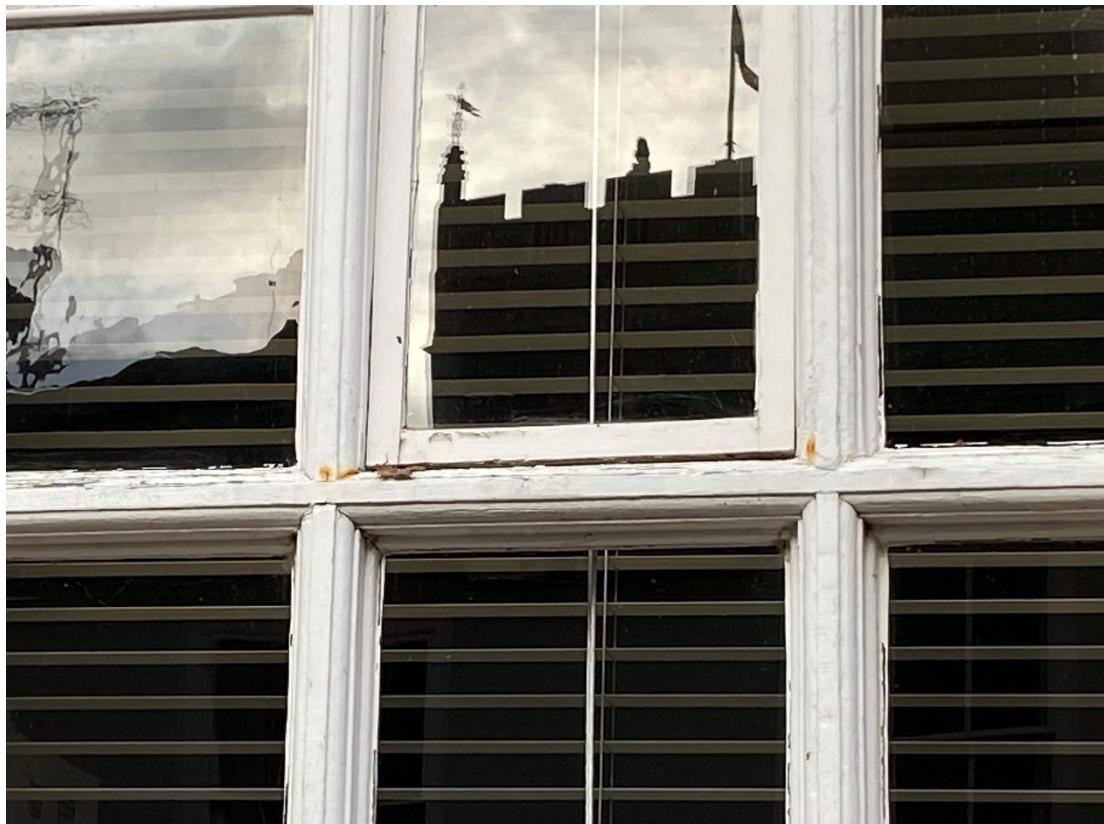
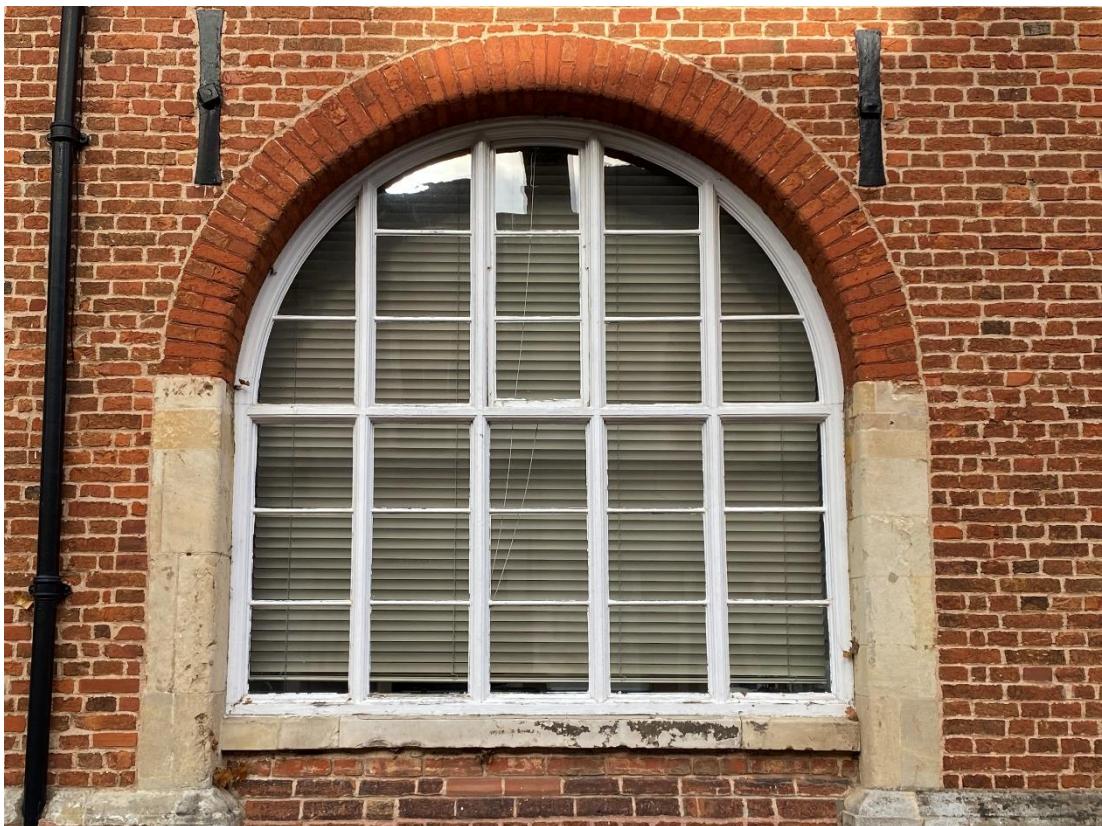
Condition: opening light works. The past scarfed joints show inside. The stone sill is cracked and requires grouting up. The timber sill is in poor condition, particularly in the centre, and requires renewal. The mullion and jamb feet are also decayed and new ends need to be scarfed on. There are some rust stains from fixings in the upper part where the mullions join the transom in particular. The foot of the east mullion above the transom is slightly distorted as if there may be some filler here: assume some timber piece repairs may be needed. General redecoration is required, with renewal of putty on the upward-facing surfaces. Glass in the lower tier all seems to be modern float glass. The upper tier lower west pane is older glass, the remaining clear float.

4.6 Window W14

Repairs recommended: repair timberwork, renew putty, redecorate.

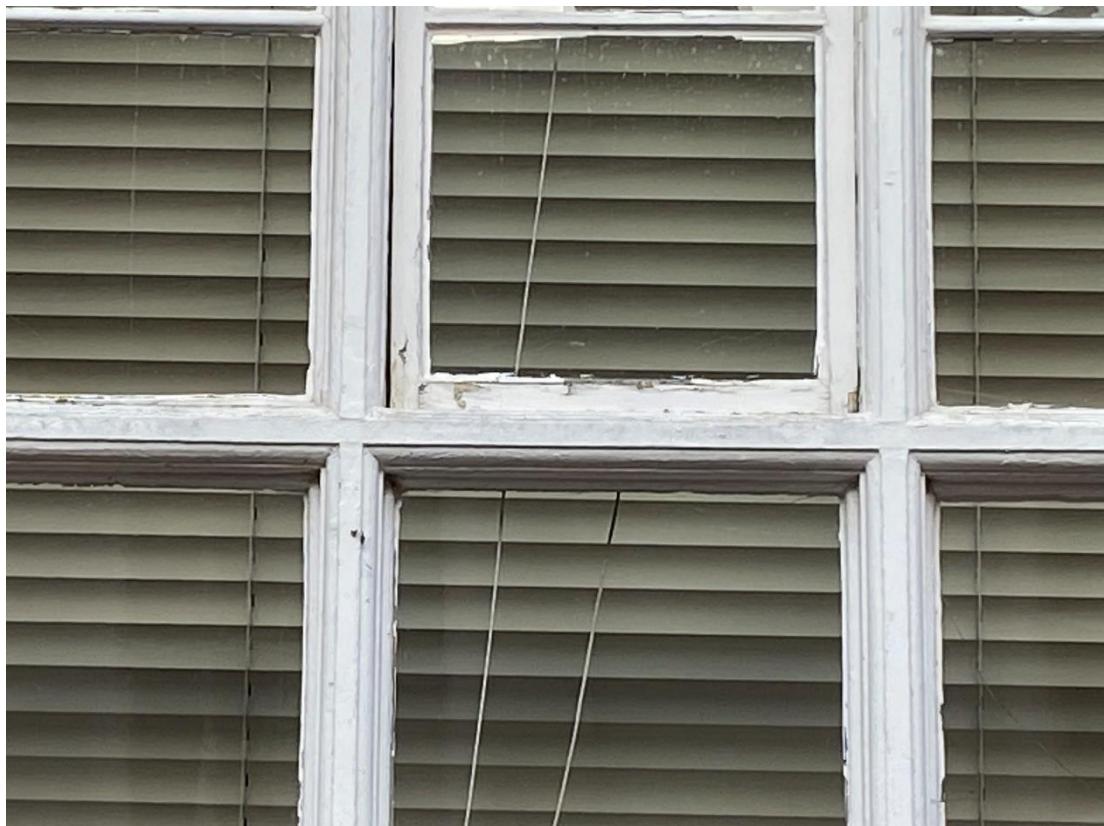
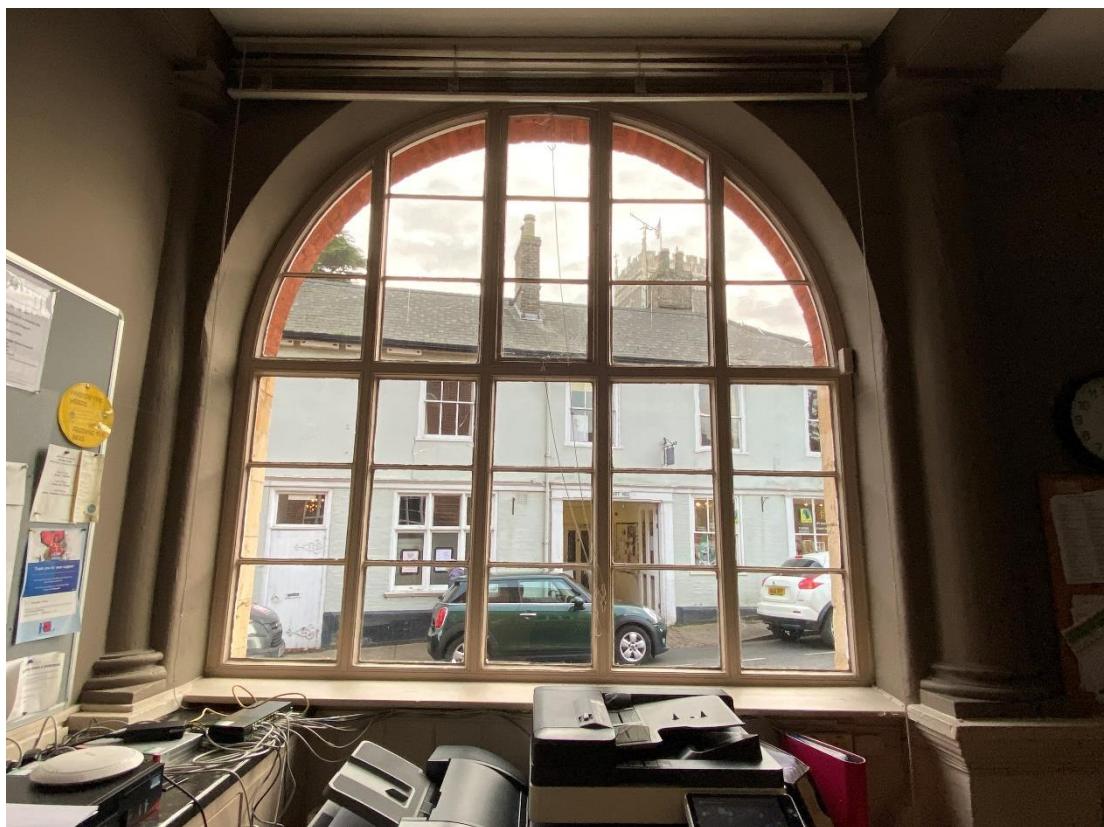
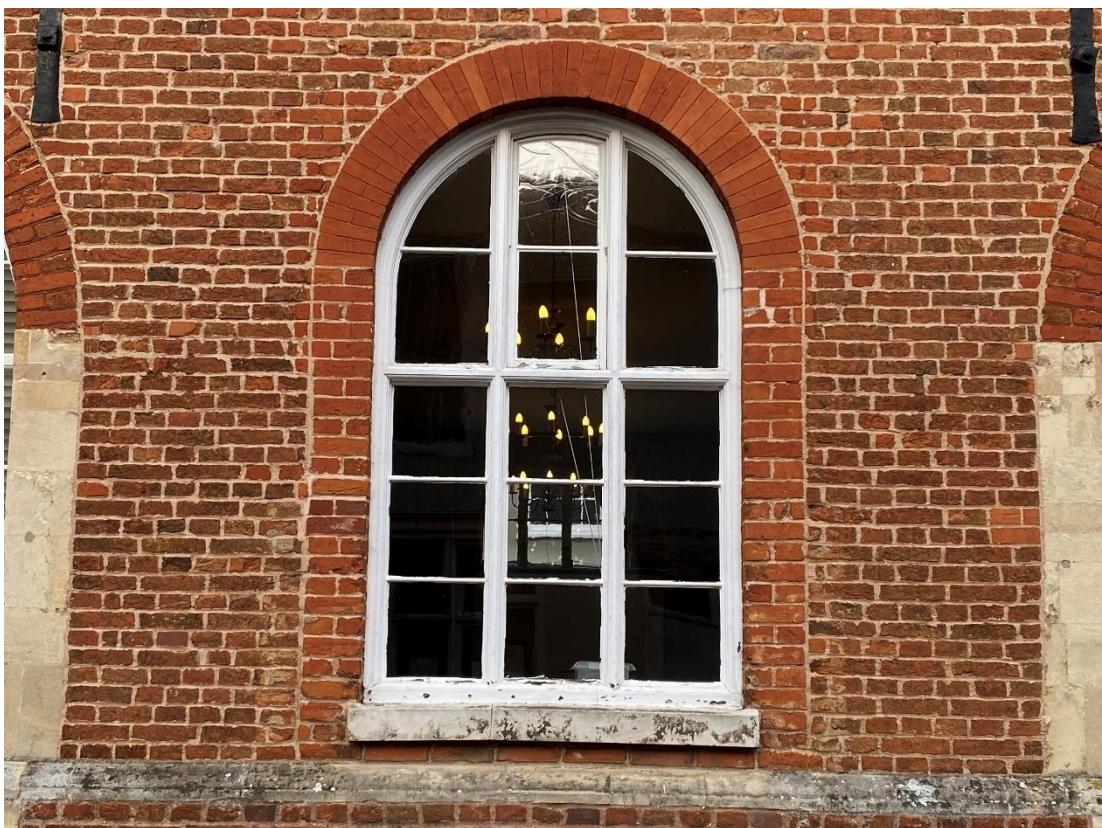
Condition: inside: the opening light works. There is a mortar makeup of the stone sill under the timber in the centre part of the window which is cracked and needs to be remade. The sill timberwork has lost its paint finish in places; given the defects present in W14, allow provisionally to renew the sill here with the mullion and jamb feet. The timberwork appears satisfactory generally. The lower tier second from east topmost pane is cracked and needs to be renewed (clear float glass). The exterior generally needs repainting with renewal of putty.

4.7 Window W15

Repairs recommended: repair timberwork, renew putty, redecorate.

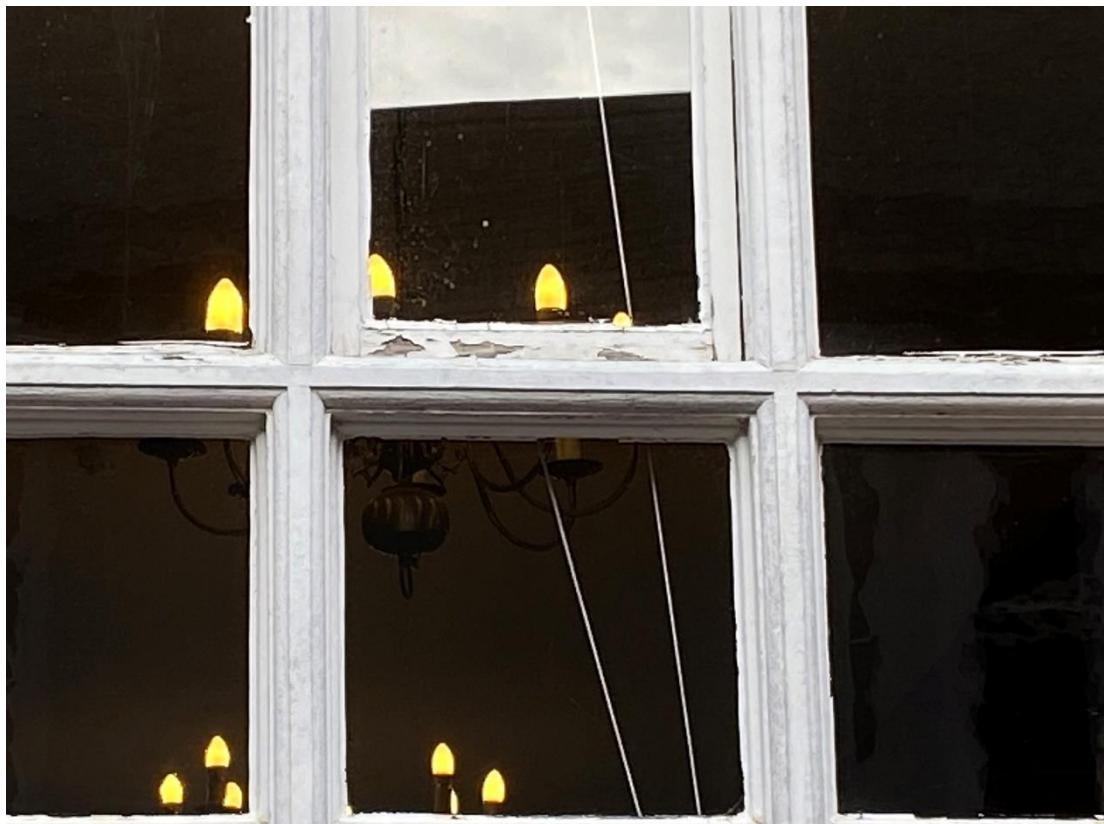
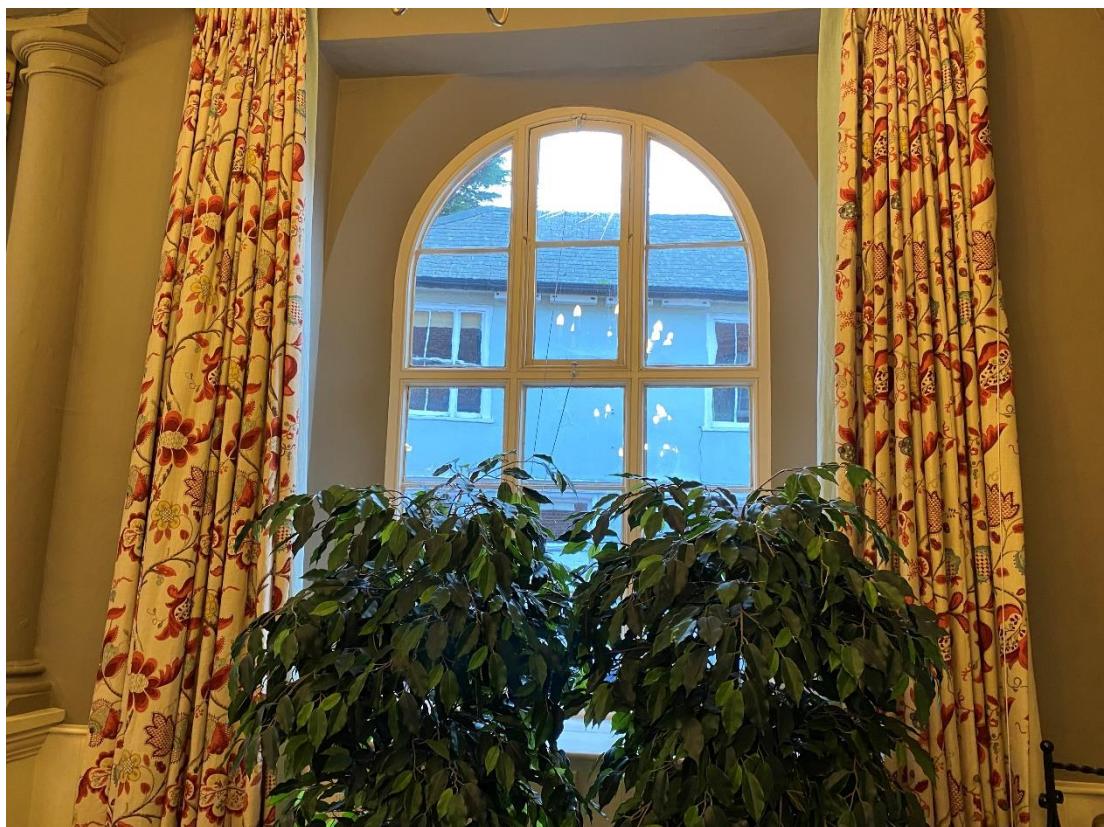
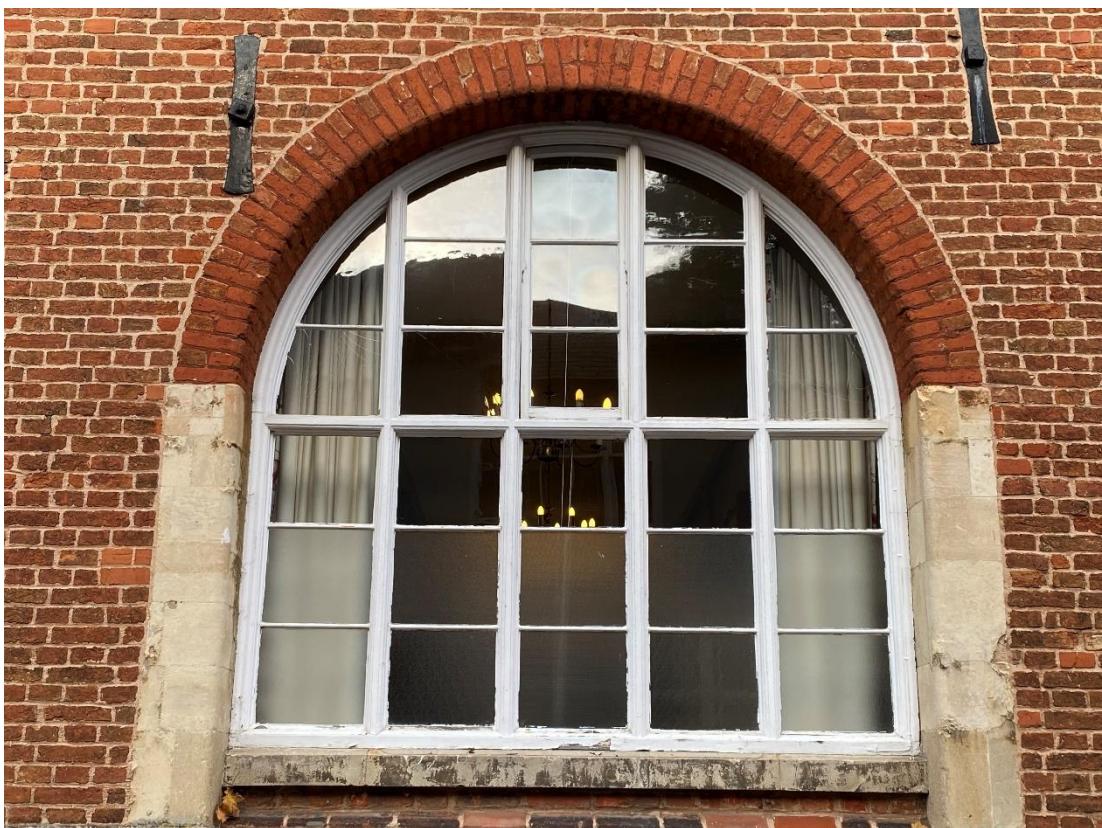
Condition: inside: opening light works but stiff: ease. Outer sill suspect, central bead decayed at sill level. General note: the glazing bars appear to be metal. Outside: the sill is cracked and the crack should be grouted. The sill is badly decayed throughout its length, the feet of the two mullions are decayed and the glazing beads at sill level are decayed. Safe access to check the foot of the opening light was not possible but paint has flaked off here and there is potential for decay: assume some timber renewal needed there. Full redecoration is required with renewal of defective putty.

4.8 Window W16

Repairs recommended: repair timberwork, renew putty, redecorate.

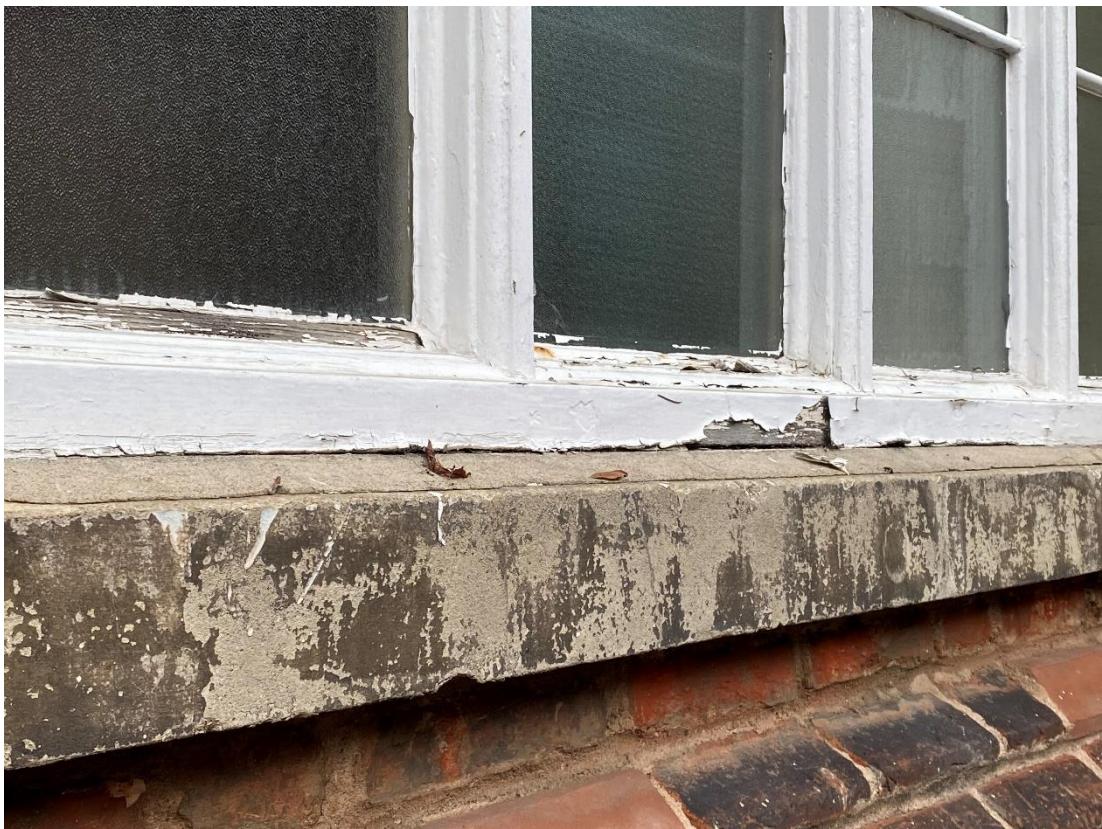
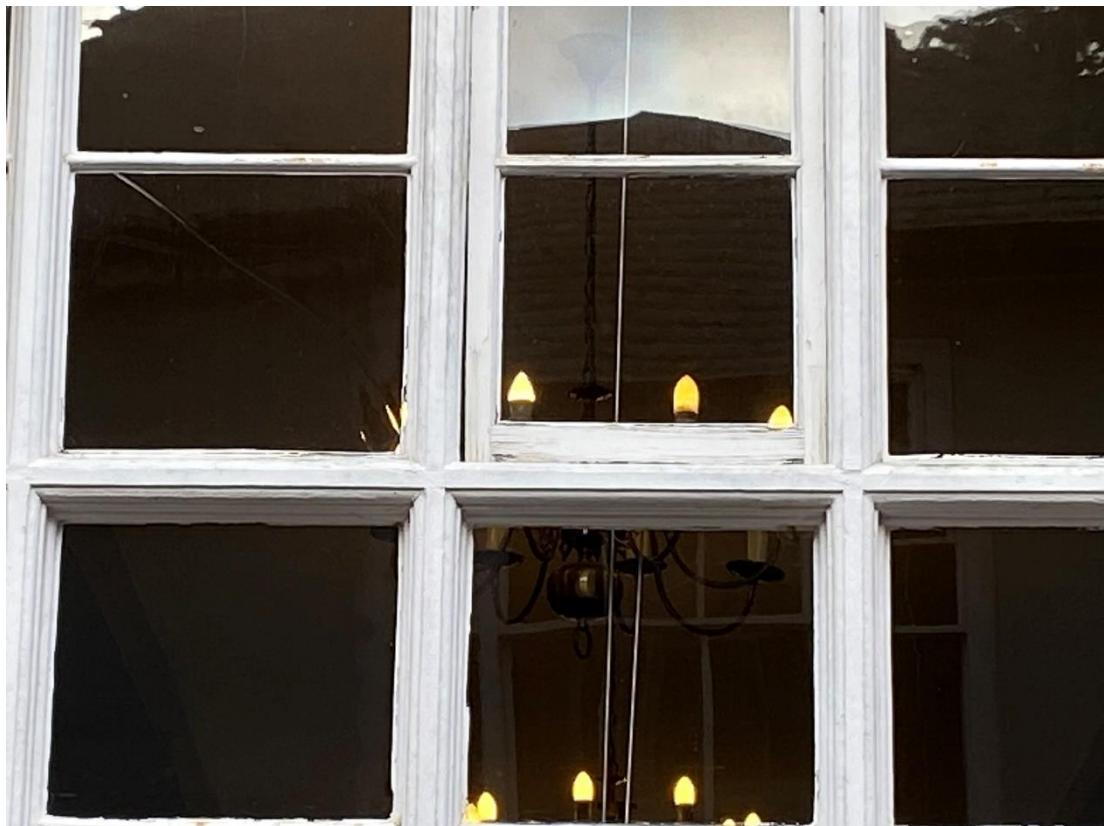
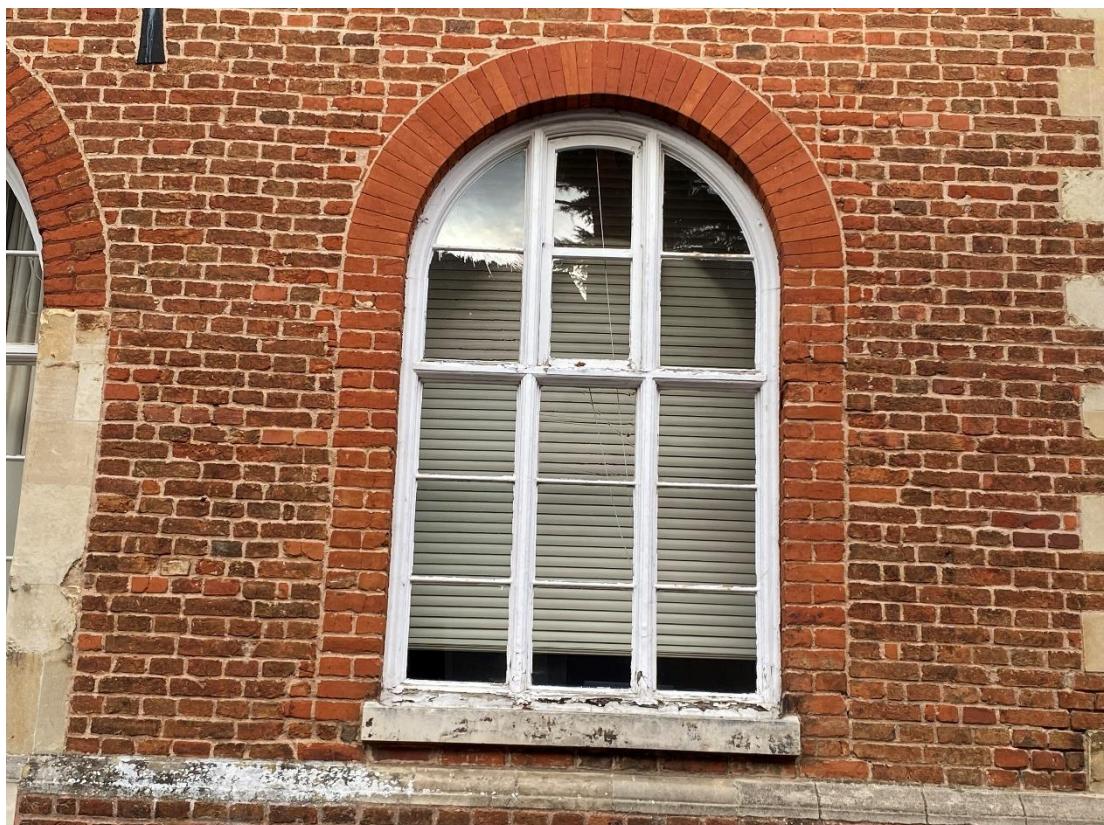
Condition: the inner sill board is cracked and it is here that water appears in heavy driving rain. Apart from splits to the sill board, satisfactory on the inside but the sill board soffit may be decayed (?); release, check and provisionally renew. The stone sill has a mortar flaunching in the centre part which needs to be remade: water is found to appear from under the internal sill in certain rain conditions and it is most likely that this drives in the gap between the timber sill and the mortar flaunching. The water ingress suggest that the sill is likely to be in poor condition and should be renewed provisionally. The paint is lost from the bottom rail of the opening light: safe access for inspection was not possible but assume some timber renewal needed. General repainting required, together with remaking defective putty.

4.9 Window W17

Repairs recommended: repair timberwork, renew putty, redecorate.

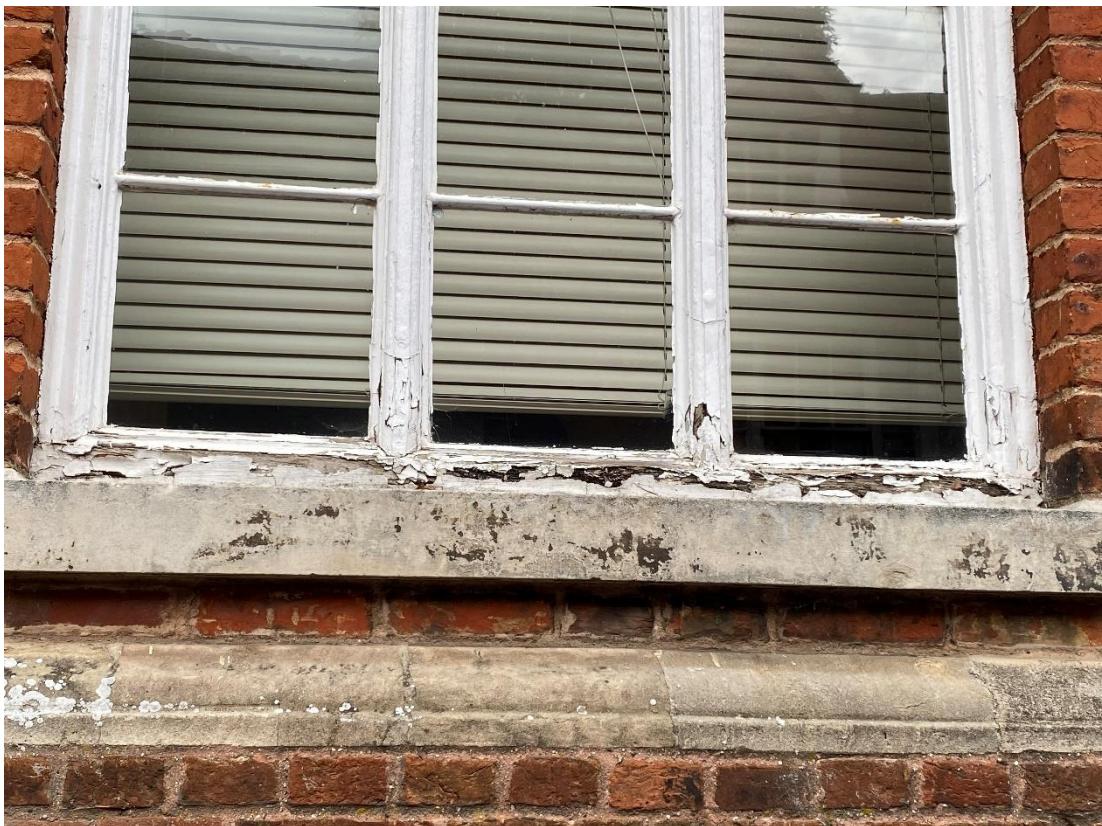
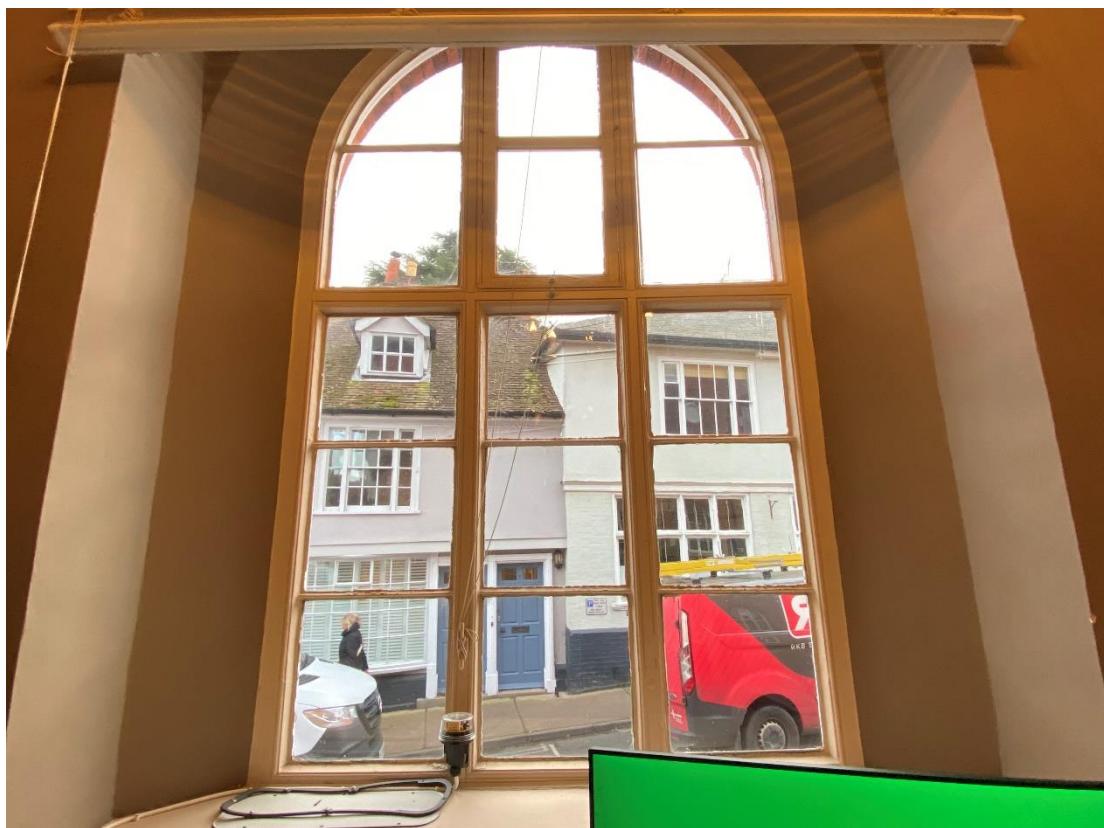
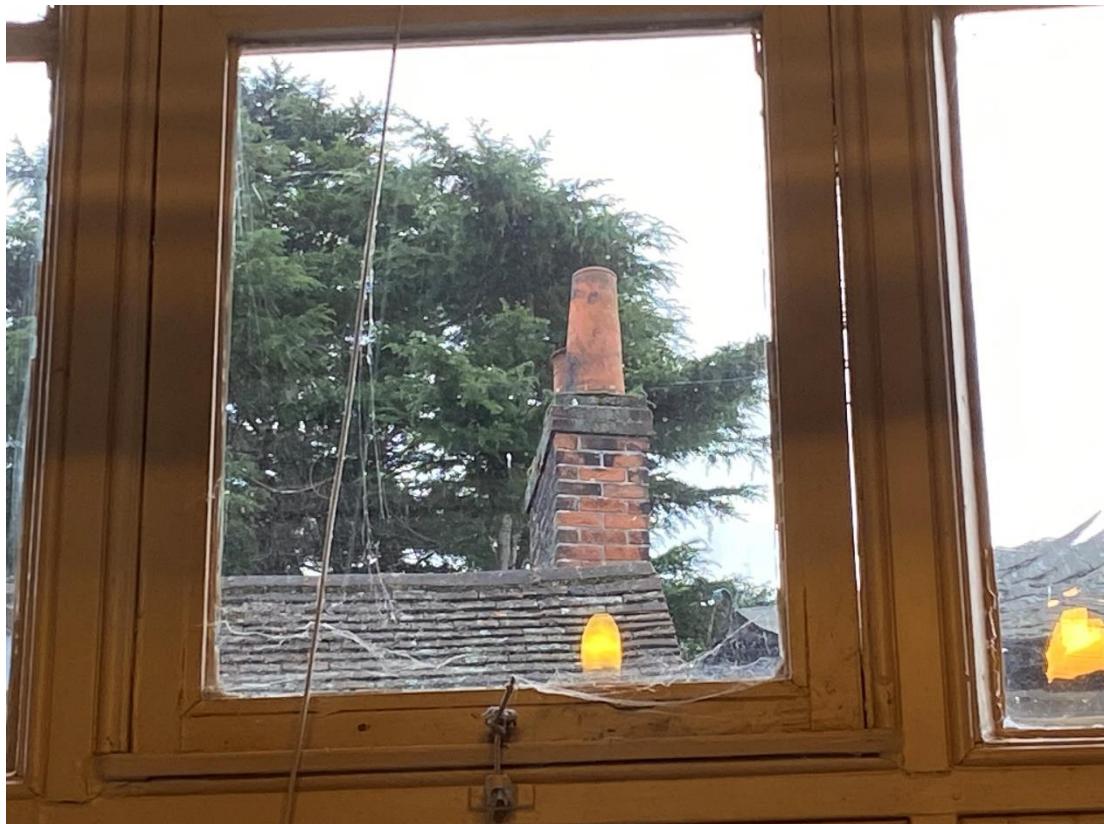
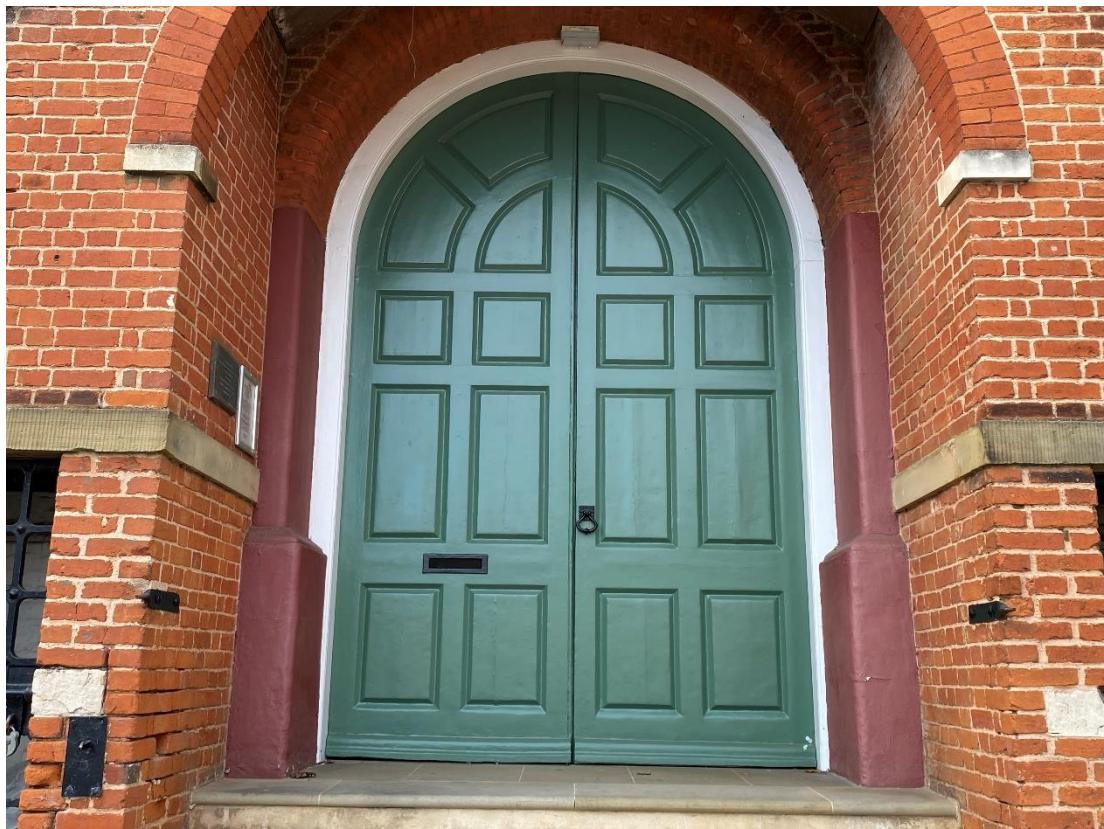
Condition: the opening light shows light through the vertical joints and more efficient sealing is needed. The cill, mullion feet and the foot of the east jamb are badly decayed and need to be renewed. The foot of the west jamb is not soft or showing any other defect but assume some renewal will be necessary. Safe access to assess the condition of the transom was not possible and the loss of paint finishes here suggests there may be some defects. Some cutting back and renewal of timber may be needed. The glass is generally satisfactory except for the upper tier west light upper pane which is cracked: renew. Generally decoration is needed with renewal of defective putty.

4.10 Window W18

Repairs recommended: repair timberwork, renew putty, redecorate.
