**CONDITION SURVEY REPORT
OF
SHIRE HALL
WOODBRIDGE
SUFFOLK
IP12 4LP**

Client: Woodbridge Town Council
Market Hill
Woodbridge
Suffolk
IP12 4LP

Date: May 2019

Ref: CT/FA/19552~rep

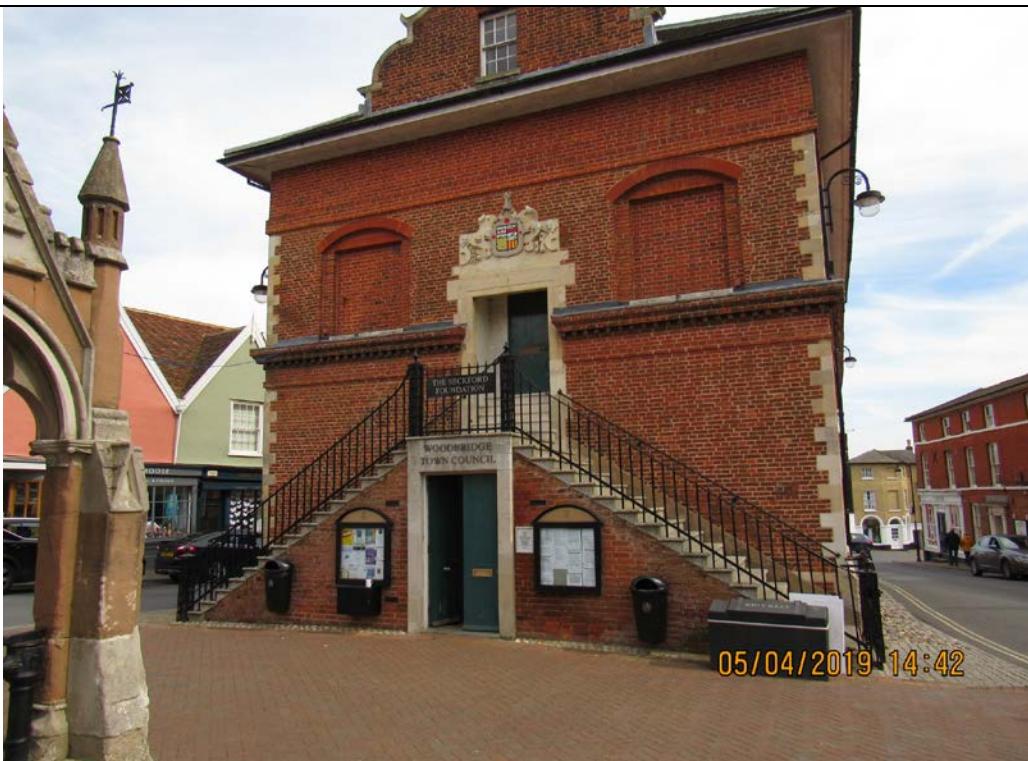
Photograph 01
View on East Elevation. Second entrance

- 2.1 This is a prominent building, positioned in the centre of the popular tourist town of Woodbridge. **See photo 1** in Appendix A.
- 2.2 The Shire Hall was originally constructed in around 1575 as a Court house upstairs, and remained functioning as this until **1986**. It was then used as a museum. At present, the first floor is used as storage by a 3rd party.

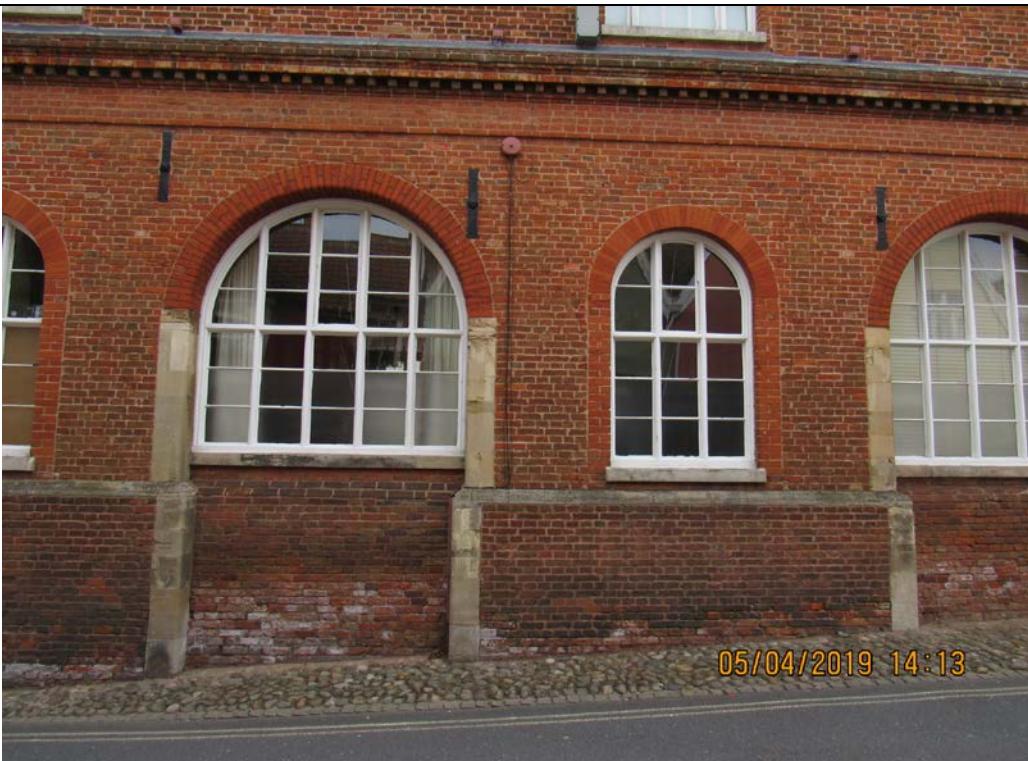
Photograph 02
General view on North side Elevation
showing masonry walls and curved arched windows.

- 3.2.1 The exterior is brick with fixed windows with built in tilt frames for ventilation. **See photo 2.**
- 3.2.2 The bricks are in good condition for their age, with a few showing signs of deterioration / delamination at ground floor level on the west wall. **See photo 47.**

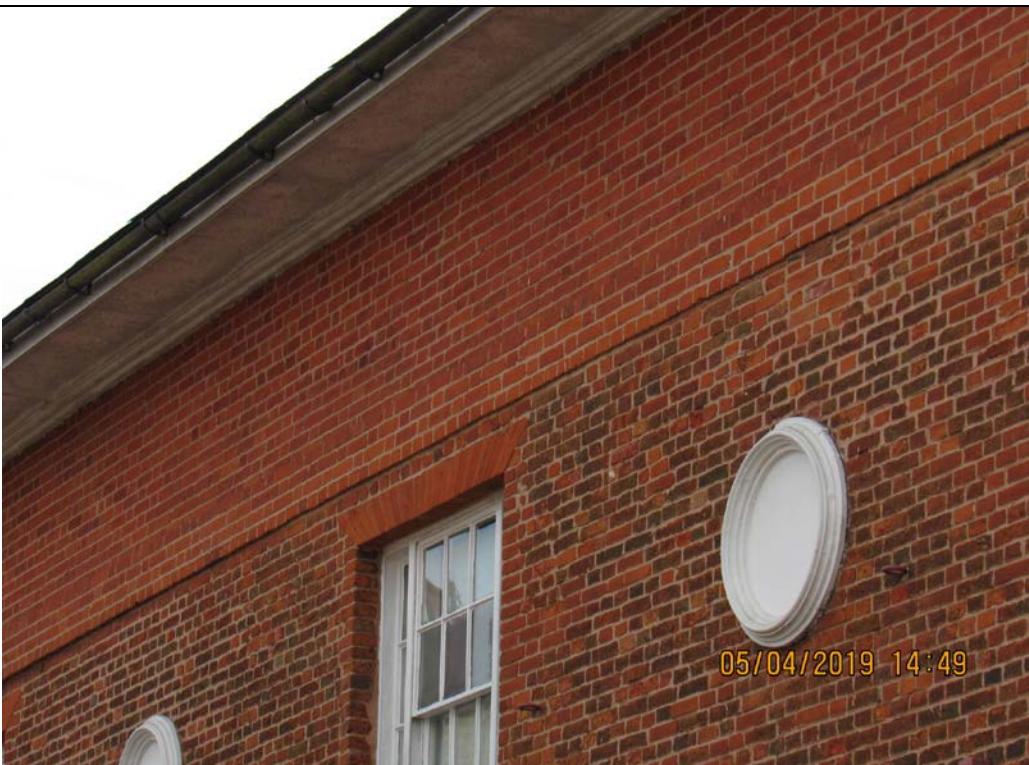
Photograph 03
Side Elevation showing band of
repaired brickwork at Eaves level.

- 3.2.3 There is a band of brickwork at eaves level which has been recently repaired / rebuilt. **See photo 3.**
- 3.2.4 The large arched windows and the brickwork below have clearly been added at a later date to the original brickwork. The original stone quoins are clearly visible either side of the infill brickwork. **See photo 4 and 5.**

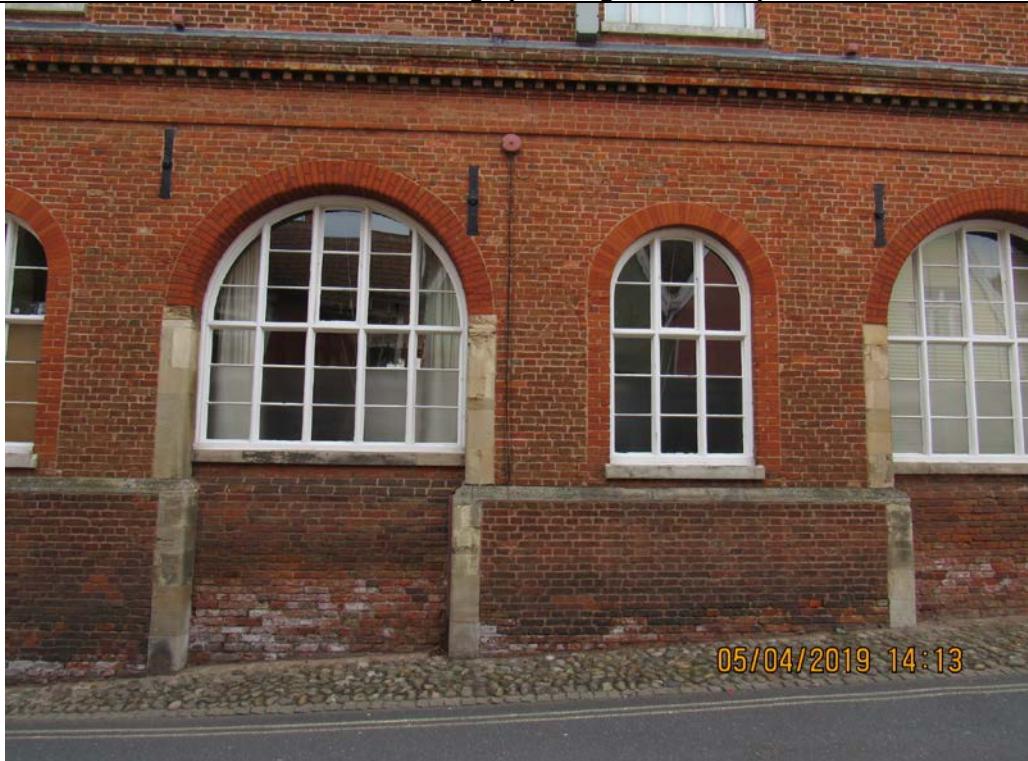
Photograph 06
Larger brick arches springing off original stone quoins.
Smaller windows clearly cut in later.

- 3.2.5 It was observed that the smaller arched windows do not have the same brickwork to the arches. This leads to the assumption that these smaller windows were again cut out of the original brickwork. **See photos 6, 7 and 8.**

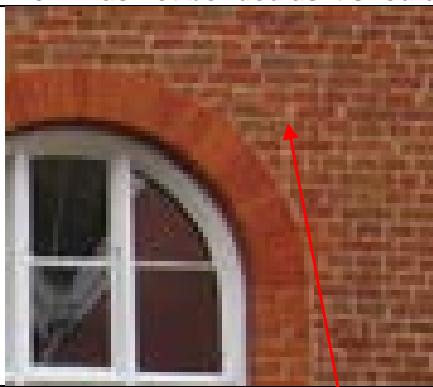
Photograph 08

This photo shows where the brickwork around the arch was rebuilt once the new arch was formed.

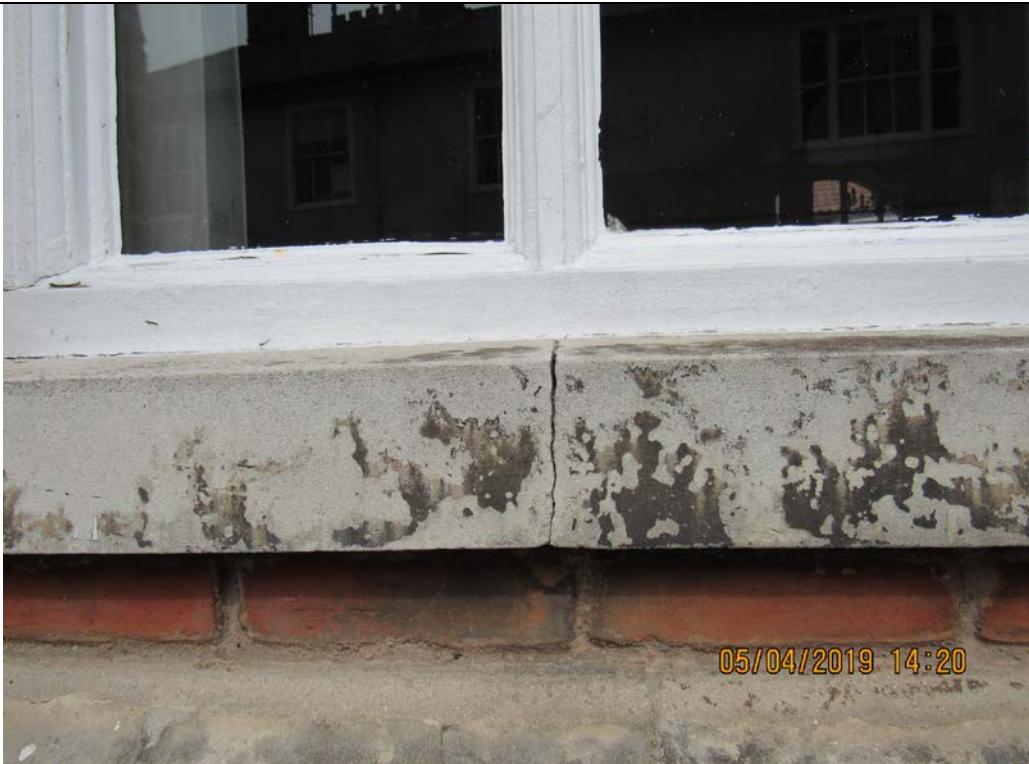
Photograph 09

- 3.2.6 A number of the window sills to the smaller windows have broken their backs. They appear to be tilting downwards at their ends, which is a classic failure. The ends of the sills have been built into the brickwork either side of the windows. The brickwork on the sides has a greater load and is pushing downwards. The brickwork under the smaller windows were once loaded, but the introduction of the windows released this load.

- 3.2.8 Either way the movement is probably historic and the damage to the sill may have been there for a long time.
- 3.2.9 However, these cracks do need to be addressed as they are currently allowing water ingress, which is not good for the long-term performance of the timber window frames.

Cracked stone window sill on ground floor level. (Note crack wider at top)

- 3.2.10 The cracks could be re-stitched together with a proprietary masonry anchor. The crack could then be repaired with a resin-based product that could be colour matched.

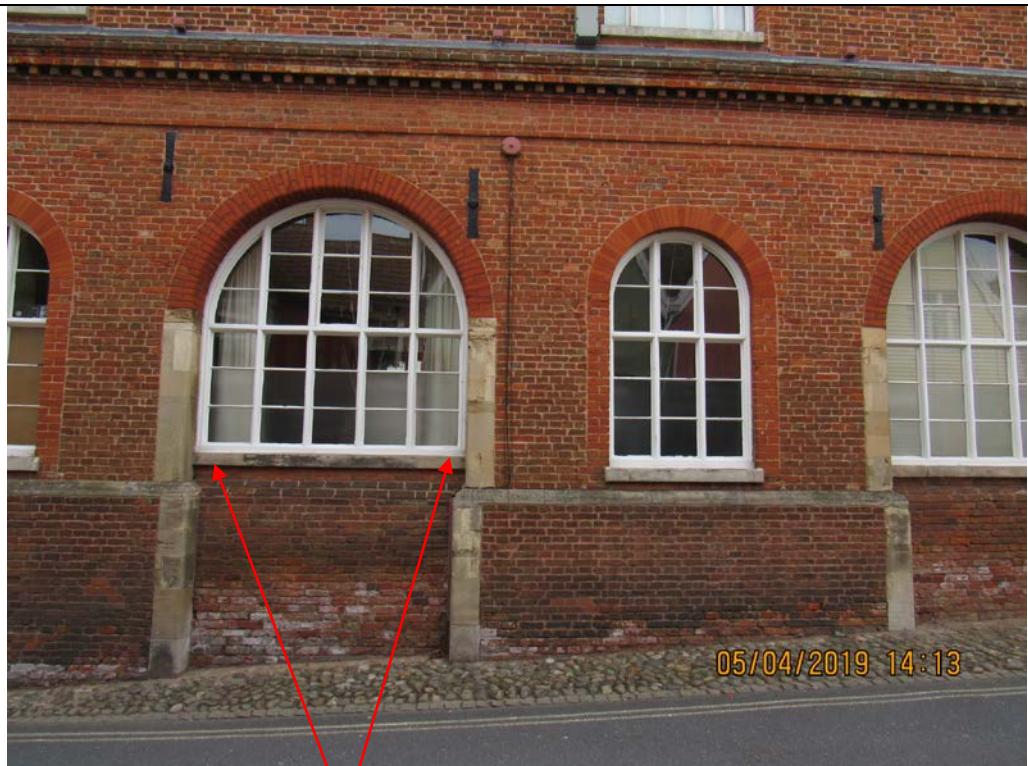
Photograph 11
Previously repaired sills

- 3.2.12 It was noted that this repair procedure has previously been undertaken on other window sills, which appear to have been successful and are starting to weather down now. **See photos 9, 10 and 11.**

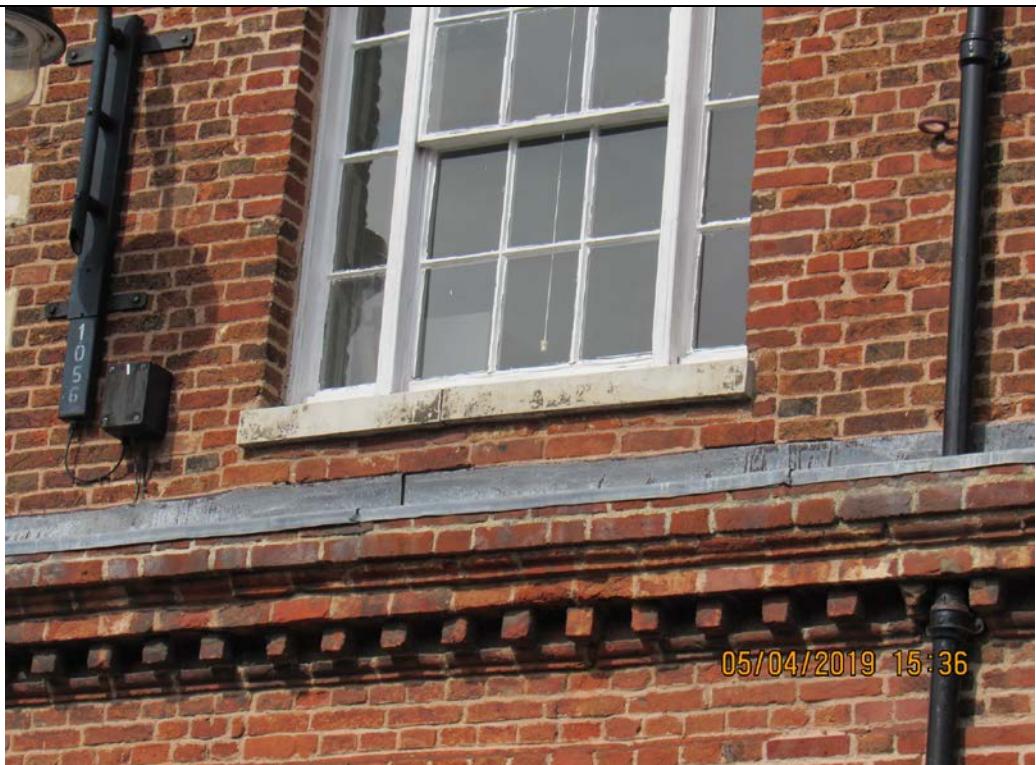
Photograph 12
Cracked window sill on upper floor.

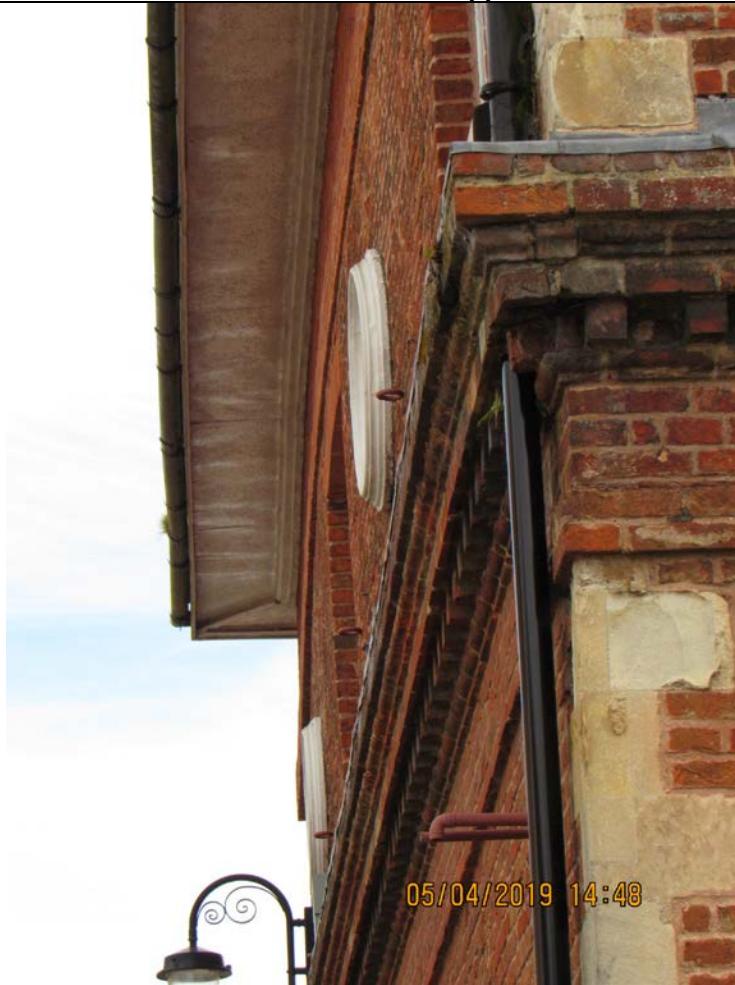
Photograph 13

- 3.2.15 This work had obviously been a fairly large contract, involving a considerable amount of scaffolding, in the centre of such a busy town.
- 3.2.16 It was observed that this new brickwork has a substantial longitudinal bow in it at the top. This is on both the longitudinal sides. This suggests that it was rebuilt with the bow in it. This would have been undertaken to follow the original bowed walls and roof. **See photo 13.**

- 3.2.17 This suggests there has been historic roof spread, which at some time has pushed the brick wall out of plumb and caused the masonry to fail which needed rebuilding.

- 3.2.20 It may be possible to retrospectively install tie rods at upper eaves level. There are already tie rods visible at first floor level on the outside of the building. **See photo 14.**

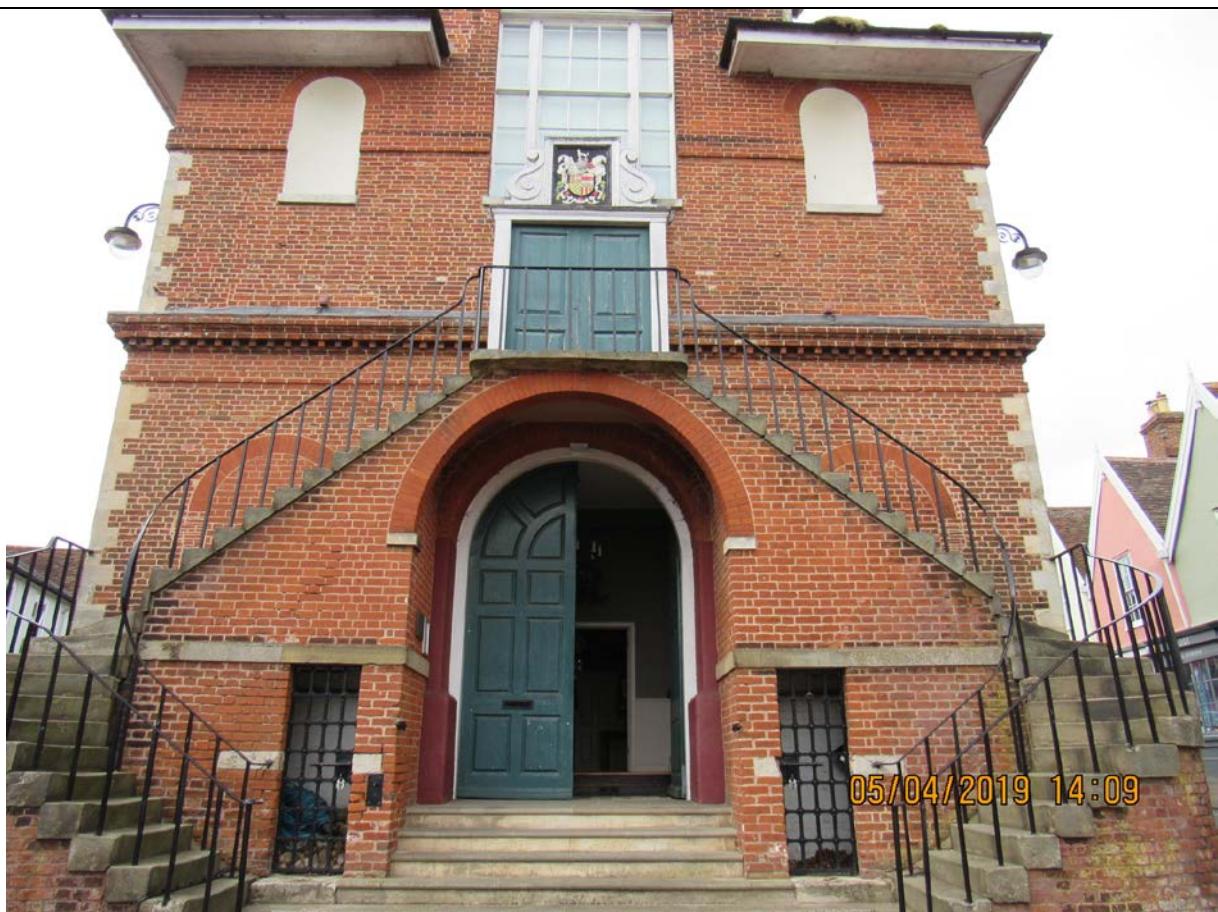
Photograph 15

- 3.4.1 The Balustrades appear in reasonable condition for their age. However, there are a few issues which need to be highlighted. **See photo 15.**
- 3.4.2 These steps are used for many events, notably for wedding functions and public ceremonies, such as Remembrance Day. They are also not restricted to the general public and revellers on a Saturday night.

- 3.4.10 At this stage we would recommend the council undertakes a formal Risk Assessment for these Balustrades, with regards to the frequency of use.
- 3.4.11 It would be a fair assessment that in any rolling year over 1,000 people will use these steps, be it paid for, public function, or unconsented use.

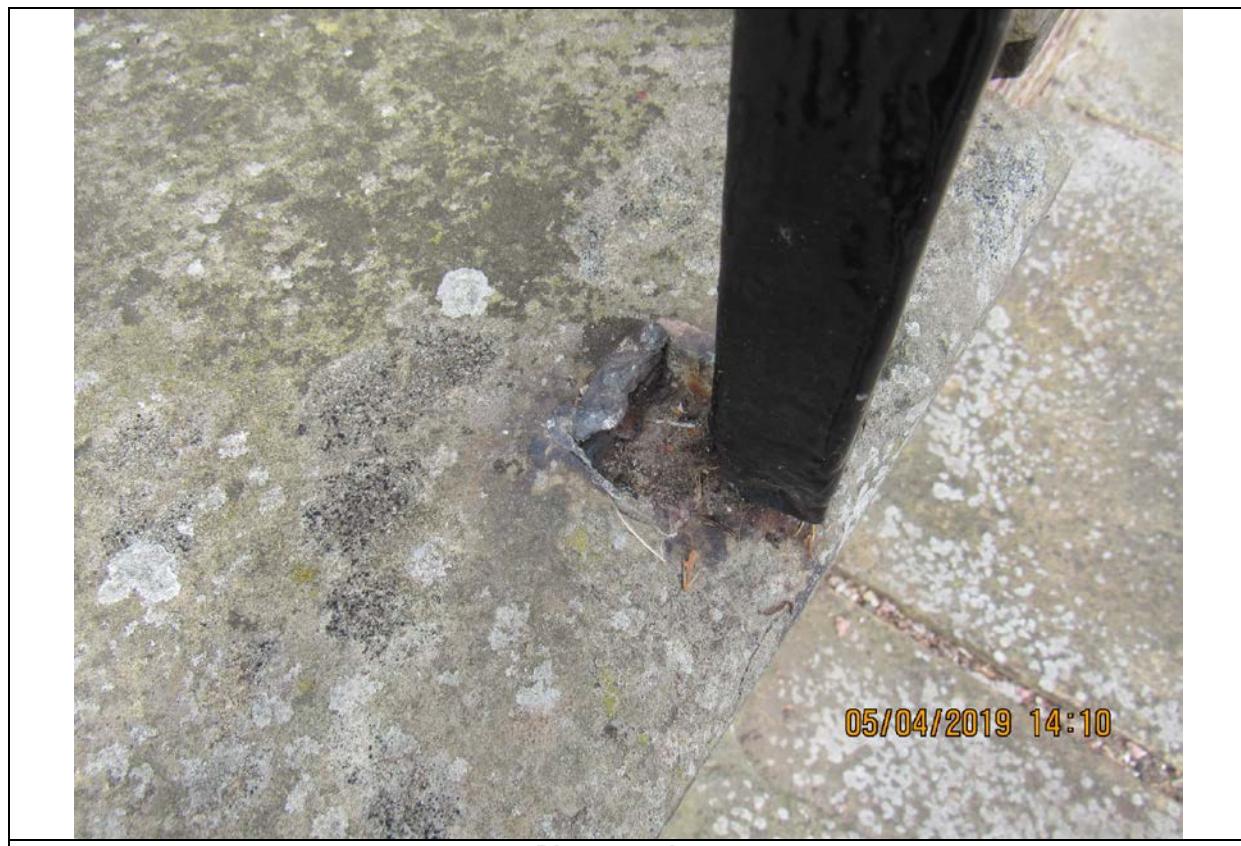
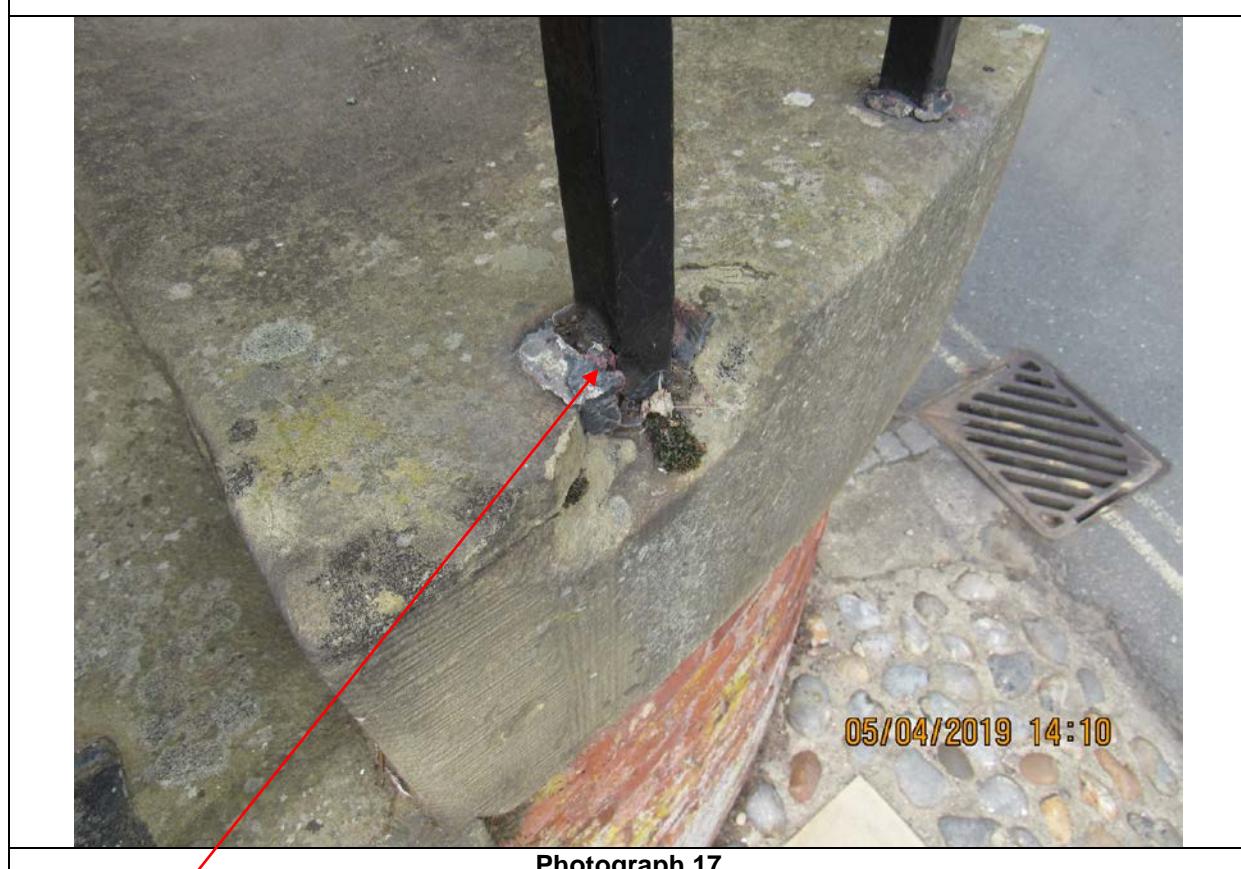
- 3.4.9 On the main entrance steps to the east we did observe at least 2 posts which have failed completely. **See photos 16, 17 and 18.**

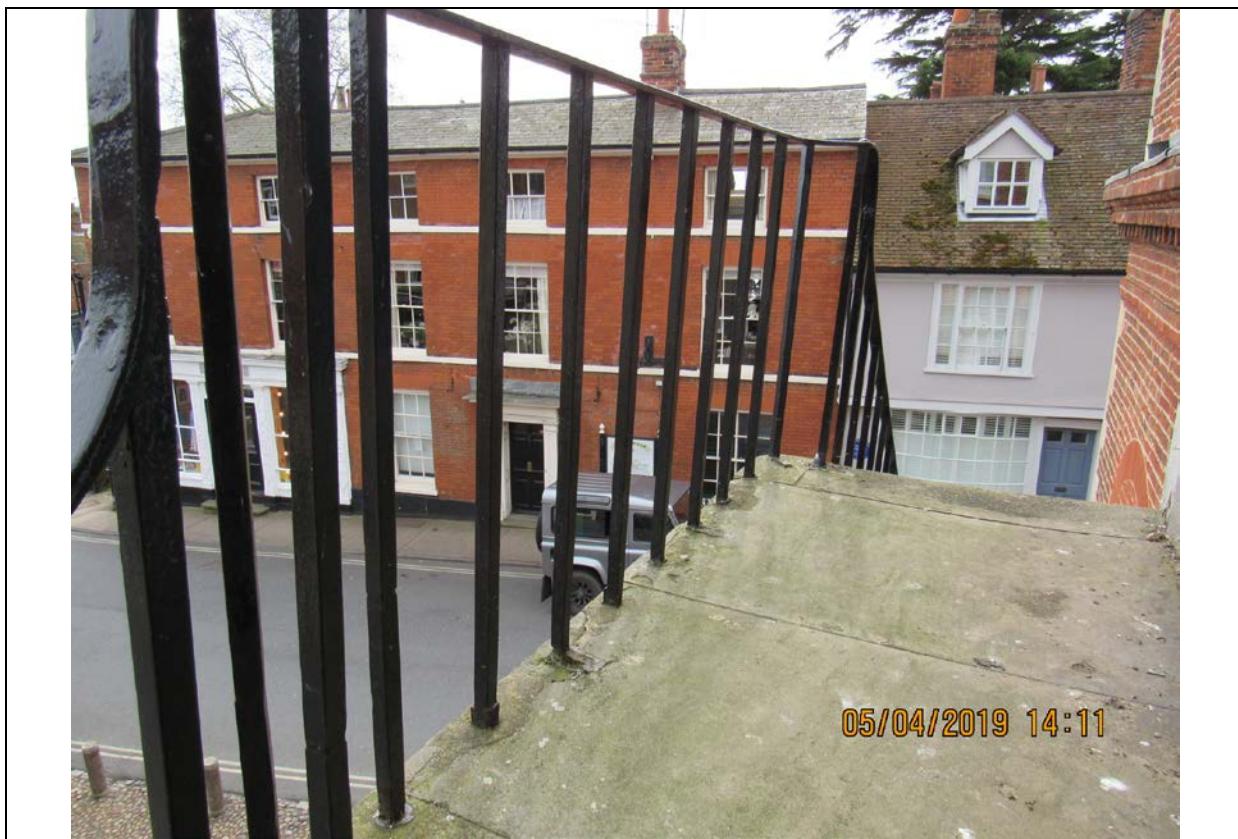
Photograph 18
The existing balcony is only 900mm (3feet) high and not 1100mm

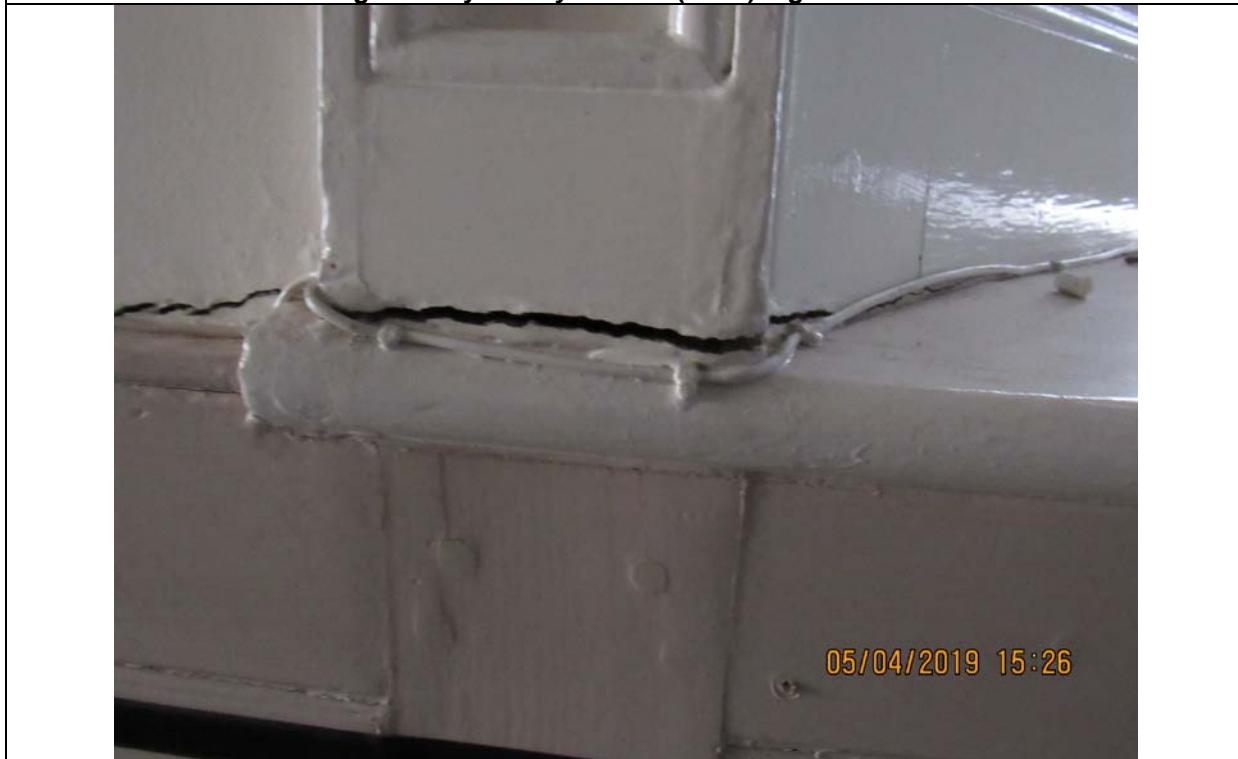
- 3.5.1 We have previously discussed the bowed walls and roof spread at first floor eaves level. When we were inspecting the first floor internally, we did observe some fairly large horizontal and diagonal cracks in the external walls. **See photos 19, 20, 21, 22, 23 and 24.**

Photograph 19
Internal cracks

- 3.5.3 It is recommended that these cracks be filled and painted, then inspected on a monthly basis to see if they re-appear. If they re-appear then we will need to do further investigations.

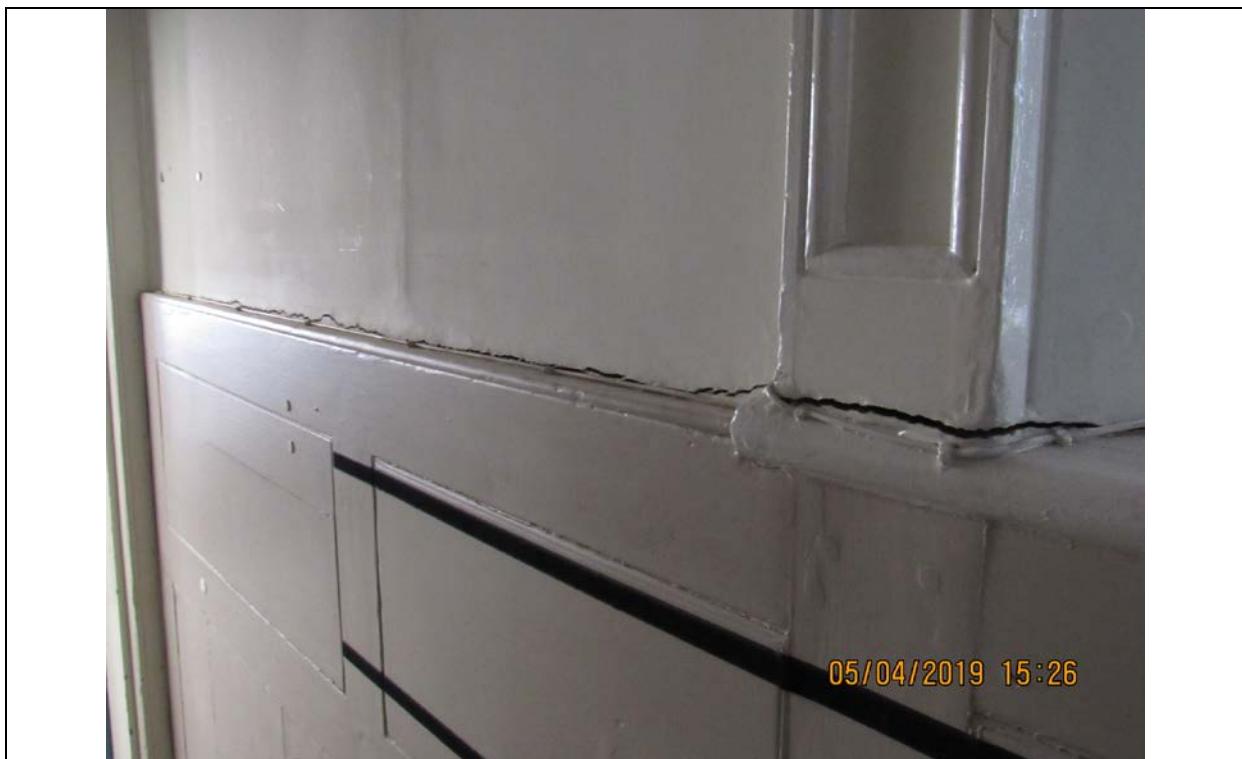
Photograph 20
Internal cracks extending along wall

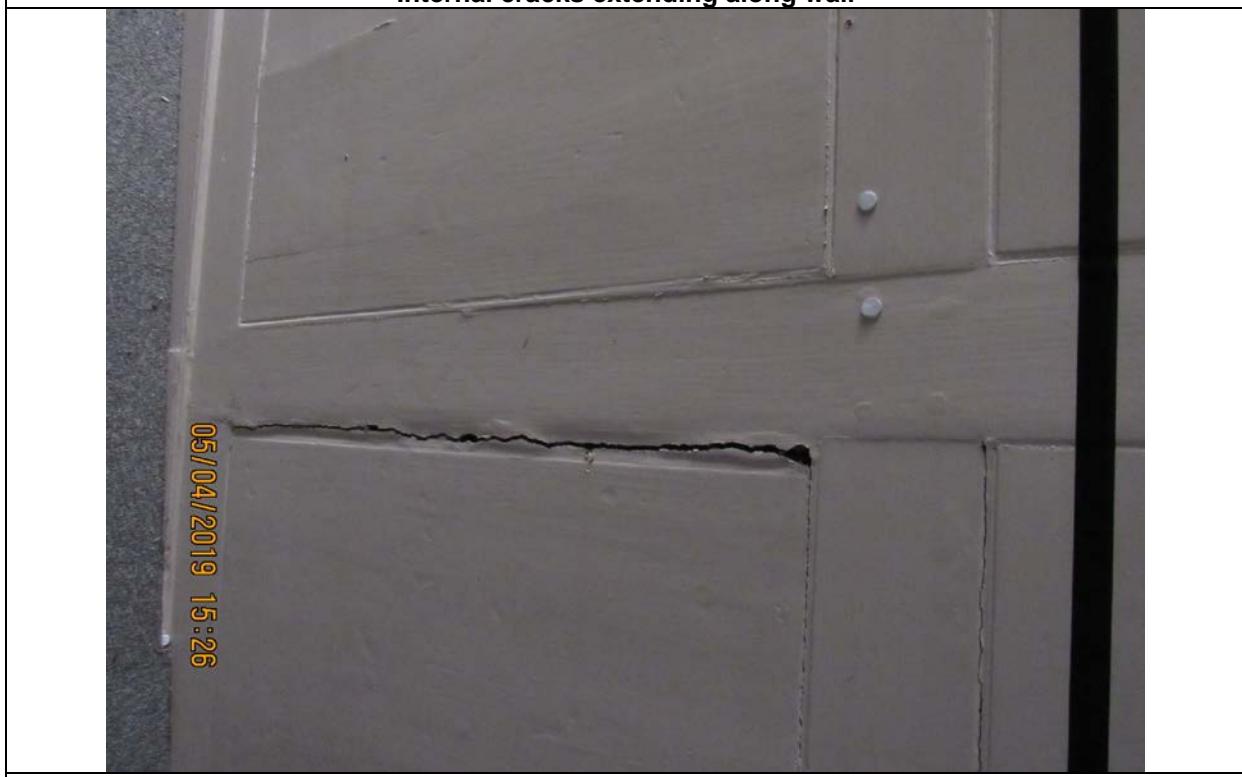
Photograph 21
Cracks in panelling

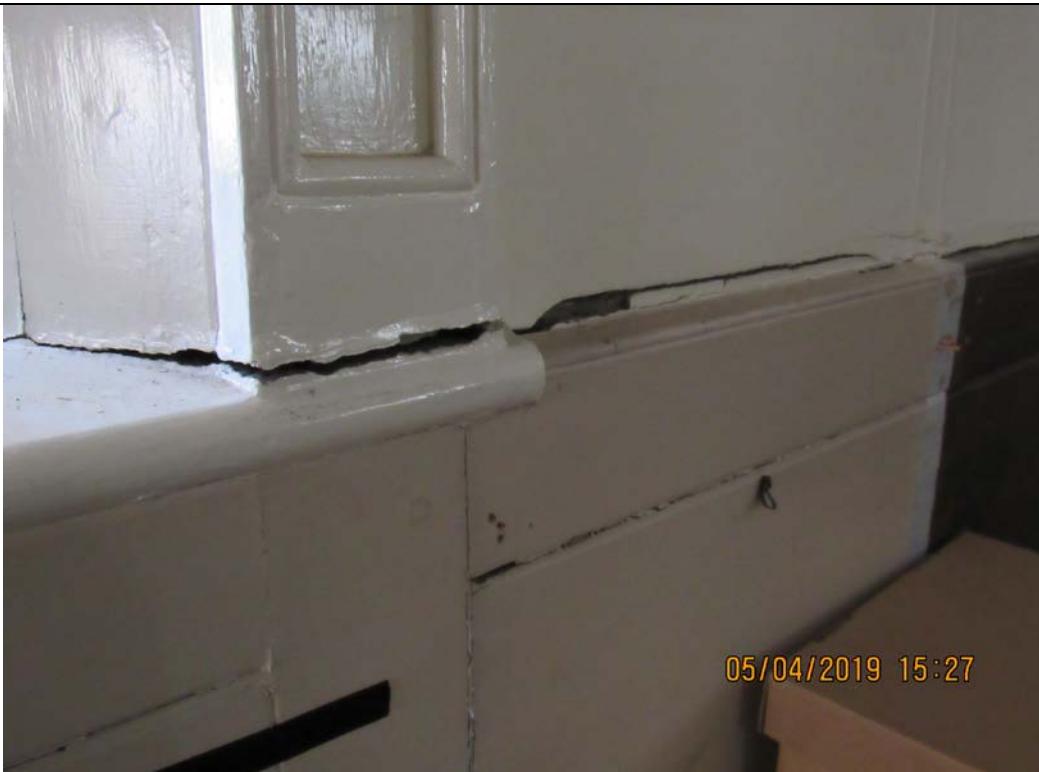
Photograph 22
Similar Cracks the other side of the window.

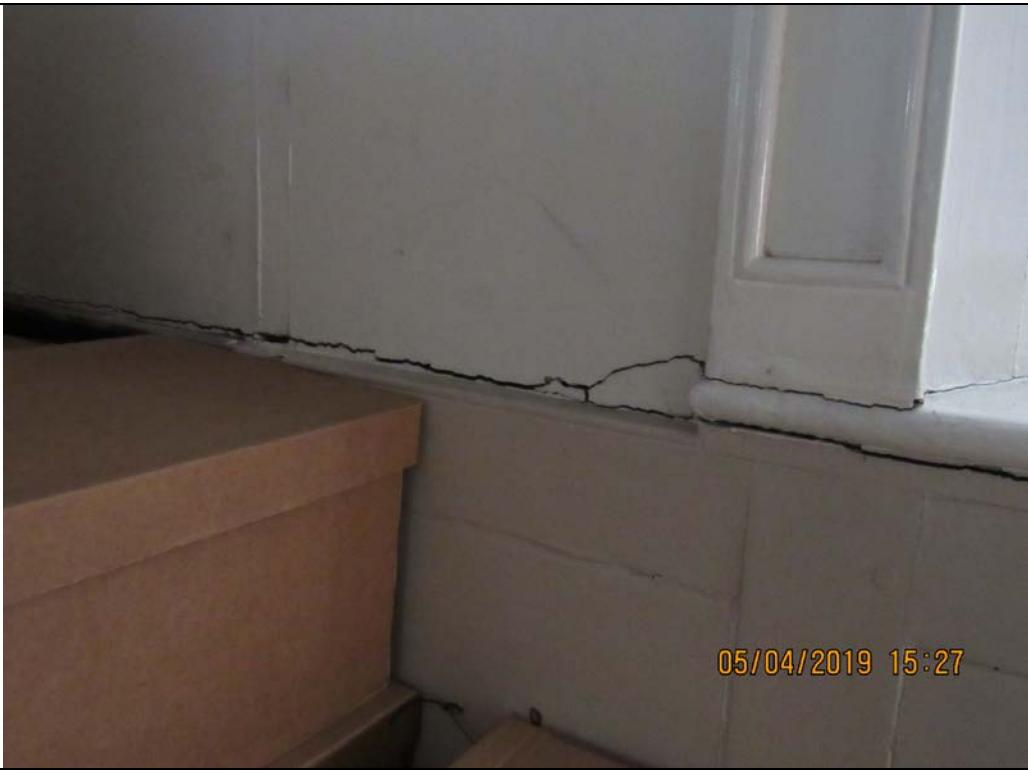
Photograph 23
Similar cracks on the other side wall.

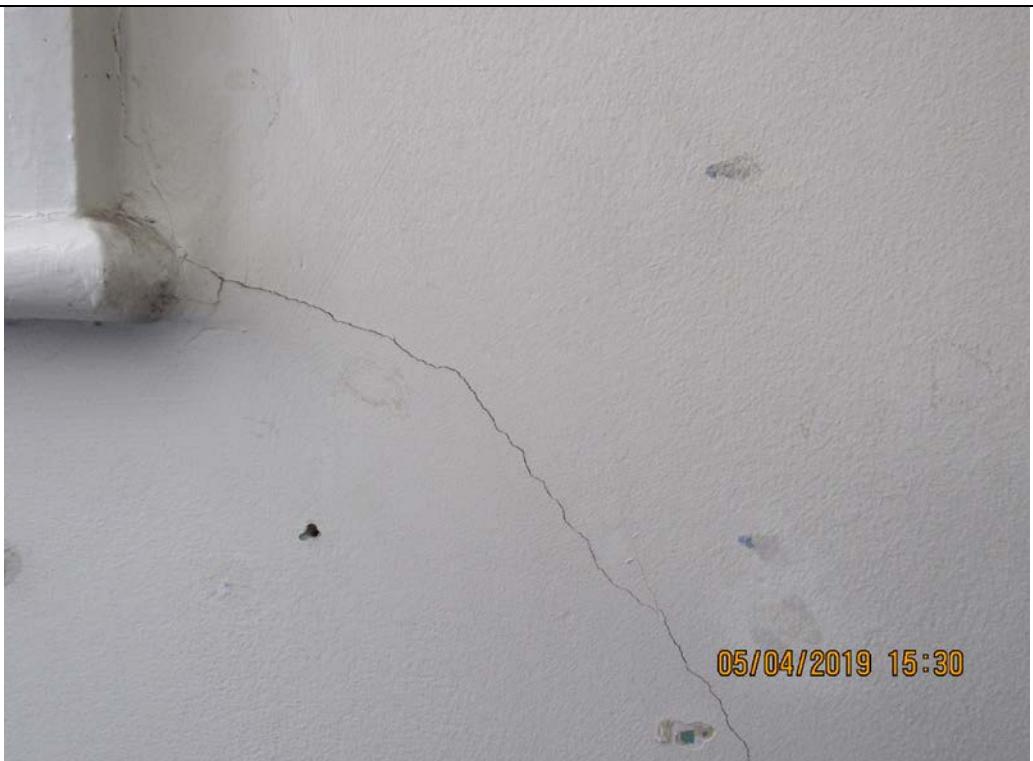
Photograph 24
Diagonal Cracks leading from corner of window

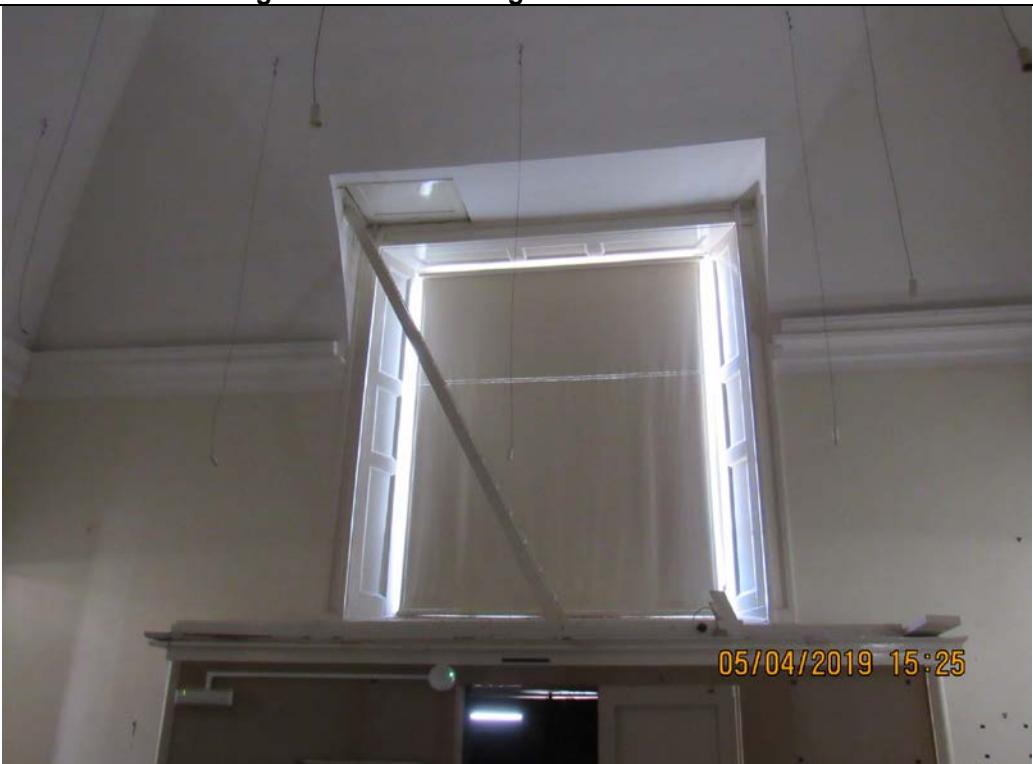
- 3.6.3 The access to the clock, that needs regular attendance, does not meet modern requirements regarding fall from height under C.D.M. (Construction Design Management) Regulations. We would recommend a formal Risk Assessment and Method Statement be undertaken on this activity. **See photo 25**

Photograph 25
Ladder access to clock and hatch to confined space behind clock

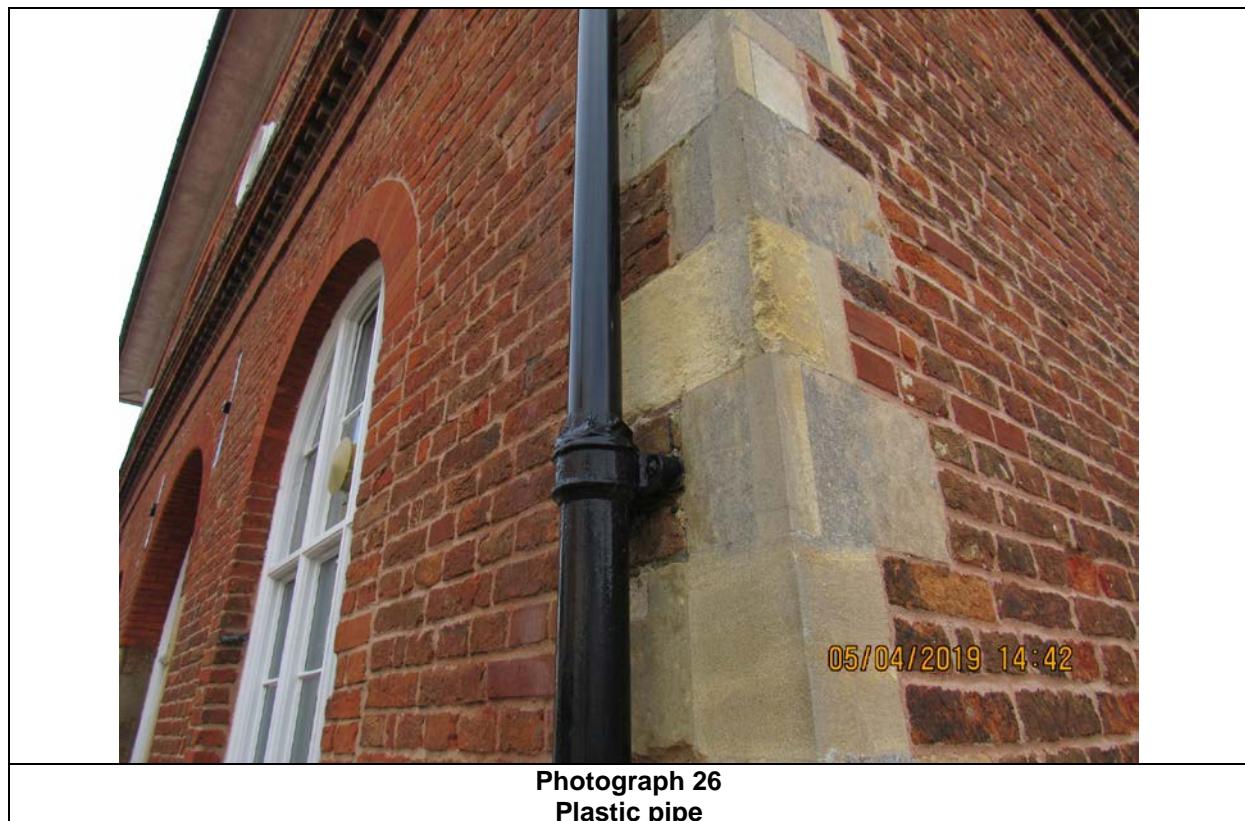
- 3.6.5 One of the rainwater pipes to the north elevation has a section missing, which has been replaced temporarily with a plastic pipe. This is probably only a temporary fix, as plastic is not inducive with listed buildings. However, anti-climb guards could be installed. **See photo 26**

Photograph 26
Plastic pipe

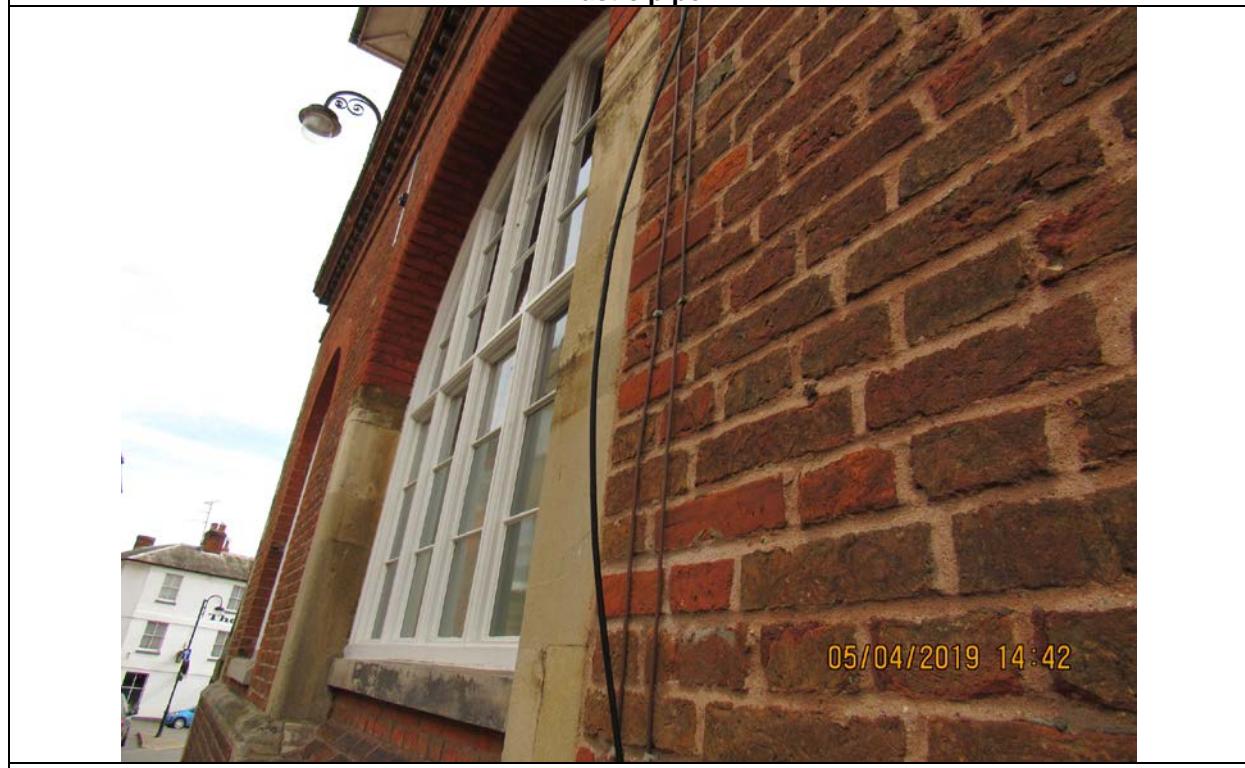
- 3.6.6 There is some cabling mounted externally which appears to go to an old electric bell. We tested the fire alarm and this bell did not activate. One of the cables was loose and had obviously been pulled away from the building recently. **See photo 27 and 28.**

Photograph 27
External loose wiring

- 3.6.7 This wiring should be tested to see if it is still alive and remove if dead, or install it in ducting if alive.
- 3.6.8 The exterior white gloss to the windows is starting to peel and has exposed the raw wood. There were a few areas showing sign of decaying woodwork. It may be prudent to have these windows re-painted before the situation deteriorates further. We consider this work could be undertaken from a cherry picker, rather than the need for access via scaffolding. **See photos 29, 30, 31 and 32.**

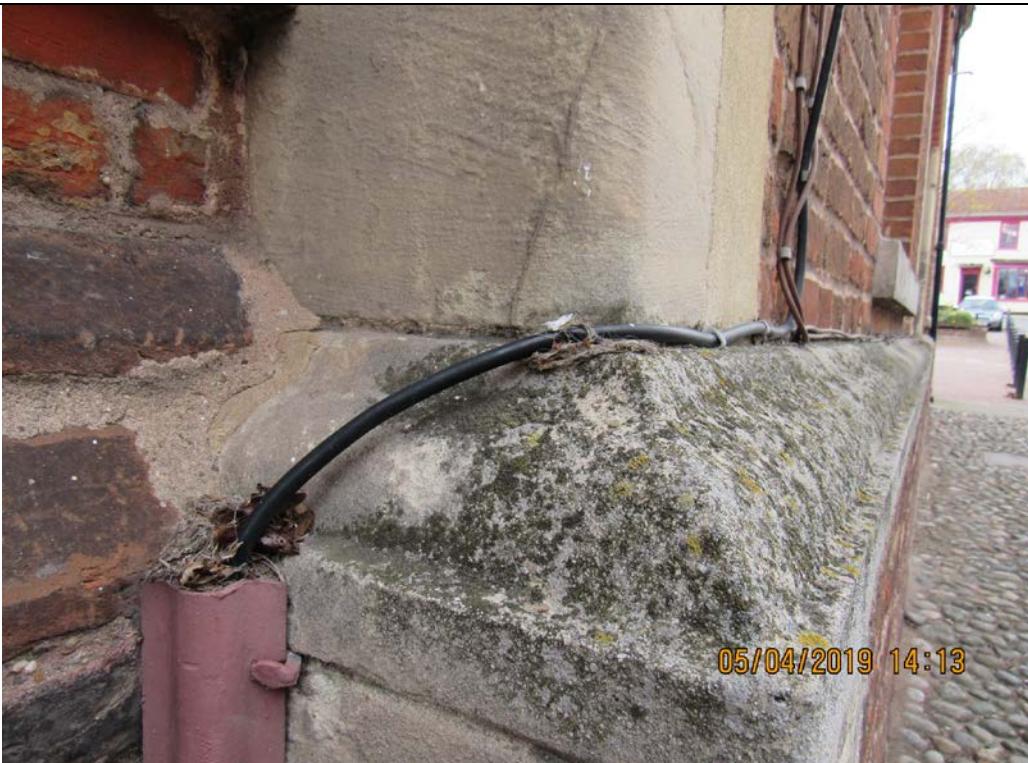
Photograph 28
External wiring

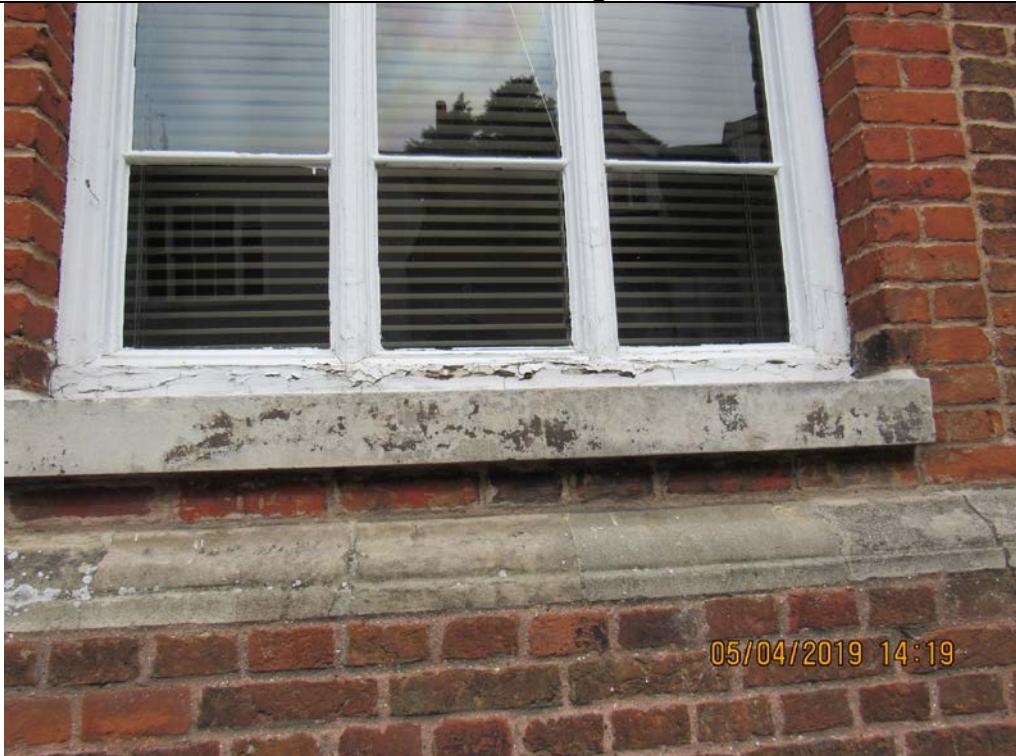
Photograph 29
Peeling paintwork

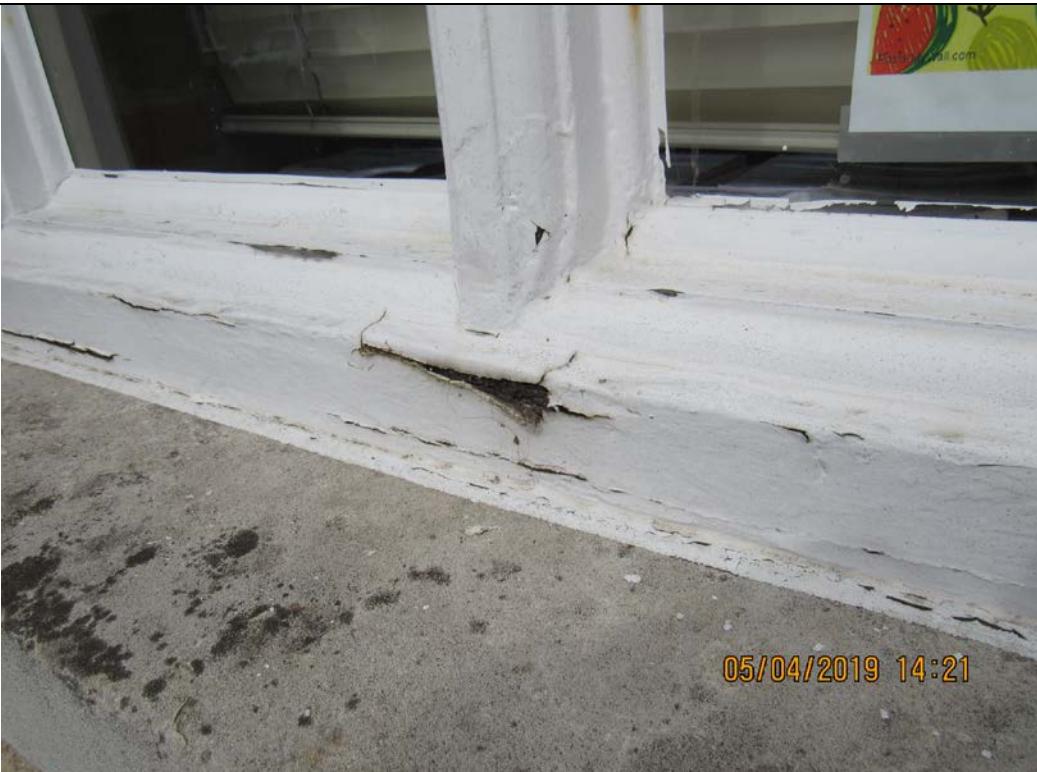
Photograph 31
Window frame beginning to decay
