**CONDITION SURVEY REPORT
OF
SHIRE HALL
WOODBRIDGE
SUFFOLK
IP12 4LP**

Client: Woodbridge Town Council
Market Hill
Woodbridge
Suffolk
IP12 4LP

Date: May 2019

Ref: CT/FA/19552~rep

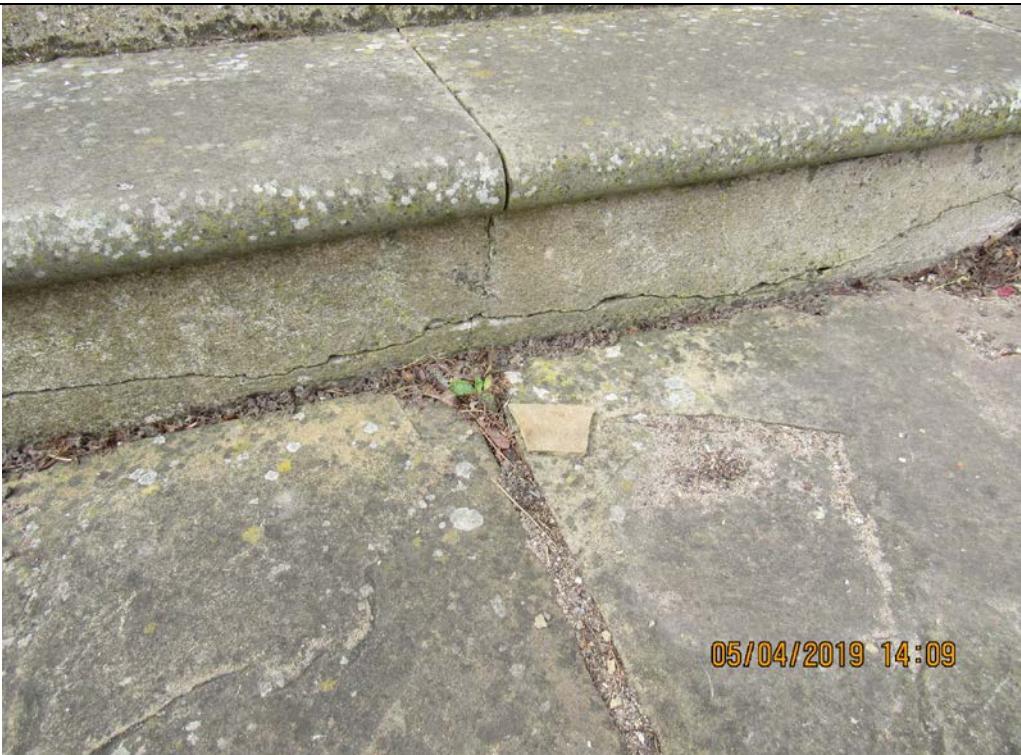
- 3.6.12 While I was inspecting the outside, I did observe several pieces of loose masonry on the floor. These were relatively small pieces, but still a Health & Safety issue. **See photos 33 and 34 and 35.**

Photograph 33
Fallen masonry render on ground outside main entrance (East end)

- 3.6.13 Where they have fallen from is not exactly clear. We would recommend a complete surface check conducted from an elevated platform, i.e. a cherry picker. **See photo 46.**

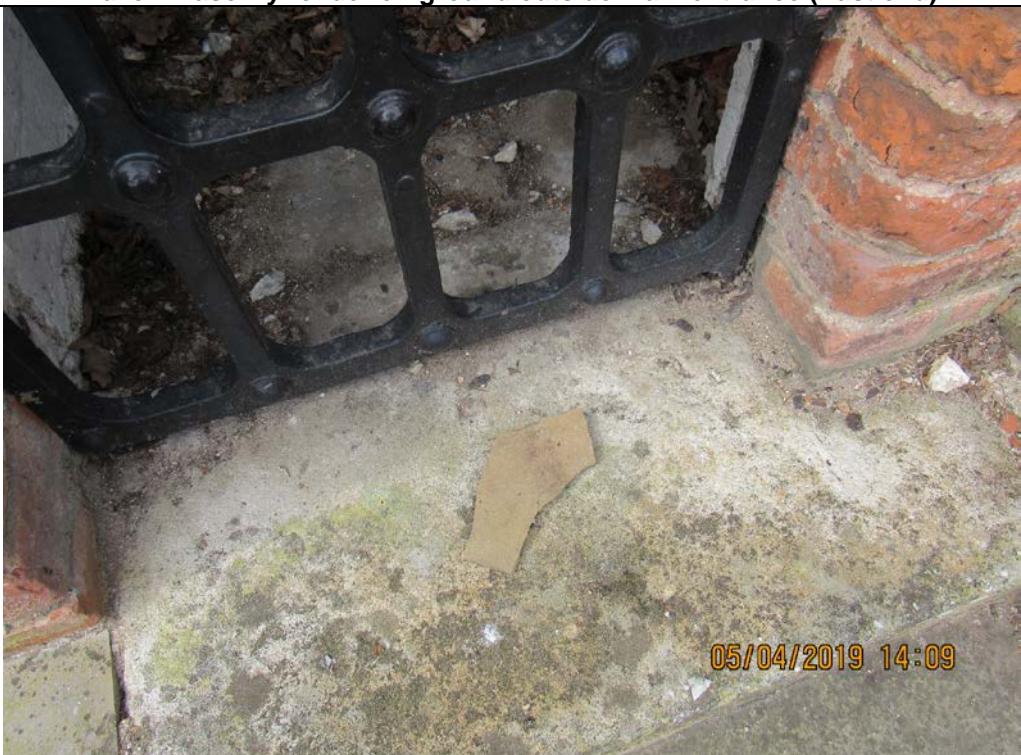
Photograph 34
Piece of render on floor (East end)

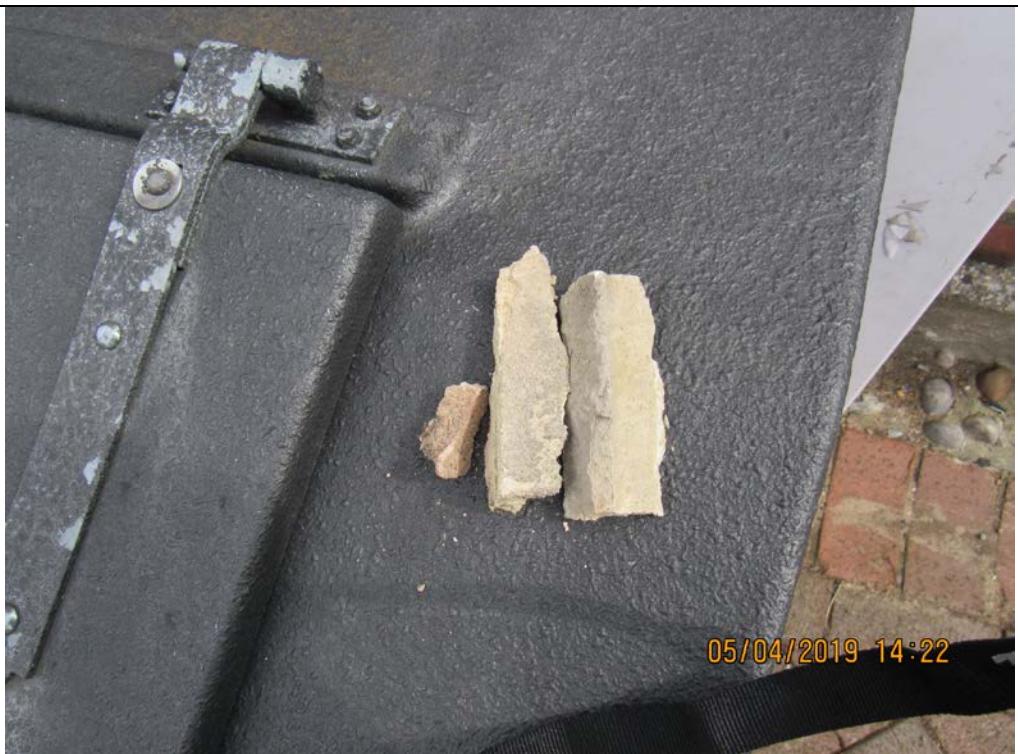
Photograph 35
Loose render collected from North and West elevations

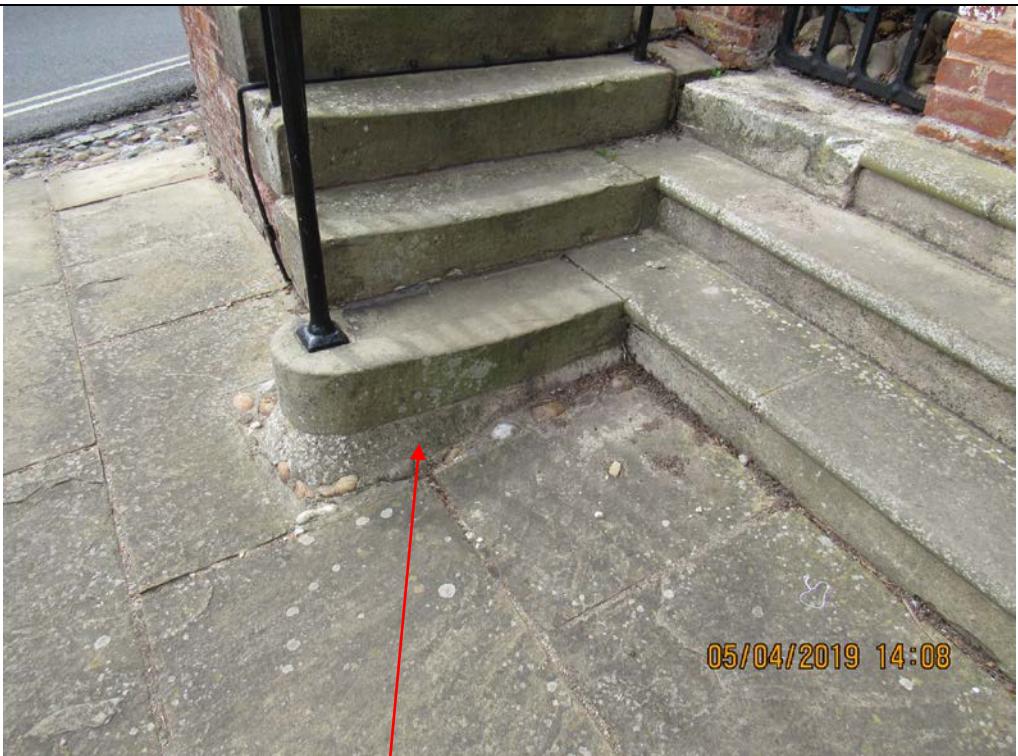
- 3.6.20 The rise to be bottom step is not uniform to the rest of the stairs, bearing in mind the age of the building, this is still a trip hazard. The stone slabs at ground floor level could be raised slightly to reduce this. Another option would be to create a complete level platform between both sets of stairs. This would create a safer gathering area for wedding and functions. This will have to be approved by the Conservation Officer and the Local Planning Department. The other option is for the council to carry out a Risk Assessment under slips, trips and falls from a Health and Safety aspect. **See photo 36, 37 and 38.**
- 3.6.21 This could be constructed with similar stone blocks and would provide a better gathering platform for functions and events.

Photograph 36
Excesses bottom step compared to others

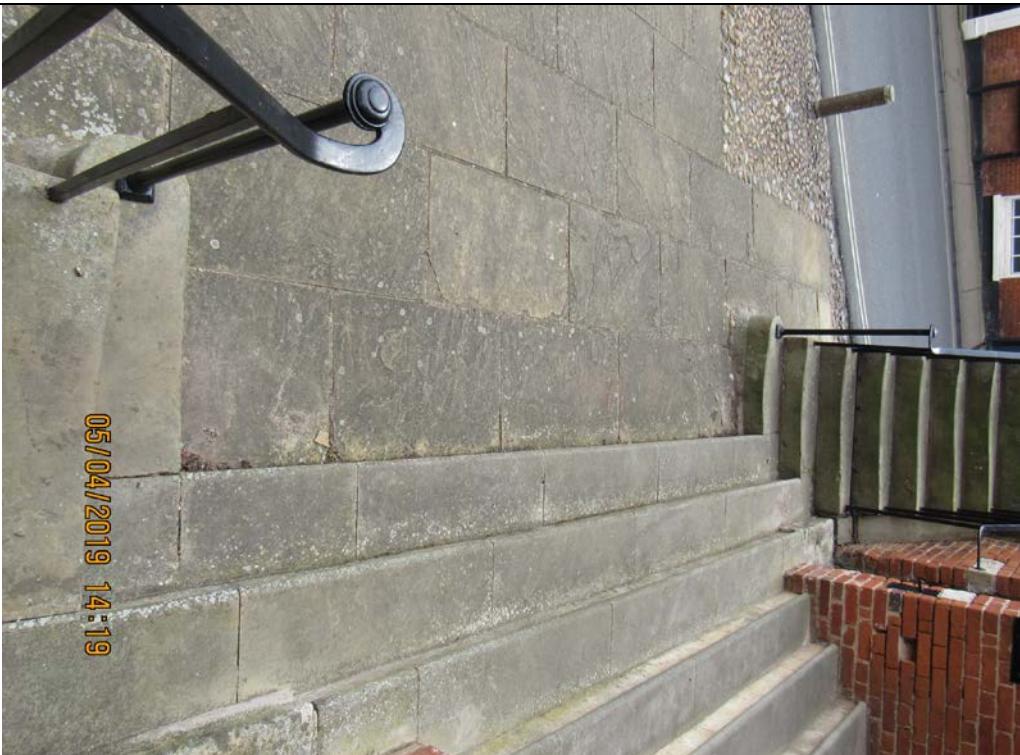
Photograph 37
Possible infill from one side to the other.

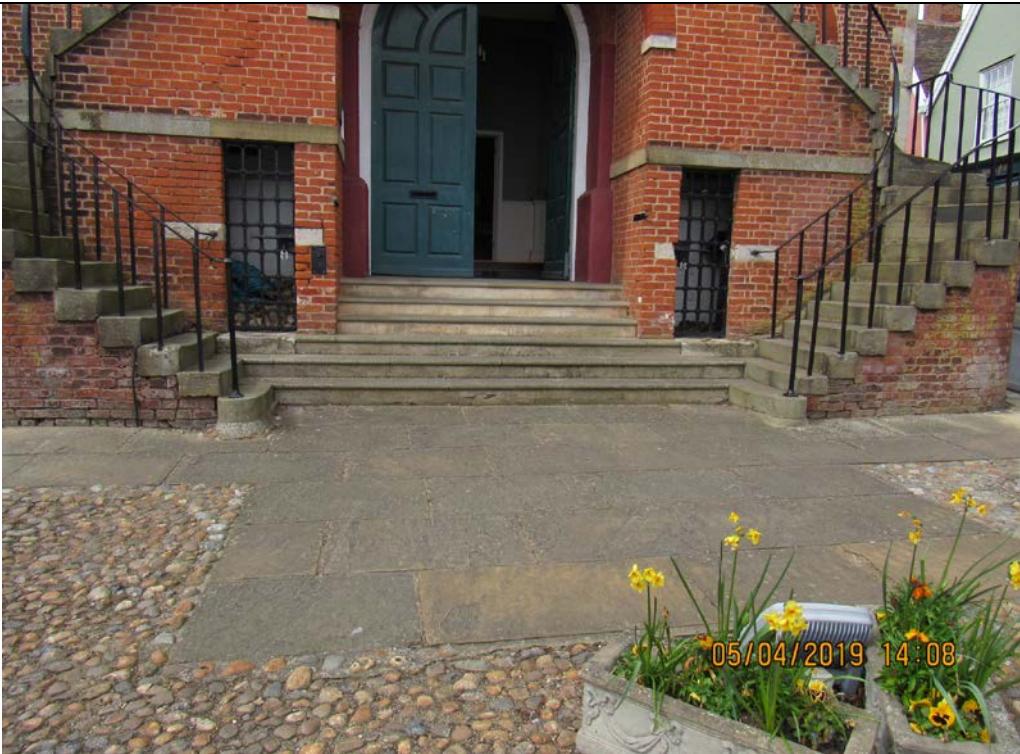
Photograph 38
Possible infill of steps.

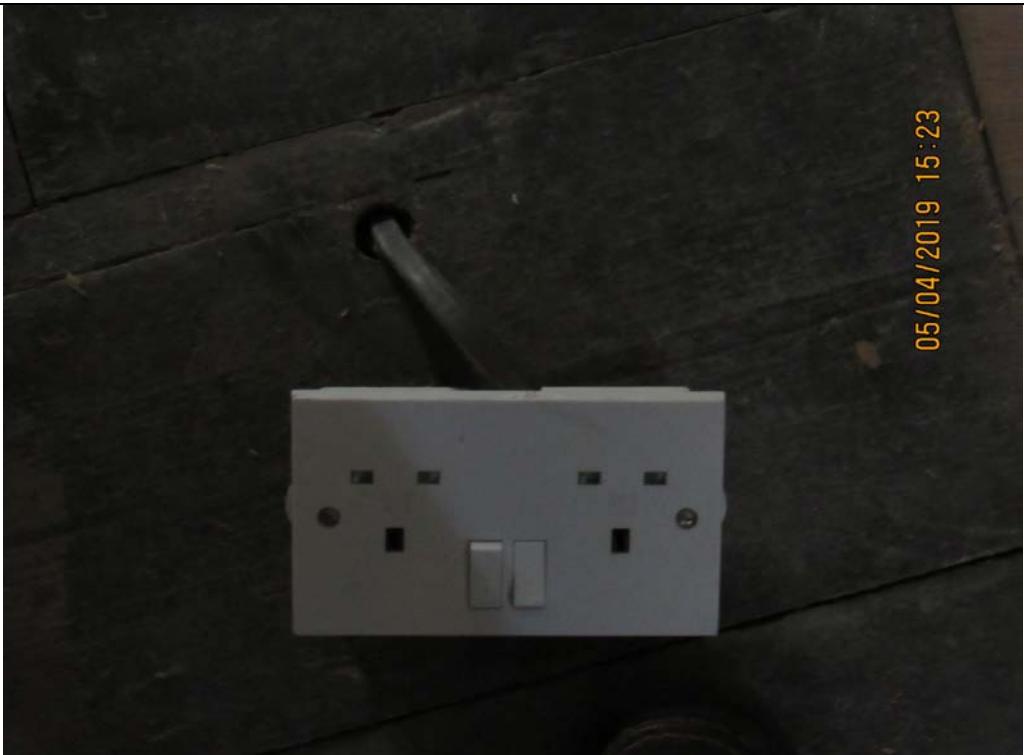
Photograph 39
Loose socket and exposed wiring

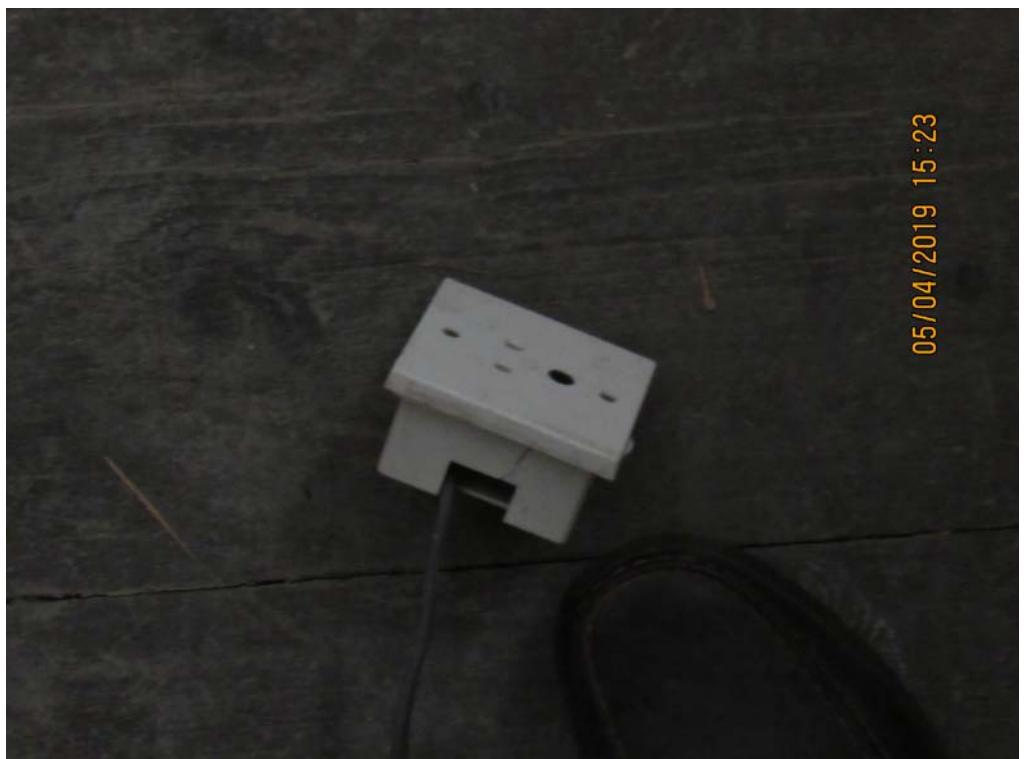
Photograph 40
Old round pin socket with exposed wiring

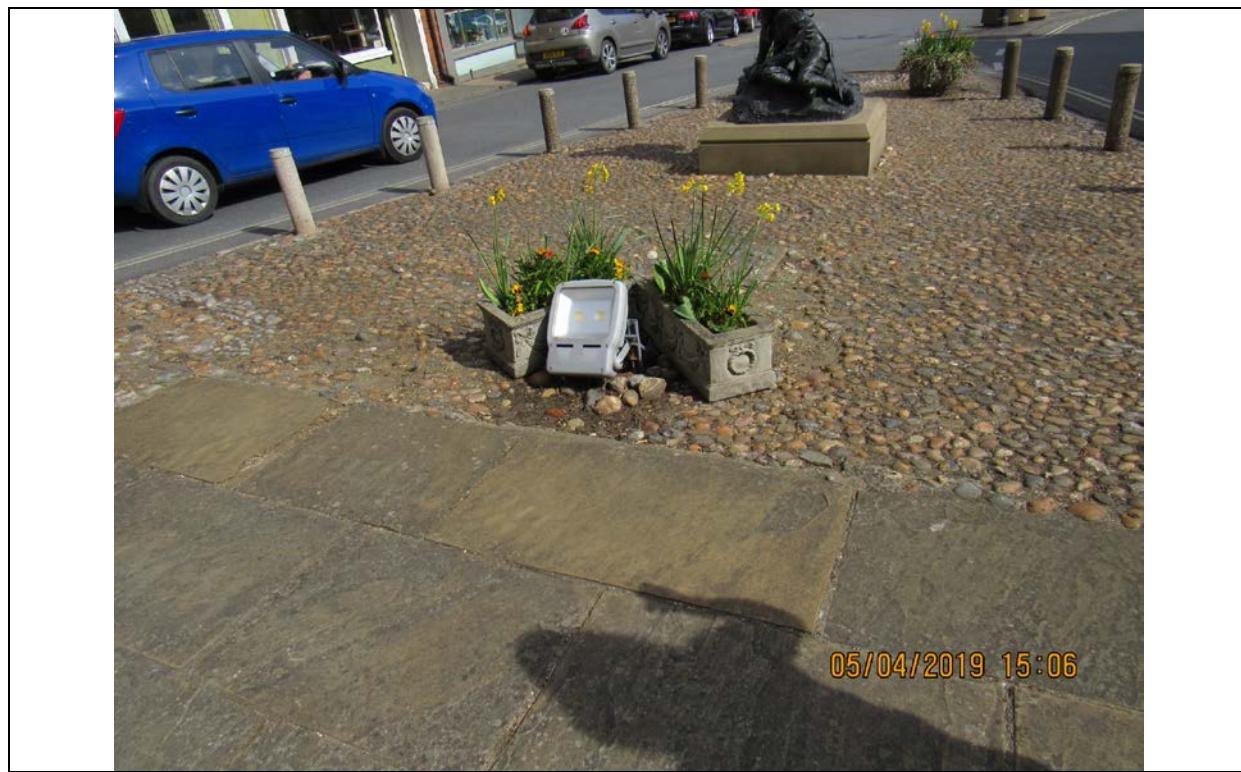
Photograph 41
Unguarded external flood lamp at Ground level

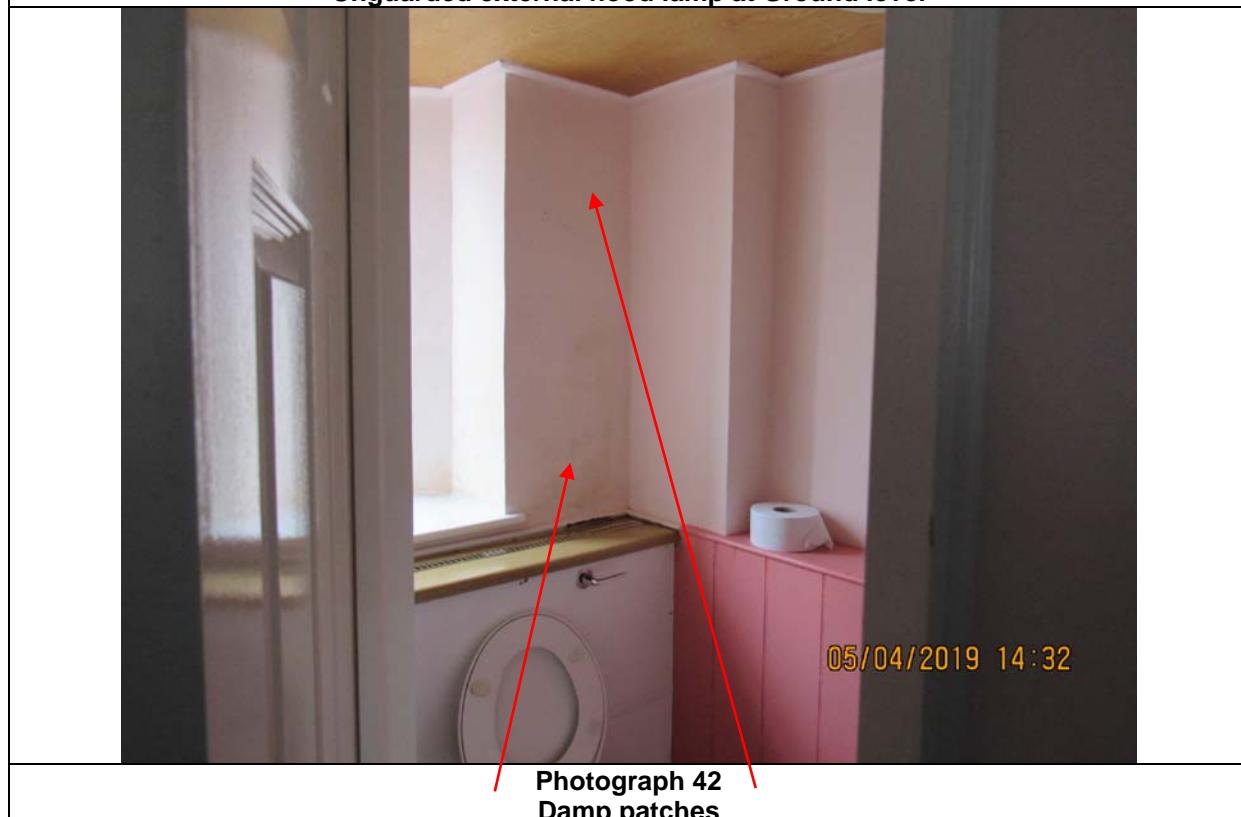
Photograph 42
Damp patches

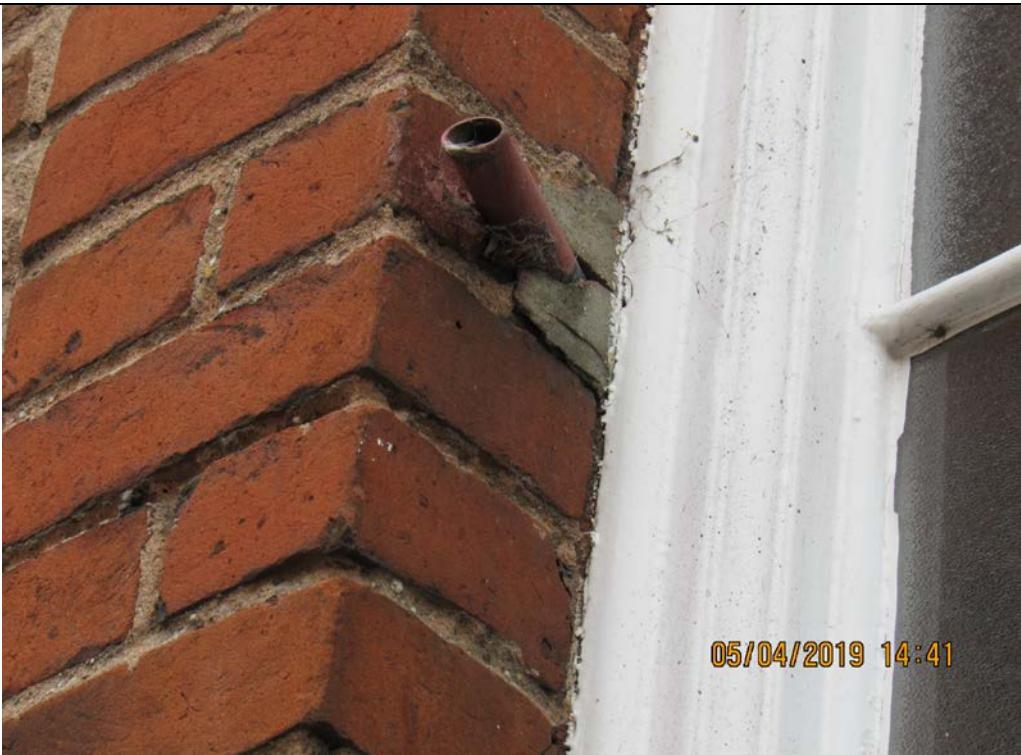
Photograph 43
Pipe outside corresponding to damp patches

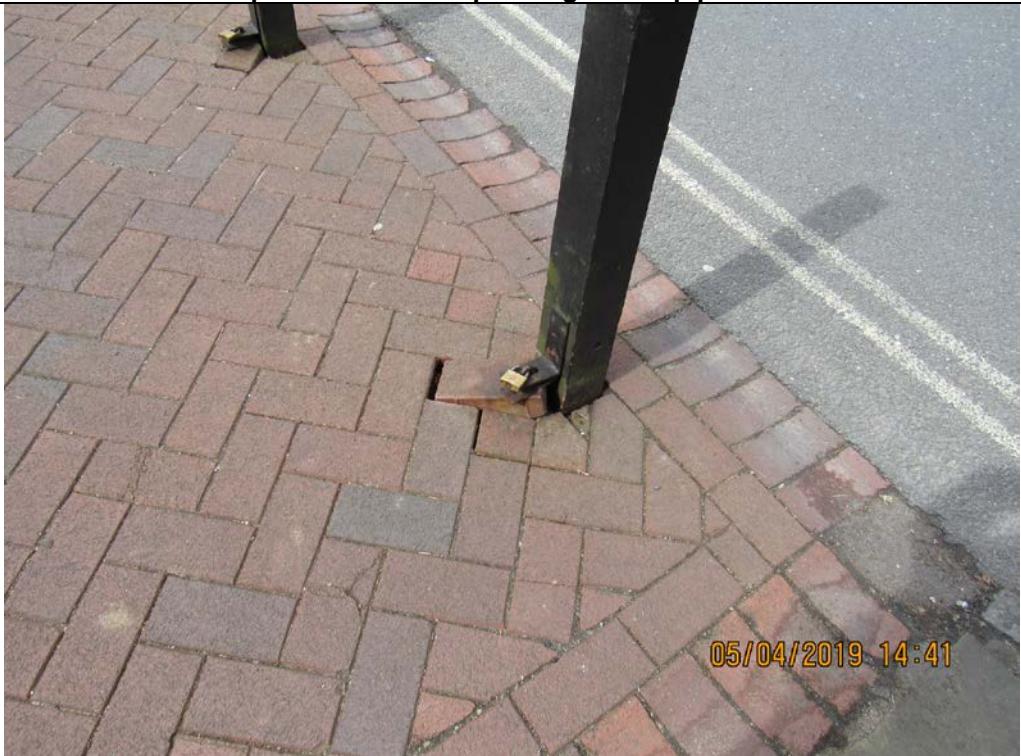
- 3.6.30 This could be undertaken from a cherry picker as previously mentioned, every six months.
- 3.6.31 Externally, there are some missing and loose paving slabs. This is where the weekly market is held. These need to be repaired as they are a tripping hazard. **See photos 44 and 45.**

Photograph 44
Protruding pacing block (over 50mm protrusion)

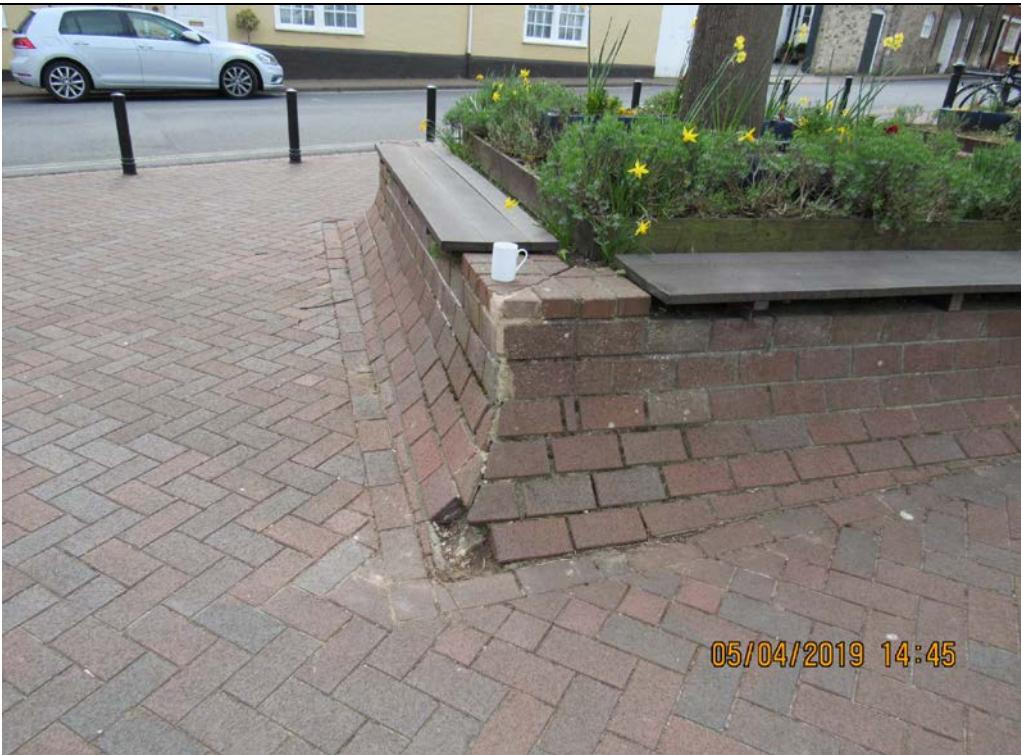
Photograph 45
Missing block paving exposing sharp point.

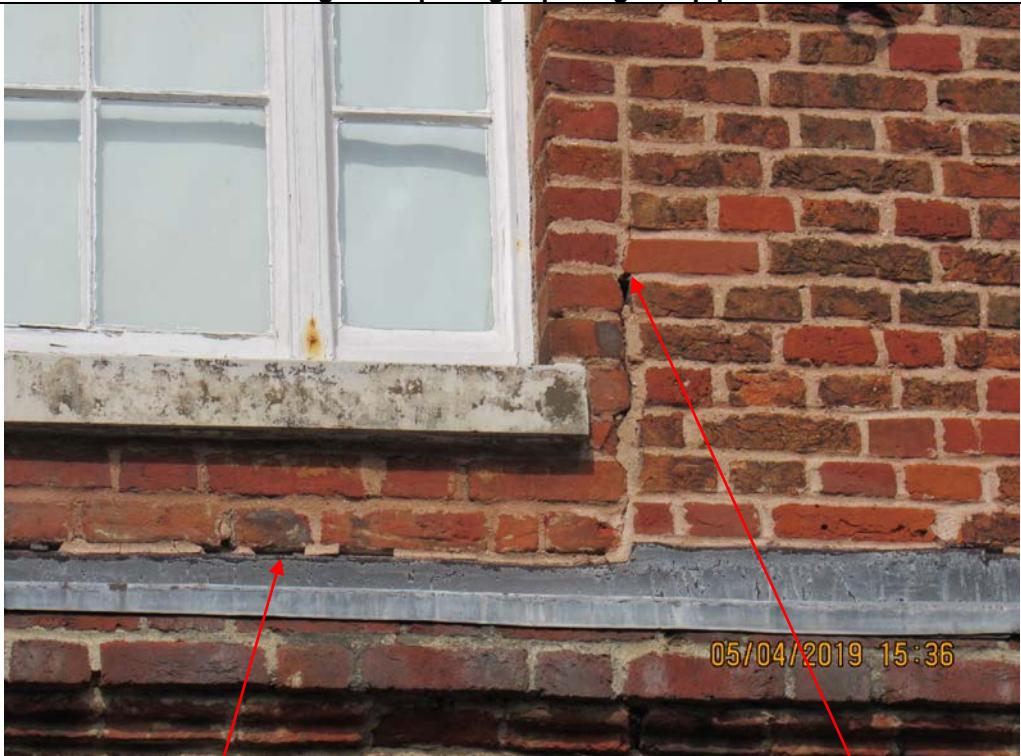
Photograph 46
Poor brickwork around upper windows and missing mortar (North wall)

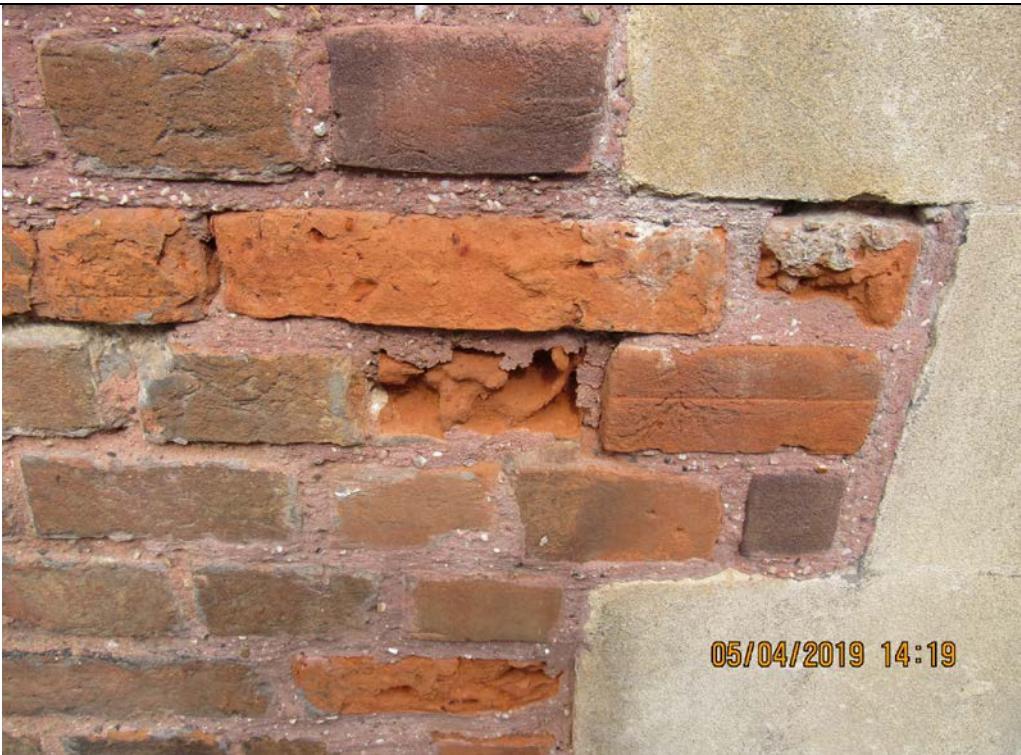
- 3.2.1 The exterior is brick with fixed windows with built in tilt frames for ventilation. **See photo 2.**
- 3.2.2 The bricks are in good condition for their age, with a few showing signs of deterioration / delamination at ground floor level on the west wall. **See photo 47.**

Photograph 47
Delaminating brickwork to south elevation.

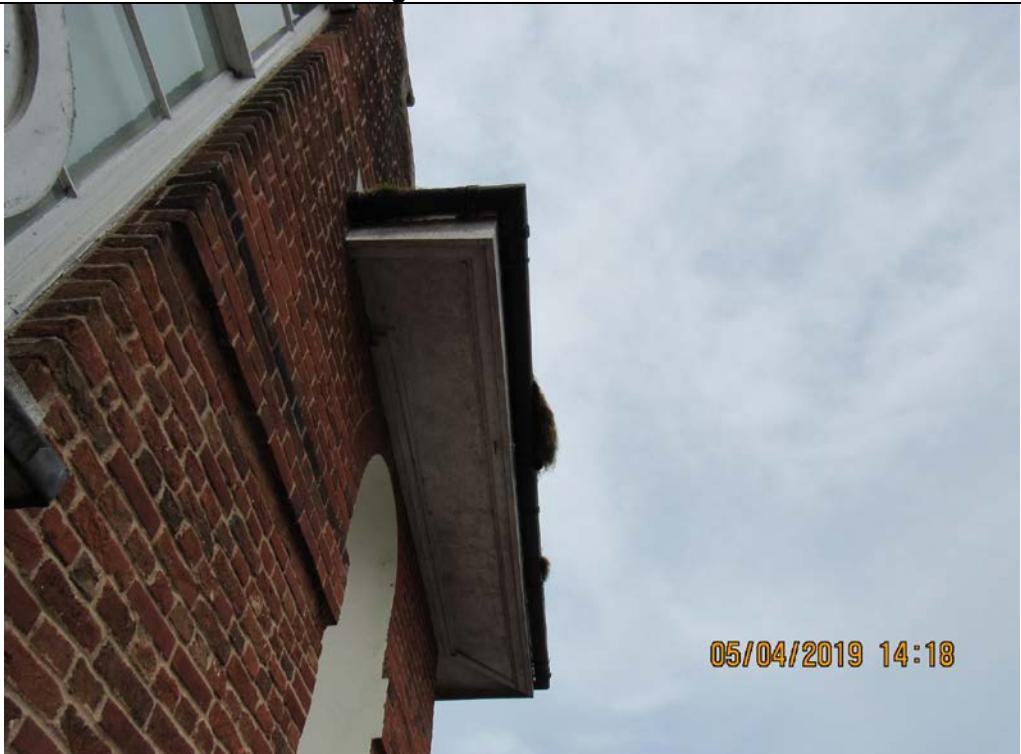
Photograph 48
Clear gutters of vegetation.

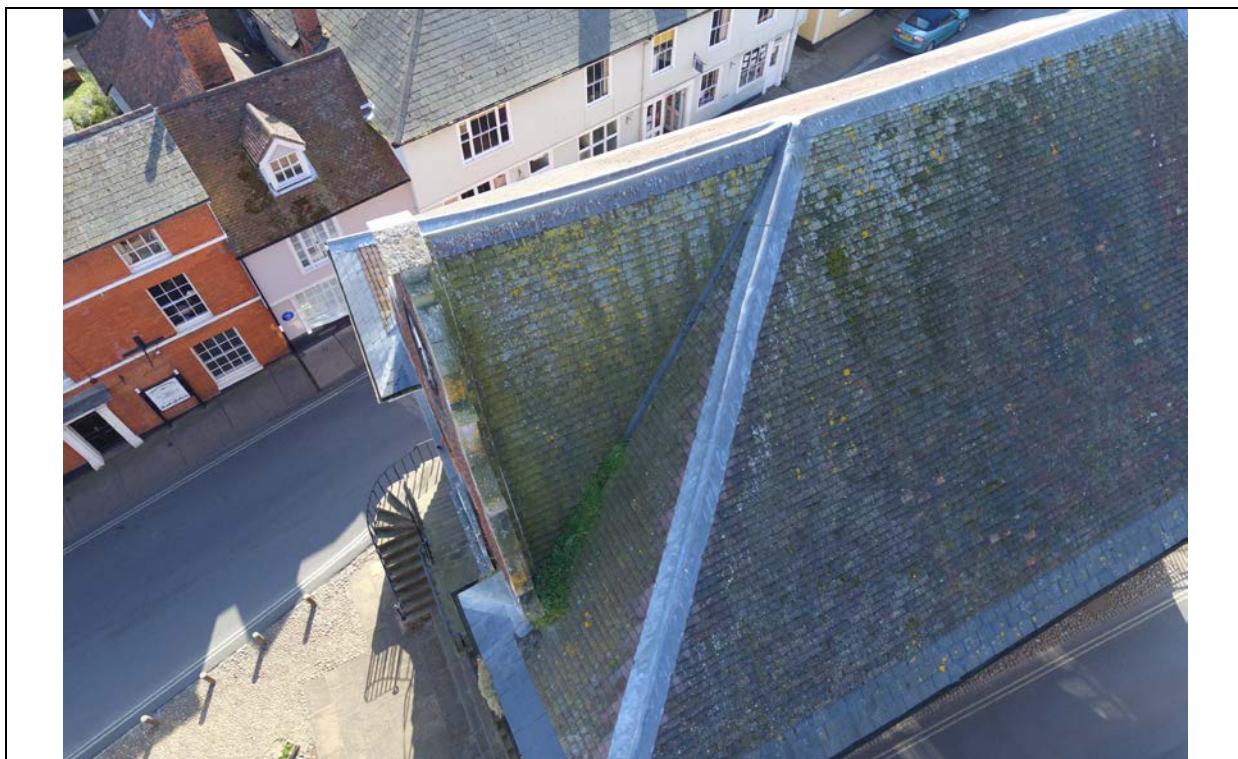
Photograph 49
Vegetation in valley gutter.

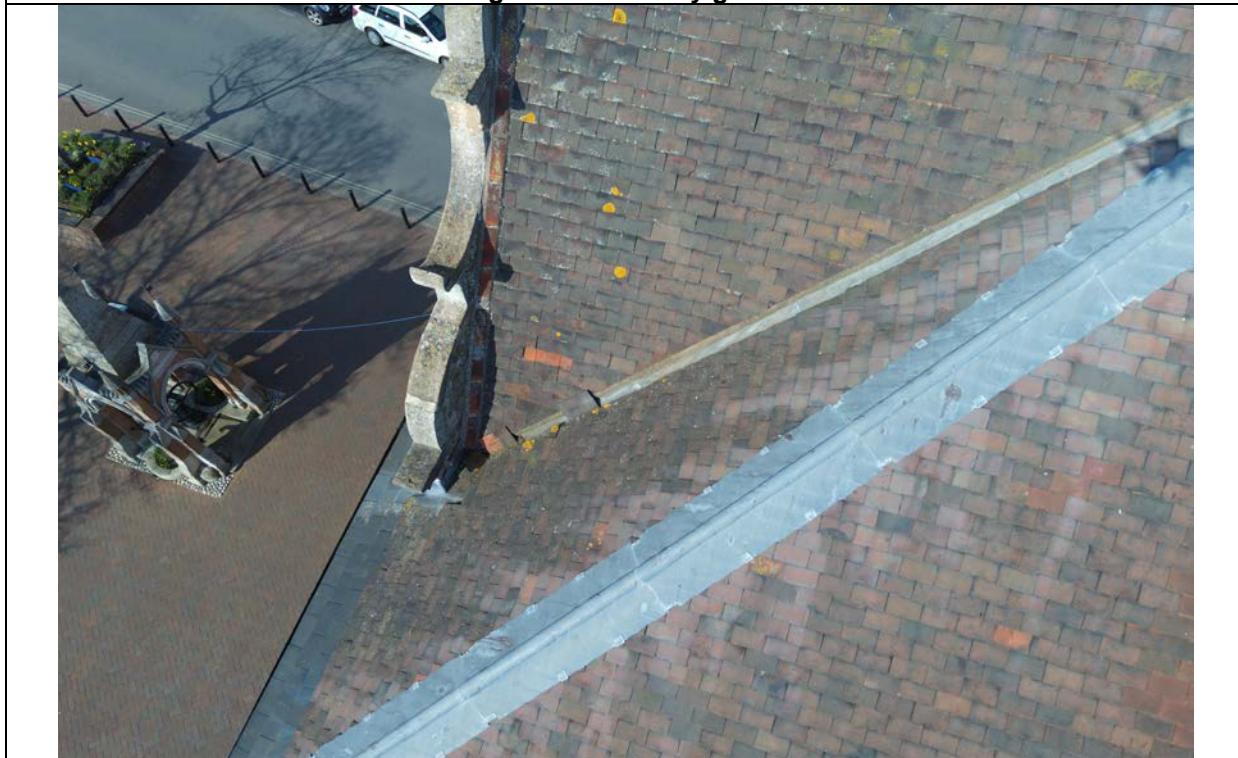
- 3.6.33 The roof needs a visual inspection from a cherry picker or drone survey to establish why roof tiles are becoming loose, when it appears the roof has had a lot of work retiling recently.
See photo 50 from drone survey.

Photograph 50
Dislodged roof Tiles.

- 3.6.19 Loose tiles sliding off a high roof in a public area needs to be addressed. A full gutter guard could be fitted at fascia level. **See Appendix D.**

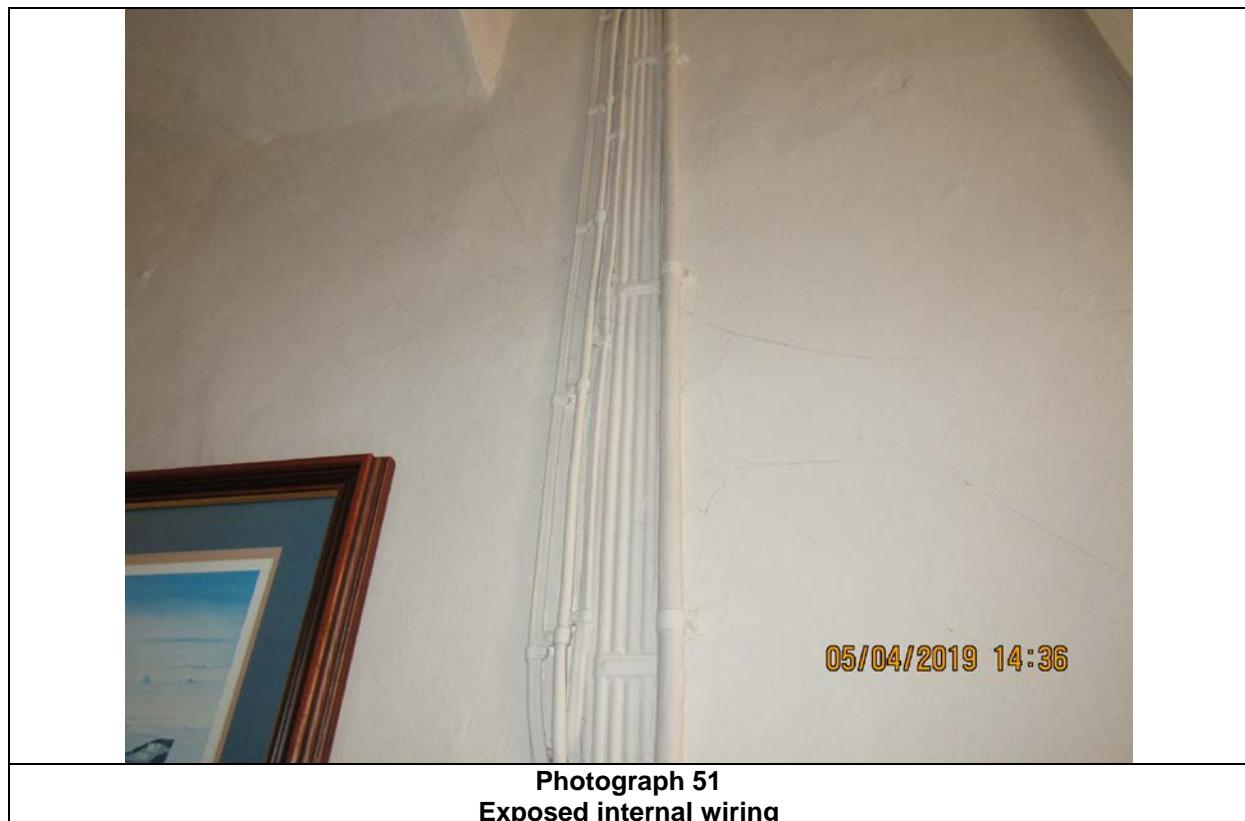
**Photograph 51
Exposed internal wiring**

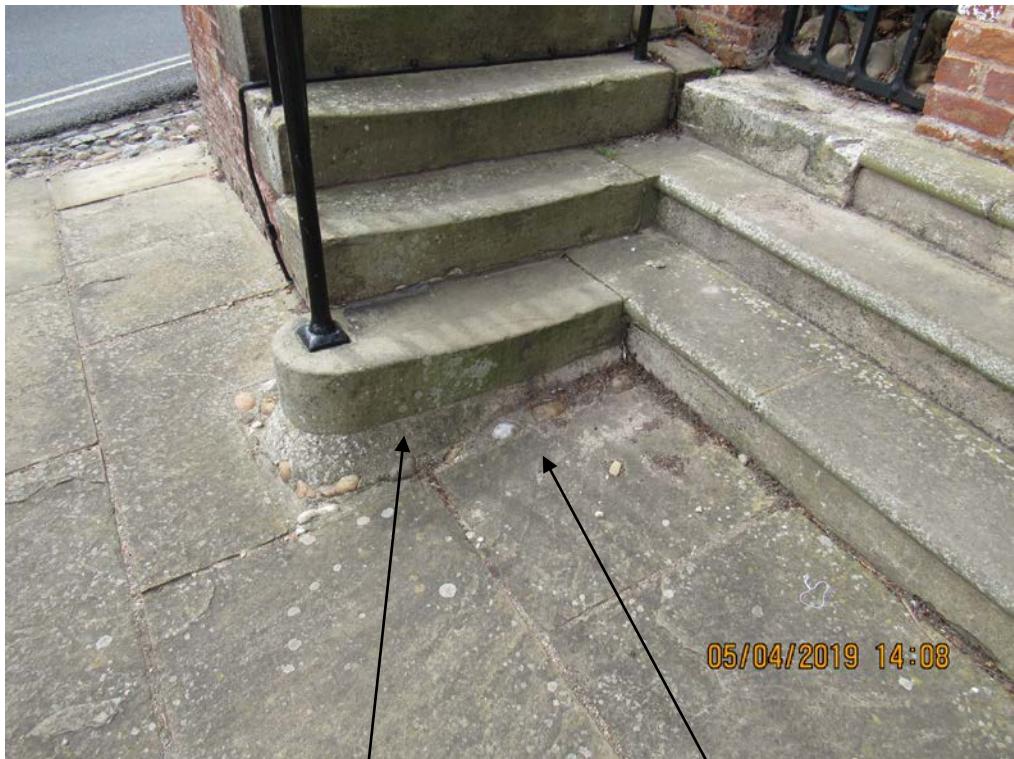
Photograph E3
Excessive bottom step and sloping flagstone. Requires reworking.

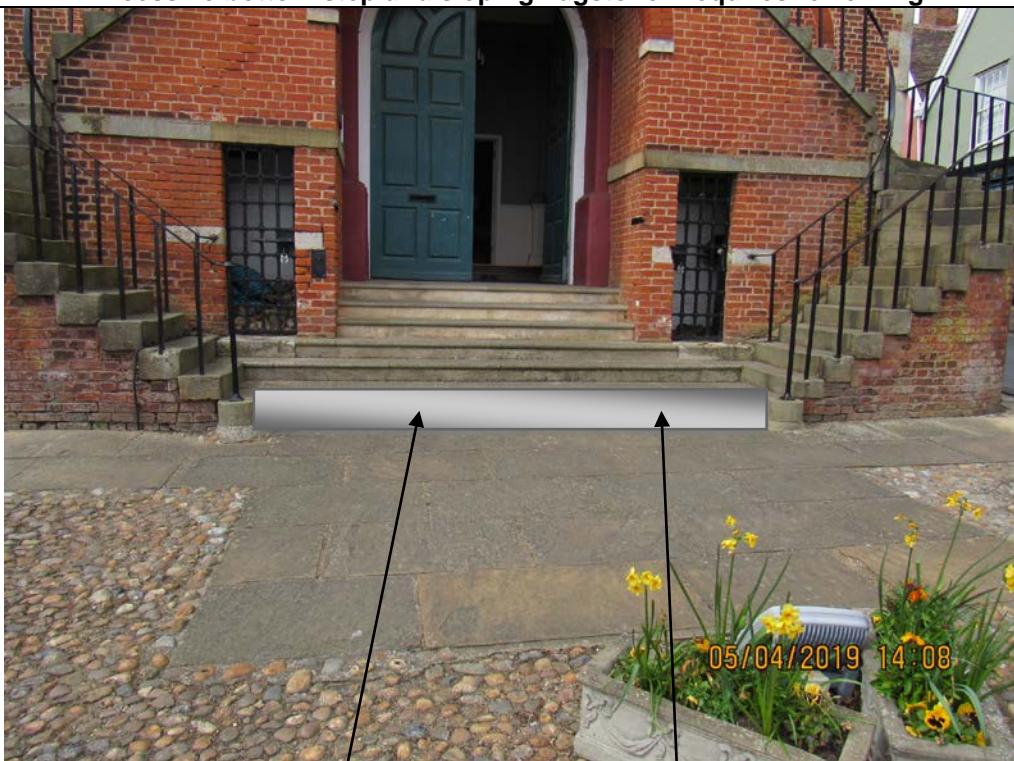
Photograph E4
Suggest full width infill.

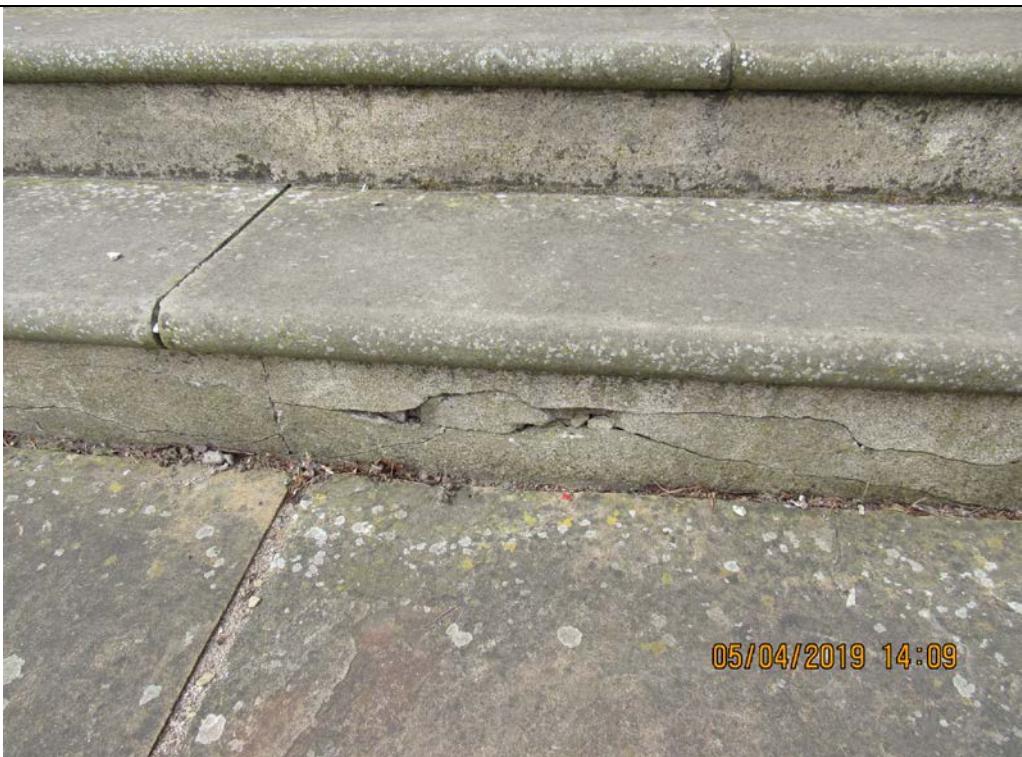
Photograph E5
Cracked and loose render.

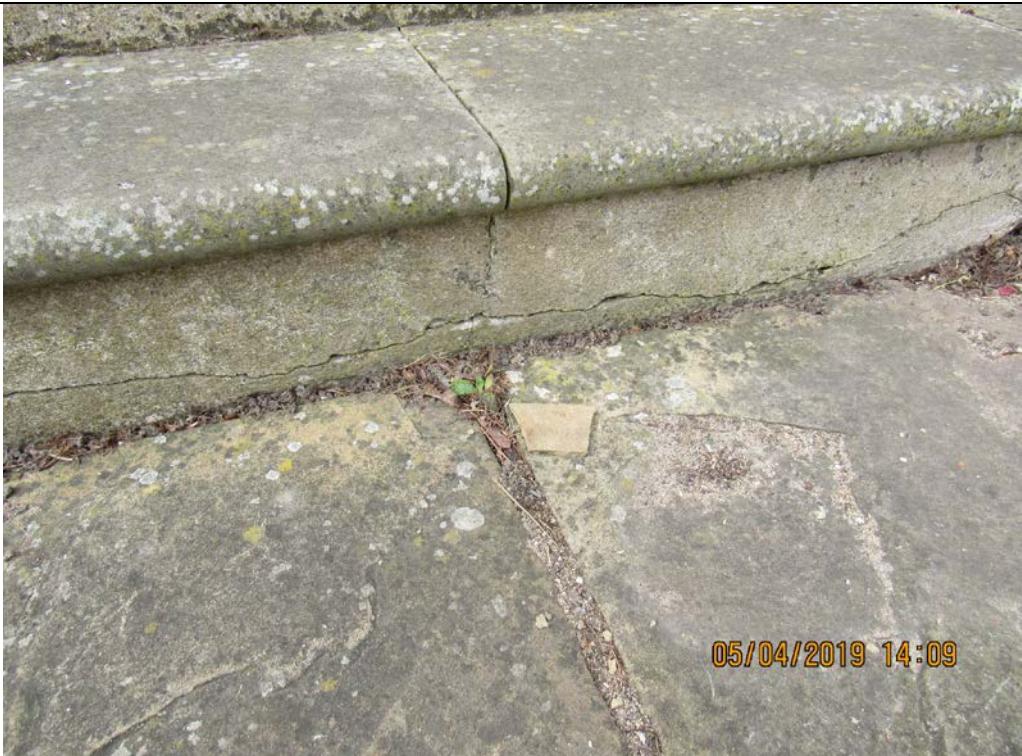
Photograph E6
Fallen masonry seen at time of visit on ground outside of front entrance.

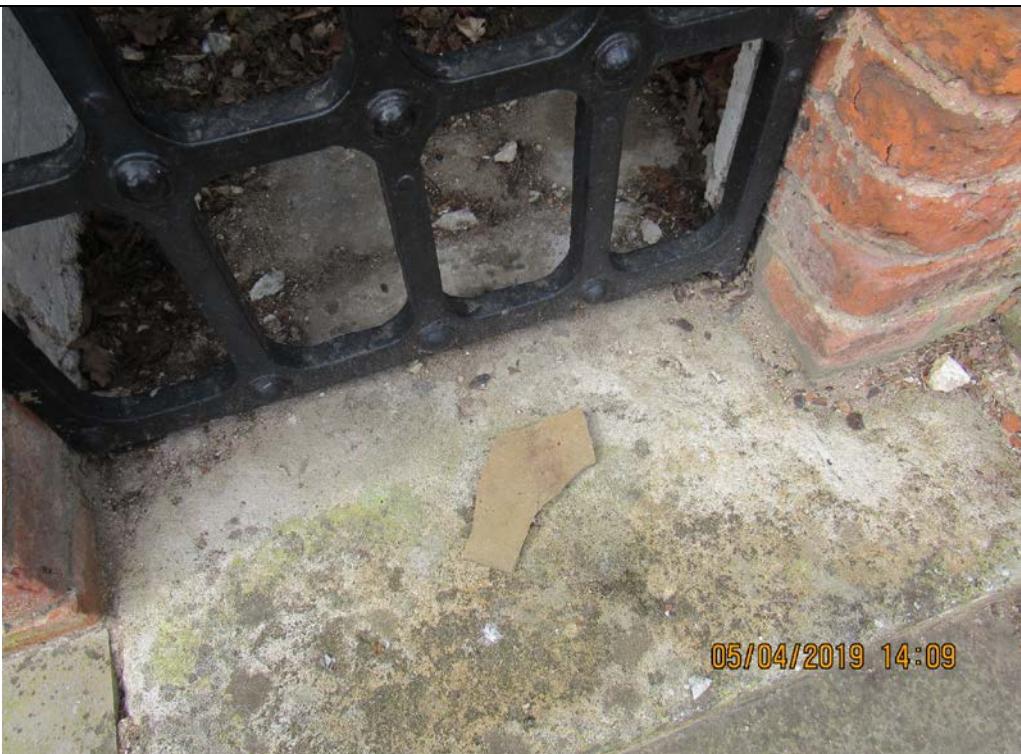
Photograph E7
Another piece of fallen masonry outside one of the front Gaols.

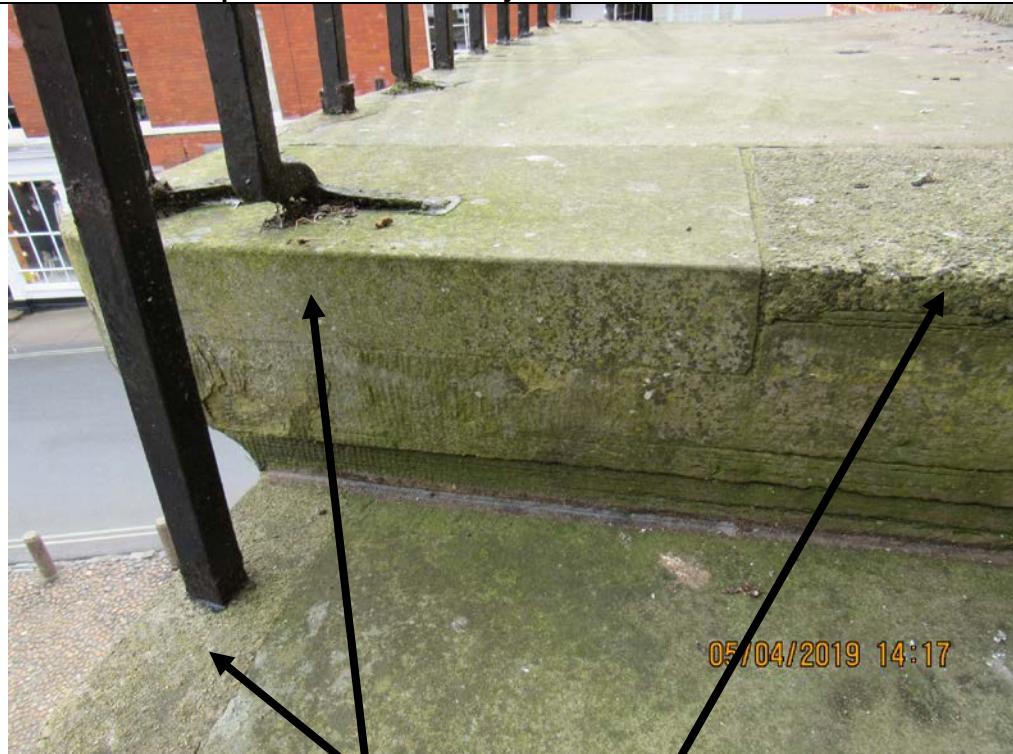
- 4.5 There have been several previous repairs in the past. However there does not appear to have been a co-ordinated programme to control the flow of the rain water on these steps. There is no fall to the balcony to shed the water. The top surface of stones could be reworked to achieve this.

Photograph E8
At least 2 no separate repairs visible to Balcony Stonework.

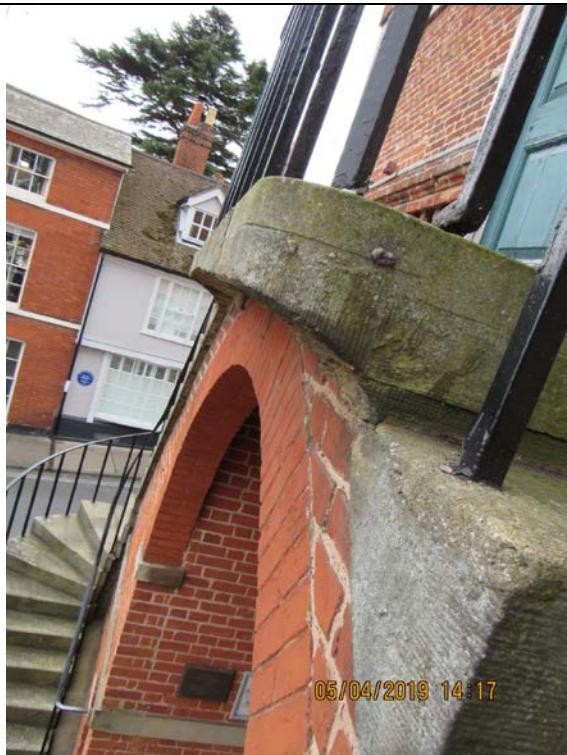
Photograph E9
Stone balcony spanning onto brick arch.

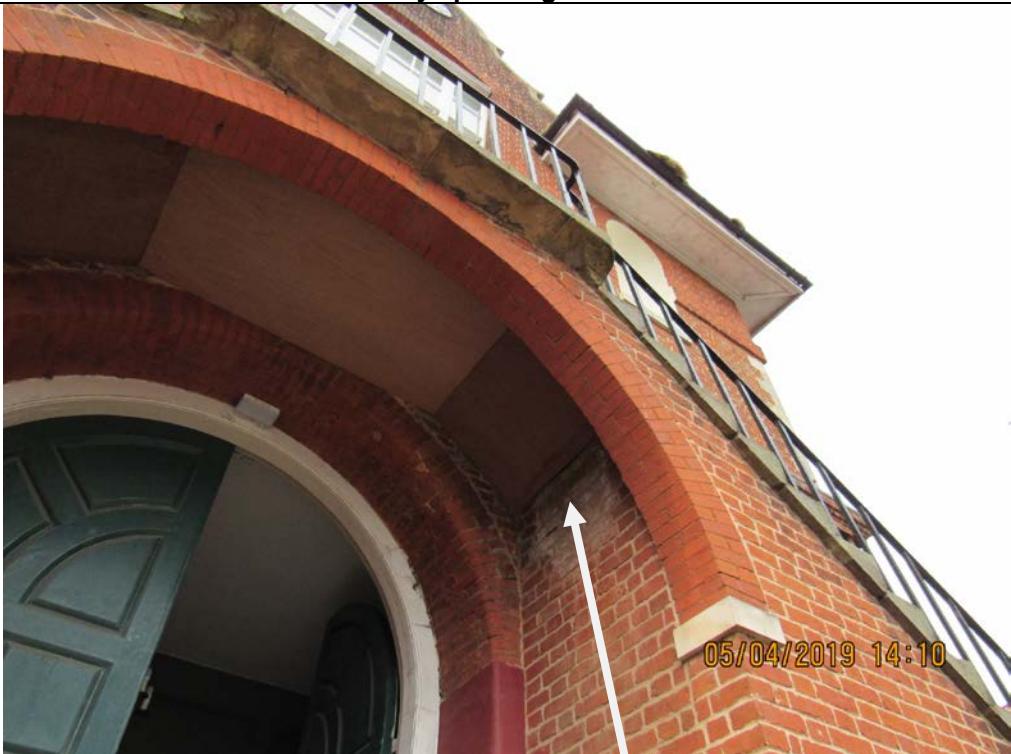
Photograph E10
Staining from water penetration clearly visible.

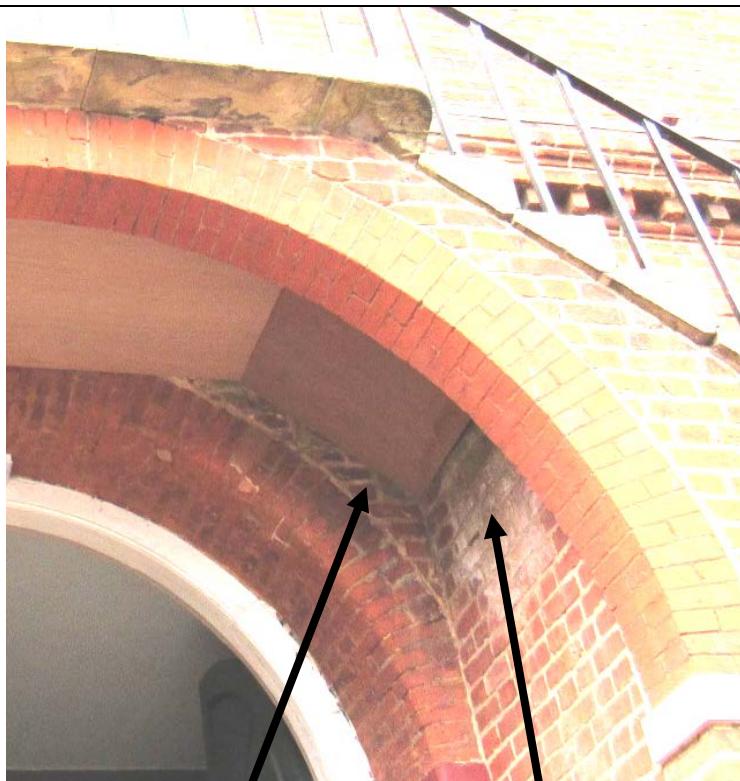
Photograph E11

Brickwork is vertical. We assume no brick arch and stonework spans from building to independent brick arch. Hence the bad staining.
