**CONDITION SURVEY REPORT
OF
SHIRE HALL
WOODBRIDGE
SUFFOLK
IP12 4LP**

Client: Woodbridge Town Council
Market Hill
Woodbridge
Suffolk
IP12 4LP

Date: May 2019

Ref: CT/FA/19552~rep

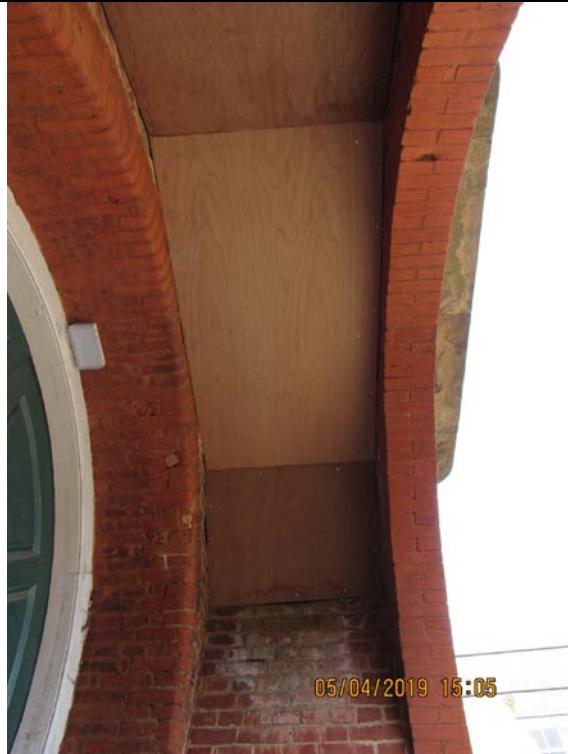
Photograph E12

- 3.3.5 Boarding has been erected directly under the balcony stonework in an attempt to reduce the risk of falling stonework onto the public and employees of the Council. However, it is now difficult to observe the condition of the underside of the balcony and see how much of the stonework has recently become loose.

Temporary boarding erected to prevent falling stonework. However unable to inspect condition of underside of stonework.
