Asbestos Re-inspection Report (with Priority Assessments)

**Abbotsbury Primary School
Abbotsbury Road, Morden, SM4 5JS**

Job Number: B93700/1
Issue Date: 27/03/2023
Issue No: 1

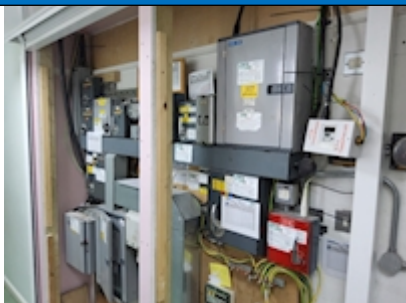
Building	Abbotsbury Primary School			Floor	0		
Location Description	003: Corridor			Record Origin Report	B15641		
Item	Flashguards

Level of Identification (ID)	Presumed (P)	Sample No.					
Material	Textile	Extent	Numerous No.				
Accessibility	Usually inaccessible or unlikely to be disturbed						
Identification	Chrysotile						
Material Assessment							
Product Type	2	Condition	1	Surface Treatment	2	Asbestos Type	1
Priority Assessment (for more detail see Section 4.0)							
Occupant Activity	1	Disturbance	1	Human Exposure	1	Maintenance Activity	1
Scoring Summary							
Material Score	6	Priority Score	4	Total Risk	10	Risk Priority	LOW
Recommended Action	Manage and Re-inspect						
Further Information	Presumed ACM Flashguards within live electrical services, previously presumed to contain ACM's by Tribal Environmental Services in report J041099, presumed to contain chrysotile.

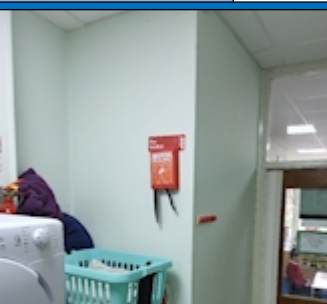
Building	Abbotsbury Primary School			Floor	0		
Location Description	003: Corridor			Record Origin Report	B15641		
Item	Riser panel

Level of Identification (ID)	Presumed (P)	Sample No.					
Material	Insulating Board	Extent	3 m ²				
Accessibility	Occasionally likely to be disturbed						
Identification	Amosite						
Material Assessment							
Product Type	2	Condition	1	Surface Treatment	2	Asbestos Type	2
Priority Assessment (for more detail see Section 4.0)							
Occupant Activity	1	Disturbance	1	Human Exposure	1	Maintenance Activity	1
Scoring Summary							
Material Score	7	Priority Score	4	Total Risk	11	Risk Priority	LOW
Recommended Action	Manage and Re-inspect						
Further Information	Presumed ACM board lining within sealed riser, previously presumed to contain ACM's by Tribal Environmental Services in report J041099, presumed to contain Amosite. Presumed to remain in situ

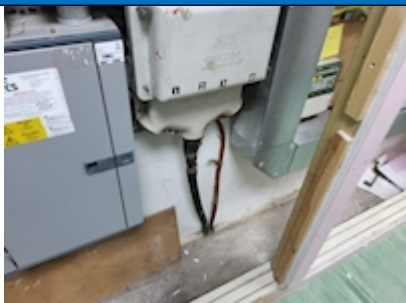
Building	Abbotsbury Primary School			Floor	0		
Location Description	003: Corridor			Record Origin Report	B15641		
Item	Bitumen wrap to electrical wiring

Level of Identification (ID)	Presumed (P)	Sample No.					
Material	Bitumen Product	Extent	1 lm				
Accessibility	Occasionally likely to be disturbed						
Identification	Chrysotile						
Material Assessment							
Product Type	1	Condition	1	Surface Treatment	0	Asbestos Type	1
Priority Assessment (for more detail see Section 4.0)							
Occupant Activity	2	Disturbance	1	Human Exposure	2	Maintenance Activity	1
Scoring Summary							
Material Score	3	Priority Score	6	Total Risk	9	Risk Priority	LOW
Recommended Action	Manage and Re-inspect						
Further Information	Presumed ACM bitumen wrap to live electrical services, previously presumed to contain ACM's by Noble HSC in report J14071, presumed to contain chrysotile

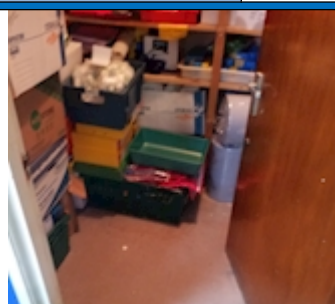
Building	Abbotsbury Primary School			Floor	0		
Location Description	009A: Store Room			Record Origin Report	B15641		
Item	Floor tiles and adhesive

Level of Identification (ID)	Strongly Presumed (SP)	Sample No.					
Material	Hard Set Thermal Insulation	Extent	6 m ²				
Accessibility	Easily disturbed						
Identification	Chrysotile						
Material Assessment							
Product Type	3	Condition	1	Surface Treatment	1	Asbestos Type	1
Priority Assessment (for more detail see Section 4.0)							
Occupant Activity	1	Disturbance	2	Human Exposure	1	Maintenance Activity	1
Scoring Summary							
Material Score	6	Priority Score	5	Total Risk	11	Risk Priority	LOW
Recommended Action	Manage and Re-inspect						
Further Information	Both floor tile and adhesive contain asbestos. Grey floor tiles. Floor tiles, previously sampled as sample 0006 in report B-87308, found to contain chrysotile.

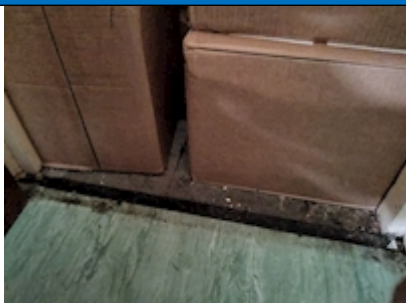
Building	Abbotsbury Primary School			Floor	0		
Location Description	009D: Store			Record Origin Report	B15641		
Item	Floor tiles

Level of Identification (ID)	Strongly Presumed (SP)	Sample No.					
Material	Floor Tiles (Thermoplastic)	Extent	1 m ²				
Accessibility	Occasionally likely to be disturbed						
Identification	Chrysotile						
Material Assessment							
Product Type	1	Condition	1	Surface Treatment	0	Asbestos Type	1
Priority Assessment (for more detail see Section 4.0)							
Occupant Activity	0	Disturbance	1	Human Exposure	1	Maintenance Activity	1
Scoring Summary							
Material Score	3	Priority Score	3	Total Risk	6	Risk Priority	VERY LOW
Recommended Action	Manage and Re-inspect						
Further Information	Visually consistent with sample number 0006. Grey floor tiles. Floor tiles, previously crossed referenced to sample 0006 in report B-87308, found to contain chrysotile.

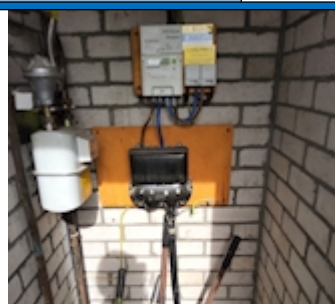
Building	Abbotsbury Primary School			Floor	0		
Location Description	011: Cupboard (Bungalow).			Record Origin Report	B15641		
Item	Electrics

Level of Identification (ID)	Strongly Presumed (SP)	Sample No.					
Material	Textile	Extent	1 m ²				
Accessibility	Occasionally likely to be disturbed						
Identification	Chrysotile						
Material Assessment							
Product Type	2	Condition	1	Surface Treatment	1	Asbestos Type	1
Priority Assessment (for more detail see Section 4.0)							
Occupant Activity	0	Disturbance	1	Human Exposure	1	Maintenance Activity	1
Scoring Summary							
Material Score	5	Priority Score	3	Total Risk	8	Risk Priority	VERY LOW
Recommended Action	Manage and Re-inspect						
Further Information	Textile within live electrics and cable wrap

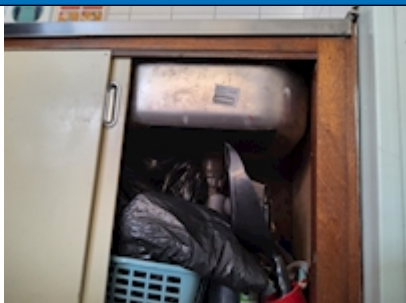
Building	Abbotsbury Primary School			Floor	0		
Location Description	014: Classroom year 1 Cedar			Record Origin Report	B15641		
Item	Bitumen sink pad

Level of Identification (ID)	Strongly Presumed (SP)	Sample No.					
Material	Bitumen Product	Extent	1 No.				
Accessibility	Easily disturbed						
Identification	Chrysotile						
Material Assessment							
Product Type	1	Condition	1	Surface Treatment	0	Asbestos Type	1
Priority Assessment (for more detail see Section 4.0)							
Occupant Activity	1	Disturbance	1	Human Exposure	3	Maintenance Activity	1
Scoring Summary							
Material Score	3	Priority Score	6	Total Risk	9	Risk Priority	LOW
Recommended Action	Manage and Re-inspect						
Further Information	Bitumen sink pad, previously sampled by Noble HSC as sample GS20810/09 in report J14071, found to contain chrysotile.

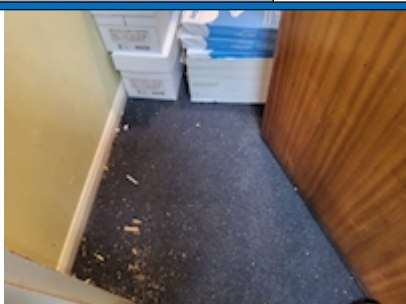
Building	Abbotsbury Primary School			Floor	0		
Location Description	020a: Cupboard in hall			Record Origin Report	B15641		
Item	Floor Tiles

Level of Identification (ID)	Strongly Presumed (SP)	Sample No.					
Material	Floor Tiles (Thermoplastic)	Extent	4 m ²				
Accessibility	Occasionally likely to be disturbed						
Identification	Chrysotile						
Material Assessment							
Product Type	1	Condition	1	Surface Treatment	0	Asbestos Type	1
Priority Assessment (for more detail see Section 4.0)							
Occupant Activity	0	Disturbance	1	Human Exposure	1	Maintenance Activity	1
Scoring Summary							
Material Score	3	Priority Score	3	Total Risk	6	Risk Priority	VERY LOW
Recommended Action	Manage and Re-inspect						
Further Information	Visually consistent with sample number GS20810/01. Floor tiles, previously cross referenced by Noble HSC to sample GS20810/01 in report J14071, found to contain chrysotile.

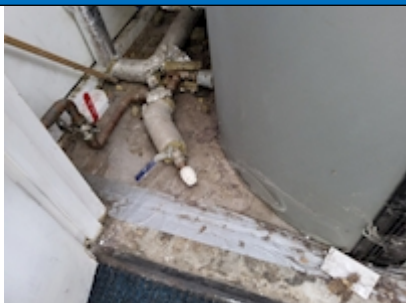
Building	Abbotsbury Primary School			Floor	0		
Location Description	031: Plant Room			Record Origin Report	B15641		
Item	Floor tiles

Level of Identification (ID)	Strongly Presumed (SP)	Sample No.					
Material	Floor Tiles (Thermoplastic)	Extent	3 m ²				
Accessibility	Easily disturbed						
Identification	Chrysotile						
Material Assessment							
Product Type	1	Condition	1	Surface Treatment	0	Asbestos Type	1
Priority Assessment (for more detail see Section 4.0)							
Occupant Activity	1	Disturbance	1	Human Exposure	2	Maintenance Activity	2
Scoring Summary							
Material Score	3	Priority Score	6	Total Risk	9	Risk Priority	LOW
Recommended Action	Manage and Re-inspect						
Further Information	Visually consistent with sample number GS20810/11. Floor tiles, previously cross referenced by Noble HSC to sample GS20810/11 in report J14071, found to contain chrysotile.

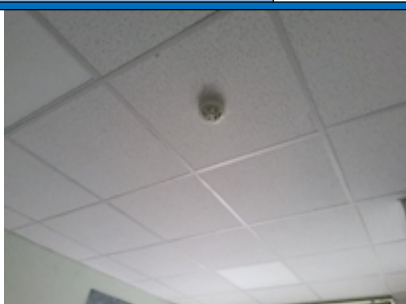
Building	Abbotsbury Primary School			Floor	0		
Location Description	039: Deputy heads office			Record Origin Report	B15641		
Item	Residue to ceiling

Level of Identification (ID)	Strongly Presumed (SP)	Sample No.					
Material	Bitumen Product	Extent	12 m ²				
Accessibility	Usually inaccessible or unlikely to be disturbed						
Identification	Chrysotile						
Material Assessment							
Product Type	1	Condition	1	Surface Treatment	0	Asbestos Type	1
Priority Assessment (for more detail see Section 4.0)							
Occupant Activity	1	Disturbance	1	Human Exposure	2	Maintenance Activity	1
Scoring Summary							
Material Score	3	Priority Score	5	Total Risk	8	Risk Priority	VERY LOW
Recommended Action	Manage and Re-inspect						
Further Information	Visually consistent with sample number 0001. Bitumen residue to the metal trim of the main straw ceiling blocks. previously crossed referenced to sample 0001 in report B-87308, found to contain chrysotile.No change

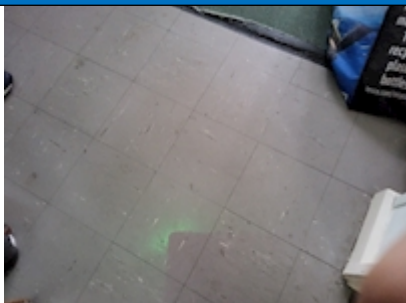
Building	Abbotsbury Primary School			Floor	0		
Location Description	039: Deputy heads office			Record Origin Report	B15641		
Item	Floor Tiles

Level of Identification (ID)	Strongly Presumed (SP)	Sample No.					
Material	Floor Tiles (Thermoplastic)	Extent	12 m ²				
Accessibility	Occasionally likely to be disturbed						
Identification	Chrysotile						
Material Assessment							
Product Type	1	Condition	1	Surface Treatment	0	Asbestos Type	1
Priority Assessment (for more detail see Section 4.0)							
Occupant Activity	1	Disturbance	2	Human Exposure	2	Maintenance Activity	1
Scoring Summary							
Material Score	3	Priority Score	6	Total Risk	9	Risk Priority	LOW
Recommended Action	Manage and Re-inspect						
Further Information	Visually consistent with sample number GS20810/01. Floor tiles, previously cross referenced by Noble HSC to sample GS20810/01 in report J14071, found to contain chrysotile.

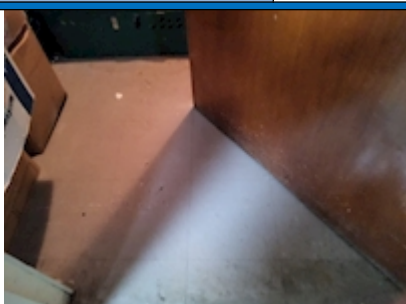
Building	Abbotsbury Primary School			Floor	0		
Location Description	040: Cupboard			Record Origin Report	B15641		
Item	Floor tiles

Level of Identification (ID)	Strongly Presumed (SP)	Sample No.					
Material	Floor Tiles (Thermoplastic)	Extent	3 m ²				
Accessibility	Occasionally likely to be disturbed						
Identification	Chrysotile						
Material Assessment							
Product Type	1	Condition	1	Surface Treatment	0	Asbestos Type	1
Priority Assessment (for more detail see Section 4.0)							
Occupant Activity	0	Disturbance	1	Human Exposure	1	Maintenance Activity	1
Scoring Summary							
Material Score	3	Priority Score	3	Total Risk	6	Risk Priority	VERY LOW
Recommended Action	Manage and Re-inspect						
Further Information	Visually consistent with sample number GS20810/01. Floor tiles, previously cross referenced by Noble HSC to sample GS20810/01 in report J14071, found to contain chrysotile.

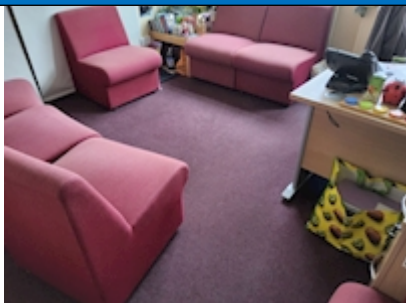
Building	Abbotsbury Primary School			Floor	0		
Location Description	041: Head teachers office			Record Origin Report	B15641		
Item	Floor tiles and adhesive

Level of Identification (ID)	Presumed (P)	Sample No.					
Material	Floor Tiles (Thermoplastic)	Extent	25 m ²				
Accessibility	Usually inaccessible or unlikely to be disturbed						
Identification	Chrysotile						
Material Assessment							
Product Type	1	Condition	1	Surface Treatment	0	Asbestos Type	1
Priority Assessment (for more detail see Section 4.0)							
Occupant Activity	1	Disturbance	1	Human Exposure	1	Maintenance Activity	1
Scoring Summary							
Material Score	3	Priority Score	4	Total Risk	7	Risk Priority	VERY LOW
Recommended Action	Manage and Re-inspect						
Further Information	Adhesive Below carpet and screed. previously sampled as sample 0003 in report B-87308, found to contain chrysotile.

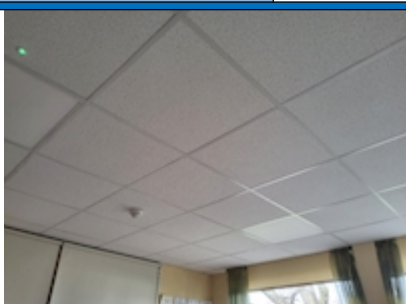
Building	Abbotsbury Primary School			Floor	0		
Location Description	041: Head teachers office			Record Origin Report	B15641		
Item	Residue to ceiling

Level of Identification (ID)	Strongly Presumed (SP)	Sample No.					
Material	Bitumen Product	Extent	25 m ²				
Accessibility	Usually inaccessible or unlikely to be disturbed						
Identification	Chrysotile						
Material Assessment							
Product Type	1	Condition	1	Surface Treatment	0	Asbestos Type	1
Priority Assessment (for more detail see Section 4.0)							
Occupant Activity	1	Disturbance	1	Human Exposure	2	Maintenance Activity	1
Scoring Summary							
Material Score	3	Priority Score	5	Total Risk	8	Risk Priority	VERY LOW
Recommended Action	Manage and Re-inspect						
Further Information	Visually consistent with sample number 0001. Bitumen residue to the metal trim of the main straw ceiling blocks. previously crossed referenced to sample 0001 in report B-87308, found to contain chrysotile.

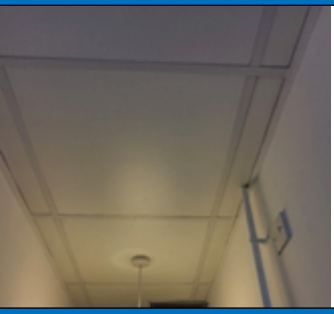
Building	Abbotsbury Primary School			Floor	0		
Location Description	042: WC (Male)			Record Origin Report	B15641		
Item	Residue to ceiling

Level of Identification (ID)	Strongly Presumed (SP)	Sample No.					
Material	Bitumen Product	Extent	2 m ²				
Accessibility	Usually inaccessible or unlikely to be disturbed						
Identification	Chrysotile						
Material Assessment							
Product Type	1	Condition	1	Surface Treatment	0	Asbestos Type	1
Priority Assessment (for more detail see Section 4.0)							
Occupant Activity	1	Disturbance	1	Human Exposure	1	Maintenance Activity	1
Scoring Summary							
Material Score	3	Priority Score	4	Total Risk	7	Risk Priority	VERY LOW
Recommended Action	Manage and Re-inspect						
Further Information	Visually consistent with sample number 0001. Bitumen residue to the metal trim of the main straw ceiling blocks. previously crossed referenced to sample 0001 in report B-87308, found to contain chrysotile. No change

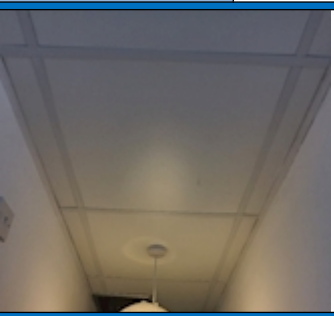
Building	Abbotsbury Primary School			Floor	0		
Location Description	043: WC (Female)			Record Origin Report	B15641		
Item	Residue to ceiling

Level of Identification (ID)	Strongly Presumed (SP)	Sample No.					
Material	Bitumen Product	Extent	2 m ²				
Accessibility	Usually inaccessible or unlikely to be disturbed						
Identification	Chrysotile						
Material Assessment							
Product Type	1	Condition	1	Surface Treatment	0	Asbestos Type	1
Priority Assessment (for more detail see Section 4.0)							
Occupant Activity	1	Disturbance	1	Human Exposure	1	Maintenance Activity	1
Scoring Summary							
Material Score	3	Priority Score	4	Total Risk	7	Risk Priority	VERY LOW
Recommended Action	Manage and Re-inspect						
Further Information	Visually consistent with sample number 0001. Bitumen residue to the metal trim of the main straw ceiling blocks. previously crossed referenced to sample 0001 in report B-87308, found to contain chrysotile. No change

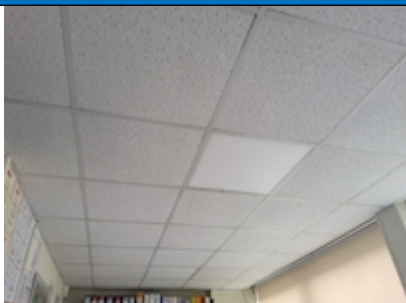
Building	Abbotsbury Primary School			Floor	0		
Location Description	044: Admin office			Record Origin Report	B15641		
Item	Residue to ceiling

Level of Identification (ID)	Strongly Presumed (SP)	Sample No.					
Material	Bitumen Product	Extent	25 m ²				
Accessibility	Usually inaccessible or unlikely to be disturbed						
Identification	Chrysotile						
Material Assessment							
Product Type	1	Condition	1	Surface Treatment	0	Asbestos Type	1
Priority Assessment (for more detail see Section 4.0)							
Occupant Activity	1	Disturbance	1	Human Exposure	2	Maintenance Activity	1
Scoring Summary							
Material Score	3	Priority Score	5	Total Risk	8	Risk Priority	VERY LOW
Recommended Action	Manage and Re-inspect						
Further Information	Bitumen residue to the metal trim of the main straw ceiling blocks. previously sampled as sample 0001 in report B-87308, found to contain chrysotile. No change on reinspection 18/3/22

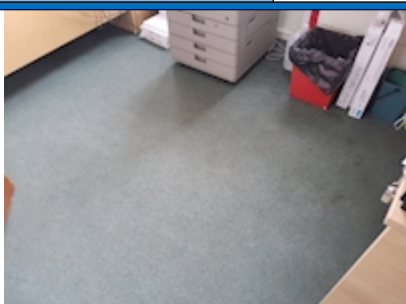
Building	Abbotsbury Primary School			Floor	0		
Location Description	044: Admin office			Record Origin Report	B15641		
Item	Floor tiles and adhesive

Level of Identification (ID)	Strongly Presumed (SP)	Sample No.					
Material	Floor Tiles (Thermoplastic)	Extent	25 m ²				
Accessibility	Usually inaccessible or unlikely to be disturbed						
Identification	Chrysotile						
Material Assessment							
Product Type	1	Condition	1	Surface Treatment	0	Asbestos Type	1
Priority Assessment (for more detail see Section 4.0)							
Occupant Activity	1	Disturbance	1	Human Exposure	2	Maintenance Activity	1
Scoring Summary							
Material Score	3	Priority Score	5	Total Risk	8	Risk Priority	VERY LOW
Recommended Action	Manage and Re-inspect						
Further Information	Both floor tile and adhesive contain asbestos. Grey floor tiles with bitumen adhesive below carpet. Floor tiles, previously sampled as sample 0002 in report B-87308, found to contain chrysotile.

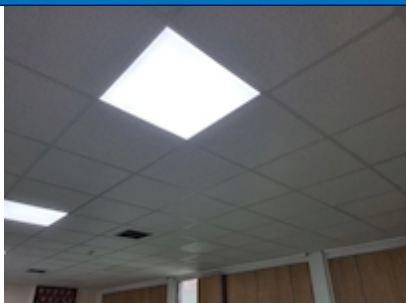
Building	Abbotsbury Primary School			Floor	0		
Location Description	046: Lobby			Record Origin Report	B15641		
Item	Residue to ceiling

Level of Identification (ID)	Strongly Presumed (SP)	Sample No.					
Material	Bitumen Product	Extent	2 m ²				
Accessibility	Usually inaccessible or unlikely to be disturbed						
Identification	Chrysotile						
Material Assessment							
Product Type	1	Condition	1	Surface Treatment	0	Asbestos Type	1
Priority Assessment (for more detail see Section 4.0)							
Occupant Activity	2	Disturbance	1	Human Exposure	2	Maintenance Activity	1
Scoring Summary							
Material Score	3	Priority Score	6	Total Risk	9	Risk Priority	LOW
Recommended Action	Manage and Re-inspect						
Further Information	Visually consistent with sample number 0001. Bitumen residue to the metal trim of the main straw ceiling blocks. previously crossed referenced to sample 0001 in report B-87308, found to contain chrysotile.

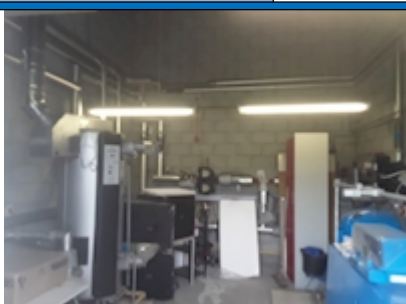
Building	Abbotsbury Primary School			Floor	0		
Location Description	071: Boiler Room			Record Origin Report	B60464		
Item	Boiler room

Level of Identification (ID)	Inspected Area (IA)	Sample No.					
Material		Extent					
Accessibility	Usually inaccessible or unlikely to be disturbed						
Identification							
Material Assessment							
Product Type		Condition		Surface Treatment		Asbestos Type	
Priority Assessment (for more detail see Section 4.0)							
Occupant Activity		Disturbance		Human Exposure		Maintenance Activity	
Scoring Summary							
Material Score		Priority Score		Total Risk		Risk Priority	
Recommended Action	No Recommendation Required						
Further Information	All plant is post the era in which asbestos would have been used. Dates and visual inspection prove this.

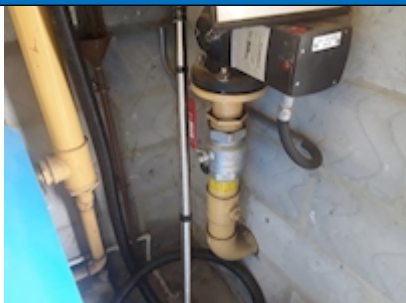
Building	Abbotsbury Primary School			Floor	0		
Location Description	071: Boiler Room			Record Origin Report	B60464		
Item	Gasket

Level of Identification (ID)	Sample (S)	Sample No.	S0001				
Material	Gaskets	Extent	1 No.				
Accessibility							
Identification	No Asbestos Detected						
Material Assessment							
Product Type	0	Condition	0	Surface Treatment	0	Asbestos Type	0
Priority Assessment (for more detail see Section 4.0)							
Occupant Activity	0	Disturbance	0	Human Exposure	0	Maintenance Activity	0
Scoring Summary							
Material Score	0	Priority Score	0	Total Risk	0	Risk Priority	N/A
Recommended Action	No Recommendation Required						
Further Information	To yellow pipework to right on entrance

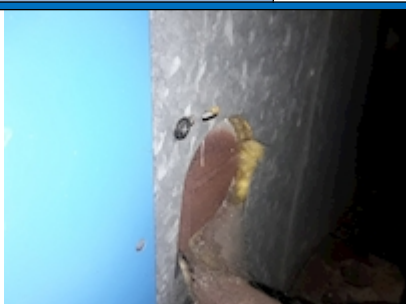
Building	Abbotsbury Primary School			Floor	0		
Location Description	071: Boiler Room			Record Origin Report	B60464		
Item	Insulation

Level of Identification (ID)	Sample (S)	Sample No.	S0002				
Material	Lagging / Loose Insulation	Extent	1 m ²				
Accessibility							
Identification	No Asbestos Detected						
Material Assessment							
Product Type	0	Condition	0	Surface Treatment	0	Asbestos Type	0
Priority Assessment (for more detail see Section 4.0)							
Occupant Activity	0	Disturbance	0	Human Exposure	0	Maintenance Activity	0
Scoring Summary							
Material Score	0	Priority Score	0	Total Risk	0	Risk Priority	N/A
Recommended Action	No Recommendation Required						
Further Information	Located to rear of blue heating boiler

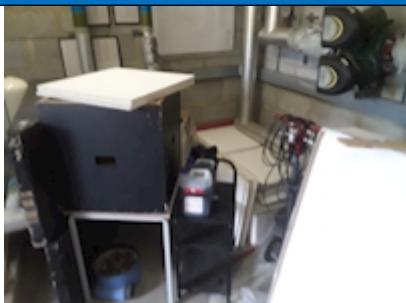
Building	Abbotsbury Primary School			Floor	0		
Location Description	071: Boiler Room			Record Origin Report	B60464		
Item	Insulating board panels

Level of Identification (ID)	Sample (S)	Sample No.	S0003				
Material	Insulating Board	Extent	10 m ²				
Accessibility							
Identification	No Asbestos Detected						
Material Assessment							
Product Type	0	Condition	0	Surface Treatment	0	Asbestos Type	0
Priority Assessment (for more detail see Section 4.0)							
Occupant Activity	0	Disturbance	0	Human Exposure	0	Maintenance Activity	0
Scoring Summary							
Material Score	0	Priority Score	0	Total Risk	0	Risk Priority	N/A
Recommended Action	No Recommendation Required						
Further Information	Located loosely around location - sample taken to prove no asbestos

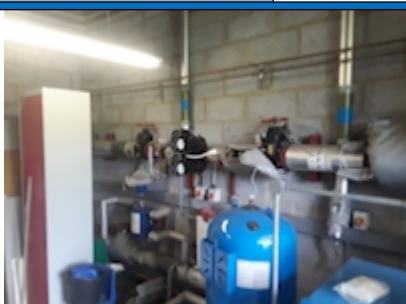
Building	Abbotsbury Primary School			Floor	0		
Location Description	071: Boiler Room			Record Origin Report	B60464		
Item	Gasket

Level of Identification (ID)	Sample (S)	Sample No.	S0004				
Material	Gaskets	Extent	16 No.				
Accessibility							
Identification	No Asbestos Detected						
Material Assessment							
Product Type	0	Condition	0	Surface Treatment	0	Asbestos Type	0
Priority Assessment (for more detail see Section 4.0)							
Occupant Activity	0	Disturbance	0	Human Exposure	0	Maintenance Activity	0
Scoring Summary							
Material Score	0	Priority Score	0	Total Risk	0	Risk Priority	N/A
Recommended Action	No Recommendation Required						
Further Information	All gaskets to RHS wall

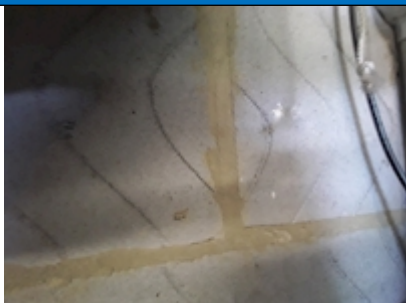
Building	Abbotsbury Primary School			Floor	0		
Location Description	071: Boiler Room			Record Origin Report	B60464		
Item	Thermal insulation residue to wall

Level of Identification (ID)	Sample (S)	Sample No.	S0005				
Material	Lagging / Loose Insulation	Extent	<1 lm				
Accessibility							
Identification	No Asbestos Detected						
Material Assessment							
Product Type	0	Condition	0	Surface Treatment	0	Asbestos Type	0
Priority Assessment (for more detail see Section 4.0)							
Occupant Activity	0	Disturbance	0	Human Exposure	0	Maintenance Activity	0
Scoring Summary							
Material Score	0	Priority Score	0	Total Risk	0	Risk Priority	N/A
Recommended Action	No Recommendation Required						
Further Information	Located to rear wall

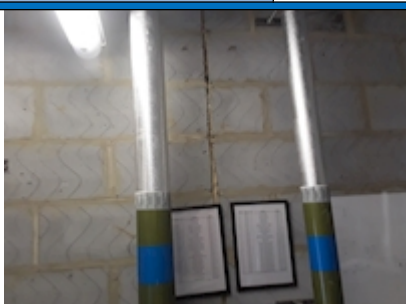
Building	Abbotsbury Primary School			Floor	0		
Location Description	071: Boiler Room			Record Origin Report	B60464		
Item	Expansion joint

Level of Identification (ID)	Sample (S)	Sample No.	S0006				
Material	Mastic	Extent	3 lm				
Accessibility							
Identification	No Asbestos Detected						
Material Assessment							
Product Type	0	Condition	0	Surface Treatment	0	Asbestos Type	0
Priority Assessment (for more detail see Section 4.0)							
Occupant Activity	0	Disturbance	0	Human Exposure	0	Maintenance Activity	0
Scoring Summary							
Material Score	0	Priority Score	0	Total Risk	0	Risk Priority	N/A
Recommended Action	No Recommendation Required						
Further Information

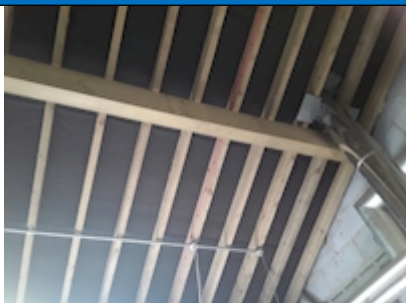
Building	Abbotsbury Primary School			Floor	0		
Location Description	071: Boiler Room			Record Origin Report	B60464		
Item	Roof felt

Level of Identification (ID)	Sample (S)	Sample No.	S0007				
Material	Bitumen Product	Extent	12 m ²				
Accessibility							
Identification	No Asbestos Detected						
Material Assessment							
Product Type	0	Condition	0	Surface Treatment	0	Asbestos Type	0
Priority Assessment (for more detail see Section 4.0)							
Occupant Activity	0	Disturbance	0	Human Exposure	0	Maintenance Activity	0
Scoring Summary							
Material Score	0	Priority Score	0	Total Risk	0	Risk Priority	N/A
Recommended Action	No Recommendation Required						
Further Information

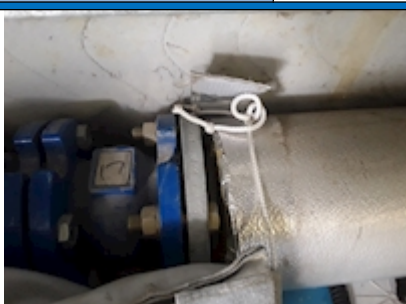
Building	Abbotsbury Primary School			Floor	0		
Location Description	071: Boiler Room			Record Origin Report	B60464		
Item	Gasket

Level of Identification (ID)	Sample (S)	Sample No.	S0008				
Material	Gaskets	Extent	1 No.				
Accessibility							
Identification	No Asbestos Detected						
Material Assessment							
Product Type	0	Condition	0	Surface Treatment	0	Asbestos Type	0
Priority Assessment (for more detail see Section 4.0)							
Occupant Activity	0	Disturbance	0	Human Exposure	0	Maintenance Activity	0
Scoring Summary							
Material Score	0	Priority Score	0	Total Risk	0	Risk Priority	N/A
Recommended Action	No Recommendation Required						
Further Information	To blue pipework to left on entrance
