Asbestos Re-inspection Report (with Priority Assessments)

**Merton Abbey Primary School
High Path, London, SW19 2JY**

Job Number: B95971/1
Issue Date: 14/04/2023
Issue No: 1

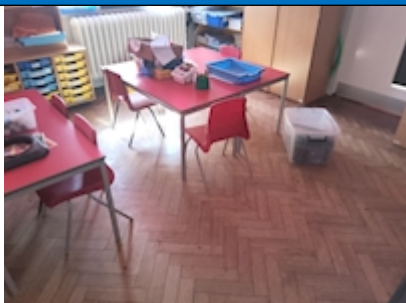
Building	Merton Abbey Primary School			Floor	0		
Location Description	0/018: Classroom			Record Origin Report	B15789		
Item	Bitumen adhesive beneath parquet flooring

Level of Identification (ID)	Presumed (P)	Sample No.					
Material	Bitumen Product	Extent	40 m ²				
Accessibility	Usually inaccessible or unlikely to be disturbed						
Identification	Chrysotile						
Material Assessment							
Product Type	1	Condition	0	Surface Treatment	0	Asbestos Type	1
Priority Assessment (for more detail see Section 4.0)							
Occupant Activity	0	Disturbance	1	Human Exposure	3	Maintenance Activity	0
Scoring Summary							
Material Score	2	Priority Score	4	Total Risk	6	Risk Priority	VERY LOW
Recommended Action	Not sampled – Sample Required						
Further Information	No change as of reinspection 2023.

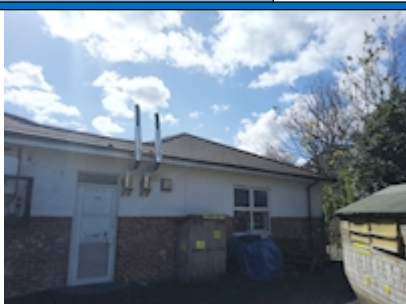
Building	Merton Abbey Primary School			Floor	Ext		
Location Description	Ext: External			Record Origin Report	B15789		
Item	Cement roof tiles

Level of Identification (ID)	Strongly Presumed (SP)	Sample No.					
Material	Cement Product	Extent	200 m ²				
Accessibility	Usually inaccessible or unlikely to be disturbed						
Identification	Chrysotile						
Material Assessment							
Product Type	1	Condition	1	Surface Treatment	1	Asbestos Type	1
Priority Assessment (for more detail see Section 4.0)							
Occupant Activity	0	Disturbance	0	Human Exposure	0	Maintenance Activity	1
Scoring Summary							
Material Score	4	Priority Score	1	Total Risk	5	Risk Priority	VERY LOW
Recommended Action	Manage and Re-inspect						
Further Information	No change as of reinspection 2023.

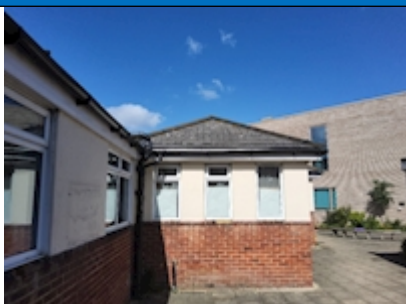
Building	Merton Abbey Primary School			Floor	Ext		
Location Description	Ext: External			Record Origin Report	B15789		
Item	Cement roof tiles

Level of Identification (ID)	Strongly Presumed (SP)	Sample No.					
Material	Cement Product	Extent	200 m ²				
Accessibility	Usually inaccessible or unlikely to be disturbed						
Identification	Chrysotile						
Material Assessment							
Product Type	1	Condition	1	Surface Treatment	1	Asbestos Type	1
Priority Assessment (for more detail see Section 4.0)							
Occupant Activity	0	Disturbance	1	Human Exposure	0	Maintenance Activity	1
Scoring Summary							
Material Score	4	Priority Score	2	Total Risk	6	Risk Priority	VERY LOW
Recommended Action	Manage and Re-inspect						
Further Information	No change as of reinspection 2023
