# Asbestos Re-inspection Report (with Priority Assessments)

**Gorringe Park Primary School  
Sandy Lane, Mitcham, Surrey, CR4 2YA**

Job Number: B94125/1  
Issue Date: 27/03/2023  
Issue No: 1

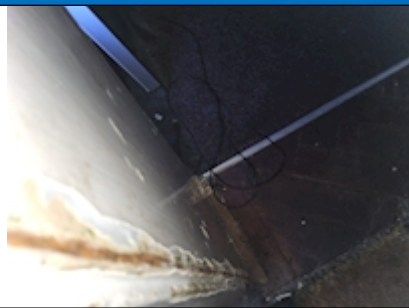
<b>Building</b>	Gorrington Park Primary School			<b>Floor</b>	0		
<b>Location Description</b>	0/002: Living Area			<b>Record Origin Report</b>	B16349		
<b>Item</b>	Bitumen adhesive to parquet flooring

<b>Level of Identification (ID)</b>	Presumed (P)	<b>Sample No.</b>					
<b>Material</b>	Bitumen Product	<b>Extent</b>	17 m <sup>2</sup>				
<b>Accessibility</b>	Usually inaccessible or unlikely to be disturbed						
<b>Identification</b>	Chrysotile						
<b>Material Assessment</b>							
<b>Product Type</b>	1	<b>Condition</b>	1	<b>Surface Treatment</b>	0	<b>Asbestos Type</b>	1
<b>Priority Assessment (for more detail see Section 4.0)</b>							
<b>Occupant Activity</b>	1	<b>Disturbance</b>	1	<b>Human Exposure</b>	2	<b>Maintenance Activity</b>	1
<b>Scoring Summary</b>							
<b>Material Score</b>	3	<b>Priority Score</b>	5	<b>Total Risk</b>	8	<b>Risk Priority</b>	VERY LOW
<b>Recommended Action</b>	<b>Not sampled – Sample Required</b>

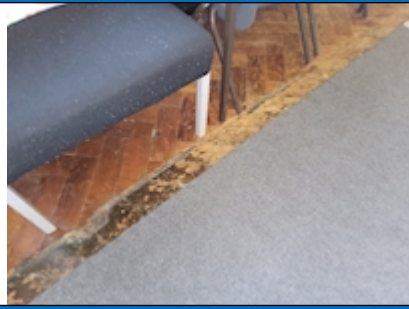
<b>Building</b>	Gorrington Park Primary School			<b>Floor</b>	0		
<b>Location Description</b>	0/002: Classroom			<b>Record Origin Report</b>	B16349		
<b>Item</b>	Bitumen adhesive to parquet flooring

<b>Level of Identification (ID)</b>	Presumed (P)	<b>Sample No.</b>					
<b>Material</b>	Bitumen Product	<b>Extent</b>	65 m <sup>2</sup>				
<b>Accessibility</b>	Usually inaccessible or unlikely to be disturbed						
<b>Identification</b>	Chrysotile						
<b>Material Assessment</b>							
<b>Product Type</b>	1	<b>Condition</b>	1	<b>Surface Treatment</b>	0	<b>Asbestos Type</b>	1
<b>Priority Assessment (for more detail see Section 4.0)</b>							
<b>Occupant Activity</b>	1	<b>Disturbance</b>	1	<b>Human Exposure</b>	3	<b>Maintenance Activity</b>	1
<b>Scoring Summary</b>							
<b>Material Score</b>	3	<b>Priority Score</b>	6	<b>Total Risk</b>	9	<b>Risk Priority</b>	LOW
<b>Recommended Action</b>	<b>Not sampled – Sample Required</b>

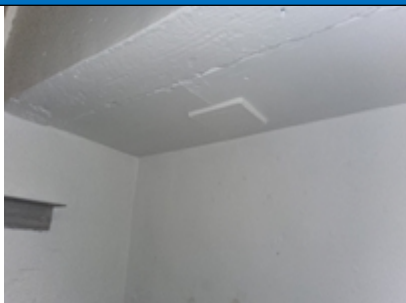
<b>Building</b>	Gorrington Park Primary School			<b>Floor</b>	0		
<b>Location Description</b>	0/002: Year 6 Classroom			<b>Record Origin Report</b>	B16349		
<b>Item</b>	Panel to fireplace

<b>Level of Identification (ID)</b>	Strongly Presumed (SP)	<b>Sample No.</b>					
<b>Material</b>	Insulating Board	<b>Extent</b>	1 m <sup>2</sup>				
<b>Accessibility</b>	Occasionally likely to be disturbed						
<b>Identification</b>	Amosite						
<b>Material Assessment</b>							
<b>Product Type</b>	2	<b>Condition</b>	1	<b>Surface Treatment</b>	1	<b>Asbestos Type</b>	2
<b>Priority Assessment (for more detail see Section 4.0)</b>							
<b>Occupant Activity</b>	1	<b>Disturbance</b>	1	<b>Human Exposure</b>	3	<b>Maintenance Activity</b>	1
<b>Scoring Summary</b>							
<b>Material Score</b>	6	<b>Priority Score</b>	6	<b>Total Risk</b>	12	<b>Risk Priority</b>	LOW
<b>Recommended Action</b>	<b>Manage and Re-inspect</b>

<b>Further Information</b>	Panel to fireplace, previously sampled by Noble HSC as sample GS190810/02 in report J14071, found to contain amosite. No change as of reinspection 2023.

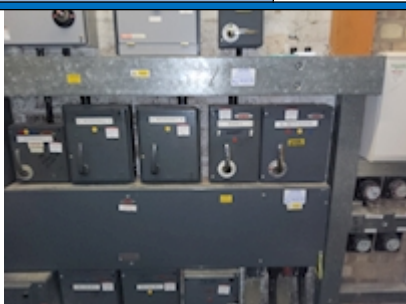
<b>Building</b>	Gorrington Park Primary School			<b>Floor</b>	0		
<b>Location Description</b>	0/004: Electrical Switch Room			<b>Record Origin Report</b>	B16349		
<b>Item</b>	Flashguards within electrics

<b>Level of Identification (ID)</b>	Presumed (P)	<b>Sample No.</b>					
<b>Material</b>	Textile	<b>Extent</b>	2 No.				
<b>Accessibility</b>	Usually inaccessible or unlikely to be disturbed						
<b>Identification</b>	Chrysotile						
<b>Material Assessment</b>							
<b>Product Type</b>	2	<b>Condition</b>	1	<b>Surface Treatment</b>	1	<b>Asbestos Type</b>	1
<b>Priority Assessment (for more detail see Section 4.0)</b>							
<b>Occupant Activity</b>	1	<b>Disturbance</b>	1	<b>Human Exposure</b>	1	<b>Maintenance Activity</b>	2
<b>Scoring Summary</b>							
<b>Material Score</b>	5	<b>Priority Score</b>	5	<b>Total Risk</b>	10	<b>Risk Priority</b>	LOW
<b>Recommended Action</b>	<b>Not sampled – Sample Required</b>

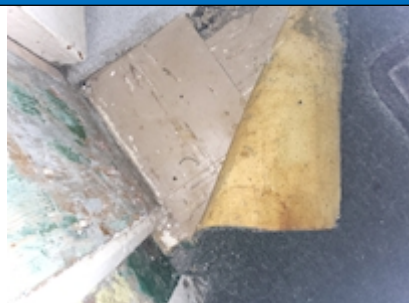
<b>Building</b>	Gorrington Park Primary School			<b>Floor</b>	0		
<b>Location Description</b>	0/004: Toilet			<b>Record Origin Report</b>	B16349		
<b>Item</b>	Floor tiles below vinyl

<b>Level of Identification (ID)</b>	Strongly Presumed (SP)	<b>Sample No.</b>					
<b>Material</b>	Floor Tiles (Thermoplastic)	<b>Extent</b>	2 m <sup>2</sup>				
<b>Accessibility</b>	Usually inaccessible or unlikely to be disturbed						
<b>Identification</b>	Chrysotile						
<b>Material Assessment</b>							
<b>Product Type</b>	1	<b>Condition</b>	1	<b>Surface Treatment</b>	0	<b>Asbestos Type</b>	1
<b>Priority Assessment (for more detail see Section 4.0)</b>							
<b>Occupant Activity</b>	1	<b>Disturbance</b>	1	<b>Human Exposure</b>	1	<b>Maintenance Activity</b>	1
<b>Scoring Summary</b>							
<b>Material Score</b>	3	<b>Priority Score</b>	4	<b>Total Risk</b>	7	<b>Risk Priority</b>	VERY LOW
<b>Recommended Action</b>	<b>Manage and Re-inspect</b>

<b>Further Information</b>	Visually consistent with sample number GS190810/26. Floor tiles below vinyl, previously cross referenced by Noble HSC to sample GS190810/26 in report J14071, found to contain chrysotile.

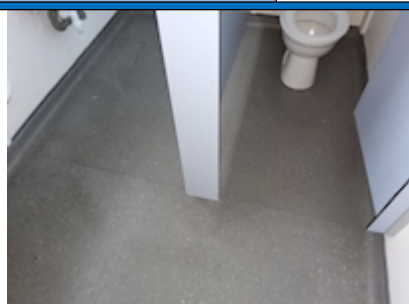
<b>Building</b>	Gorrington Park Primary School			<b>Floor</b>	0		
<b>Location Description</b>	0/005: Toilet			<b>Record Origin Report</b>	B16349		
<b>Item</b>	Floor tiles below vinyl

<b>Level of Identification (ID)</b>	Strongly Presumed (SP)	<b>Sample No.</b>					
<b>Material</b>	Floor Tiles (Thermoplastic)	<b>Extent</b>	2 m <sup>2</sup>				
<b>Accessibility</b>	Usually inaccessible or unlikely to be disturbed						
<b>Identification</b>	Chrysotile						
<b>Material Assessment</b>							
<b>Product Type</b>	1	<b>Condition</b>	1	<b>Surface Treatment</b>	0	<b>Asbestos Type</b>	1
<b>Priority Assessment (for more detail see Section 4.0)</b>							
<b>Occupant Activity</b>	2	<b>Disturbance</b>	1	<b>Human Exposure</b>	2	<b>Maintenance Activity</b>	1
<b>Scoring Summary</b>							
<b>Material Score</b>	3	<b>Priority Score</b>	6	<b>Total Risk</b>	9	<b>Risk Priority</b>	LOW
<b>Recommended Action</b>	<b>Manage and Re-inspect</b>

<b>Further Information</b>	Floor tiles below vinyl, sampled by Noble HSC as GS190810/26 in report J14071, found to contain chrysotile. No change as of reinspection 2023.

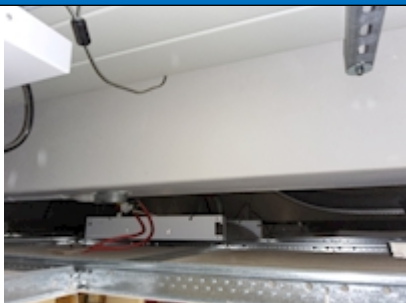
<b>Building</b>	Gorrington Park Primary School			<b>Floor</b>	0		
<b>Location Description</b>	0/006: ICT Room			<b>Record Origin Report</b>	B16349		
<b>Item</b>	Board panel to ceiling

<b>Level of Identification (ID)</b>	Strongly Presumed (SP)	<b>Sample No.</b>					
<b>Material</b>	Insulating Board	<b>Extent</b>	1 m <sup>2</sup>				
<b>Accessibility</b>	Occasionally likely to be disturbed						
<b>Identification</b>	Amosite						
<b>Material Assessment</b>							
<b>Product Type</b>	2	<b>Condition</b>	1	<b>Surface Treatment</b>	1	<b>Asbestos Type</b>	2
<b>Priority Assessment (for more detail see Section 4.0)</b>							
<b>Occupant Activity</b>	1	<b>Disturbance</b>	1	<b>Human Exposure</b>	3	<b>Maintenance Activity</b>	1
<b>Scoring Summary</b>							
<b>Material Score</b>	6	<b>Priority Score</b>	6	<b>Total Risk</b>	12	<b>Risk Priority</b>	LOW
<b>Recommended Action</b>	<b>Manage and Re-inspect</b>

<b>Further Information</b>	Insulation board to ceiling, previously sampled by Noble HSC as sample GS180810/04 in report J14071, found to contain Amosite. No change as of reinspection 2023.

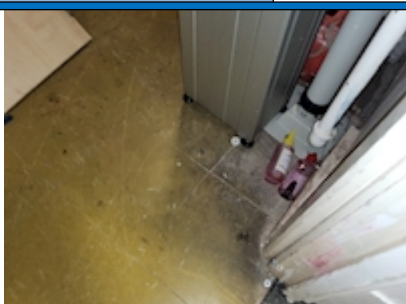
<b>Building</b>	Gorrington Park Primary School			<b>Floor</b>	0		
<b>Location Description</b>	0/007: Store Room			<b>Record Origin Report</b>	B16349		
<b>Item</b>	Floor tiles below carpet

<b>Level of Identification (ID)</b>	Strongly Presumed (SP)	<b>Sample No.</b>					
<b>Material</b>	Floor Tiles (Thermoplastic)	<b>Extent</b>	14 m <sup>2</sup>				
<b>Accessibility</b>	Usually inaccessible or unlikely to be disturbed						
<b>Identification</b>	Chrysotile						
<b>Material Assessment</b>							
<b>Product Type</b>	1	<b>Condition</b>	1	<b>Surface Treatment</b>	0	<b>Asbestos Type</b>	1
<b>Priority Assessment (for more detail see Section 4.0)</b>							
<b>Occupant Activity</b>	1	<b>Disturbance</b>	1	<b>Human Exposure</b>	1	<b>Maintenance Activity</b>	1
<b>Scoring Summary</b>							
<b>Material Score</b>	3	<b>Priority Score</b>	4	<b>Total Risk</b>	7	<b>Risk Priority</b>	VERY LOW
<b>Recommended Action</b>	<b>Manage and Re-inspect</b>

<b>Further Information</b>	Visually consistent with sample number GS180810/03 tiles, previously cross referenced by Noble HSC to sample GS180810/03 in report J14071, found to contain chrysotile. No change as of reinspection 2023.

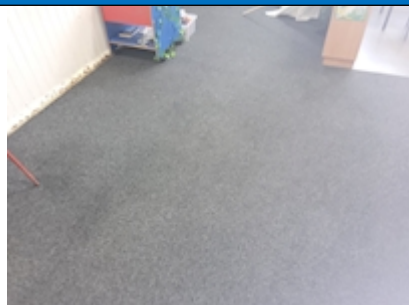
<b>Building</b>	Gorrington Park Primary School			<b>Floor</b>	0		
<b>Location Description</b>	0/008: Classroom			<b>Record Origin Report</b>	B16349		
<b>Item</b>	Bitumen adhesive to parquet flooring

<b>Level of Identification (ID)</b>	Presumed (P)	<b>Sample No.</b>					
<b>Material</b>	Bitumen Product	<b>Extent</b>	30 m <sup>2</sup>				
<b>Accessibility</b>	Usually inaccessible or unlikely to be disturbed						
<b>Identification</b>	Chrysotile						
<b>Material Assessment</b>							
<b>Product Type</b>	1	<b>Condition</b>	1	<b>Surface Treatment</b>	0	<b>Asbestos Type</b>	1
<b>Priority Assessment (for more detail see Section 4.0)</b>							
<b>Occupant Activity</b>	1	<b>Disturbance</b>	1	<b>Human Exposure</b>	3	<b>Maintenance Activity</b>	1
<b>Scoring Summary</b>							
<b>Material Score</b>	3	<b>Priority Score</b>	6	<b>Total Risk</b>	9	<b>Risk Priority</b>	LOW
<b>Recommended Action</b>	Not sampled – Sample Required

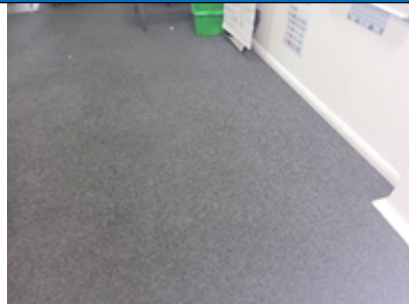
<b>Level of Identification (ID)</b>	Presumed (P)	<b>Sample No.</b>					
<b>Material</b>	Bitumen Product	<b>Extent</b>	30 m <sup>2</sup>				
<b>Accessibility</b>	Usually inaccessible or unlikely to be disturbed						
<b>Identification</b>	Chrysotile						
<b>Material Assessment</b>							
<b>Product Type</b>	1	<b>Condition</b>	1	<b>Surface Treatment</b>	0	<b>Asbestos Type</b>	1
<b>Priority Assessment (for more detail see Section 4.0)</b>							
<b>Occupant Activity</b>	1	<b>Disturbance</b>	0	<b>Human Exposure</b>	3	<b>Maintenance Activity</b>	1
<b>Scoring Summary</b>							
<b>Material Score</b>	3	<b>Priority Score</b>	5	<b>Total Risk</b>	8	<b>Risk Priority</b>	VERY LOW
<b>Recommended Action</b>	Not sampled – Sample Required

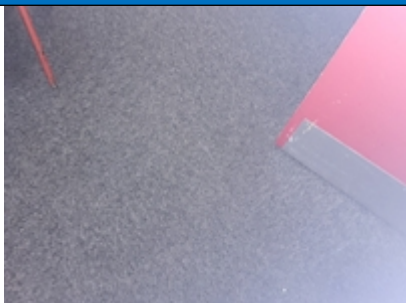
<b>Level of Identification (ID)</b>	Presumed (P)	<b>Sample No.</b>					
<b>Material</b>	Bitumen Product	<b>Extent</b>	30 m <sup>2</sup>				
<b>Accessibility</b>	Usually inaccessible or unlikely to be disturbed						
<b>Identification</b>	Chrysotile						
<b>Material Assessment</b>							
<b>Product Type</b>	1	<b>Condition</b>	1	<b>Surface Treatment</b>	0	<b>Asbestos Type</b>	1
<b>Priority Assessment (for more detail see Section 4.0)</b>							
<b>Occupant Activity</b>	1	<b>Disturbance</b>	0	<b>Human Exposure</b>	3	<b>Maintenance Activity</b>	1
<b>Scoring Summary</b>							
<b>Material Score</b>	3	<b>Priority Score</b>	5	<b>Total Risk</b>	8	<b>Risk Priority</b>	VERY LOW
<b>Recommended Action</b>	<b>Not sampled – Sample Required</b>

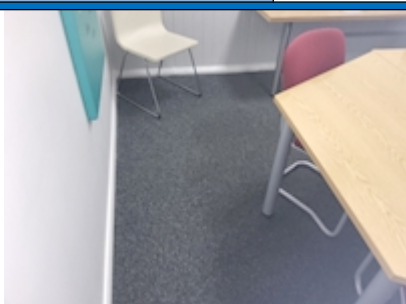
<b>Level of Identification (ID)</b>	Presumed (P)	<b>Sample No.</b>					
<b>Material</b>	Bitumen Product	<b>Extent</b>	25 m <sup>2</sup>				
<b>Accessibility</b>	Usually inaccessible or unlikely to be disturbed						
<b>Identification</b>	Chrysotile						
<b>Material Assessment</b>							
<b>Product Type</b>	1	<b>Condition</b>	1	<b>Surface Treatment</b>	0	<b>Asbestos Type</b>	1
<b>Priority Assessment (for more detail see Section 4.0)</b>							
<b>Occupant Activity</b>	1	<b>Disturbance</b>	1	<b>Human Exposure</b>	2	<b>Maintenance Activity</b>	1
<b>Scoring Summary</b>							
<b>Material Score</b>	3	<b>Priority Score</b>	5	<b>Total Risk</b>	8	<b>Risk Priority</b>	VERY LOW
<b>Recommended Action</b>	<b>Not sampled – Sample Required</b>

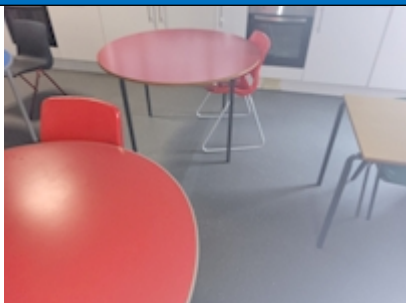
<b>Level of Identification (ID)</b>	Presumed (P)	<b>Sample No.</b>					
<b>Material</b>	Bitumen Product	<b>Extent</b>	30 m <sup>2</sup>				
<b>Accessibility</b>	Usually inaccessible or unlikely to be disturbed						
<b>Identification</b>	Chrysotile						
<b>Material Assessment</b>							
<b>Product Type</b>	1	<b>Condition</b>	1	<b>Surface Treatment</b>	0	<b>Asbestos Type</b>	1
<b>Priority Assessment (for more detail see Section 4.0)</b>							
<b>Occupant Activity</b>	1	<b>Disturbance</b>	1	<b>Human Exposure</b>	2	<b>Maintenance Activity</b>	1
<b>Scoring Summary</b>							
<b>Material Score</b>	3	<b>Priority Score</b>	5	<b>Total Risk</b>	8	<b>Risk Priority</b>	VERY LOW
<b>Recommended Action</b>	<b>Not sampled – Sample Required</b>

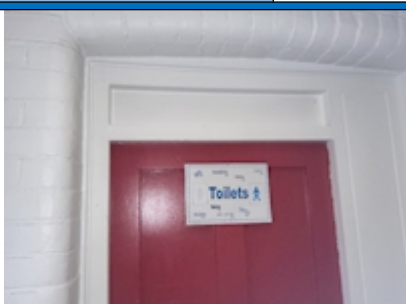
<b>Level of Identification (ID)</b>	Strongly Presumed (SP)	<b>Sample No.</b>					
<b>Material</b>	Insulating Board	<b>Extent</b>	1 m <sup>2</sup>				
<b>Accessibility</b>	Occasionally likely to be disturbed						
<b>Identification</b>	Amosite						
<b>Material Assessment</b>							
<b>Product Type</b>	2	<b>Condition</b>	1	<b>Surface Treatment</b>	1	<b>Asbestos Type</b>	2
<b>Priority Assessment (for more detail see Section 4.0)</b>							
<b>Occupant Activity</b>	1	<b>Disturbance</b>	1	<b>Human Exposure</b>	1	<b>Maintenance Activity</b>	1
<b>Scoring Summary</b>							
<b>Material Score</b>	6	<b>Priority Score</b>	4	<b>Total Risk</b>	10	<b>Risk Priority</b>	LOW
<b>Recommended Action</b>	<b>Manage and Re-inspect</b>

<b>Further Information</b>	Door Header panel, previously sampled by Noble HSC as sample MP180810/03 in report J14071, found to contain amosite. no change as of reinspection 2023.

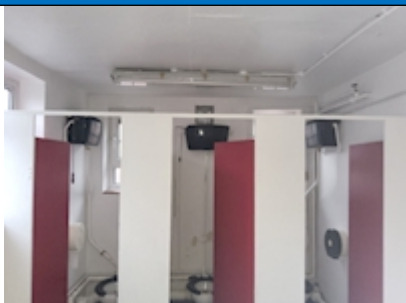
<b>Level of Identification (ID)</b>	Strongly Presumed (SP)	<b>Sample No.</b>					
<b>Material</b>	Plastic / Resin	<b>Extent</b>	3 No.				
<b>Accessibility</b>	Occasionally likely to be disturbed						
<b>Identification</b>	Amosite						
<b>Material Assessment</b>							
<b>Product Type</b>	1	<b>Condition</b>	1	<b>Surface Treatment</b>	0	<b>Asbestos Type</b>	2
<b>Priority Assessment (for more detail see Section 4.0)</b>							
<b>Occupant Activity</b>	1	<b>Disturbance</b>	1	<b>Human Exposure</b>	1	<b>Maintenance Activity</b>	1
<b>Scoring Summary</b>							
<b>Material Score</b>	4	<b>Priority Score</b>	4	<b>Total Risk</b>	8	<b>Risk Priority</b>	VERY LOW
<b>Recommended Action</b>	<b>Manage and Re-inspect</b>						
<b>Further Information</b>	Toilet Cistern x3, previously sampled by Noble HSC as sample MP180810/04 in report J14071, found to contain amosite.no change as of reinspection 2023.

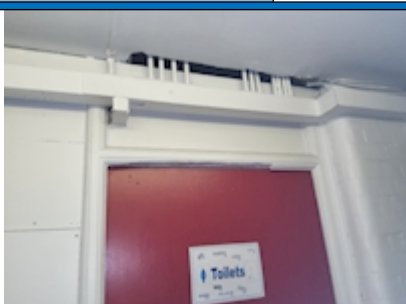
<b>Level of Identification (ID)</b>	Strongly Presumed (SP)	<b>Sample No.</b>					
<b>Material</b>	Insulating Board	<b>Extent</b>	1 m <sup>2</sup>				
<b>Accessibility</b>	Occasionally likely to be disturbed						
<b>Identification</b>	Amosite						
<b>Material Assessment</b>							
<b>Product Type</b>	2	<b>Condition</b>	1	<b>Surface Treatment</b>	1	<b>Asbestos Type</b>	2
<b>Priority Assessment (for more detail see Section 4.0)</b>							
<b>Occupant Activity</b>	1	<b>Disturbance</b>	1	<b>Human Exposure</b>	1	<b>Maintenance Activity</b>	1
<b>Scoring Summary</b>							
<b>Material Score</b>	6	<b>Priority Score</b>	4	<b>Total Risk</b>	10	<b>Risk Priority</b>	LOW
<b>Recommended Action</b>	<b>Manage and Re-inspect</b>

<b>Further Information</b>	Door Header panel, previously cross referenced by Noble HSC to sample MP180810/03 in report J14071, found to contain amosite. No change as of reinspection 2023.

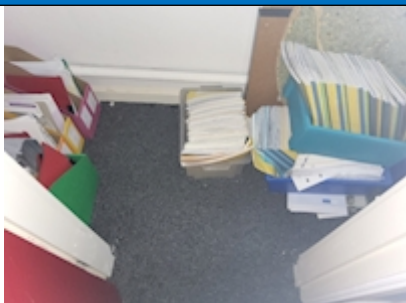
<b>Level of Identification (ID)</b>	Strongly Presumed (SP)	<b>Sample No.</b>					
<b>Material</b>	Bitumen Product	<b>Extent</b>	2 m <sup>2</sup>				
<b>Accessibility</b>	Usually inaccessible or unlikely to be disturbed						
<b>Identification</b>	Chrysotile						
<b>Material Assessment</b>							
<b>Product Type</b>	1	<b>Condition</b>	1	<b>Surface Treatment</b>	0	<b>Asbestos Type</b>	1
<b>Priority Assessment (for more detail see Section 4.0)</b>							
<b>Occupant Activity</b>	1	<b>Disturbance</b>	1	<b>Human Exposure</b>	1	<b>Maintenance Activity</b>	1
<b>Scoring Summary</b>							
<b>Material Score</b>	3	<b>Priority Score</b>	4	<b>Total Risk</b>	7	<b>Risk Priority</b>	VERY LOW
<b>Recommended Action</b>	<b>Manage and Re-inspect</b>

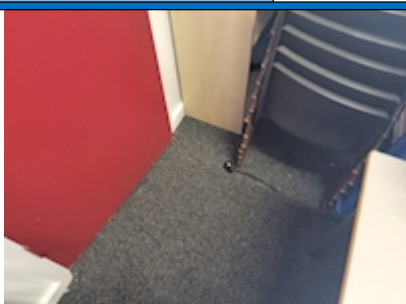
<b>Level of Identification (ID)</b>	Strongly Presumed (SP)	<b>Sample No.</b>					
<b>Material</b>	Bitumen Product	<b>Extent</b>	12 m <sup>2</sup>				
<b>Accessibility</b>	Usually inaccessible or unlikely to be disturbed						
<b>Identification</b>	Chrysotile						
<b>Material Assessment</b>							
<b>Product Type</b>	1	<b>Condition</b>	1	<b>Surface Treatment</b>	0	<b>Asbestos Type</b>	1
<b>Priority Assessment (for more detail see Section 4.0)</b>							
<b>Occupant Activity</b>	1	<b>Disturbance</b>	1	<b>Human Exposure</b>	2	<b>Maintenance Activity</b>	1
<b>Scoring Summary</b>							
<b>Material Score</b>	3	<b>Priority Score</b>	5	<b>Total Risk</b>	8	<b>Risk Priority</b>	VERY LOW
<b>Recommended Action</b>	<b>Manage and Re-inspect</b>

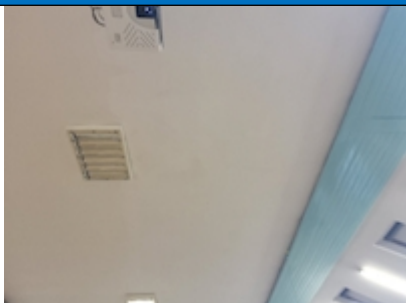
<b>Level of Identification (ID)</b>	Strongly Presumed (SP)	<b>Sample No.</b>					
<b>Material</b>	Textured Coating	<b>Extent</b>	200 m <sup>2</sup>				
<b>Accessibility</b>	Usually inaccessible or unlikely to be disturbed						
<b>Identification</b>	Chrysotile						
<b>Material Assessment</b>							
<b>Product Type</b>	1	<b>Condition</b>	1	<b>Surface Treatment</b>	0	<b>Asbestos Type</b>	1
<b>Priority Assessment (for more detail see Section 4.0)</b>							
<b>Occupant Activity</b>	1	<b>Disturbance</b>	1	<b>Human Exposure</b>	3	<b>Maintenance Activity</b>	2
<b>Scoring Summary</b>							
<b>Material Score</b>	3	<b>Priority Score</b>	7	<b>Total Risk</b>	10	<b>Risk Priority</b>	LOW
<b>Recommended Action</b>	<b>Manage and Re-inspect</b>

<b>Further Information</b>	Visually consistent with sample number MP180810/06. Textured coating, previously cross referenced by Noble HSC to sample MP180810/06 in report J14071, found to contain chrysotile. No change as of reinspection 2023.

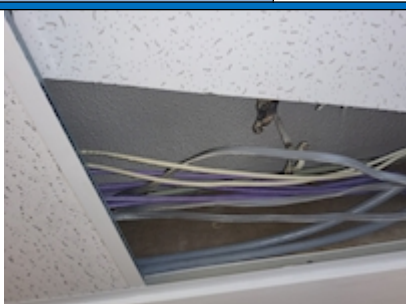
<b>Level of Identification (ID)</b>	Strongly Presumed (SP)	<b>Sample No.</b>					
<b>Material</b>	Textured Coating	<b>Extent</b>	25 m <sup>2</sup>				
<b>Accessibility</b>	Occasionally likely to be disturbed						
<b>Identification</b>	Chrysotile						
<b>Material Assessment</b>							
<b>Product Type</b>	1	<b>Condition</b>	1	<b>Surface Treatment</b>	0	<b>Asbestos Type</b>	1
<b>Priority Assessment (for more detail see Section 4.0)</b>							
<b>Occupant Activity</b>	2	<b>Disturbance</b>	2	<b>Human Exposure</b>	2	<b>Maintenance Activity</b>	1
<b>Scoring Summary</b>							
<b>Material Score</b>	3	<b>Priority Score</b>	7	<b>Total Risk</b>	10	<b>Risk Priority</b>	LOW
<b>Recommended Action</b>	<b>Manage and Re-inspect</b>

<b>Further Information</b>	Visually consistent with sample number MP180810/06. Textured coating, previously cross referenced by Noble HSC to sample MP180810/06 in report J14071, found to contain chrysotile. No change as of reinspection 2023.

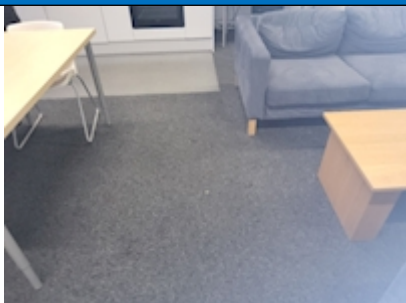
<b>Level of Identification (ID)</b>	Presumed (P)	<b>Sample No.</b>					
<b>Material</b>	Bitumen Product	<b>Extent</b>	30 m <sup>2</sup>				
<b>Accessibility</b>	Usually inaccessible or unlikely to be disturbed						
<b>Identification</b>	Chrysotile						
<b>Material Assessment</b>							
<b>Product Type</b>	1	<b>Condition</b>	1	<b>Surface Treatment</b>	0	<b>Asbestos Type</b>	1
<b>Priority Assessment (for more detail see Section 4.0)</b>							
<b>Occupant Activity</b>	1	<b>Disturbance</b>	1	<b>Human Exposure</b>	2	<b>Maintenance Activity</b>	1
<b>Scoring Summary</b>							
<b>Material Score</b>	3	<b>Priority Score</b>	5	<b>Total Risk</b>	8	<b>Risk Priority</b>	VERY LOW
<b>Recommended Action</b>	<b>Not sampled – Sample Required</b>

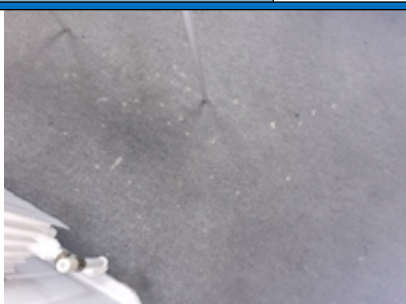
<b>Level of Identification (ID)</b>	Presumed (P)	<b>Sample No.</b>					
<b>Material</b>	Bitumen Product	<b>Extent</b>	30 m <sup>2</sup>				
<b>Accessibility</b>	Usually inaccessible or unlikely to be disturbed						
<b>Identification</b>	Chrysotile						
<b>Material Assessment</b>							
<b>Product Type</b>	1	<b>Condition</b>	1	<b>Surface Treatment</b>	0	<b>Asbestos Type</b>	1
<b>Priority Assessment (for more detail see Section 4.0)</b>							
<b>Occupant Activity</b>	1	<b>Disturbance</b>	0	<b>Human Exposure</b>	3	<b>Maintenance Activity</b>	1
<b>Scoring Summary</b>							
<b>Material Score</b>	3	<b>Priority Score</b>	5	<b>Total Risk</b>	8	<b>Risk Priority</b>	VERY LOW
<b>Recommended Action</b>	<b>Not sampled – Sample Required</b>

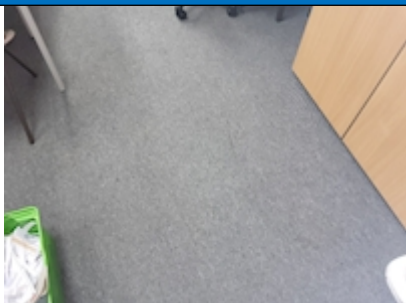
<b>Level of Identification (ID)</b>	Presumed (P)	<b>Sample No.</b>					
<b>Material</b>	Bitumen Product	<b>Extent</b>	30 m <sup>2</sup>				
<b>Accessibility</b>	Usually inaccessible or unlikely to be disturbed						
<b>Identification</b>	Chrysotile						
<b>Material Assessment</b>							
<b>Product Type</b>	1	<b>Condition</b>	1	<b>Surface Treatment</b>	0	<b>Asbestos Type</b>	1
<b>Priority Assessment (for more detail see Section 4.0)</b>							
<b>Occupant Activity</b>	1	<b>Disturbance</b>	0	<b>Human Exposure</b>	3	<b>Maintenance Activity</b>	1
<b>Scoring Summary</b>							
<b>Material Score</b>	3	<b>Priority Score</b>	5	<b>Total Risk</b>	8	<b>Risk Priority</b>	VERY LOW
<b>Recommended Action</b>	<b>Not sampled – Sample Required</b>

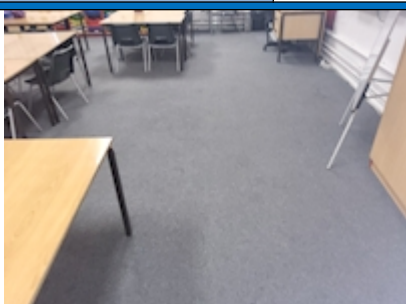
<b>Level of Identification (ID)</b>	Presumed (P)	<b>Sample No.</b>					
<b>Material</b>	Bitumen Product	<b>Extent</b>	30 m <sup>2</sup>				
<b>Accessibility</b>	Usually inaccessible or unlikely to be disturbed						
<b>Identification</b>	Chrysotile						
<b>Material Assessment</b>							
<b>Product Type</b>	1	<b>Condition</b>	1	<b>Surface Treatment</b>	0	<b>Asbestos Type</b>	1
<b>Priority Assessment (for more detail see Section 4.0)</b>							
<b>Occupant Activity</b>	1	<b>Disturbance</b>	0	<b>Human Exposure</b>	3	<b>Maintenance Activity</b>	1
<b>Scoring Summary</b>							
<b>Material Score</b>	3	<b>Priority Score</b>	5	<b>Total Risk</b>	8	<b>Risk Priority</b>	VERY LOW
<b>Recommended Action</b>	<b>Not sampled – Sample Required</b>

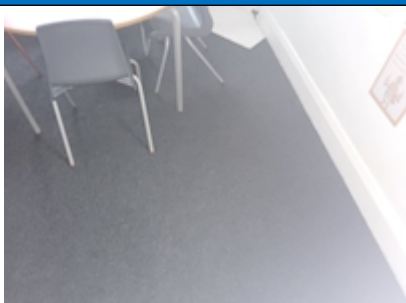
<b>Level of Identification (ID)</b>	Presumed (P)	<b>Sample No.</b>					
<b>Material</b>	Bitumen Product	<b>Extent</b>	10 m <sup>2</sup>				
<b>Accessibility</b>	Usually inaccessible or unlikely to be disturbed						
<b>Identification</b>	Chrysotile						
<b>Material Assessment</b>							
<b>Product Type</b>	1	<b>Condition</b>	1	<b>Surface Treatment</b>	0	<b>Asbestos Type</b>	1
<b>Priority Assessment (for more detail see Section 4.0)</b>							
<b>Occupant Activity</b>	1	<b>Disturbance</b>	1	<b>Human Exposure</b>	1	<b>Maintenance Activity</b>	1
<b>Scoring Summary</b>							
<b>Material Score</b>	3	<b>Priority Score</b>	4	<b>Total Risk</b>	7	<b>Risk Priority</b>	VERY LOW
<b>Recommended Action</b>	Not sampled – Sample Required

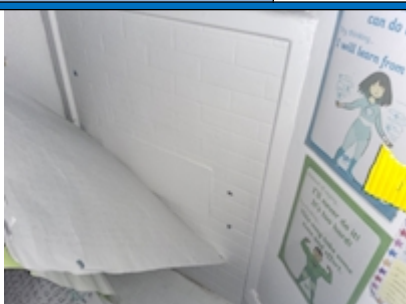
<b>Level of Identification (ID)</b>	Strongly Presumed (SP)	<b>Sample No.</b>					
<b>Material</b>	Cement Product	<b>Extent</b>	2 m <sup>2</sup>				
<b>Accessibility</b>	Occasionally likely to be disturbed						
<b>Identification</b>	Chrysotile						
<b>Material Assessment</b>							
<b>Product Type</b>	1	<b>Condition</b>	1	<b>Surface Treatment</b>	1	<b>Asbestos Type</b>	1
<b>Priority Assessment (for more detail see Section 4.0)</b>							
<b>Occupant Activity</b>	1	<b>Disturbance</b>	1	<b>Human Exposure</b>	1	<b>Maintenance Activity</b>	1
<b>Scoring Summary</b>							
<b>Material Score</b>	4	<b>Priority Score</b>	4	<b>Total Risk</b>	8	<b>Risk Priority</b>	VERY LOW
<b>Recommended Action</b>	Manage and Re-inspect

<b>Further Information</b>	Cement fire place surround, previously sampled by Noble HSC as sample GS180810/10 in report J14071, found to contain chrysotile. No change as of reinspection 2023.

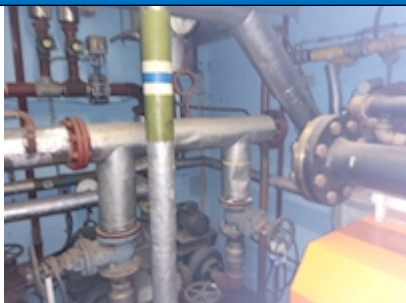
<b>Level of Identification (ID)</b>	Strongly Presumed (SP)	<b>Sample No.</b>					
<b>Material</b>	Gaskets	<b>Extent</b>	10 No.				
<b>Accessibility</b>	Occasionally likely to be disturbed						
<b>Identification</b>	Chrysotile						
<b>Material Assessment</b>							
<b>Product Type</b>	2	<b>Condition</b>	1	<b>Surface Treatment</b>	1	<b>Asbestos Type</b>	1
<b>Priority Assessment (for more detail see Section 4.0)</b>							
<b>Occupant Activity</b>	1	<b>Disturbance</b>	1	<b>Human Exposure</b>	1	<b>Maintenance Activity</b>	1
<b>Scoring Summary</b>							
<b>Material Score</b>	5	<b>Priority Score</b>	4	<b>Total Risk</b>	9	<b>Risk Priority</b>	LOW
<b>Recommended Action</b>	<b>Manage and Re-inspect</b>						
<b>Further Information</b>	Visually consistent with sample number GS190810/04. Gaskets to pipework, previously cross referenced by Noble HSC to sample GS190810/04 in report J14071, found to contain chrysotile. No change as of reinspection.

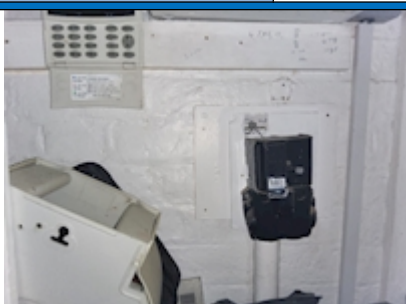
<b>Level of Identification (ID)</b>	Strongly Presumed (SP)	<b>Sample No.</b>					
<b>Material</b>	Insulating Board	<b>Extent</b>	1 m <sup>2</sup>				
<b>Accessibility</b>	Occasionally likely to be disturbed						
<b>Identification</b>	Amosite						
<b>Material Assessment</b>							
<b>Product Type</b>	2	<b>Condition</b>	1	<b>Surface Treatment</b>	1	<b>Asbestos Type</b>	2
<b>Priority Assessment (for more detail see Section 4.0)</b>							
<b>Occupant Activity</b>	2	<b>Disturbance</b>	1	<b>Human Exposure</b>	2	<b>Maintenance Activity</b>	1
<b>Scoring Summary</b>							
<b>Material Score</b>	6	<b>Priority Score</b>	6	<b>Total Risk</b>	12	<b>Risk Priority</b>	LOW
<b>Recommended Action</b>	<b>Manage and Re-inspect</b>

<b>Further Information</b>	Panel to electrical cupboard, previously sampled by Noble HSC to sample GS180810/16 in report J14071, found to contain amosite. No change as of reinspection 2023.

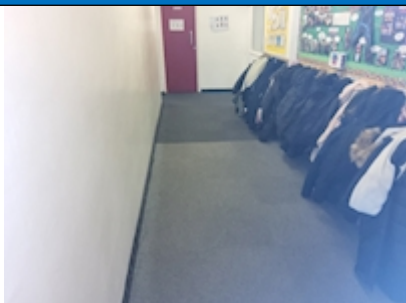
<b>Level of Identification (ID)</b>	Strongly Presumed (SP)	<b>Sample No.</b>					
<b>Material</b>	Floor Tiles (Thermoplastic)	<b>Extent</b>	35 m <sup>2</sup>				
<b>Accessibility</b>	Usually inaccessible or unlikely to be disturbed						
<b>Identification</b>	Chrysotile						
<b>Material Assessment</b>							
<b>Product Type</b>	1	<b>Condition</b>	1	<b>Surface Treatment</b>	0	<b>Asbestos Type</b>	1
<b>Priority Assessment (for more detail see Section 4.0)</b>							
<b>Occupant Activity</b>	2	<b>Disturbance</b>	1	<b>Human Exposure</b>	2	<b>Maintenance Activity</b>	1
<b>Scoring Summary</b>							
<b>Material Score</b>	3	<b>Priority Score</b>	6	<b>Total Risk</b>	9	<b>Risk Priority</b>	LOW
<b>Recommended Action</b>	<b>Manage and Re-inspect</b>

<b>Further Information</b>	Visually consistent with sample number GS180810/15. Floor tiles below carpet, previously cross referenced by Noble HSC to sample GS180810/15 in report J14071, found to contain chrysotile.no change as of reinspection 2023

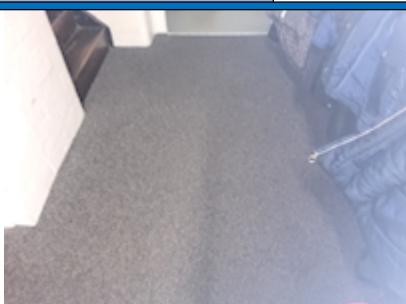
<b>Level of Identification (ID)</b>	Presumed (P)	<b>Sample No.</b>					
<b>Material</b>	Bitumen Product	<b>Extent</b>	15 m <sup>2</sup>				
<b>Accessibility</b>	Usually inaccessible or unlikely to be disturbed						
<b>Identification</b>	Chrysotile						
<b>Material Assessment</b>							
<b>Product Type</b>	1	<b>Condition</b>	1	<b>Surface Treatment</b>	0	<b>Asbestos Type</b>	1
<b>Priority Assessment (for more detail see Section 4.0)</b>							
<b>Occupant Activity</b>	2	<b>Disturbance</b>	1	<b>Human Exposure</b>	2	<b>Maintenance Activity</b>	1
<b>Scoring Summary</b>							
<b>Material Score</b>	3	<b>Priority Score</b>	6	<b>Total Risk</b>	9	<b>Risk Priority</b>	LOW
<b>Recommended Action</b>	<b>Not sampled – Sample Required</b>

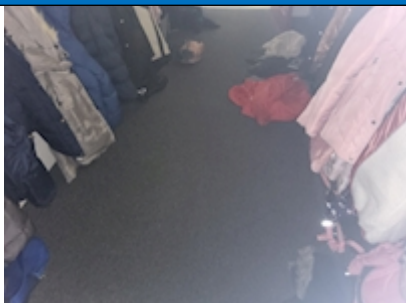
<b>Level of Identification (ID)</b>	Presumed (P)	<b>Sample No.</b>					
<b>Material</b>	Bitumen Product	<b>Extent</b>	15 m <sup>2</sup>				
<b>Accessibility</b>	Usually inaccessible or unlikely to be disturbed						
<b>Identification</b>	Chrysotile						
<b>Material Assessment</b>							
<b>Product Type</b>	1	<b>Condition</b>	1	<b>Surface Treatment</b>	0	<b>Asbestos Type</b>	1
<b>Priority Assessment (for more detail see Section 4.0)</b>							
<b>Occupant Activity</b>	2	<b>Disturbance</b>	1	<b>Human Exposure</b>	2	<b>Maintenance Activity</b>	1
<b>Scoring Summary</b>							
<b>Material Score</b>	3	<b>Priority Score</b>	6	<b>Total Risk</b>	9	<b>Risk Priority</b>	LOW
<b>Recommended Action</b>	<b>Not sampled – Sample Required</b>

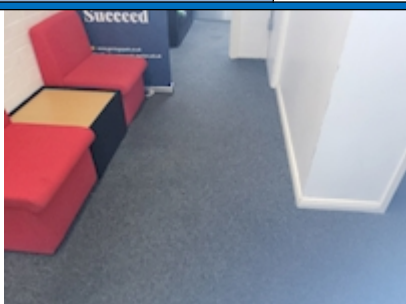
<b>Level of Identification (ID)</b>	Presumed (P)	<b>Sample No.</b>					
<b>Material</b>	Bitumen Product	<b>Extent</b>	15 m <sup>2</sup>				
<b>Accessibility</b>	Usually inaccessible or unlikely to be disturbed						
<b>Identification</b>	Chrysotile						
<b>Material Assessment</b>							
<b>Product Type</b>	1	<b>Condition</b>	1	<b>Surface Treatment</b>	0	<b>Asbestos Type</b>	1
<b>Priority Assessment (for more detail see Section 4.0)</b>							
<b>Occupant Activity</b>	2	<b>Disturbance</b>	1	<b>Human Exposure</b>	2	<b>Maintenance Activity</b>	1
<b>Scoring Summary</b>							
<b>Material Score</b>	3	<b>Priority Score</b>	6	<b>Total Risk</b>	9	<b>Risk Priority</b>	LOW
<b>Recommended Action</b>	<b>Not sampled – Sample Required</b>

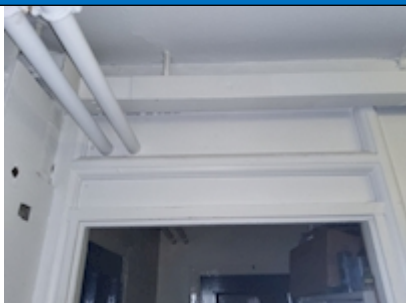
<b>Level of Identification (ID)</b>	Strongly Presumed (SP)	<b>Sample No.</b>					
<b>Material</b>	Insulating Board	<b>Extent</b>	1 m <sup>2</sup>				
<b>Accessibility</b>	Occasionally likely to be disturbed						
<b>Identification</b>	Amosite						
<b>Material Assessment</b>							
<b>Product Type</b>	2	<b>Condition</b>	1	<b>Surface Treatment</b>	1	<b>Asbestos Type</b>	2
<b>Priority Assessment (for more detail see Section 4.0)</b>							
<b>Occupant Activity</b>	2	<b>Disturbance</b>	1	<b>Human Exposure</b>	2	<b>Maintenance Activity</b>	1
<b>Scoring Summary</b>							
<b>Material Score</b>	6	<b>Priority Score</b>	6	<b>Total Risk</b>	12	<b>Risk Priority</b>	LOW
<b>Recommended Action</b>	<b>Manage and Re-inspect</b>

<b>Further Information</b>	Visually consistent with sample number MP180810/03 Door Header panel, previously sampled by Noble HSC as sample MP180810/03 in report J14071, found to contain amosite. Outside of 0/035A. No change as of reinspection 2023

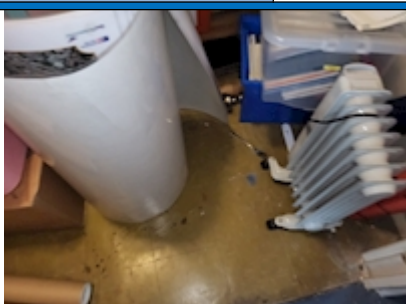
<b>Level of Identification (ID)</b>	Strongly Presumed (SP)	<b>Sample No.</b>					
<b>Material</b>	Floor Tiles (Thermoplastic)	<b>Extent</b>	2 m <sup>2</sup>				
<b>Accessibility</b>	Usually inaccessible or unlikely to be disturbed						
<b>Identification</b>	Chrysotile						
<b>Material Assessment</b>							
<b>Product Type</b>	1	<b>Condition</b>	1	<b>Surface Treatment</b>	0	<b>Asbestos Type</b>	1
<b>Priority Assessment (for more detail see Section 4.0)</b>							
<b>Occupant Activity</b>	1	<b>Disturbance</b>	1	<b>Human Exposure</b>	1	<b>Maintenance Activity</b>	1
<b>Scoring Summary</b>							
<b>Material Score</b>	3	<b>Priority Score</b>	4	<b>Total Risk</b>	7	<b>Risk Priority</b>	VERY LOW
<b>Recommended Action</b>	<b>Manage and Re-inspect</b>

<b>Further Information</b>	Floor tiles, previously sampled by Noble HSC as sample GS180810/05 in report J14071, found to contain chrysotile. No change as of reinspection 2023.

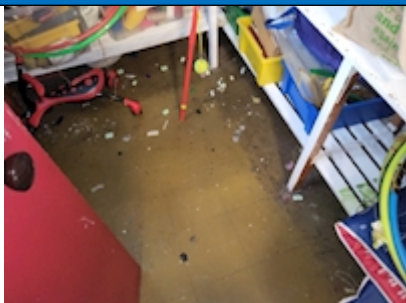
<b>Level of Identification (ID)</b>	Strongly Presumed (SP)	<b>Sample No.</b>					
<b>Material</b>	Floor Tiles (Thermoplastic)	<b>Extent</b>	5 m <sup>2</sup>				
<b>Accessibility</b>	Usually inaccessible or unlikely to be disturbed						
<b>Identification</b>	Chrysotile						
<b>Material Assessment</b>							
<b>Product Type</b>	1	<b>Condition</b>	1	<b>Surface Treatment</b>	0	<b>Asbestos Type</b>	1
<b>Priority Assessment (for more detail see Section 4.0)</b>							
<b>Occupant Activity</b>	1	<b>Disturbance</b>	1	<b>Human Exposure</b>	1	<b>Maintenance Activity</b>	1
<b>Scoring Summary</b>							
<b>Material Score</b>	3	<b>Priority Score</b>	4	<b>Total Risk</b>	7	<b>Risk Priority</b>	VERY LOW
<b>Recommended Action</b>	<b>Manage and Re-inspect</b>

<b>Further Information</b>	Visually consistent with sample number GS180810/10 Floor tiles, previously sampled by Noble HSC as sample GS180810/05 in report J14071, found to contain chrysotile.no change as of reinspection 2023.

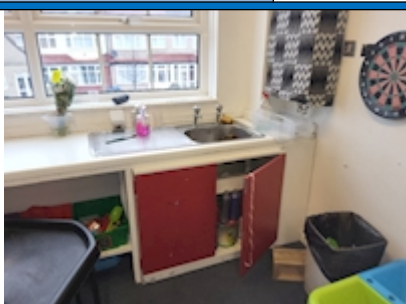
<b>Level of Identification (ID)</b>	Strongly Presumed (SP)	<b>Sample No.</b>					
<b>Material</b>	Bitumen Product	<b>Extent</b>	1 No.				
<b>Accessibility</b>	Occasionally likely to be disturbed						
<b>Identification</b>	Chrysotile						
<b>Material Assessment</b>							
<b>Product Type</b>	1	<b>Condition</b>	1	<b>Surface Treatment</b>	0	<b>Asbestos Type</b>	1
<b>Priority Assessment (for more detail see Section 4.0)</b>							
<b>Occupant Activity</b>	1	<b>Disturbance</b>	1	<b>Human Exposure</b>	3	<b>Maintenance Activity</b>	1
<b>Scoring Summary</b>							
<b>Material Score</b>	3	<b>Priority Score</b>	6	<b>Total Risk</b>	9	<b>Risk Priority</b>	LOW
<b>Recommended Action</b>	<b>Manage and Re-inspect</b>						
<b>Further Information</b>	Sink pad, previously sampled by Pennington Choices as sample 015 in report SV54025, found to contain chrysotile.No change as of reinspection 2023.

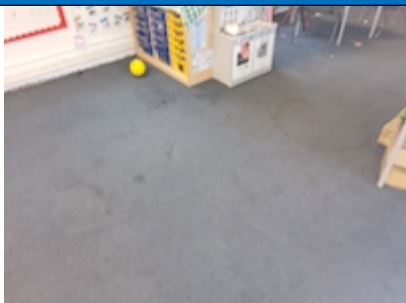
<b>Level of Identification (ID)</b>	Strongly Presumed (SP)	<b>Sample No.</b>					
<b>Material</b>	Floor Tiles (Thermoplastic)	<b>Extent</b>	30 m <sup>2</sup>				
<b>Accessibility</b>	Usually inaccessible or unlikely to be disturbed						
<b>Identification</b>	Chrysotile						
<b>Material Assessment</b>							
<b>Product Type</b>	1	<b>Condition</b>	1	<b>Surface Treatment</b>	0	<b>Asbestos Type</b>	1
<b>Priority Assessment (for more detail see Section 4.0)</b>							
<b>Occupant Activity</b>	1	<b>Disturbance</b>	1	<b>Human Exposure</b>	3	<b>Maintenance Activity</b>	1
<b>Scoring Summary</b>							
<b>Material Score</b>	3	<b>Priority Score</b>	6	<b>Total Risk</b>	9	<b>Risk Priority</b>	LOW
<b>Recommended Action</b>	<b>Manage and Re-inspect</b>

<b>Further Information</b>	Visually consistent with sample number GS180810/10 Floor tiles, previously sampled by Noble HSC as sample GS180810/05 in report J14071, found to contain chrysotile.no change as of reinspection 2023.

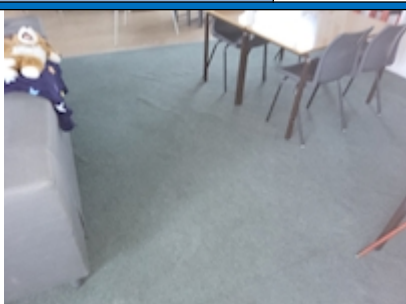
<b>Level of Identification (ID)</b>	Presumed (P)	<b>Sample No.</b>					
<b>Material</b>	Bitumen Product	<b>Extent</b>	65 m <sup>2</sup>				
<b>Accessibility</b>	Usually inaccessible or unlikely to be disturbed						
<b>Identification</b>	Chrysotile						
<b>Material Assessment</b>							
<b>Product Type</b>	1	<b>Condition</b>	1	<b>Surface Treatment</b>	0	<b>Asbestos Type</b>	1
<b>Priority Assessment (for more detail see Section 4.0)</b>							
<b>Occupant Activity</b>	1	<b>Disturbance</b>	1	<b>Human Exposure</b>	3	<b>Maintenance Activity</b>	1
<b>Scoring Summary</b>							
<b>Material Score</b>	3	<b>Priority Score</b>	6	<b>Total Risk</b>	9	<b>Risk Priority</b>	LOW
<b>Recommended Action</b>	<b>Not sampled – Sample Required</b>

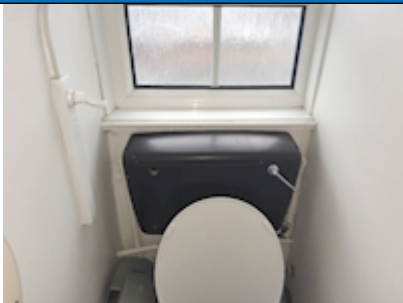
<b>Level of Identification (ID)</b>	Strongly Presumed (SP)	<b>Sample No.</b>					
<b>Material</b>	Plastic / Resin	<b>Extent</b>	1 No.				
<b>Accessibility</b>	Occasionally likely to be disturbed						
<b>Identification</b>	Amosite						
<b>Material Assessment</b>							
<b>Product Type</b>	1	<b>Condition</b>	1	<b>Surface Treatment</b>	0	<b>Asbestos Type</b>	2
<b>Priority Assessment (for more detail see Section 4.0)</b>							
<b>Occupant Activity</b>	1	<b>Disturbance</b>	1	<b>Human Exposure</b>	1	<b>Maintenance Activity</b>	1
<b>Scoring Summary</b>							
<b>Material Score</b>	4	<b>Priority Score</b>	4	<b>Total Risk</b>	8	<b>Risk Priority</b>	VERY LOW
<b>Recommended Action</b>	<b>Manage and Re-inspect</b>						
<b>Further Information</b>	Visually consistent with sample number MP180810/04. Toilet Cistern, previously cross referenced by Noble HSC to sample MP180810/04 in report J14071, found to contain amosite.No change as of reinspection 2023

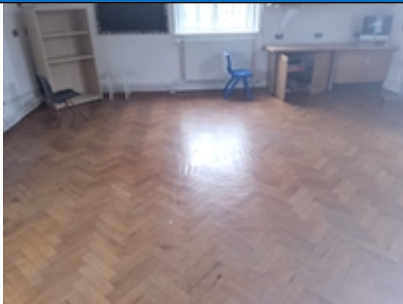
<b>Level of Identification (ID)</b>	Presumed (P)	<b>Sample No.</b>					
<b>Material</b>	Bitumen Product	<b>Extent</b>	47 m <sup>2</sup>				
<b>Accessibility</b>	Usually inaccessible or unlikely to be disturbed						
<b>Identification</b>	Chrysotile						
<b>Material Assessment</b>							
<b>Product Type</b>	1	<b>Condition</b>	1	<b>Surface Treatment</b>	0	<b>Asbestos Type</b>	1
<b>Priority Assessment (for more detail see Section 4.0)</b>							
<b>Occupant Activity</b>	1	<b>Disturbance</b>	1	<b>Human Exposure</b>	2	<b>Maintenance Activity</b>	1
<b>Scoring Summary</b>							
<b>Material Score</b>	3	<b>Priority Score</b>	5	<b>Total Risk</b>	8	<b>Risk Priority</b>	VERY LOW
<b>Recommended Action</b>	<b>Not sampled – Sample Required</b>

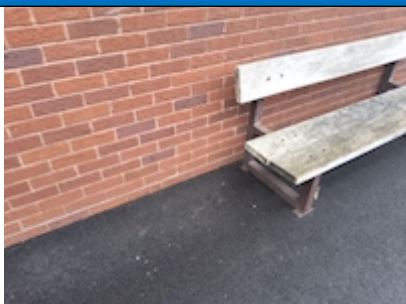
<b>Level of Identification (ID)</b>	Strongly Presumed (SP)	<b>Sample No.</b>					
<b>Material</b>	Bitumen Product	<b>Extent</b>	70 lm				
<b>Accessibility</b>	Usually inaccessible or unlikely to be disturbed						
<b>Identification</b>	Chrysotile						
<b>Material Assessment</b>							
<b>Product Type</b>	1	<b>Condition</b>	1	<b>Surface Treatment</b>	0	<b>Asbestos Type</b>	1
<b>Priority Assessment (for more detail see Section 4.0)</b>							
<b>Occupant Activity</b>	2	<b>Disturbance</b>	1	<b>Human Exposure</b>	3	<b>Maintenance Activity</b>	0
<b>Scoring Summary</b>							
<b>Material Score</b>	3	<b>Priority Score</b>	6	<b>Total Risk</b>	9	<b>Risk Priority</b>	LOW
<b>Recommended Action</b>	<b>Manage and Re-inspect</b>

<b>Further Information</b>	Damp proof course to perimeter of Gym, previously sampled by Noble HSC as sample GS190810/05 in report J14071, found to contain chrysotile.no change as of reinspection 2023.
