Asbestos Re-inspection Report
(with Priority Assessments)

West Wimbledon Primary School
Bodnant Gardens, Raynes Park, London, SW20 0BZ

Job Number: B14464/1
Issue Date: 26/02/2021
Issue No: 1

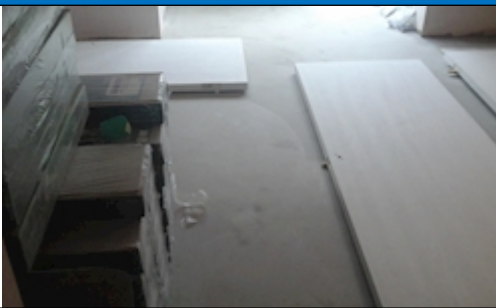
Building	West Wimbledon Primary School			Floor	0		
Location Description	0/002-0/006: Caretakers House						
Item	Floor Tiles and Adhesive

Level of Identification (ID)	Strongly Presumed (SP)	Sample No.					
Material	Floor Tiles (Thermoplastic)	Extent	6 m ²				
Accessibility							
Identification	Asbestos Removed						
Material Assessment							
Product Type	0	Condition	0	Surface Treatment	0	Asbestos Type	0
Priority Assessment (for more detail see Section 4.0)							
Occupant Activity	0	Disturbance	0	Human Exposure	0	Maintenance Activity	0
Scoring Summary							
Material Score	0	Priority Score	0	Total Risk	0	Risk Priority	N/A
Recommended Action	No Recommendation Required						
Further Information	Previously sampled by Lucion in report 71841 sample GS250910/10

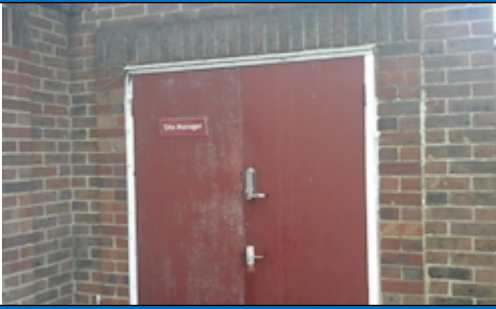
Building	West Wimbledon Primary School			Floor	0		
Location Description	0/004A: Caretakers Office						
Item	Putty Around Door Frame

Level of Identification (ID)	Strongly Presumed (SP)	Sample No.					
Material	Mastic	Extent	3 lm				
Accessibility	Occasionally likely to be disturbed						
Identification	Chrysotile						
Material Assessment							
Product Type	1	Condition	1	Surface Treatment	0	Asbestos Type	1
Priority Assessment (for more detail see Section 4.0)							
Occupant Activity	1	Disturbance	1	Human Exposure	2	Maintenance Activity	0
Scoring Summary							
Material Score	3	Priority Score	4	Total Risk	7	Risk Priority	VERY LOW
Recommended Action	Manage and Re-inspect						
Further Information	Previously sampled by Lucion in report 71841 sample GS250910/01

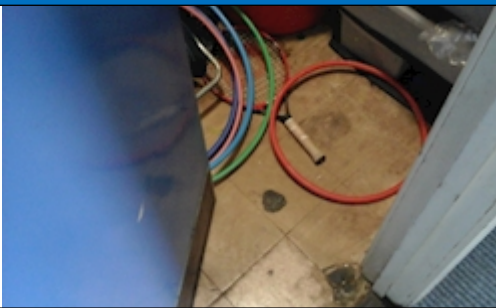
Building	West Wimbledon Primary School			Floor	0									
Location Description	0/012: Stores													
Item	Floor Tiles and Adhesive

Level of Identification (ID)	Strongly Presumed (SP)	Sample No.												
Material	Floor Tiles (Thermoplastic)	Extent	4 m ²											
Accessibility	Occasionally likely to be disturbed													
Identification	Chrysotile													
Material Assessment														
Product Type	1	Condition	1	Surface Treatment	0	Asbestos Type	1							
Priority Assessment (for more detail see Section 4.0)														
Occupant Activity	0	Disturbance	1	Human Exposure	1	Maintenance Activity	0							
Scoring Summary														
Material Score	3	Priority Score	2	Total Risk	5	Risk Priority	VERY LOW							
Recommended Action	Manage and Re-inspect													
Further Information	Previously cross referenced by Lucion in report 71841 sample GS250910/14

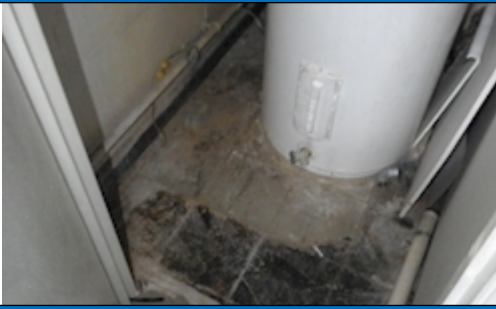
Building	West Wimbledon Primary School			Floor	0									
Location Description	0/023: Boiler Room													
Item	Floor Tiles and Adhesive

Level of Identification (ID)	Strongly Presumed (SP)	Sample No.												
Material	Floor Tiles (Thermoplastic)	Extent	2 m ²											
Accessibility	Occasionally likely to be disturbed													
Identification	Chrysotile													
Material Assessment														
Product Type	1	Condition	1	Surface Treatment	0	Asbestos Type	1							
Priority Assessment (for more detail see Section 4.0)														
Occupant Activity	1	Disturbance	1	Human Exposure	1	Maintenance Activity	2							
Scoring Summary														
Material Score	3	Priority Score	5	Total Risk	8	Risk Priority	VERY LOW							
Recommended Action	Manage and Re-inspect													
Further Information	Previously sampled by Life Environmental in report B-71626 sample S0001

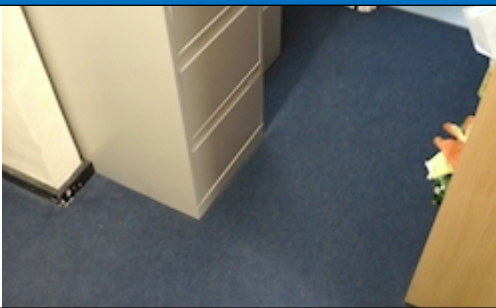
Building	West Wimbledon Primary School			Floor	0									
Location Description	0/023C: Store 01													
Item	Floor Tiles and Adhesive

Level of Identification (ID)	Strongly Presumed (SP)	Sample No.												
Material	Floor Tiles (Thermoplastic)	Extent	8 m ²											
Accessibility	Occasionally likely to be disturbed													
Identification	Chrysotile													
Material Assessment														
Product Type	1	Condition	1	Surface Treatment	0	Asbestos Type	1							
Priority Assessment (for more detail see Section 4.0)														
Occupant Activity	0	Disturbance	1	Human Exposure	1	Maintenance Activity	0							
Scoring Summary														
Material Score	3	Priority Score	2	Total Risk	5	Risk Priority	VERY LOW							
Recommended Action	Manage and Re-inspect													
Further Information	Previously sampled by Lucion in report 71841 sample GS250910/11 Under carpet

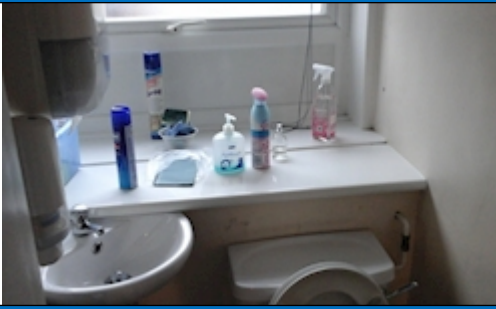
Building	West Wimbledon Primary School			Floor	0									
Location Description	0/024: Head Teachers WC													
Item	Cement Windowsill

Level of Identification (ID)	Strongly Presumed (SP)	Sample No.												
Material	Cement Product	Extent	3 lm											
Accessibility	Occasionally likely to be disturbed													
Identification	Chrysotile													
Material Assessment														
Product Type	1	Condition	0	Surface Treatment	1	Asbestos Type	1							
Priority Assessment (for more detail see Section 4.0)														
Occupant Activity	1	Disturbance	1	Human Exposure	1	Maintenance Activity	0							
Scoring Summary														
Material Score	3	Priority Score	3	Total Risk	6	Risk Priority	VERY LOW							
Recommended Action	Manage and Re-inspect													
Further Information	Previously sampled by Lucion Presumed to still be present under UPVC

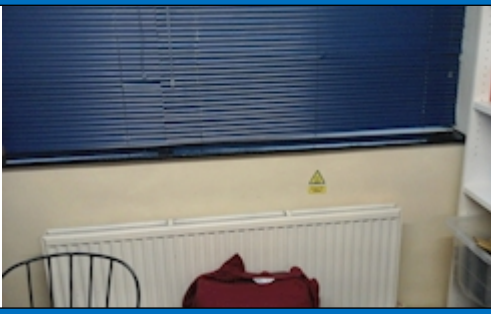
Building	West Wimbledon Primary School			Floor	0		
Location Description	0/025: Head Teachers Office						
Item	Cement Windowsill

Level of Identification (ID)	Strongly Presumed (SP)	Sample No.					
Material	Cement Product	Extent	4 lm				
Accessibility	Occasionally likely to be disturbed						
Identification	Chrysotile						
Material Assessment							
Product Type	1	Condition	0	Surface Treatment	1	Asbestos Type	1
Priority Assessment (for more detail see Section 4.0)							
Occupant Activity	1	Disturbance	1	Human Exposure	2	Maintenance Activity	0
Scoring Summary							
Material Score	3	Priority Score	4	Total Risk	7	Risk Priority	VERY LOW
Recommended Action	Manage and Re-inspect						
Further Information	Previously sampled by Lucion

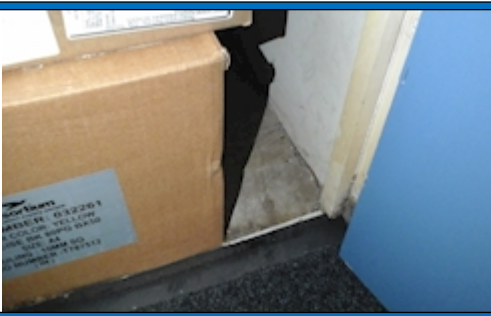
Building	West Wimbledon Primary School			Floor	0		
Location Description	0/027: Store 02						
Item	Floor Tiles and Adhesive

Level of Identification (ID)	Strongly Presumed (SP)	Sample No.					
Material	Floor Tiles (Thermoplastic)	Extent	2 m²				
Accessibility	Occasionally likely to be disturbed						
Identification	Chrysotile						
Material Assessment							
Product Type	1	Condition	1	Surface Treatment	0	Asbestos Type	1
Priority Assessment (for more detail see Section 4.0)							
Occupant Activity	0	Disturbance	1	Human Exposure	1	Maintenance Activity	0
Scoring Summary							
Material Score	3	Priority Score	2	Total Risk	5	Risk Priority	VERY LOW
Recommended Action	Manage and Re-inspect						
Further Information	Previously cross referenced by Lucion in report 71841 sample GS250910/09

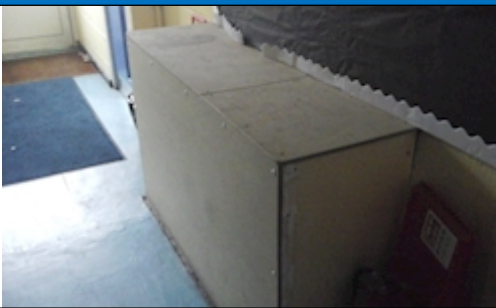
Building	West Wimbledon Primary School			Floor	0		
Location Description	0/037: Corridor						
Item	Gasket to Pipework

Level of Identification (ID)	Strongly Presumed (SP)	Sample No.					
Material	Gaskets	Extent	1 No.				
Accessibility	Easily disturbed						
Identification	Chrysotile						
Material Assessment							
Product Type	2	Condition	0	Surface Treatment	2	Asbestos Type	1
Priority Assessment (for more detail see Section 4.0)							
Occupant Activity	2	Disturbance	1	Human Exposure	2	Maintenance Activity	1
Scoring Summary							
Material Score	5	Priority Score	6	Total Risk	11	Risk Priority	LOW
Recommended Action	Manage and Re-inspect						
Further Information	Within Boxing, presumed to still be present

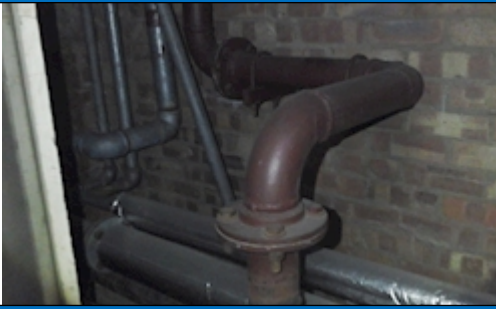
Building	West Wimbledon Primary School			Floor	0		
Location Description	0/038C: Service Duct						
Item	Gaskets to Pipework

Level of Identification (ID)	Strongly Presumed (SP)	Sample No.					
Material	Gaskets	Extent	20 No.				
Accessibility	Occasionally likely to be disturbed						
Identification	Chrysotile						
Material Assessment							
Product Type	2	Condition	0	Surface Treatment	2	Asbestos Type	1
Priority Assessment (for more detail see Section 4.0)							
Occupant Activity	0	Disturbance	1	Human Exposure	0	Maintenance Activity	0
Scoring Summary							
Material Score	5	Priority Score	1	Total Risk	6	Risk Priority	VERY LOW
Recommended Action	Manage and Re-inspect						
Further Information	Previously sampled by Lucion in report 71841 sample GS250810/12

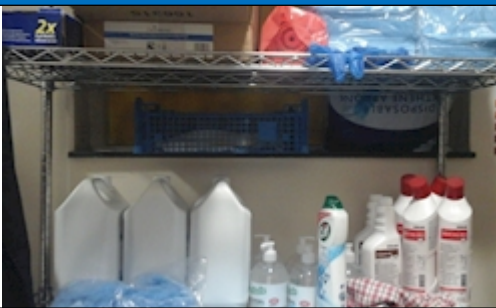
Building	West Wimbledon Primary School			Floor	0		
Location Description	0/040: Kitchen Stores						
Item	Cement Windowsill

Level of Identification (ID)	Strongly Presumed (SP)	Sample No.					
Material	Cement Product	Extent	1.5 lm				
Accessibility	Occasionally likely to be disturbed						
Identification	Chrysotile						
Material Assessment							
Product Type	1	Condition	0	Surface Treatment	1	Asbestos Type	1
Priority Assessment (for more detail see Section 4.0)							
Occupant Activity	0	Disturbance	1	Human Exposure	1	Maintenance Activity	0
Scoring Summary							
Material Score	3	Priority Score	2	Total Risk	5	Risk Priority	VERY LOW
Recommended Action	Manage and Re-inspect						
Further Information	Previously sampled by Lucion

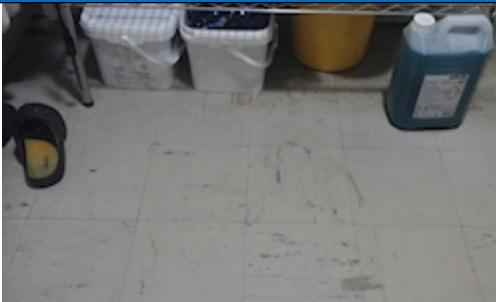
Building	West Wimbledon Primary School			Floor	0		
Location Description	0/040: Kitchen Stores						
Item	Floor Tiles and Adhesive

Level of Identification (ID)	Strongly Presumed (SP)	Sample No.					
Material	Floor Tiles (Thermoplastic)	Extent	5 m²				
Accessibility	Occasionally likely to be disturbed						
Identification	Chrysotile						
Material Assessment							
Product Type	1	Condition	1	Surface Treatment	0	Asbestos Type	1
Priority Assessment (for more detail see Section 4.0)							
Occupant Activity	0	Disturbance	1	Human Exposure	1	Maintenance Activity	0
Scoring Summary							
Material Score	3	Priority Score	2	Total Risk	5	Risk Priority	VERY LOW
Recommended Action	Manage and Re-inspect						
Further Information	Previously sampled by Lucion in report 71841 sample GS250910/11

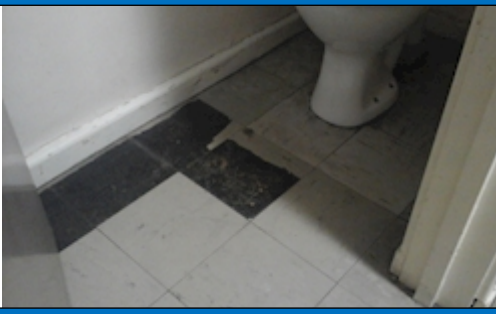
Building	West Wimbledon Primary School			Floor	0		
Location Description	0/040B: Kitchen WC						
Item	Floor Tiles and Adhesive

Level of Identification (ID)	Strongly Presumed (SP)	Sample No.					
Material	Floor Tiles (Thermoplastic)	Extent	2 m ²				
Accessibility	Occasionally likely to be disturbed						
Identification	Chrysotile						
Material Assessment							
Product Type	1	Condition	1	Surface Treatment	0	Asbestos Type	1
Priority Assessment (for more detail see Section 4.0)							
Occupant Activity	0	Disturbance	1	Human Exposure	1	Maintenance Activity	0
Scoring Summary							
Material Score	3	Priority Score	2	Total Risk	5	Risk Priority	VERY LOW
Recommended Action	Manage and Re-inspect						
Further Information	Previously sampled by Lucion in report 71841 sample GS250910/11

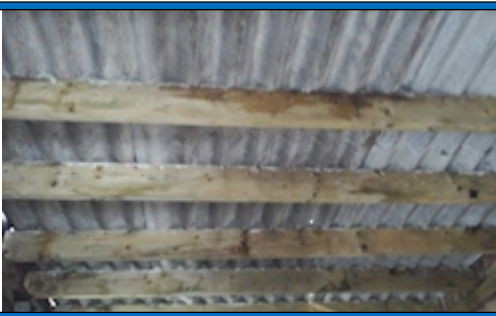
Building	West Wimbledon Primary School			Floor	0		
Location Description	0/043 & 0/043A: Store 03						
Item	Cement Roofing

Level of Identification (ID)	Strongly Presumed (SP)	Sample No.					
Material	Cement Product	Extent	24 lm				
Accessibility	Easily disturbed						
Identification	Chrysotile						
Material Assessment							
Product Type	1	Condition	0	Surface Treatment	1	Asbestos Type	1
Priority Assessment (for more detail see Section 4.0)							
Occupant Activity	0	Disturbance	2	Human Exposure	1	Maintenance Activity	0
Scoring Summary							
Material Score	3	Priority Score	3	Total Risk	6	Risk Priority	VERY LOW
Recommended Action	Manage and Re-inspect						
Further Information	Strongly presumed as by Lucion in report 71841

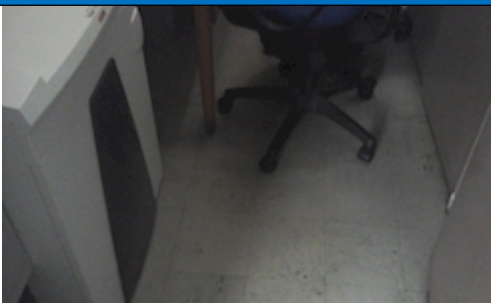
Building	West Wimbledon Primary School			Floor	0		
Location Description	0/046: Kitchen Office						
Item	Floor Tiles and Adhesive

Level of Identification (ID)	Strongly Presumed (SP)	Sample No.					
Material	Floor Tiles (Thermoplastic)	Extent	6 m ²				
Accessibility	Occasionally likely to be disturbed						
Identification	Chrysotile						
Material Assessment							
Product Type	1	Condition	1	Surface Treatment	0	Asbestos Type	1
Priority Assessment (for more detail see Section 4.0)							
Occupant Activity	1	Disturbance	1	Human Exposure	2	Maintenance Activity	0
Scoring Summary							
Material Score	3	Priority Score	4	Total Risk	7	Risk Priority	VERY LOW
Recommended Action	Manage and Re-inspect						
Further Information	Previously sampled by Lucion in report 71841 sample GS250910/11

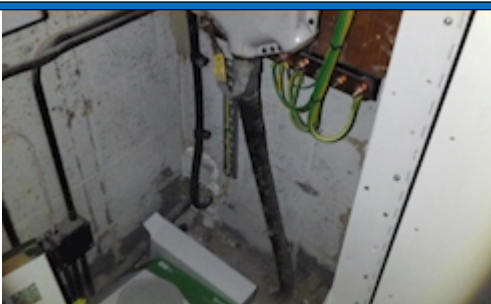
Building	West Wimbledon Primary School			Floor	0		
Location Description	0/048A: Electrical Cupboard						
Item	Cable Wrap

Level of Identification (ID)	Presumed (P)	Sample No.					
Material	Bitumen Product	Extent	1.5 lm				
Accessibility	Occasionally likely to be disturbed						
Identification	Chrysotile						
Material Assessment							
Product Type	1	Condition	0	Surface Treatment	0	Asbestos Type	1
Priority Assessment (for more detail see Section 4.0)							
Occupant Activity	0	Disturbance	1	Human Exposure	0	Maintenance Activity	0
Scoring Summary							
Material Score	2	Priority Score	1	Total Risk	3	Risk Priority	VERY LOW
Recommended Action	Manage and Re-inspect						
Further Information	As per Lucion report 71841

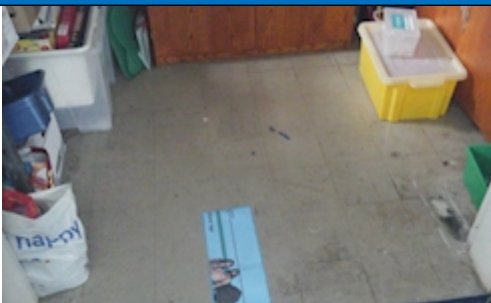
Building	West Wimbledon Primary School			Floor	0									
Location Description	0/050: Store 04													
Item	Floor Tiles and Adhesive

Level of Identification (ID)	Strongly Presumed (SP)	Sample No.												
Material	Floor Tiles (Thermoplastic)	Extent	8 m ²											
Accessibility	Occasionally likely to be disturbed													
Identification	Chrysotile													
Material Assessment														
Product Type	1	Condition	1	Surface Treatment	0	Asbestos Type	1							
Priority Assessment (for more detail see Section 4.0)														
Occupant Activity	1	Disturbance	1	Human Exposure	0	Maintenance Activity	0							
Scoring Summary														
Material Score	3	Priority Score	2	Total Risk	5	Risk Priority	VERY LOW							
Recommended Action	Manage and Re-inspect													
Further Information	Previously sampled by Lucion in report 71841 sample GS250910/11

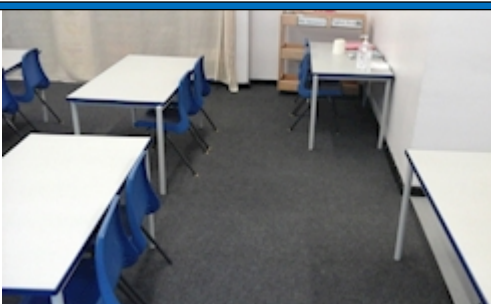
Building	West Wimbledon Primary School			Floor	0									
Location Description	0/054: Classroom													
Item	Floor Tiles and Adhesive

Level of Identification (ID)	Strongly Presumed (SP)	Sample No.												
Material	Floor Tiles (Thermoplastic)	Extent	65 m ²											
Accessibility	Occasionally likely to be disturbed													
Identification	Chrysotile													
Material Assessment														
Product Type	1	Condition	1	Surface Treatment	0	Asbestos Type	1							
Priority Assessment (for more detail see Section 4.0)														
Occupant Activity	1	Disturbance	1	Human Exposure	3	Maintenance Activity	1							
Scoring Summary														
Material Score	3	Priority Score	6	Total Risk	9	Risk Priority	LOW							
Recommended Action	Manage and Re-inspect													
Further Information	Previously sampled by Lucion in report 71841 sample GS250910/11 Under carpet and modern lino

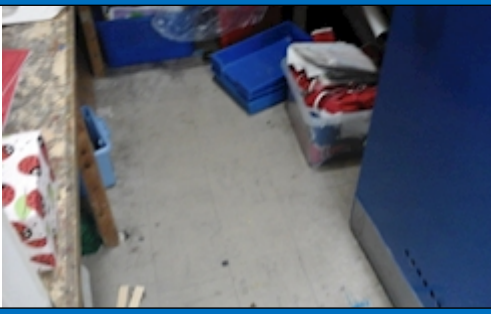
Building	West Wimbledon Primary School			Floor	0		
Location Description	0/055: Store 05						
Item	Floor Tiles and Adhesive

Level of Identification (ID)	Strongly Presumed (SP)	Sample No.					
Material	Floor Tiles (Thermoplastic)	Extent	8 m ²				
Accessibility	Occasionally likely to be disturbed						
Identification	Chrysotile						
Material Assessment							
Product Type	1	Condition	1	Surface Treatment	0	Asbestos Type	1
Priority Assessment (for more detail see Section 4.0)							
Occupant Activity	1	Disturbance	1	Human Exposure	0	Maintenance Activity	0
Scoring Summary							
Material Score	3	Priority Score	2	Total Risk	5	Risk Priority	VERY LOW
Recommended Action	Manage and Re-inspect						
Further Information	Previously sampled by Lucion in report 71841 sample GS250910/11

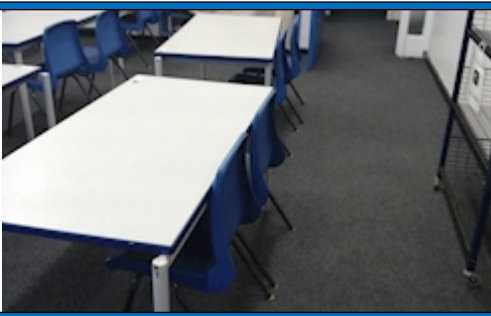
Building	West Wimbledon Primary School			Floor	0		
Location Description	0/056: Classroom						
Item	Floor Tiles and Adhesive

Level of Identification (ID)	Strongly Presumed (SP)	Sample No.					
Material	Floor Tiles (Thermoplastic)	Extent	65 m ²				
Accessibility	Occasionally likely to be disturbed						
Identification	Chrysotile						
Material Assessment							
Product Type	1	Condition	1	Surface Treatment	0	Asbestos Type	1
Priority Assessment (for more detail see Section 4.0)							
Occupant Activity	1	Disturbance	1	Human Exposure	3	Maintenance Activity	1
Scoring Summary							
Material Score	3	Priority Score	6	Total Risk	9	Risk Priority	LOW
Recommended Action	Manage and Re-inspect						
Further Information	Previously sampled by Lucion in report 71841 sample GS250910/11 Under carpet and modern lino

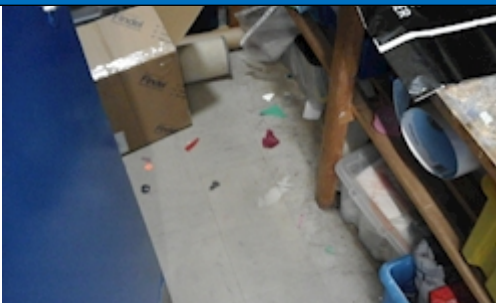
Building	West Wimbledon Primary School			Floor	0		
Location Description	0/057: Store 06						
Item	Floor Tiles and Adhesive

Level of Identification (ID)	Strongly Presumed (SP)	Sample No.					
Material	Floor Tiles (Thermoplastic)	Extent	5 m ²				
Accessibility	Occasionally likely to be disturbed						
Identification	Chrysotile						
Material Assessment							
Product Type	1	Condition	1	Surface Treatment	0	Asbestos Type	1
Priority Assessment (for more detail see Section 4.0)							
Occupant Activity	1	Disturbance	1	Human Exposure	0	Maintenance Activity	0
Scoring Summary							
Material Score	3	Priority Score	2	Total Risk	5	Risk Priority	VERY LOW
Recommended Action	Manage and Re-inspect						
Further Information	Previously sampled by Lucion in report 71841 sample GS250910/11

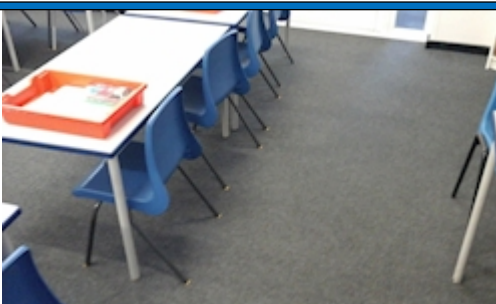
Building	West Wimbledon Primary School			Floor	0		
Location Description	0/058: Classroom						
Item	Floor Tiles and Adhesive

Level of Identification (ID)	Strongly Presumed (SP)	Sample No.					
Material	Floor Tiles (Thermoplastic)	Extent	65 m ²				
Accessibility	Occasionally likely to be disturbed						
Identification	Chrysotile						
Material Assessment							
Product Type	1	Condition	1	Surface Treatment	0	Asbestos Type	1
Priority Assessment (for more detail see Section 4.0)							
Occupant Activity	1	Disturbance	1	Human Exposure	3	Maintenance Activity	1
Scoring Summary							
Material Score	3	Priority Score	6	Total Risk	9	Risk Priority	LOW
Recommended Action	Manage and Re-inspect						
Further Information	Previously sampled by Lucion in report 71841 sample GS250910/11 Under carpet and modern lino

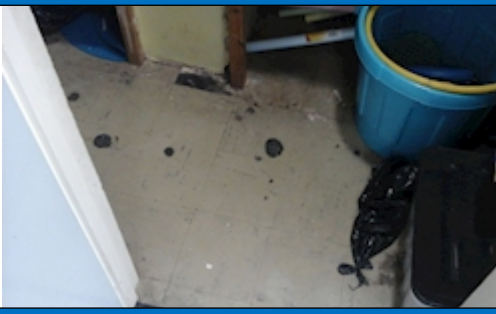
Level of Identification (ID)	Strongly Presumed (SP)	Sample No.					
Material	Floor Tiles (Thermoplastic)	Extent	7 m ²				
Accessibility	Occasionally likely to be disturbed						
Identification	Chrysotile						
Material Assessment							
Product Type	1	Condition	1	Surface Treatment	0	Asbestos Type	1
Priority Assessment (for more detail see Section 4.0)							
Occupant Activity	1	Disturbance	1	Human Exposure	0	Maintenance Activity	0
Scoring Summary							
Material Score	3	Priority Score	2	Total Risk	5	Risk Priority	VERY LOW
Recommended Action	Manage and Re-inspect						
Further Information	Previously sampled by Lucion in report 71841 sample GS250910/11

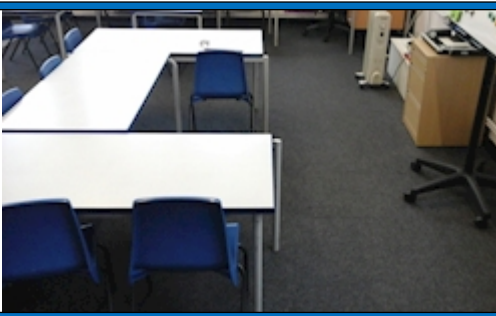
Level of Identification (ID)	Strongly Presumed (SP)	Sample No.					
Material	Floor Tiles (Thermoplastic)	Extent	65 m ²				
Accessibility	Occasionally likely to be disturbed						
Identification	Chrysotile						
Material Assessment							
Product Type	1	Condition	1	Surface Treatment	0	Asbestos Type	1
Priority Assessment (for more detail see Section 4.0)							
Occupant Activity	1	Disturbance	1	Human Exposure	3	Maintenance Activity	1
Scoring Summary							
Material Score	3	Priority Score	6	Total Risk	9	Risk Priority	LOW
Recommended Action	Manage and Re-inspect						
Further Information	Previously sampled by Lucion in report 71841 sample GS250910/11 Under carpet and modern lino

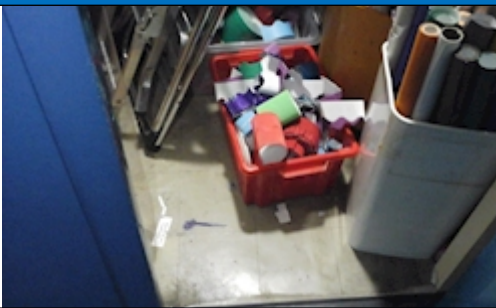
Level of Identification (ID)	Strongly Presumed (SP)	Sample No.												
Material	Floor Tiles (Thermoplastic)	Extent	8 m ²											
Accessibility	Occasionally likely to be disturbed													
Identification	Chrysotile													
Material Assessment														
Product Type	1	Condition	1	Surface Treatment	0	Asbestos Type	1							
Priority Assessment (for more detail see Section 4.0)														
Occupant Activity	0	Disturbance	1	Human Exposure	1	Maintenance Activity	0							
Scoring Summary														
Material Score	3	Priority Score	2	Total Risk	5	Risk Priority	VERY LOW							
Recommended Action	Manage and Re-inspect													
Further Information	Previously sampled by Lucion in report 71841 sample GS250910/09

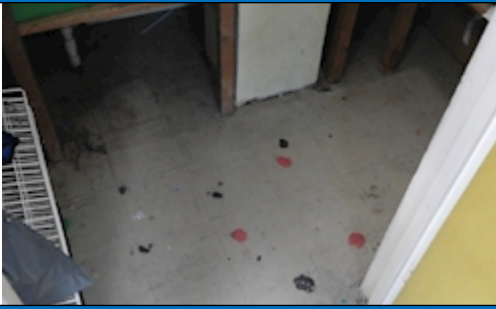
Level of Identification (ID)	Strongly Presumed (SP)	Sample No.												
Material	Floor Tiles (Thermoplastic)	Extent	8 m ²											
Accessibility	Occasionally likely to be disturbed													
Identification	Chrysotile													
Material Assessment														
Product Type	1	Condition	1	Surface Treatment	0	Asbestos Type	1							
Priority Assessment (for more detail see Section 4.0)														
Occupant Activity	1	Disturbance	1	Human Exposure	0	Maintenance Activity	0							
Scoring Summary														
Material Score	3	Priority Score	2	Total Risk	5	Risk Priority	VERY LOW							
Recommended Action	Manage and Re-inspect													
Further Information	Previously sampled by Lucion in report 71841 sample GS250910/11

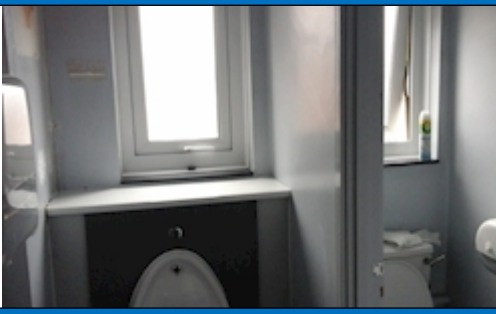
Level of Identification (ID)	Strongly Presumed (SP)	Sample No.					
Material	Cement Product	Extent	2 lm				
Accessibility	Occasionally likely to be disturbed						
Identification	Chrysotile						
Material Assessment							
Product Type	1	Condition	0	Surface Treatment	1	Asbestos Type	1
Priority Assessment (for more detail see Section 4.0)							
Occupant Activity	1	Disturbance	1	Human Exposure	1	Maintenance Activity	0
Scoring Summary							
Material Score	3	Priority Score	3	Total Risk	6	Risk Priority	VERY LOW
Recommended Action	Manage and Re-inspect						
Further Information	Previously sampled by Lucion in report 71841 dated Feb 2015

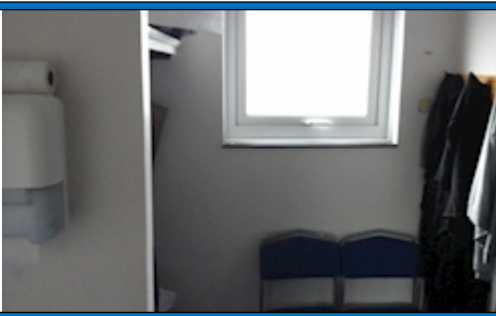
Level of Identification (ID)	Strongly Presumed (SP)	Sample No.					
Material	Cement Product	Extent	3 lm				
Accessibility	Occasionally likely to be disturbed						
Identification	Chrysotile						
Material Assessment							
Product Type	1	Condition	0	Surface Treatment	1	Asbestos Type	1
Priority Assessment (for more detail see Section 4.0)							
Occupant Activity	1	Disturbance	1	Human Exposure	1	Maintenance Activity	0
Scoring Summary							
Material Score	3	Priority Score	3	Total Risk	6	Risk Priority	VERY LOW
Recommended Action	Manage and Re-inspect						
Further Information	Previously sampled by Lucion in report 71841 dated Feb 2015

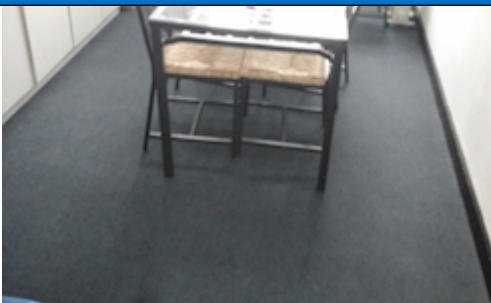
Level of Identification (ID)	Strongly Presumed (SP)	Sample No.					
Material	Floor Tiles (Thermoplastic)	Extent	20 m ²				
Accessibility	Occasionally likely to be disturbed						
Identification	Chrysotile						
Material Assessment							
Product Type	1	Condition	1	Surface Treatment	0	Asbestos Type	1
Priority Assessment (for more detail see Section 4.0)							
Occupant Activity	1	Disturbance	1	Human Exposure	2	Maintenance Activity	0
Scoring Summary							
Material Score	3	Priority Score	4	Total Risk	7	Risk Priority	VERY LOW
Recommended Action	Manage and Re-inspect						
Further Information	Previously sampled by Lucion in report 71841 sample GS250910/11 Under carpet. This used to be a classroom and has now been split into an office and meeting room.

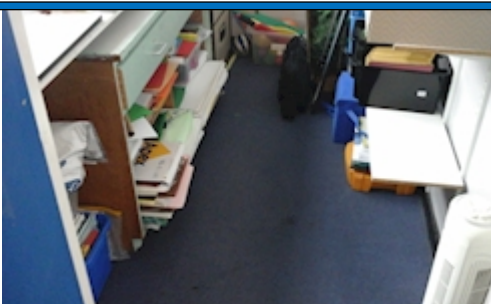
Level of Identification (ID)	Strongly Presumed (SP)	Sample No.					
Material	Floor Tiles (Thermoplastic)	Extent	8 m ²				
Accessibility	Occasionally likely to be disturbed						
Identification	Chrysotile						
Material Assessment							
Product Type	1	Condition	1	Surface Treatment	0	Asbestos Type	1
Priority Assessment (for more detail see Section 4.0)							
Occupant Activity	1	Disturbance	1	Human Exposure	0	Maintenance Activity	0
Scoring Summary							
Material Score	3	Priority Score	2	Total Risk	5	Risk Priority	VERY LOW
Recommended Action	Manage and Re-inspect						
Further Information	Previously sampled by Lucion in report 71841 sample GS240810/18 Under carpet

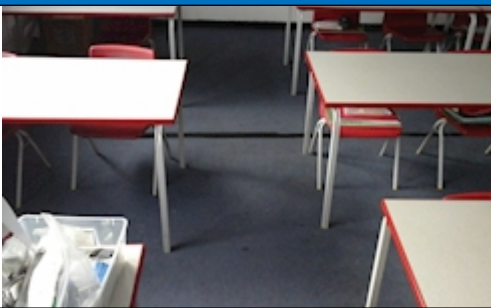
Level of Identification (ID)	Strongly Presumed (SP)	Sample No.					
Material	Floor Tiles (Thermoplastic)	Extent	50 m ²				
Accessibility	Occasionally likely to be disturbed						
Identification	Chrysotile						
Material Assessment							
Product Type	1	Condition	1	Surface Treatment	0	Asbestos Type	1
Priority Assessment (for more detail see Section 4.0)							
Occupant Activity	1	Disturbance	1	Human Exposure	3	Maintenance Activity	1
Scoring Summary							
Material Score	3	Priority Score	6	Total Risk	9	Risk Priority	LOW
Recommended Action	Manage and Re-inspect						
Further Information	Previously sampled by Lucion in report 71841 sample GS240810/18 Under carpet.

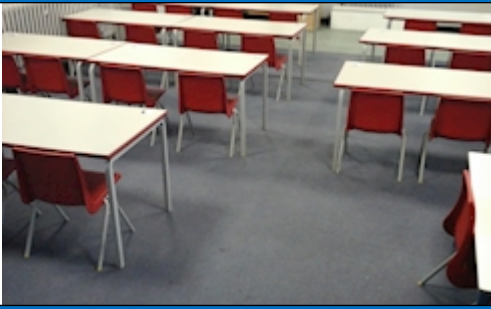
Level of Identification (ID)	Strongly Presumed (SP)	Sample No.					
Material	Floor Tiles (Thermoplastic)	Extent	50 m ²				
Accessibility	Occasionally likely to be disturbed						
Identification	Chrysotile						
Material Assessment							
Product Type	1	Condition	1	Surface Treatment	0	Asbestos Type	1
Priority Assessment (for more detail see Section 4.0)							
Occupant Activity	1	Disturbance	1	Human Exposure	3	Maintenance Activity	1
Scoring Summary							
Material Score	3	Priority Score	6	Total Risk	9	Risk Priority	LOW
Recommended Action	Manage and Re-inspect						
Further Information	Previously sampled by Lucion in report 71841 sample GS240810/18 Under carpet.

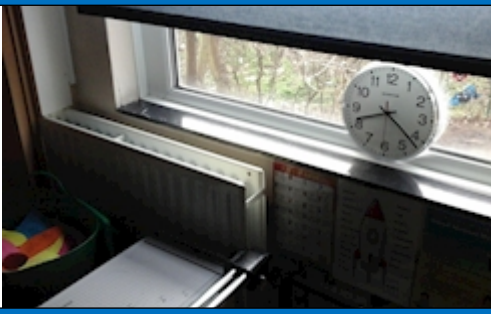
Level of Identification (ID)	Strongly Presumed (SP)	Sample No.												
Material	Cement Product	Extent	585 lm											
Accessibility	Occasionally likely to be disturbed													
Identification	Chrysotile													
Material Assessment														
Product Type	1	Condition	0	Surface Treatment	1	Asbestos Type	1							
Priority Assessment (for more detail see Section 4.0)														
Occupant Activity	1	Disturbance	2	Human Exposure	3	Maintenance Activity	0							
Scoring Summary														
Material Score	3	Priority Score	6	Total Risk	9	Risk Priority	LOW							
Recommended Action	Manage and Re-inspect													
Further Information	Previously sampled by Lucion in report 71841 dated Feb 2015

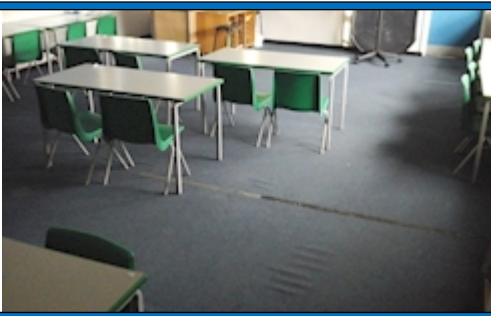
Level of Identification (ID)	Strongly Presumed (SP)	Sample No.												
Material	Floor Tiles (Thermoplastic)	Extent	50 m ²											
Accessibility	Occasionally likely to be disturbed													
Identification	Chrysotile													
Material Assessment														
Product Type	1	Condition	1	Surface Treatment	0	Asbestos Type	1							
Priority Assessment (for more detail see Section 4.0)														
Occupant Activity	1	Disturbance	1	Human Exposure	3	Maintenance Activity	1							
Scoring Summary														
Material Score	3	Priority Score	6	Total Risk	9	Risk Priority	LOW							
Recommended Action	Manage and Re-inspect													
Further Information	Previously sampled by Lucion in report 71841 sample GS240810/18 Under carpet.

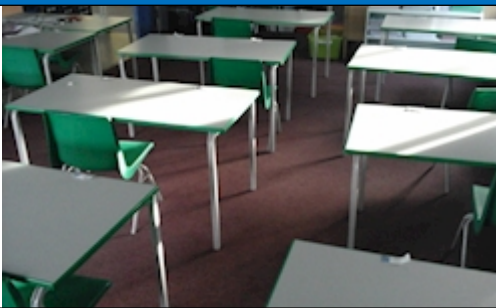
Level of Identification (ID)	Strongly Presumed (SP)	Sample No.												
Material	Floor Tiles (Thermoplastic)	Extent	50 m ²											
Accessibility	Occasionally likely to be disturbed													
Identification	Chrysotile													
Material Assessment														
Product Type	1	Condition	1	Surface Treatment	0	Asbestos Type	1							
Priority Assessment (for more detail see Section 4.0)														
Occupant Activity	1	Disturbance	1	Human Exposure	3	Maintenance Activity	1							
Scoring Summary														
Material Score	3	Priority Score	6	Total Risk	9	Risk Priority	LOW							
Recommended Action	Manage and Re-inspect													
Further Information	Previously sampled by Lucion in report 71841 sample GS240810/18 Under carpet.

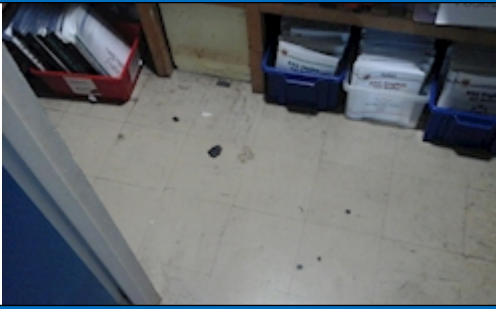
Level of Identification (ID)	Strongly Presumed (SP)	Sample No.												
Material	Floor Tiles (Thermoplastic)	Extent	55 m ²											
Accessibility	Occasionally likely to be disturbed													
Identification	Chrysotile													
Material Assessment														
Product Type	1	Condition	1	Surface Treatment	0	Asbestos Type	1							
Priority Assessment (for more detail see Section 4.0)														
Occupant Activity	0	Disturbance	2	Human Exposure	1	Maintenance Activity	0							
Scoring Summary														
Material Score	3	Priority Score	3	Total Risk	6	Risk Priority	VERY LOW							
Recommended Action	Manage and Re-inspect													
Further Information	Previously sampled by Lucion in report 71841 sample GS240810/19

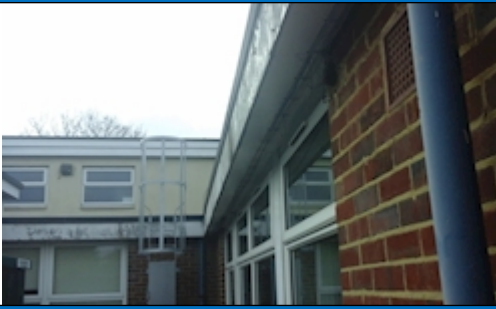
Level of Identification (ID)	Strongly Presumed (SP)	Sample No.												
Material	Cement Product	Extent	65 lm											
Accessibility	Usually inaccessible or unlikely to be disturbed													
Identification	Chrysotile													
Material Assessment														
Product Type	1	Condition	1	Surface Treatment	1	Asbestos Type	1							
Priority Assessment (for more detail see Section 4.0)														
Occupant Activity	0	Disturbance	1	Human Exposure	0	Maintenance Activity	0							
Scoring Summary														
Material Score	4	Priority Score	1	Total Risk	5	Risk Priority	VERY LOW							
Recommended Action	Manage and Re-inspect													
Further Information	As per Lucion report 71841 dated Feb 2015
