# Scope of Works – MEP System Upgrade

## West Wimbledon Primary School

Prepared for McBains

*12 June 2025*

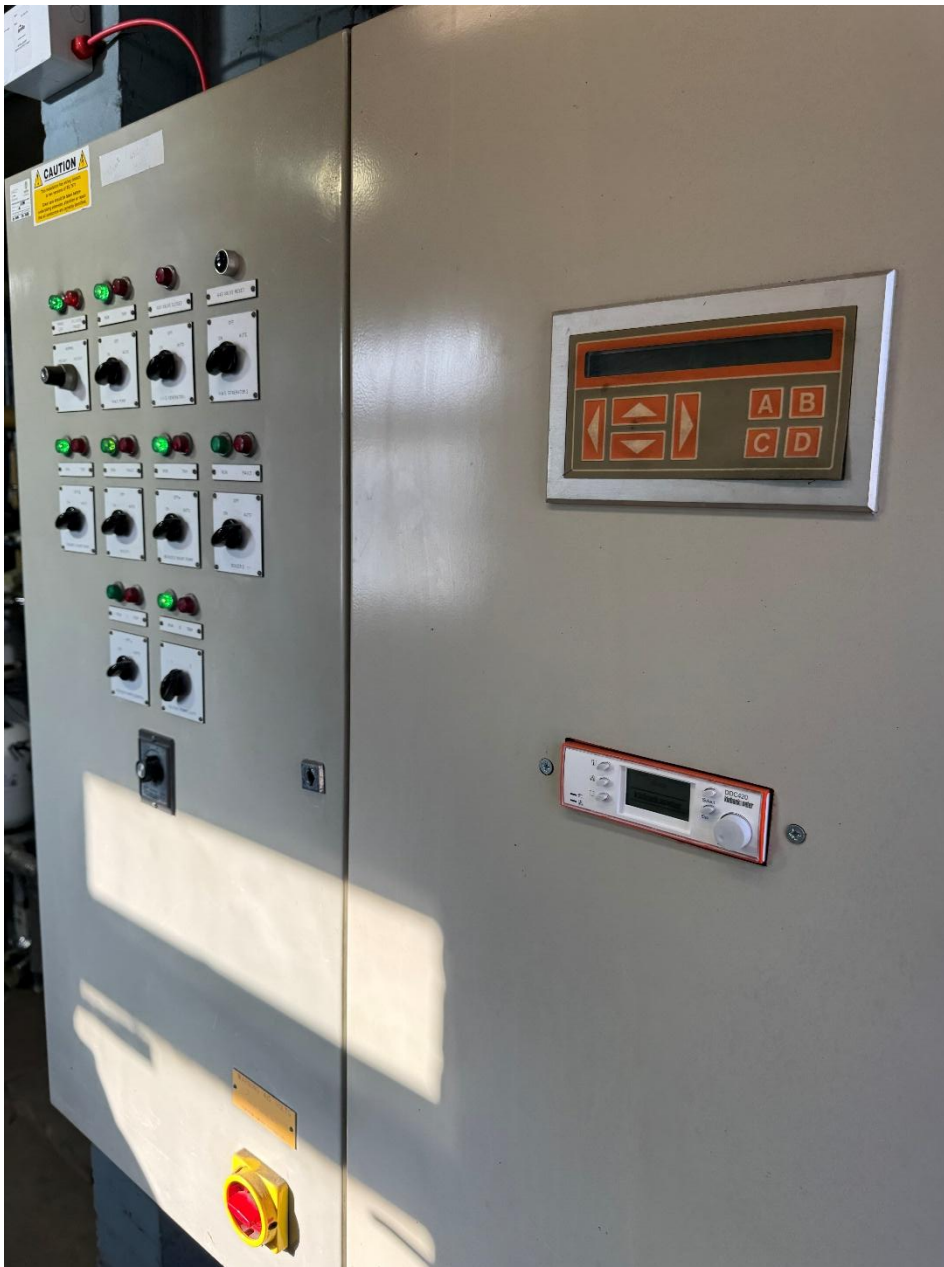
*Photograph 1- The main control plant to the plant room with an obsolete Trend controller and a smaller retrofit controller.*

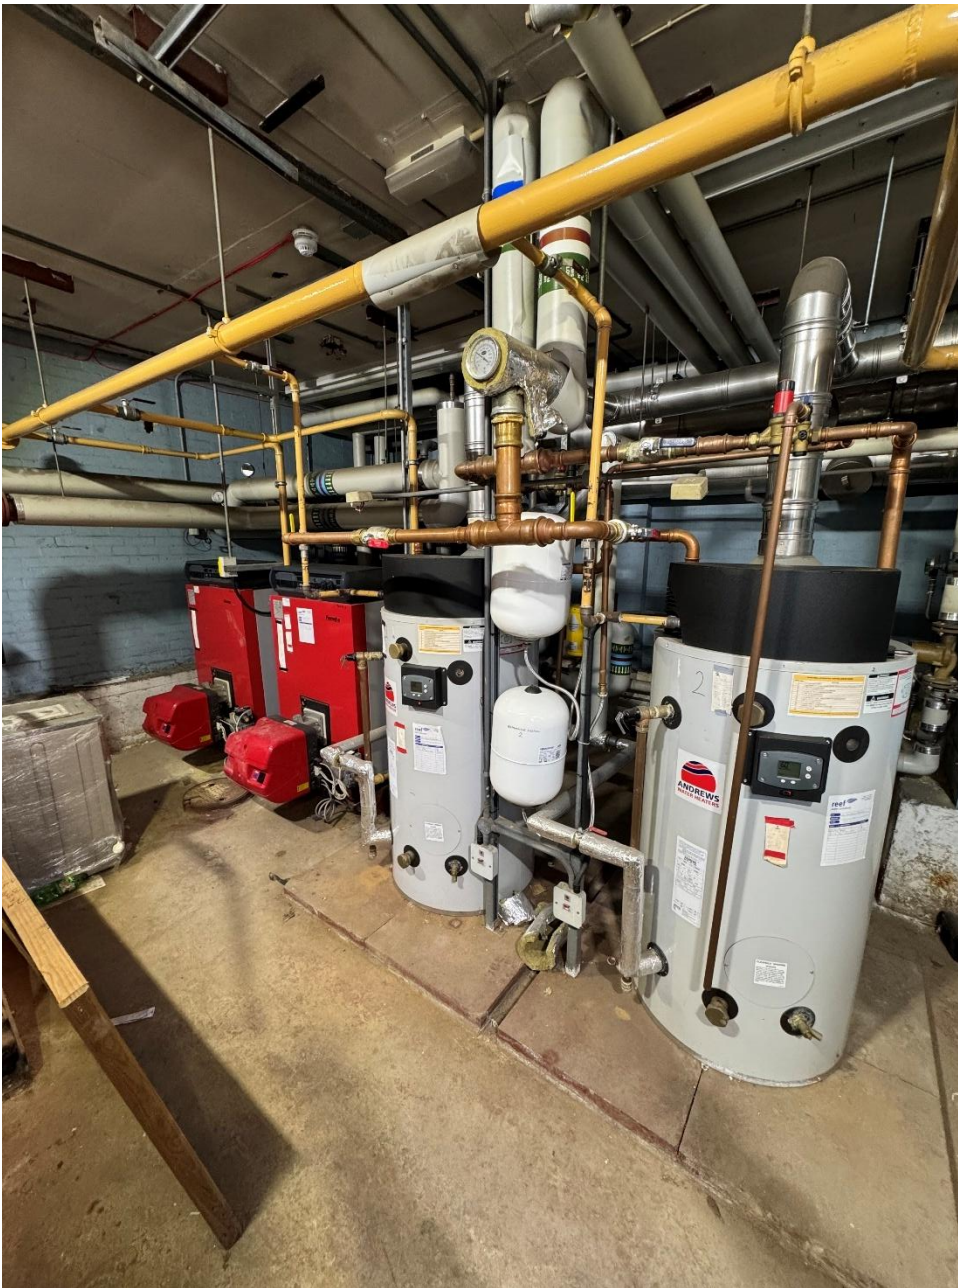
*Photograph 2 - Installed plant – two boilers and two gas-fired water heaters.*

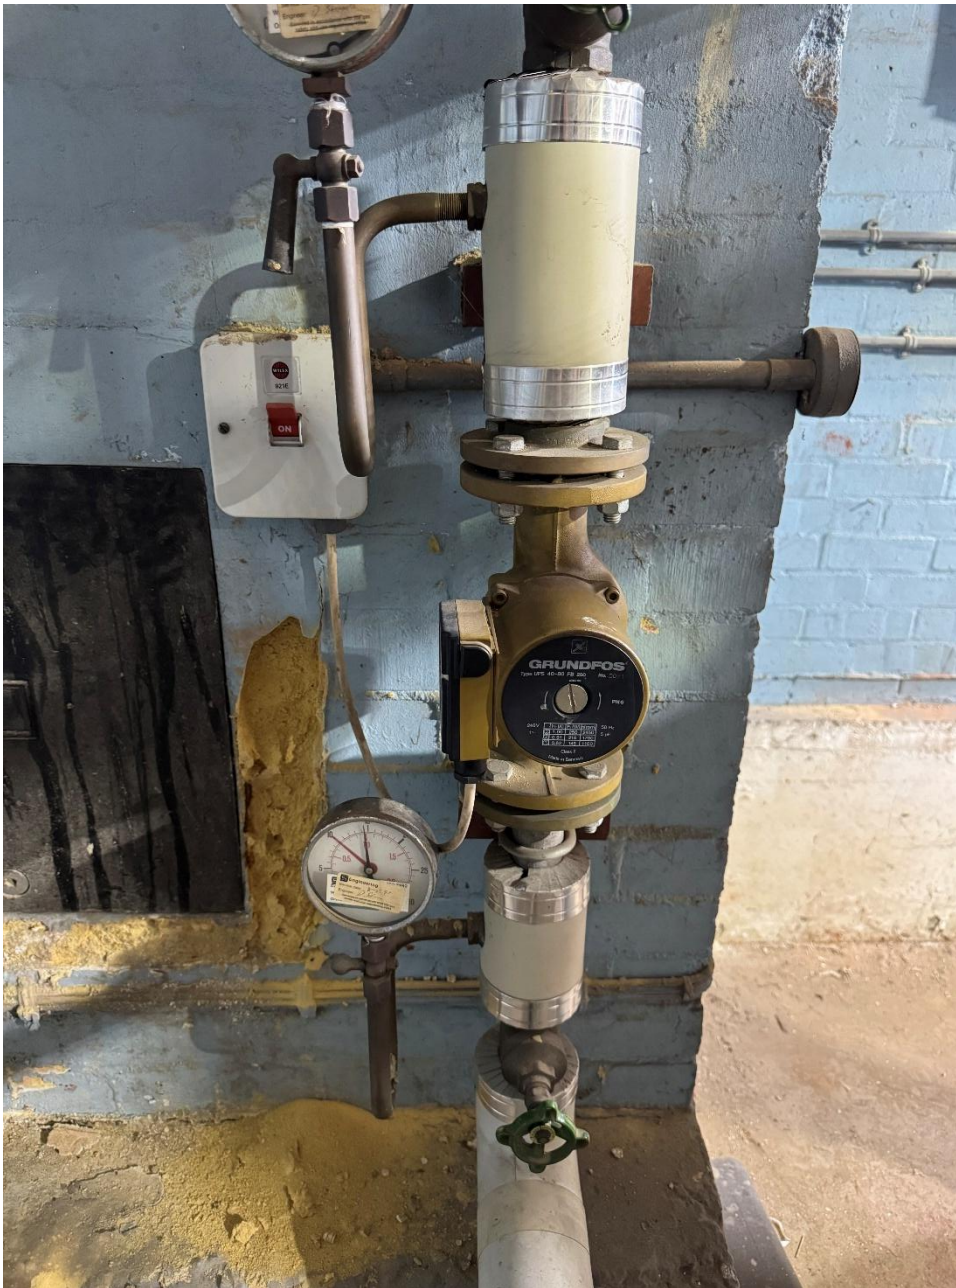
*Photograph 3 – Bronze secondary return pump*

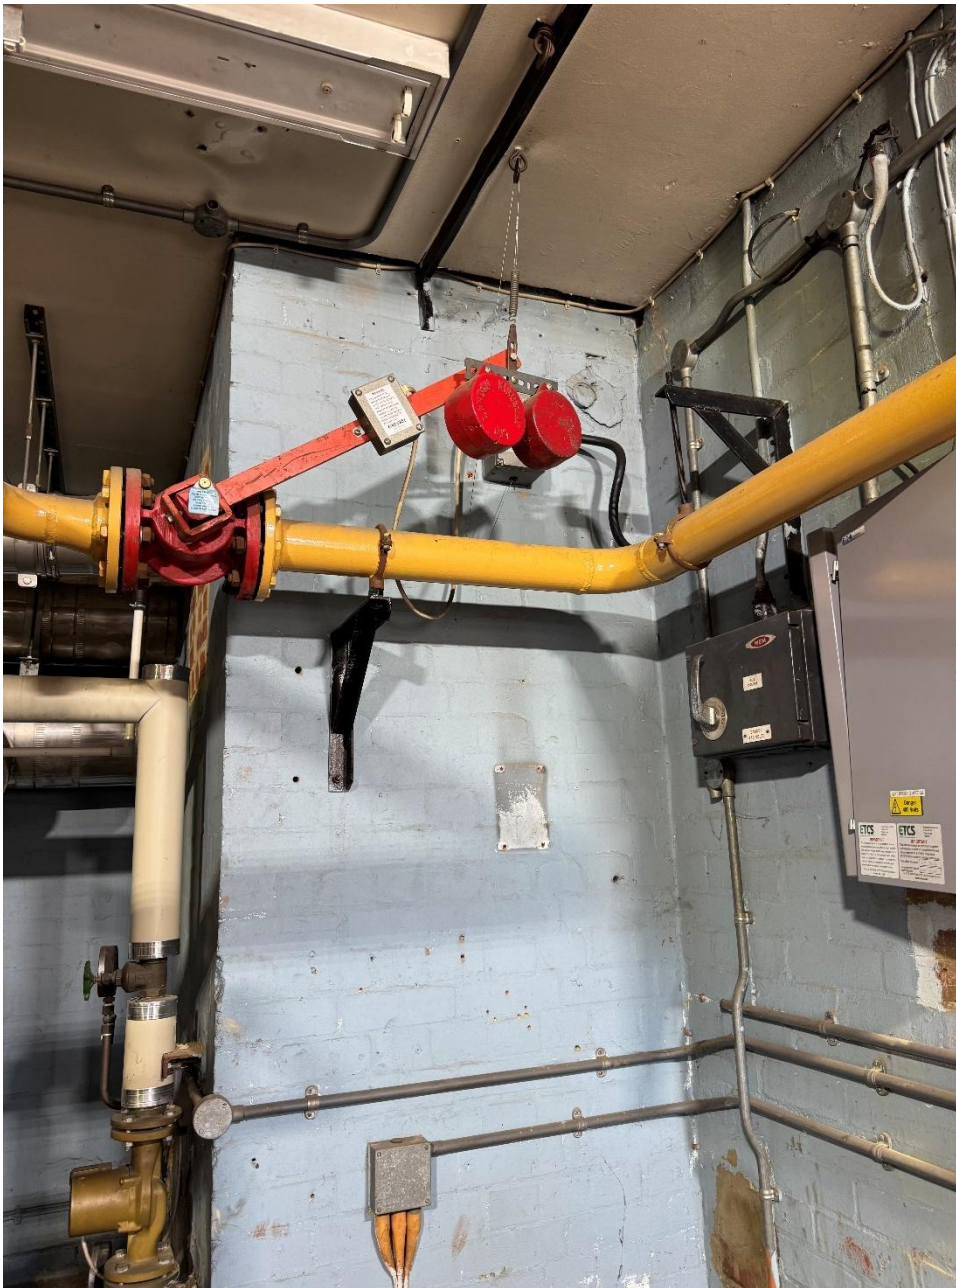
*Photograph 4- Gravity gas shut-off valve. No obsolete and should be replaced.*

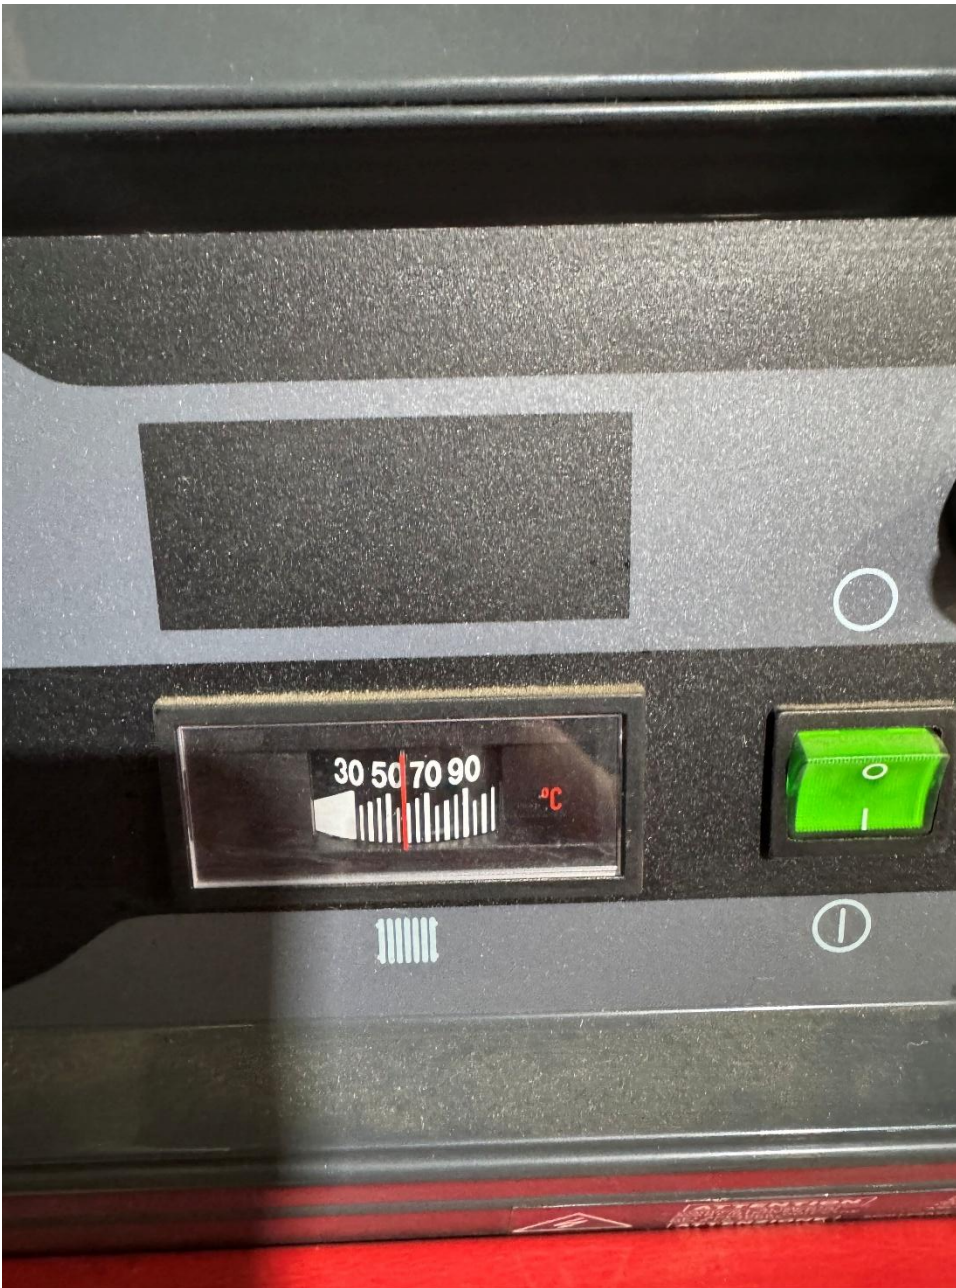
*Photograph 5 - Boiler 1 flow temperature. Approximately 60°C*

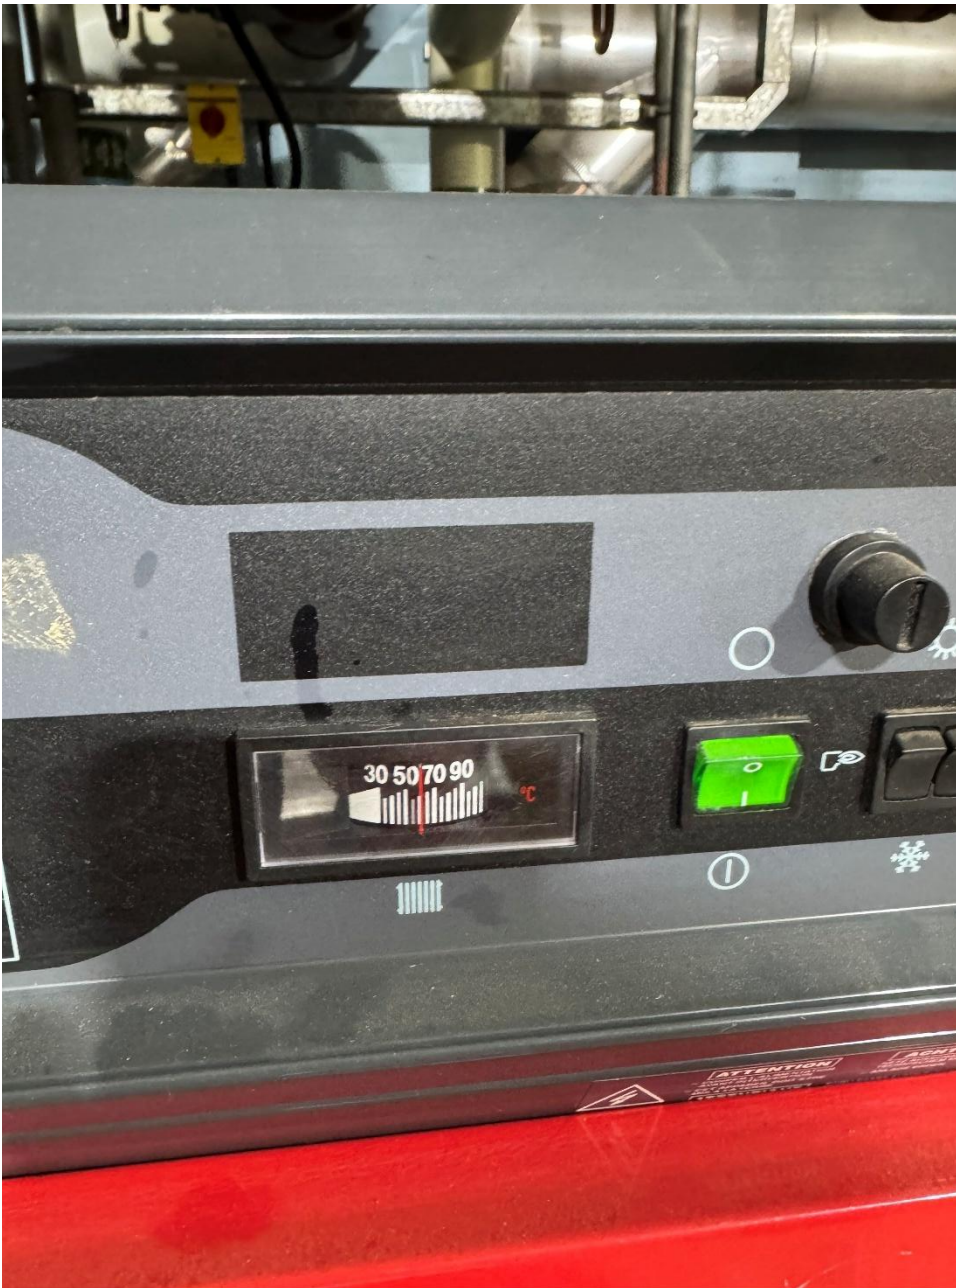
*Photograph 6 - Boiler 2 flow temperature. Approximately 60°C*

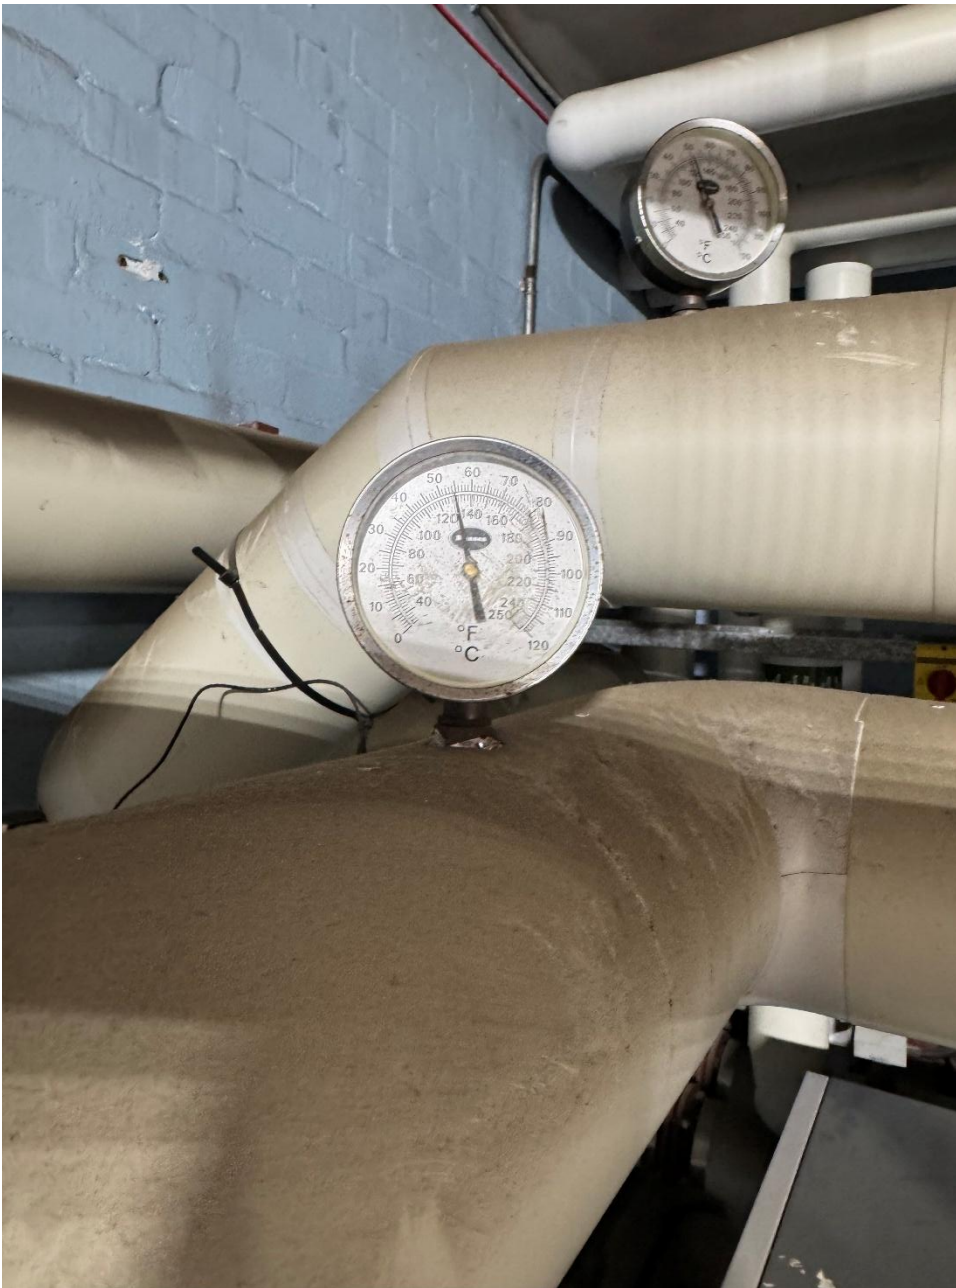
*Photograph 7 – LTHW system flow temperature 55°C*

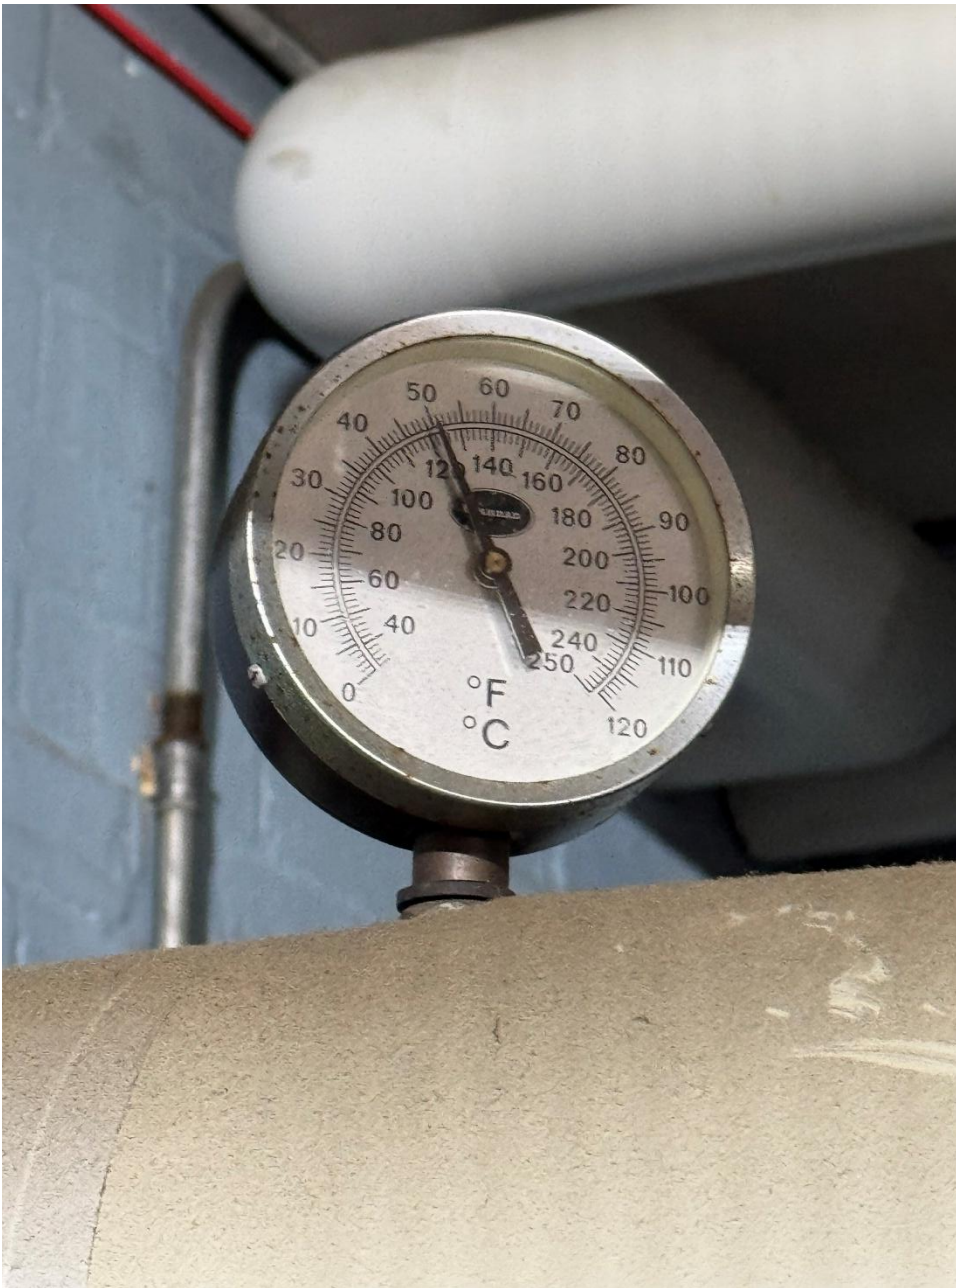
*Photograph 8 - LTHW system flow temperature 50°C*

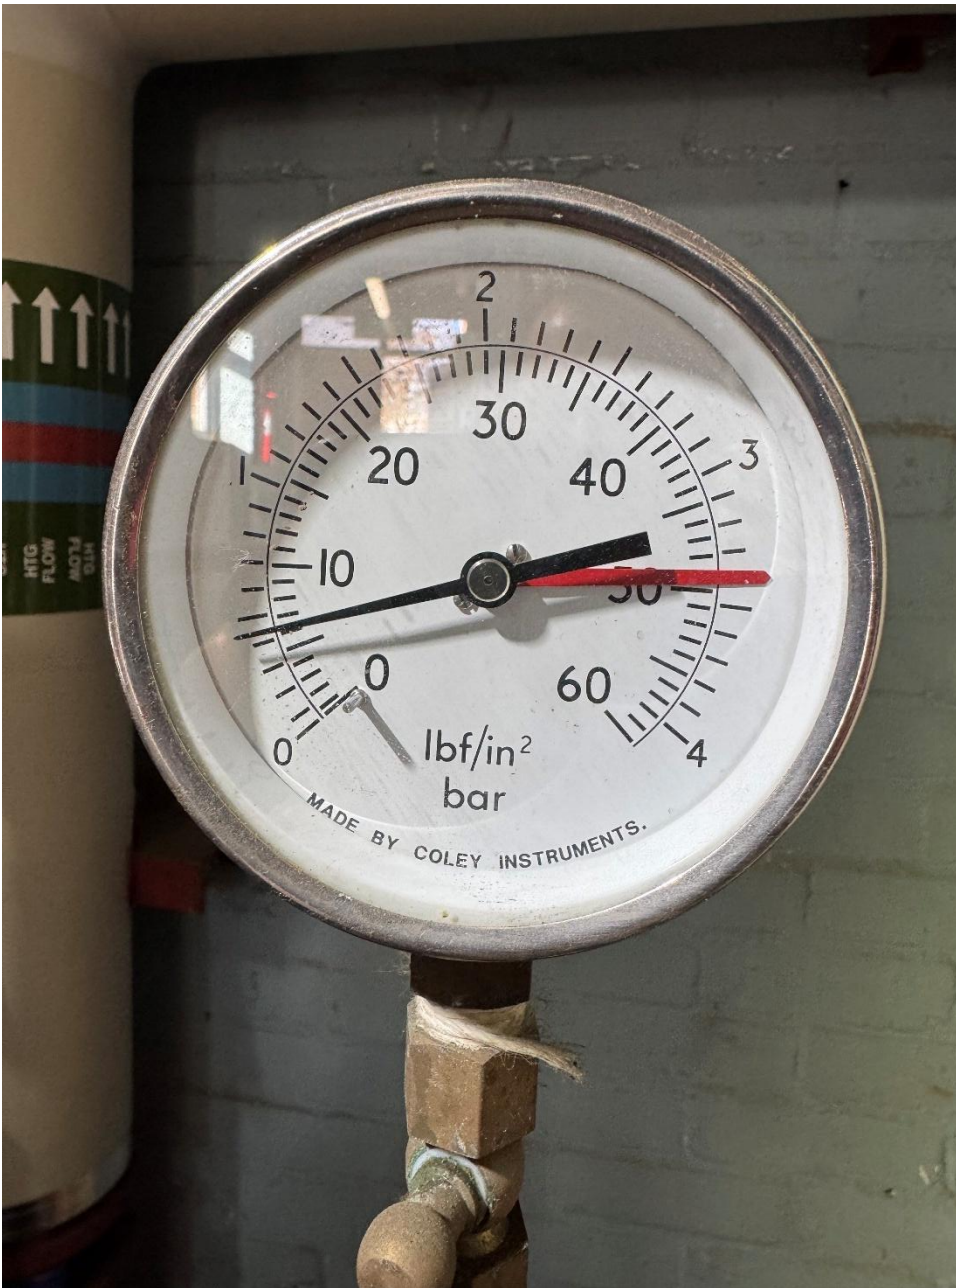
*Photograph 9 - Heating system static pressure 0.6Bar*

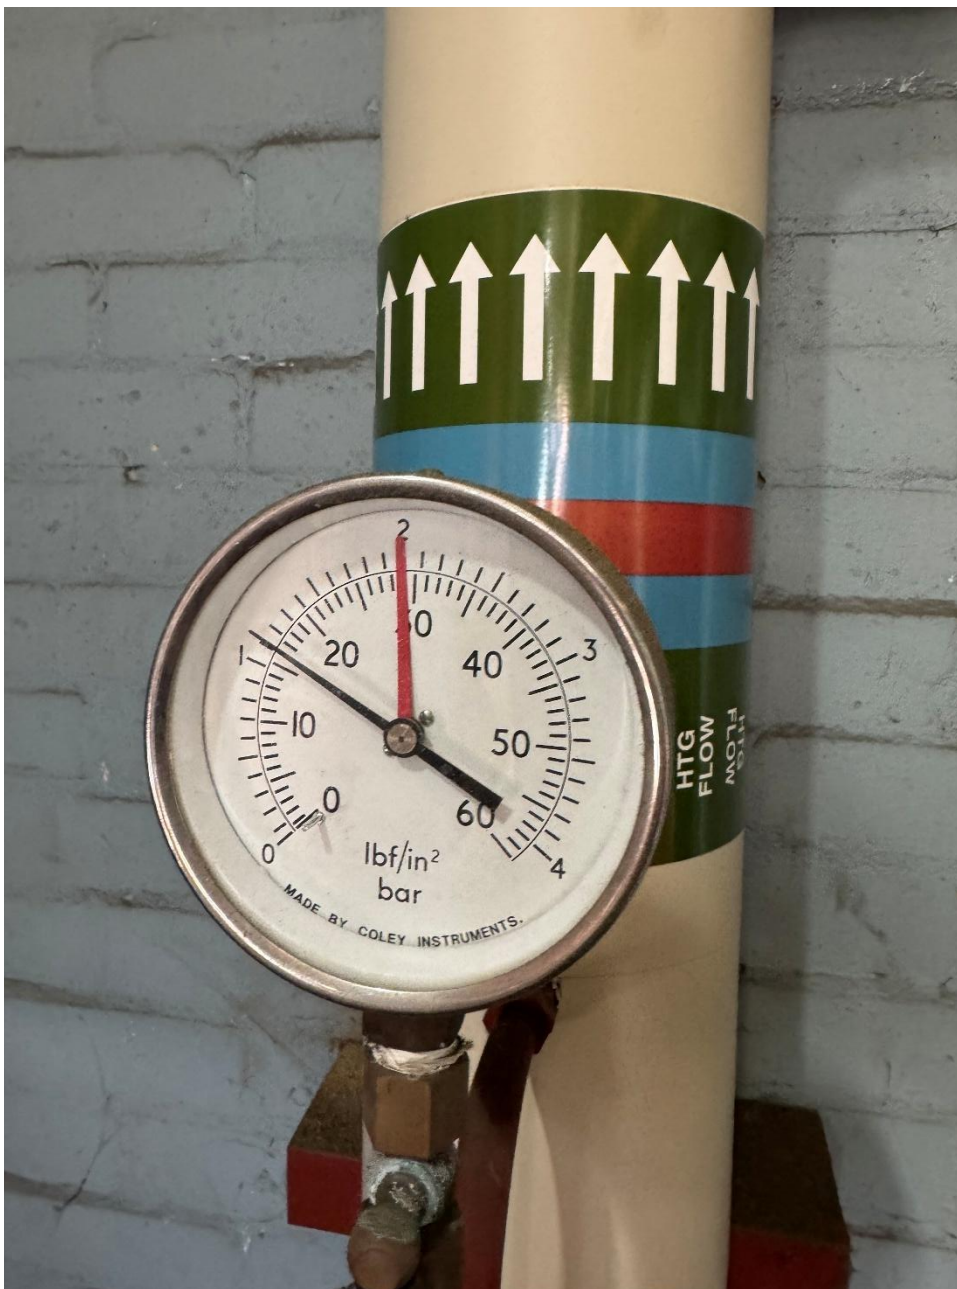
*Photograph 10 - Heating system dynamic pressure 1.2Bar*

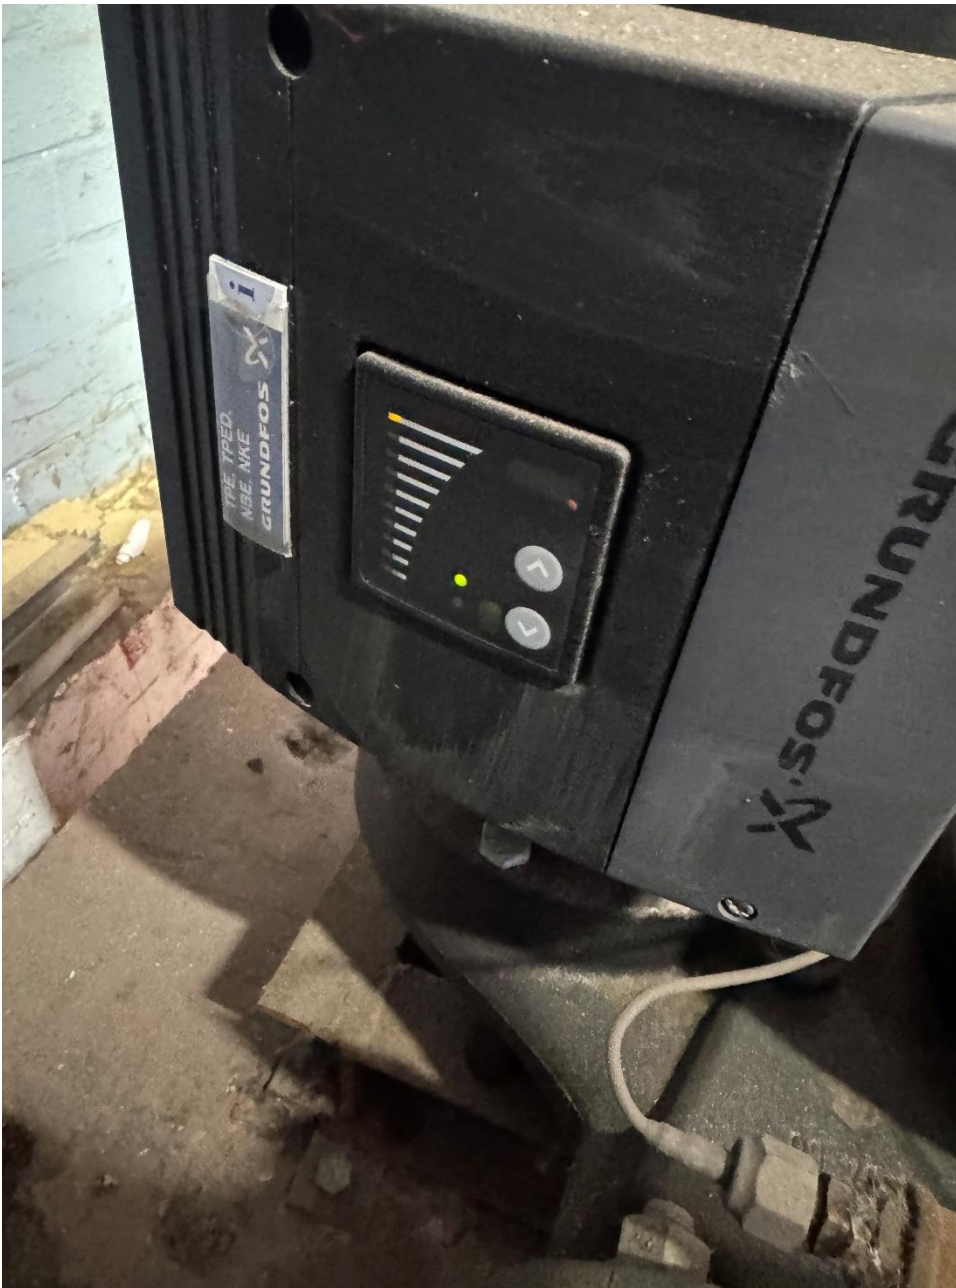
*Photograph 11- Pumps were set to high speed but not on the maximum setting.*

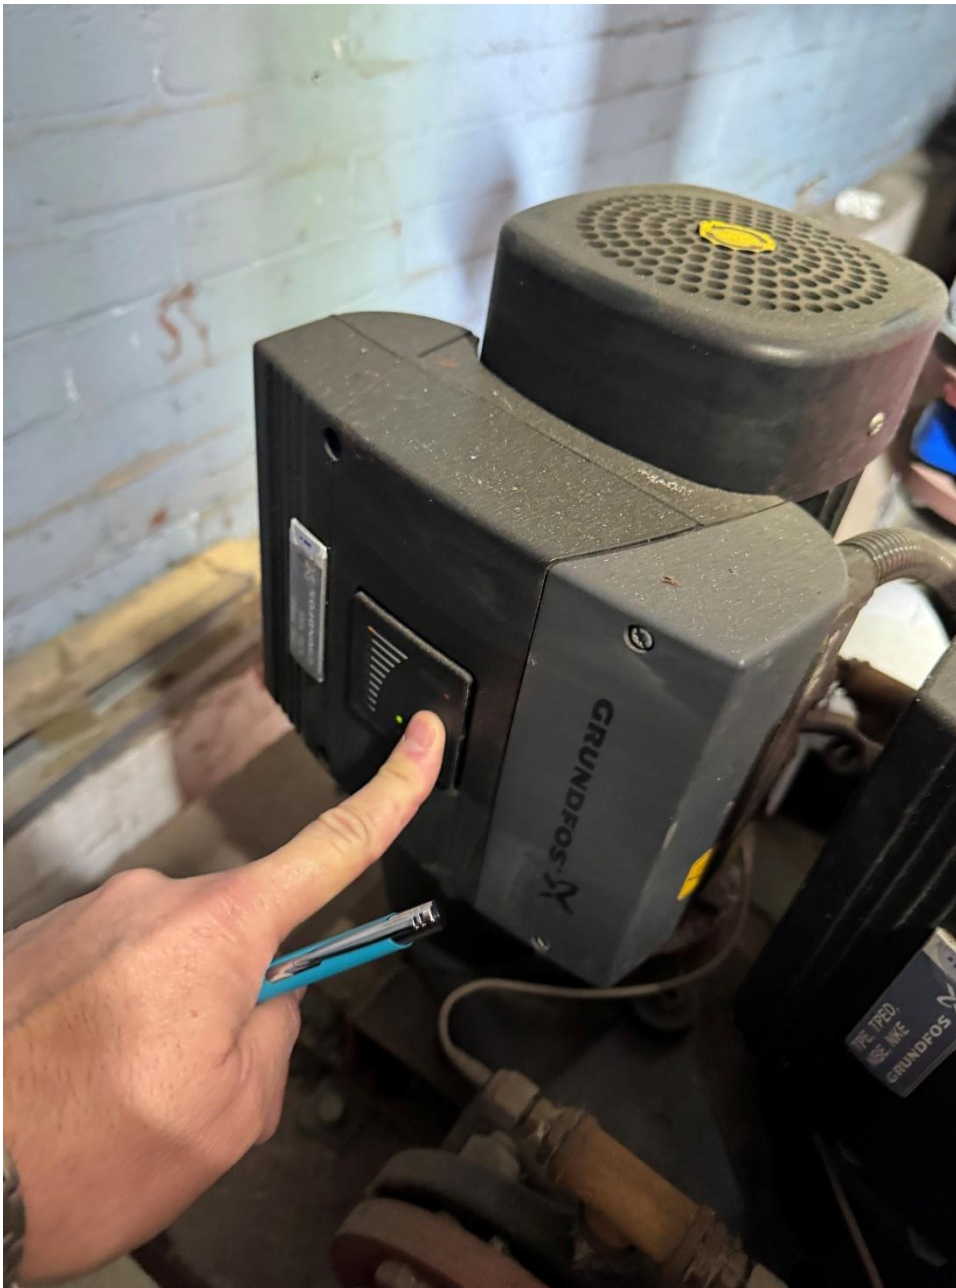
*Photograph 12 - Whitecode increased the pup speed to max by holding the controller*

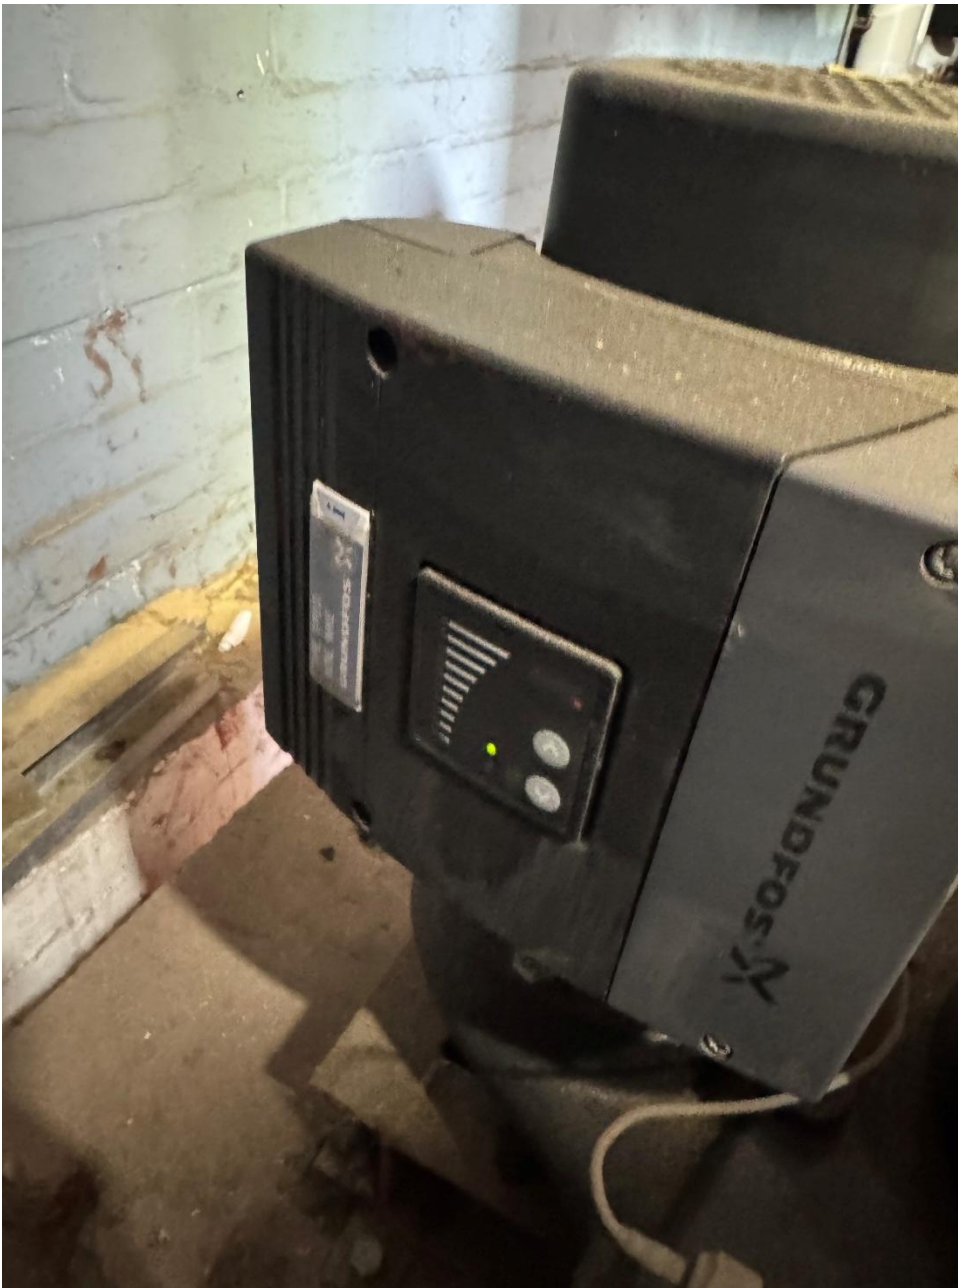
*Photograph 13 - Pumps then run at maximum*

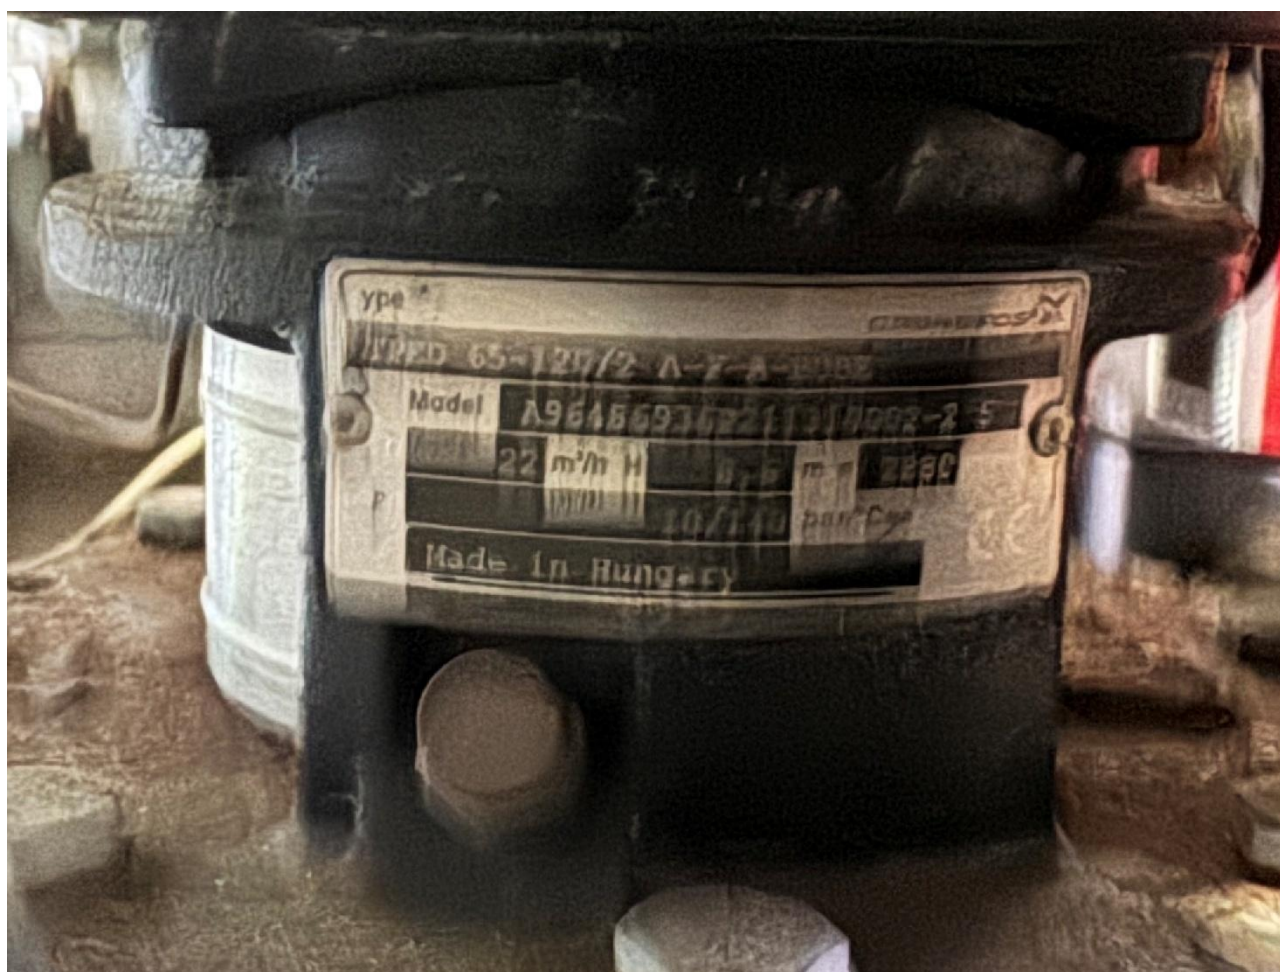
Photograph 14 – Main LTHW circulator TPED 65-120

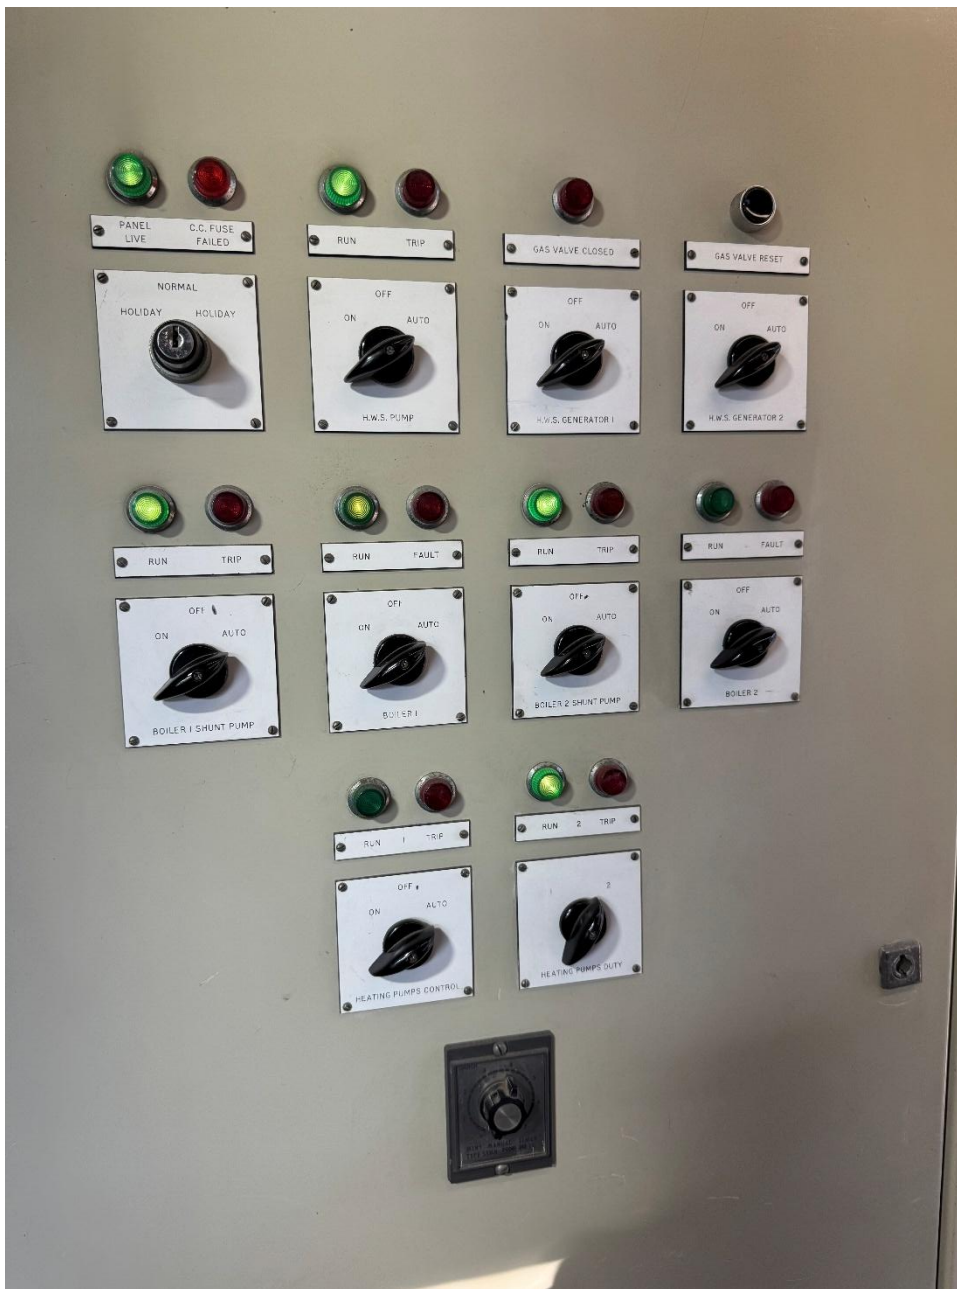
Photograph 15 - The BMS panel was noted as original to the plan room. It is beyond serviceable repair and should be replaced.

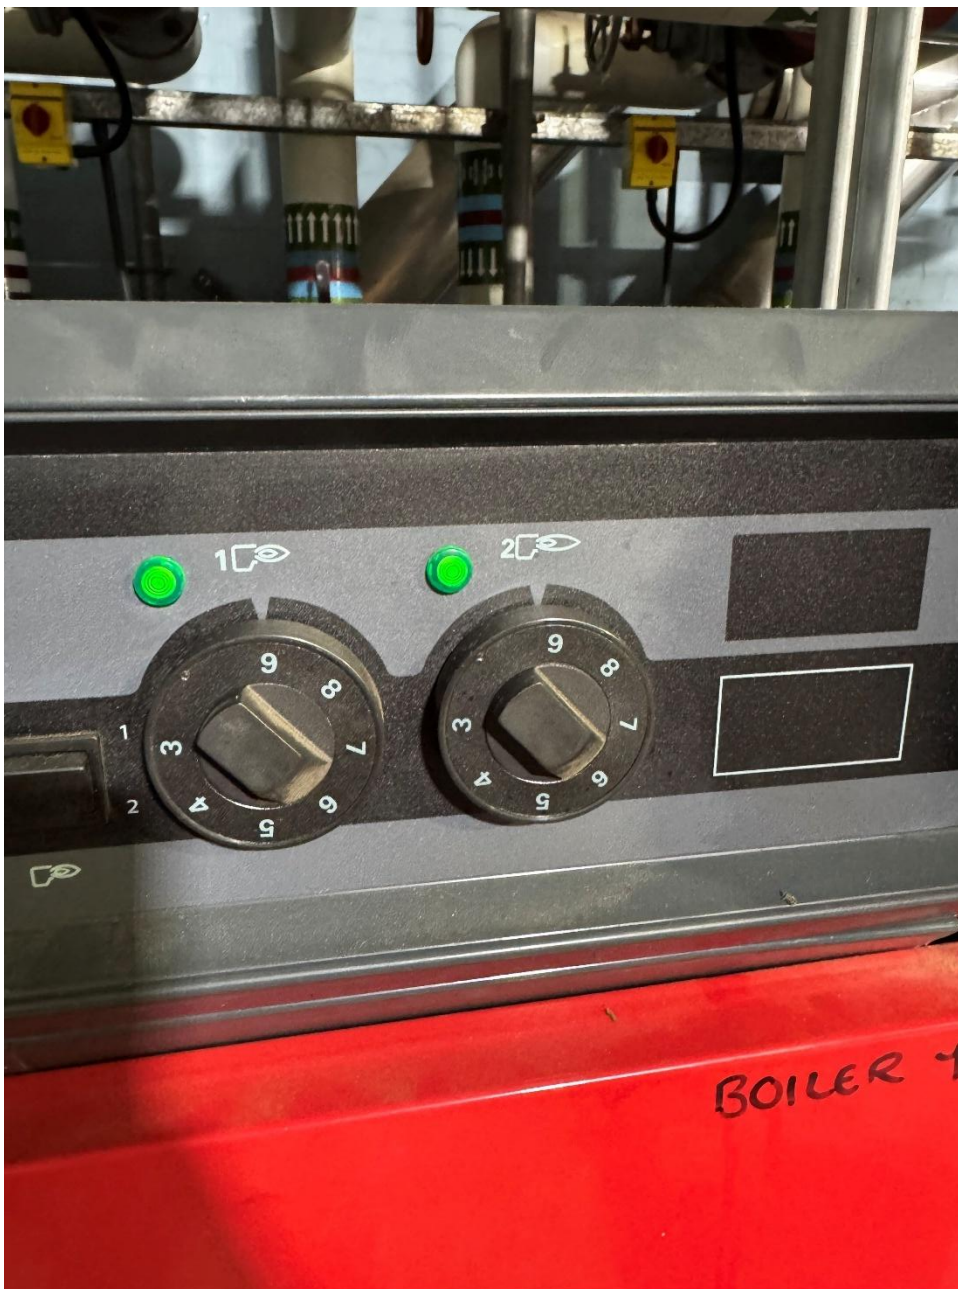
*Photograph 16 - Whitecode increased the boilers' stats to 80°C*

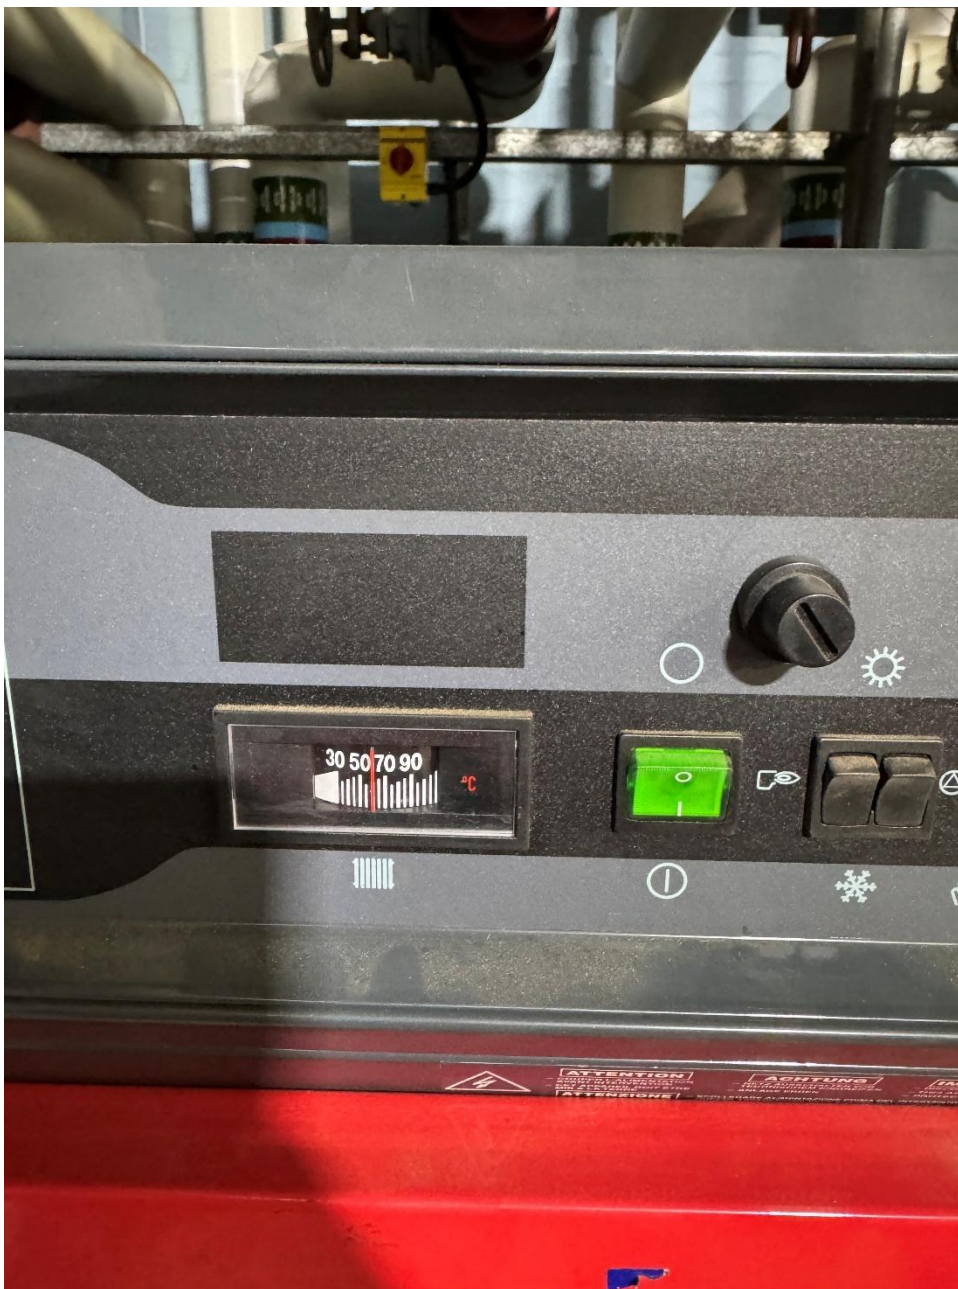
*Photograph 17- Boiler flow temperature was seen to increase.*

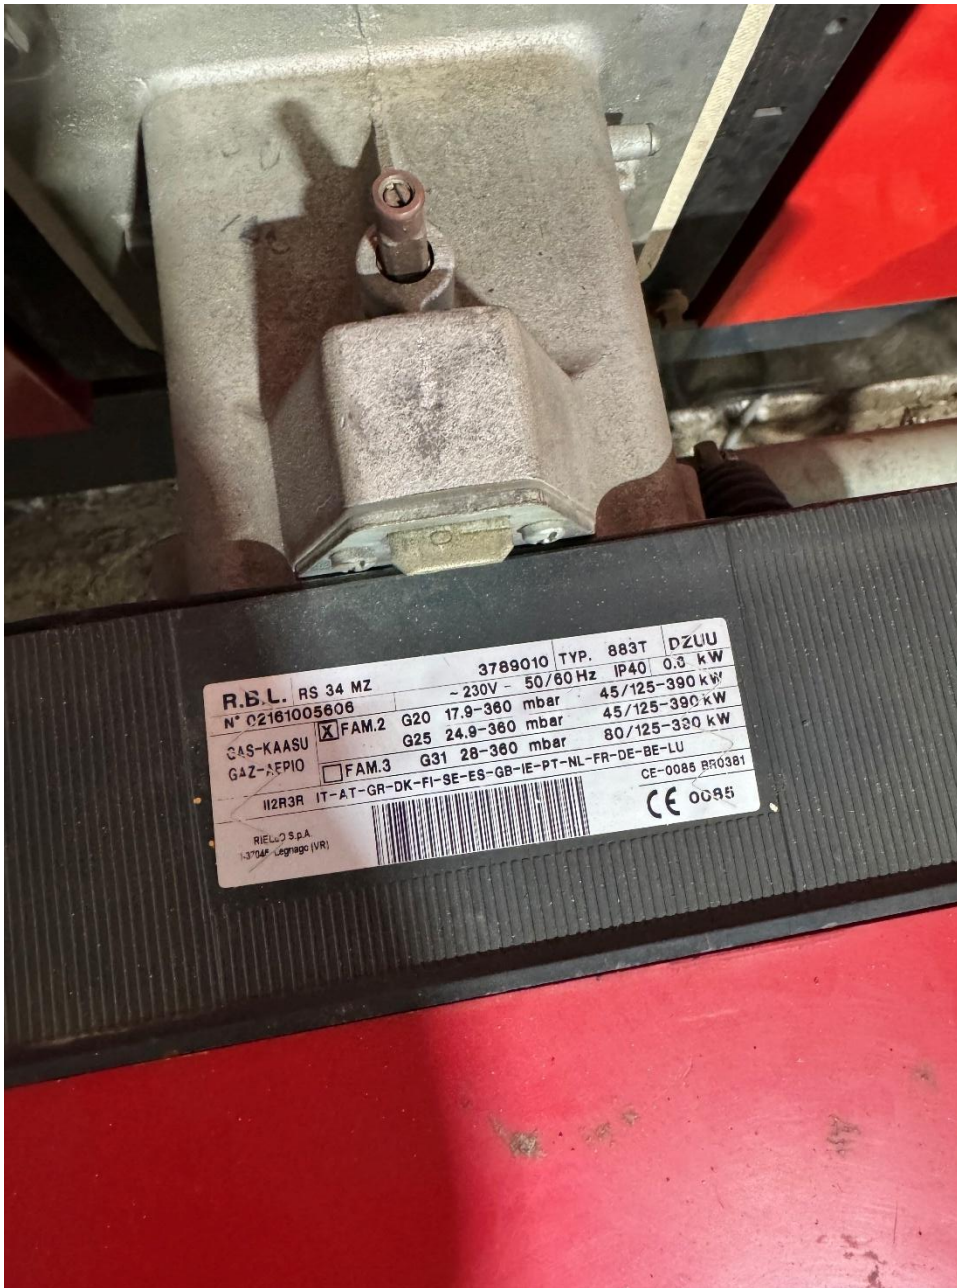
Photograph 18 – Burners are Riello RS34
