# Scope of Works – MEP System Upgrade

## West Wimbledon Primary School

Prepared for McBains

*12 June 2025*

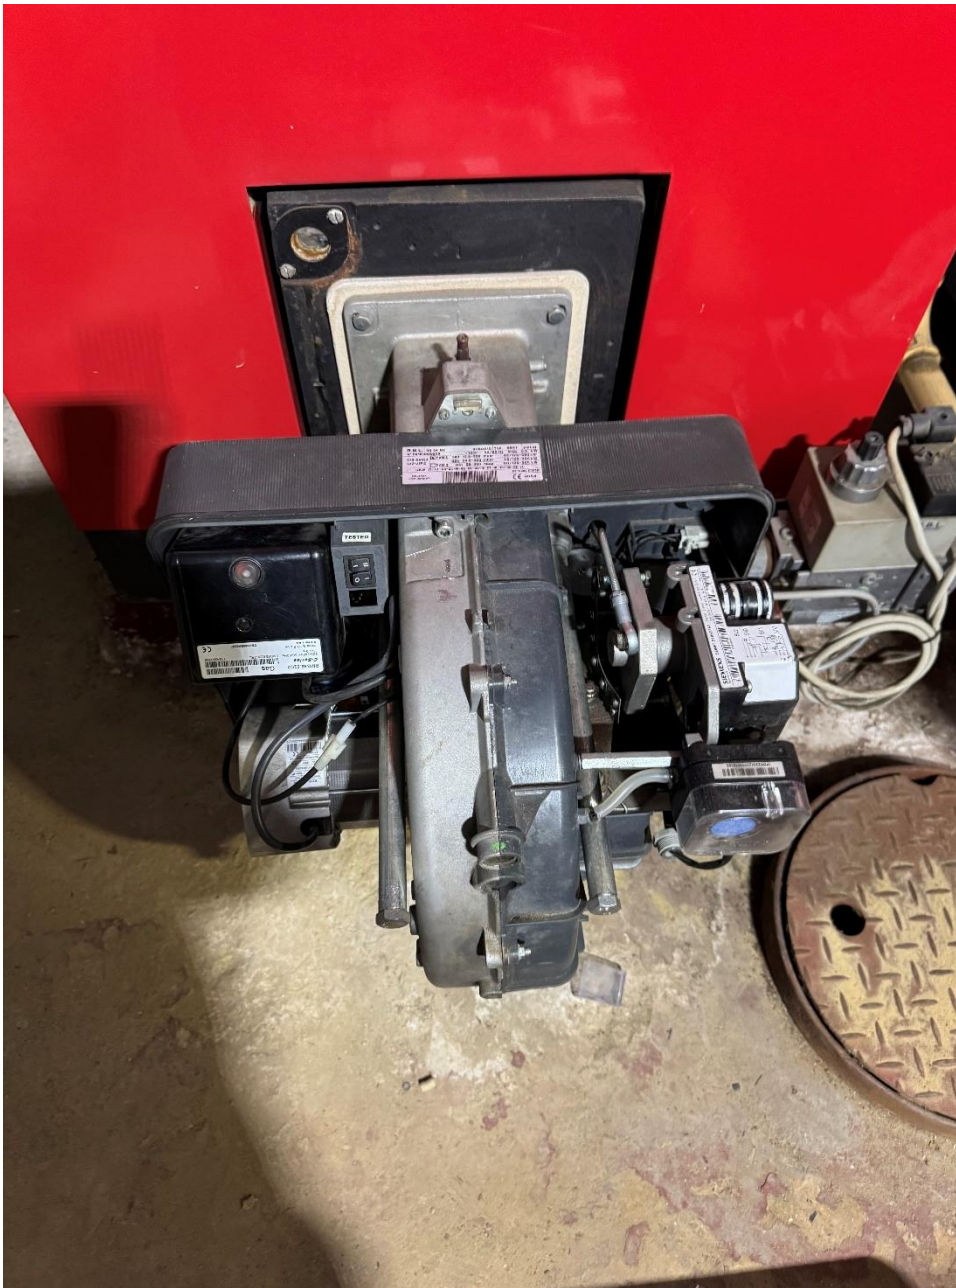
*Photograph 19 - Burner 1 was set to a 2-stage fire, providing maximum output.*

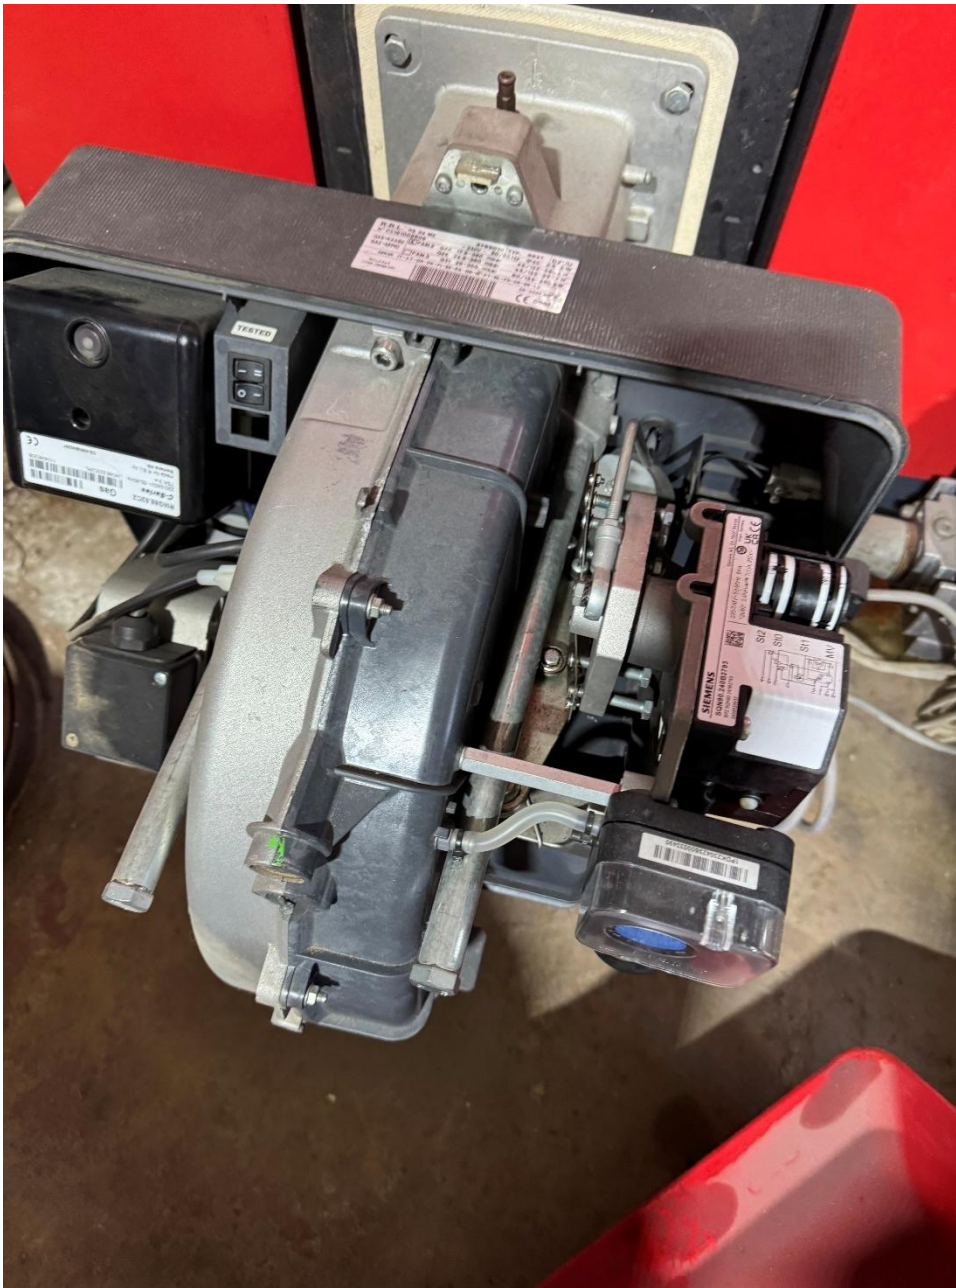
*Photograph 20 - Burner 2 was set to 2 2-stage fire, therefore providing maximum output.*

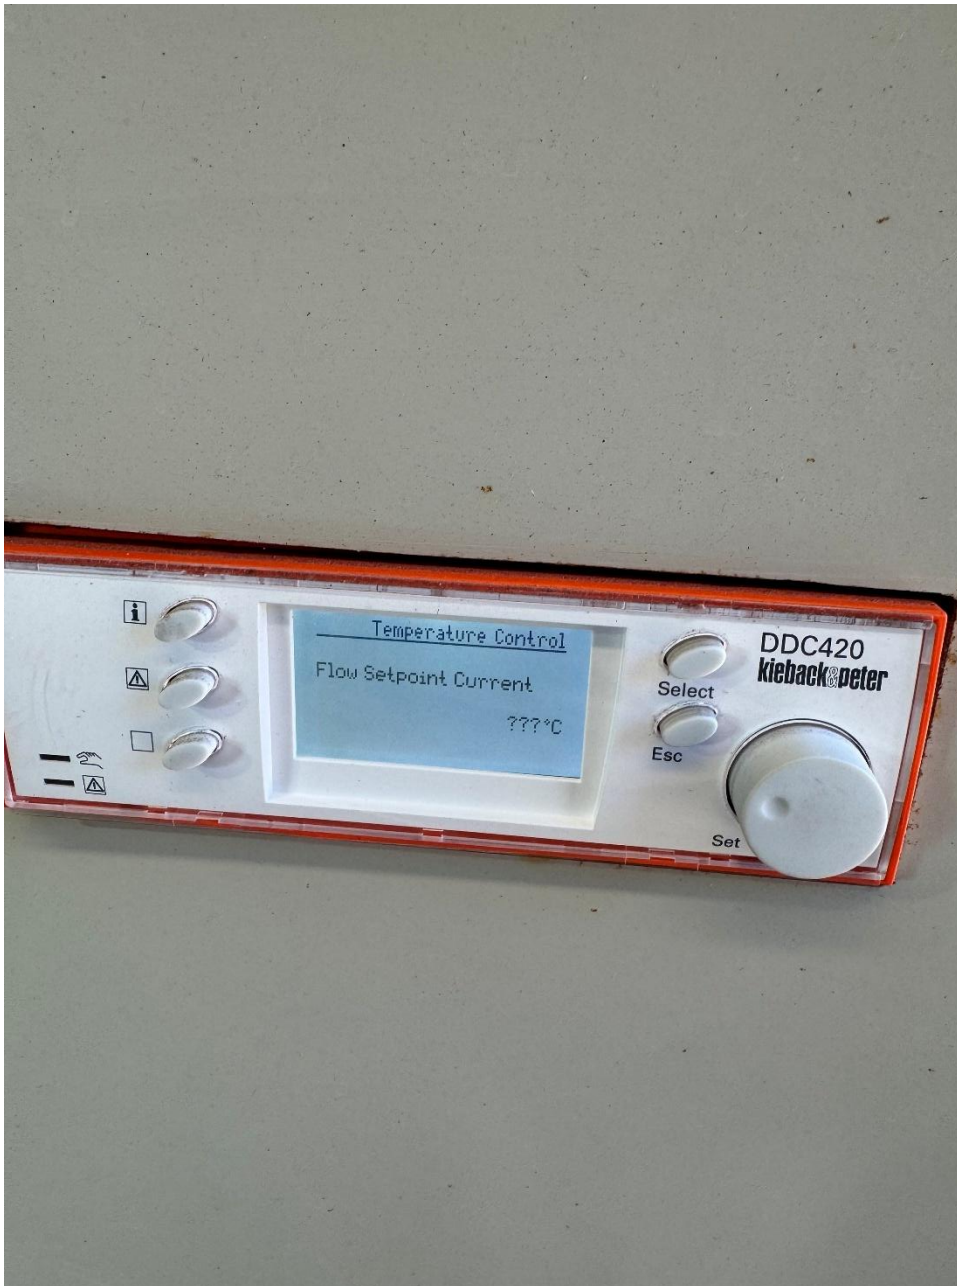
*Photograph 21- Boiler controller seem to have limited control on the plant.*

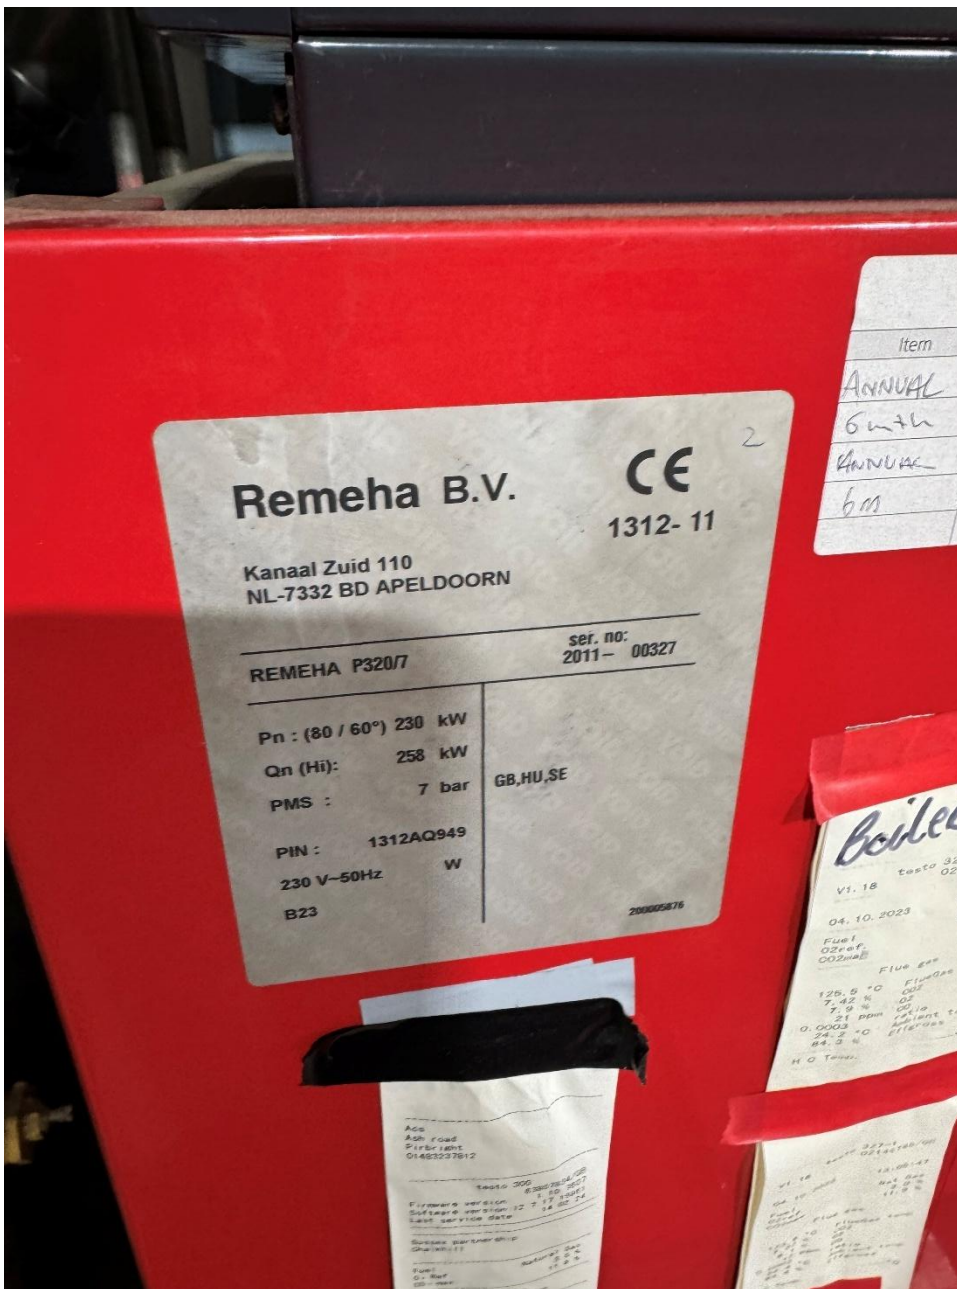
Photograph 22 – Boilers were noted as Remeha 1312- 230kW output.

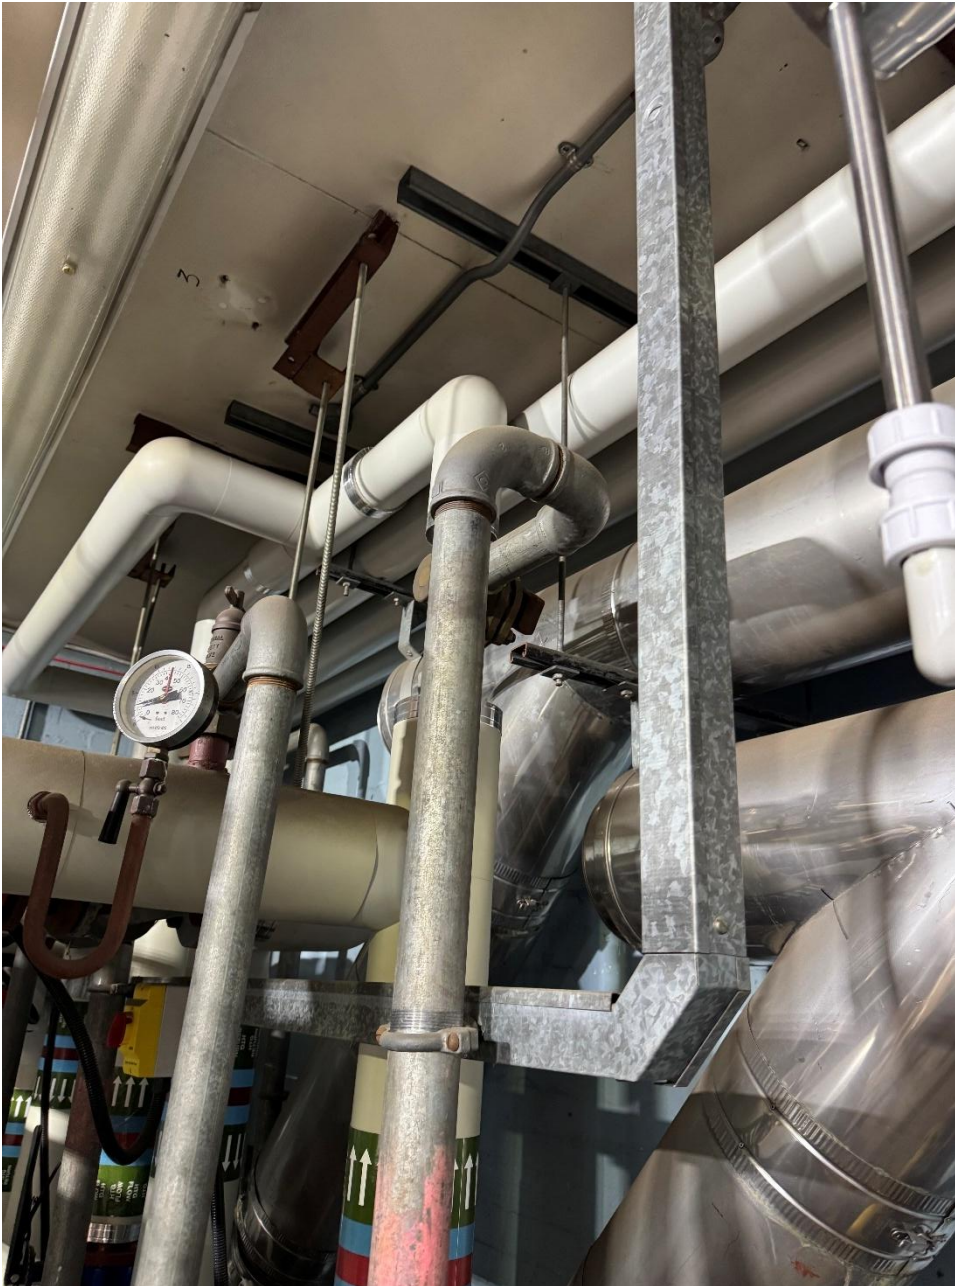
*Photograph 23 - The LTHW system was open-vented.*

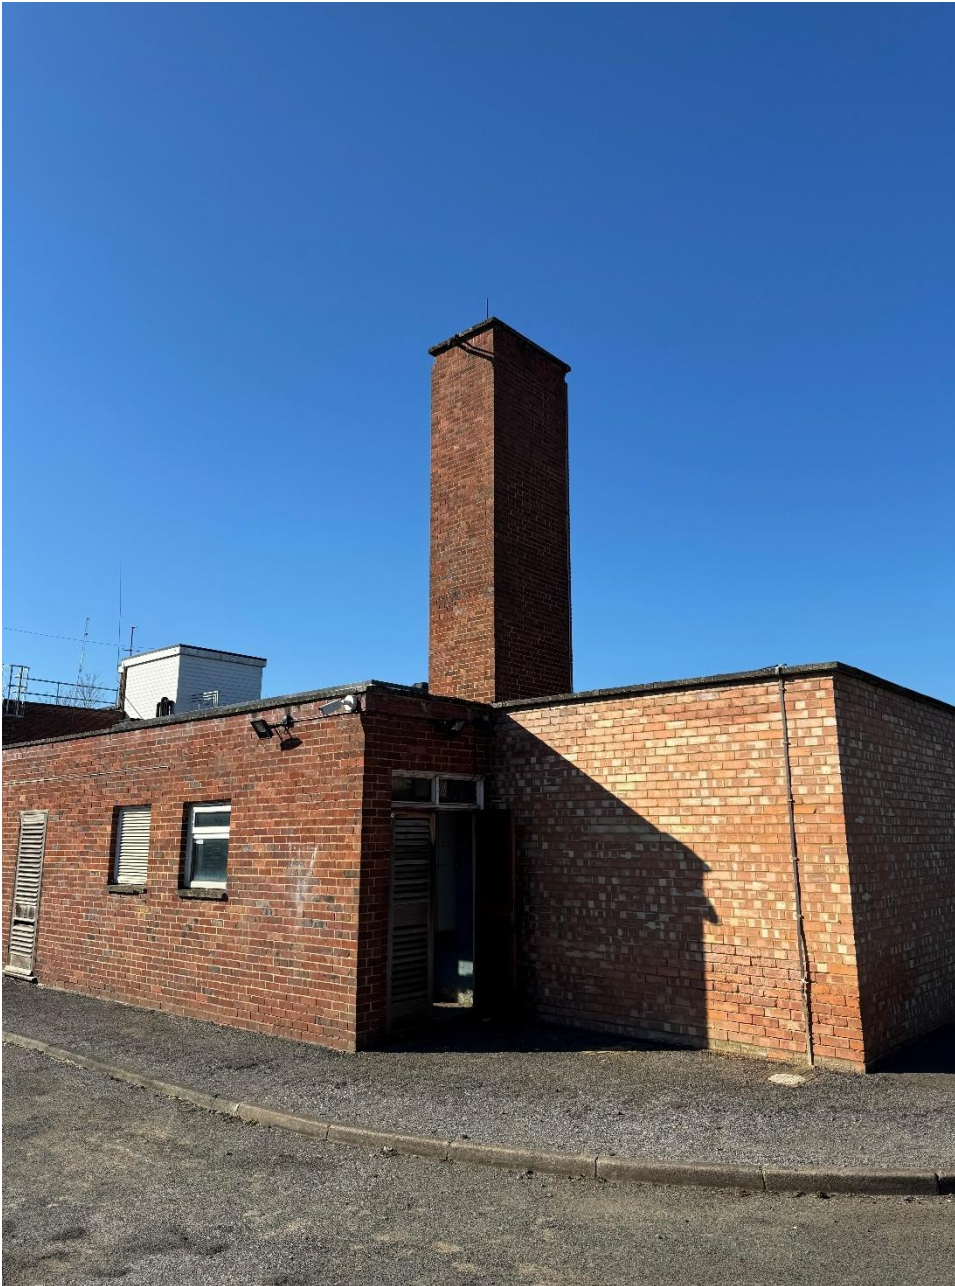
*Photograph 24 - External to the plant room. Flue terminate in this chimney.*

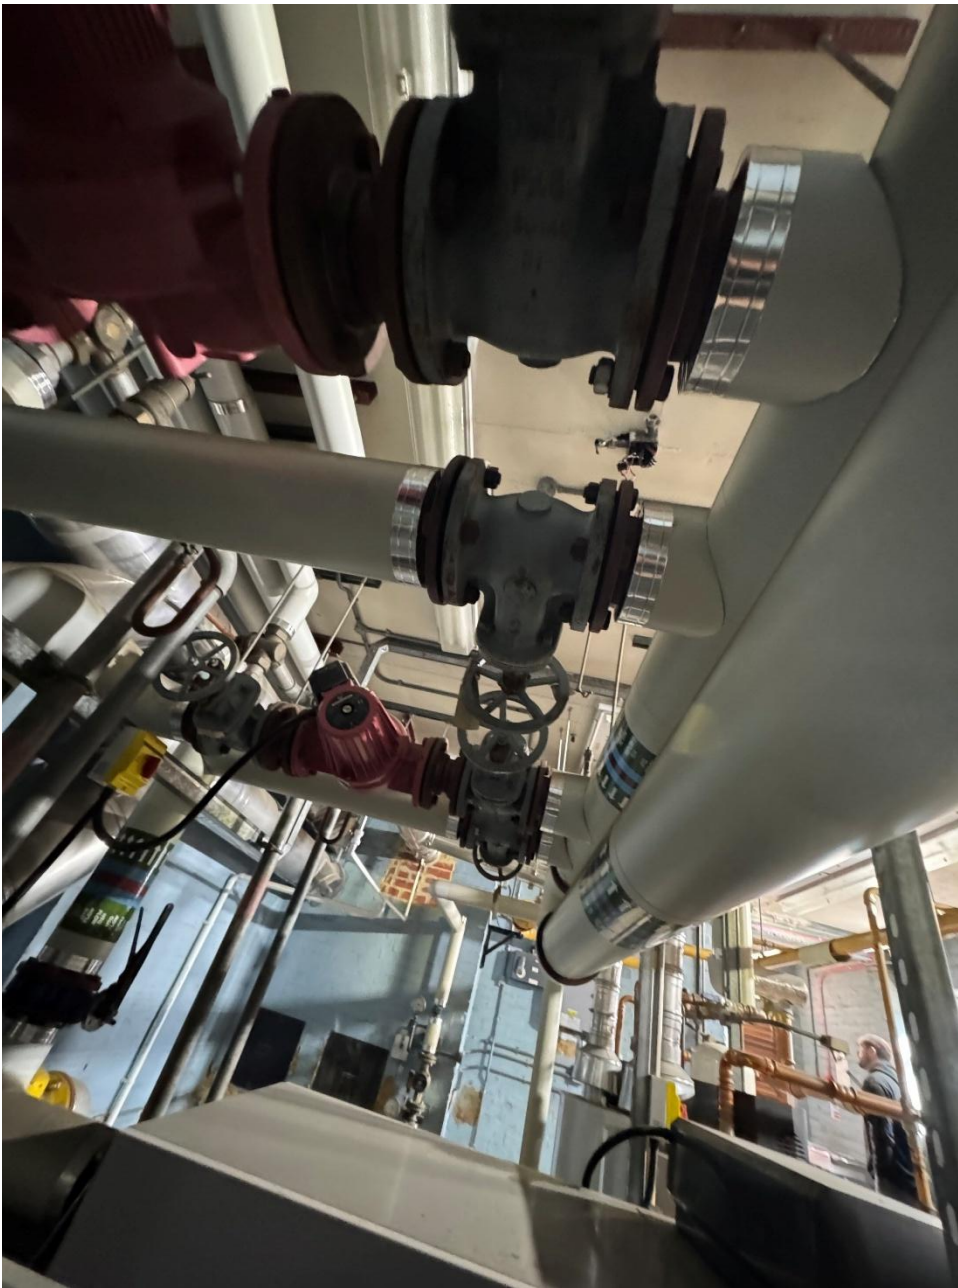
*Photograph 25 – Boilers were connected in an “injection header arrangement”.*

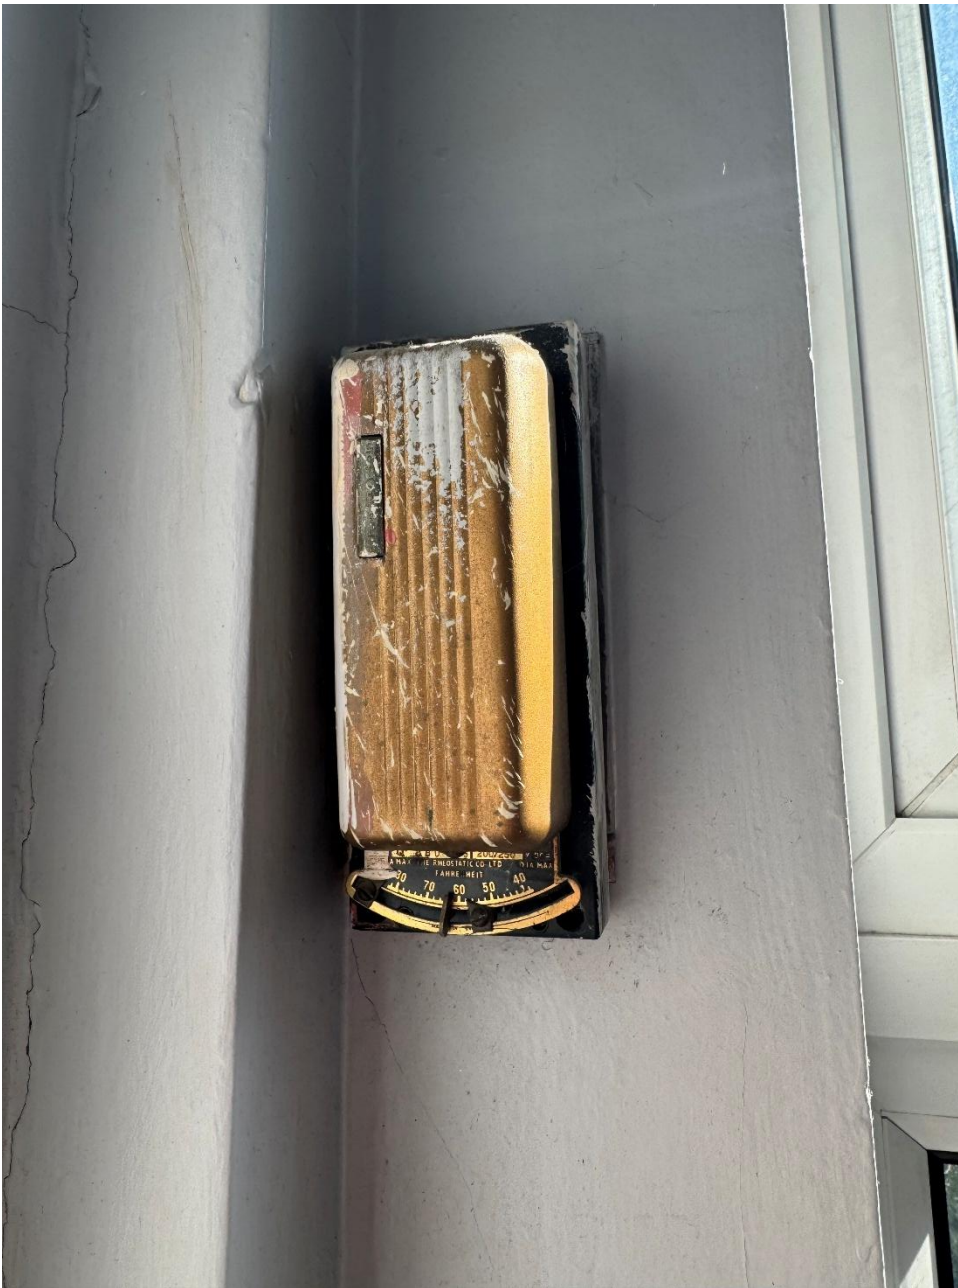
*Photograph 26- Whitecode was shown, which the school believes is the heating control thermostat.*

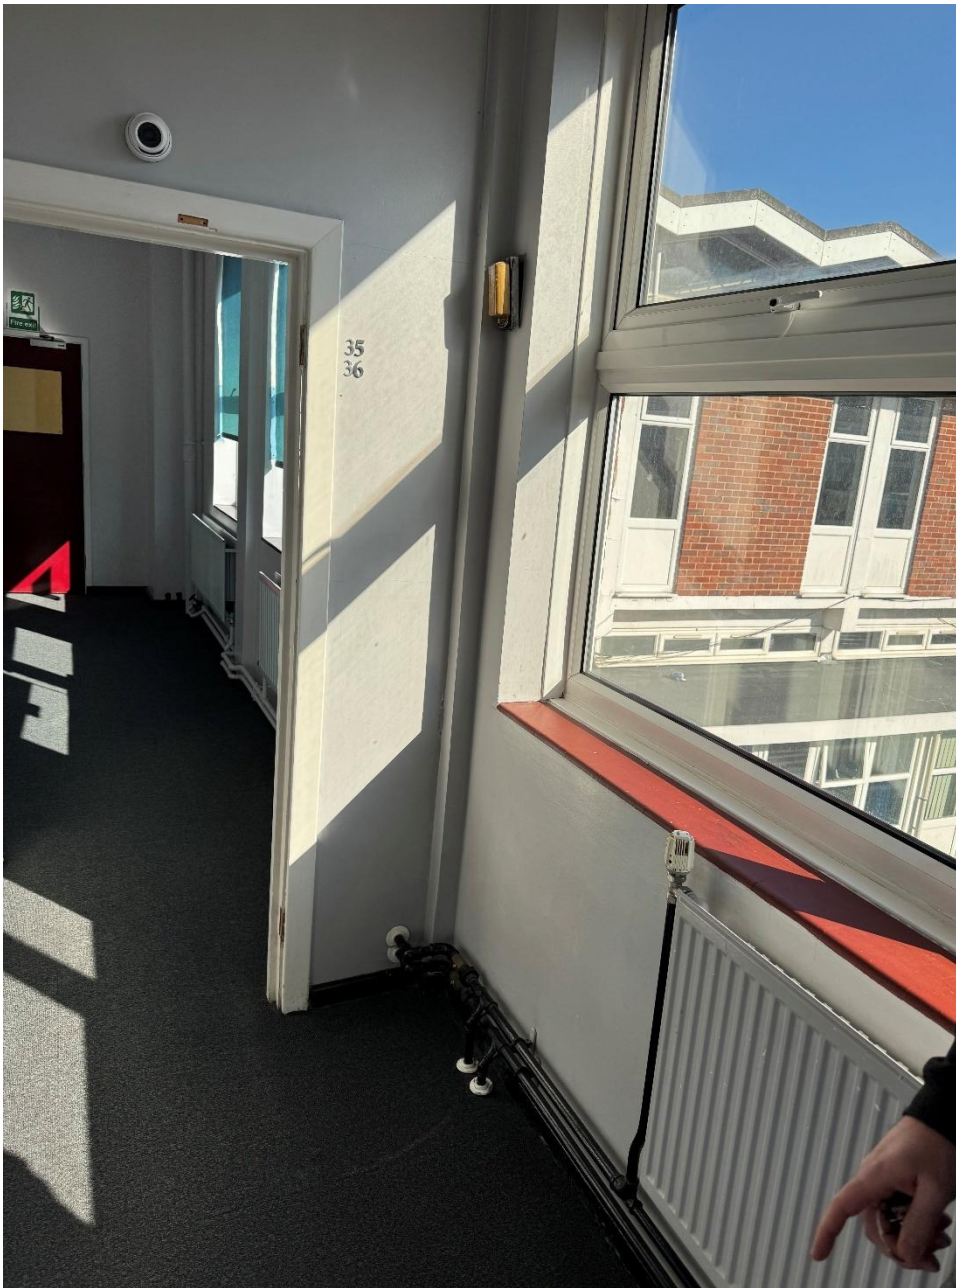
*Photograph 27 - Thermostat location in sunny corridor.*

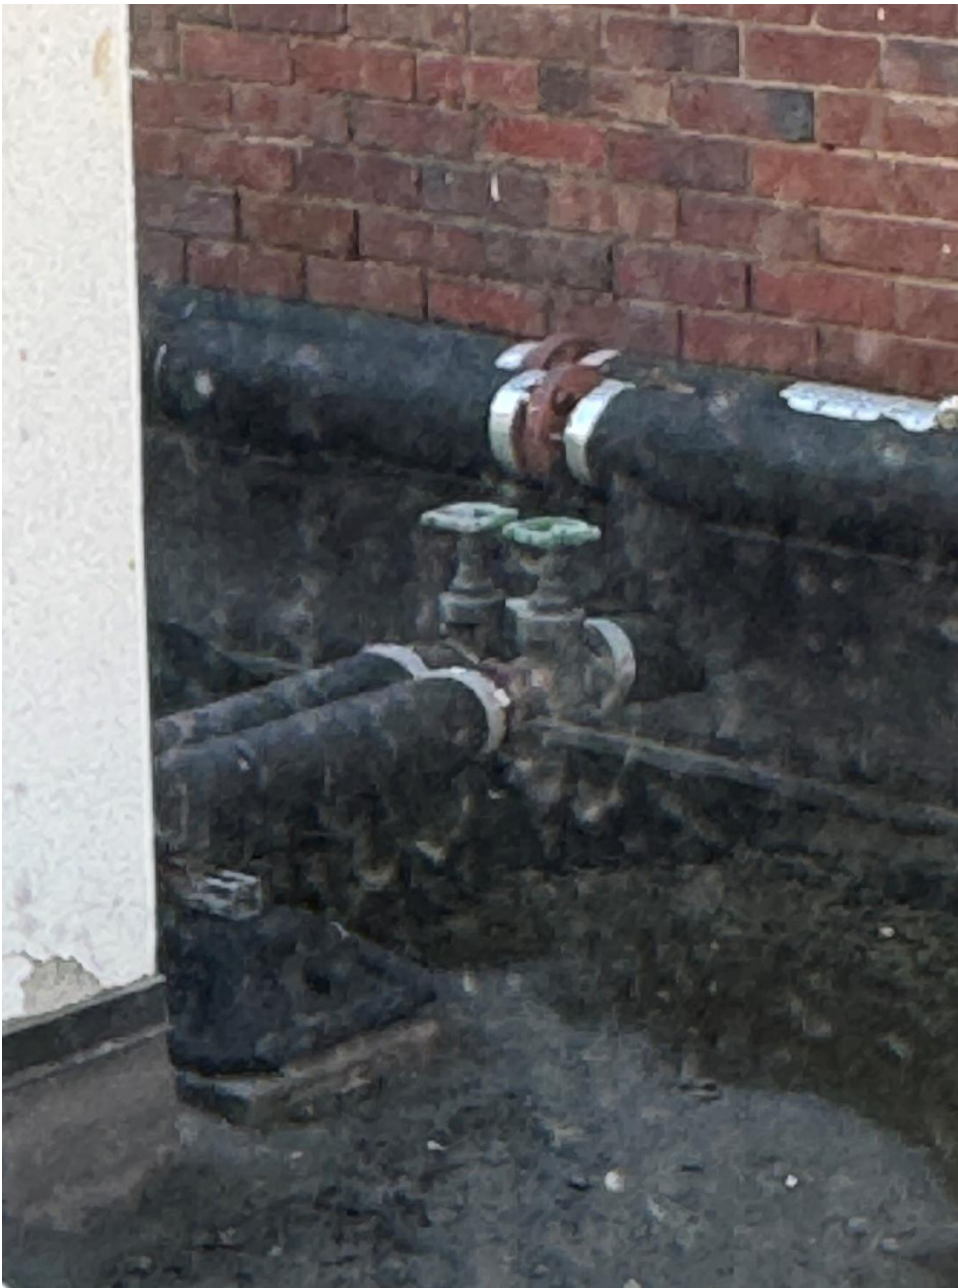
*Photograph 28 - LTHW valves could be seen outside and were uninsulated.*

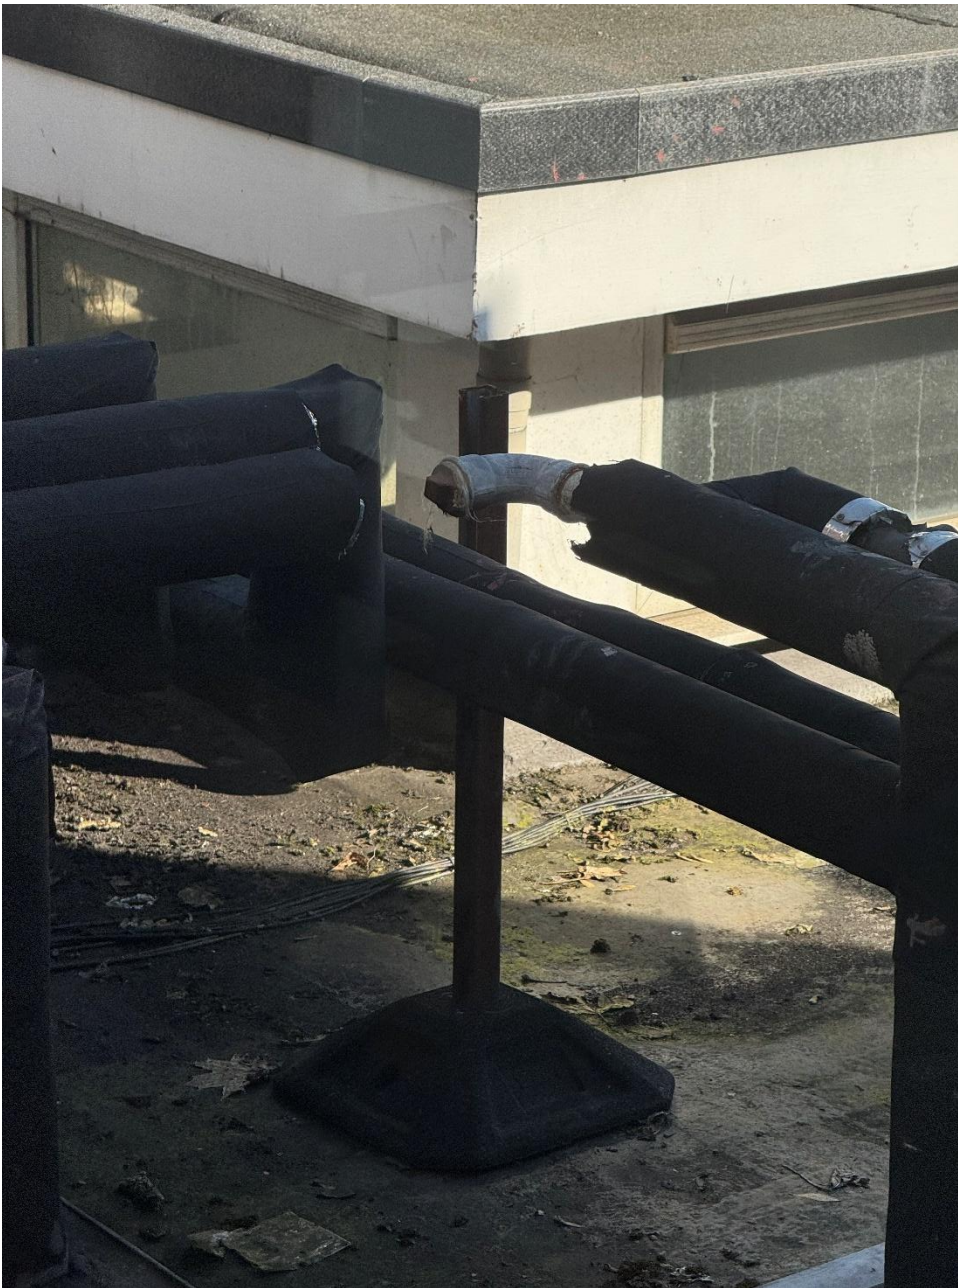
*Photograph 29 - Dead leggs could be seen.*

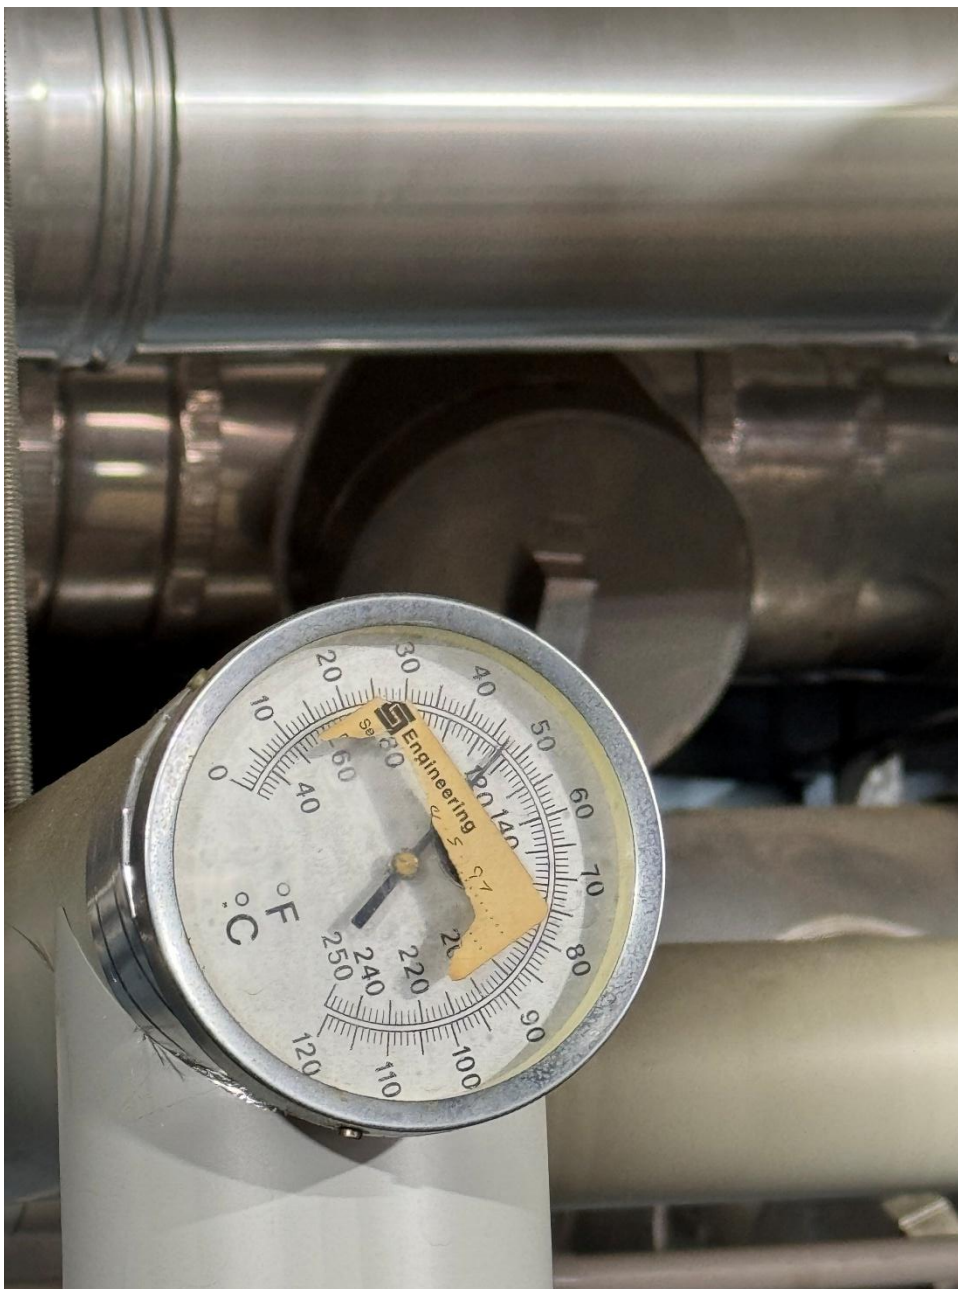
*Photograph 30 - Hot water system retrain appeared to be lower the the L8 requirment of 50°C.*

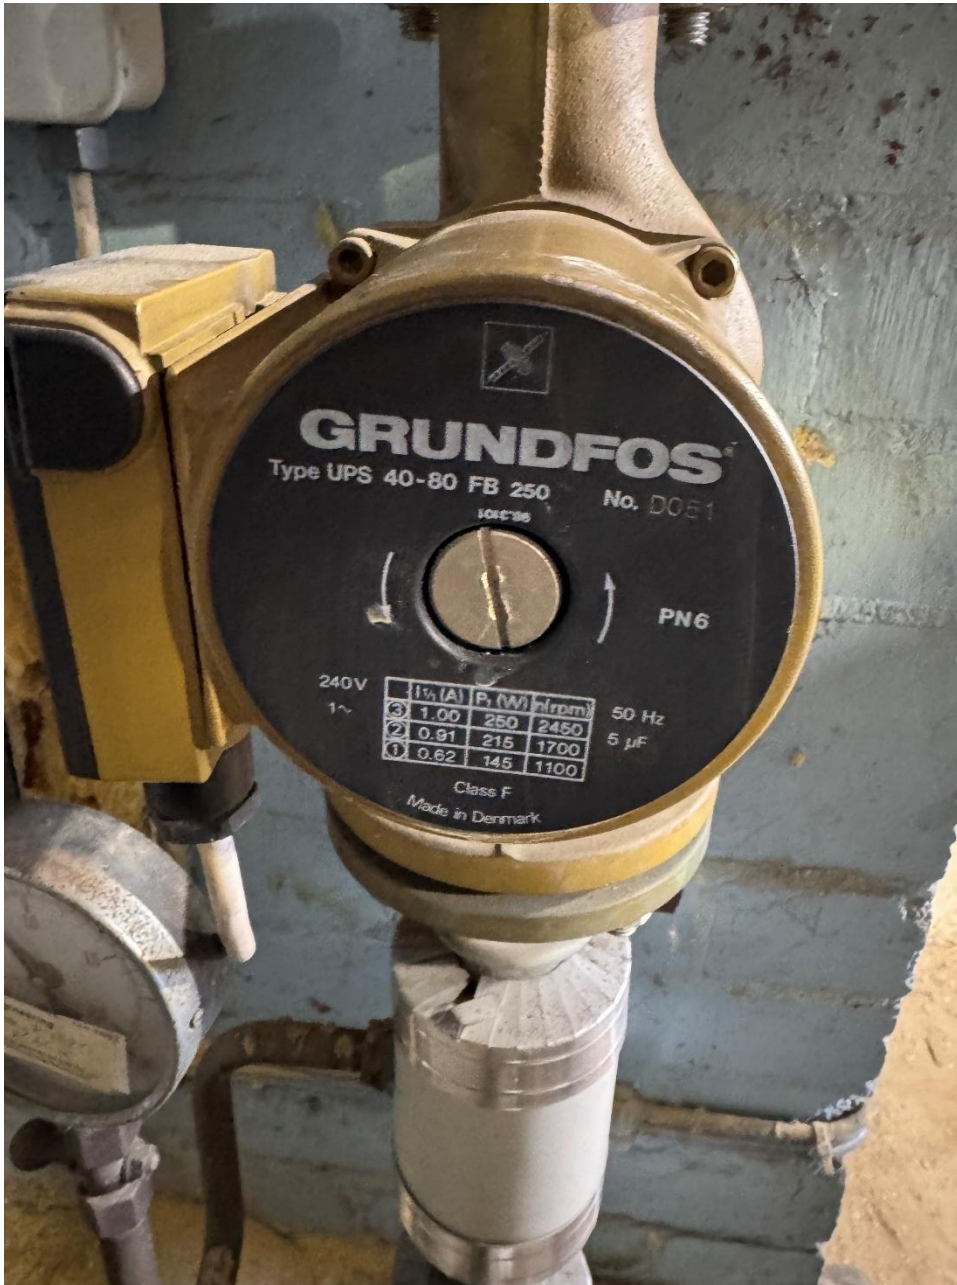
Photograph 31- Secondary return circulator was a UPS 40-80 in bronze.

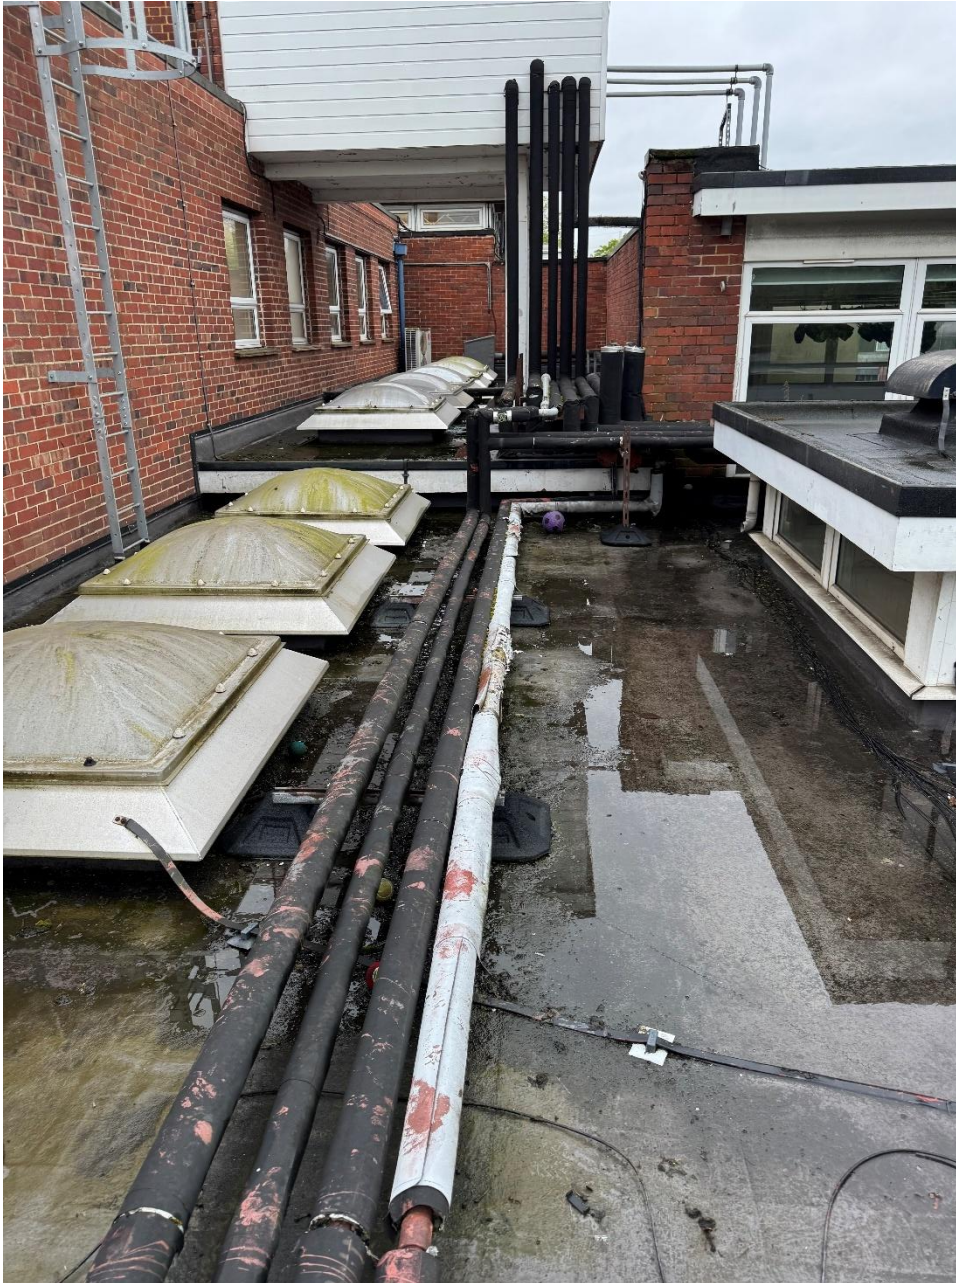
*Photograph 32 – LTHW insulation appeared to be in poor condition.*

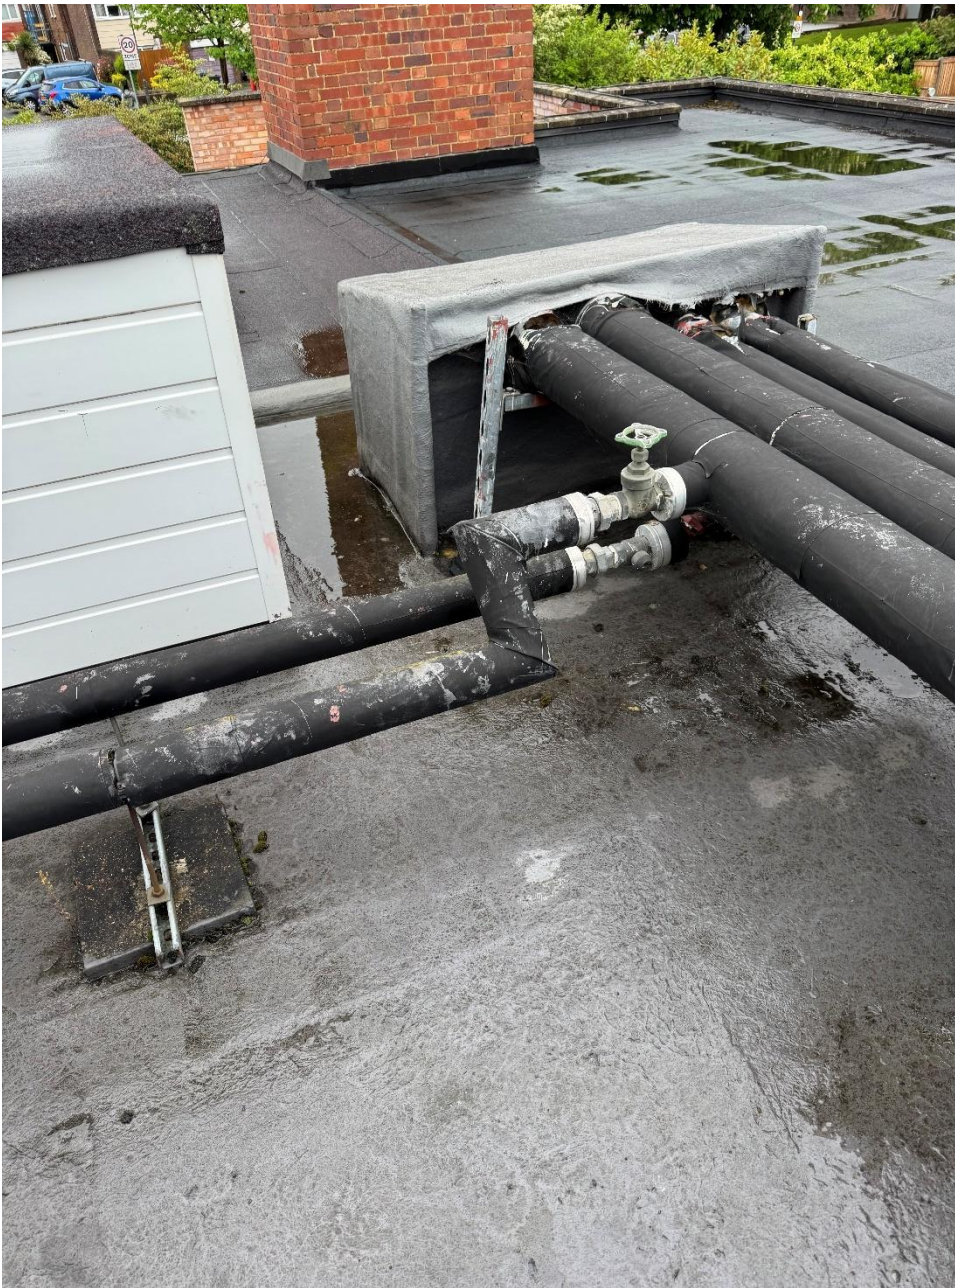
*Photograph 33 - Insulated valves feeding the main hall.*

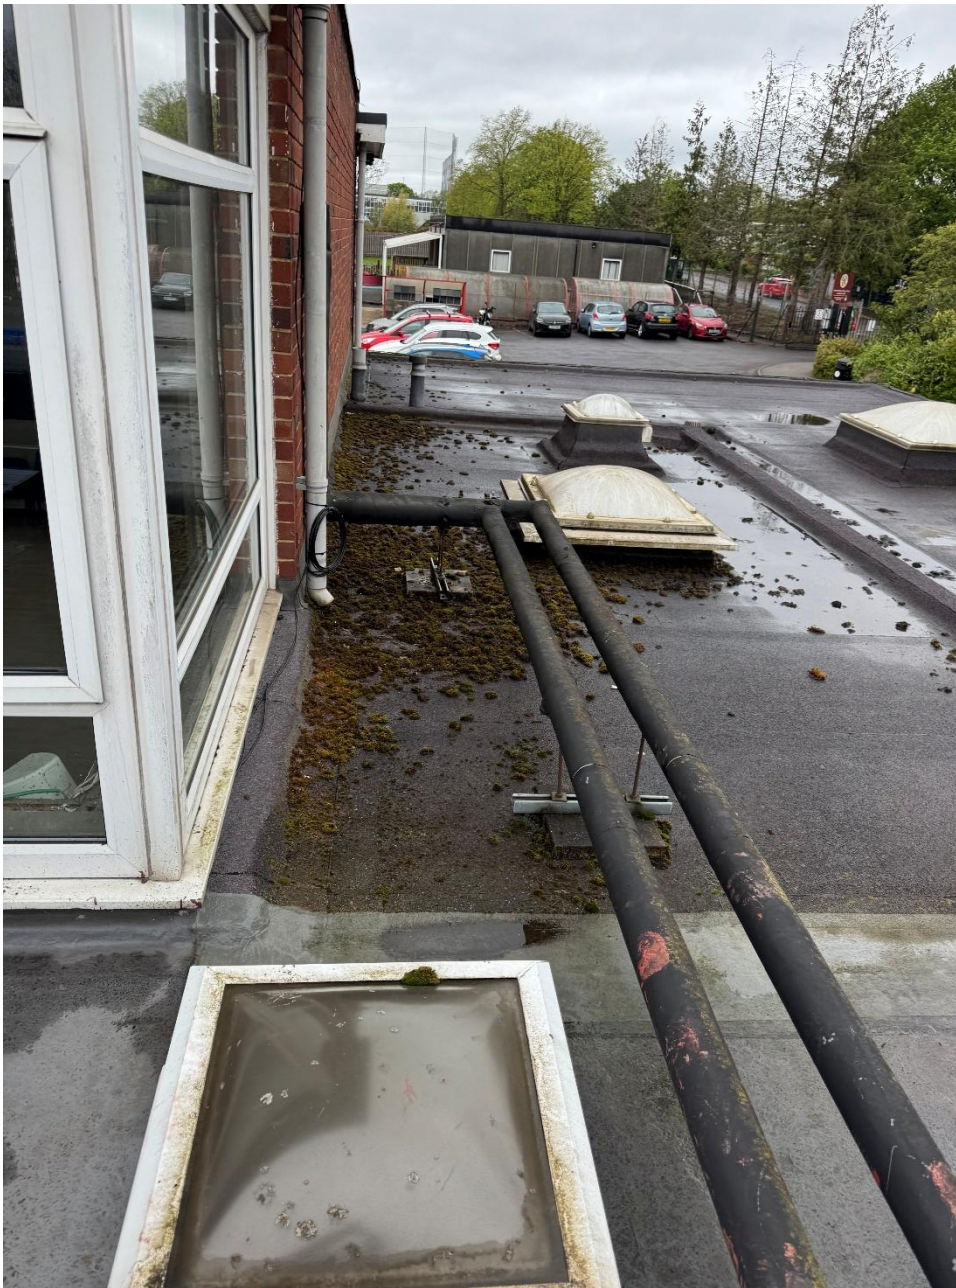
*Photograph 34 – The insulation appeared to be in poor condition.*

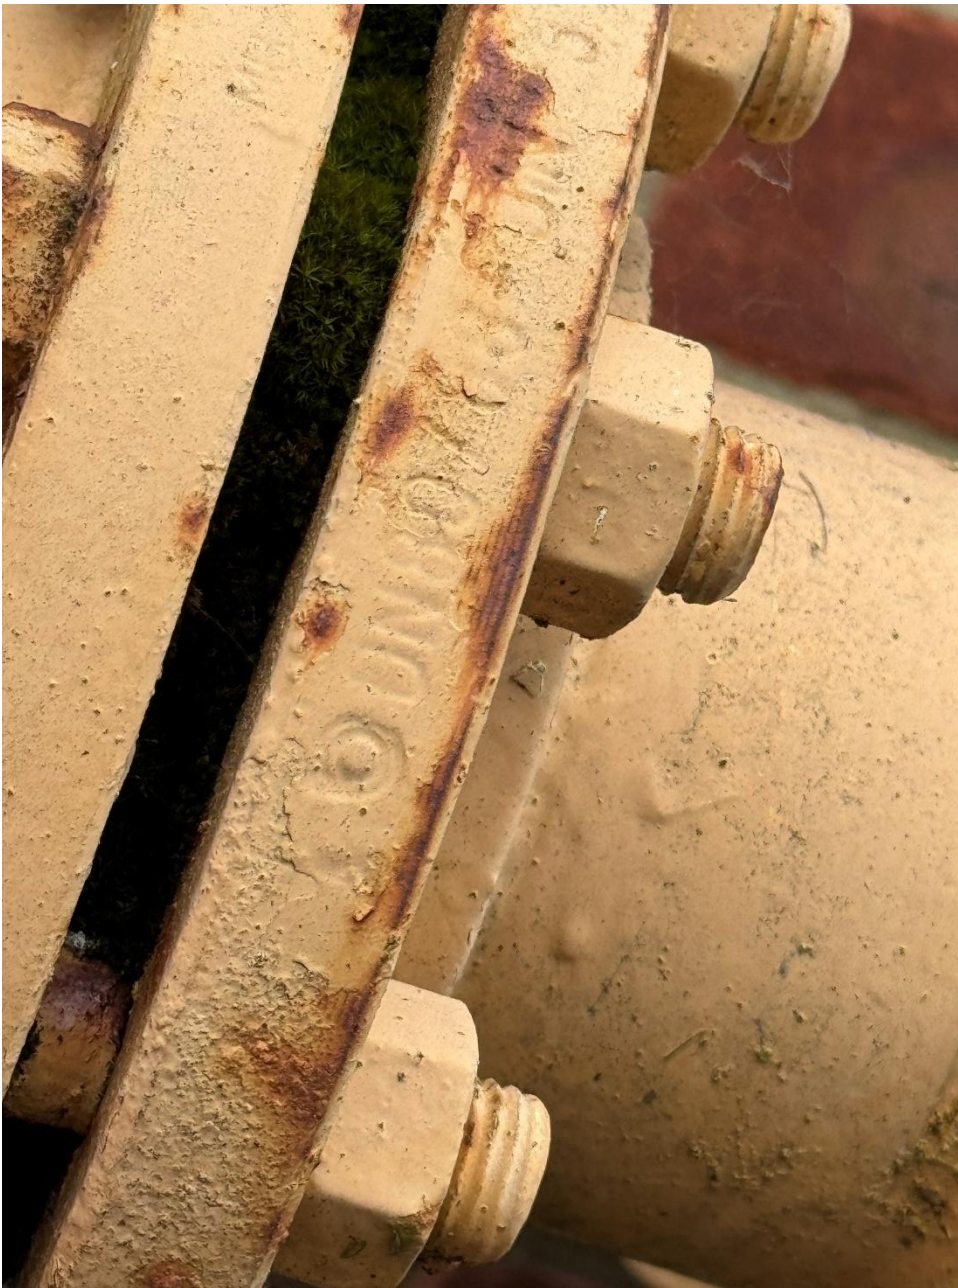
*Photograph 35 – Gas supply pipe size of DN80.*

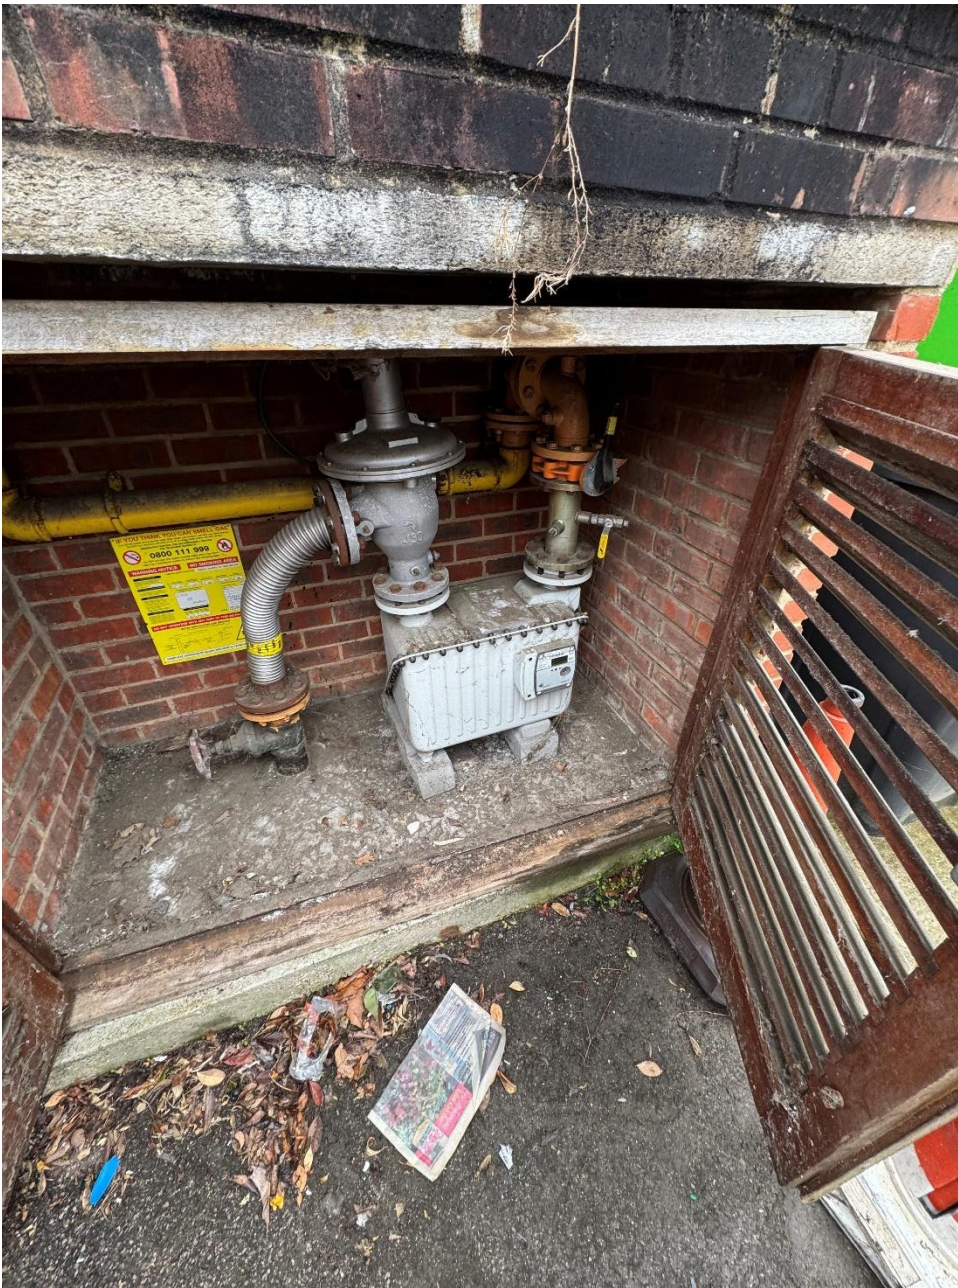
*Photograph 36 – The gas meter location.*
