# Scope of Works – MEP System Upgrade

## West Wimbledon Primary School

Prepared for McBains

*12 June 2025*

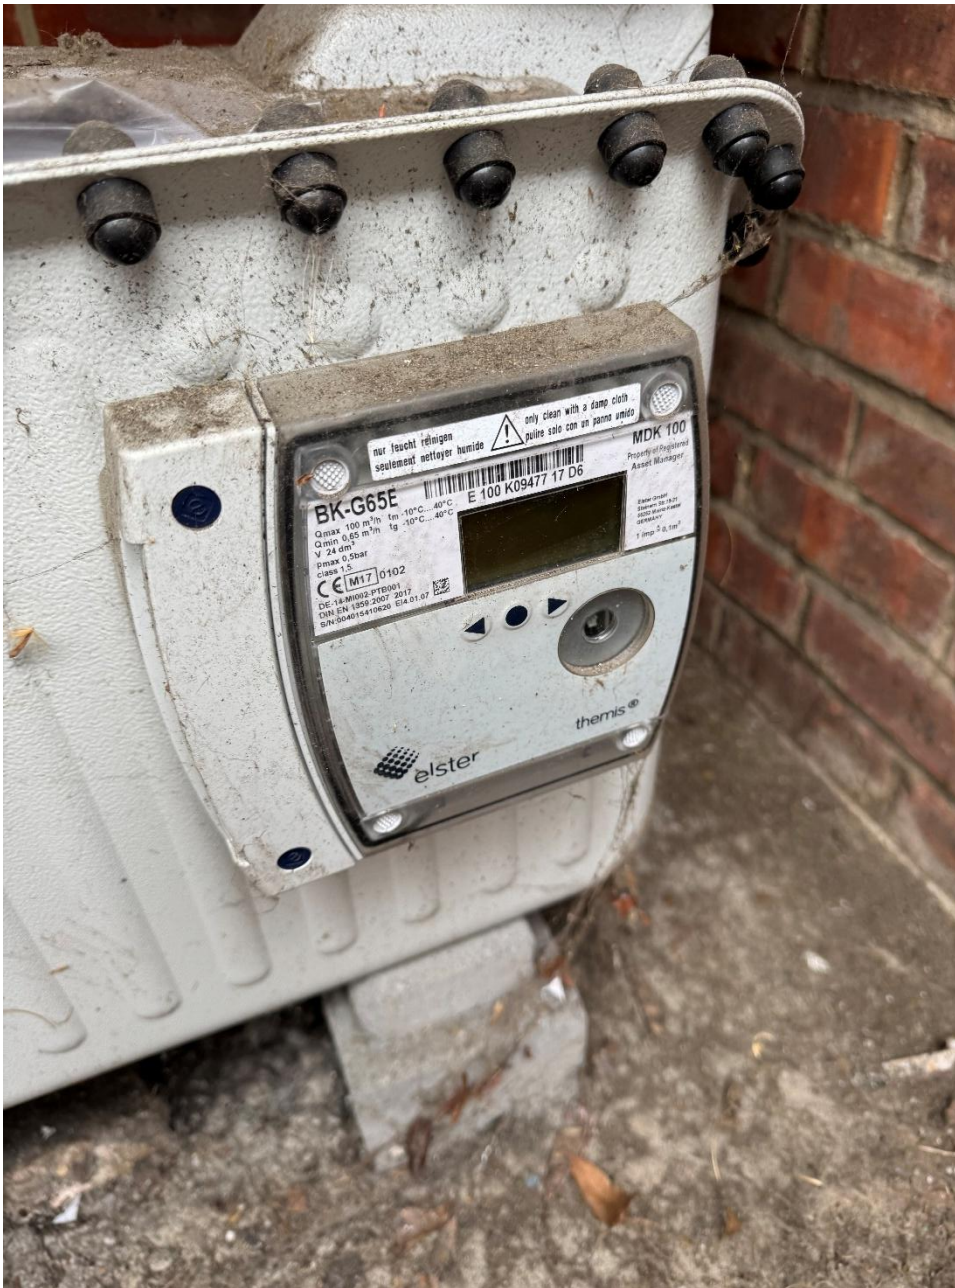
Photograph 37- Gas meter a G65.

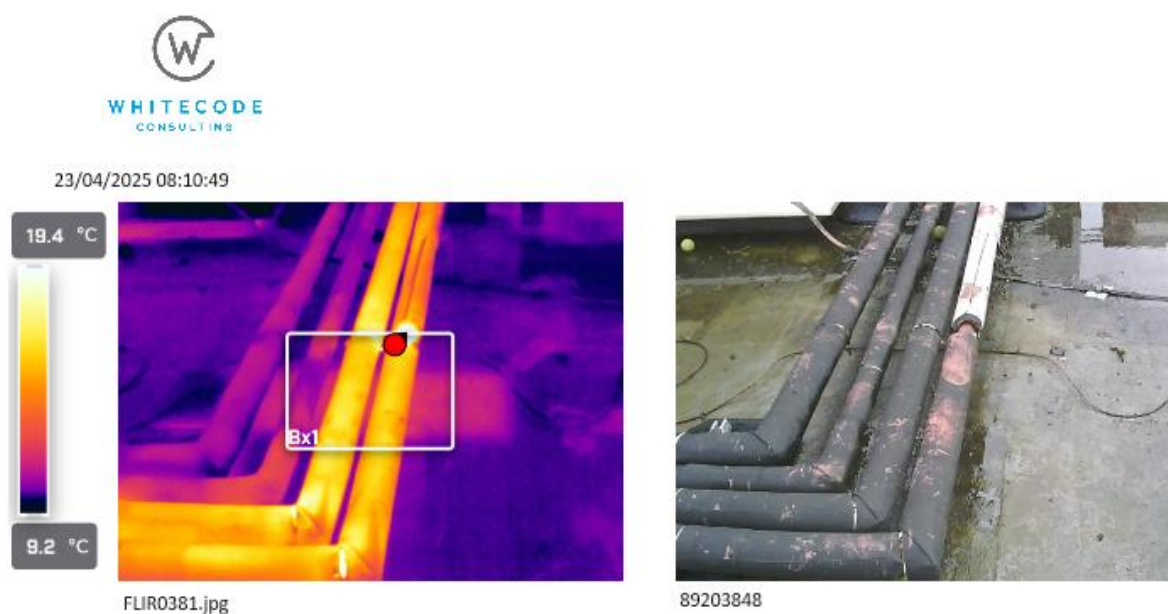
Image 1 - Insulation on the roof has failed.

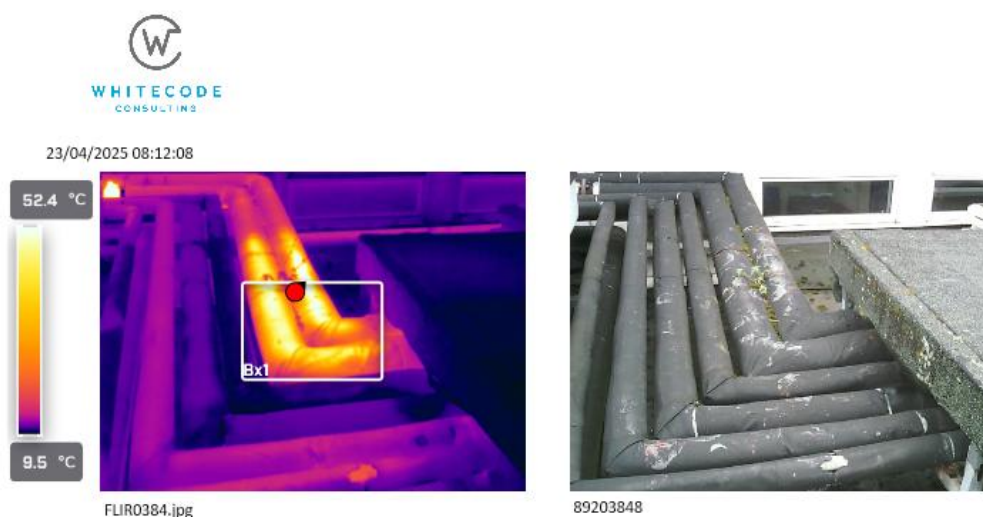
Image 2 - Insulation on the roof has failed.

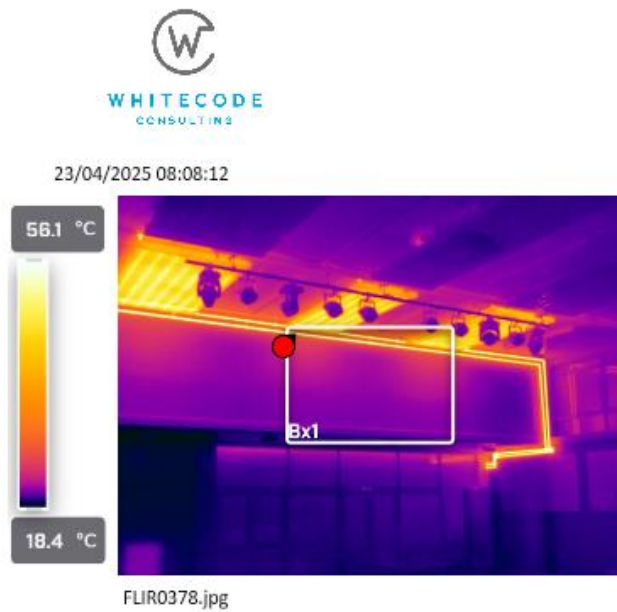
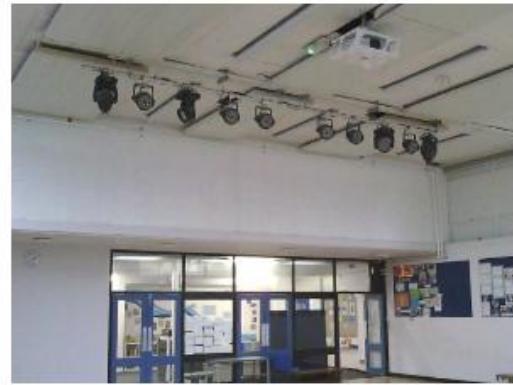
Image 3 – Only 25% of the radiant panels are operational

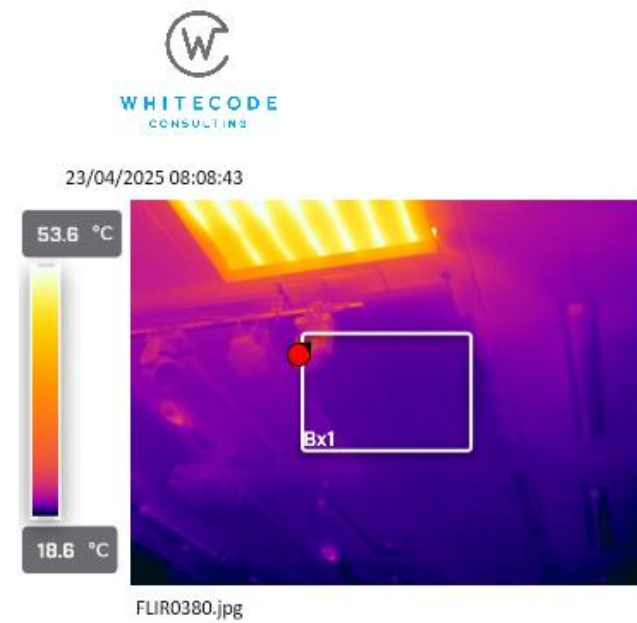
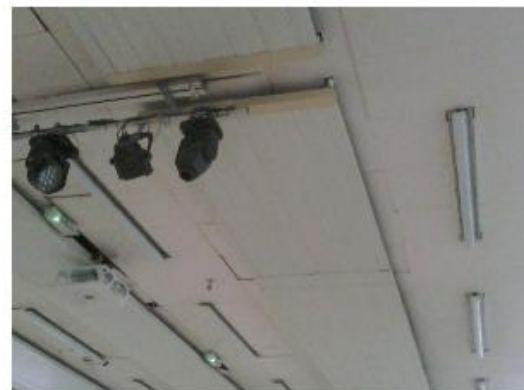
Image 4 – Only 25% of the radiant panels are operational
