14 April, 2025

LEGIONELLA RISK ASSESSMENT

West Wimbledon Primary School

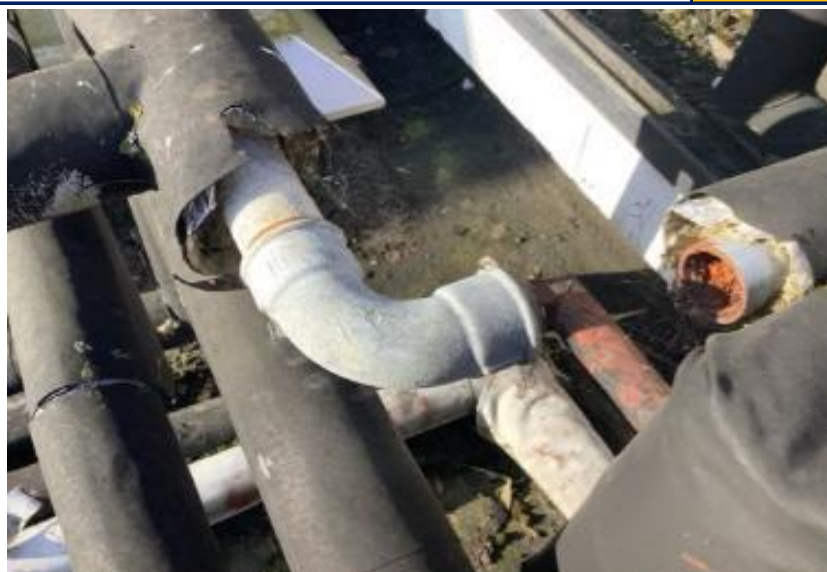
Action Required:	Applies to:	Priority:	Action Complete:
Hot & Cold Water Services	Matters of Concern		
Capped pipe on roof		MEDIUM	
Dead leg A capped pipe was noted on the roof. This appears to be a former down service pipe. This will form a dead leg on the associated service. All dead legs have the potential to harbour bacteria.			
Remove All dead legs and redundant pipe work should be removed back to the active system, with all actions recorded. This is of particular importance due to the pipe work material, as mentioned above.

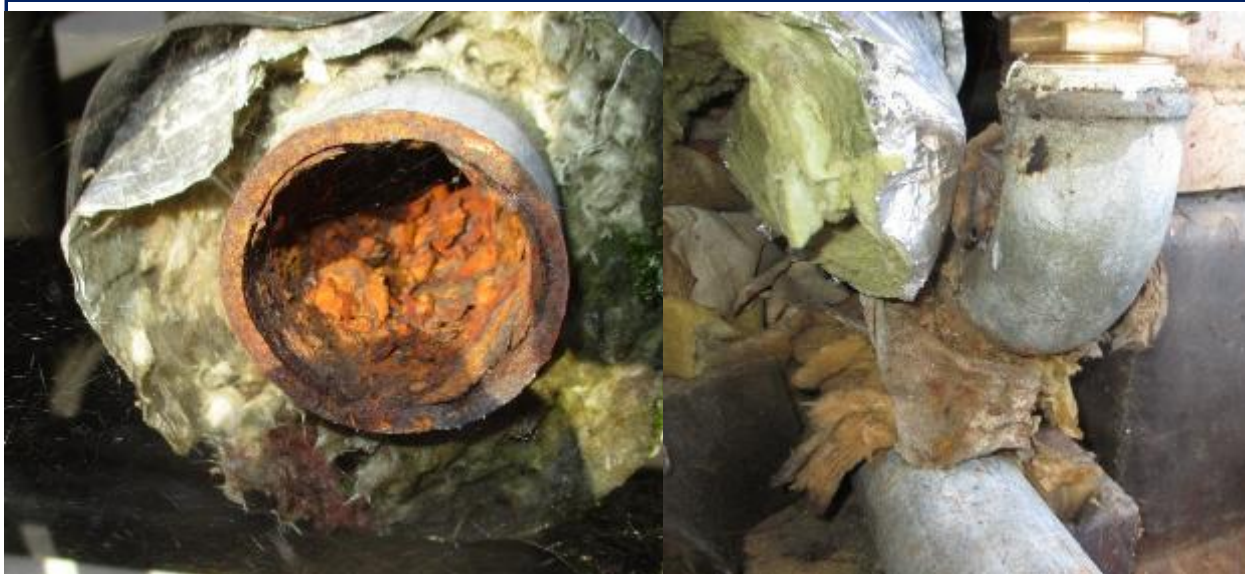
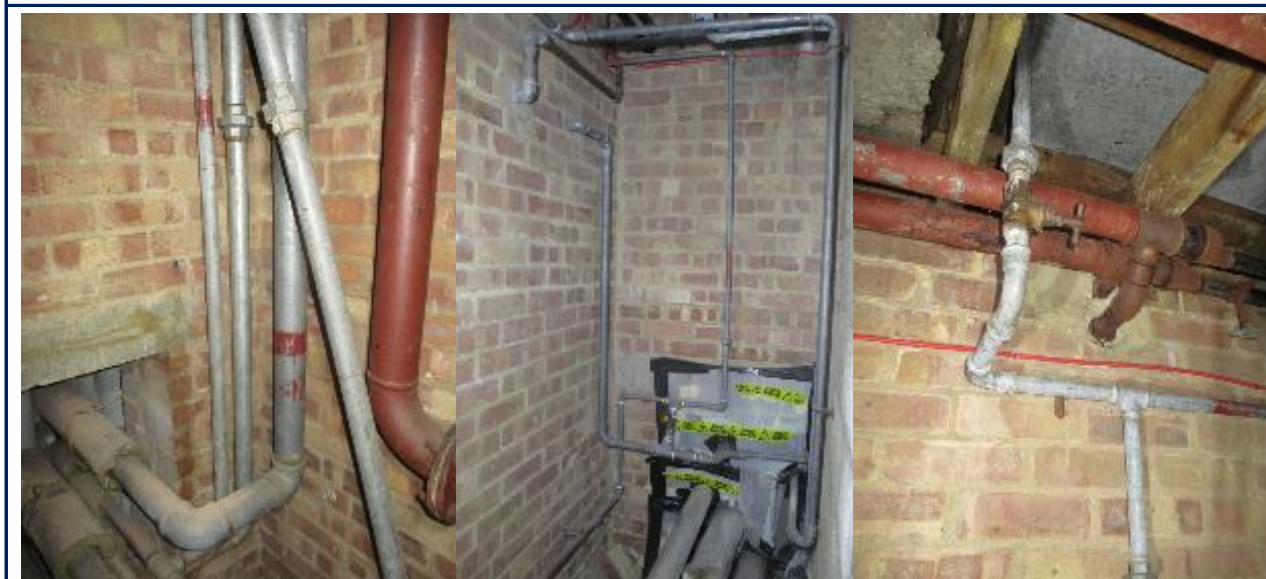
Action Required:	Applies to:	Priority:	Action Complete:
Hot & Cold Water Services	Matters of Concern		
Pipe work and materials		MEDIUM	
Much of the pipe noted on site is of galvanized steel. This material is prone to deteriorate with age, with corrosion deposits providing a nutrient source for bacteria and creating a habitat favouring the proliferation of bacteria. The poor internal surfaces can be colonised by bacteria which then form a biofilm and can be difficult to remove by disinfection.			
Regular flushing and sampling will help to minimise a potential contamination risk. A programme of refurbishment, in conjunction with removing redundant services may be advisable, particularly if sampling results indicate poor conditions. Discoloured water was seen at several outlets across site.

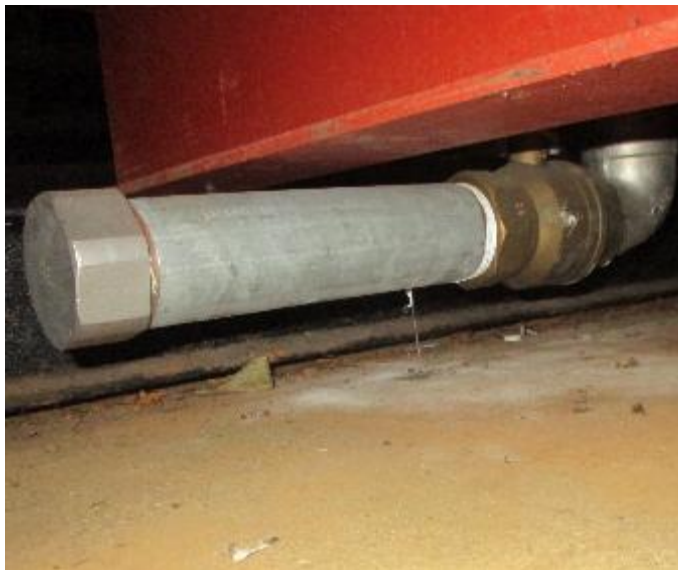
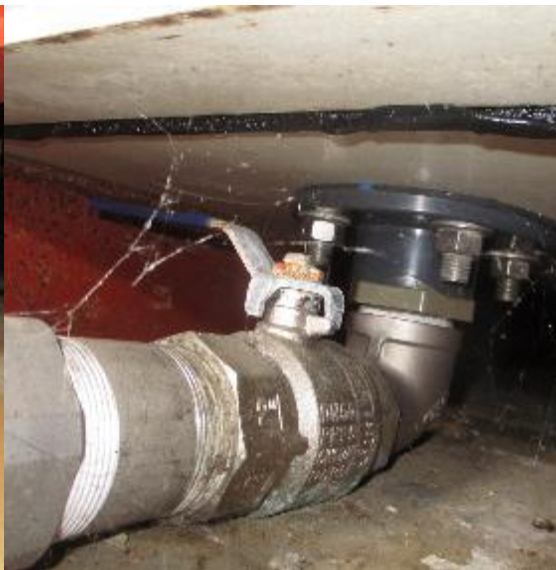
Action Required:	Applies to:	Priority:	Action Complete:
Hot & Cold Water Services	Matters of Concern		
CWST drains		ON-GOING	
It should be noted that drains have been installed on the tank bases that provide a useful facility. An isolation valve has been installed under the tank, close to the connection, but there is still a small dead leg existing.			
All dead legs, however small have the potential to harbour bacteria. Regular flushing of this for a few seconds weekly will reduce the risk from dead leg effects and may also help to reduce sediment levels. All actions should be recorded.

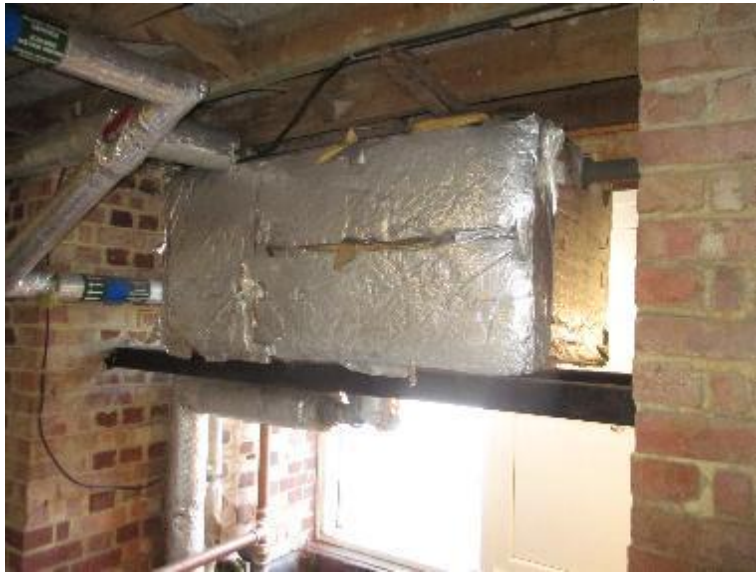
Action Required:	Applies to:	Priority:	Action Complete:
Hot & Cold Water Services	Matters of Concern		
Feed and Expansion Tank		LOW	
Some water supplies are, by their very nature, seldom used. The mains cold water feed to the LTHW should be rarely used providing the system is operating satisfactorily			
In such cases, it is recommended that some form of backflow protection is fitted as close as possible to the normally active supply to reduce any dead leg effects.

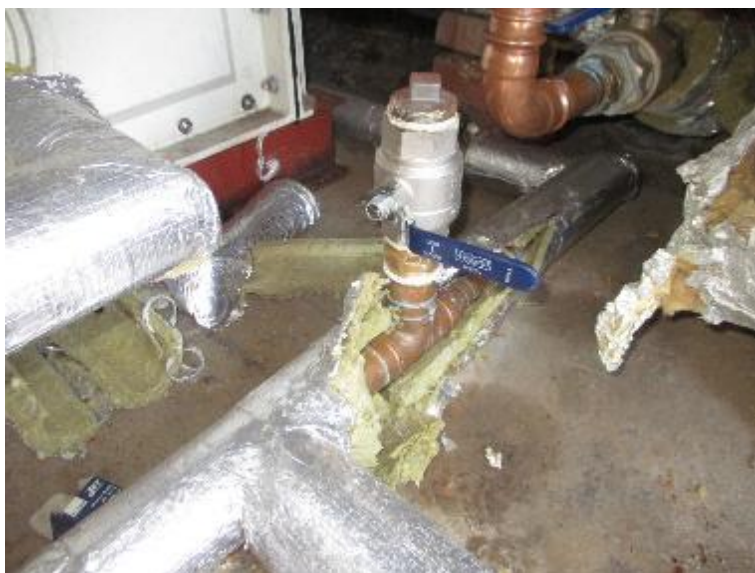
Action Required:	Applies to:	Priority:	Action Complete:
Hot & Cold Water Services	Matters of Concern		
Capped pipe		MEDIUM	
A capped pipe was noted in the tank room on the down service from CWST 1&2. This will create a dead leg on the associated pipe work. All dead legs have the potential to harbour bacteria.			
All dead legs and redundant pipe work should be removed back to the active system, with all actions recorded.

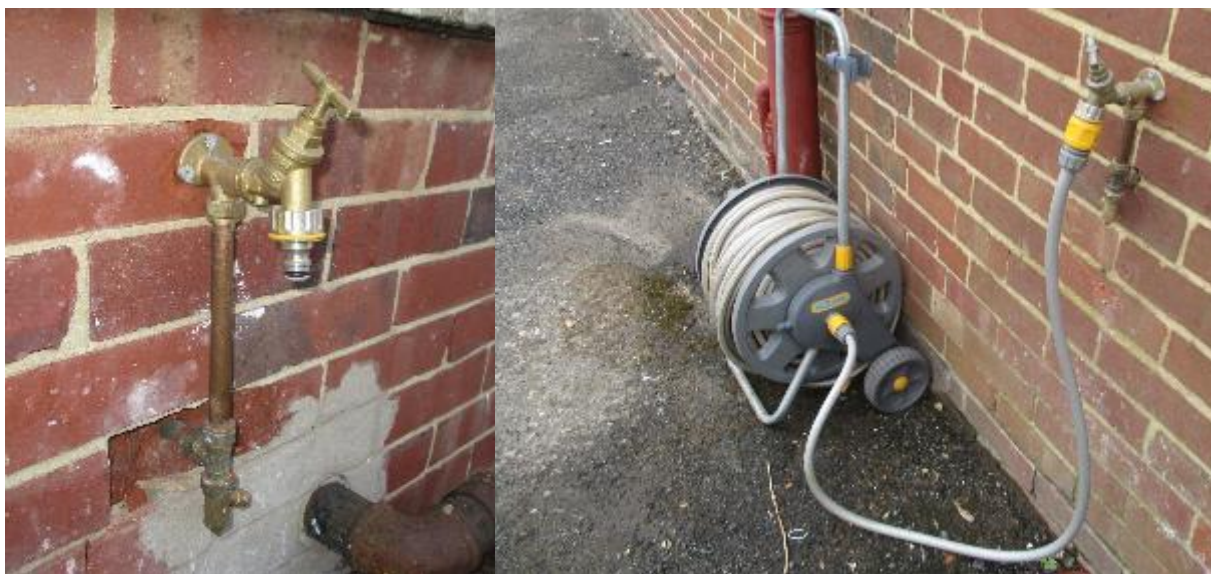
Action Required:	Applies to:	Priority:	Action Complete:
Hot & Cold Water Services	Matters of Concern		
Outside bib taps		ON-GOING	
Bib taps are often subject to seasonal variation in use.			
As such they should be included in a flushing and monitoring regime, or a suitable backflow prevention should be installed at the base of the branch serving the outlet. Where hoses are attached & coiled, care should be taken to not generate spray as the hose may have lain dormant for some time increasing the risk of bacteria build-up.

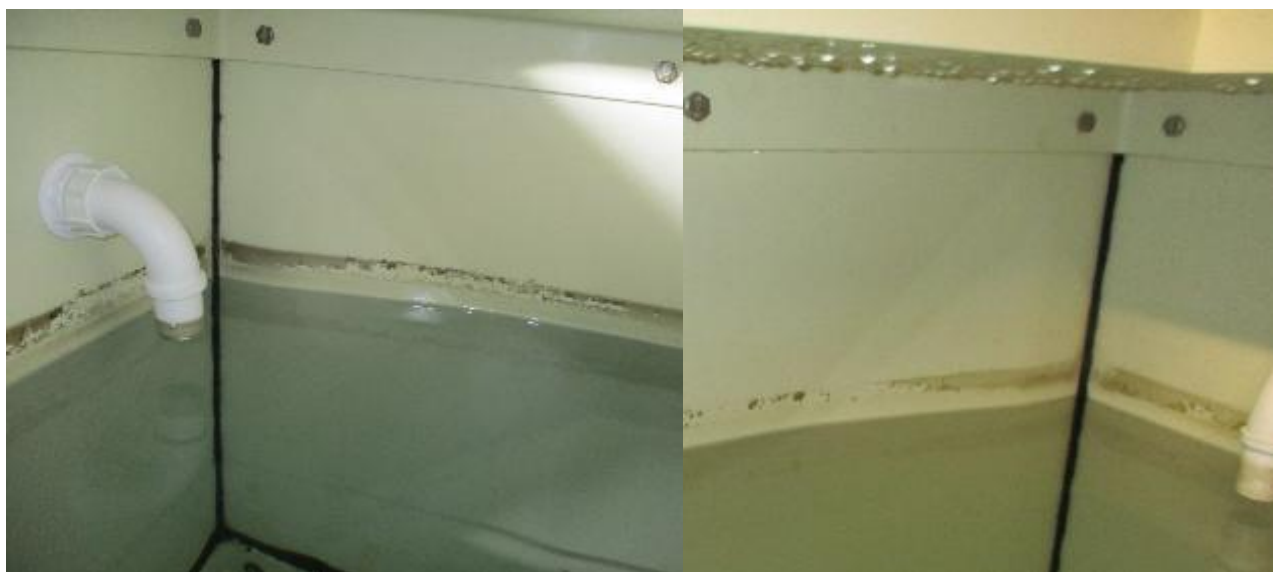
Action Required:	Applies to:	Priority:	Action Complete:
Hot & Cold Water Services	Matters of Concern		
Tank Capacity and Balance		ON-GOING	
A film was noted on the tank sides at the waterline. This suggests a low turnover of water and/or that one tank of each pair is taking most of the demand. At the time of our survey it was noted that only tank of each pair was engaging.			
Often with two or more tanks one will engage before the other with the second tank only engaging during high demand, if at all. Careful monitoring and balancing of the tank is recommended. An enhanced flushing programme should be enacted during the school holidays, particularly in the summer.

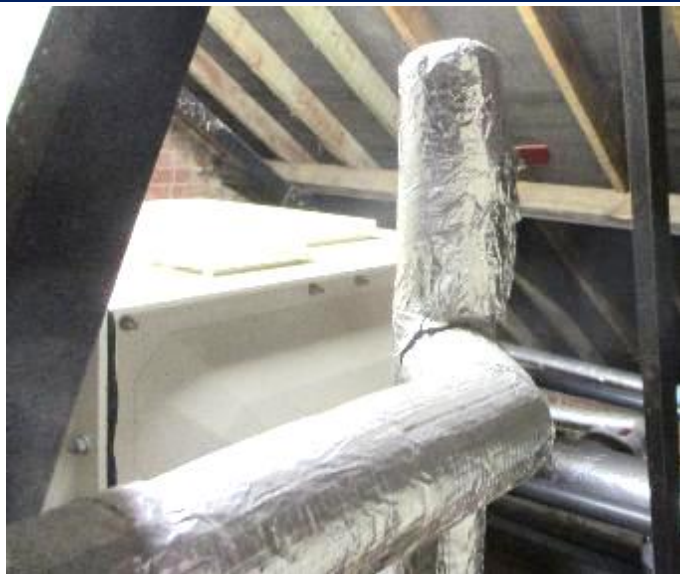
Action Required:	Applies to:	Priority:	Action Complete:
Hot & Cold Water Services	Matters of Concern		
Loft tank room vent		MEDIUM	
A capped branch was noted in the RH tank loft, possibly for venting the system. This will form a dead leg on the associated pipe work, with the potential to harbour bacteria.			
All dead legs and redundant pipe work should be removed back to the active system, with all actions recorded. Alternatively, the branch should be flushed through at least weekly, with all actions recorded.

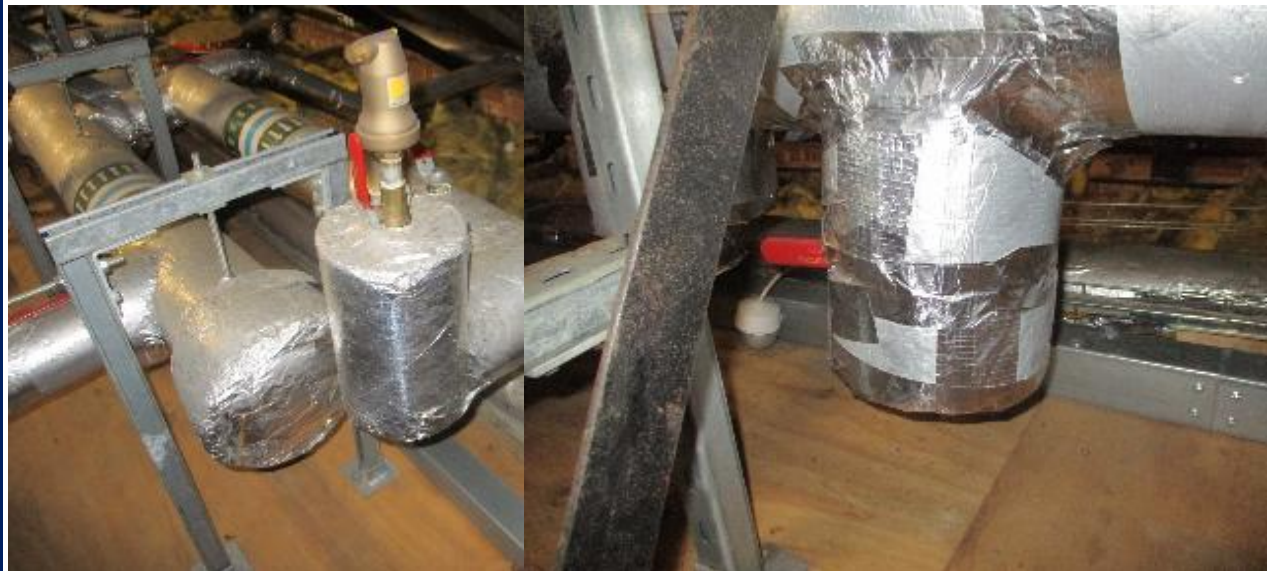
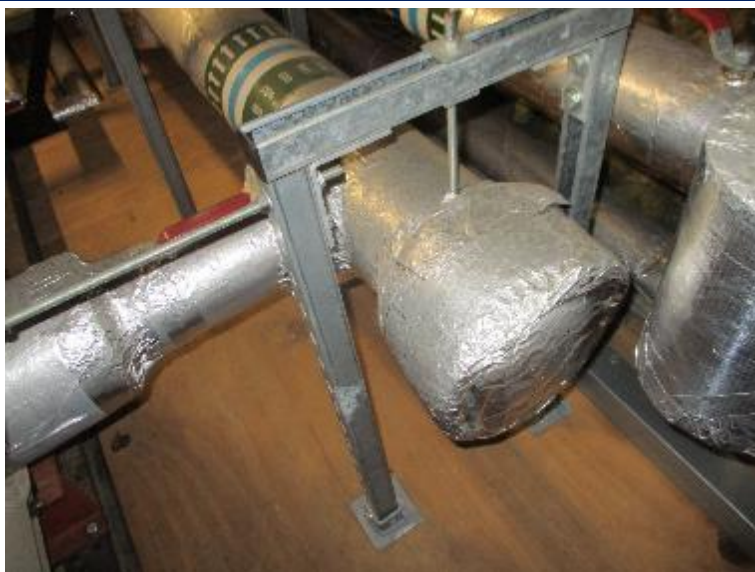
Action Required:	Applies to:	Priority:	Action Complete:
Hot & Cold Water Services	Matters of Concern		
RH loft dead leg		MEDIUM	
Dead legs were noted on the down service and on the tank outlet manifold in the RH tank loft. The dead legs have the potential to harbour bacteria.			
All dead legs, however small have the potential to harbour bacteria. If removal of the dead legs is impractical, then flushing should be carried out at least weekly.

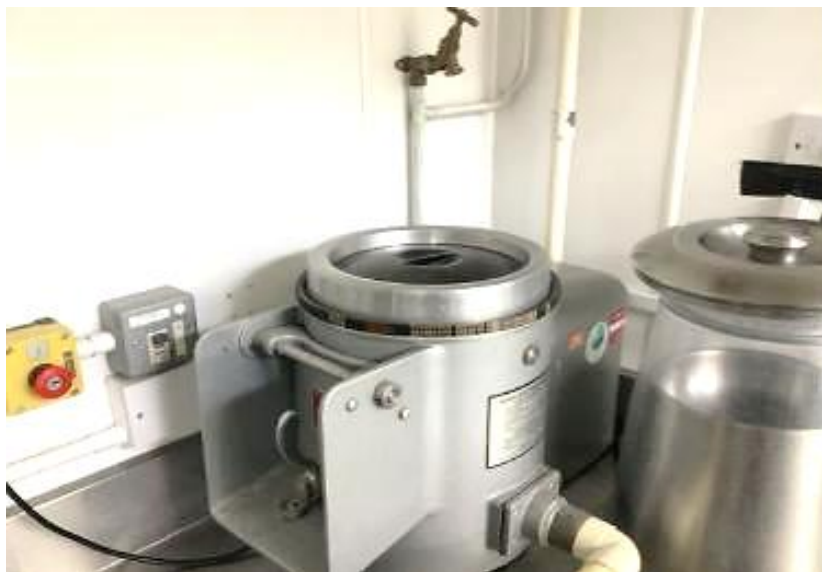
Action Required:	Applies to:	Priority:	Action Complete:
Hot & Cold Water Services	Matters of Concern		
Connected equipment		MEDIUM	
A potato peeler is connected to a bib tap in the main kitchen.			
All connected equipment and appliances should have adequate backflow protection, either in the appliance itself, or the connection point. It should be ensured that all outlets with connected equipment are not left idle, they should be flushed through regularly.

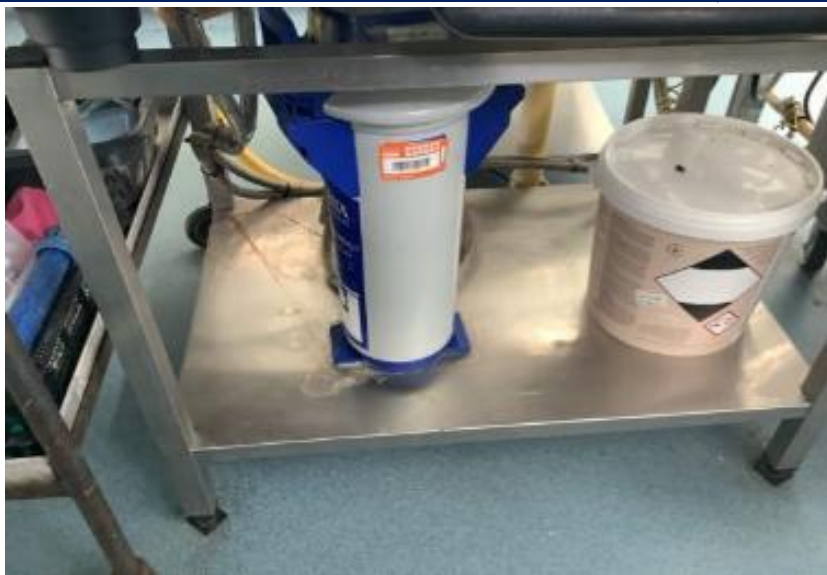
Action Required:	Applies to:	Priority:	Action Complete:
Hot & Cold Water Services	Matters of Concern		
Filters conditioners		ON-GOING	
Filters/conditioners were noted on site in the main kitchen.			
The very purpose of these is to trap debris, which can provide a harbour and nutrient source for bacteria proliferation. Filters and conditioners should be checked regularly and cleaned/serviced or replaced according to manufacturer's instructions. All actions should be recorded in the site log book.

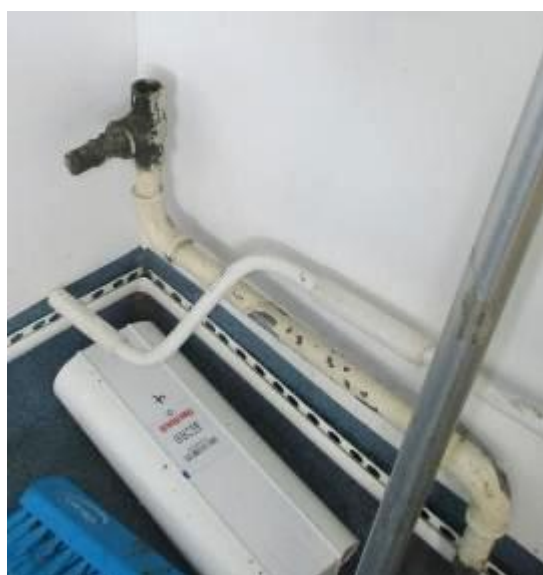
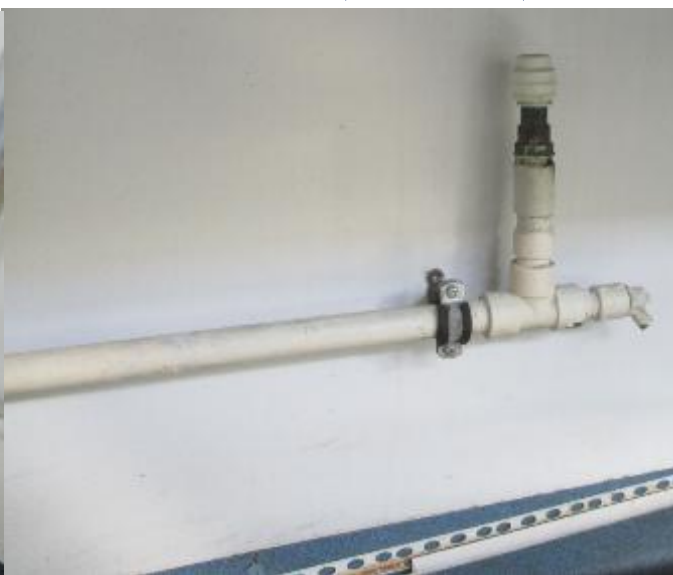
Action Required:	Applies to:	Priority:	Action Complete:
Hot & Cold Water Services	Matters of Concern		
Capped pipes in kitchen		MEDIUM	
Capped pipe were noted in the main kitchen. These will create dead legs on the associated pipe work, with the potential to harbour bacteria.			
All dead legs and redundant pipe work should be removed back to the active system, with all actions recorded

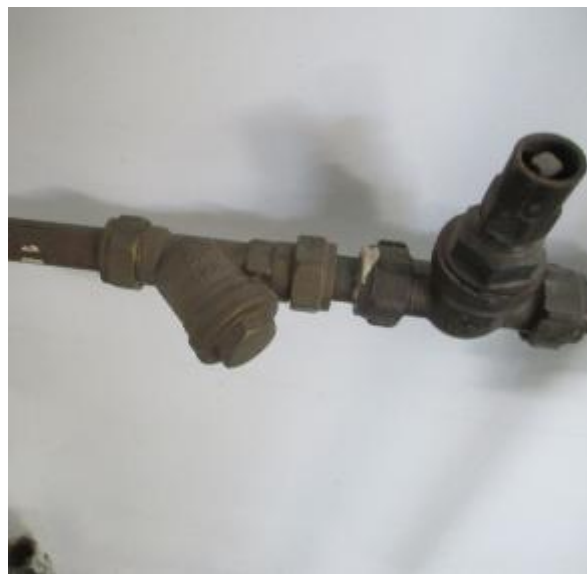
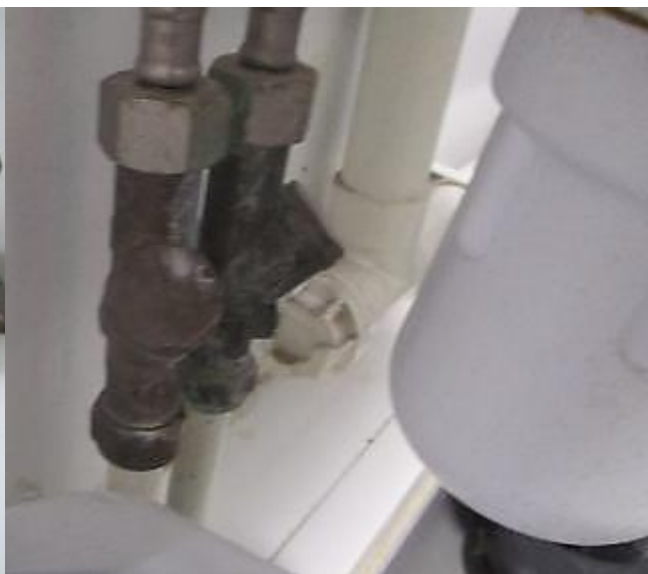
Action Required:	Applies to:	Priority:	Action Complete:
Hot & Cold Water Services	Matters of Concern		
Strainers		ON-GOING	
Strainers Were noted on the supplies to the integrated thermostatic taps and in the main kitchen. Filters and strainers are designed to trap debris, which can then provide a harbour and nutrient source for bacteria.			
All strainers should be checked and cleaned regularly according to the rate of fouling. All actions should be recorded.

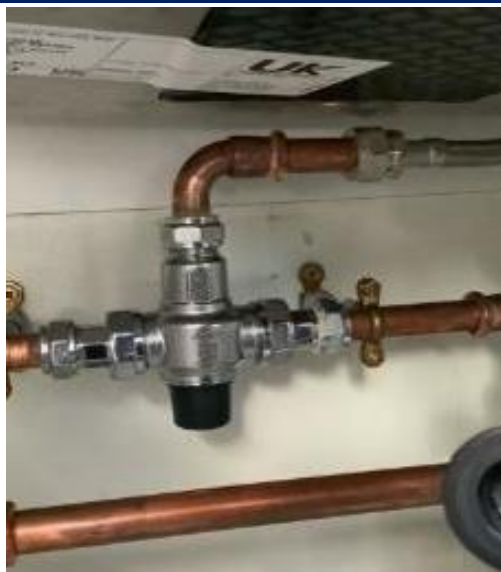
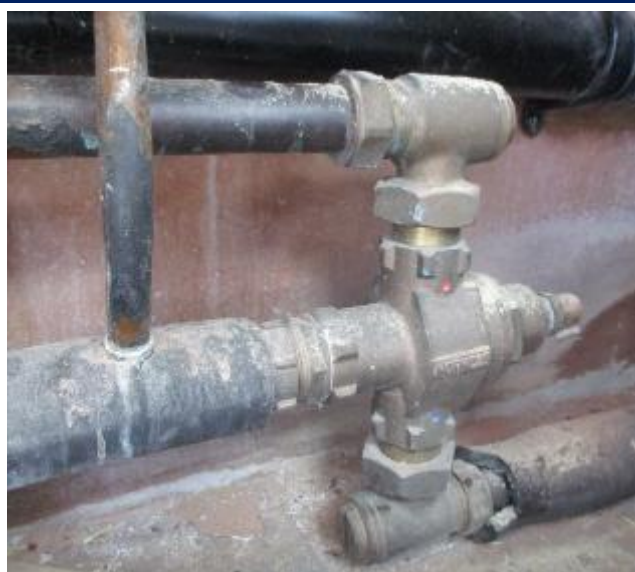
Action Required:	Applies to:	Priority:	Action Complete:
Hot & Cold Water Services	Matters of Concern		
Thermostatic Mixing Valves Access		ON-GOING	
The majority of DHWS outlets on site are regulated via Thermostatic Mixing Valves. Many of the TMVs are concealed. Some T.M.V.s do not have local isolation. Valves are required to enable servicing and safety checks.			
Adequate access is required for temperature monitoring, servicing and cleaning of the units. Regular servicing and safety checks of TMV's will ensure that safety is maintained, as well as removing the build-up of scale, as this may reduce flow capacity.

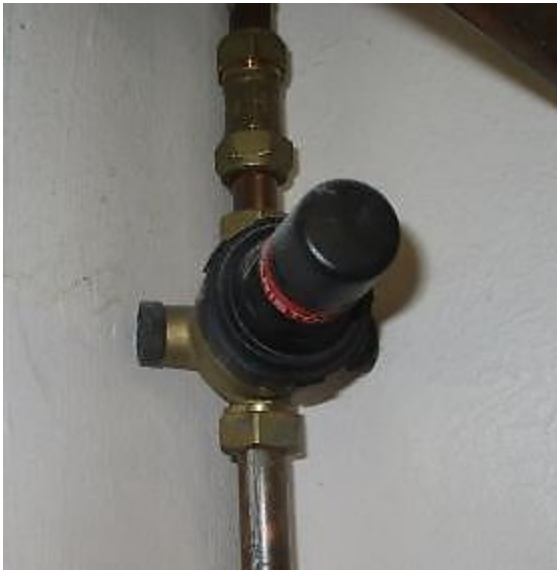
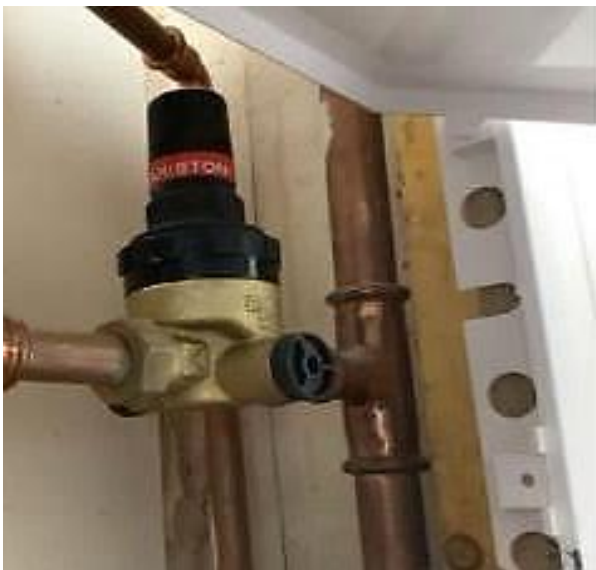
Action Required:	Applies to:	Priority:	Action Complete:
Hot & Cold Water Services	Matters of Concern		
Pressure Reducing Valves		ON-GOING	
Pressure reducing valves were noted on site.			
All Pressure reducing valves require an annual service. It should be ensured that the correct valve layout is in place to allow for these ongoing maintenance works. All actions should be recorded in the site log.

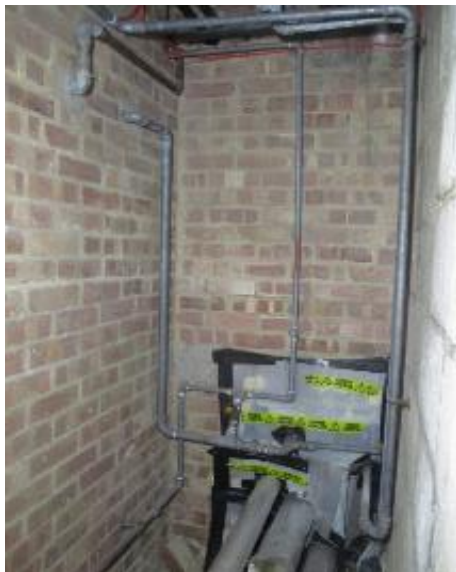
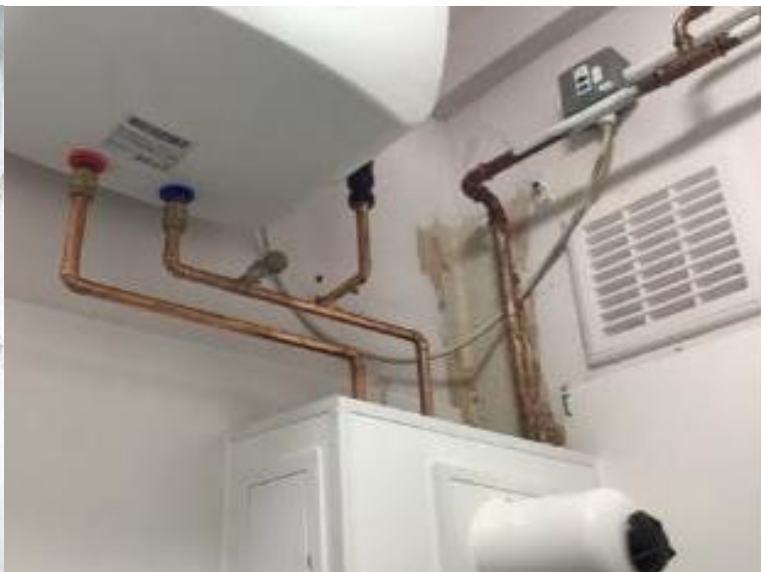
Action Required:	Applies to:	Priority:	Action Complete:
Hot & Cold Water Services	Matters of Concern		
Missing insulation and labelling.		LOW	
It was noted that much of the pipe work across site was not insulated or labelled.			
Insulation will aid in maintaining appropriate temperature by minimising heat loss/transfer and heat gain from ambient conditions. Annual checks should be carried out to ensure all areas are insulated and labelled.

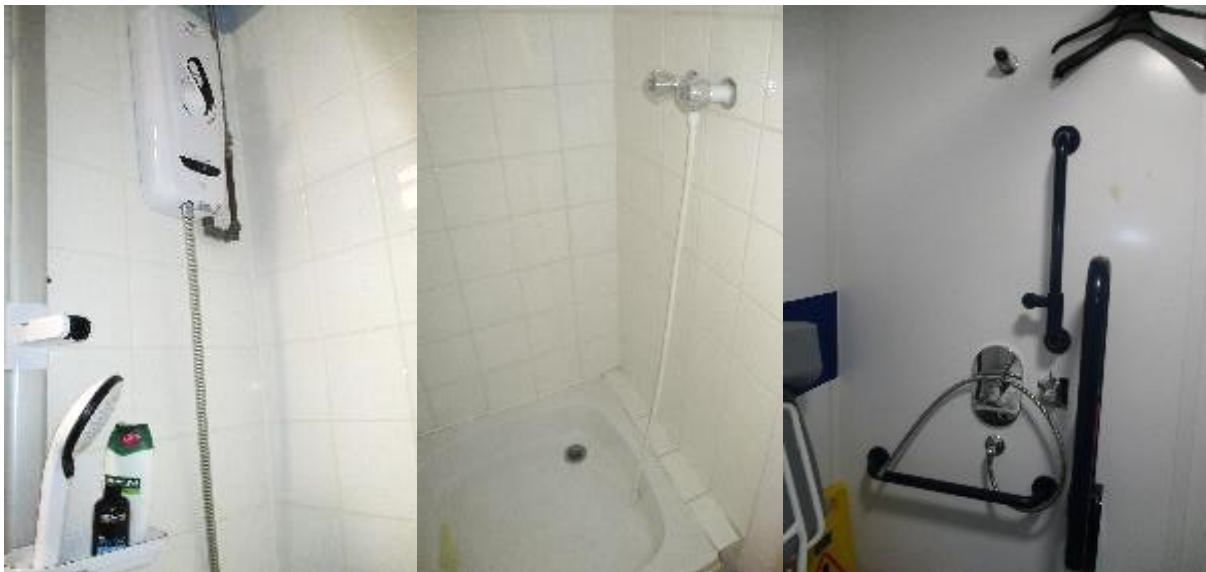
Action Required:	Applies to:	Priority:	Action Complete:
Hot & Cold Water Services	Matters of Concern		
Little Use Shower		MEDIUM	
Showers naturally create aerosols & they are considered a high risk for Legionnaires' disease. The head was removed from the shower in Female toilets 14 at the time of our survey. We were advised on site that the outlet is little used.			
Regular checks, cleaning and flushing are essential to reduce the risk to the next user; as the initial opening of the outlet may release a large amount of stagnant water. All actions should be recorded in the site log. If the outlet is deemed redundant the pipe work should be cut back to the active system.

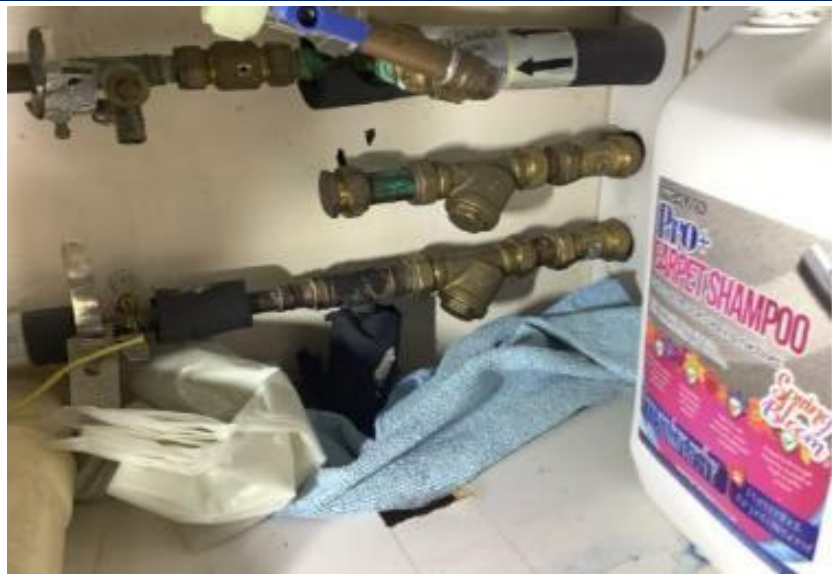
Action Required:	Applies to:	Priority:	Action Complete:
Hot & Cold Water Services	Matters of Concern		
Strainers		ON-GOING	
Strainers Were noted in the first aid room. Filters and strainers are designed to trap debris, which can then provide a harbour and nutrient source for bacteria.			
All strainers should be checked and cleaned regularly according to the rate of fouling. All actions should be recorded.

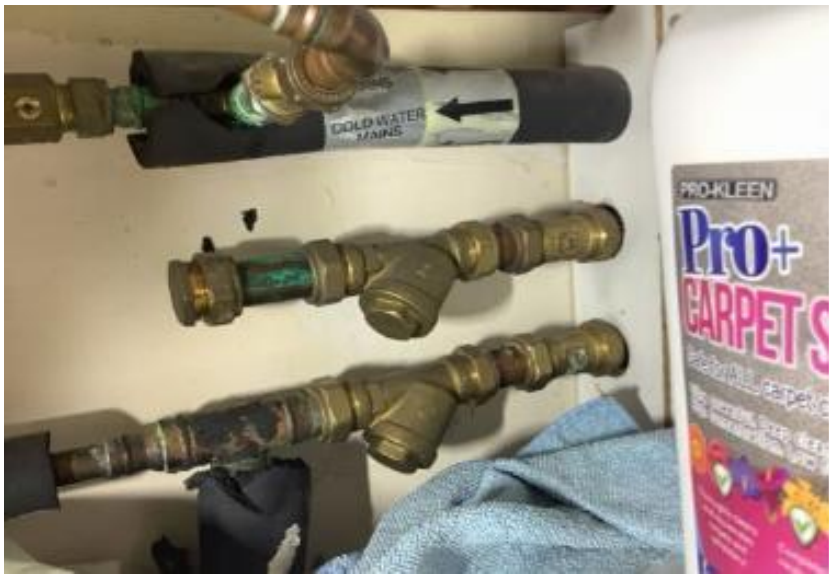
Action Required:	Applies to:	Priority:	Action Complete:
Hot & Cold Water Services	Matters of Concern		
Capped pipe		MEDIUM	
A capped pipe was noted in the first aid room under the sink. This will create a dead leg on the associated service, with the potential to harbour bacteria.			
All dead legs and redundant pipe work should be removed back to the active system, with all actions recorded.

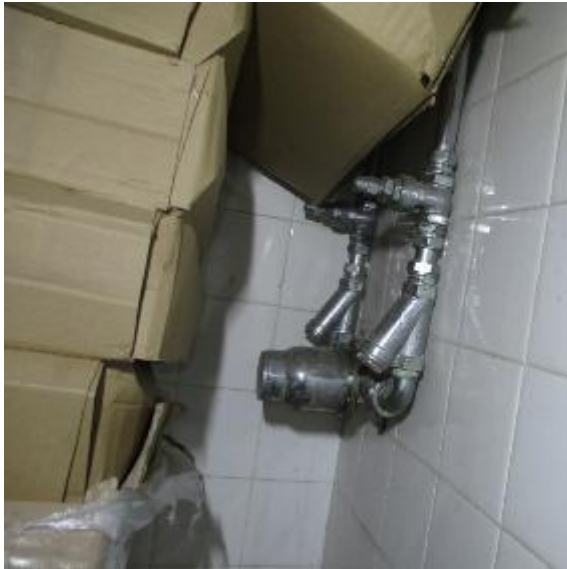
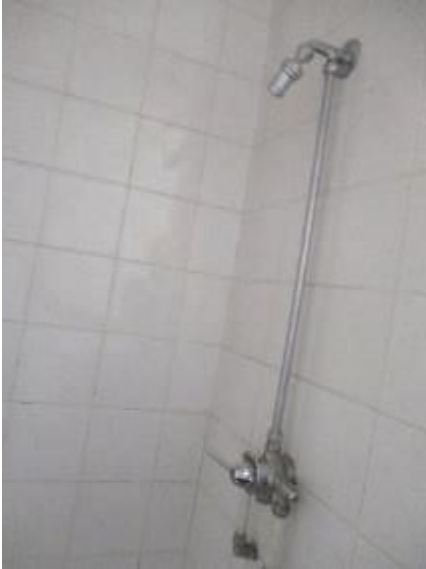
Action Required:	Applies to:	Priority:	Action Complete:
Hot & Cold Water Services	Matters of Concern		
Shower Block Disused Outlets		MEDIUM	
The "Shower Block" showers are not used and the area is used for storage. There are showers and basins in the area. This will create substantial dead legs on the associated systems, with the potential to harbour bacteria.			
All redundant pipe work should be cut back to the active system, with all actions recorded.

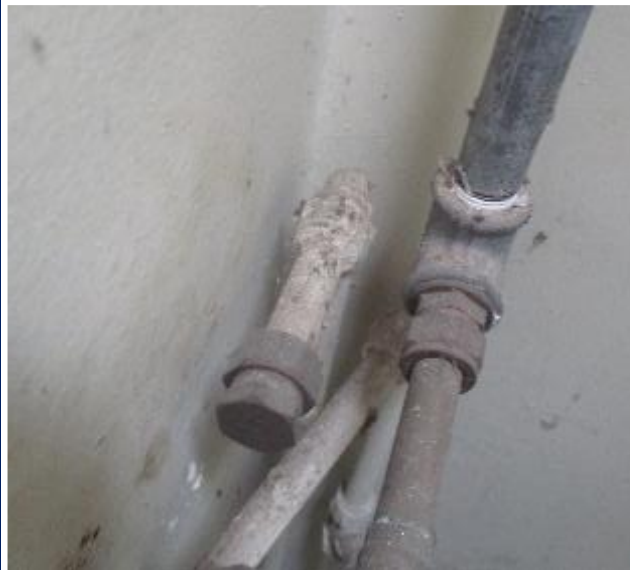
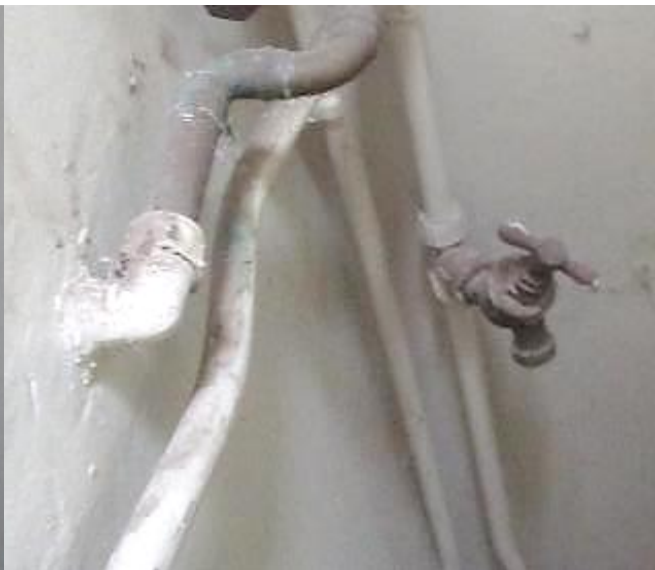
Action Required:	Applies to:	Priority:	Action Complete:
Hot & Cold Water Services	Matters of Concern		
Capped pipe and Bib Tap		MEDIUM	
A capped pipe and a bib tap were noted outside the adult toilet, adjacent the disused showers. These will create dead legs, with the potential to harbour bacteria.			
The bib tap should be included in a flushing regime. The capped pipe should be cut back to the active system. If the bib tap is deemed redundant, it to should be removed back to the active system. All actions should be recorded.

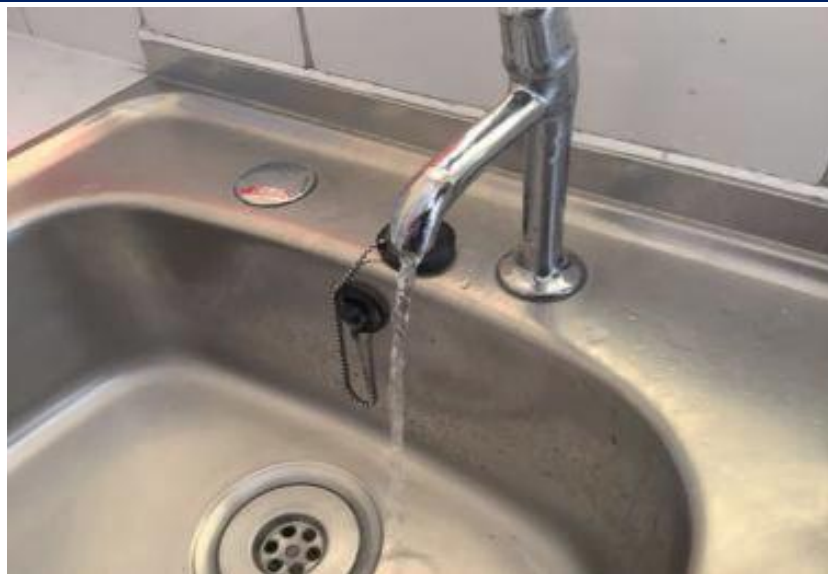
Action Required:	Applies to:	Priority:	Action Complete:
Hot & Cold Water Services	Matters of Concern		
Poor MCWS flow		MEDIUM	
Poor flow was noted from the cold water service outlet in Room 13 day care. This will create a lesser dead leg effect, as the pipe work will not be flushed through in normal use. Additionally the outlet may be shunned in favour of another.			
The flow deficiency should be investigated and rectified as soon as possible. All actions should be recorded in the site log book.

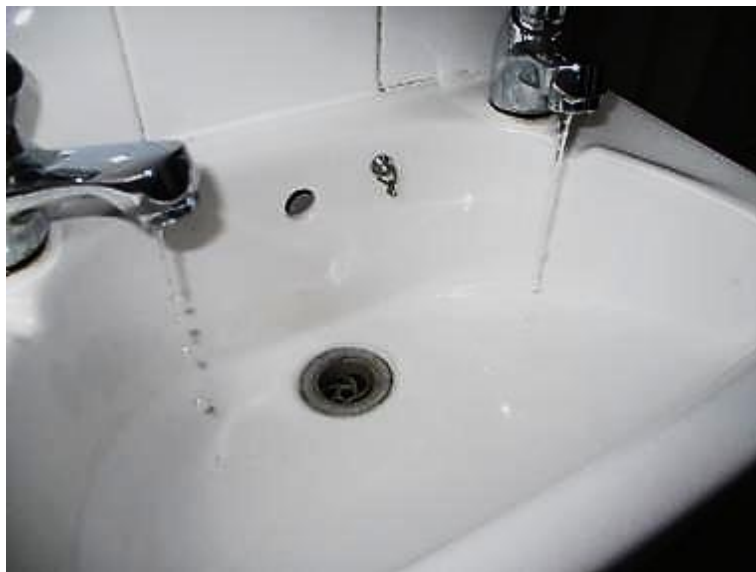
Action Required:	Applies to:	Priority:	Action Complete:
Hot & Cold Water Services	Matters of Concern		
Poor flow		MEDIUM	
Poor flow was noted from the outlets in Male toilet 14e. This will create a lesser dead leg effect, as the pipe work will not be flushed through in normal use. Additionally the outlets may be shunned in favour of another.			
The flow deficiency should be investigated and rectified as soon as possible. All actions should be recorded in the site log book.

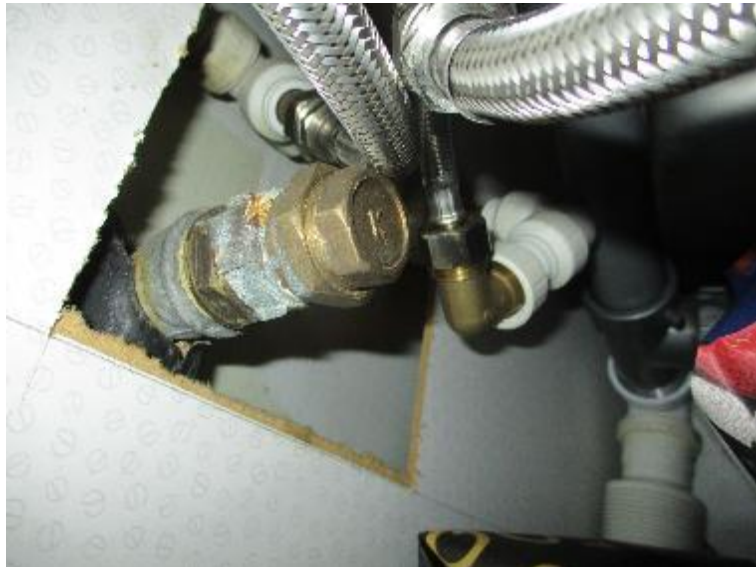
Action Required:	Applies to:	Priority:	Action Complete:
Hot & Cold Water Services	Matters of Concern		
Capped pipe Staff Room		MEDIUM	
A capped pipe was noted in the staff room on the first under the sink. This will create a dead leg on the associated service, with the potential to harbour bacteria.			
All dead legs and redundant pipe work should be removed back to the active system, with all actions recorded.

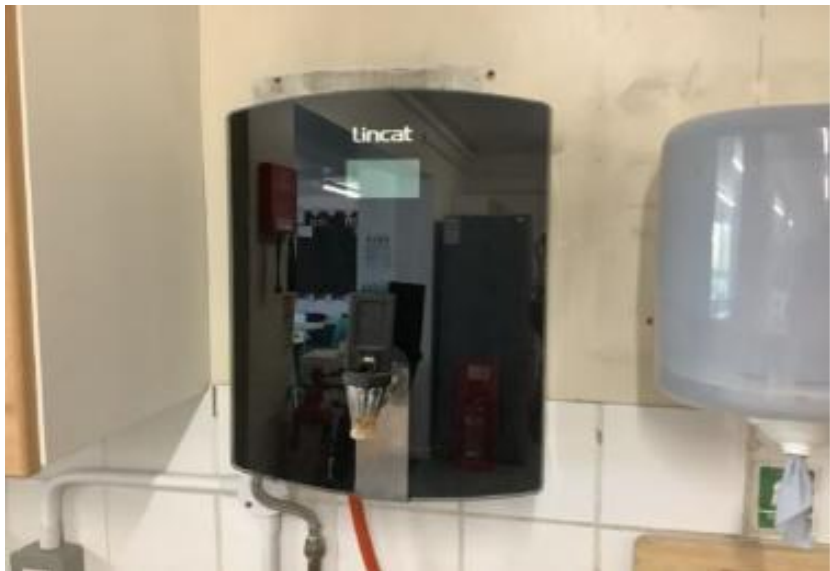
Action Required:	Applies to:	Priority:	Action Complete:
Hot & Cold Water Services	Matters of Concern		
Drinks Vending Machines		ON-GOING	
Drinks vending machines, producing boiling and chilled water, are installed in the On Site..			
The machines should be serviced and maintained according to the manufacturer's instructions, with all actions recorded.

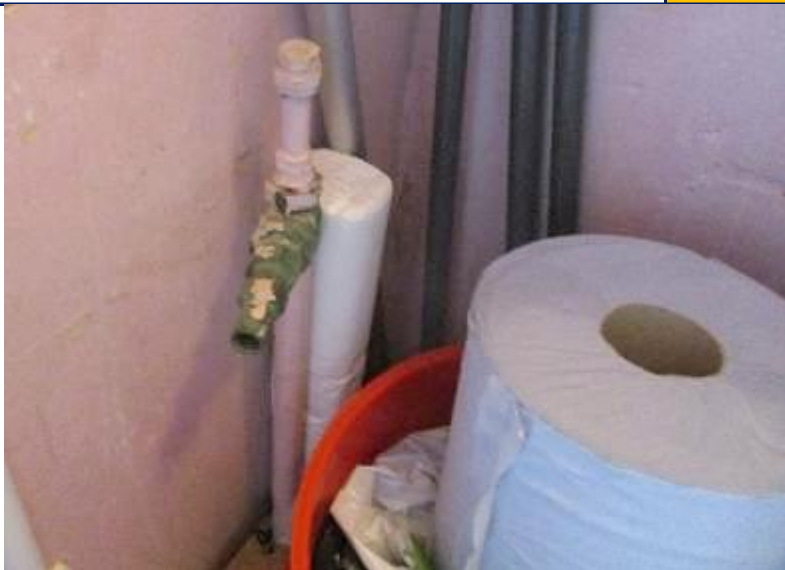
Hot & Cold Water Services	Matters of Concern		
Capped pipe		MEDIUM	
A capped pipe was noted in the cleaners cupboard in cleaners in female toilet 76 on the first floor. This will create a dead leg on the associated service, with the potential to harbour bacteria.			
All dead legs and redundant pipe work should be removed back to the active system, with all actions recorded.

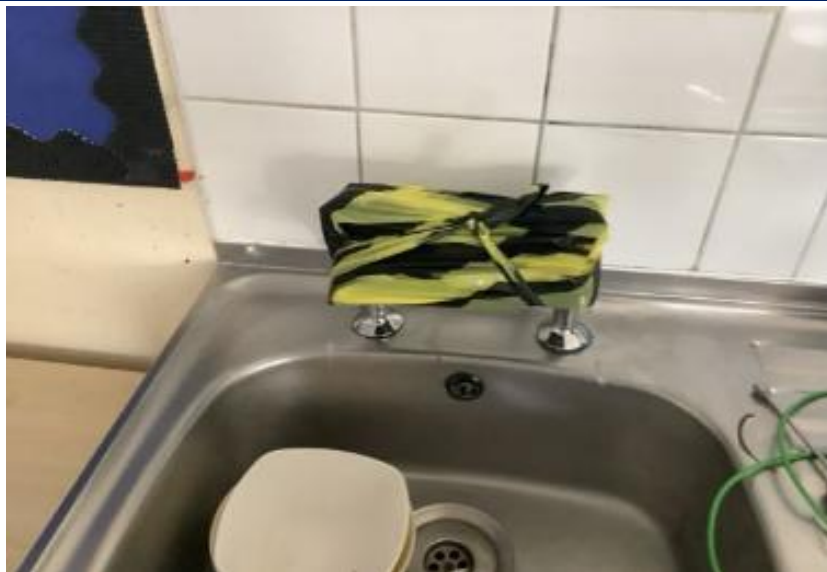
Action Required:	Applies to:	Priority:	Action Complete:
Hot & Cold Water Services	Matters of Concern		
Classroom 71		MEDIUM	
At the time of our survey, the outlets in classroom 76 were out of use. This will create a dead leg on the associated services, with the potential to harbour bacteria.			
The reason for the outlets being out of use should be rectified as soon as possible and the outlets flushed through. All actions should be recorded in the site log book. Alternatively, if deemed redundant, the pipe work should be cut back to that active system.
