Document
**Condition Survey
Report**

Project
**Merton Schools
Maintenance**

Building/Asset/Site
**West Wimbledon
Primary School**

Date
March 2022

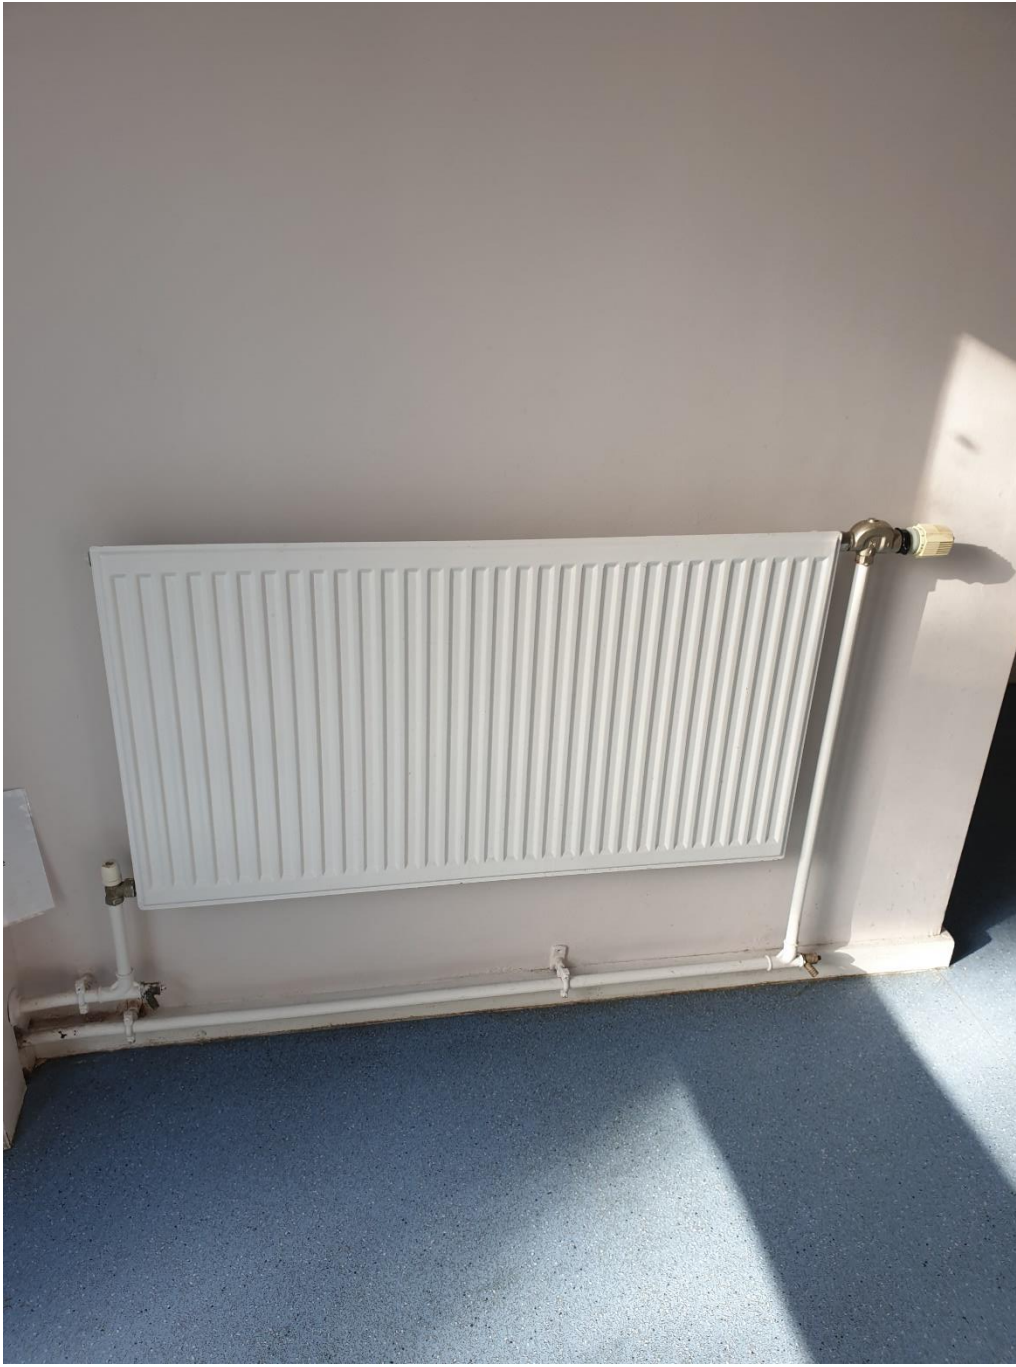
Photo 1: radiator connected to two pipe system

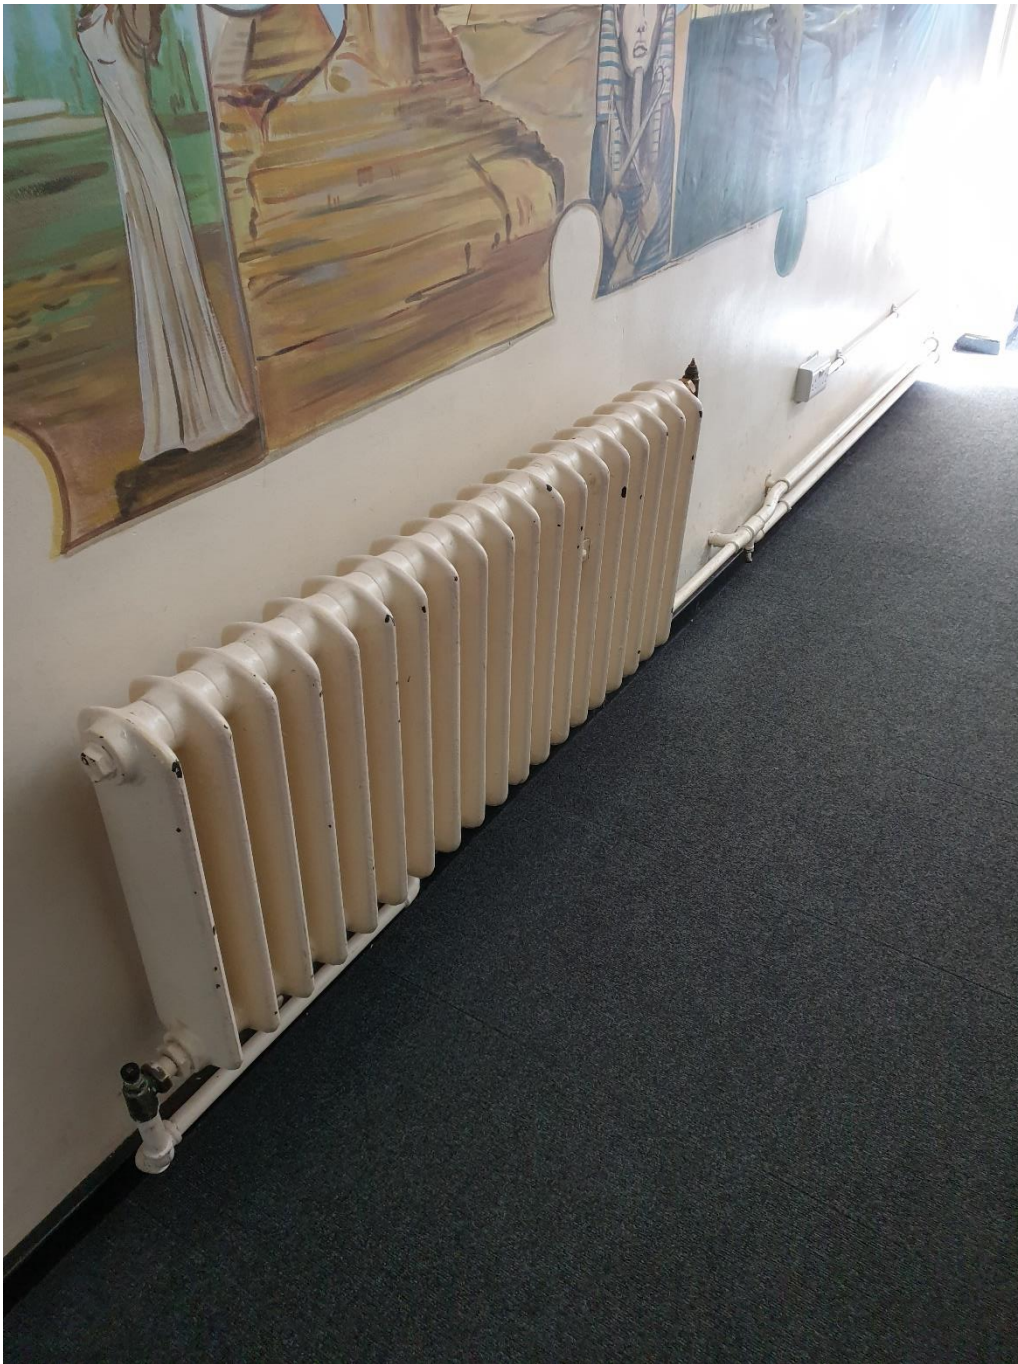
Photo 2: radiator connected to two-pipe system

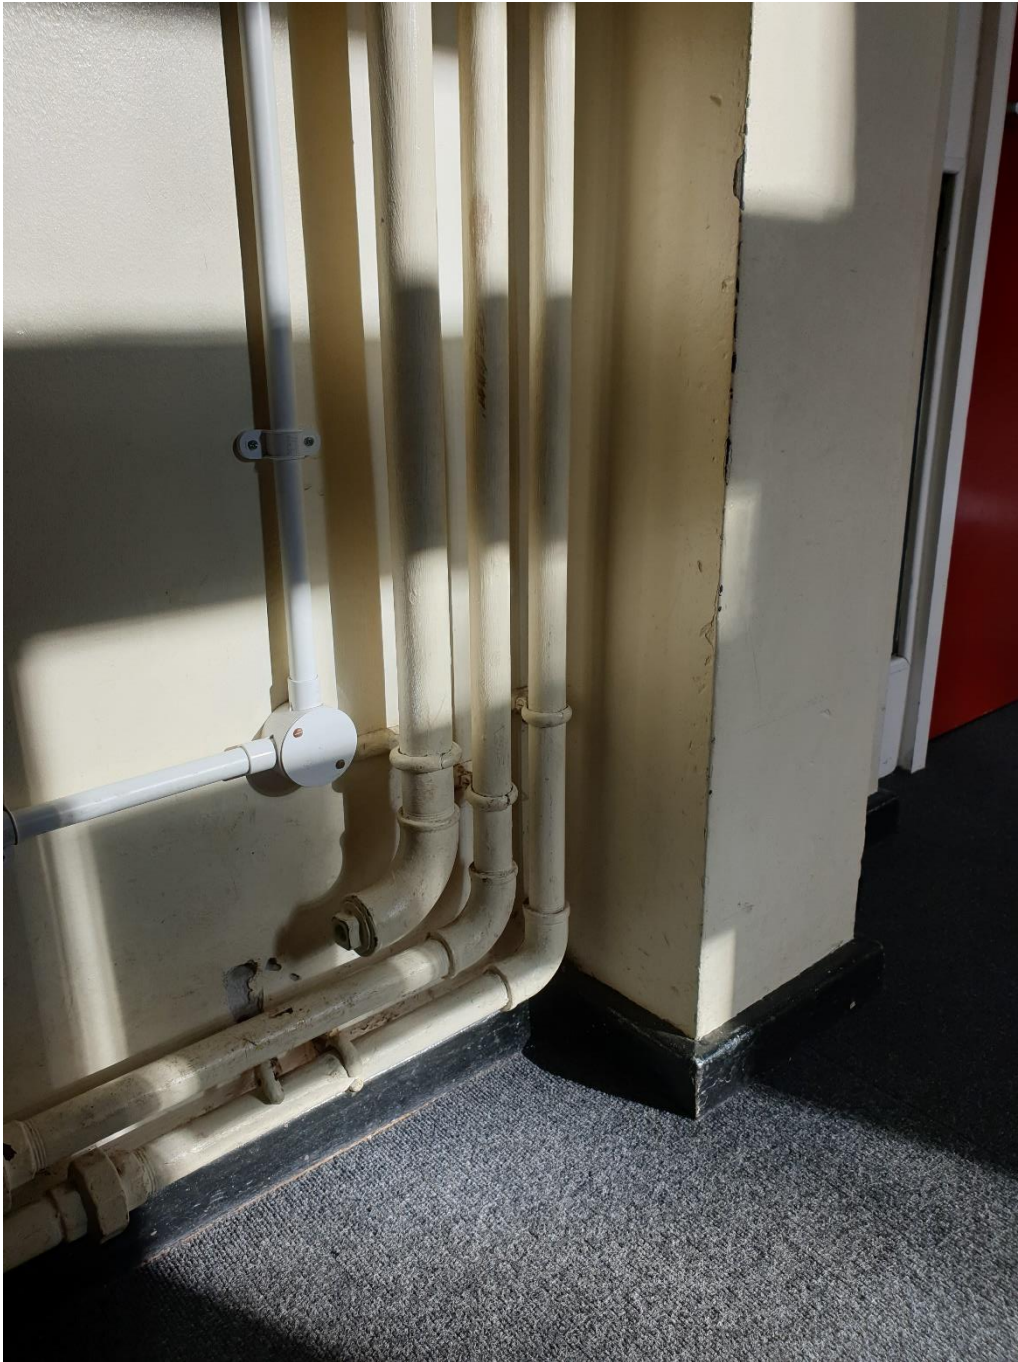
Areas where dead legs were found and highlighted on appendix A, further investigation required to find areas that may have been missed during site survey.

Photo 3: dead leg on heating system

All locations of dead legs to be investigated, to be removed when the domestic water and heating systems are drained for the works.

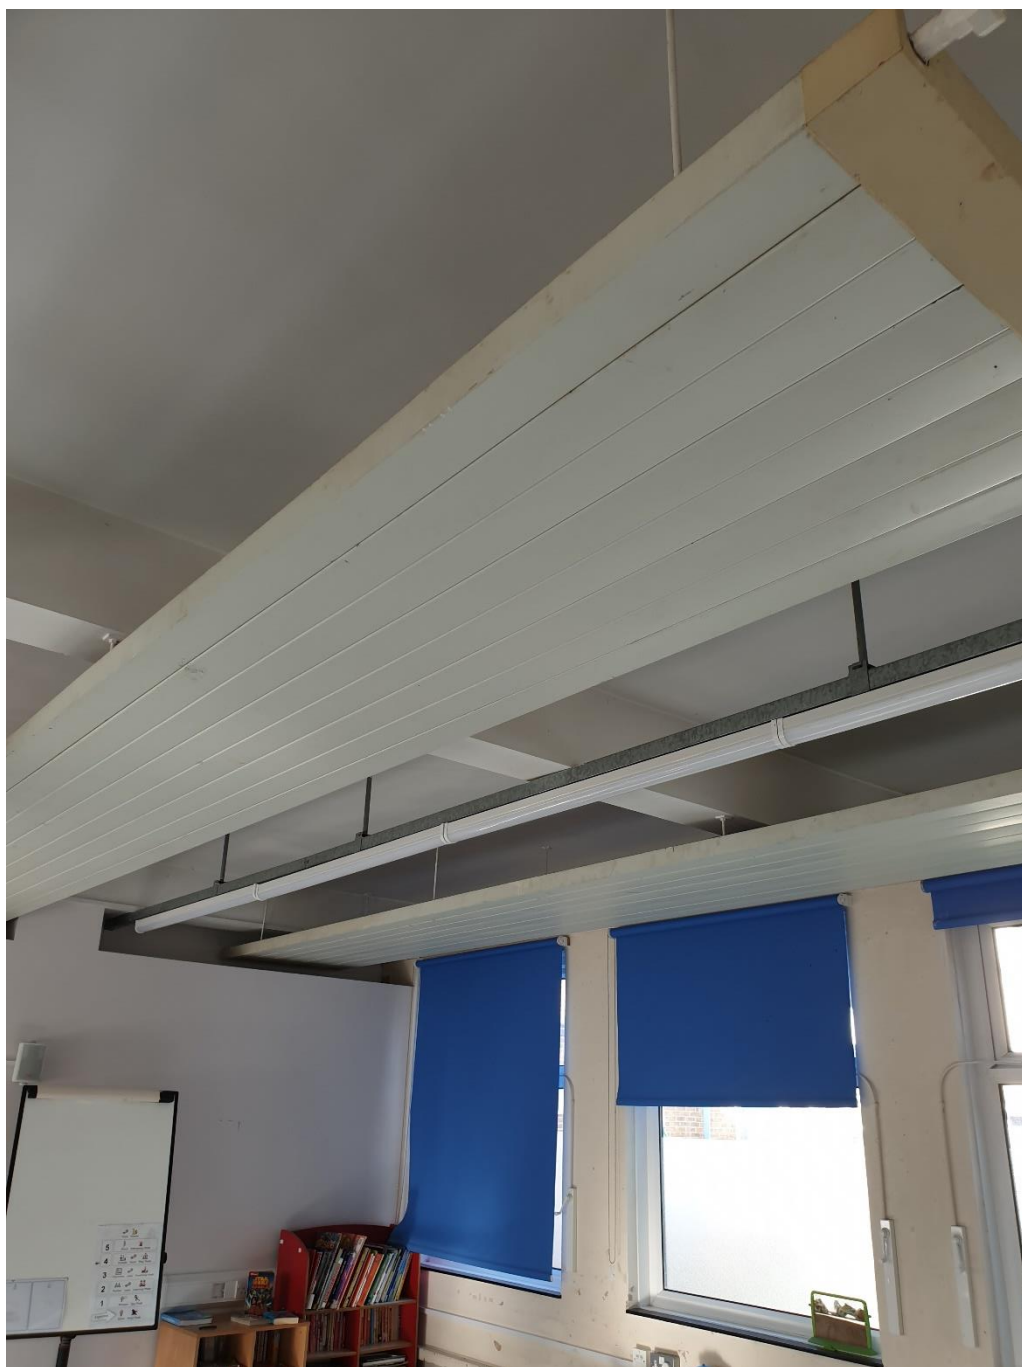
Two classrooms and the hall are heated with LTHW radiant panels on the ceiling, this system appears to be operating as intended.

Photo 4: radiant panels in classroom

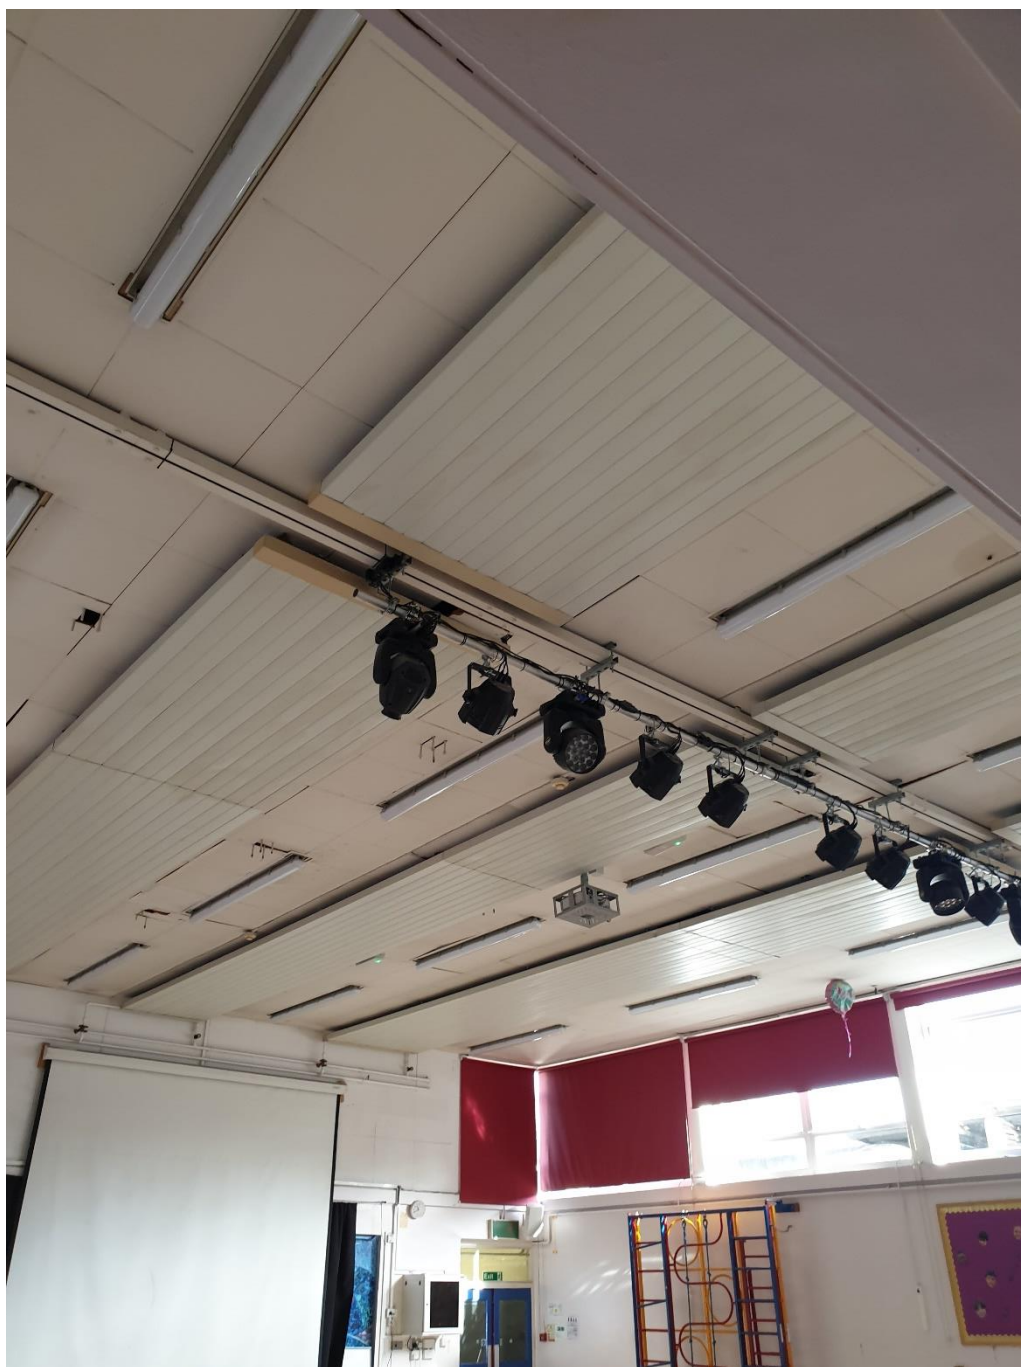
Photo 5: radiant panels in hall

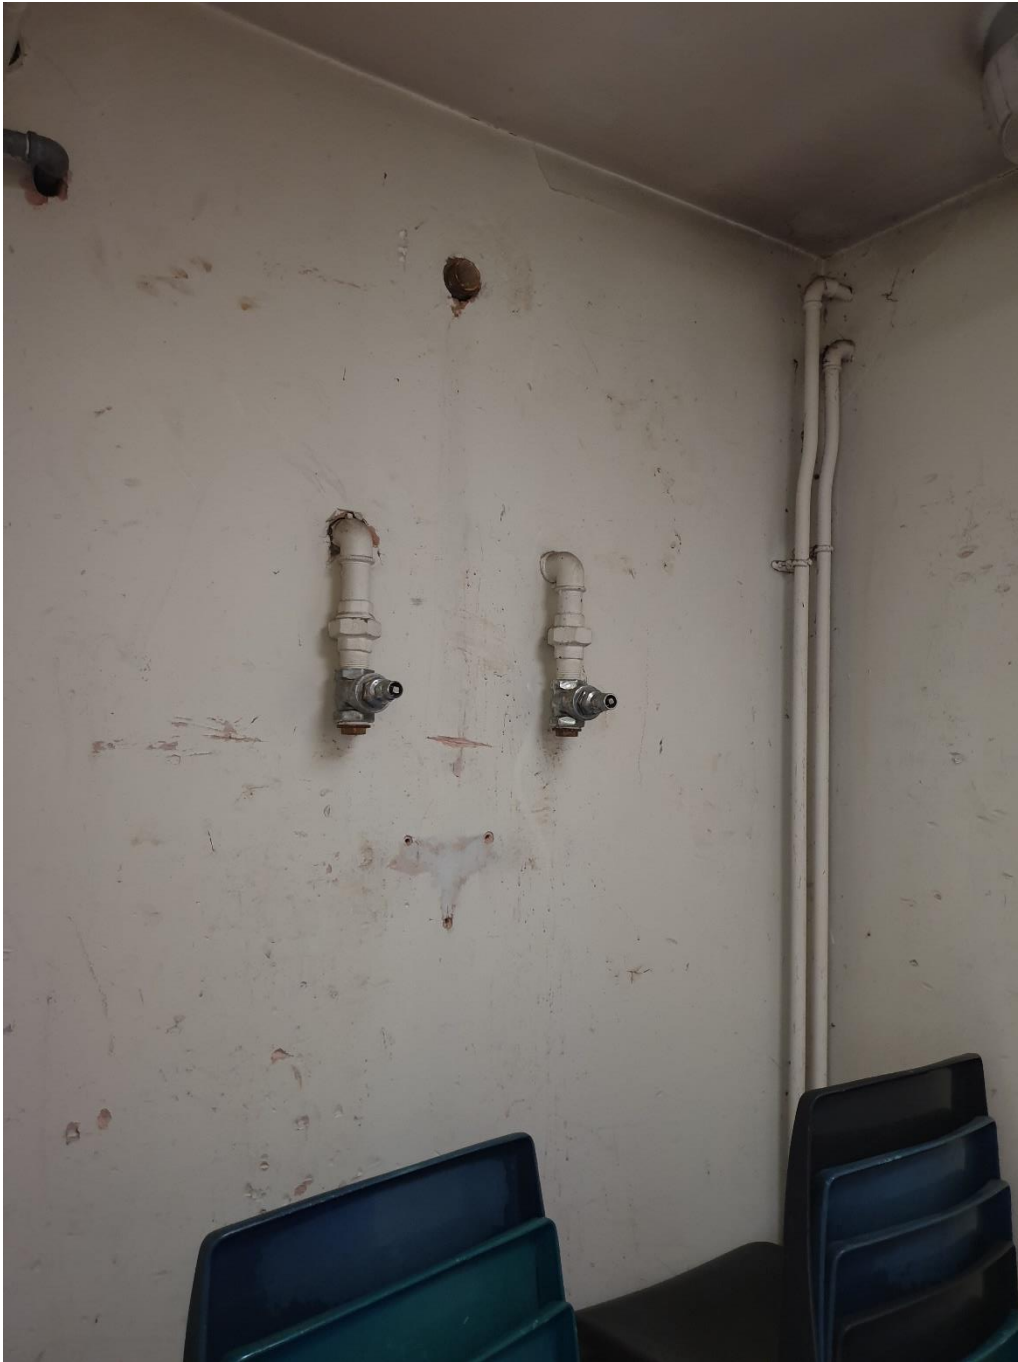
Photo 6: old shower block and domestic water dead legs

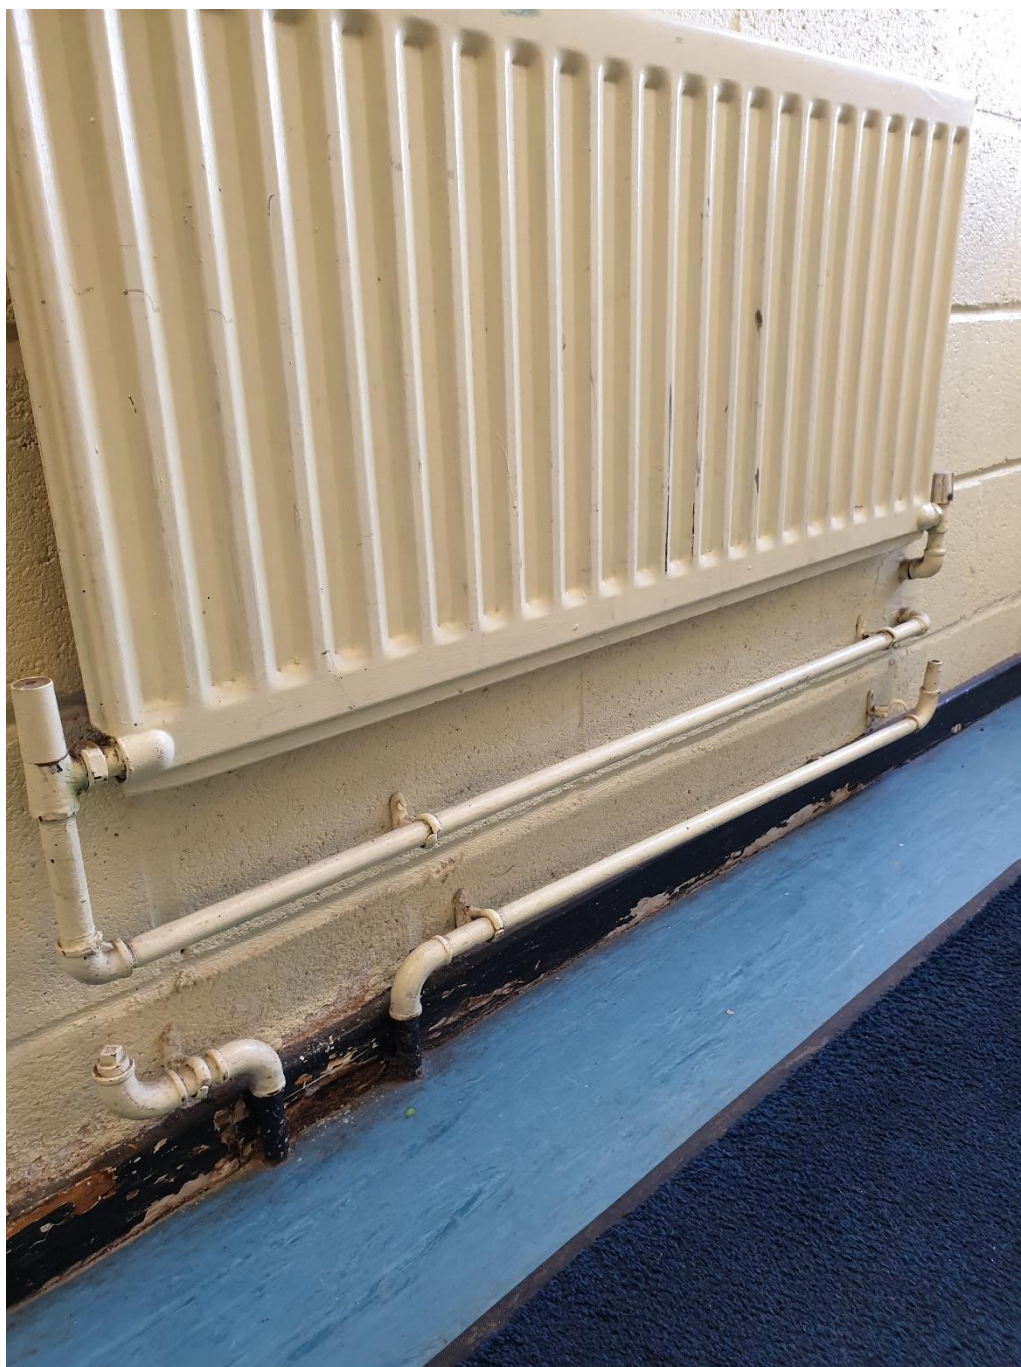
Photo 7: heating system dead legs

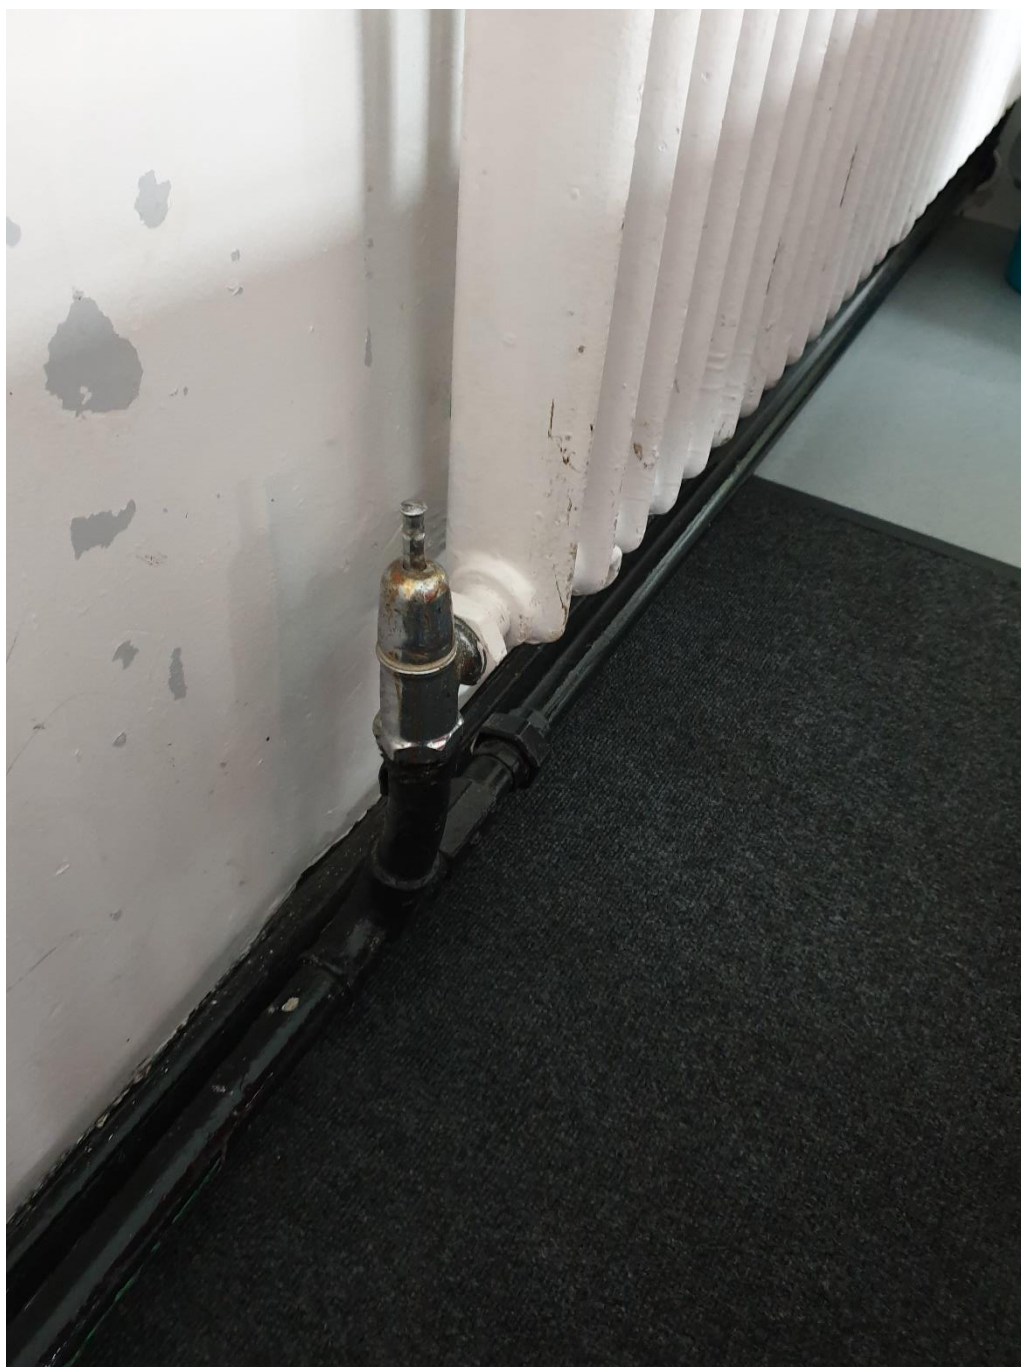
The heating system consists of Remeha gas fired condensing boilers feeding the heat emitters with LTHW. A full survey of the emitters was undertaken during the site visit, the location and type of emitters is shown on the mark-up provided in appendix A. **The LTHW system is generally arranged as a two-pipe flow and return system with the radiators are typically fitted with a LSV and TMV. However certain areas appear to be on an old single pipe system.**

Photo 8: single pipe radiator

- The malfunctioning radiators can be replaced.
- Dispose of the decommissioned radiators.
- Consideration should be given to upgrade the single pipe areas to a two-pipe system.
- If the hot air blowers in the kitchen are decommissioned, they should be replaced.
- The LTHW pipework can be power flushed to remove any debris that may be causing low flow in certain areas.

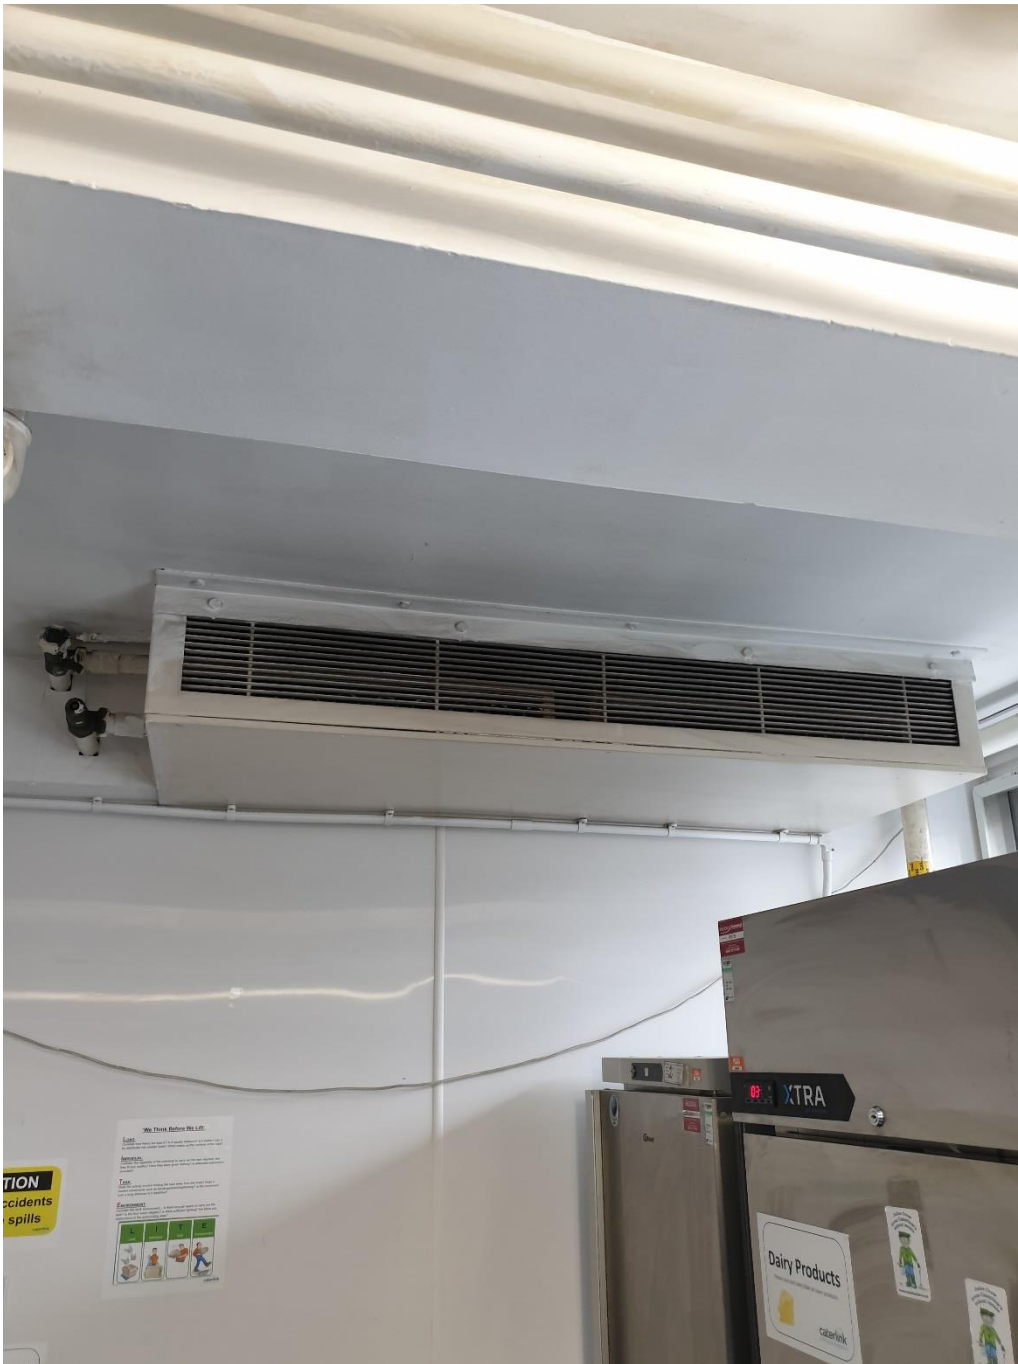
There are 2no. hot air blowers in the kitchen that have been decommissioned and may need replacing.

Photo 9: kitchen hot air blower

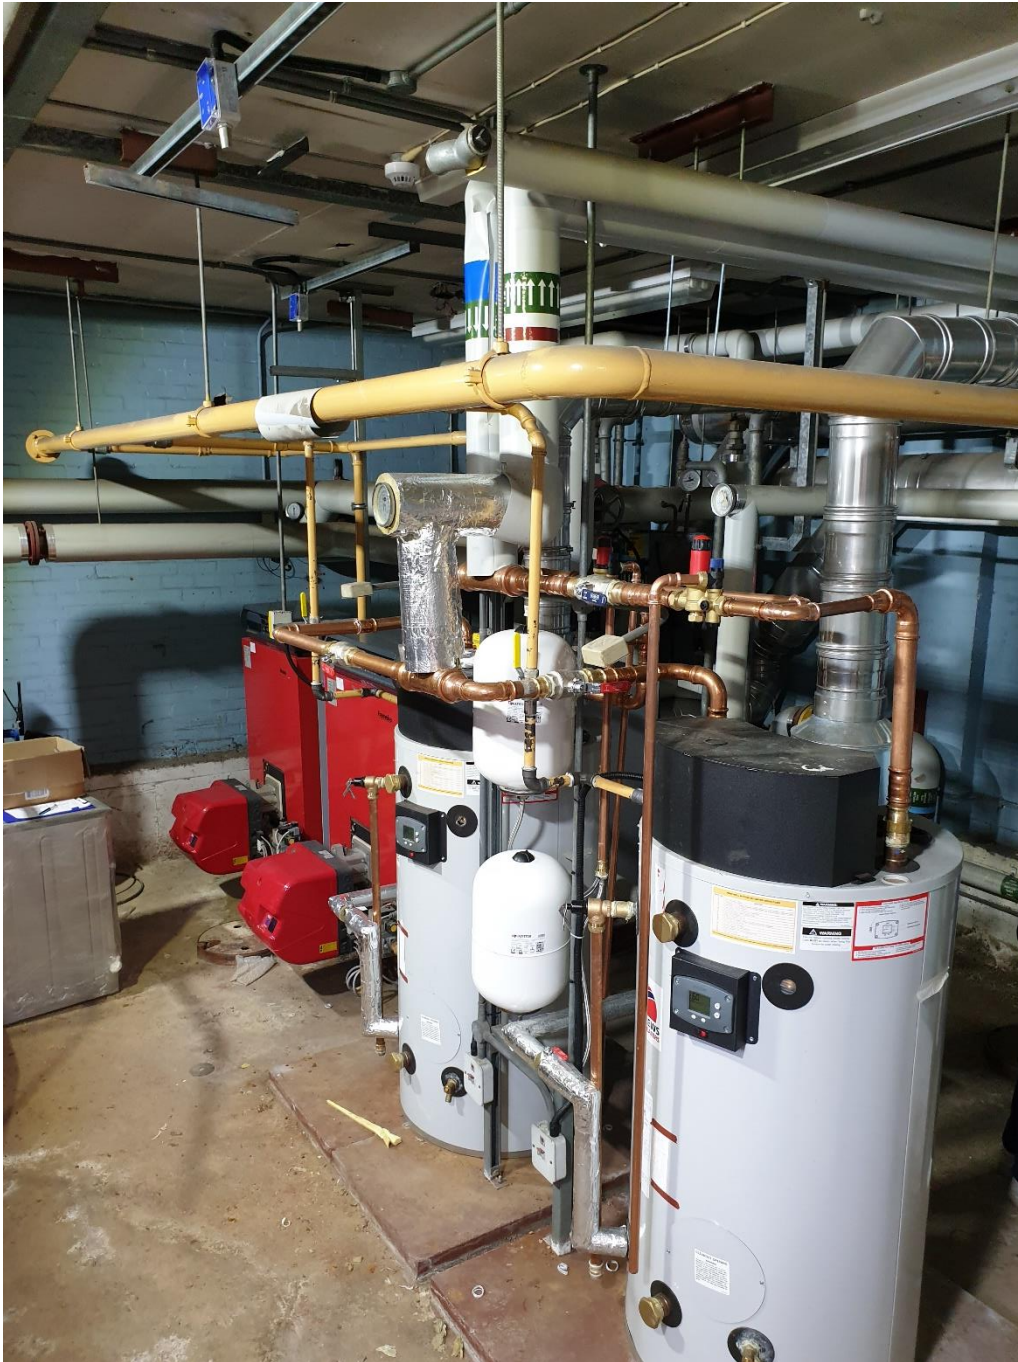
The plant room is in good condition with the heating system components within their life expectancy. The Remeha boilers are 11 years old (manufactured in 2011) and seemingly well maintained.

Photo 10: plant room

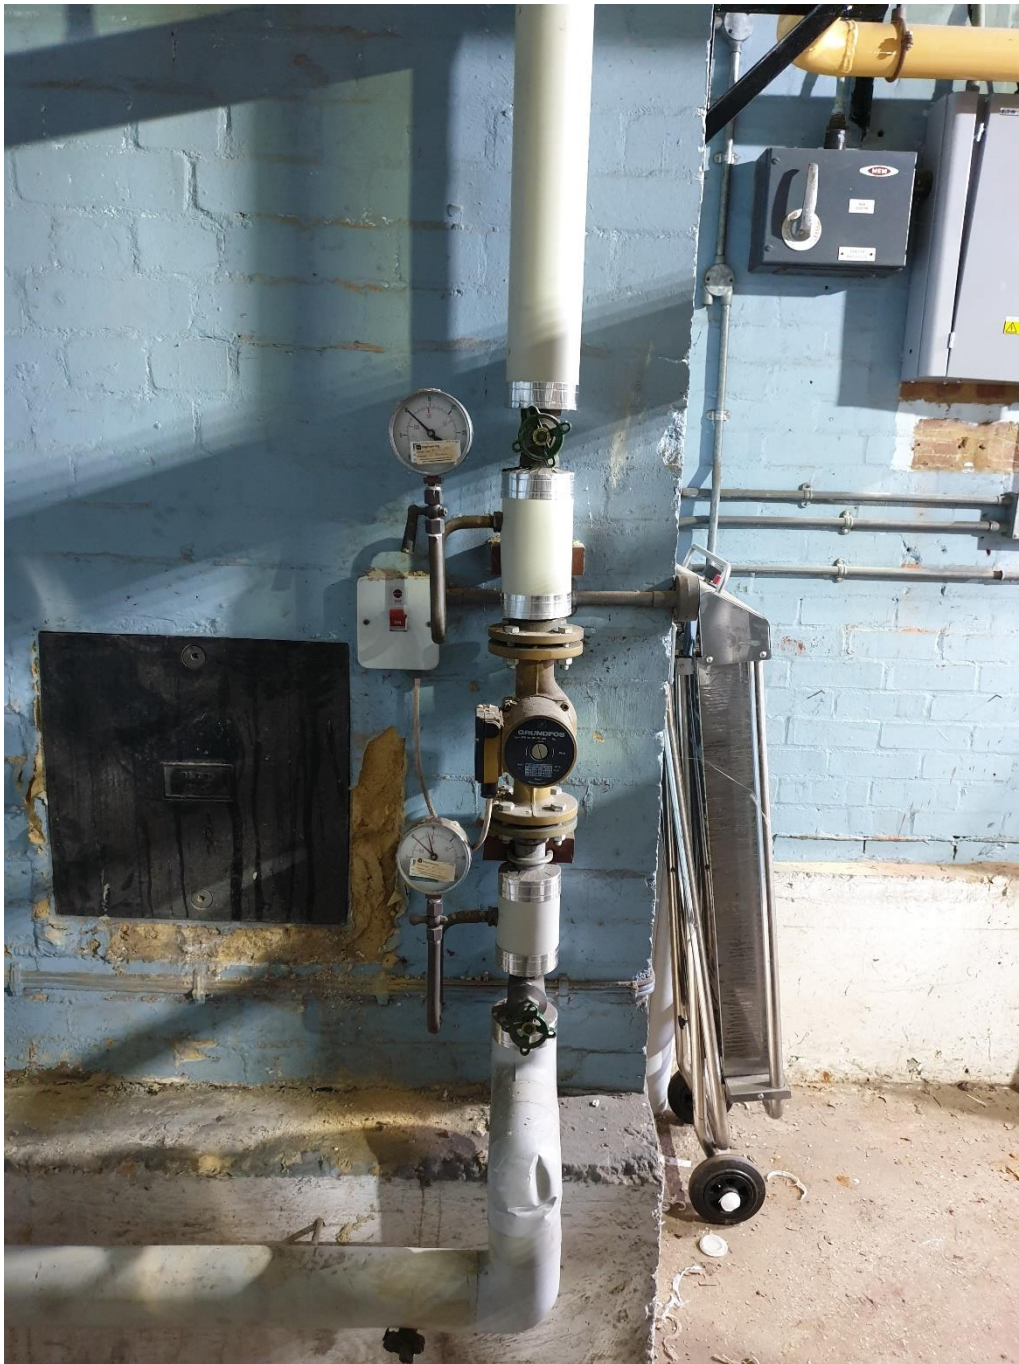
- The internal rust of the pipe network has increased the friction of the hot water pipework, meaning that the hot water return circulation pump can no longer provide the adequate flow.
- According to the site team the hot water piping routes are very long as they seem to go to the roof before dropping back down towards the kitchen; there is scope to make these more efficient and direct.

Photo 11: HW-R pump in plant room

The new cylinders are to be retained however the HW-R pump and old connecting pipework should be replaced. Despite the HW water cylinders being new, as they have been connected to an old piping system they should also be drained and checked for magnetite accumulation.

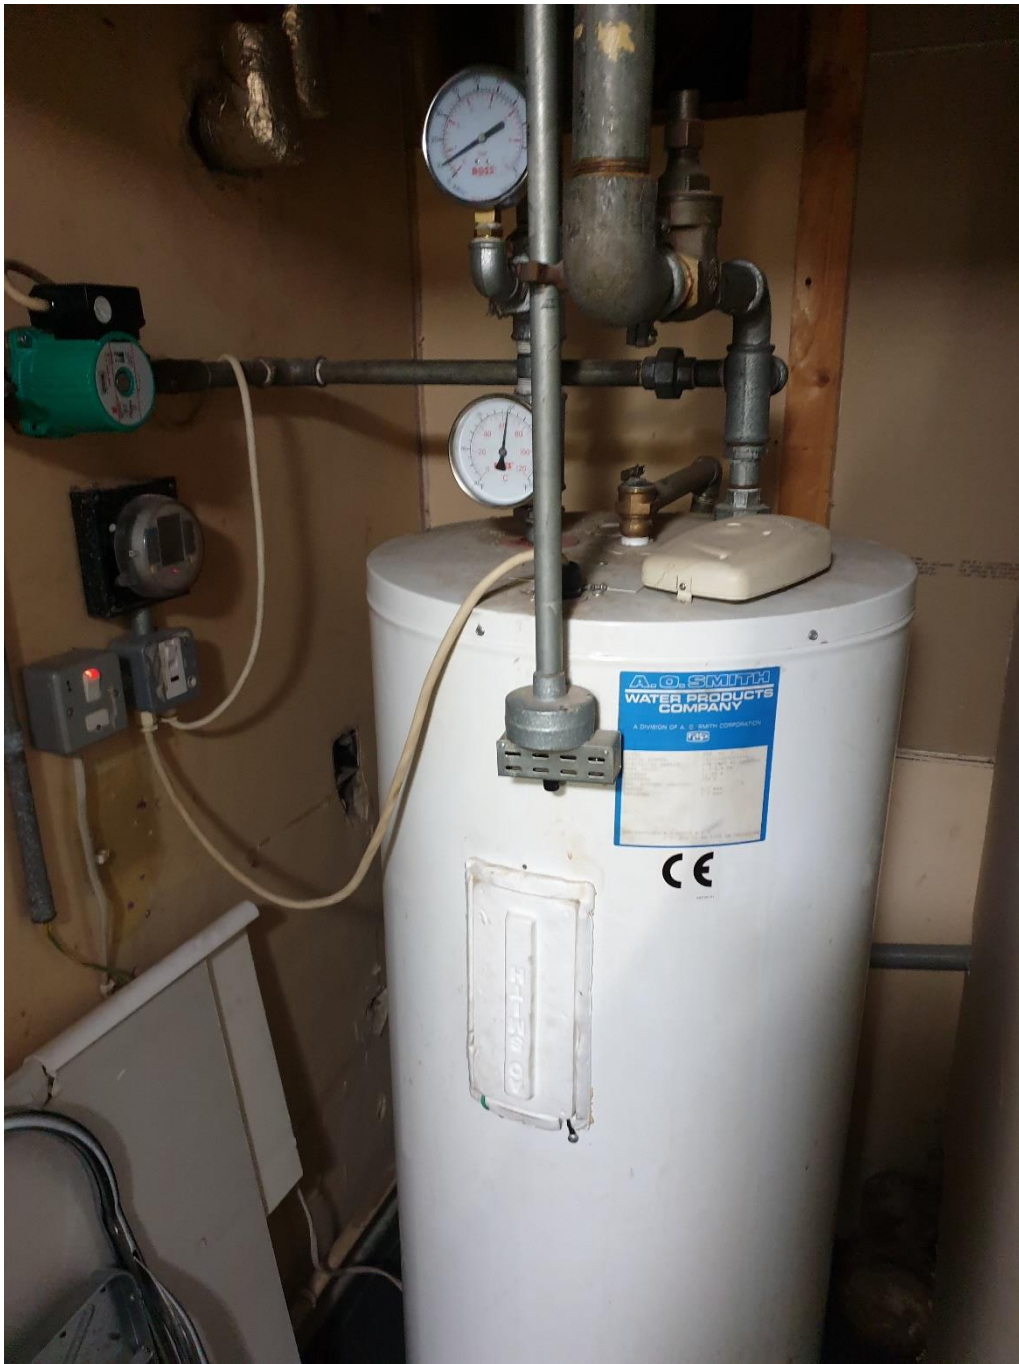
The hot water supplies to the outlets on the right side of the main entrance are part of a different network of pipes than on the left side. This can be seen in appendix B. There are no known issues with water discoloration on this side of the building. However, **the gas fired hot water cylinder next to the office is showing low temperature on the HW-R leg, circa 35°C, indicating a legionella risk.**

The HW cylinder is 20 years old (manufactured in 2002) and is due for replacement.

Photo 12: old HW cylinder and HW-R pump feeding right side of building

It is recommended to replace the existing HW cylinder and the HW-R pump as these are old and past their life expectancy.

To resolve the low temperature on the HW-R leg it is recommended to introduce POU water heaters in some of the areas fed from this cylinder as this will alleviate the load on the HW-R pump. The following areas are suggested to be fed for a POU water heater:
