Asbestos Re-inspection Report
(with Priority Assessments)
Cranmer Primary School
Cranmer Road, Mitcham, CR4 4XU

Job Number: B16018/1
Issue Date: 18/03/2021
Issue No: 1

London Borough of Merton	Life Environmental Services Limited
Merton Civic Centre, London Road, Morden, Surrey, SM4 5DX	4 Ducketts Wharf, South Street, Bishop's Stortford, Hertfordshire, CM23 3AR
	Tel: 01279 503117

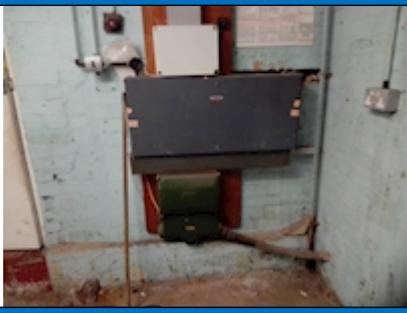
Building	Cranmer Primary School			Floor	-1		
Location Description	0/B02: Plant Room			Record Origin Report	B16018		
Item	Flashguards

Level of Identification (ID)	Presumed (P)	Sample No.					
Material	Textile	Extent	3 No.				
Accessibility	Usually inaccessible or unlikely to be disturbed						
Identification	Chrysotile						
Material Assessment							
Product Type	2	Condition	1	Surface Treatment	2	Asbestos Type	1
Priority Assessment (for more detail see Section 4.0)							
Occupant Activity	1	Disturbance	0	Human Exposure	1	Maintenance Activity	0
Scoring Summary							
Material Score	6	Priority Score	2	Total Risk	8	Risk Priority	VERY LOW
Recommended Action	Not sampled – Sample Required						
Further Information

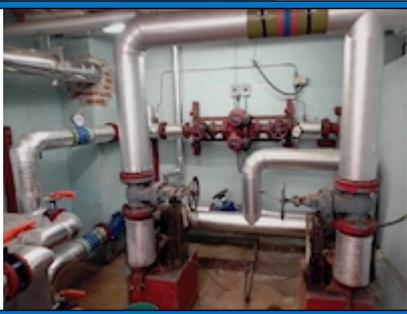
Building	Cranmer Primary School			Floor	-1		
Location Description	0/B02: Plant Room			Record Origin Report	B16018		
Item	Gaskets

Level of Identification (ID)	Strongly Presumed (SP)	Sample No.					
Material	Gaskets	Extent	20 No.				
Accessibility	Usually inaccessible or unlikely to be disturbed						
Identification	Chrysotile						
Material Assessment							
Product Type	2	Condition	1	Surface Treatment	2	Asbestos Type	1
Priority Assessment (for more detail see Section 4.0)							
Occupant Activity	1	Disturbance	0	Human Exposure	1	Maintenance Activity	2
Scoring Summary							
Material Score	6	Priority Score	4	Total Risk	10	Risk Priority	LOW
Recommended Action	Manage and Re-inspect						
Further Information	Visually consistent with sample reference MP260810/04

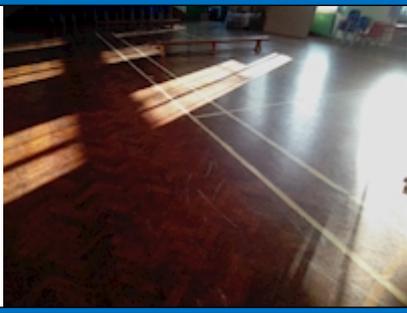
Building	Cranmer Primary School			Floor	0		
Location Description	0/022: Assembly Hall			Record Origin Report	B16018		
Item	Bitumen adhesive beneath parquet flooring

Level of Identification (ID)	Presumed (P)	Sample No.					
Material	Bitumen Product	Extent	75 m ²				
Accessibility	Usually inaccessible or unlikely to be disturbed						
Identification	Chrysotile						
Material Assessment							
Product Type	1	Condition	1	Surface Treatment	0	Asbestos Type	1
Priority Assessment (for more detail see Section 4.0)							
Occupant Activity	3	Disturbance	1	Human Exposure	2	Maintenance Activity	1
Scoring Summary							
Material Score	3	Priority Score	7	Total Risk	10	Risk Priority	LOW
Recommended Action	Not sampled – Sample Required						
Further Information

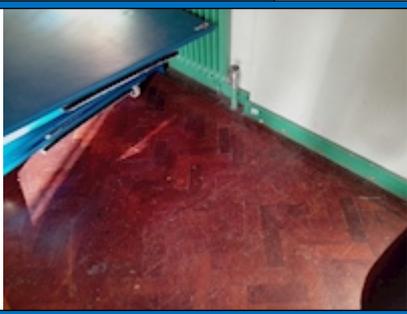
Building	Cranmer Primary School			Floor	0		
Location Description	0/022: Assembly Hall			Record Origin Report	B16018		
Item	Thermal insulation to pipework within floor duct

Level of Identification (ID)	Presumed (P)	Sample No.					
Material	Hard Set Thermal Insulation	Extent	60 lm				
Accessibility	Usually inaccessible or unlikely to be disturbed						
Identification	Amosite						
Material Assessment							
Product Type	3	Condition	1	Surface Treatment	1	Asbestos Type	2
Priority Assessment (for more detail see Section 4.0)							
Occupant Activity	3	Disturbance	1	Human Exposure	2	Maintenance Activity	1
Scoring Summary							
Material Score	7	Priority Score	7	Total Risk	14	Risk Priority	MEDIUM
Recommended Action	Not sampled – Sample Required						
Further Information

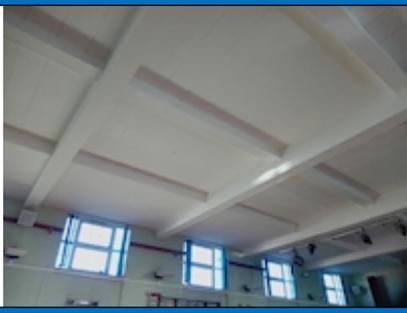
Building	Cranmer Primary School			Floor	0		
Location Description	0/022: Assembly Hall			Record Origin Report	B16018		
Item	Boards forming side

Level of Identification (ID)	Presumed (P)	Sample No.					
Material	Insulating Board	Extent	75 m ²				
Accessibility	Usually inaccessible or unlikely to be disturbed						
Identification	Amosite						
Material Assessment							
Product Type	2	Condition	0	Surface Treatment	1	Asbestos Type	2
Priority Assessment (for more detail see Section 4.0)							
Occupant Activity	3	Disturbance	1	Human Exposure	2	Maintenance Activity	1
Scoring Summary							
Material Score	5	Priority Score	7	Total Risk	12	Risk Priority	LOW
Recommended Action	Not sampled – Sample Required						
Further Information

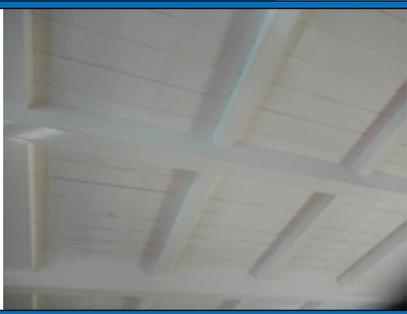
Building	Cranmer Primary School			Floor	0		
Location Description	0/022: Assembly Hall			Record Origin Report	B16018		
Item	Cement ceiling panels

Level of Identification (ID)	Strongly Presumed (SP)	Sample No.	XGS2608 10/06				
Material	Cement Product	Extent	150 m ²				
Accessibility	Usually inaccessible or unlikely to be disturbed						
Identification	Chrysotile						
Material Assessment							
Product Type	1	Condition	0	Surface Treatment	1	Asbestos Type	1
Priority Assessment (for more detail see Section 4.0)							
Occupant Activity	3	Disturbance	1	Human Exposure	2	Maintenance Activity	1
Scoring Summary							
Material Score	3	Priority Score	7	Total Risk	10	Risk Priority	LOW
Recommended Action	Manage and Re-inspect						
Further Information	Visually consistent with sample reference MP260810/06

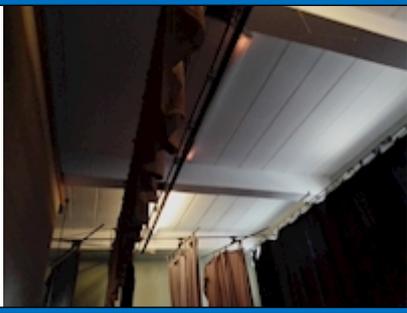
Building	Cranmer Primary School			Floor	0		
Location Description	0/022B: Raised Stage Area			Record Origin Report	B16018		
Item	Cement ceiling panels

Level of Identification (ID)	Strongly Presumed (SP)	Sample No.	SGS2608 10/06				
Material	Cement Product	Extent	40 m ²				
Accessibility	Usually inaccessible or unlikely to be disturbed						
Identification	Chrysotile						
Material Assessment							
Product Type	1	Condition	0	Surface Treatment	1	Asbestos Type	1
Priority Assessment (for more detail see Section 4.0)							
Occupant Activity	1	Disturbance	1	Human Exposure	0	Maintenance Activity	0
Scoring Summary							
Material Score	3	Priority Score	2	Total Risk	5	Risk Priority	VERY LOW
Recommended Action	Manage and Re-inspect						
Further Information	Previous sample reference SGS260810/06

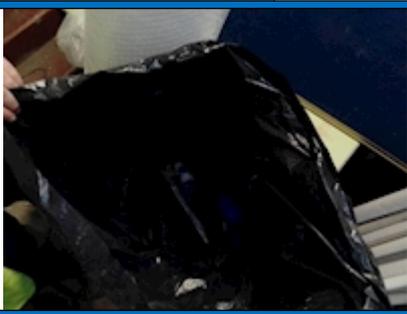
Building	Cranmer Primary School			Floor	0		
Location Description	0/023: Boiler Room			Record Origin Report	B16018		
Item	Redundant toilet cistern

Level of Identification (ID)	Strongly Presumed (SP)	Sample No.	SMP2608 10/02				
Material	Composite Material	Extent	1 No.				
Accessibility	Easily disturbed						
Identification	Amosite						
Material Assessment							
Product Type	1	Condition	0	Surface Treatment	0	Asbestos Type	2
Priority Assessment (for more detail see Section 4.0)							
Occupant Activity	0	Disturbance	1	Human Exposure	0	Maintenance Activity	0
Scoring Summary							
Material Score	3	Priority Score	1	Total Risk	4	Risk Priority	VERY LOW
Recommended Action	Remove						
Further Information	Previous sample reference SMP260810/02

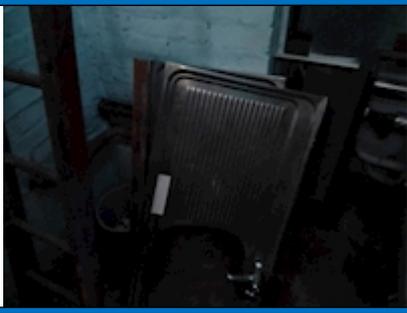
Building	Cranmer Primary School			Floor	0		
Location Description	0/023: Boiler Room			Record Origin Report	B16018		
Item	Sink pads to redundant sinks

Level of Identification (ID)	Strongly Presumed (SP)	Sample No.					
Material	Bitumen Product	Extent	4 No.				
Accessibility	Usually inaccessible or unlikely to be disturbed						
Identification	Chrysotile						
Material Assessment							
Product Type	1	Condition	0	Surface Treatment	0	Asbestos Type	1
Priority Assessment (for more detail see Section 4.0)							
Occupant Activity	0	Disturbance	0	Human Exposure	0	Maintenance Activity	0
Scoring Summary							
Material Score	2	Priority Score	0	Total Risk	2	Risk Priority	VERY LOW
Recommended Action	Manage and Re-inspect						
Further Information	Visually consistent with sample reference MP260810/03

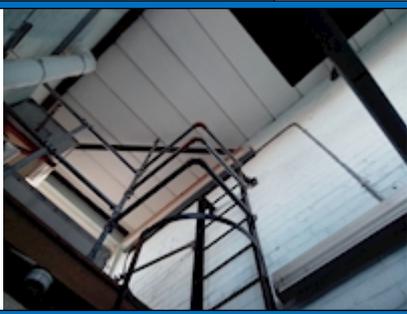
Building	Cranmer Primary School			Floor	0		
Location Description	0/023: Boiler Room			Record Origin Report	B16018		
Item	Cement ceiling panels

Level of Identification (ID)	Strongly Presumed (SP)	Sample No.	XGS2608 10/06				
Material	Cement Product	Extent	30 m ²				
Accessibility	Usually inaccessible or unlikely to be disturbed						
Identification	Chrysotile						
Material Assessment							
Product Type	1	Condition	0	Surface Treatment	1	Asbestos Type	1
Priority Assessment (for more detail see Section 4.0)							
Occupant Activity	0	Disturbance	1	Human Exposure	0	Maintenance Activity	0
Scoring Summary							
Material Score	3	Priority Score	1	Total Risk	4	Risk Priority	VERY LOW
Recommended Action	Manage and Re-inspect						
Further Information	Visually consistent with sample reference MP260810/06

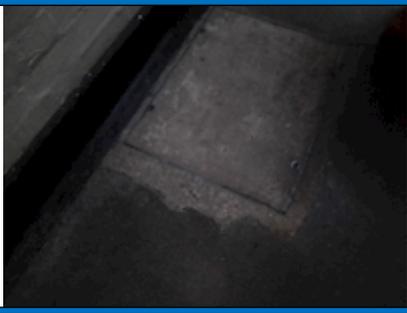
Building	Cranmer Primary School			Floor	0		
Location Description	0/026: Corridor			Record Origin Report	B16018		
Item	Cement shuttering within duct

Level of Identification (ID)	Presumed (P)	Sample No.					
Material	Cement Product	Extent	10 m ²				
Accessibility	Usually inaccessible or unlikely to be disturbed						
Identification	Chrysotile						
Material Assessment							
Product Type	1	Condition	0	Surface Treatment	1	Asbestos Type	1
Priority Assessment (for more detail see Section 4.0)							
Occupant Activity	2	Disturbance	1	Human Exposure	2	Maintenance Activity	1
Scoring Summary							
Material Score	3	Priority Score	6	Total Risk	9	Risk Priority	LOW
Recommended Action	Not sampled – Sample Required						
Further Information

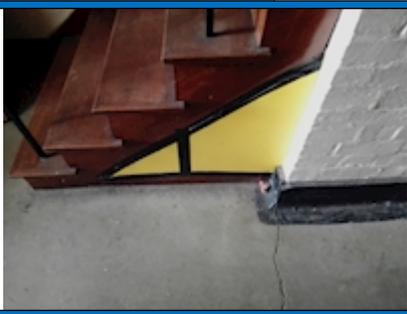
Building	Cranmer Primary School			Floor	0		
Location Description	0/026: Corridor			Record Origin Report	B16018		
Item	Insulating board infill panels to stairs

Level of Identification (ID)	Strongly Presumed (SP)	Sample No.					
Material	Insulating Board	Extent	3 m ²				
Accessibility	Easily disturbed						
Identification	Amosite						
Material Assessment							
Product Type	2	Condition	0	Surface Treatment	1	Asbestos Type	2
Priority Assessment (for more detail see Section 4.0)							
Occupant Activity	1	Disturbance	1	Human Exposure	2	Maintenance Activity	1
Scoring Summary							
Material Score	5	Priority Score	5	Total Risk	10	Risk Priority	LOW
Recommended Action	Manage and Re-inspect						
Further Information	Visually consistent with sample reference GS260810/09

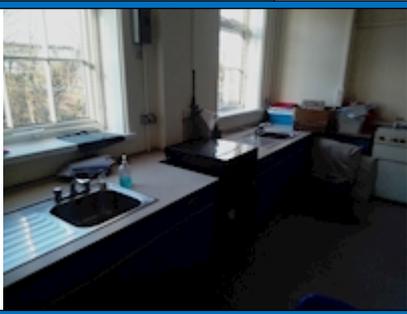
Building	Cranmer Primary School			Floor	1		
Location Description	0/105: Food Technology Room			Record Origin Report	B16018		
Item	Sink pad

Level of Identification (ID)	Strongly Presumed (SP)	Sample No.	SMP2608 10/03				
Material	Bitumen Product	Extent	2 No.				
Accessibility	Occasionally likely to be disturbed						
Identification	Chrysotile						
Material Assessment							
Product Type	1	Condition	1	Surface Treatment	0	Asbestos Type	1
Priority Assessment (for more detail see Section 4.0)							
Occupant Activity	1	Disturbance	1	Human Exposure	2	Maintenance Activity	1
Scoring Summary							
Material Score	3	Priority Score	5	Total Risk	8	Risk Priority	VERY LOW
Recommended Action	Manage and Re-inspect						
Further Information	Previous sample reference SMP260810/03

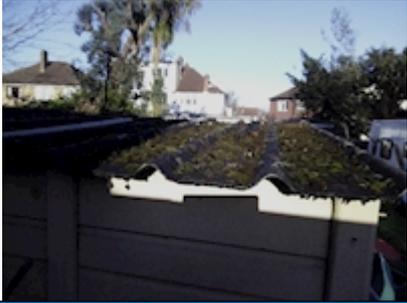
Building	Cranmer Primary School			Floor	Ext		
Location Description	2/013A: Shed By Boiler Room			Record Origin Report	B16018		
Item	Cement roof sheets

Level of Identification (ID)	Strongly Presumed (SP)	Sample No.	SMP2608 10/05				
Material	Cement Product	Extent	8 m ²				
Accessibility	Usually inaccessible or unlikely to be disturbed						
Identification	Crocidolite						
Material Assessment							
Product Type	1	Condition	1	Surface Treatment	1	Asbestos Type	3
Priority Assessment (for more detail see Section 4.0)							
Occupant Activity	0	Disturbance	0	Human Exposure	0	Maintenance Activity	0
Scoring Summary							
Material Score	6	Priority Score	0	Total Risk	6	Risk Priority	VERY LOW
Recommended Action	Manage and Re-inspect						
Further Information	Previous sample reference SMP260810/05

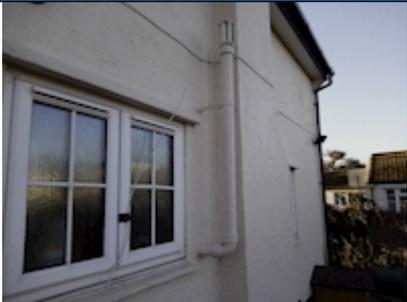
Building	Cranmer Primary School			Floor	Ext		
Location Description	Caretakers House: Caretakers House External			Record Origin Report	B16018		
Item	Cement flue pipe

Level of Identification (ID)	Strongly Presumed (SP)	Sample No.	SMP2608 10/09				
Material	Cement Product	Extent	3 lm				
Accessibility	Occasionally likely to be disturbed						
Identification	Chrysotile						
Material Assessment							
Product Type	1	Condition	1	Surface Treatment	1	Asbestos Type	1
Priority Assessment (for more detail see Section 4.0)							
Occupant Activity	0	Disturbance	1	Human Exposure	0	Maintenance Activity	0
Scoring Summary							
Material Score	4	Priority Score	1	Total Risk	5	Risk Priority	VERY LOW
Recommended Action	Manage and Re-inspect						
Further Information	Previous sample reference SMP260810/09

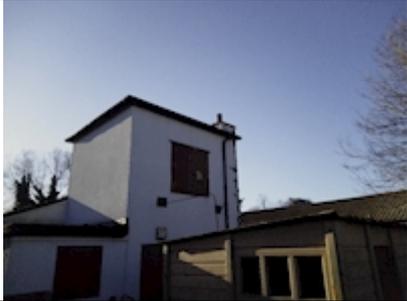
Building	Cranmer Primary School			Floor	Ext		
Location Description	Kitchen Block: External			Record Origin Report	B16018		
Item	Cement flue pipe

Level of Identification (ID)	Strongly Presumed (SP)	Sample No.					
Material	Cement Product	Extent	1 No.				
Accessibility	Usually inaccessible or unlikely to be disturbed						
Identification	Chrysotile						
Material Assessment							
Product Type	1	Condition	1	Surface Treatment	1	Asbestos Type	1
Priority Assessment (for more detail see Section 4.0)							
Occupant Activity	0	Disturbance	0	Human Exposure	0	Maintenance Activity	0
Scoring Summary							
Material Score	4	Priority Score	0	Total Risk	4	Risk Priority	VERY LOW
Recommended Action	Manage and Re-inspect						
Further Information
