Asbestos Re-inspection Report (with Priority Assessments)

Hatfeild Primary School
Lower Morden Lane, Morden, SM4 4SJ

Job Number: B89525/1

Issue Date: 22/02/2023

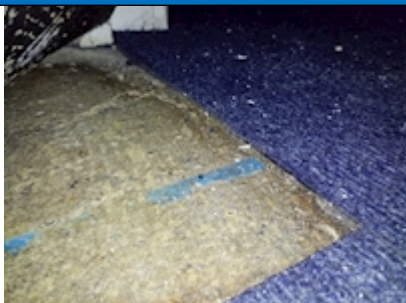
Building	Hatfeild Primary School			Floor	0		
Location Description	0/043: Classroom			Record Origin Report	B62913		
Item	Floor Covering

Level of Identification (ID)	Inspected Area (IA)	Sample No.					
Material		Extent					
Accessibility							
Identification							
Material Assessment							
Product Type		Condition		Surface Treatment		Asbestos Type	
Priority Assessment (for more detail see Section 4.0)							
Occupant Activity		Disturbance		Human Exposure		Maintenance Activity	
Scoring Summary							
Material Score		Priority Score		Total Risk		Risk Priority	
Recommended Action	No Recommendation Required						
Further Information	Modern Materials to Concrete

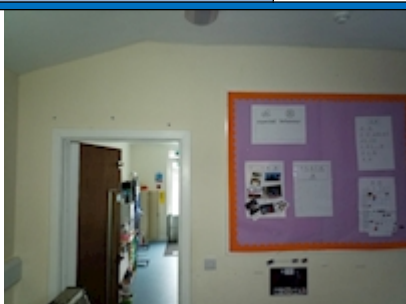
Building	Hatfeild Primary School			Floor	0		
Location Description	0/043: Classroom			Record Origin Report	B62913		
Item	Board and Substructure

Level of Identification (ID)	Sample (S)	Sample No.	S0001				
Material	Insulating Board	Extent	6 m ²				
Accessibility							
Identification	No Asbestos Detected						
Material Assessment							
Product Type	0	Condition	0	Surface Treatment	0	Asbestos Type	0
Priority Assessment (for more detail see Section 4.0)							
Occupant Activity	0	Disturbance	0	Human Exposure	0	Maintenance Activity	0
Scoring Summary							
Material Score	0	Priority Score	0	Total Risk	0	Risk Priority	N/A
Recommended Action	No Recommendation Required						
Further Information	Board and Substructure to classroom 045b/044

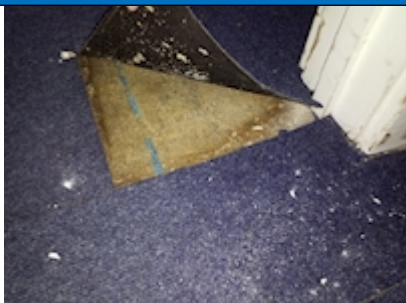
Building	Hatfeild Primary School			Floor	0		
Location Description	0/044: Classroom			Record Origin Report	B62913		
Item	Floor Covering

Level of Identification (ID)	Inspected Area (IA)	Sample No.					
Material		Extent					
Accessibility							
Identification							
Material Assessment							
Product Type		Condition		Surface Treatment		Asbestos Type	
Priority Assessment (for more detail see Section 4.0)							
Occupant Activity		Disturbance		Human Exposure		Maintenance Activity	
Scoring Summary							
Material Score		Priority Score		Total Risk		Risk Priority	
Recommended Action	No Recommendation Required						
Further Information	Modern Materials to Concrete

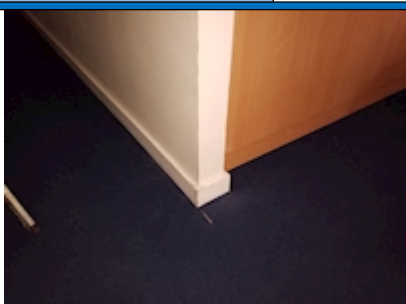
Building	Hatfeild Primary School			Floor	0		
Location Description	0/045b: Classroom			Record Origin Report	B62913		
Item	Floor Covering

Level of Identification (ID)	Inspected Area (IA)	Sample No.					
Material		Extent					
Accessibility							
Identification							
Material Assessment							
Product Type		Condition		Surface Treatment		Asbestos Type	
Priority Assessment (for more detail see Section 4.0)							
Occupant Activity		Disturbance		Human Exposure		Maintenance Activity	
Scoring Summary							
Material Score		Priority Score		Total Risk		Risk Priority	
Recommended Action	No Recommendation Required						
Further Information	Modern Materials to Concrete

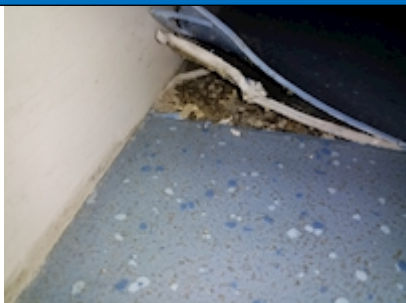
Building	Hatfeild Primary School			Floor	0		
Location Description	0/045b: Classroom			Record Origin Report	B62913		
Item	Floor Covering

Level of Identification (ID)	Inspected Area (IA)	Sample No.					
Material		Extent					
Accessibility							
Identification							
Material Assessment							
Product Type		Condition		Surface Treatment		Asbestos Type	
Priority Assessment (for more detail see Section 4.0)							
Occupant Activity		Disturbance		Human Exposure		Maintenance Activity	
Scoring Summary							
Material Score		Priority Score		Total Risk		Risk Priority	
Recommended Action	No Recommendation Required						
Further Information	Modern Materials to Concrete

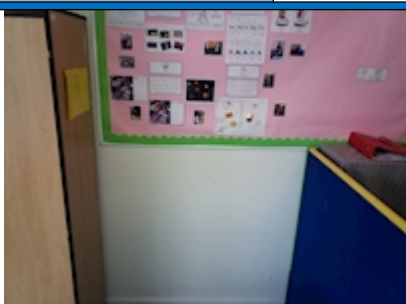
Building	Hatfeild Primary School			Floor	0		
Location Description	0/045b: Classroom			Record Origin Report	B62913		
Item	Board and Substructure

Level of Identification (ID)	Sample (S)	Sample No.	S0002				
Material	Insulating Board	Extent	6 m ²				
Accessibility							
Identification	No Asbestos Detected						
Material Assessment							
Product Type	0	Condition	0	Surface Treatment	0	Asbestos Type	0
Priority Assessment (for more detail see Section 4.0)							
Occupant Activity	0	Disturbance	0	Human Exposure	0	Maintenance Activity	0
Scoring Summary							
Material Score	0	Priority Score	0	Total Risk	0	Risk Priority	N/A
Recommended Action	No Recommendation Required						
Further Information	Board and Substructure to classroom 044/043

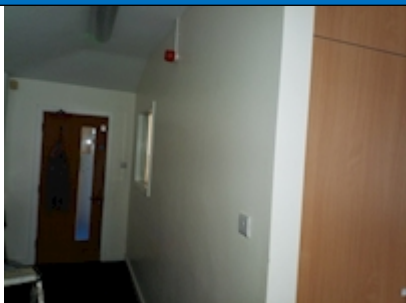
Building	Hatfield Primary School			Floor	0		
Location Description	0/045b: Classroom			Record Origin Report	B62913		
Item	Board and Substracter

Level of Identification (ID)	Sample (S)	Sample No.	S0003				
Material	Insulating Board	Extent	10 m ²				
Accessibility							
Identification	No Asbestos Detected						
Material Assessment							
Product Type	0	Condition	0	Surface Treatment	0	Asbestos Type	0
Priority Assessment (for more detail see Section 4.0)							
Occupant Activity	0	Disturbance	0	Human Exposure	0	Maintenance Activity	0
Scoring Summary							
Material Score	0	Priority Score	0	Total Risk	0	Risk Priority	N/A
Recommended Action	No Recommendation Required						
Further Information	Board and Substracter to classroom 044/043

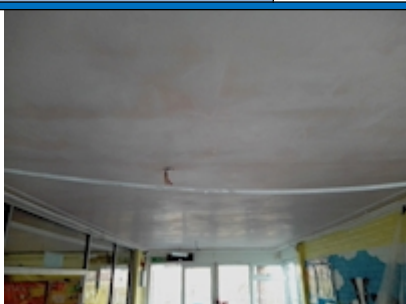
Building	Hatfield Primary School			Floor	0		
Location Description	2/001: Lobby			Record Origin Report	B14465		
Item	Textured coating to ceiling (has now been removed by Merton)

Level of Identification (ID)	Inspected Area (IA)	Sample No.					
Material		Extent					
Accessibility							
Identification							
Material Assessment							
Product Type		Condition		Surface Treatment		Asbestos Type	
Priority Assessment (for more detail see Section 4.0)							
Occupant Activity		Disturbance		Human Exposure		Maintenance Activity	
Scoring Summary							
Material Score		Priority Score		Total Risk		Risk Priority	
Recommended Action	No Recommendation Required						
Further Information	No suspect materials seen

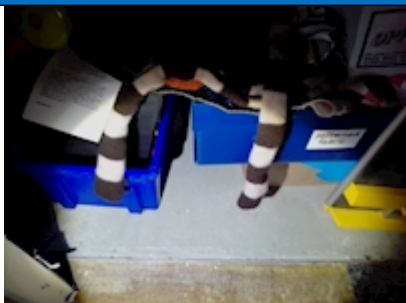
Building	Hatfeild Primary School			Floor	0		
Location Description	2/004: Store			Record Origin Report	B14465		
Item	Bitumen adhesive residue to floor (has now been removed by Merton) Textured coating to ceiling (has now been removed by Merton)

Level of Identification (ID)	Inspected Area (IA)	Sample No.					
Material		Extent					
Accessibility							
Identification							
Material Assessment							
Product Type		Condition		Surface Treatment		Asbestos Type	
Priority Assessment (for more detail see Section 4.0)							
Occupant Activity		Disturbance		Human Exposure		Maintenance Activity	
Scoring Summary							
Material Score		Priority Score		Total Risk		Risk Priority	
Recommended Action	No Recommendation Required						
Further Information	No suspect materials seen

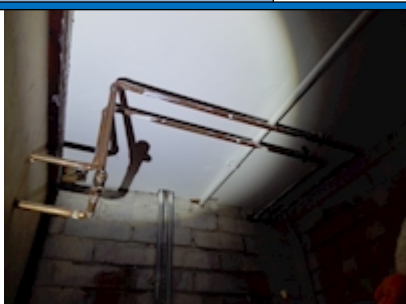
Building	Hatfeild Primary School			Floor	0		
Location Description	2/004: Store			Record Origin Report	B14465		
Item	Textured coating to ceiling (has now been removed by Merton)

Level of Identification (ID)	Inspected Area (IA)	Sample No.					
Material		Extent					
Accessibility							
Identification							
Material Assessment							
Product Type		Condition		Surface Treatment		Asbestos Type	
Priority Assessment (for more detail see Section 4.0)							
Occupant Activity		Disturbance		Human Exposure		Maintenance Activity	
Scoring Summary							
Material Score		Priority Score		Total Risk		Risk Priority	
Recommended Action	No Recommendation Required						
Further Information	No suspect materials seen

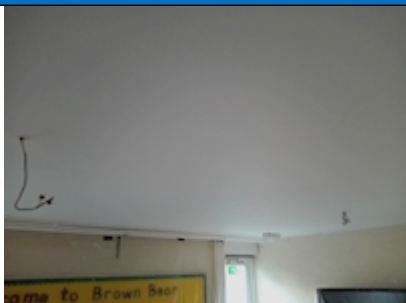
Building	Hatfeild Primary School			Floor	0		
Location Description	2/005: Sensory Room			Record Origin Report	B14465		
Item	Textured coating to ceiling (has now been removed by Merton)

Level of Identification (ID)	Inspected Area (IA)	Sample No.					
Material		Extent					
Accessibility							
Identification							
Material Assessment							
Product Type		Condition		Surface Treatment		Asbestos Type	
Priority Assessment (for more detail see Section 4.0)							
Occupant Activity		Disturbance		Human Exposure		Maintenance Activity	
Scoring Summary							
Material Score		Priority Score		Total Risk		Risk Priority	
Recommended Action	No Recommendation Required						
Further Information	No suspect materials seen

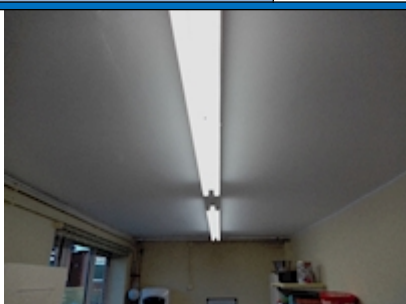
Building	Hatfeild Primary School			Floor	0		
Location Description	2/006: Kitchen			Record Origin Report	B14465		
Item	Textured coating to ceiling (has now been removed by Merton)

Level of Identification (ID)	Inspected Area (IA)	Sample No.					
Material		Extent					
Accessibility							
Identification							
Material Assessment							
Product Type		Condition		Surface Treatment		Asbestos Type	
Priority Assessment (for more detail see Section 4.0)							
Occupant Activity		Disturbance		Human Exposure		Maintenance Activity	
Scoring Summary							
Material Score		Priority Score		Total Risk		Risk Priority	
Recommended Action	No Recommendation Required						
Further Information	No suspect materials seen

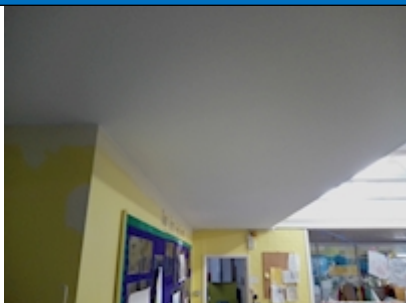
Building	Hatfeild Primary School			Floor	0		
Location Description	2/007: Classroom			Record Origin Report	B14465		
Item	Textured coating to ceiling (has now been removed by Merton)

Level of Identification (ID)	Inspected Area (IA)	Sample No.					
Material		Extent					
Accessibility							
Identification							
Material Assessment							
Product Type		Condition		Surface Treatment		Asbestos Type	
Priority Assessment (for more detail see Section 4.0)							
Occupant Activity		Disturbance		Human Exposure		Maintenance Activity	
Scoring Summary							
Material Score		Priority Score		Total Risk		Risk Priority	
Recommended Action	No Recommendation Required						
Further Information	No suspect materials seen

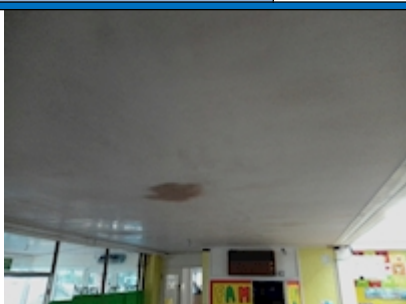
Building	Hatfeild Primary School			Floor	0		
Location Description	2/007A: Classroom			Record Origin Report	B14465		
Item	Textured coating to ceiling (has now been removed by Merton)

Level of Identification (ID)	Inspected Area (IA)	Sample No.					
Material		Extent					
Accessibility							
Identification							
Material Assessment							
Product Type		Condition		Surface Treatment		Asbestos Type	
Priority Assessment (for more detail see Section 4.0)							
Occupant Activity		Disturbance		Human Exposure		Maintenance Activity	
Scoring Summary							
Material Score		Priority Score		Total Risk		Risk Priority	
Recommended Action	No Recommendation Required						
Further Information	No suspect materials seen

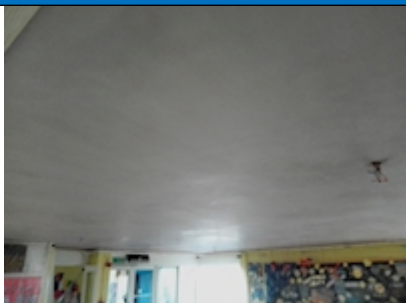
Building	Hatfeild Primary School			Floor	0		
Location Description	2/007B: Classroom			Record Origin Report	B14465		
Item	Textured coating to ceiling (has now been removed by Merton)

Level of Identification (ID)	Inspected Area (IA)	Sample No.					
Material		Extent					
Accessibility							
Identification							
Material Assessment							
Product Type		Condition		Surface Treatment		Asbestos Type	
Priority Assessment (for more detail see Section 4.0)							
Occupant Activity		Disturbance		Human Exposure		Maintenance Activity	
Scoring Summary							
Material Score		Priority Score		Total Risk		Risk Priority	
Recommended Action	No Recommendation Required						
Further Information	No suspect materials seen

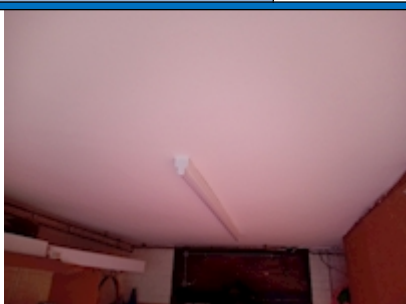
Building	Hatfeild Primary School			Floor	0		
Location Description	2/008: Boiler Room			Record Origin Report	B14465		
Item	Textured coating to ceiling (has now been removed by Merton)

Level of Identification (ID)	Inspected Area (IA)	Sample No.					
Material		Extent					
Accessibility							
Identification							
Material Assessment							
Product Type		Condition		Surface Treatment		Asbestos Type	
Priority Assessment (for more detail see Section 4.0)							
Occupant Activity		Disturbance		Human Exposure		Maintenance Activity	
Scoring Summary							
Material Score		Priority Score		Total Risk		Risk Priority	
Recommended Action	No Recommendation Required						
Further Information	No suspect materials seen

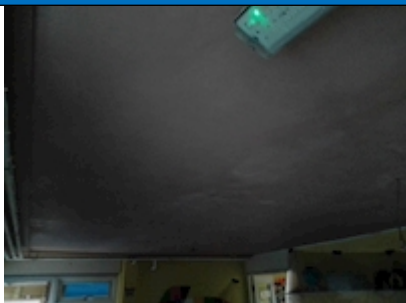
Building	Hatfeild Primary School			Floor	0		
Location Description	2/009: Play Area			Record Origin Report	B14465		
Item	Textured coating to ceiling (has now been removed by Merton)

Level of Identification (ID)	Inspected Area (IA)	Sample No.					
Material		Extent					
Accessibility							
Identification							
Material Assessment							
Product Type		Condition		Surface Treatment		Asbestos Type	
Priority Assessment (for more detail see Section 4.0)							
Occupant Activity		Disturbance		Human Exposure		Maintenance Activity	
Scoring Summary							
Material Score		Priority Score		Total Risk		Risk Priority	
Recommended Action	No Recommendation Required						
Further Information	No suspect materials seen

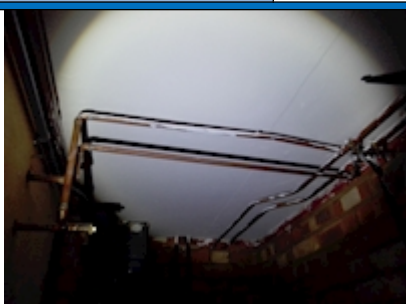
Building	Hatfeild Primary School			Floor	0		
Location Description	2/010: Store			Record Origin Report	B14465		
Item	Textured coating to ceiling (has now been removed by Merton)

Level of Identification (ID)	Inspected Area (IA)	Sample No.					
Material		Extent					
Accessibility							
Identification							
Material Assessment							
Product Type		Condition		Surface Treatment		Asbestos Type	
Priority Assessment (for more detail see Section 4.0)							
Occupant Activity		Disturbance		Human Exposure		Maintenance Activity	
Scoring Summary							
Material Score		Priority Score		Total Risk		Risk Priority	
Recommended Action	No Recommendation Required						
Further Information	No suspect materials seen

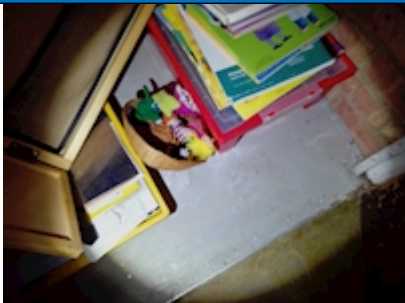
Building	Hatfeild Primary School			Floor	0		
Location Description	2/010: Store			Record Origin Report	B14465		
Item	Bitumen adhesive residue to floor (has now been removed by Merton) Textured coating to ceiling (has now been removed by Merton)

Level of Identification (ID)	Inspected Area (IA)	Sample No.					
Material		Extent					
Accessibility							
Identification							
Material Assessment							
Product Type		Condition		Surface Treatment		Asbestos Type	
Priority Assessment (for more detail see Section 4.0)							
Occupant Activity		Disturbance		Human Exposure		Maintenance Activity	
Scoring Summary							
Material Score		Priority Score		Total Risk		Risk Priority	
Recommended Action	No Recommendation Required						
Further Information	No suspect materials seen

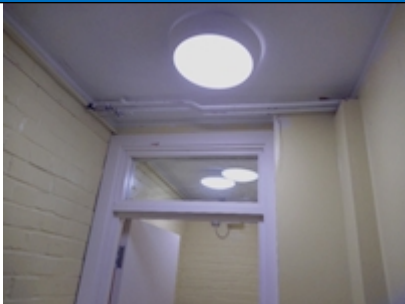
Building	Hatfeild Primary School			Floor	0		
Location Description	2/012: WC			Record Origin Report	B14465		
Item	Textured coating to ceiling (has now been removed by Merton)

Level of Identification (ID)	Inspected Area (IA)	Sample No.					
Material		Extent					
Accessibility							
Identification							
Material Assessment							
Product Type		Condition		Surface Treatment		Asbestos Type	
Priority Assessment (for more detail see Section 4.0)							
Occupant Activity		Disturbance		Human Exposure		Maintenance Activity	
Scoring Summary							
Material Score		Priority Score		Total Risk		Risk Priority	
Recommended Action	No Recommendation Required						
Further Information	No suspect materials seen

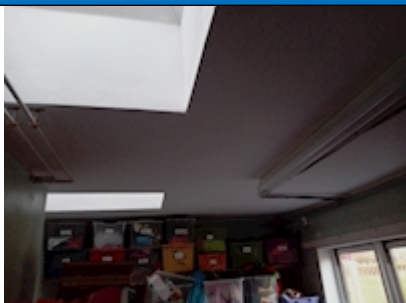
Building	Hatfeild Primary School			Floor	0		
Location Description	2/013: Store			Record Origin Report	B14465		
Item	Textured coating to ceiling (has now been removed by Merton)

Level of Identification (ID)	Inspected Area (IA)	Sample No.					
Material		Extent					
Accessibility							
Identification							
Material Assessment							
Product Type		Condition		Surface Treatment		Asbestos Type	
Priority Assessment (for more detail see Section 4.0)							
Occupant Activity		Disturbance		Human Exposure		Maintenance Activity	
Scoring Summary							
Material Score		Priority Score		Total Risk		Risk Priority	
Recommended Action	No Recommendation Required						
Further Information	No suspect materials seen

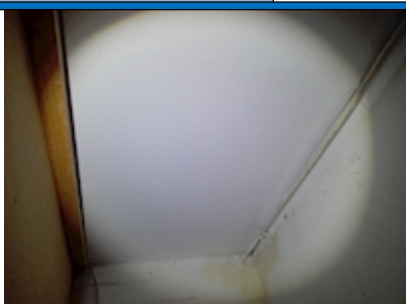
Building	Hatfeild Primary School			Floor	0		
Location Description	2/015: Store			Record Origin Report	B14465		
Item	Textured coating to ceiling (has now been removed by Merton)

Level of Identification (ID)	Inspected Area (IA)	Sample No.					
Material		Extent					
Accessibility							
Identification							
Material Assessment							
Product Type		Condition		Surface Treatment		Asbestos Type	
Priority Assessment (for more detail see Section 4.0)							
Occupant Activity		Disturbance		Human Exposure		Maintenance Activity	
Scoring Summary							
Material Score		Priority Score		Total Risk		Risk Priority	
Recommended Action	No Recommendation Required						
Further Information	No suspect materials seen

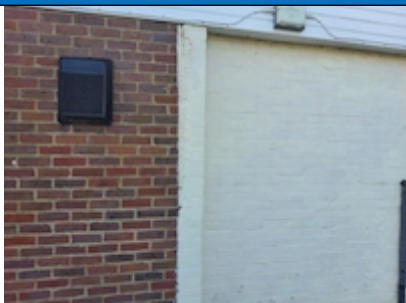
Building	Hatfeild Primary School				Floor	Ext	
Location Description	Ext: External				Record Origin Report	B14465	
Item	Mastic expansion joint to kitchen wall

Level of Identification (ID)	Strongly Presumed (SP)	Sample No.					
Material	Composite Material	Extent	5 lm				
Accessibility	Usually inaccessible or unlikely to be disturbed						
Identification	Chrysotile						
Material Assessment							
Product Type	1	Condition	0	Surface Treatment	0	Asbestos Type	1
Priority Assessment (for more detail see Section 4.0)							
Occupant Activity	0	Disturbance	0	Human Exposure	0	Maintenance Activity	1
Scoring Summary							
Material Score	2	Priority Score	1	Total Risk	3	Risk Priority	VERY LOW
Recommended Action	Manage and Re-inspect						
Further Information

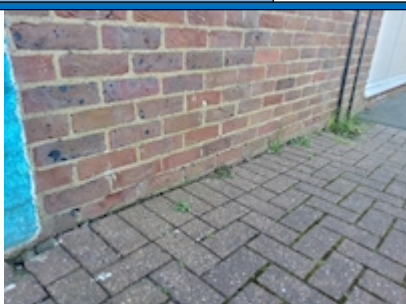
Building	Hatfeild Primary School				Floor	Ext	
Location Description	Ext: External				Record Origin Report	B14465	
Item	Damp proof course

Level of Identification (ID)	Strongly Presumed (SP)	Sample No.					
Material	Bitumen Product	Extent	500 lm				
Accessibility	Usually inaccessible or unlikely to be disturbed						
Identification	Chrysotile						
Material Assessment							
Product Type	1	Condition	0	Surface Treatment	0	Asbestos Type	1
Priority Assessment (for more detail see Section 4.0)							
Occupant Activity	0	Disturbance	1	Human Exposure	0	Maintenance Activity	1
Scoring Summary							
Material Score	2	Priority Score	2	Total Risk	4	Risk Priority	VERY LOW
Recommended Action	Manage and Re-inspect						
Further Information
