ASBESTOS REINSPECTION SURVEY
OF
MALMESBURY PRIMARY SCHOOL, MALMESBURY ROAD, MORDEN, SURREY, SM4 6HG

CLIENT: LONDON BOROUGH OF MERTON
CIVIC CENTRE, LONDON ROAD, MORDEN, SM4 5DX

UPRN NO: N/A
PROJECT NO: J994913
DATE: December 2024

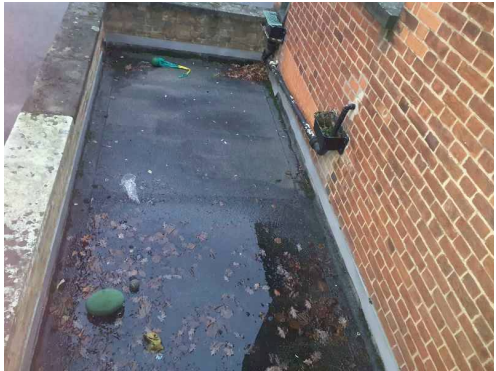
FLOOR/LOCATION:	External External Block A	
DESCRIPTION:	Presumed asbestos containing materials within roofing felt	
RECOMMENDATIONS:	Conduct further investigation prior to relevant maintenance / refurbishment / demolition work	
EXTENT:	>50m ² or >50m pipe run	
SAMPLE REF:	Presumed	
RESULT:	Presumed Crocidolite (or unknown)

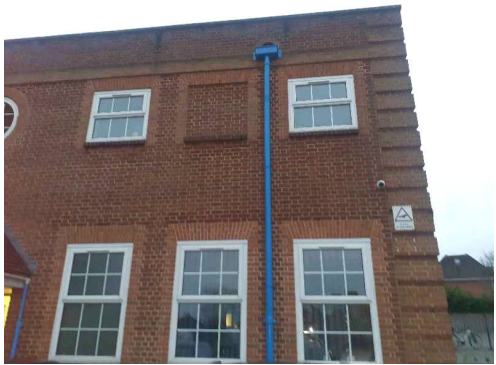
FLOOR/LOCATION:	External External Block A	
DESCRIPTION:	Presumed asbestos containing materials within sealant to windows and doors	
RECOMMENDATIONS:	Conduct further investigation prior to relevant maintenance / refurbishment / demolition work	
EXTENT:	>50m ² or >50m pipe run	
SAMPLE REF:	Presumed	
RESULT:	Presumed Crocidolite (or unknown)

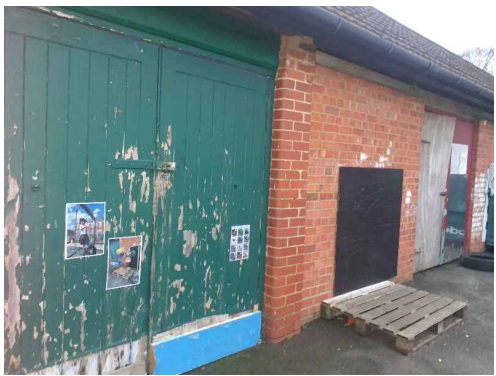
FLOOR/LOCATION:	External External Block B Store	
DESCRIPTION:	Presumed asbestos containing materials within sealant to door frame	
RECOMMENDATIONS:	Conduct further investigation prior to relevant maintenance / refurbishment / demolition work	
EXTENT:	10 - 50 m ² or 10 - 50m pipe run	
SAMPLE REF:	Presumed	
RESULT:	Presumed Crocidolite (or unknown)

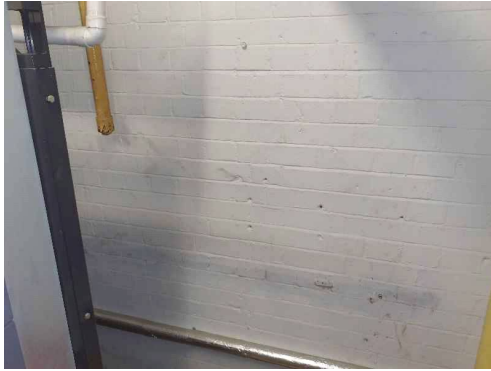
FLOOR/LOCATION:	Z-Sub Level 1 B/002 Boiler Room	
DESCRIPTION:	Presumed asbestos containing materials within wall plugs	
RECOMMENDATIONS:	Conduct further investigation prior to relevant maintenance / refurbishment / demolition work	
EXTENT:	10 - 50 m ² or 10 - 50m pipe run	
SAMPLE REF:	Presumed	
RESULT:	Presumed Crocidolite (or unknown)

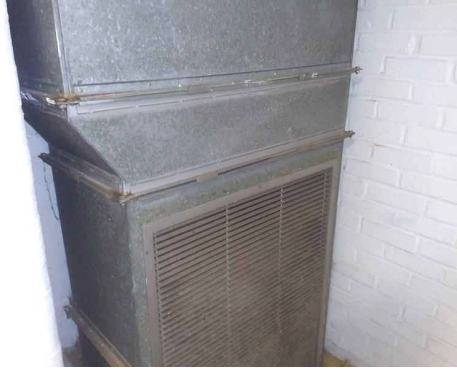
FLOOR/LOCATION:	Z-Sub Level 1 B/002 Boiler Room	
DESCRIPTION:	Presumed asbestos containing materials within mastic to ducting	
RECOMMENDATIONS:	Conduct further investigation prior to relevant maintenance / refurbishment / demolition work	
EXTENT:	10 - 50 m ² or 10 - 50m pipe run	
SAMPLE REF:	Presumed	
RESULT:	Presumed Crocidolite (or unknown)

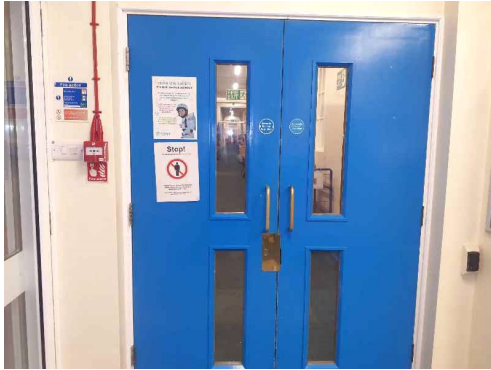
FLOOR/LOCATION:	Ground Floor 002 Throughout Ground Floor	
DESCRIPTION:	Presumed asbestos containing materials within fire doors	
RECOMMENDATIONS:	Conduct further investigation prior to relevant maintenance / refurbishment / demolition work	
EXTENT:	10 - 50 m ² or 10 - 50m pipe run	
SAMPLE REF:	Presumed	
RESULT:	Presumed Crocidolite (or unknown)

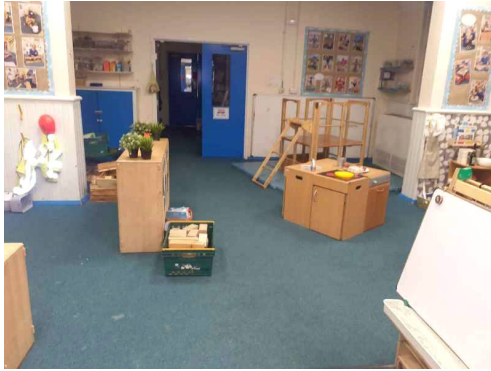
FLOOR/LOCATION:	Ground Floor 002 Throughout Ground Floor	
DESCRIPTION:	Presumed asbestos containing materials within below fitted carpet	
RECOMMENDATIONS:	Conduct further investigation prior to relevant maintenance / refurbishment / demolition work	
EXTENT:	>50m² or >50m pipe run	
SAMPLE REF:	Presumed	
RESULT:	Presumed Crocidolite (or unknown)

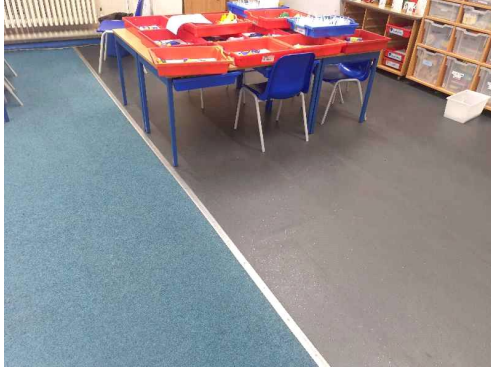
FLOOR/LOCATION:	Ground Floor 002 Throughout Ground Floor	
DESCRIPTION:	Presumed asbestos containing materials below timber parquet flooring under carpet/linoleum	
RECOMMENDATIONS:	Conduct further investigation prior to relevant maintenance / refurbishment / demolition work	
EXTENT:	>50m² or >50m pipe run	
SAMPLE REF:	Presumed	
RESULT:	Presumed Crocidolite (or unknown)

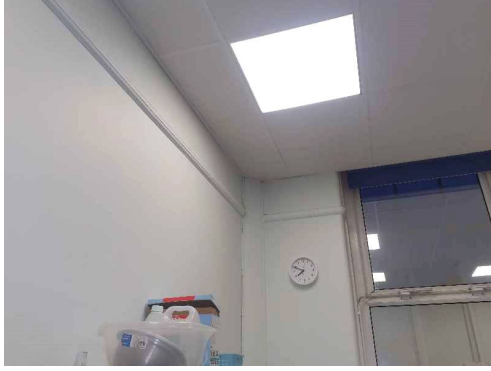
FLOOR/LOCATION:	Ground Floor 002 Throughout Ground Floor	
DESCRIPTION:	Presumed asbestos containing materials within timber boxings throughout	
RECOMMENDATIONS:	Conduct further investigation prior to relevant maintenance / refurbishment / demolition work	
EXTENT:	>50m² or >50m pipe run	
SAMPLE REF:	Presumed	
RESULT:	Presumed Crocidolite (or unknown)

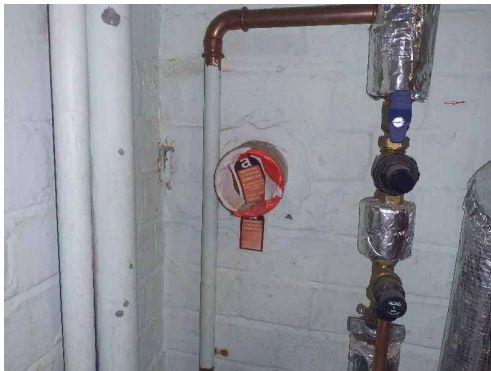
Man											
Man		1st Floor / 1/033 Cleaners Store (1)	1 - 3 (1)	Cement pipe collar (1)	1m ^L (1)	Unsealed (1)	Low Damage (1)	Low (1)	MPS/MW/1/069/18 {XY005217} / Chrysotile (1)	4 + 4 = 8	Very Low
Man	1st Floor / 1/033 Cleaners Store	-	All other areas visually no asbestos identified	-	-	-	-		-	-	No further action required
Man											
Man	External / External Block A (0)	None (0)	Presumed asbestos containing materials within roofing felt (1)	108m² (3)	Composite Material (0)	Good Condition (0)	Low (1)	Crocidolite (or unknown) (3)	4 + 4 = 8	Very Low	Conduct further investigation prior to relevant maintenance / refurbishment / demolition work
Man	External / External Block A (0)	None (0)	Presumed asbestos containing materials within sealant to windows and doors (1)	100m ^L (3)	Composite Material (0)	Good Condition (0)	High (3)	Crocidolite (or unknown) (3)	4 + 6 = 10	Low	Conduct further investigation prior to relevant maintenance / refurbishment / demolition work

FLOOR/LOCATION:	1st Floor 1/033 Cleaners Store	
DESCRIPTION:	Cement pipe collar	
RECOMMENDATIONS:	Encapsulate	
EXTENT:	<10m² or <10m pipe run	
SAMPLE REF:	MPS/MW/1/069/18 {XY005217}	
RESULT:	Chrysotile
