Inspection Halton Village Hall

Date of issue: 20th November 2024

BATTRAM ASSOCIATES

HALTON VILLAGE HALL, INSPECTION

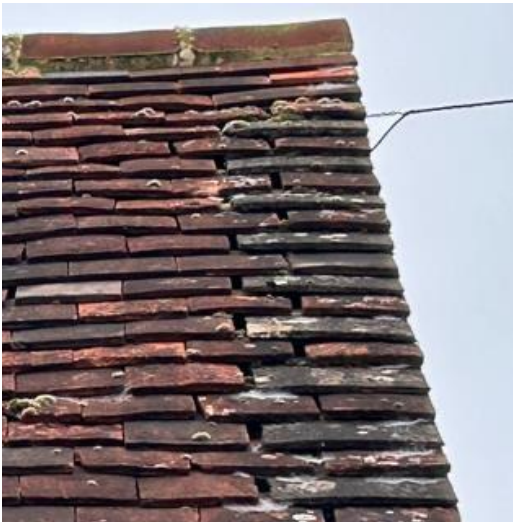
Ref	Element & description	Condition	Recommendation	Year
	<i>South facing roof</i>			
1	Roof slope	<p>Gapping noted between tiles to the eastern end of the roof. The end tiles had been replaced with 'tile and a half' in concrete tiles. As the ridge was straight and true and the roof slope had not dipped, we infer when the tiles were replaced, the spacing between the tiles had not been altered to suit rather than a defect with the rafters. There was no sign of internal water ingress at the time of inspection.</p>

Monitor into the long term.	Monitor

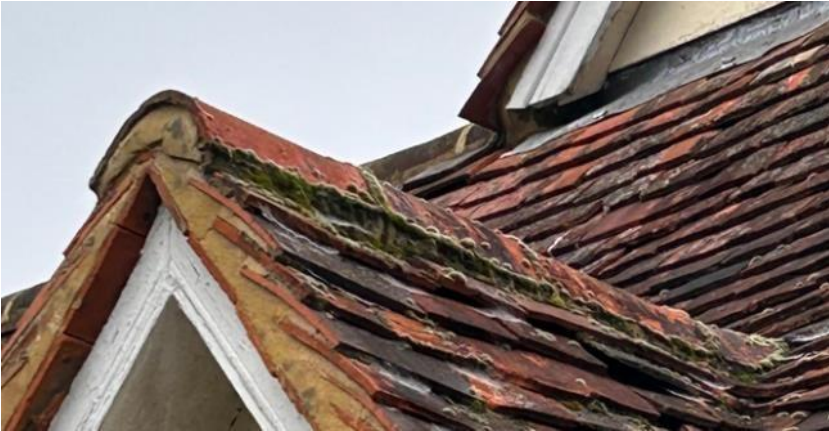
ROOF ELEMENTS see attached plan for exact location of item				
Ref	Element & description	Condition	Recommendation	Year
3	RHS dormer roof—ridge	<p>Moss present to benching and vertical joints. Intact for now.</p>

<p>Repair in the medium term. Ridge is becoming frost damaged, replacement ridge tiles will be required.</p>	4
4	RHS dormer roof—mortared verge	<p>Vertical cracks noted with staining and shaded to the lower elements. The mortar appeared quite sandy which can be more friable.</p>	<p>Rake out loose material and re-point with lime.</p>	3

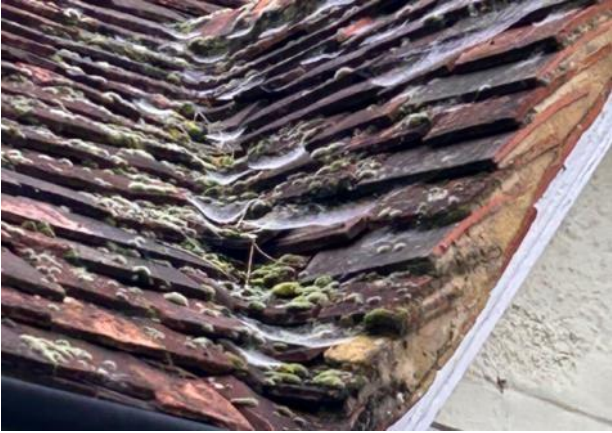
5	RHS dormer roof– LHS valley	<p>Moss present to valley– holding water in the slope and at the lower elements of the mortared verge. Small void/open area noted.</p>

<p>Clear moss and re-set any valley tiles. Possible replacement of some tiles if poor condition.</p>	<p>1 Maint</p>
---	--------------------------------	---	--	--------------------

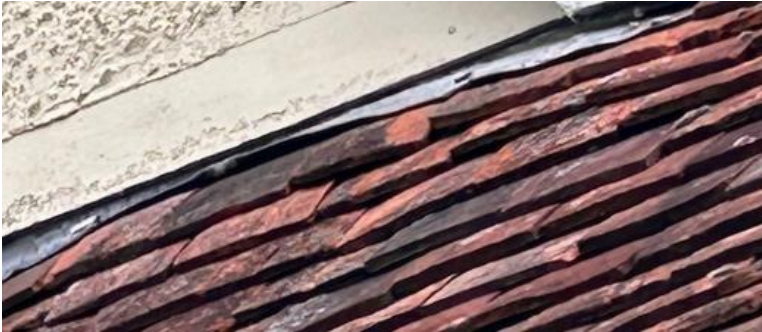
Ref	Element & description	Condition	Recommendation	Year
6	Roof slope – lead flashing at the junction with upper gable	<p>Lead flashing starting to lift but generally intact.</p>

<p>Monitor for now, beat down/repair if the lead continues to lift.</p>	<p>Monitor</p>

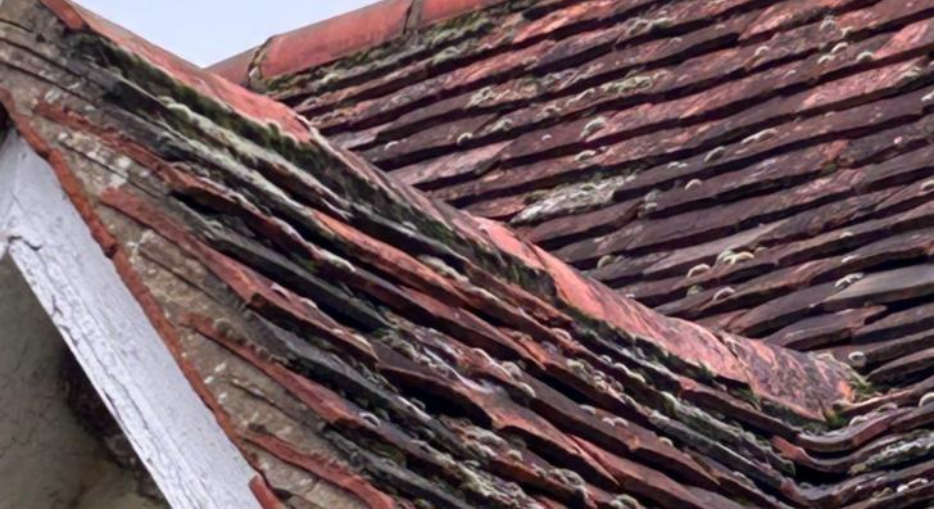
7	LHS dormer roof —ridge	<p>Moss present to benching and vertical joints. Intact for now although benching eroded. Ridge tiles also becoming frost damaged.</p>

<p>Lift and replace with new matching ridge tiles.</p>	3
---	------------------------	---	--	---

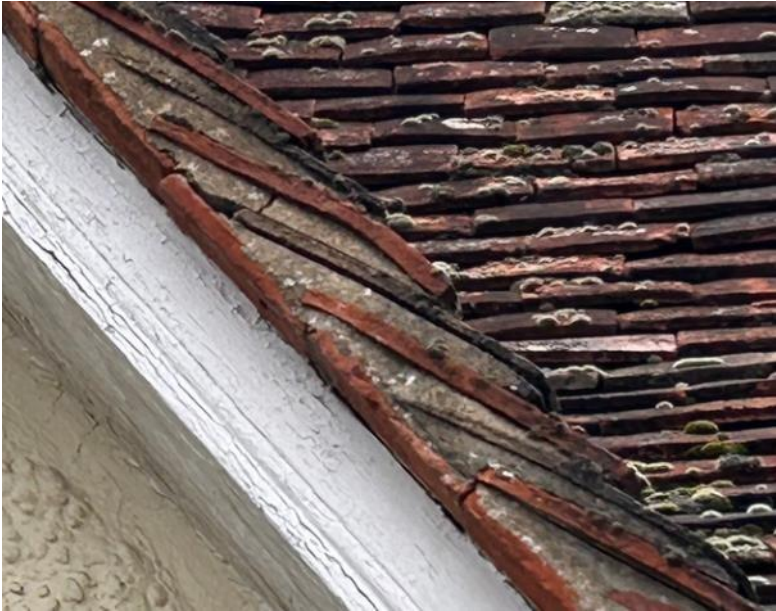
Ref	Element & description	Condition	Recommendation	year
8	LHS <i>dormer</i> , <i>RHS</i> valley	Moss present to valley. 2no valley tiles frost damaged.	Clear moss. Replace affected tiles.	1 and Maint'
9	LHS dormer, mortared verge	Cracks present, especially to RHS mid level. <div>

</div>	Re-point and make good.	3

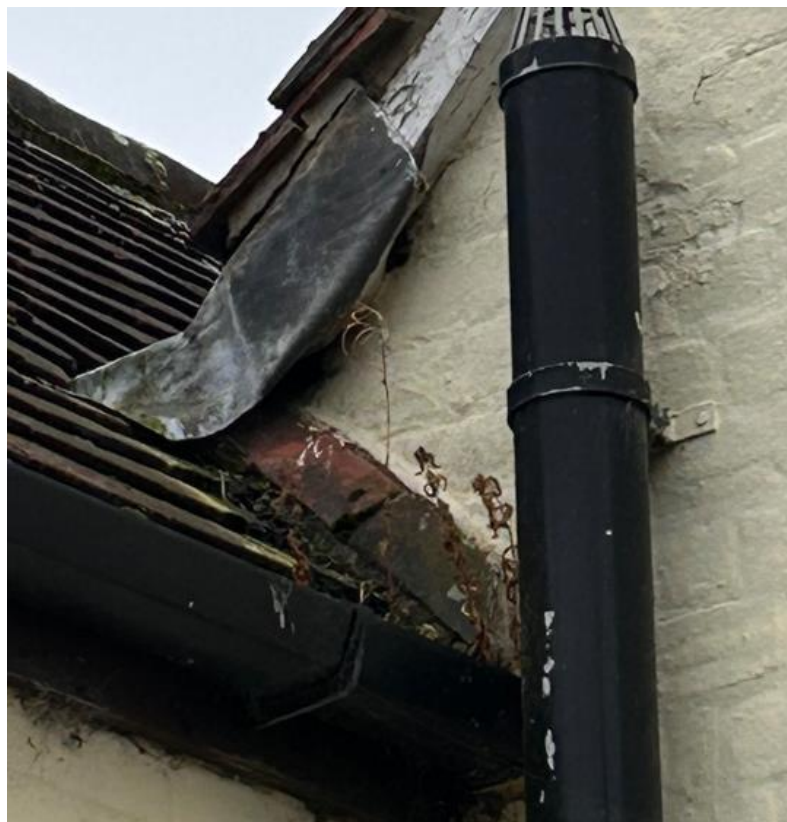
When viewed from the ground, the lead appeared to be intact albeit with a crack between the lead and the below mortar. The tiled fillet below was covered in algae and the guttering was blocked with plants. Internally at the foot of the stairs, damp ingress was seen to be pushing sideways through the wall. This is partly due to water being able to run down the wall. See comments and photos in EXTERNAL WALLS for further notes about damp at the bottom of the wall.

Clear the gutter.

Annually monitor the tile fillet and lead details and the internal ceilings into the future for any possible leaks. Liaise with neighbour as required.

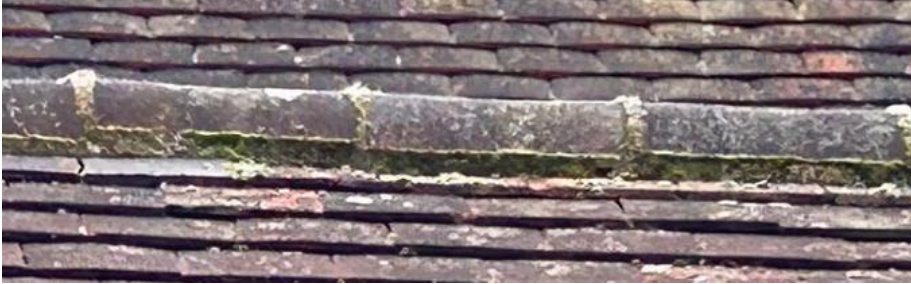
Ref	Element & description	Condition	Recommendation	Year
13	Western pitched roof—half round ridge southern	<p>When viewed from the ground, the western side of the ridge was in satisfactory order. Moss seen to the mortar benching and vertical joints. Slightly eroding mortar noted.</p>

<p>Monitor annually.</p> <p>Some mortar repairs likely in the medium/long term.</p>	<p>Monitor</p> <p>3-5</p>

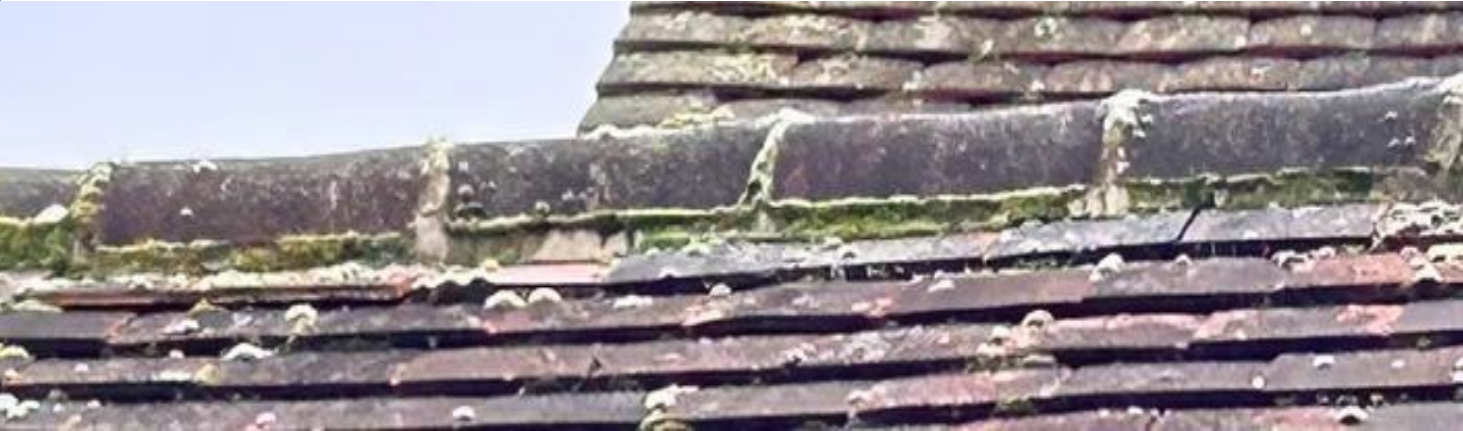
14	Western pitched roof—half round ridge, end ridge tile at the north	<p>End ridge tile had dropped slightly, moss covering present with decay noted to some of the other benching.</p>

<p>Mortar repairs will be needed in the medium term. Dependent on the severity of the winters, these repairs may be needed in the shorter term.</p>	3-5
----	--	--	---	-----

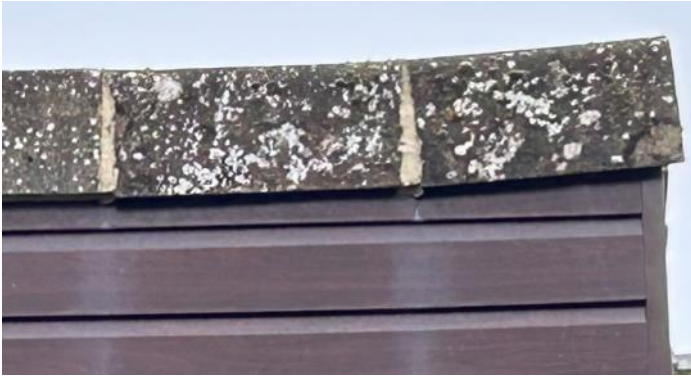
15	High level clerestory coping detail	<p>Joints intact between the coping stones. Stains running down the cladding below to indicate water runs down the joints. This is not an ideal detail as in the long term more maintenance will be required.</p>

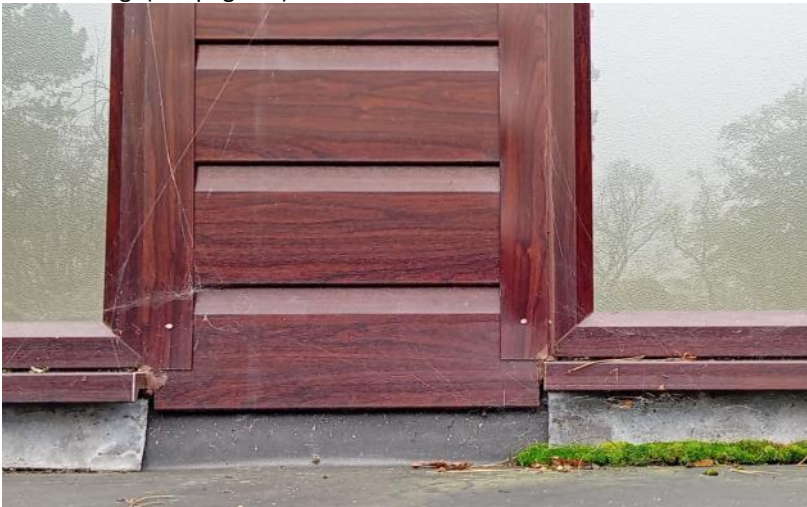
Monitor annually for decaying mortar.	Montitor
15a	Clerestory cladding and flat roof	<p>Rubber roof covering in good order. Moss buildup in front of RHS window to be removed. Brown mastic noted to the junction of cladding and sills – internal sign of water ingress in toilet ceiling. (see page 48)</p>

<p>Remove moss regularly.</p> <p>Remove some of the cladding between the windows and find out why the rainwater is being driven into the stud walling, and finding its way down past the back of the roof upstand, into the WC ceiling below.</p>	<p>Maint'</p> <p>1</p>

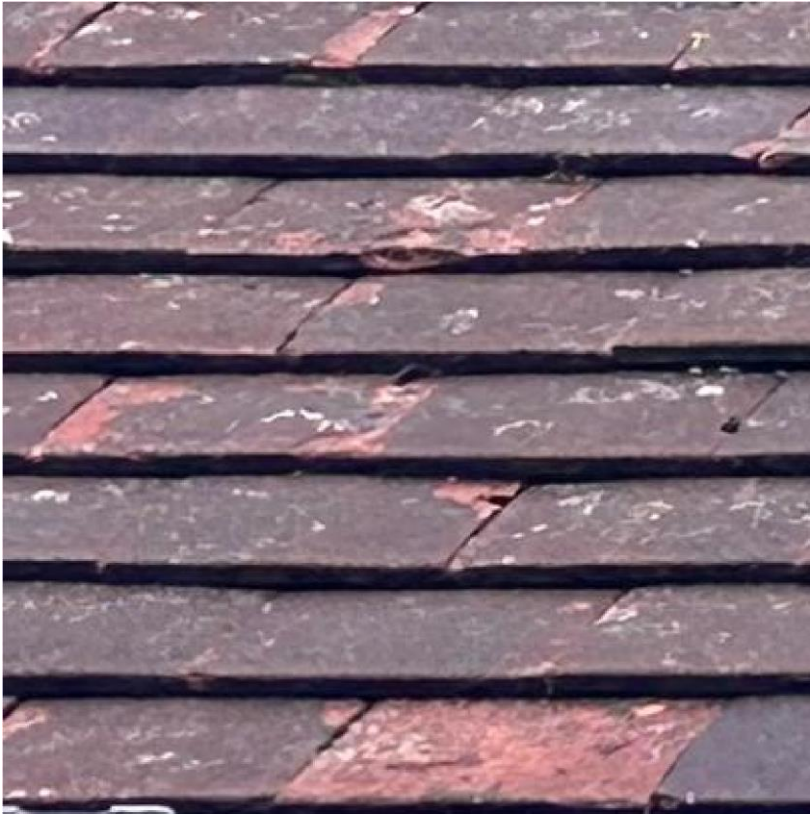
16	Western pitched roof— western facing slope	<p>Tiles presently in good order. Sporadic tiles are becoming frost damaged.</p>

<p>Monitor and replace significantly damaged tiles as part of routine maintenance. Likely from year 3-5</p>	<p>Maint' M</p>
----	---	--	---	---------------------

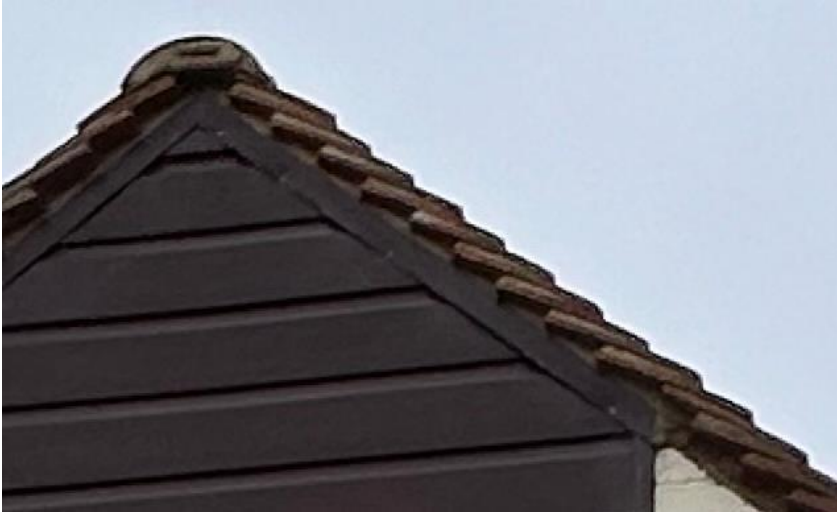
Ref	Element & description	Condition	Recommendation	Year
17	Western pitched roof – northern mortared verge	<p>Intact at present. Relatively recent repairs to the apex and the upper 1/3 on the RHS.</p>

Monitor into the future.	Monitor

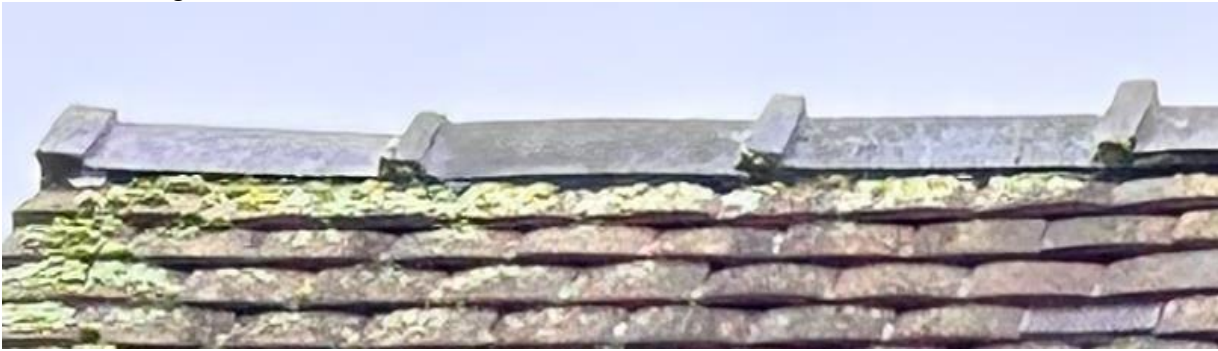
20	Eastern pitched roof (main hall) - interlocking tile ridge	<p>When viewed from the ground, it was noted to be slightly undulating. Minimal mortar benching was present. Moss to benching where visible.</p>

Monitor into the future.	Monitor
20A	Valley between pitched roof constructions	Viewed from the roof light in the office, the valley was clear and free flowing. The EDPM type roof covering was in good order to the areas we could see.	Inspect bi-annually to ensure the valley is clear.	Maint'
21	Eastern pitched roof (main hall) - western roof slope	Only c. top 20 courses visible from the ground. Generally satisfactory order. Moss/lichen growth noted to tiles directly below the ridge.	Monitor into the future.	Monitor
22	Eastern pitched roof (main hall) - eastern roof slope	Viewed from the road, in good order. These tiles appeared to be a more recent installation than the western slope.	Monitor into the future.	Monitor

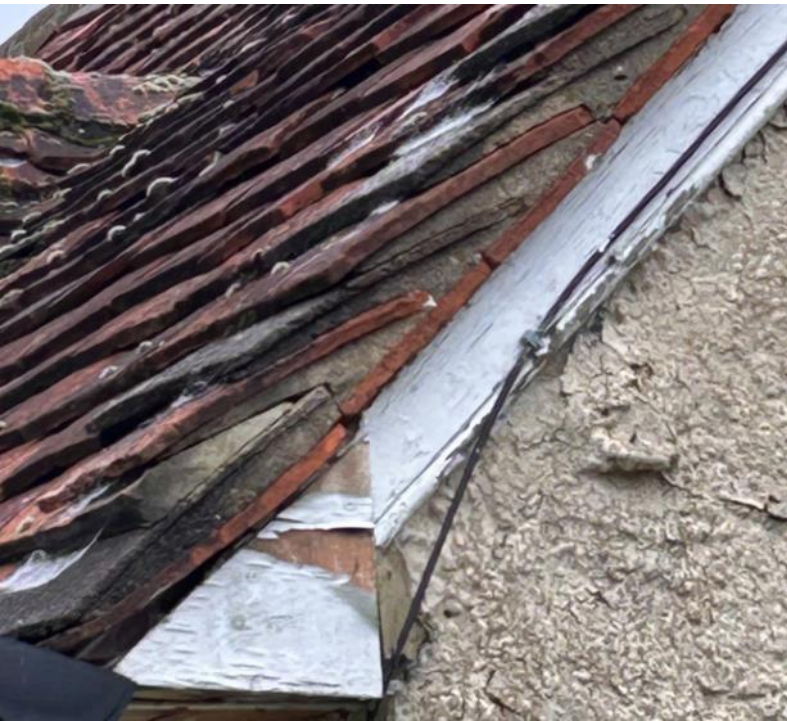
Ref	Element & description	Condition	Recommendation	Year
25	Northern gable of the front elevation roof range – LHS verge	Shaded throughout . Vertical cracks to the lower elements of the benching

Re-point in the medium term.	3

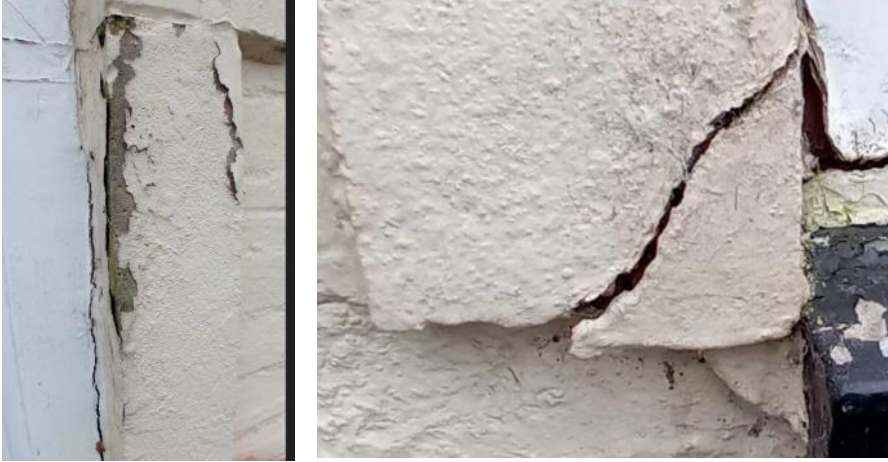
Ref	Element & description	Condition	Recommendation	Year
<i>Our observations commence on the N elevation of the main hall and working anti- clockwise around the building</i>				
EW 1	Main hall – north wall	<p>Applied cement framing adjacent to the window jambs. Paint coating peeling significantly, tapping hollow to indicate moisture is behind the cement</p>

Remove all failed material. Inspect the wall behind. A new detail should be designed in a suitable material e.g. lime render.	1

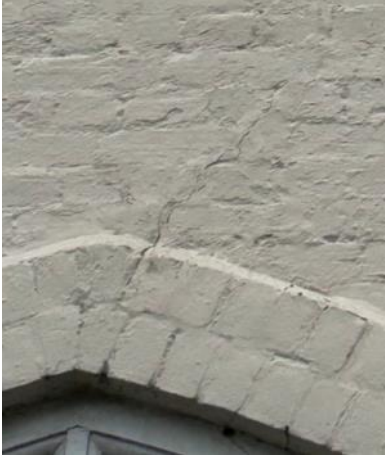
EW 2	Main hall – north wall: Brick arch above window	<p>Hairline crack vertically and heading up to RHS. This appears to have returned through the paint coating—evidence of historic making good. Typical defect noted at the weaker area at the head of the arch. Replicated internally— see internal wall record.</p>

Monitor annually.	Monitor
---------	--	---	-------------------	---------

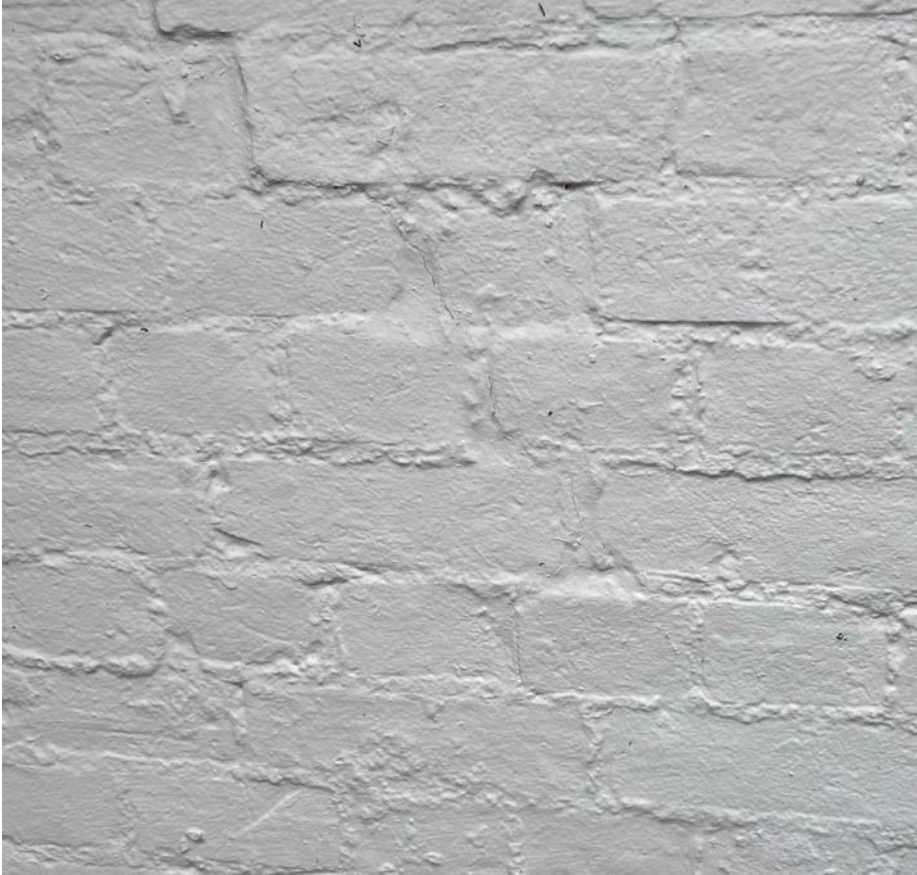
EW 4	Main hall – north wall: below feature window	<p>Diagonal hairline crack from the LHS sill, stopping 3no courses above the plinth. Signs of historic making good, the crack has opened up again (hairline):</p>

<p>To monitor.</p> <p>See comments also about removal of the inappropriate paint coating.</p>	Monitor
---------	---	---	---	---------

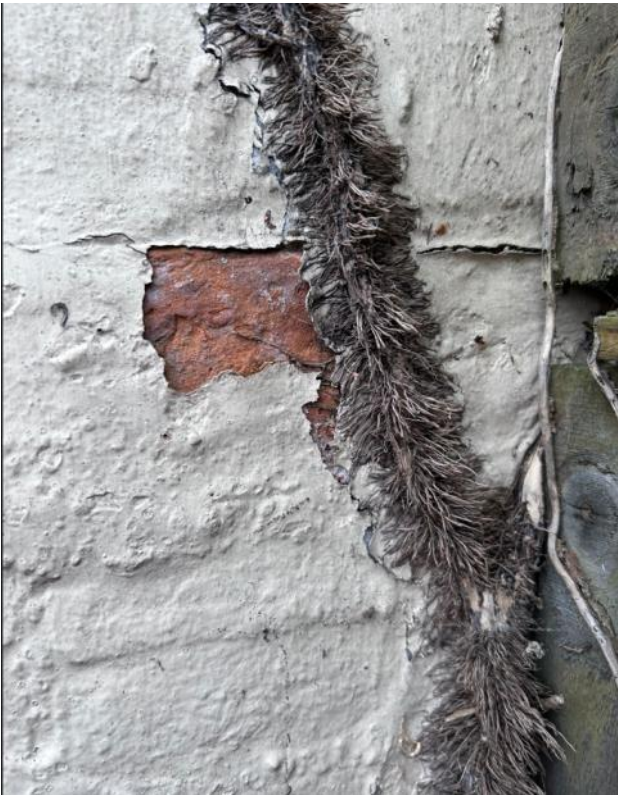
<p>EW 5</p>	<p>Main hall – north wall: brickwork</p>	<p>Bubbles seen coming through, raised and slightly bubbling mortar joints. Paint sections peeled to RHS mid height. Peeling paint at the head of the plinth.</p> <p>The paint covering is incompatible with the age and construction of the brickwork behind. The paint is preventing the brickwork from breathing, trapping moisture within the walling.</p>

<p>Remove paint covering and paint with fully breathable paint system. Some lime repointing of joints may be required when paint is removed.</p>

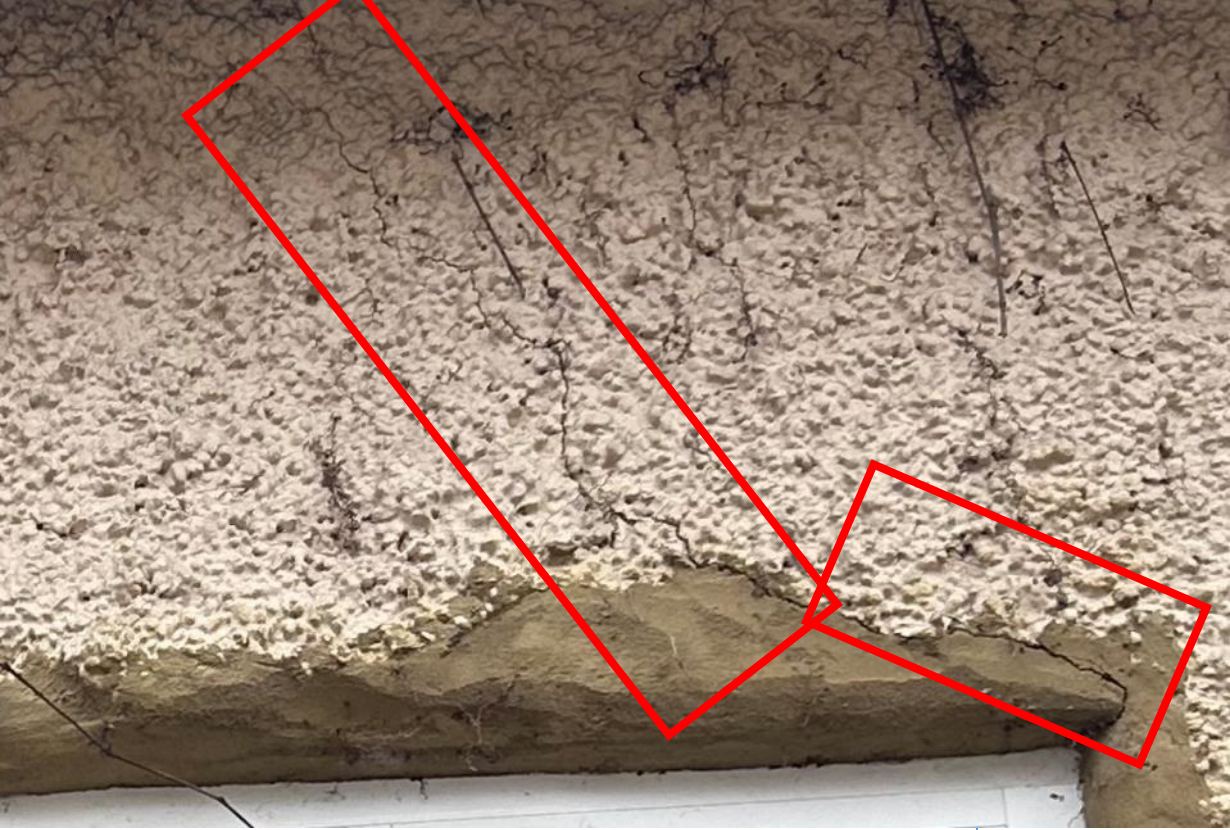
Ref	Element & description	Condition	Recommendation	Year
EW 8	Main hall– east wall , coarse pebbledash render: around fire doors	Cracks seen to mortar making good, linked to cracks to render above. Mortar also tapping hollow.	Render to be removed. Lime render should be used in replacement, to be fully designed out once the face of the wall is exposed. Careful attention to detail needed around window reveal.	1

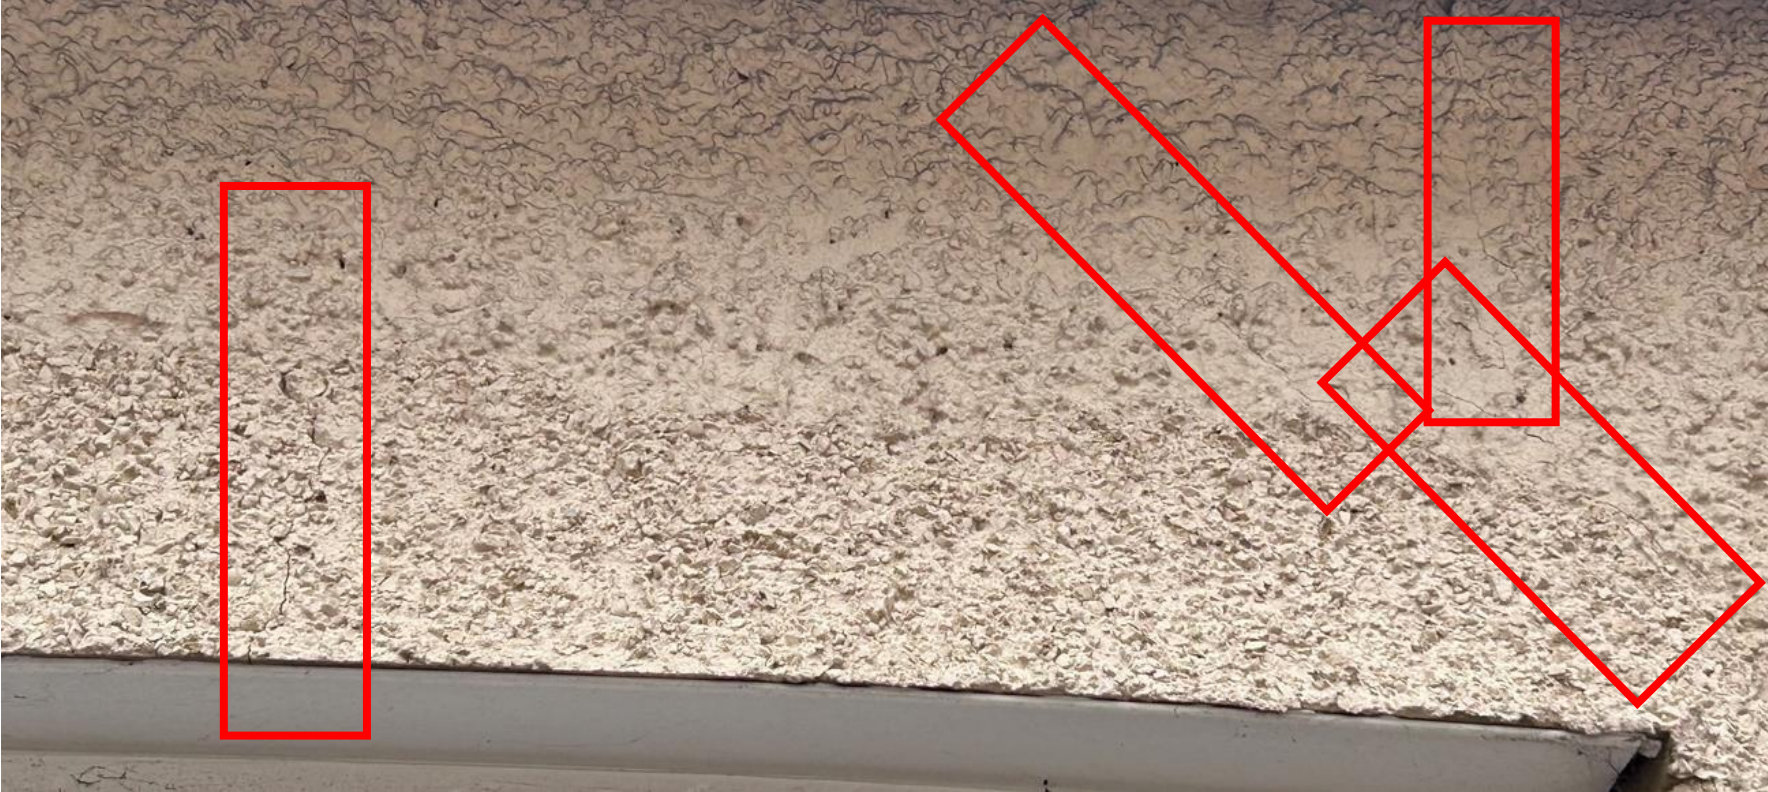
Ref	Element & description	Condition	Recommendation	Year
EW 9	Main hall– east wall , coarse pebbledash render: head of W1	Cracks seen to render. Tapping hollow to indicate moisture behind and failure of rendered surface.	Render to be removed. Lime render should be used in replacement, to be fully designed out once the face of the wall is exposed.	1

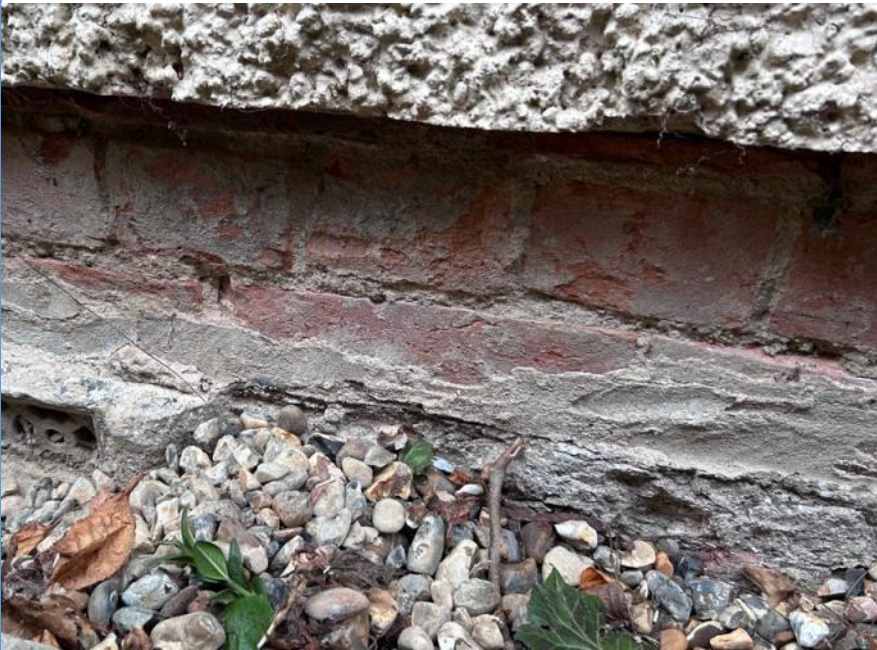
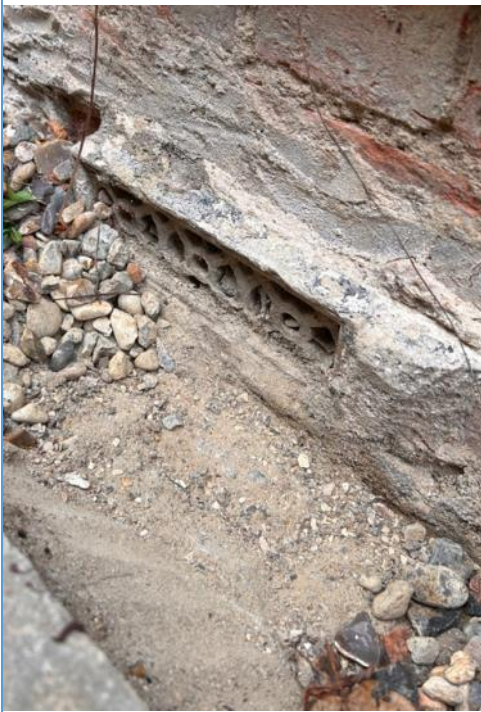
<p>EW 10</p>	<p>Main hall– east wall , base of the wall LHS fire doors and below W1.</p>	<p>Render removed from the lower 3/4no courses. Lime mortar joints were mostly intact, some friable joints noted. Some spalling/damage to the face of the lowest course of bricks where render has been removed.</p> <p>Airbrick ventilating subfloor was concealed with gravel. Concrete has been cast into a channel beneath the gravel. This supposed 'French drain' detail was formed incorrectly, the concrete holds the water at the base of the wall. This is the opposite to what a true well designed French drain should achieve. See further comments about the same channel at EW13 below.</p>

<p>Nominal lime re-pointing required– proposed lime render should be detailed to ensure brickwork protected but remain higher than ground level.</p> <p>See RAINWATER GOODS AND DRAINAGE FOR FURTHER RECOMMENDATIONS</p> <p>See recommendations in EW15 for discussion of the ground levels.</p>

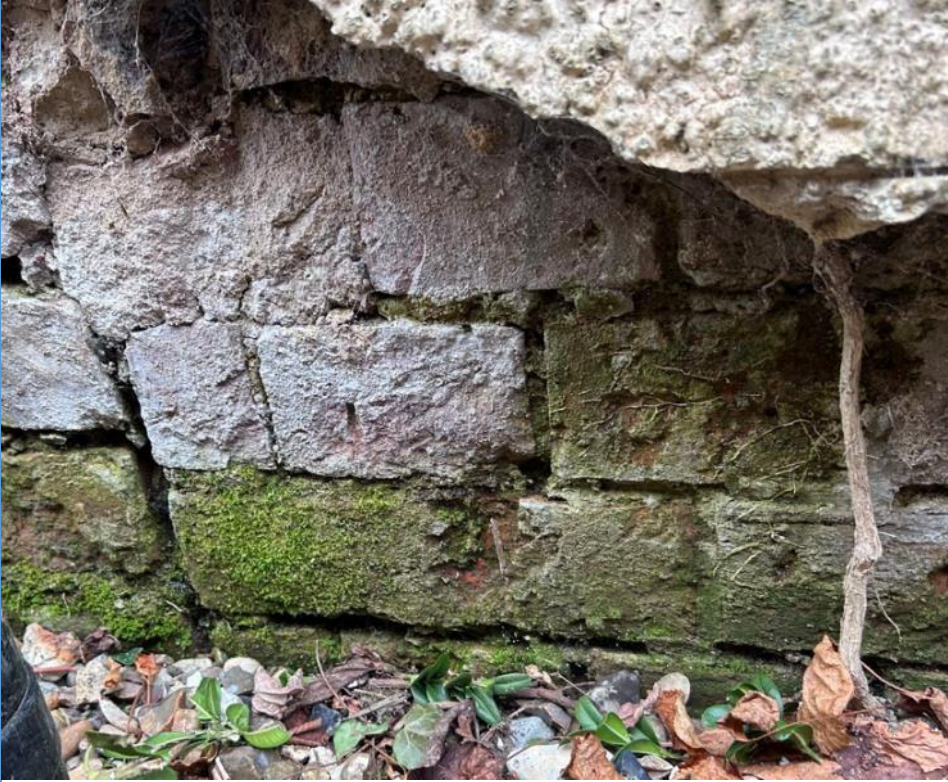
EW 12	Main hall– east wall exposed brickwork at the base of the wall around downpipe.	<p>Exposed brickwork in poor condition. Some hard cement render facing remains. Green algae and moss throughout, missing mortar and remaining mortar wet and crumbling.</p>

Rake out loose material, lime re-pointing required– proposed lime render should be detailed to ensure brickwork protected but remain higher than ground level.	1
----------	---	---	--	---

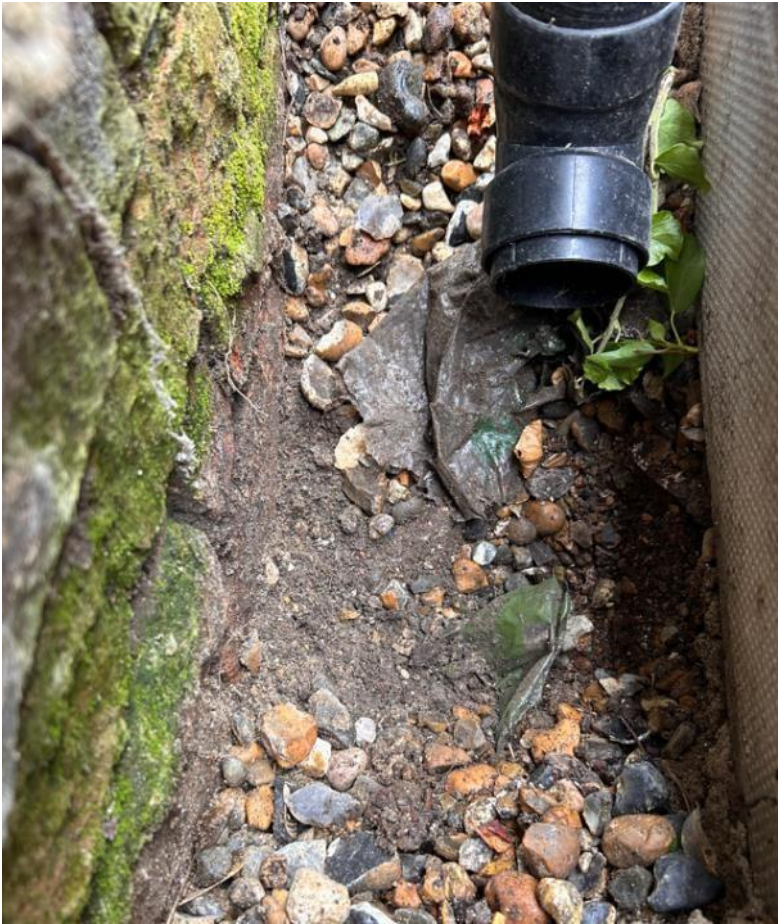
EW 13	Main hall– east wall : base of the wall around downpipe.	<p>Improper design and installation of a 'French drain'. Plastic sheeting found at the base of the gravel channel– again this ensures water sits at the base of the wall. This will cause long term issues with the brickwork and in turn possibly the suspended floor joists (see comments re FLOORS. The downpipe was also blocked.</p>

<p>Remove all gravel to channel to allow for well designed solution to drainage from the downpipe. See RAINWATER GOODS AND DRAINAGE FOR RECOMMENDATIONS</p> <p>Clear downpipe.</p> <p>See recommendations in EW15 for discussion of the ground levels.</p>	1
----------	--	---	--	---

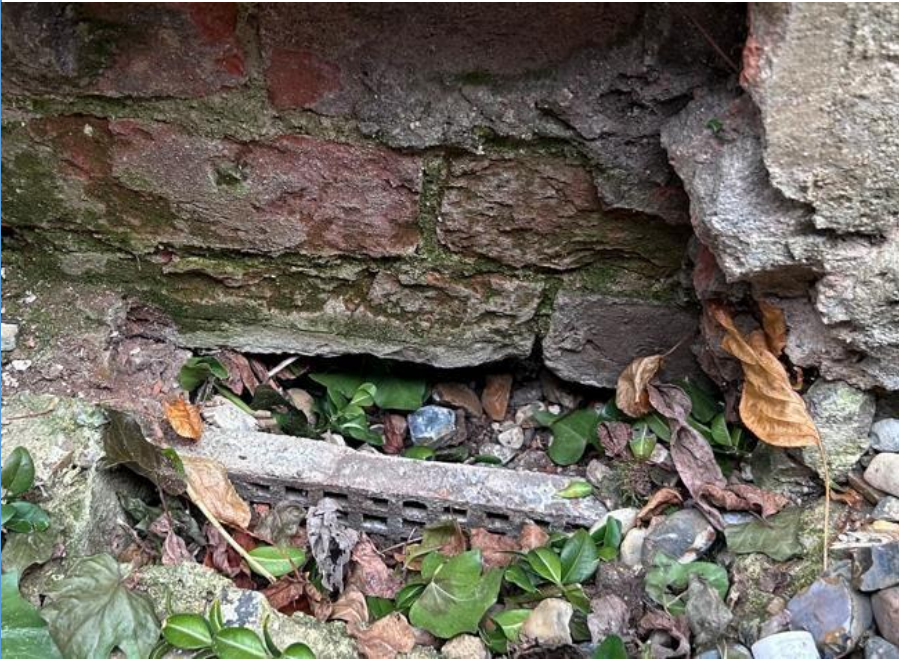
Ref	Element & description	Condition	Recommendation	Year
EW 14	Main hall– east wall LHS single fire door	Holes in pebbledash render. Hollow and cracked throughout .	Render to be removed. Lime render should be used in replacement, to be fully designed out once the face of the wall is exposed.	1
EW 15	Main hall– east wall : base of the wall LHS single fire door	<p>Airbrick and void was covered in gravel and leaf debris. This prevents adequate ventilation of the subfloor. The Some brickwork joints wet and friable. See comments about the FLOORS F2 later in this report.</p>

<p>Clear all the debris , re-site airbrick to ensure ventilation without open void to the subfloor.</p> <p>Lime re-point brickwork before any render is applied.</p> <p>Consideration should be given to any gravel at the base of the walls. The airbricks should remain above ground level and haunched around to ensure they do not become blocked. It is recommended the areas around the airbricks are reduced by circa 200mm to ensure good ventilation and prevent moisture becoming trapped in the base of the wall (see FLOORS for comments on the effects internally. Haunches should be provided around the air bricks.</p> <p>It is essential regular maintenance includes keeping the airbricks clear of debris.</p>	1

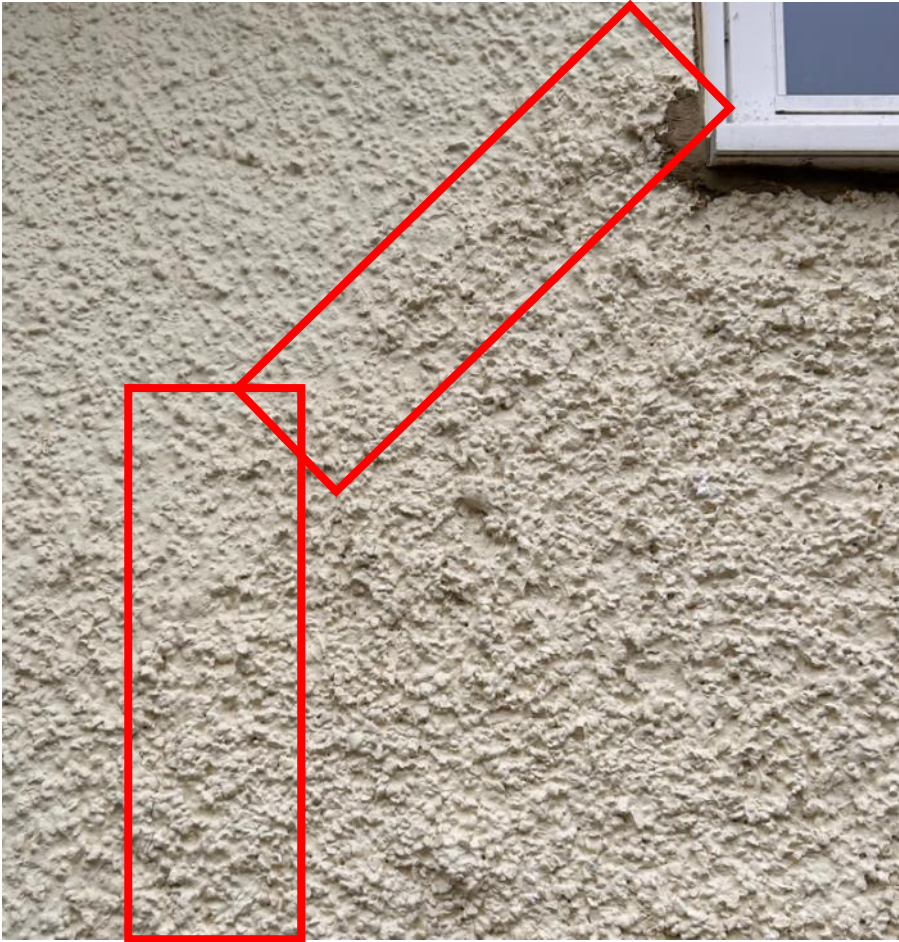
EW 17	Front (south) elevation– pebbledash render high level	Diagonal cracks to lower LHS and RHS of both first floor windows . Previous making good of render to these locations. Tapping slightly hollow to infer some background damp.

As render currently intact, use fine filler and monitor.	1
----------	--	---	--	---

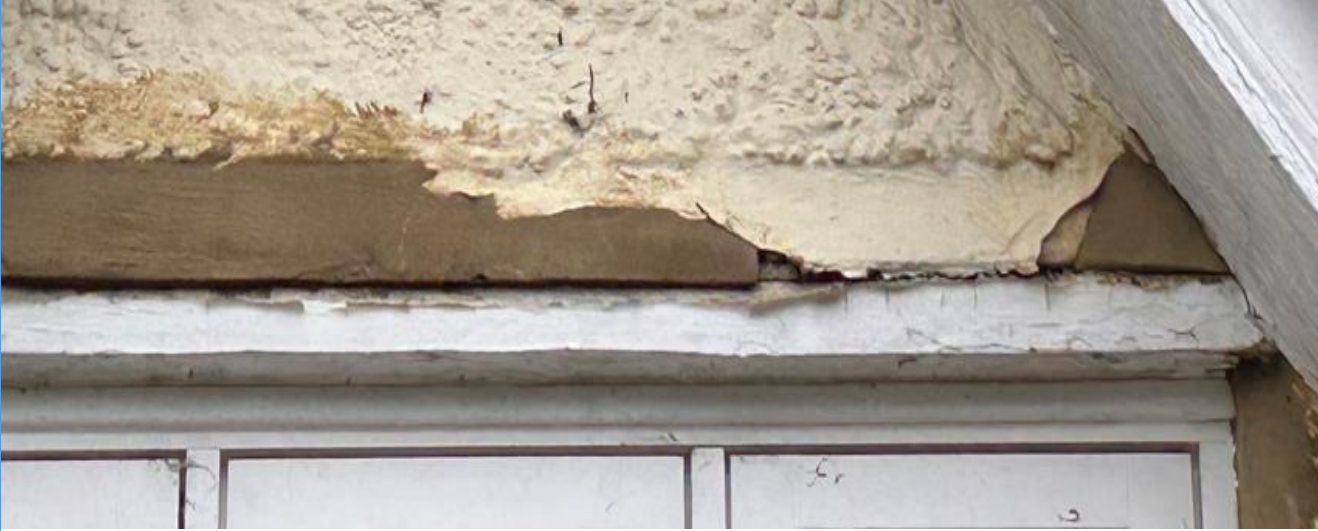
EW 18	Front (south) elevation— around first floor windows	<p>Inappropriate use of sand and cement mortar to make good around windows. This was poor workmanship and now failing. Hollow and render to the gable also tapping hollow.</p>

Remove all and replace in lime mortar. Repair render to gable. Any paint should be breathable.	1
EW 19	Front (south) elevation— high level render	<p>Hairline crack from the eaves behind downpipe, travelling and disappearing behind sign. Further hairline vertical crack from the eaves to the LHS of the upper LHS window, dissipating c.1m into wall below.</p>	As render currently intact, use fine filler and monitor.	1 and Monitor

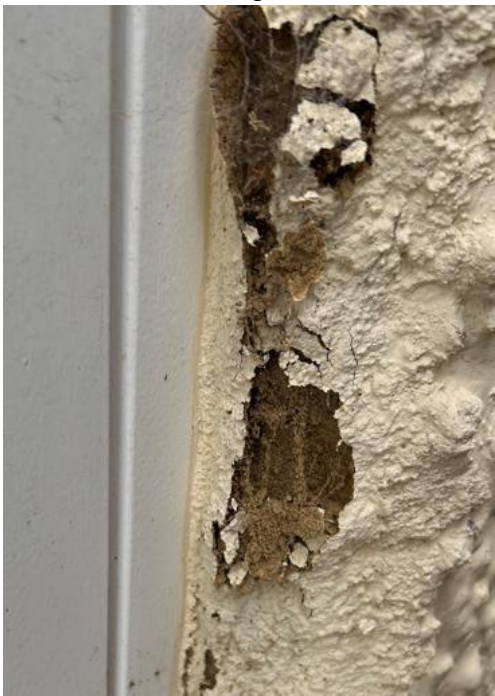
EW 21	Front (south) elevation– pebbledash render around RHS window	<p>Failed render and made good area. Sand and cement mortar behind had totally crumbled.</p>

<p>Remove all failed material and repair in lime. Paint with breathable paint</p>	1
EW 22	Front (south) elevation– rendered plinth at low level	<p>Bubbling paint to plinth surface. Tapping very hollow to the lower LHS of the RHS window, less to the lower LHS of the LHS window.</p>	<p>As intact for now, monitor and review at Y5.</p>	Monitor Y5
EW 23	West elevation– neighbours courtyard.	<p>We have noted in ROOF elements the blocked guttering at the neighbours' roof. Looking over the wall, we noted a good deal of vegetation on the floor below. As before, we suspect rainwater is overspilling the blocked guttering, running down the wall and pooling on their paving. This is causing damp to migrate sideways to the walling– smells of damp and slightly bubbling paint work was noted at the foot of the stairs.</p>	<p>It is essential the gutter and downpipe are cleared and the vegetation removed from the base of the wall.</p>	1 and Maint'

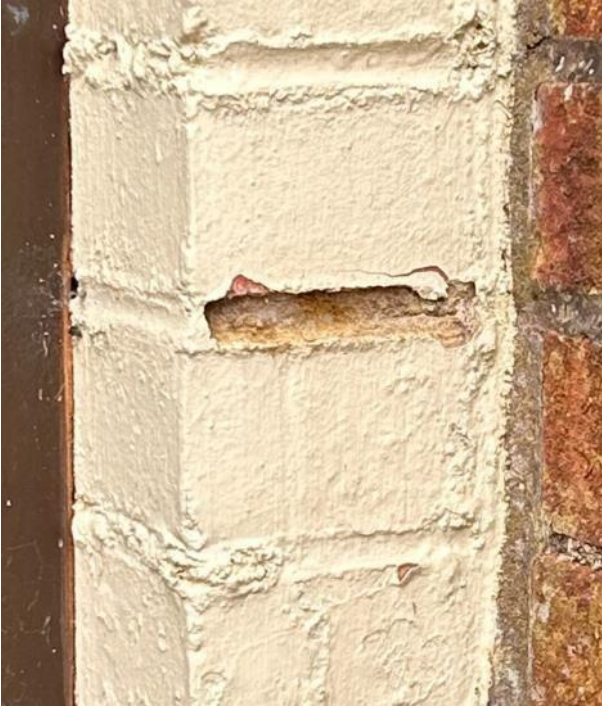
<p>EW 24</p>	<p>West elevation– painted brickwork</p>	<p>RHS entrance door: bubbling paint coating with some blistering to the mortar joints. One exposed and friable joint where paint has pushed off. As before, the use of an incompatible paint system is trapping moisture behind.</p> <p>Elsewhere on the elevation, the paint system was in better condition with less evidence of trapped moisture.</p> <p>The type of brick is more resistant to moisture– as such the actions are not urgent.</p>

<p>Ideally, remove paint coating to isolated area. Re-point joints and apply breathable paint system.</p> <p>Monitor remaining paintwork.</p>	<p>3– economies of scale may mean it should be packaged with N wall works.</p>
------------------	--	---	---	--

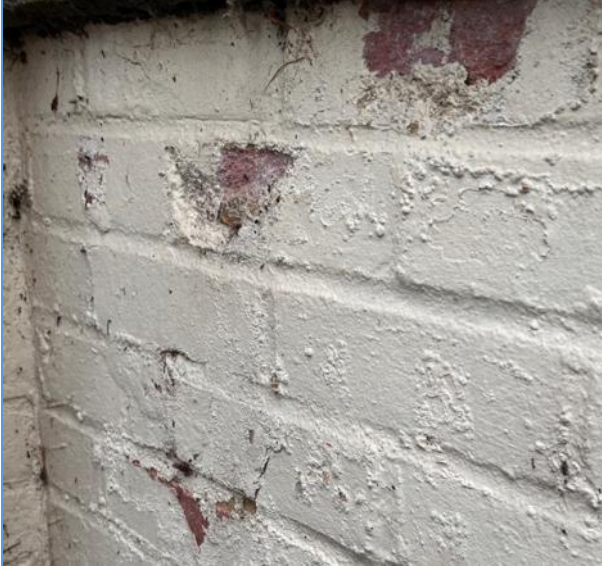
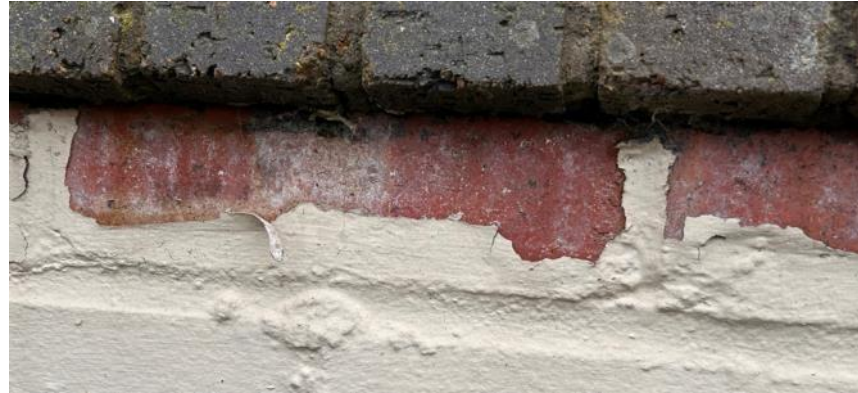
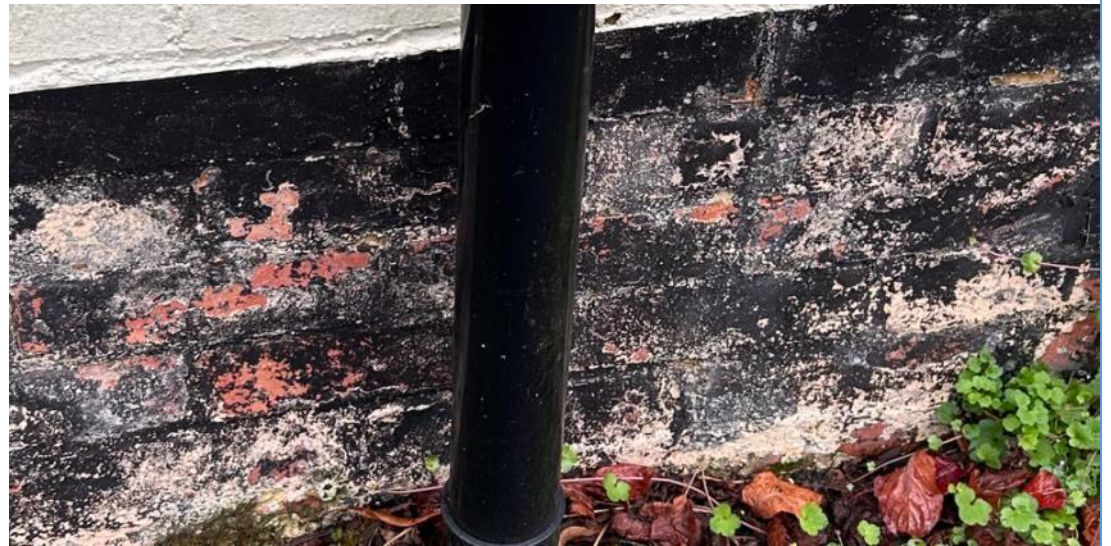
Bubbling paint and raised mortar joints. More advanced below sill and to black painted plinth. The type of brick is more resistant to moisture— as such the actions are not urgent.

Ideally, the paint coating should be removed from the wall. Re-applied paint will cause further damage and compromise the breathability of the system.

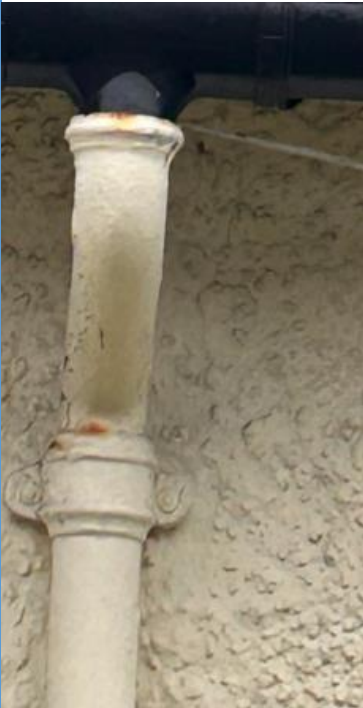
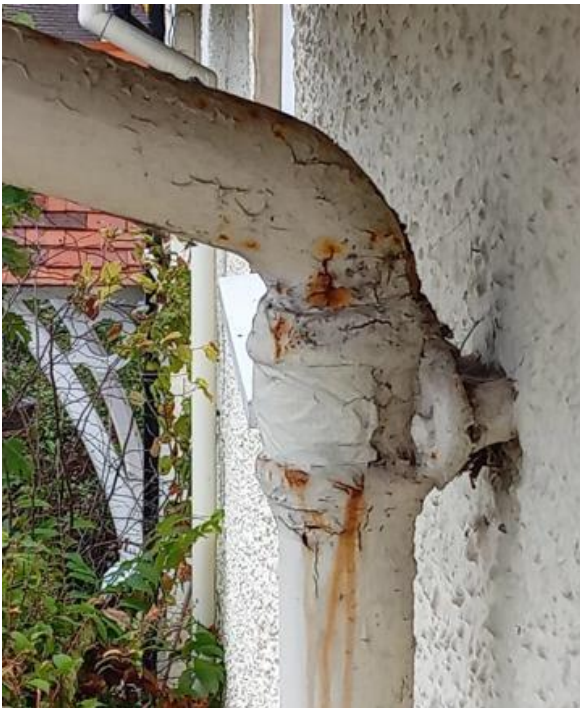
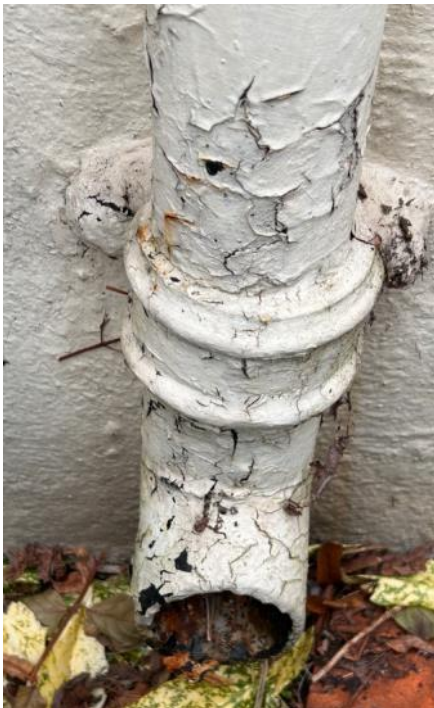
RW 1	Front elevation—cast iron downpipes	<p>Staining and rusting noted to the swanneck sections. Tape was seen to the swanneck at the LHS downpipe. Paint flaking to the shoes.</p> <div>

</div>	<p>Ensure clear .</p> <p>Take apart swannecks and ensure all are well fitted.</p> <p>Brush down and apply rust inhibitor, paint.</p> <div>
