Inspection Halton Village Hall

Date of issue: 20th November 2024

BATTRAM ASSOCIATES

HALTON VILLAGE HALL, INSPECTION

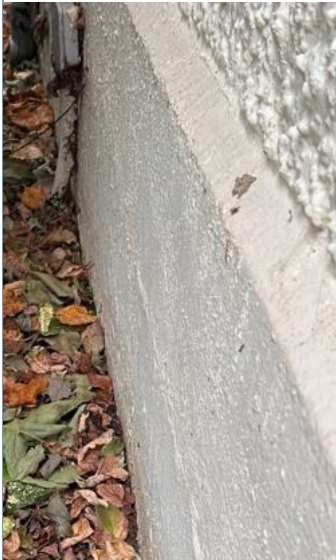
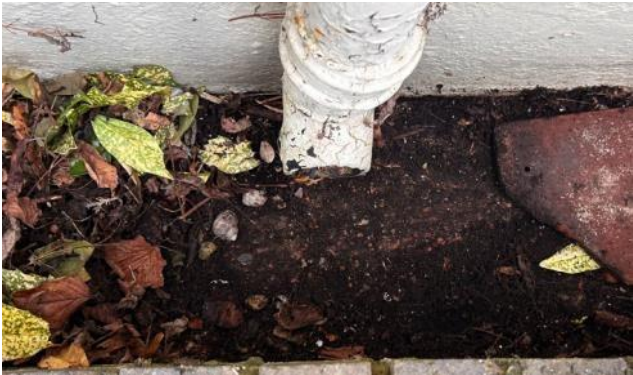
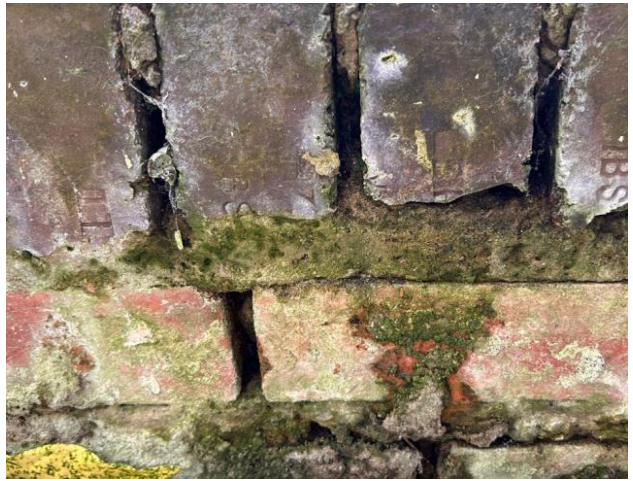
RW 2	Front elevation— drainage channel	<p>The downpipes at the front elevation discharge into concrete lined channel. It is presumed this channel falls and connects with that of the neighbours. It is unknown where the water drains to from there. At our inspection, the channel was filled with leaves and quarry tile debris from the path works. The neighbours' section was also completely blocked. Water does not drain away from the base of the wall. In times of heavy rain, water is able to splash back onto the rear face of the retaining wall, this has contributed to extensive mortar decay.</p>	<p>Urgently need to clear the debris from the channel, and also the neighbouring side where we suspect the water flows to—they should have a gulley, which may also need clearing and unblocking.</p> <p>Will need clearing twice a year</p>	1 and Maint`
---------	-----------------------------------	---	--	--------------

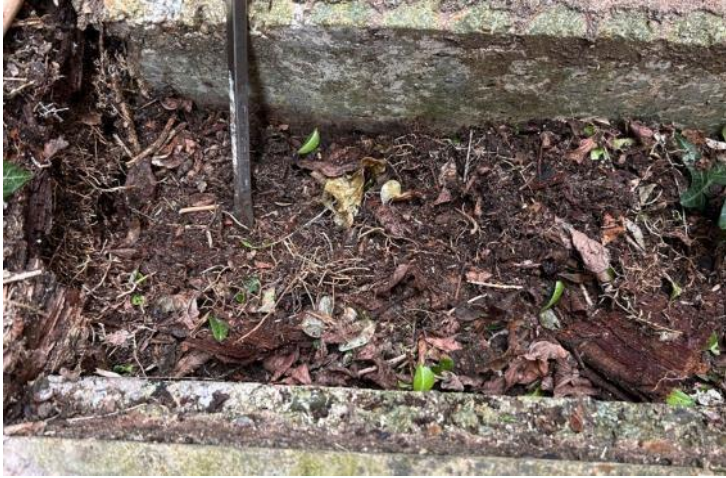
Ref	Element & description	Condition	Recommendation	Year
RW 3	Drainage channel to the side path	<p>This channel had concrete sides but a large depth of soil to the base. The channel did not appear to connect to any formal drainage. It intercepts any rainwater running down the path but is reliant on water percolating through the soil to drain.</p>

<p>As not accepting rainwater from downpipes and in the absence of nearby drainage options , although not ideal this can remain as is.</p> <p>Keep clear</p>	Maint`

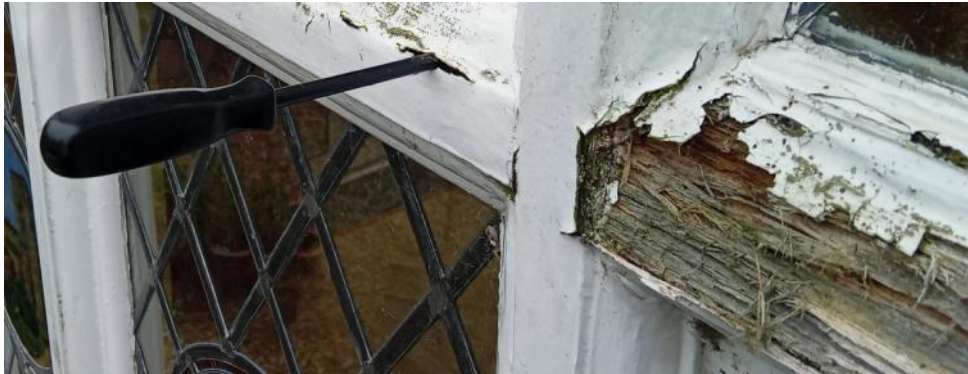
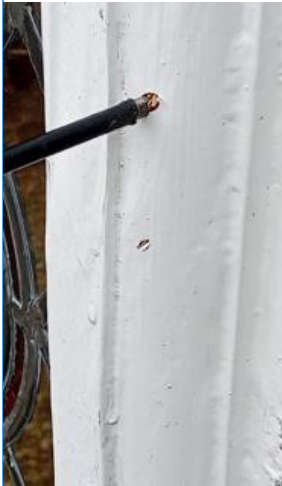
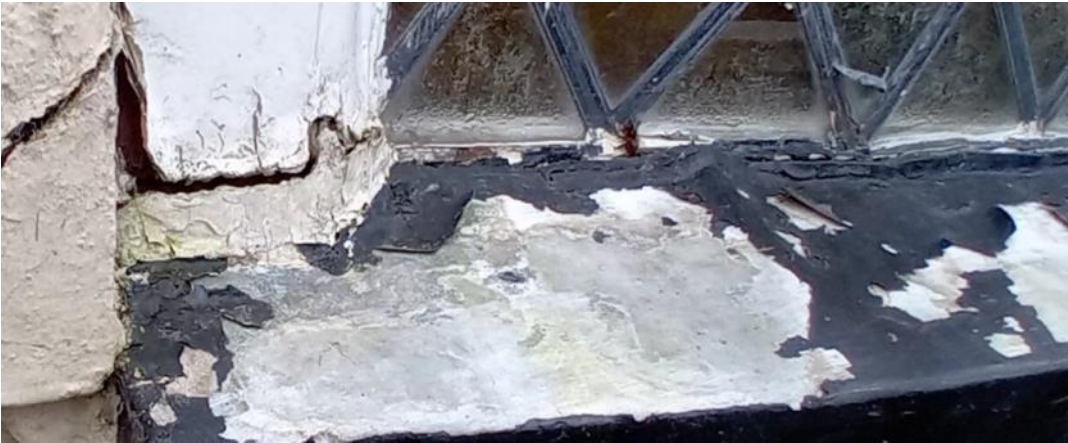
<p>W1 North elevation— leaded window</p>	<p>Several repairs noted to this window frame, in addition to many years of overpainting.</p> <p>The timber frame was wholly rotten and had past repairs. The BSA report carried out in 2018 urged repairs to be carried out, but seemingly no professional repairs had been carried out so by overpainting the rotting wood has been “sealed in” and caused fast degradation of the wood fibres—as seen in photo below. For a long time, water has passed into the window reveal and base at the rear of the failed sill.</p>

<p>Urgent works are required.</p> <p>The window should be removed. The leaded panes should be set aside and re-used where possible. Especial care should be taken with the painted roundels.</p> <p>A new hardwood window frame and sill is required. A specialist joiner (eg A&H Joinery of Tring (Tim Delderfield) and leaded/ stained glass expert (eg Chapel Glass) should be consulted and employed to complete the works.</p>	<p>1</p>
