# Asbestos Re-inspection Report (with Priority Assessments)

**Dundonald Primary School**  
**Dundonald Road, London, SW19 3QH**

Job Number: B119310/1  
Issue Date: 06/11/2023  
Issue No: 1

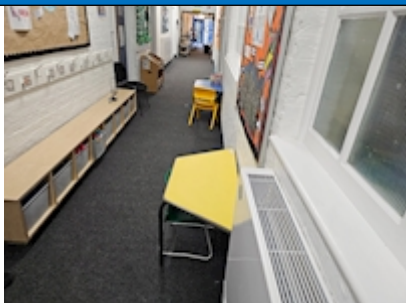
<b>Building</b>	Dundonald Primary School			<b>Floor</b>	0		
<b>Location Description</b>	1/011: Corridor			<b>Record Origin Report</b>	B119310		
<b>Item</b>	Insulation debris in voids in concrete floor

<b>Level of Identification (ID)</b>	Strongly Presumed (SP)	<b>Sample No.</b>					
<b>Material</b>	Lagging / Loose Insulation	<b>Extent</b>	<30 m <sup>2</sup>				
<b>Accessibility</b>	Usually inaccessible or unlikely to be disturbed						
<b>Identification</b>	Crocidolite						
<b>Material Assessment</b>							
<b>Product Type</b>	3	<b>Condition</b>	3	<b>Surface Treatment</b>	3	<b>Asbestos Type</b>	3
<b>Priority Assessment (for more detail see Section 4.0)</b>							
<b>Occupant Activity</b>	0	<b>Disturbance</b>	1	<b>Human Exposure</b>	2	<b>Maintenance Activity</b>	1
<b>Scoring Summary</b>							
<b>Material Score</b>	12	<b>Priority Score</b>	4	<b>Total Risk</b>	16	<b>Risk Priority</b>	<b>MEDIUM</b>

<b>Recommended Action</b>	<b>Manage / Remove if Affected by Scope of Works</b>						
<b>Further Information</b>	Records present on old site surveys showing insulation debris below the concrete in pipe voids - No access at present

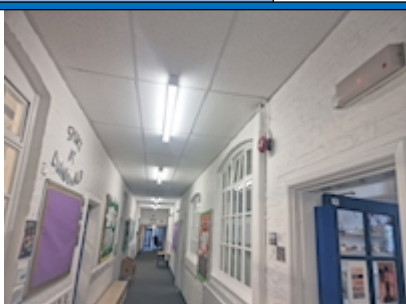
<b>Building</b>	Dundonald Primary School			<b>Floor</b>	0		
<b>Location Description</b>	1/011: Corridor			<b>Record Origin Report</b>	B119310		
<b>Item</b>	Textured coating brick walls

<b>Level of Identification (ID)</b>	Cross Reference (X)	<b>Sample No.</b>	X0003				
<b>Material</b>	Textured Coating	<b>Extent</b>	60 m <sup>2</sup>				
<b>Accessibility</b>							
<b>Identification</b>	No Asbestos Detected						
<b>Material Assessment</b>							
<b>Product Type</b>	0	<b>Condition</b>	0	<b>Surface Treatment</b>	0	<b>Asbestos Type</b>	0
<b>Priority Assessment (for more detail see Section 4.0)</b>							
<b>Occupant Activity</b>	0	<b>Disturbance</b>	0	<b>Human Exposure</b>	0	<b>Maintenance Activity</b>	0
<b>Scoring Summary</b>							
<b>Material Score</b>	0	<b>Priority Score</b>	0	<b>Total Risk</b>	0	<b>Risk Priority</b>	<b>N/A</b>
<b>Recommended Action</b>	<b>No Recommendation Required</b>

<b>Further Information</b>	Textured coating to brick walls

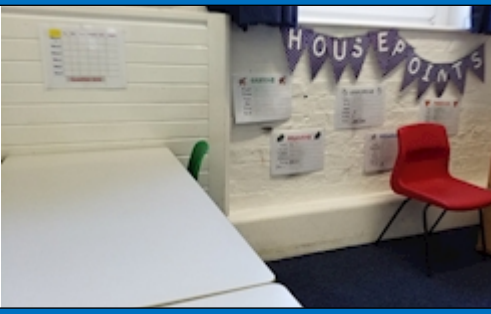
<b>Building</b>	Dundonald Primary School			<b>Floor</b>	0		
<b>Location Description</b>	1/012: Classroom 3R			<b>Record Origin Report</b>	B2228		
<b>Item</b>	Textured coating brick walls

<b>Level of Identification (ID)</b>	Sample (S)	<b>Sample No.</b>	S0003				
<b>Material</b>	Textured Coating	<b>Extent</b>	60 m <sup>2</sup>				
<b>Accessibility</b>							
<b>Identification</b>	No Asbestos Detected						
<b>Material Assessment</b>							
<b>Product Type</b>	0	<b>Condition</b>	0	<b>Surface Treatment</b>	0	<b>Asbestos Type</b>	0
<b>Priority Assessment (for more detail see Section 4.0)</b>							
<b>Occupant Activity</b>	0	<b>Disturbance</b>	0	<b>Human Exposure</b>	0	<b>Maintenance Activity</b>	0
<b>Scoring Summary</b>							
<b>Material Score</b>	0	<b>Priority Score</b>	0	<b>Total Risk</b>	0	<b>Risk Priority</b>	N/A
<b>Recommended Action</b>	<b>No Recommendation Required</b>						
<b>Further Information</b>	Textured coating to brick walls

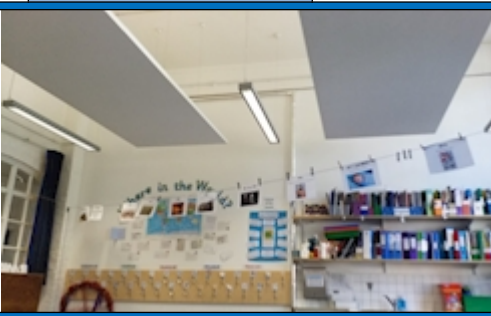
<b>Building</b>	Dundonald Primary School			<b>Floor</b>	0		
<b>Location Description</b>	1/012: Classroom 3R			<b>Record Origin Report</b>	B2228		
<b>Item</b>	Insulation to pipework

<b>Level of Identification (ID)</b>	Sample (S)	<b>Sample No.</b>	S0004				
<b>Material</b>	Lagging / Loose Insulation	<b>Extent</b>	16 lm				
<b>Accessibility</b>							
<b>Identification</b>	No Asbestos Detected						
<b>Material Assessment</b>							
<b>Product Type</b>	0	<b>Condition</b>	0	<b>Surface Treatment</b>	0	<b>Asbestos Type</b>	0
<b>Priority Assessment (for more detail see Section 4.0)</b>							
<b>Occupant Activity</b>	0	<b>Disturbance</b>	0	<b>Human Exposure</b>	0	<b>Maintenance Activity</b>	0
<b>Scoring Summary</b>							
<b>Material Score</b>	0	<b>Priority Score</b>	0	<b>Total Risk</b>	0	<b>Risk Priority</b>	N/A
<b>Recommended Action</b>	<b>No Recommendation Required</b>						
<b>Further Information</b>	MMMF insulation to associated pipework in room

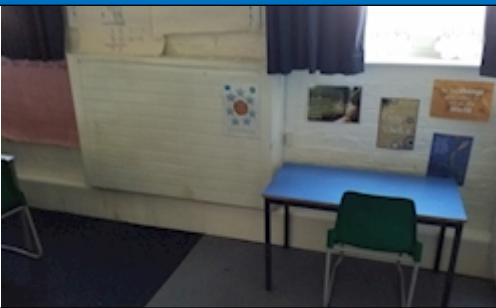
<b>Building</b>	Dundonald Primary School			<b>Floor</b>	0		
<b>Location Description</b>	1/012A: Classroom 3C			<b>Record Origin Report</b>	B2228		
<b>Item</b>	Textured coating brick walls

<b>Level of Identification (ID)</b>	Cross Reference (X)	<b>Sample No.</b>	X0003				
<b>Material</b>	Textured Coating	<b>Extent</b>	50 m <sup>2</sup>				
<b>Accessibility</b>							
<b>Identification</b>	No Asbestos Detected						
<b>Material Assessment</b>							
<b>Product Type</b>	0	<b>Condition</b>	0	<b>Surface Treatment</b>	0	<b>Asbestos Type</b>	0
<b>Priority Assessment (for more detail see Section 4.0)</b>							
<b>Occupant Activity</b>	0	<b>Disturbance</b>	0	<b>Human Exposure</b>	0	<b>Maintenance Activity</b>	0
<b>Scoring Summary</b>							
<b>Material Score</b>	0	<b>Priority Score</b>	0	<b>Total Risk</b>	0	<b>Risk Priority</b>	N/A
<b>Recommended Action</b>	<b>No Recommendation Required</b>						
<b>Further Information</b>	Textured coating to brick walls

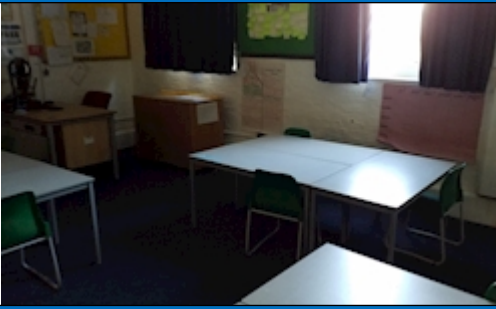
<b>Building</b>	Dundonald Primary School			<b>Floor</b>	0		
<b>Location Description</b>	1/012A: Classroom 3C			<b>Record Origin Report</b>	B2228		
<b>Item</b>	Insulation to pipework

<b>Level of Identification (ID)</b>	Cross Reference (X)	<b>Sample No.</b>	X0004				
<b>Material</b>	Lagging / Loose Insulation	<b>Extent</b>	12 lm				
<b>Accessibility</b>							
<b>Identification</b>	No Asbestos Detected						
<b>Material Assessment</b>							
<b>Product Type</b>	0	<b>Condition</b>	0	<b>Surface Treatment</b>	0	<b>Asbestos Type</b>	0
<b>Priority Assessment (for more detail see Section 4.0)</b>							
<b>Occupant Activity</b>	0	<b>Disturbance</b>	0	<b>Human Exposure</b>	0	<b>Maintenance Activity</b>	0
<b>Scoring Summary</b>							
<b>Material Score</b>	0	<b>Priority Score</b>	0	<b>Total Risk</b>	0	<b>Risk Priority</b>	N/A
<b>Recommended Action</b>	<b>No Recommendation Required</b>						
<b>Further Information</b>	MMMF insulation to associated pipework in room

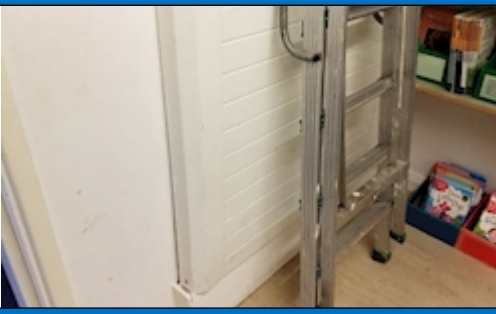
<b>Building</b>	Dundonald Primary School			<b>Floor</b>	0		
<b>Location Description</b>	1/013: PE Store			<b>Record Origin Report</b>	B2228		
<b>Item</b>	Textured coating brick walls

<b>Level of Identification (ID)</b>	Cross Reference (X)	<b>Sample No.</b>	X0003				
<b>Material</b>	Textured Coating	<b>Extent</b>	12 m <sup>2</sup>				
<b>Accessibility</b>							
<b>Identification</b>	No Asbestos Detected						
<b>Material Assessment</b>							
<b>Product Type</b>	0	<b>Condition</b>	0	<b>Surface Treatment</b>	0	<b>Asbestos Type</b>	0
<b>Priority Assessment (for more detail see Section 4.0)</b>							
<b>Occupant Activity</b>	0	<b>Disturbance</b>	0	<b>Human Exposure</b>	0	<b>Maintenance Activity</b>	0
<b>Scoring Summary</b>							
<b>Material Score</b>	0	<b>Priority Score</b>	0	<b>Total Risk</b>	0	<b>Risk Priority</b>	N/A
<b>Recommended Action</b>	<b>No Recommendation Required</b>						
<b>Further Information</b>	Textured coating to brick walls

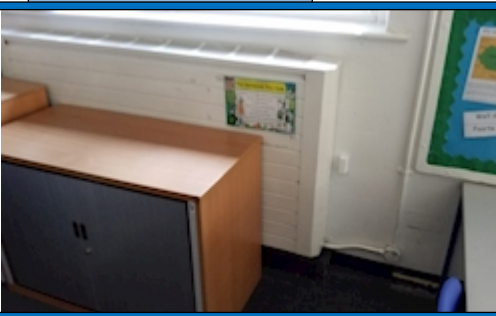
<b>Building</b>	Dundonald Primary School			<b>Floor</b>	0		
<b>Location Description</b>	1/018: Classroom 2H			<b>Record Origin Report</b>	B2228		
<b>Item</b>	Textured coating brick walls

<b>Level of Identification (ID)</b>	Cross Reference (X)	<b>Sample No.</b>	X0001				
<b>Material</b>	Textured Coating	<b>Extent</b>	60 m <sup>2</sup>				
<b>Accessibility</b>							
<b>Identification</b>	No Asbestos Detected						
<b>Material Assessment</b>							
<b>Product Type</b>	0	<b>Condition</b>	0	<b>Surface Treatment</b>	0	<b>Asbestos Type</b>	0
<b>Priority Assessment (for more detail see Section 4.0)</b>							
<b>Occupant Activity</b>	0	<b>Disturbance</b>	0	<b>Human Exposure</b>	0	<b>Maintenance Activity</b>	0
<b>Scoring Summary</b>							
<b>Material Score</b>	0	<b>Priority Score</b>	0	<b>Total Risk</b>	0	<b>Risk Priority</b>	N/A
<b>Recommended Action</b>	<b>No Recommendation Required</b>						
<b>Further Information</b>	Textured coating to brick walls

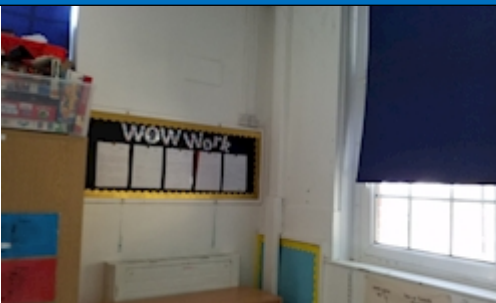
<b>Building</b>	Dundonald Primary School			<b>Floor</b>	0		
<b>Location Description</b>	1/018: Classroom 2H			<b>Record Origin Report</b>	B2228		
<b>Item</b>	Insulation to pipework

<b>Level of Identification (ID)</b>	Cross Reference (X)	<b>Sample No.</b>	X0002				
<b>Material</b>	Lagging / Loose Insulation	<b>Extent</b>	20 lm				
<b>Accessibility</b>							
<b>Identification</b>	No Asbestos Detected						
<b>Material Assessment</b>							
<b>Product Type</b>	0	<b>Condition</b>	0	<b>Surface Treatment</b>	0	<b>Asbestos Type</b>	0
<b>Priority Assessment (for more detail see Section 4.0)</b>							
<b>Occupant Activity</b>	0	<b>Disturbance</b>	0	<b>Human Exposure</b>	0	<b>Maintenance Activity</b>	0
<b>Scoring Summary</b>							
<b>Material Score</b>	0	<b>Priority Score</b>	0	<b>Total Risk</b>	0	<b>Risk Priority</b>	N/A
<b>Recommended Action</b>	<b>No Recommendation Required</b>						
<b>Further Information</b>	MMM insulation to associated pipework in room

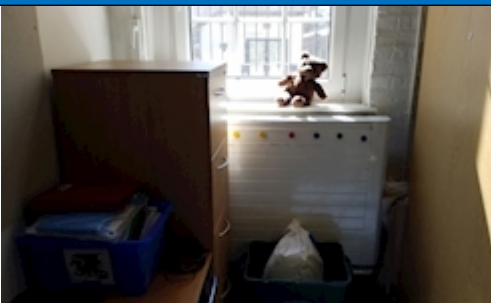
<b>Building</b>	Dundonald Primary School			<b>Floor</b>	0		
<b>Location Description</b>	1/021: Deputy Head			<b>Record Origin Report</b>	B2228		
<b>Item</b>	Textured coating brick walls

<b>Level of Identification (ID)</b>	Cross Reference (X)	<b>Sample No.</b>	X0001				
<b>Material</b>	Textured Coating	<b>Extent</b>	30 m <sup>2</sup>				
<b>Accessibility</b>							
<b>Identification</b>	No Asbestos Detected						
<b>Material Assessment</b>							
<b>Product Type</b>	0	<b>Condition</b>	0	<b>Surface Treatment</b>	0	<b>Asbestos Type</b>	0
<b>Priority Assessment (for more detail see Section 4.0)</b>							
<b>Occupant Activity</b>	0	<b>Disturbance</b>	0	<b>Human Exposure</b>	0	<b>Maintenance Activity</b>	0
<b>Scoring Summary</b>							
<b>Material Score</b>	0	<b>Priority Score</b>	0	<b>Total Risk</b>	0	<b>Risk Priority</b>	N/A
<b>Recommended Action</b>	<b>No Recommendation Required</b>						
<b>Further Information</b>	Textured coating to brick walls

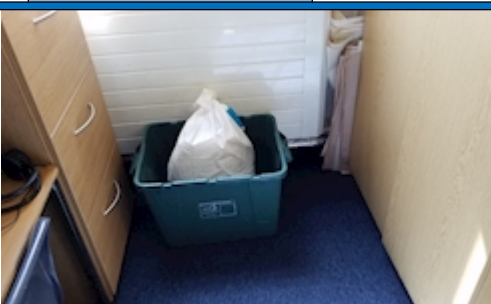
<b>Building</b>	Dundonald Primary School			<b>Floor</b>	0		
<b>Location Description</b>	1/021: Deputy Head			<b>Record Origin Report</b>	B2228		
<b>Item</b>	Insulation to pipework

<b>Level of Identification (ID)</b>	Cross Reference (X)	<b>Sample No.</b>	X0002				
<b>Material</b>	Lagging / Loose Insulation	<b>Extent</b>	10 lm				
<b>Accessibility</b>							
<b>Identification</b>	No Asbestos Detected						
<b>Material Assessment</b>							
<b>Product Type</b>	0	<b>Condition</b>	0	<b>Surface Treatment</b>	0	<b>Asbestos Type</b>	0
<b>Priority Assessment (for more detail see Section 4.0)</b>							
<b>Occupant Activity</b>	0	<b>Disturbance</b>	0	<b>Human Exposure</b>	0	<b>Maintenance Activity</b>	0
<b>Scoring Summary</b>							
<b>Material Score</b>	0	<b>Priority Score</b>	0	<b>Total Risk</b>	0	<b>Risk Priority</b>	N/A
<b>Recommended Action</b>	<b>No Recommendation Required</b>						
<b>Further Information</b>	MMMF insulation to associated pipework in room

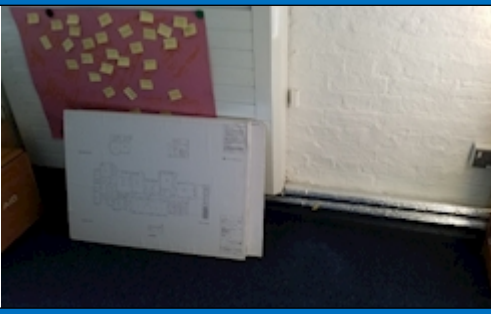
<b>Building</b>	Dundonald Primary School			<b>Floor</b>	0		
<b>Location Description</b>	1/021A: Head Teachers			<b>Record Origin Report</b>	B2228		
<b>Item</b>	Textured coating brick walls

<b>Level of Identification (ID)</b>	Cross Reference (X)	<b>Sample No.</b>	X0001				
<b>Material</b>	Textured Coating	<b>Extent</b>	30 m²				
<b>Accessibility</b>							
<b>Identification</b>	No Asbestos Detected						
<b>Material Assessment</b>							
<b>Product Type</b>	0	<b>Condition</b>	0	<b>Surface Treatment</b>	0	<b>Asbestos Type</b>	0
<b>Priority Assessment (for more detail see Section 4.0)</b>							
<b>Occupant Activity</b>	0	<b>Disturbance</b>	0	<b>Human Exposure</b>	0	<b>Maintenance Activity</b>	0
<b>Scoring Summary</b>							
<b>Material Score</b>	0	<b>Priority Score</b>	0	<b>Total Risk</b>	0	<b>Risk Priority</b>	N/A
<b>Recommended Action</b>	<b>No Recommendation Required</b>						
<b>Further Information</b>	Textured coating to brick walls

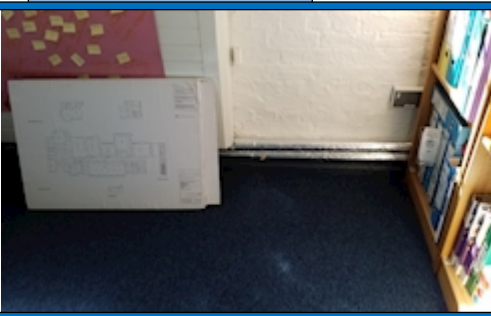
<b>Building</b>	Dundonald Primary School			<b>Floor</b>	0		
<b>Location Description</b>	1/021A: Head Teachers			<b>Record Origin Report</b>	B2228		
<b>Item</b>	Insulation to pipework

<b>Level of Identification (ID)</b>	Cross Reference (X)	<b>Sample No.</b>	X0002				
<b>Material</b>	Lagging / Loose Insulation	<b>Extent</b>	12 lm				
<b>Accessibility</b>							
<b>Identification</b>	No Asbestos Detected						
<b>Material Assessment</b>							
<b>Product Type</b>	0	<b>Condition</b>	0	<b>Surface Treatment</b>	0	<b>Asbestos Type</b>	0
<b>Priority Assessment (for more detail see Section 4.0)</b>							
<b>Occupant Activity</b>	0	<b>Disturbance</b>	0	<b>Human Exposure</b>	0	<b>Maintenance Activity</b>	0
<b>Scoring Summary</b>							
<b>Material Score</b>	0	<b>Priority Score</b>	0	<b>Total Risk</b>	0	<b>Risk Priority</b>	N/A
<b>Recommended Action</b>	<b>No Recommendation Required</b>						
<b>Further Information</b>	MMMF insulation to associated pipework in room

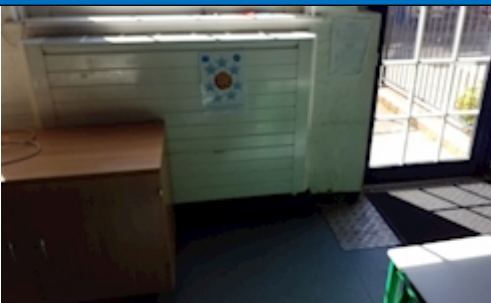
<b>Level of Identification (ID)</b>	Sample (S)	<b>Sample No.</b>	S0001				
<b>Material</b>	Textured Coating	<b>Extent</b>	40 m <sup>2</sup>				
<b>Accessibility</b>							
<b>Identification</b>	No Asbestos Detected						
<b>Material Assessment</b>							
<b>Product Type</b>	0	<b>Condition</b>	0	<b>Surface Treatment</b>	0	<b>Asbestos Type</b>	0
<b>Priority Assessment (for more detail see Section 4.0)</b>							
<b>Occupant Activity</b>	0	<b>Disturbance</b>	0	<b>Human Exposure</b>	0	<b>Maintenance Activity</b>	0
<b>Scoring Summary</b>							
<b>Material Score</b>	0	<b>Priority Score</b>	0	<b>Total Risk</b>	0	<b>Risk Priority</b>	N/A
<b>Recommended Action</b>	<b>No Recommendation Required</b>						
<b>Further Information</b>	Textured coating to brick walls

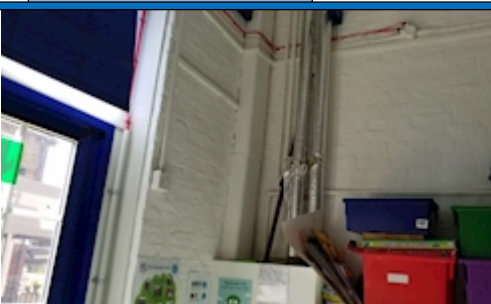
<b>Level of Identification (ID)</b>	Sample (S)	<b>Sample No.</b>	S0002				
<b>Material</b>	Lagging / Loose Insulation	<b>Extent</b>	20 lm				
<b>Accessibility</b>							
<b>Identification</b>	No Asbestos Detected						
<b>Material Assessment</b>							
<b>Product Type</b>	0	<b>Condition</b>	0	<b>Surface Treatment</b>	0	<b>Asbestos Type</b>	0
<b>Priority Assessment (for more detail see Section 4.0)</b>							
<b>Occupant Activity</b>	0	<b>Disturbance</b>	0	<b>Human Exposure</b>	0	<b>Maintenance Activity</b>	0
<b>Scoring Summary</b>							
<b>Material Score</b>	0	<b>Priority Score</b>	0	<b>Total Risk</b>	0	<b>Risk Priority</b>	N/A
<b>Recommended Action</b>	<b>No Recommendation Required</b>						
<b>Further Information</b>	MMMF insulation to associated pipework in room

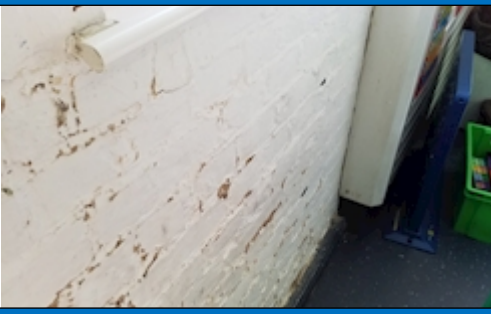
<b>Level of Identification (ID)</b>	Cross Reference (X)	<b>Sample No.</b>	X0001				
<b>Material</b>	Textured Coating	<b>Extent</b>	40 m <sup>2</sup>				
<b>Accessibility</b>							
<b>Identification</b>	No Asbestos Detected						
<b>Material Assessment</b>							
<b>Product Type</b>	0	<b>Condition</b>	0	<b>Surface Treatment</b>	0	<b>Asbestos Type</b>	0
<b>Priority Assessment (for more detail see Section 4.0)</b>							
<b>Occupant Activity</b>	0	<b>Disturbance</b>	0	<b>Human Exposure</b>	0	<b>Maintenance Activity</b>	0
<b>Scoring Summary</b>							
<b>Material Score</b>	0	<b>Priority Score</b>	0	<b>Total Risk</b>	0	<b>Risk Priority</b>	N/A
<b>Recommended Action</b>	<b>No Recommendation Required</b>						
<b>Further Information</b>	Textured coating to brick walls

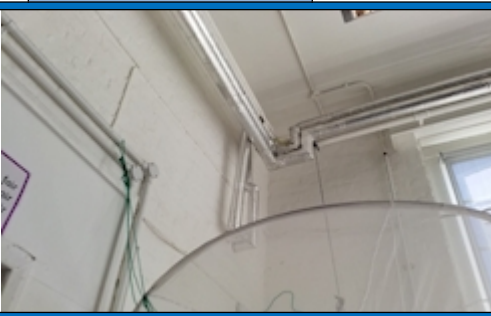
<b>Level of Identification (ID)</b>	Cross Reference (X)	<b>Sample No.</b>	X0002				
<b>Material</b>	Lagging / Loose Insulation	<b>Extent</b>	60 lm				
<b>Accessibility</b>							
<b>Identification</b>	No Asbestos Detected						
<b>Material Assessment</b>							
<b>Product Type</b>	0	<b>Condition</b>	0	<b>Surface Treatment</b>	0	<b>Asbestos Type</b>	0
<b>Priority Assessment (for more detail see Section 4.0)</b>							
<b>Occupant Activity</b>	0	<b>Disturbance</b>	0	<b>Human Exposure</b>	0	<b>Maintenance Activity</b>	0
<b>Scoring Summary</b>							
<b>Material Score</b>	0	<b>Priority Score</b>	0	<b>Total Risk</b>	0	<b>Risk Priority</b>	N/A
<b>Recommended Action</b>	<b>No Recommendation Required</b>						
<b>Further Information</b>	MMMF insulation to associated pipework in room

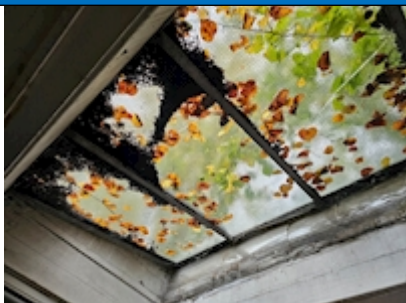
<b>Level of Identification (ID)</b>	Strongly Presumed (SP)	<b>Sample No.</b>					
<b>Material</b>	Mastic	<b>Extent</b>	3 lm				
<b>Accessibility</b>	Usually inaccessible or unlikely to be disturbed						
<b>Identification</b>	Chrysotile						
<b>Material Assessment</b>							
<b>Product Type</b>	1	<b>Condition</b>	1	<b>Surface Treatment</b>	0	<b>Asbestos Type</b>	1
<b>Priority Assessment (for more detail see Section 4.0)</b>							
<b>Occupant Activity</b>	1	<b>Disturbance</b>	1	<b>Human Exposure</b>	2	<b>Maintenance Activity</b>	1
<b>Scoring Summary</b>							
<b>Material Score</b>	3	<b>Priority Score</b>	5	<b>Total Risk</b>	8	<b>Risk Priority</b>	VERY LOW
<b>Recommended Action</b>	<b>Manage and Re-inspect</b>						
<b>Further Information</b>	Previously identified on Life environmental report B-71595.

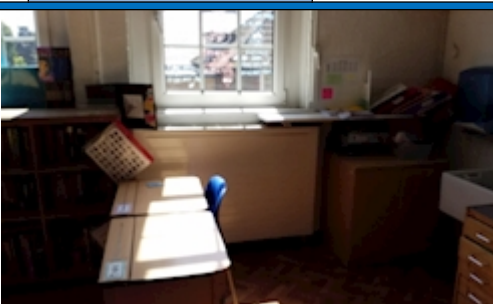
<b>Level of Identification (ID)</b>	Sample (S)	<b>Sample No.</b>	S0005				
<b>Material</b>	Textured Coating	<b>Extent</b>	30 m <sup>2</sup>				
<b>Accessibility</b>							
<b>Identification</b>	No Asbestos Detected						
<b>Material Assessment</b>							
<b>Product Type</b>	0	<b>Condition</b>	0	<b>Surface Treatment</b>	0	<b>Asbestos Type</b>	0
<b>Priority Assessment (for more detail see Section 4.0)</b>							
<b>Occupant Activity</b>	0	<b>Disturbance</b>	0	<b>Human Exposure</b>	0	<b>Maintenance Activity</b>	0
<b>Scoring Summary</b>							
<b>Material Score</b>	0	<b>Priority Score</b>	0	<b>Total Risk</b>	0	<b>Risk Priority</b>	N/A
<b>Recommended Action</b>	<b>No Recommendation Required</b>						
<b>Further Information</b>	Textured coating to brick walls

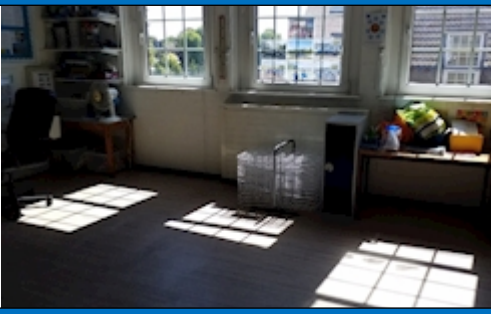
<b>Level of Identification (ID)</b>	Cross Reference (X)	<b>Sample No.</b>	X0005				
<b>Material</b>	Textured Coating	<b>Extent</b>	20 m <sup>2</sup>				
<b>Accessibility</b>							
<b>Identification</b>	No Asbestos Detected						
<b>Material Assessment</b>							
<b>Product Type</b>	0	<b>Condition</b>	0	<b>Surface Treatment</b>	0	<b>Asbestos Type</b>	0
<b>Priority Assessment (for more detail see Section 4.0)</b>							
<b>Occupant Activity</b>	0	<b>Disturbance</b>	0	<b>Human Exposure</b>	0	<b>Maintenance Activity</b>	0
<b>Scoring Summary</b>							
<b>Material Score</b>	0	<b>Priority Score</b>	0	<b>Total Risk</b>	0	<b>Risk Priority</b>	N/A
<b>Recommended Action</b>	<b>No Recommendation Required</b>						
<b>Further Information</b>	Textured coating to brick walls

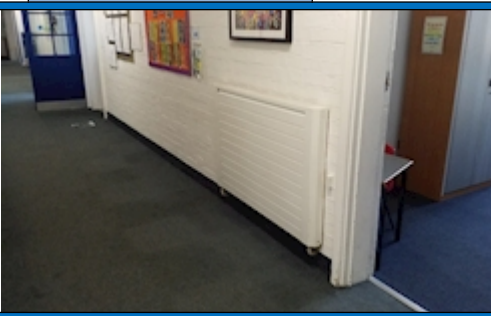
<b>Level of Identification (ID)</b>	Cross Reference (X)	<b>Sample No.</b>	X0005				
<b>Material</b>	Textured Coating	<b>Extent</b>	20 m <sup>2</sup>				
<b>Accessibility</b>							
<b>Identification</b>	No Asbestos Detected						
<b>Material Assessment</b>							
<b>Product Type</b>	0	<b>Condition</b>	0	<b>Surface Treatment</b>	0	<b>Asbestos Type</b>	0
<b>Priority Assessment (for more detail see Section 4.0)</b>							
<b>Occupant Activity</b>	0	<b>Disturbance</b>	0	<b>Human Exposure</b>	0	<b>Maintenance Activity</b>	0
<b>Scoring Summary</b>							
<b>Material Score</b>	0	<b>Priority Score</b>	0	<b>Total Risk</b>	0	<b>Risk Priority</b>	N/A
<b>Recommended Action</b>	<b>No Recommendation Required</b>						
<b>Further Information</b>	Textured coating to brick walls

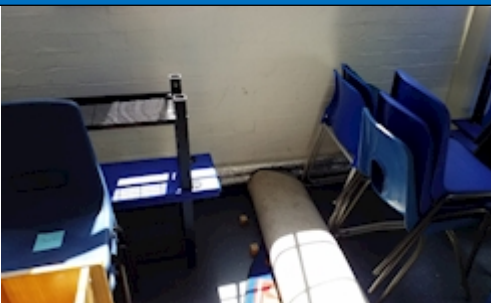
<b>Level of Identification (ID)</b>	Sample (S)	<b>Sample No.</b>	S0006				
<b>Material</b>	Lagging / Loose Insulation	<b>Extent</b>	20 lm				
<b>Accessibility</b>							
<b>Identification</b>	No Asbestos Detected						
<b>Material Assessment</b>							
<b>Product Type</b>	0	<b>Condition</b>	0	<b>Surface Treatment</b>	0	<b>Asbestos Type</b>	0
<b>Priority Assessment (for more detail see Section 4.0)</b>							
<b>Occupant Activity</b>	0	<b>Disturbance</b>	0	<b>Human Exposure</b>	0	<b>Maintenance Activity</b>	0
<b>Scoring Summary</b>							
<b>Material Score</b>	0	<b>Priority Score</b>	0	<b>Total Risk</b>	0	<b>Risk Priority</b>	N/A
<b>Recommended Action</b>	<b>No Recommendation Required</b>						
<b>Further Information</b>	MMM insulation to associated pipework in room

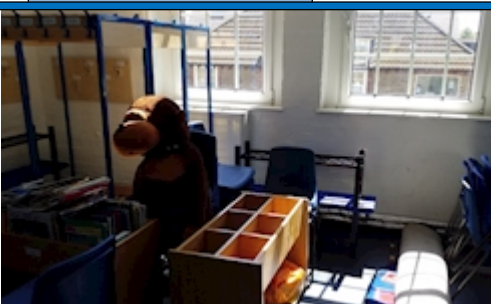
<b>Level of Identification (ID)</b>	Cross Reference (X)	<b>Sample No.</b>	X0005				
<b>Material</b>	Textured Coating	<b>Extent</b>	20 m <sup>2</sup>				
<b>Accessibility</b>							
<b>Identification</b>	No Asbestos Detected						
<b>Material Assessment</b>							
<b>Product Type</b>	0	<b>Condition</b>	0	<b>Surface Treatment</b>	0	<b>Asbestos Type</b>	0
<b>Priority Assessment (for more detail see Section 4.0)</b>							
<b>Occupant Activity</b>	0	<b>Disturbance</b>	0	<b>Human Exposure</b>	0	<b>Maintenance Activity</b>	0
<b>Scoring Summary</b>							
<b>Material Score</b>	0	<b>Priority Score</b>	0	<b>Total Risk</b>	0	<b>Risk Priority</b>	N/A
<b>Recommended Action</b>	<b>No Recommendation Required</b>						
<b>Further Information</b>	Textured coating to brick walls

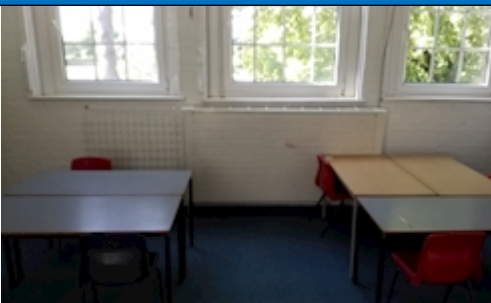
<b>Level of Identification (ID)</b>	Cross Reference (X)	<b>Sample No.</b>	X0005				
<b>Material</b>	Textured Coating	<b>Extent</b>	40 m <sup>2</sup>				
<b>Accessibility</b>							
<b>Identification</b>	No Asbestos Detected						
<b>Material Assessment</b>							
<b>Product Type</b>	0	<b>Condition</b>	0	<b>Surface Treatment</b>	0	<b>Asbestos Type</b>	0
<b>Priority Assessment (for more detail see Section 4.0)</b>							
<b>Occupant Activity</b>	0	<b>Disturbance</b>	0	<b>Human Exposure</b>	0	<b>Maintenance Activity</b>	0
<b>Scoring Summary</b>							
<b>Material Score</b>	0	<b>Priority Score</b>	0	<b>Total Risk</b>	0	<b>Risk Priority</b>	N/A
<b>Recommended Action</b>	<b>No Recommendation Required</b>						
<b>Further Information</b>	Textured coating to brick walls

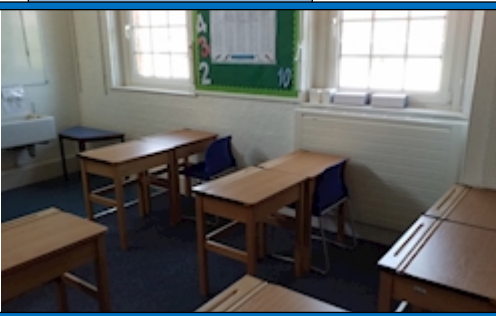
<b>Level of Identification (ID)</b>	Cross Reference (X)	<b>Sample No.</b>	X0005				
<b>Material</b>	Textured Coating	<b>Extent</b>	20 m <sup>2</sup>				
<b>Accessibility</b>							
<b>Identification</b>	No Asbestos Detected						
<b>Material Assessment</b>							
<b>Product Type</b>	0	<b>Condition</b>	0	<b>Surface Treatment</b>	0	<b>Asbestos Type</b>	0
<b>Priority Assessment (for more detail see Section 4.0)</b>							
<b>Occupant Activity</b>	0	<b>Disturbance</b>	0	<b>Human Exposure</b>	0	<b>Maintenance Activity</b>	0
<b>Scoring Summary</b>							
<b>Material Score</b>	0	<b>Priority Score</b>	0	<b>Total Risk</b>	0	<b>Risk Priority</b>	N/A
<b>Recommended Action</b>	<b>No Recommendation Required</b>						
<b>Further Information</b>	Textured coating to brick walls

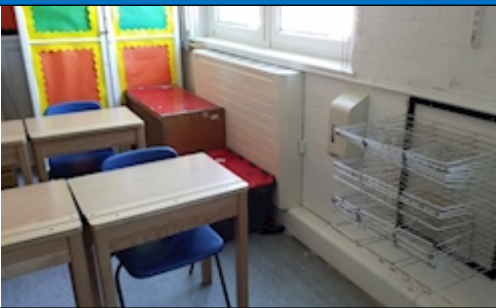
<b>Level of Identification (ID)</b>	Cross Reference (X)	<b>Sample No.</b>	X0005				
<b>Material</b>	Textured Coating	<b>Extent</b>	40 m <sup>2</sup>				
<b>Accessibility</b>							
<b>Identification</b>	No Asbestos Detected						
<b>Material Assessment</b>							
<b>Product Type</b>	0	<b>Condition</b>	0	<b>Surface Treatment</b>	0	<b>Asbestos Type</b>	0
<b>Priority Assessment (for more detail see Section 4.0)</b>							
<b>Occupant Activity</b>	0	<b>Disturbance</b>	0	<b>Human Exposure</b>	0	<b>Maintenance Activity</b>	0
<b>Scoring Summary</b>							
<b>Material Score</b>	0	<b>Priority Score</b>	0	<b>Total Risk</b>	0	<b>Risk Priority</b>	N/A
<b>Recommended Action</b>	<b>No Recommendation Required</b>						
<b>Further Information</b>	Textured coating to brick walls
