Paston Great Barn – South Range, Paston. North Walsham.Norfolk

Structural Condition Report

Ref: 241057/S Paterson

Date: 26 Mar 2025

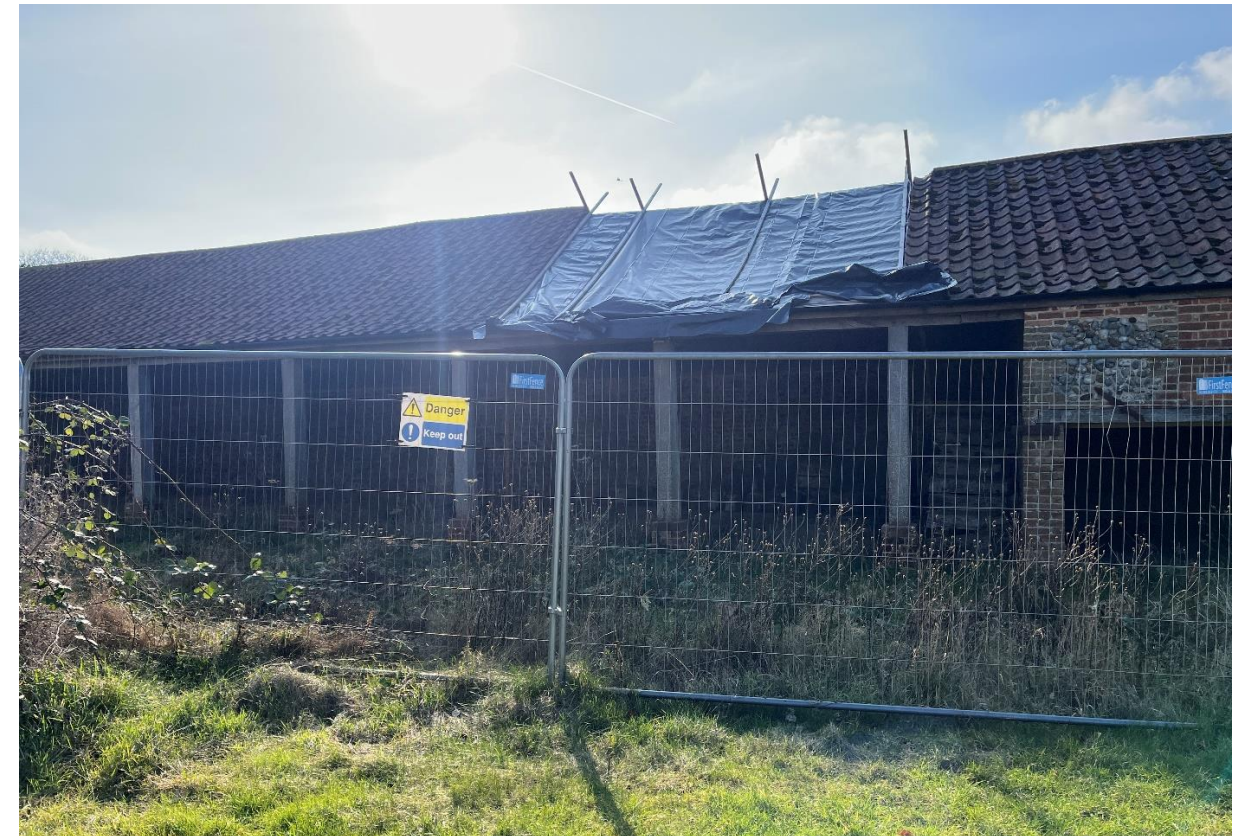
Photo 1

- 4.2.1 The area of roof local to the apparent failure was clear - with tiles removed and a temporary plastic membrane covering in place, secured with battens. This made it difficult to ascertain any distortion to the roof plane and ridge line in this area from a remote visual inspection. (Photo 1)

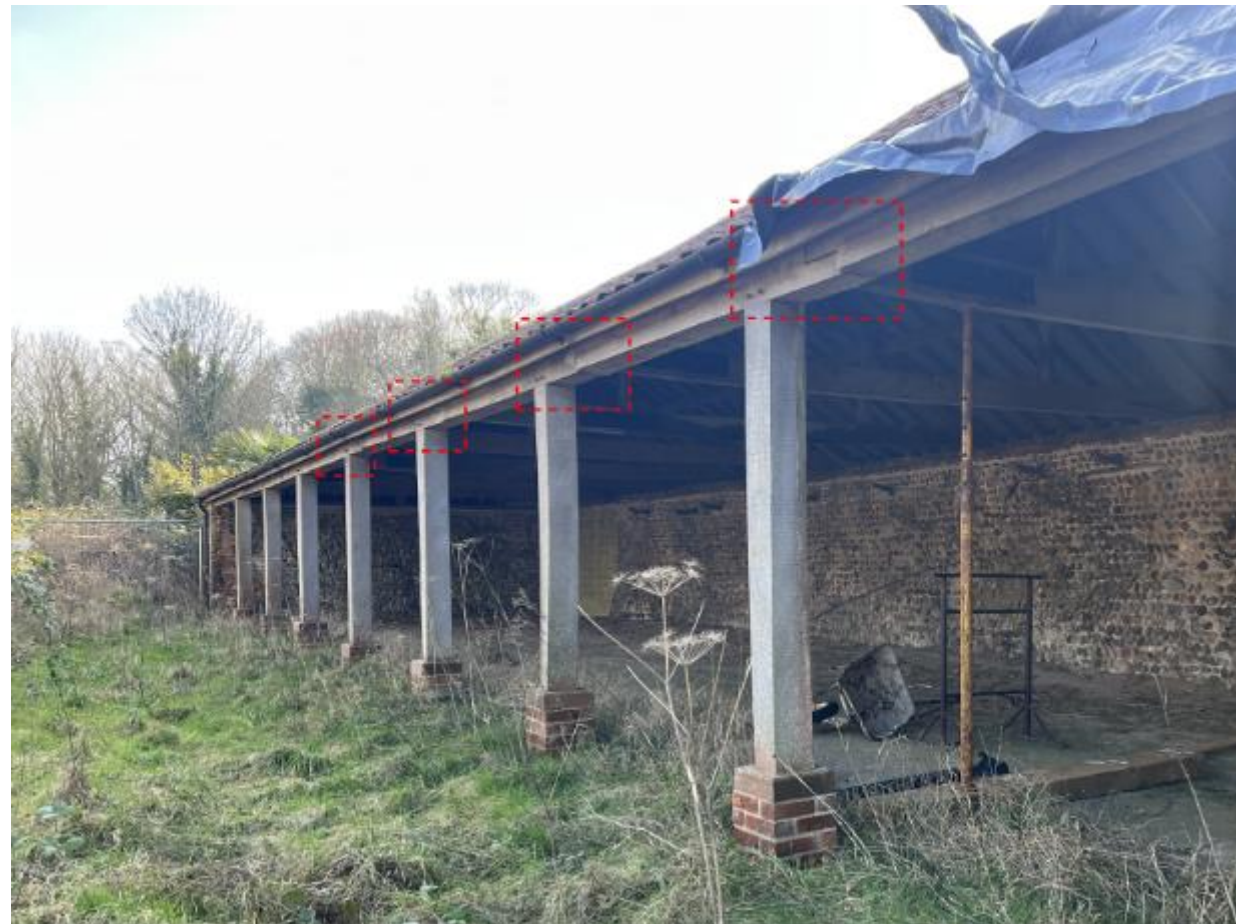
Photo 2 – overall view of the open front elevation framing, with displaced bressummer connections highlighted

- 4.2.4 The bressummer beam was formed in several pieces along its length, with each section jointed with a simple half-lap. A number of these joints were displaced; opening up with the bressummer beam generally spreading outwards to varying degrees along its length. This was most severe towards Truss I. This to be fixed with small hexagonal head screws through the top face of the joint.

5.1.10 The displacement of the half-lap connections in the bressummer has likely been contributed to by some outward thrust at the rafter feet as well as drying of the timber. The purlins were noted as of small cross section during inspection, and therefore some deflection of these in the plane of the roof pitch would result in some spread at the eaves. This does not appear to have caused instability at this time, but some simple strengthening of the half-lap connections would be advisable to better transfer any lateral forces between the trusses.

The displacement of these connections implies a lack of continuity across the half-lap joint. Whilst not yet at concerning at this stage, increasing their stiffness now may prevent this movement progressing to a point requiring more intensive intervention. This could be completed simply and unobtrusively with the introduction of stainless steel bolts through the half lap joint. The bolt heads and nuts can be counterbored and plugged with matching timber to reduce any visible impact.

This approach is presented in SK003 in Appendix A.

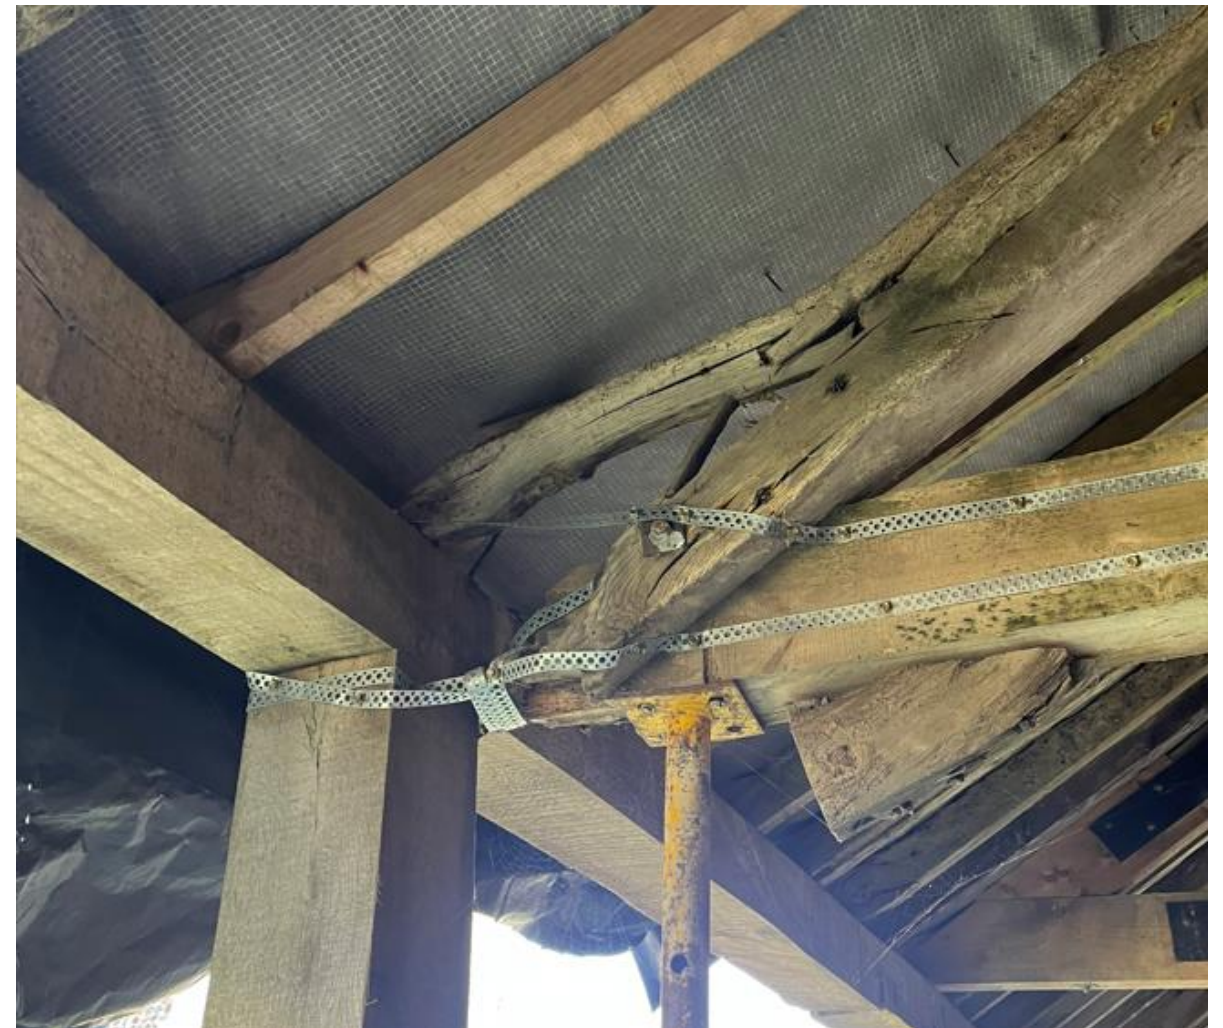
- 4.3.1 The failure of Truss I was immediately apparent. This was presented as a horizontal split along the upper chord of the truss, extending from its support on the bressummer beam. The split appeared to have occurred at the birds mouth joint of the chord over the bressummer, with the upper timber remaining in place, and the lower section split away and moved downwards (Photo 3). The previously mentioned outward spread of the bressummer, the rotation of the post, and overturning of the plinth base all concentrated on this bay are further evidence that this area of structure is compromised.

Photo 3 – Failed end of Truss I

5.1.1 The roof has clearly suffered a localised failure to Truss I. This appears mostly likely the result of its shallow cross section at its bearing support onto the bressummer beam, causing excessive shear stress in the upper chord end where compromised by excessive notching to form the birds mouth joint. Such stresses would be far in excess of those recommended by contemporary codes of practice. The presence of any decay, or pre-existing natural faults in the timber, may also have impacted the local strength of this element.

5.1.3 The damage to this section of the upper chord is clearly beyond the point of repair, and some replacement will be necessary. Replacement on an entirely 'like-for-like' basis would unfortunately merely recreate a detail which would appear to have been defective in the first instance, so additional strengthening of this joint will be required, alongside partial replacement of elements, whilst retaining the existing timber as much as possible.

This will entail the replacement of the split length of the upper chord with new, seasoned, species matched timber, with a bolted scarf connection back to sound timber of the existing chord. Whilst this does result in the loss of some historic timber, this is limited to the sections damaged beyond repair. Replacement is undertaken in matching material, and jointed using traditional techniques. The use of metal fasteners is clearly well established in this structure through previous repair.

Additionally, the bearing of the truss end must be strengthened. This will be achieved with a new timber 'corbel' bracket, fixed to the existing bressummer and post with bolted steel fasteners. This has the effect of increasing the length of the timber bearing, and allows for force transfer away from the heavily notched sections. This is a reversible addition to the existing open-front structure, with the posts and bressummer only introduced in the 1990s.

This approach is presented in SK001 in Appendix A.

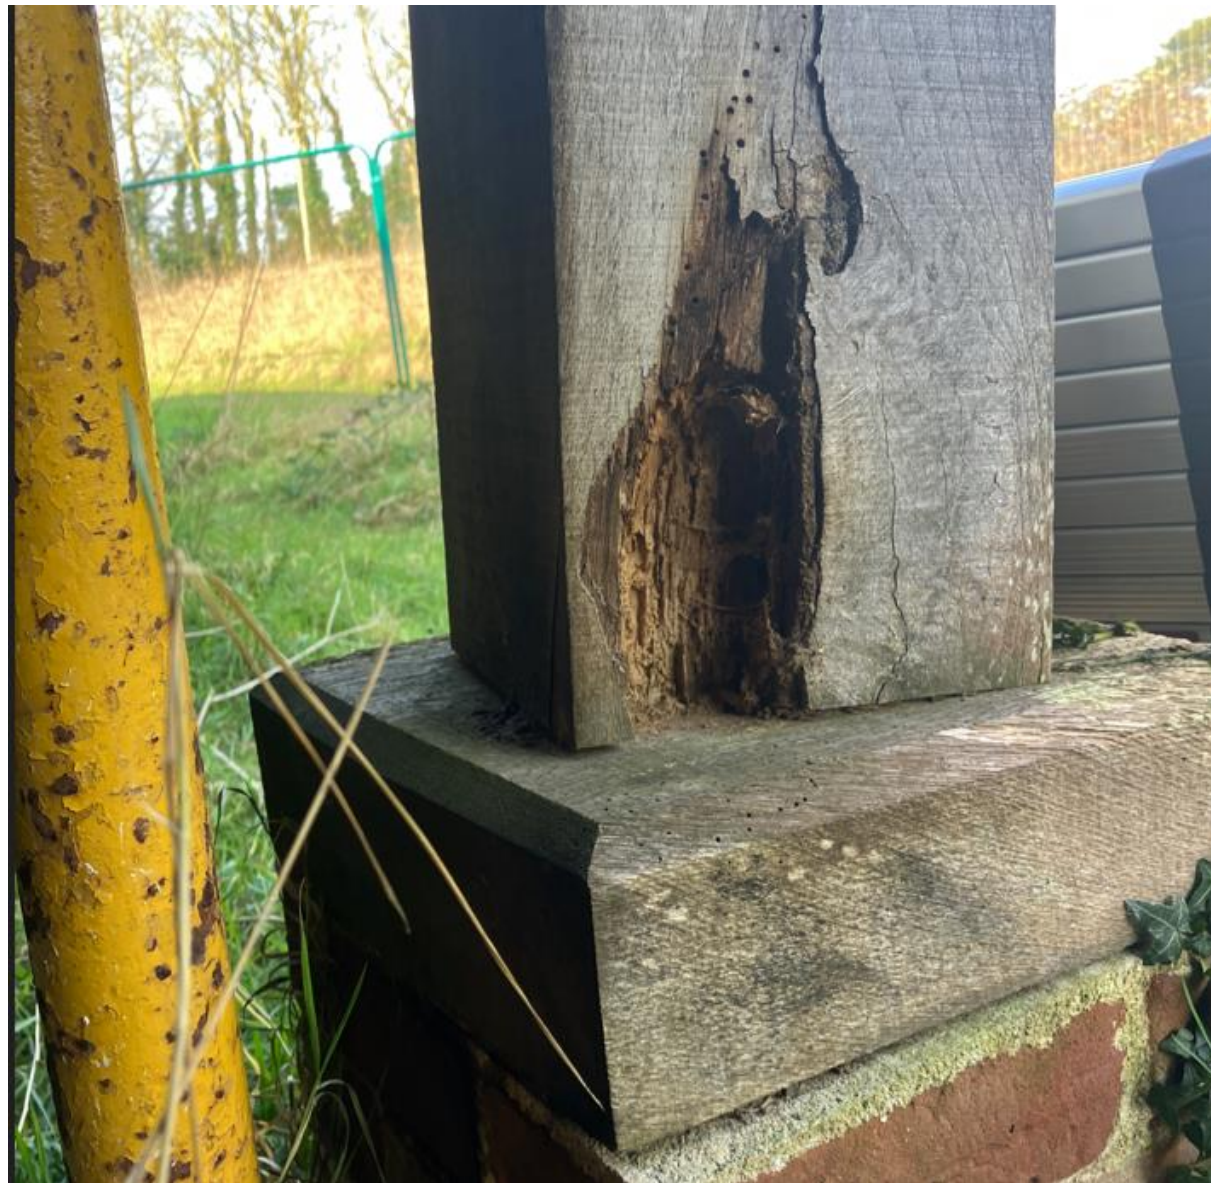
- 4.3.2 Signs of potential timber decay or infestation were noted to the base of the post to Truss I with some loss of section apparent, although the full extent of this could not be established from a visual inspection alone (Photo 4). There also appeared to be some decay to the northern end of the lower chord, however much of this was obscured by the steel strapping.

Photo 4 – Decay to base of post to Truss I

5.1.12 The potential decay noted to post base to Truss I, and to chords of Trusses F and J, do warrant further investigation. The nature of decay, and the degree of section loss, cannot be fully established by an Engineer's visual inspection, and some intrusive investigation would be required.

The extent of repair will be established following this investigation, however at this stage we would suggest the repair of the Truss I post base is likely to be required at a minimum. This can be completed with bolted half-lap joint. This element was a 1990s introduction and therefore the small loss of decayed fabric is not considered unreasonable.

The approach to repair of the post base is presented in SK004 in Appendix A.

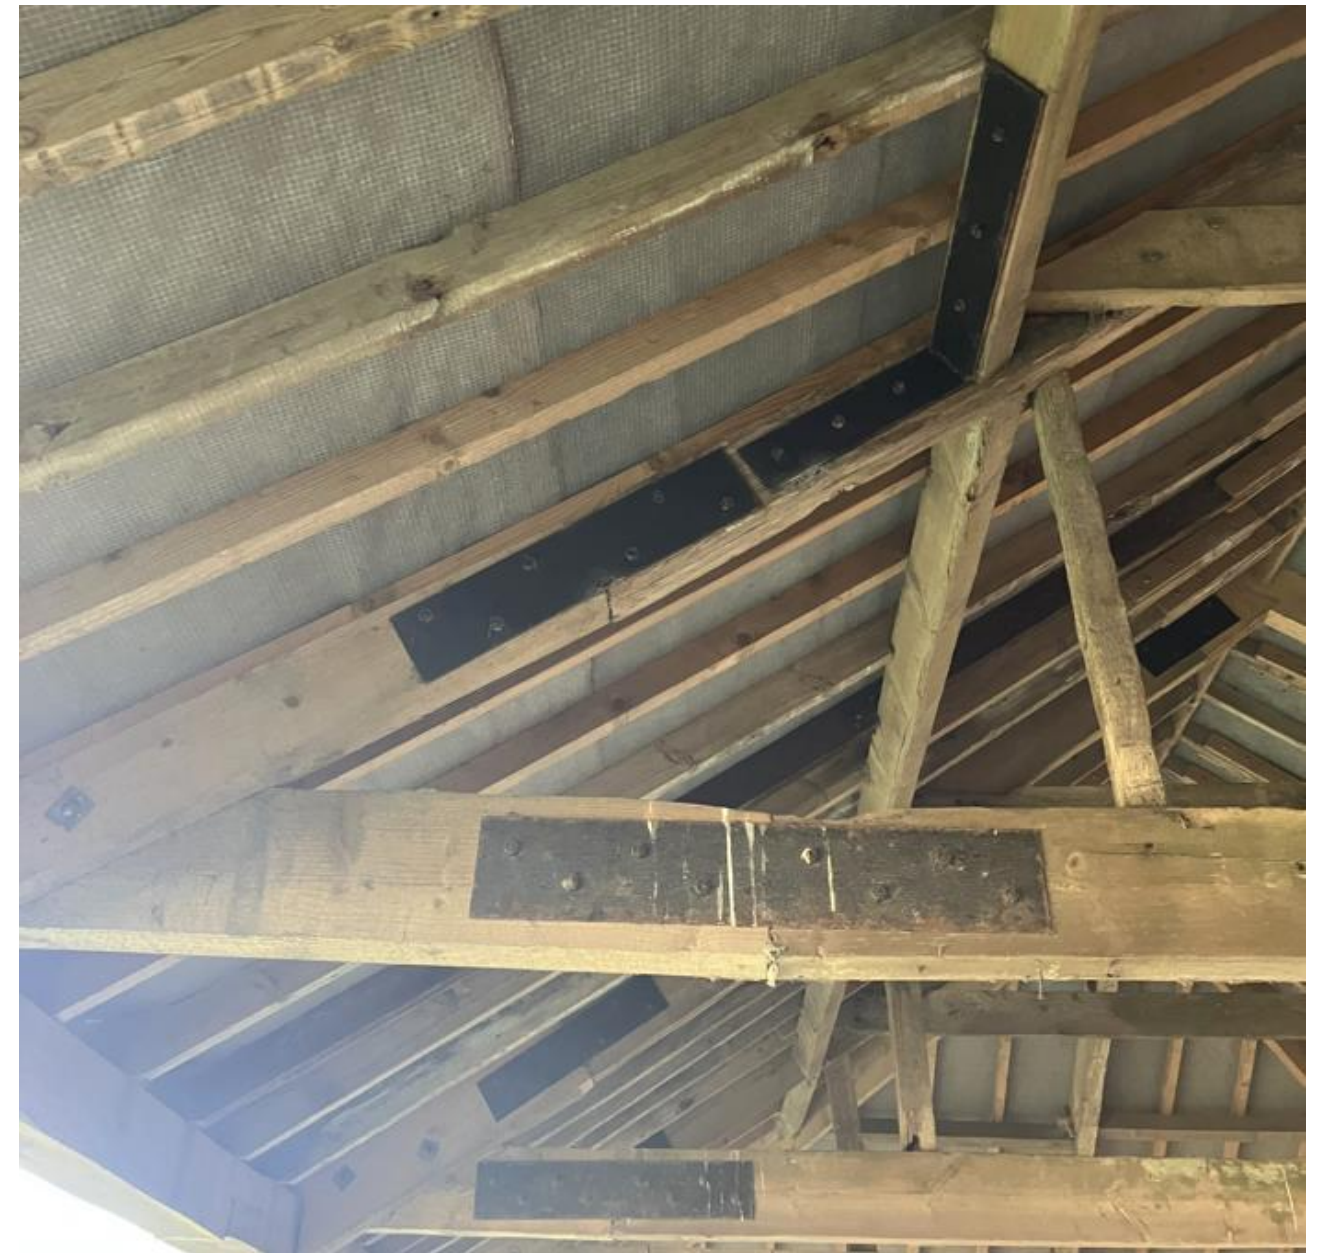
- 4.3.3 The vertical acrow props (off timber bearings on the ground) and steel strapping included in the Nicholas Warnes schedule were present and appeared to be sound at time of inspection, although its ability to meaningfully restrain any outward movement for any length of time is perhaps uncertain. Vertical propping was also present to the adjacent Truss H.
- 4.3.4 Spliced sections of timber were present to the lower chords of Trusses C, D F, G and H. These were located adjacent the northern eaves, near to the Queen Post. Newer timber of similar section size was spliced to the parent chord to the northern end, with pairs of steel plates each side, fixed with four through-bolts either side of the joint. The bolts were located near the centroid of the section, staggered vertically a short distance above and below. (Photo 5)

Photo 5 – Steel splices to lower and upper chords to eaves, with strengthening strap to purlin

5.1.5 The deflection noted to steel plate splice connections to truss chords are likely the result of initial movement, immediately after installation as the load is take up by the connection. Clearance around bolted fasteners and small gaps in joints due to construction tolerances will allow for some initial rotation as the load is applied before reaching equilibrium. These truss elements are generally axially loaded, with bending forces a more minor component. At this time we do not feel these joints are structurally compromised.

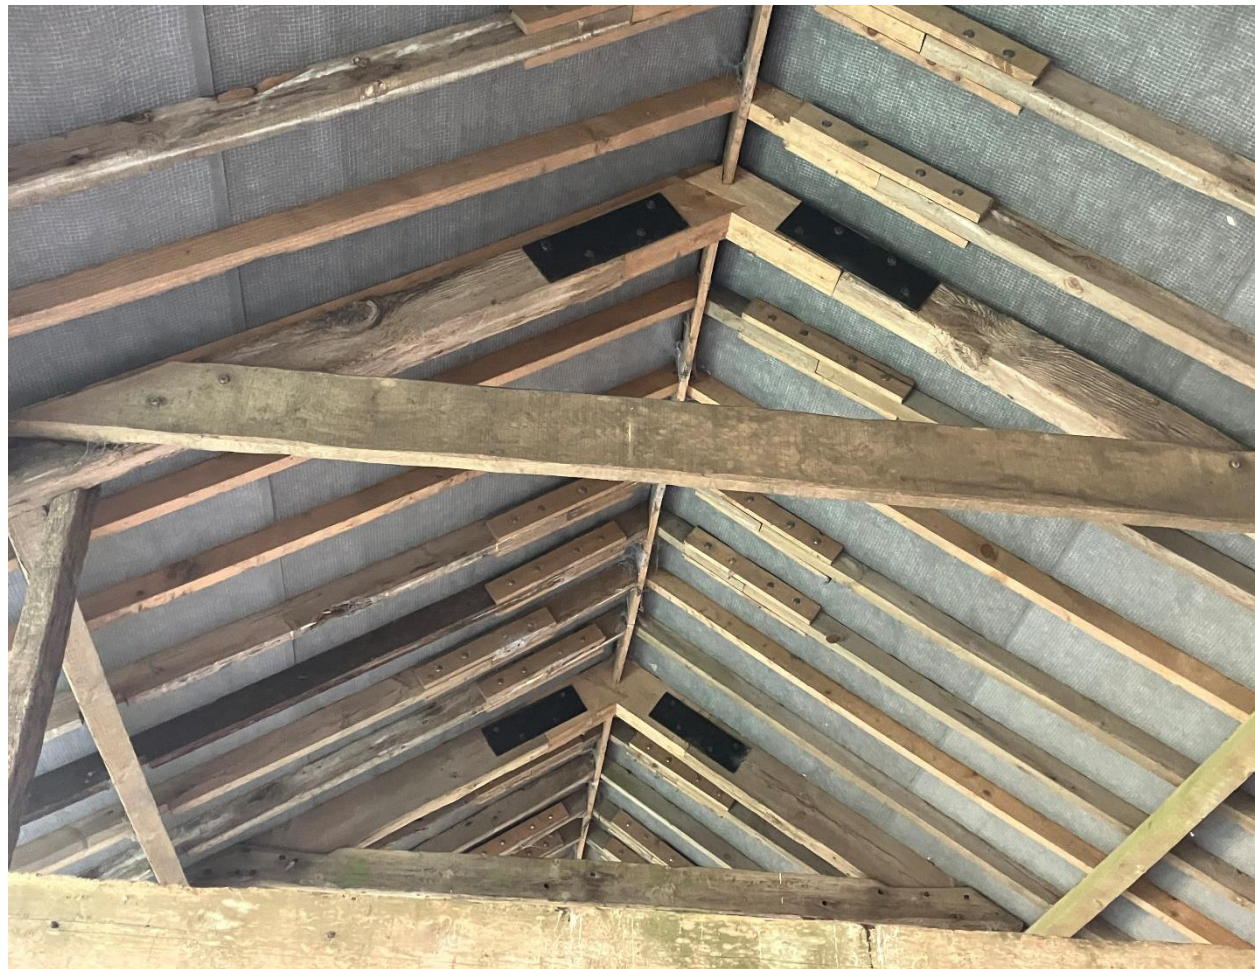
Photo 6 – Spliced ends at the ridge; in steel to the upper chords, and timber to the rafters

- 4.3.7 Similar splices were also present to the upper chords at the ridge of Trusses C, D, E and F, with newer timber to the ridge side (Photo 6). These were also present to the primary rafter to the eastern hip-end at eaves and ridge, and to the southern purlin adjacent Truss B.

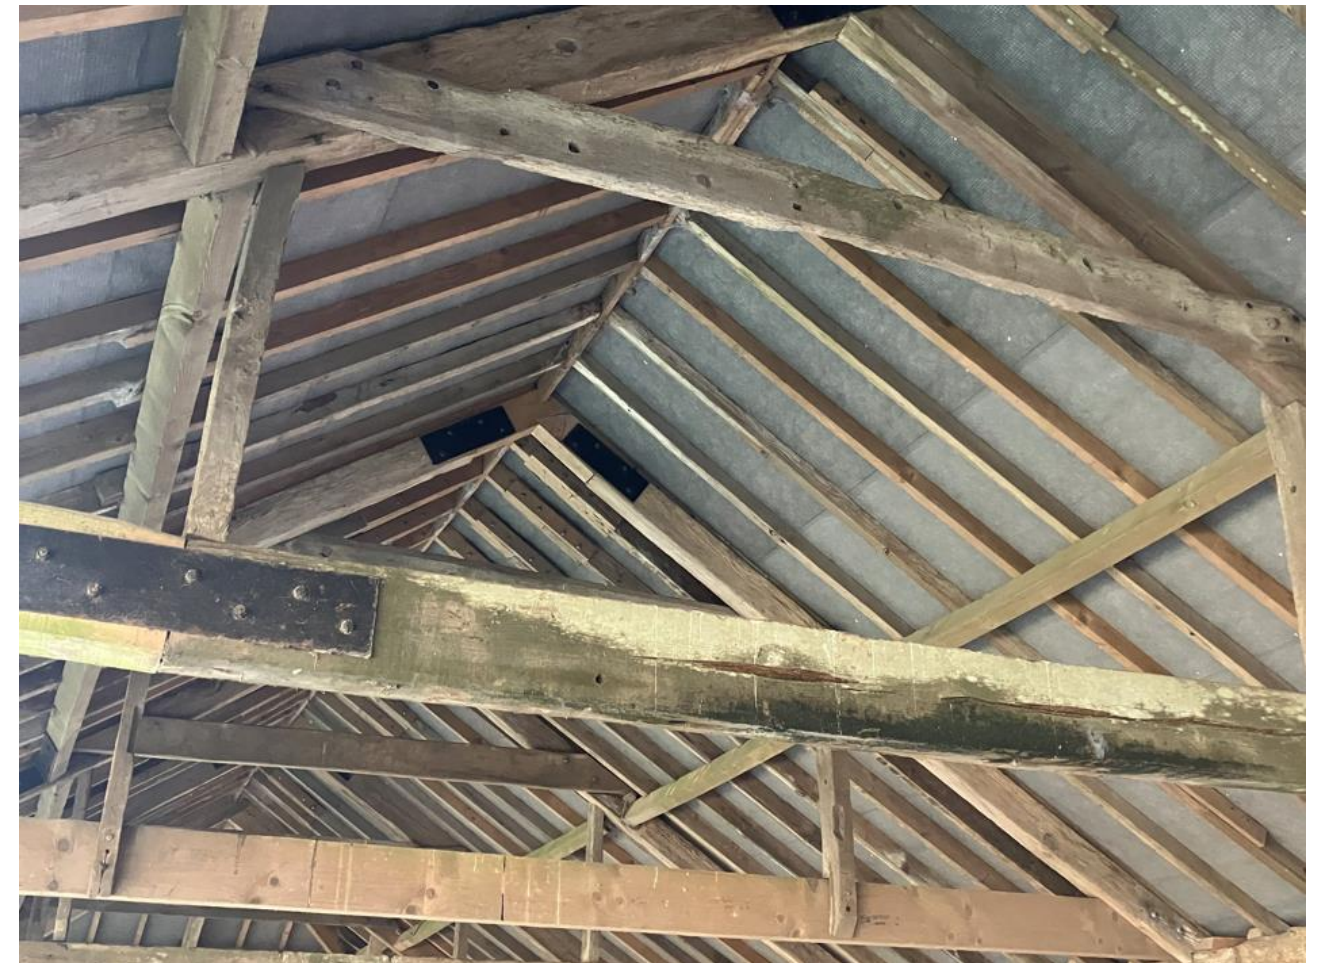
- 4.3.10 Signs of potential decay were noted to the lower chord of Truss F between the Queen Posts, as evidenced by discolouration and potential surface growth to the timber, and a horizontal split along much of this length (Photo 7). An ongoing cause of this decay, such as exposure to dampness, was not clear during inspection. As such it may be a historic issue.

Photo 7 – Discolouration and potential decay to lower chord

Truss F – allowance for bolting a new seasoned oak member of matching section to the existing lower chord, from the northern queen post to the south wall, with 12No M10 stainless steel bolts.

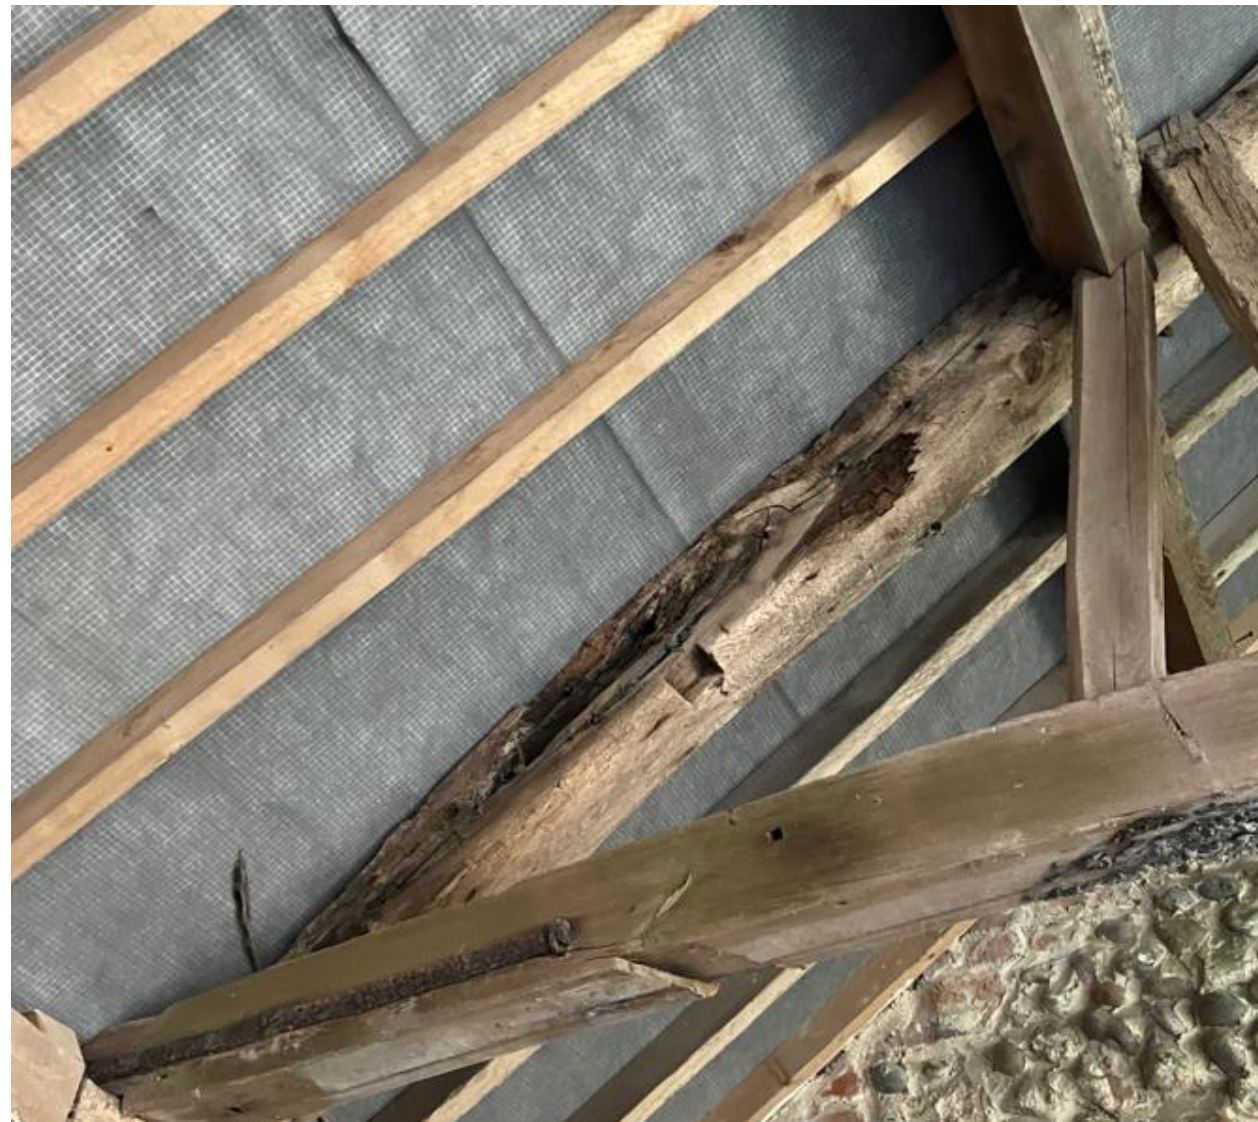
- 4.3.11 Potential decay was also noted to the southern upper chord of Truss J (Photo 8). This was evidenced by loss of section visible at the surface between the eaves and the purlin. Again, a clear ongoing cause was not evident from visual inspection.

Photo 8 – Suspected decay to Truss J upper chord

Truss J - allowance for bolting a new seasoned oak member of matching section to the existing southern upper chord between the eaves and the purlin, with 12No M10 stainless steel bolts.

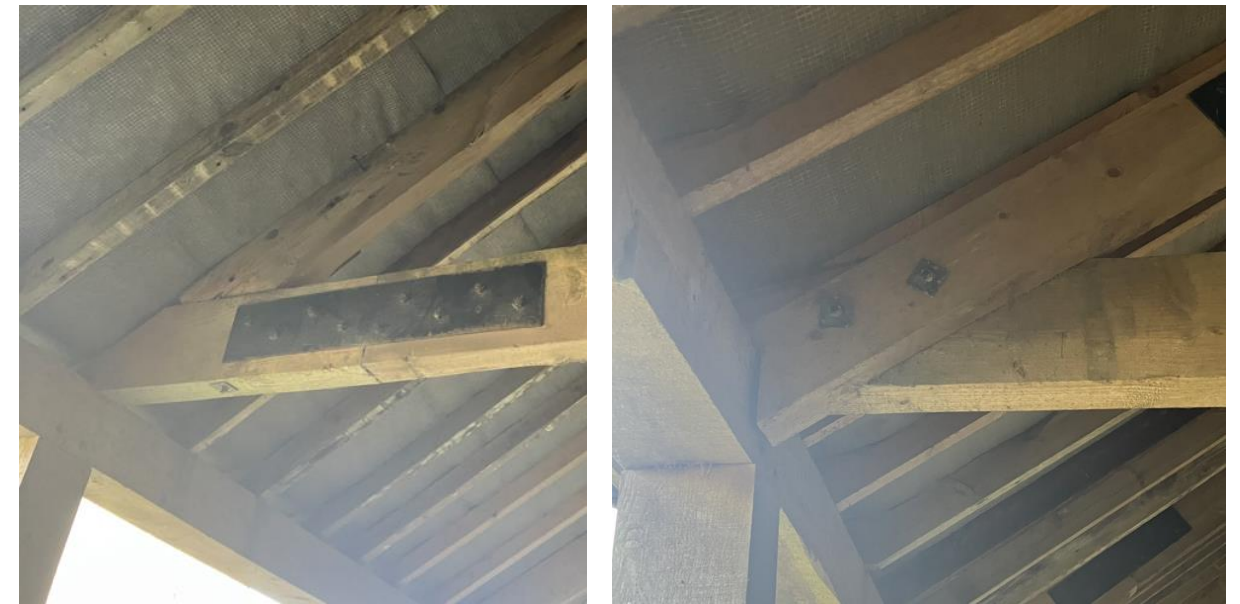
4.3.15 The arrangement of truss end bearings was variable. To Trusses G and H the arrangement was more conventional with the upper chord bearing onto the lower chord with a mitered cut (Photo 9). To other trusses, however, there was a less conventional joint with the upper chord half-lapped with the lower. This half lap joint was secured with additional modern bolts in most cases (Photo 10).

Photos 9 and 10 – Showing varying truss end details

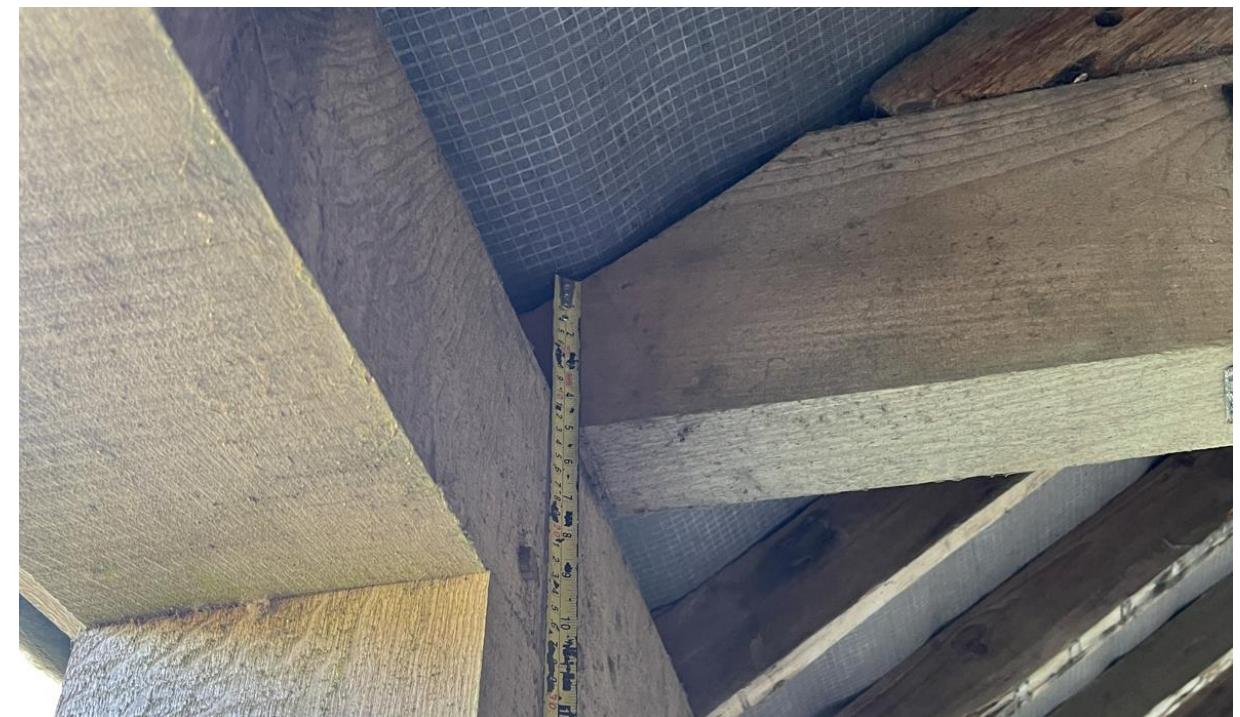
4.3.17 In all other cases the lower chord was bearing onto the bressummer or wall plate, and was notched to its top face following the roof profile, and to the northern side this left a very shallow depth remaining, less than 100mm in some instances (Photo 11).

Photo 11 – Shallow end bearing to truss end

5.1.8 The truss bearings to the northern side (onto the bressummer beam) do warrant some attention, particularly noting the failure of Truss I. These chords are heavily notched to their top side over the support, and the anticipated shear stress in the slight remaining timber is not justifiable under codes of practice. Therefore, some strengthening measures to these joints would also be prudent.

Although functioning at time of inspection, our assessment has revealed that the northern end bearings of these trusses is vulnerable to failure in a similar manner to Truss I. We'd consider that strengthening of this joint with a new timber brackets a prudent measure to reduce the risk of further failures.

This approach is presented in SK002 in Appendix A.
