Survey

Raynes Park High School Bushey Rd, London SW20 0JL

Friday, 4 July 2025

Prepared For Mc Bains

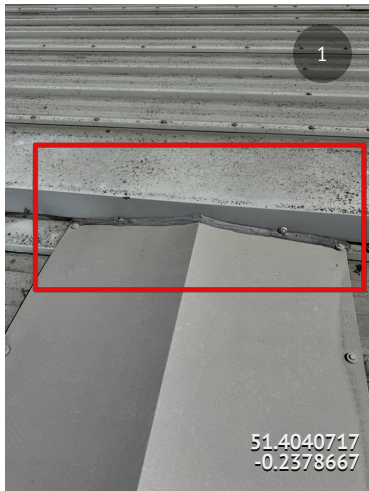
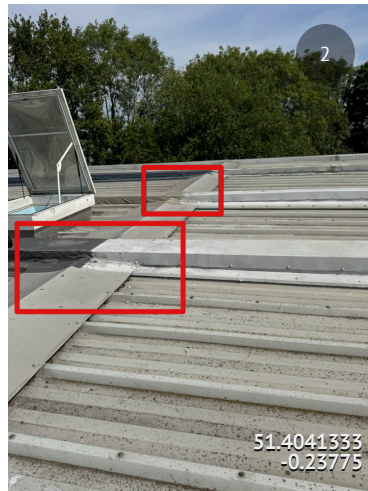
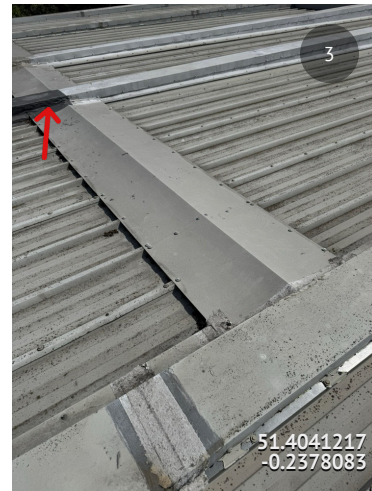
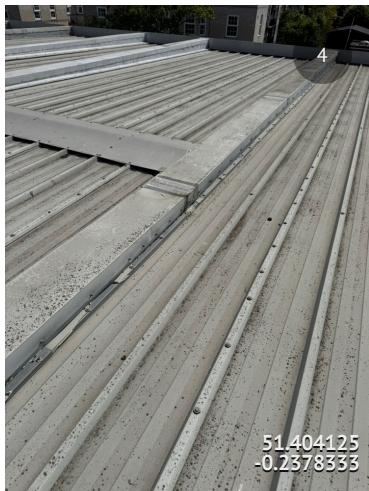
Ridge Flashing

Upon inspection, it was noted that the ridge flashing has been installed incorrectly. The current arrangement directs water toward the joints rather than allowing it to shed away, increasing the risk of water ingress and long-term damage.

I recommend that the existing ridge flashings be removed and replaced with a redesigned top hat-style flashing. This should be installed over the capping to ensure water is directed away from all joints, providing a more effective and durable weatherproofing solution.

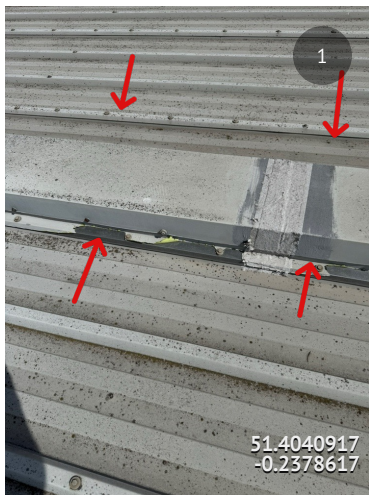
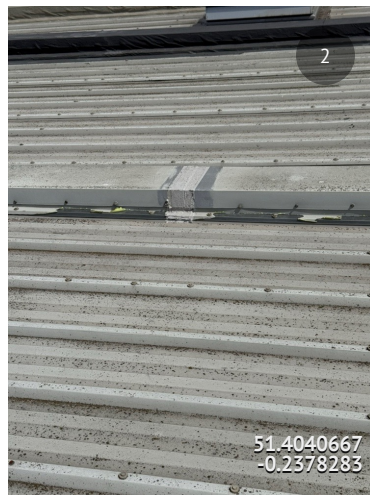
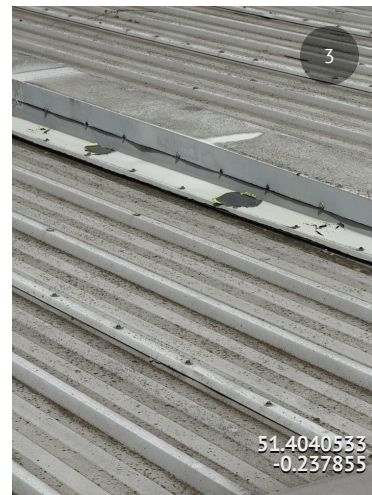
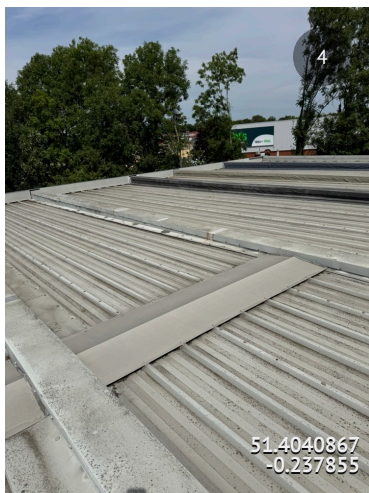
Capping

A top hat flashing has been installed in various areas of the roof, likely as a response to the number of previous repairs and incorrect detailing in those sections. Due to the extent of the existing remedial works and the compromised finishes, I recommend leaving the current top hat flashings in situ to avoid further disruption.

To ensure long-term weatherproofing and compliance with best practice, a new correctly detailed flashing should be installed over the top of the existing ones, using approved sealants in accordance with the manufacturer's recommendations.

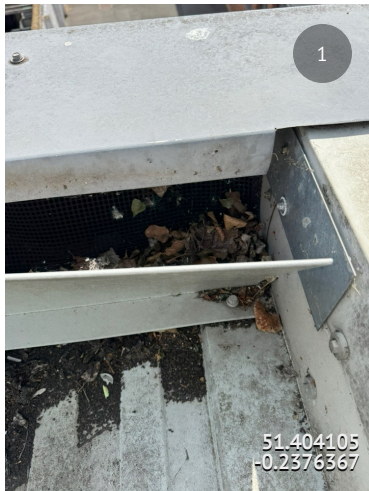
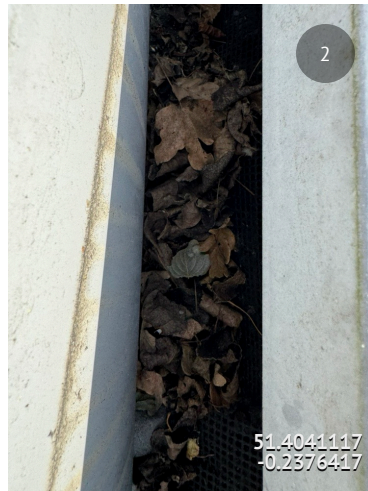
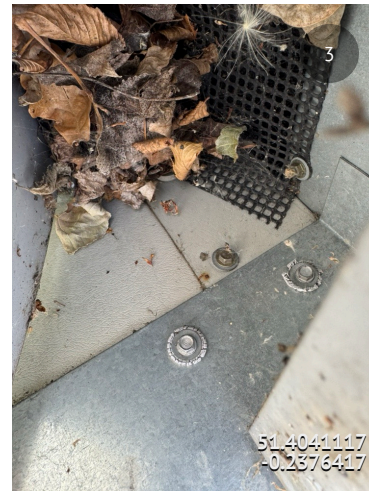
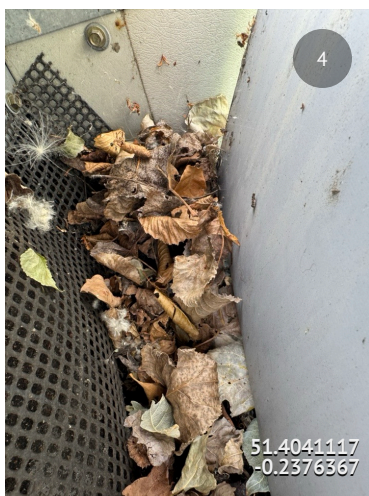
Eave Flashing

Flashing and leaf grate have been installed; however, this is leading to leaf build-up and causing water to backtrack up the roof. This is primarily due to the low pitch of the roof, which is preventing adequate drainage.

It is advised that the current grate is removed, and a new trim is installed over the top of the coping flashing. This should be designed to leave a larger opening, allowing water and debris to flow more freely and reducing the risk of future blockages.

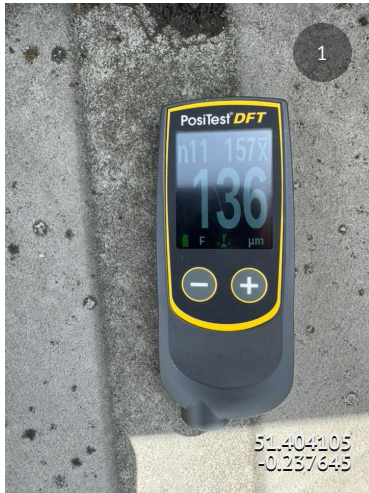
Micron Reading

During my inspection, I carried out a coating thickness (micron) reading on the metal surface. The original manufacturer-applied finish would have been approximately 200 microns, in line with standard specification.

The readings taken on site measured approximately average 150 indicating a level of degradation to the original coating. This reduction suggests either natural weathering over time or potential mechanical wear, which may impact the long-term corrosion resistance of the surface.

I recommend further monitoring of the coating condition and, if required, re-coating or applying a protective treatment to restore durability and maintain warranty compliance.
