# Asbestos Management Plan

***Property Address***  
**Falmouth Library**

**UPRN P30806A00**

# Asbestos Register

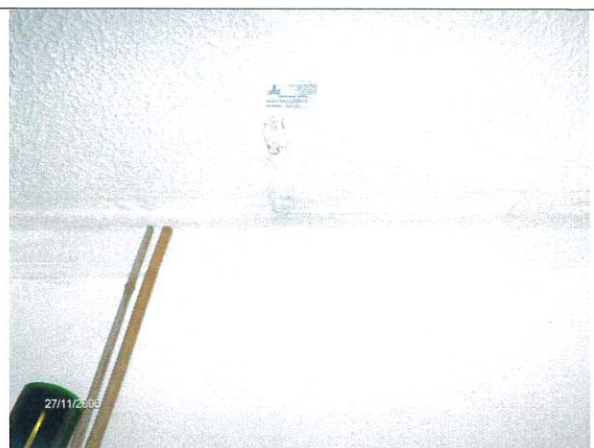
Sample Ref. No:	0806/1/0/007/01	
Material Location:	Ceiling	
Approx. Quantity (m <sup>2</sup> ):	4m <sup>2</sup>	
Accessibility:	Medium	
<b>Material Assessment Score</b>		<b>Score</b>
Product Type:	Textured Coating	1
Condition:	Good	0
Treatment:	Composite	0
Asbestos Type:	Chrysotile	1
Total:		2
Comments:

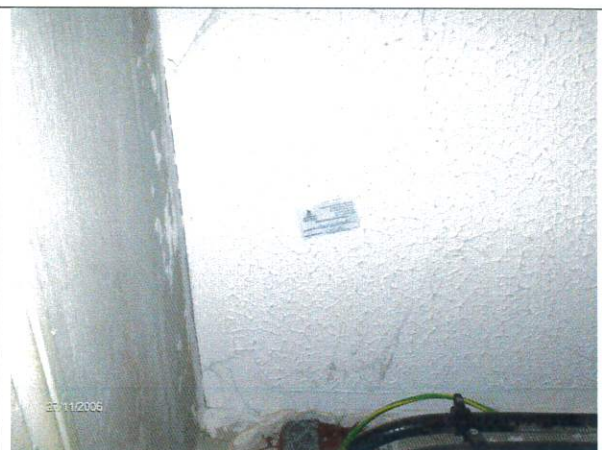
Sample Ref. No:	0806/1/0/008/01	
Material Location:	Ceiling	
Approx. Quantity (m <sup>2</sup> ):	3m <sup>2</sup>	
Accessibility:	Medium	
<b>Material Assessment Score</b>		<b>Score</b>
Product Type:	Textured Coating	1
Condition:	Good	0
Treatment:	Composite	0
Asbestos Type:	Chrysotile	1
Total:		2
Comments:

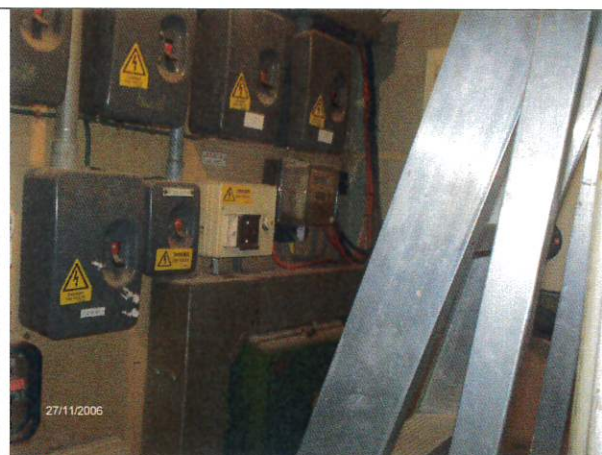
Sample Ref. No:	0806/1/0/008/P1	
Material Location:	Presumed flashguards in electrics	
Approx. Quantity (m <sup>2</sup> ):	-	
Accessibility:	Low	
<b>Material Assessment Score</b>		<b>Score</b>
Product Type:	Presumed Textile	2
Condition:	Presumed Good	0
Treatment:	Presumed Enclosed	1
Asbestos Type:	Presumed Chrysotile	1
Total:		4
Comments:

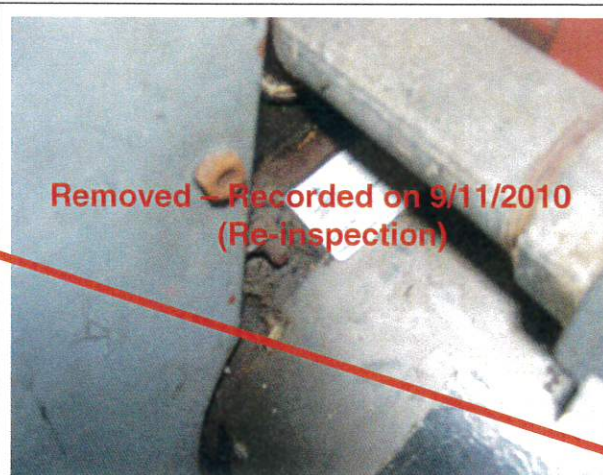
Sample Ref. No:	0806/1/0/024/01	
Material Location:	Bitumen & rope gasket to rear of boiler	
Approx. Quantity (m):	2-3 liner m	
Accessibility:	High	
<b>Material Assessment Score</b>		<b>Score</b>
Product Type:	Asbestos Textile	2
Condition:	Low damage	1
Treatment:	Unsealed	2
Asbestos Type:	Chrysotile	1
Total:		6
Comments:	Present to each section of boiler Refers to ESL sample 5558/02

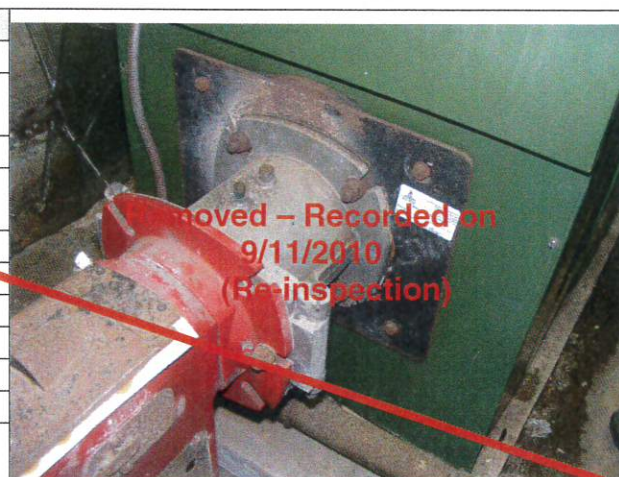
Sample Ref. No:	0806/1/0/024/02	
Material Location:	Gasket to blower pump at front of boiler	
Approx. Quantity (m²):	<1	
Accessibility:	High	
<b>Material Assessment Score</b>		<b>Score</b>
Product Type:	Asbestos Gasket	2
Condition:	Low damage	1
Treatment:	Unsealed	2
Asbestos Type:	Chrysotile	1
Total:		6
Comments:	Refers to ESL sample 5558/04

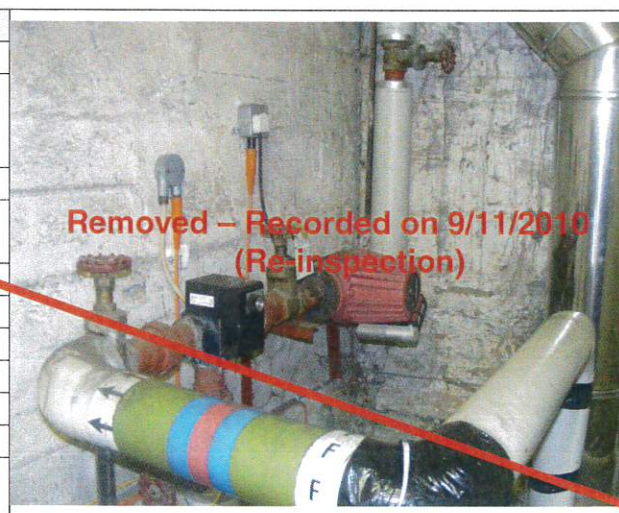
Sample Ref. No:	0806/1/0/024/P1	
Material Location:	Presumed asbestos gaskets to flange joints of pipe work throughout	
Approx. Quantity (m²):	-	
Accessibility:	High	
<b>Material Assessment Score</b>		<b>Score</b>
Product Type:	Presumed Asbestos Gasket	2
Condition:	Presumed Good	0
Treatment:	Presumed Unsealed	2
Asbestos Type:	Presumed Chrysotile	1
Total:		5
Comments:
