REPORT ON CONDITION OF:

**Municipal Building
The Moor
Falmouth
TR11 2RT**

Falmouth Town Council

30th August 2023

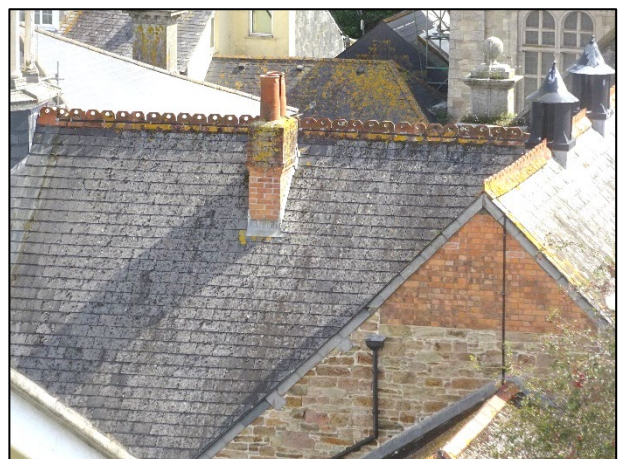
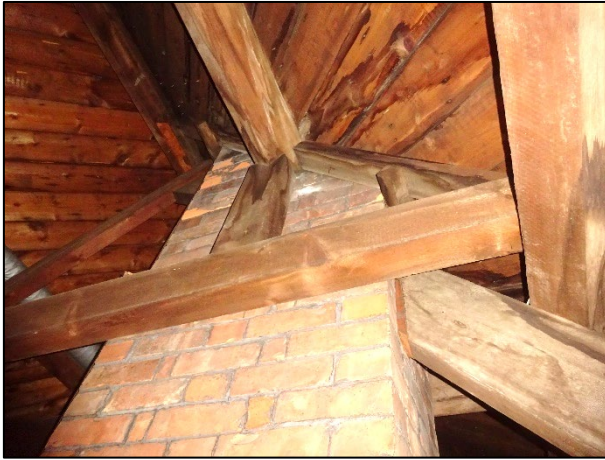
This chimney is no longer in use but remains in sound condition. It is not entirely clear as to whether the flues remain open. Regardless, it would be worthwhile fitting cowls over the head of the pots at such time that high level access is next in place for routine maintenance.

There is slight water staining to the brickwork chimney breast within the roof void, but this is not sufficient to have

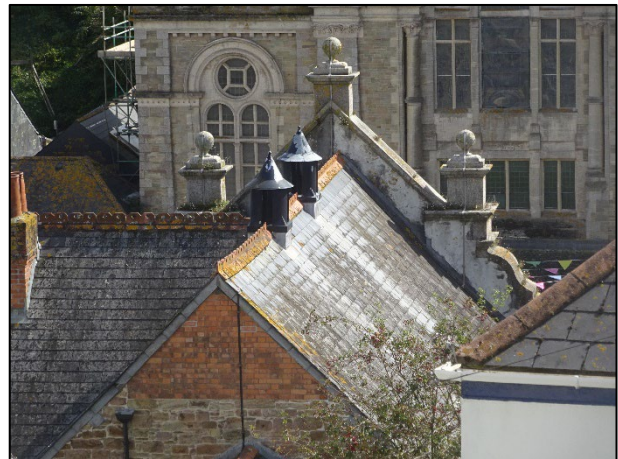
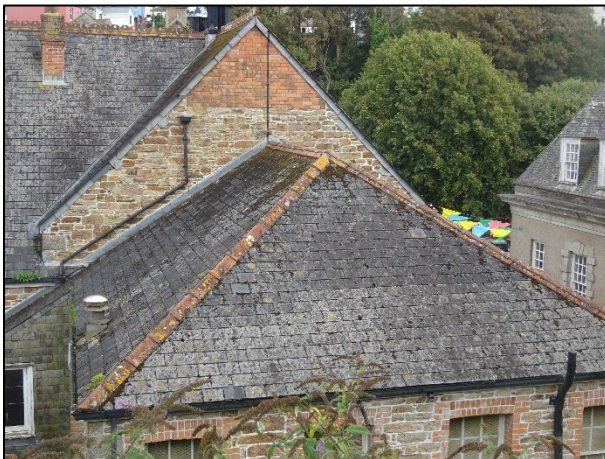
The various fibre cement slate roof coverings generally continue to perform adequately. However, the surface of the individual slates is notably dulled and this material is certainly showing some fatigue with age. Furthermore, there are several areas where there is some slight water seepage and staining evident within the main roof void beneath.

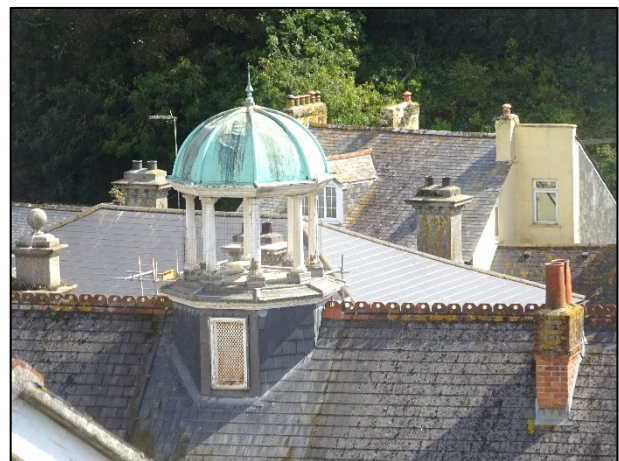
This structure is sound but the paint finishes are fading and some rippling and slight deterioration of leadwork is evident to the domed roof. We advise closer inspection with the benefit of high level access, allowing for some routine maintenance at such time.

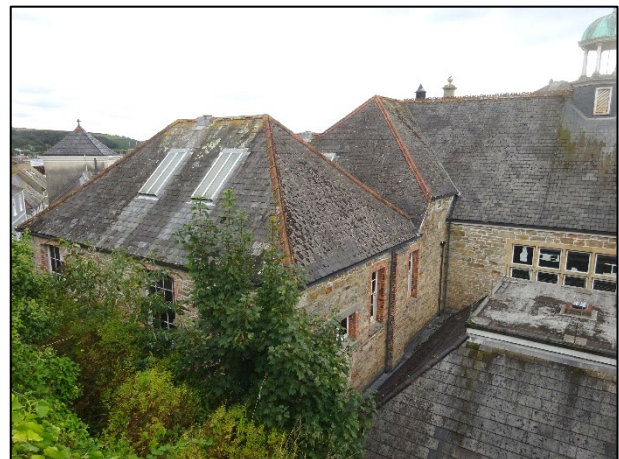
Similar to the main roof, the slate sections remain in better condition than the fibre cement slate sections and there is no immediate concern. We again advise allowance to replace the fibre cement slate roof coverings relatively short term. It would make sense to replace all of the roof covering at the same time if funds allowed.

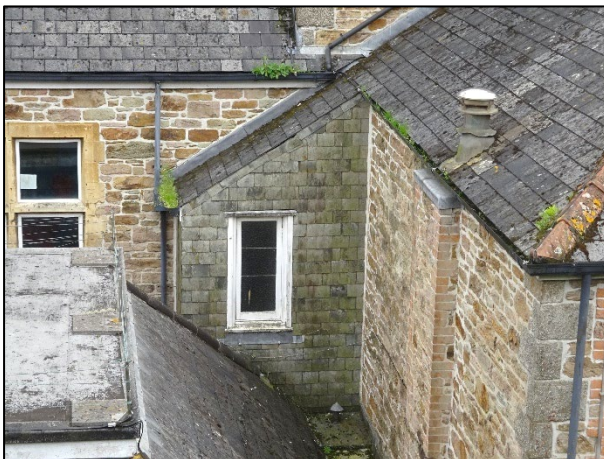
The rainwater goods remain in reasonable order but are now starting to show signs of fading to the surface finish with UV degradation and there is now quite a build-up of vegetation within various gutters.

Normal routine maintenance will require gutters to be cleared out and jointing gaskets checked and resealed from time to time. Leaking or overflowing gutters are a common cause of dampness and/or premature decay within buildings, particularly those of an older traditional construction.

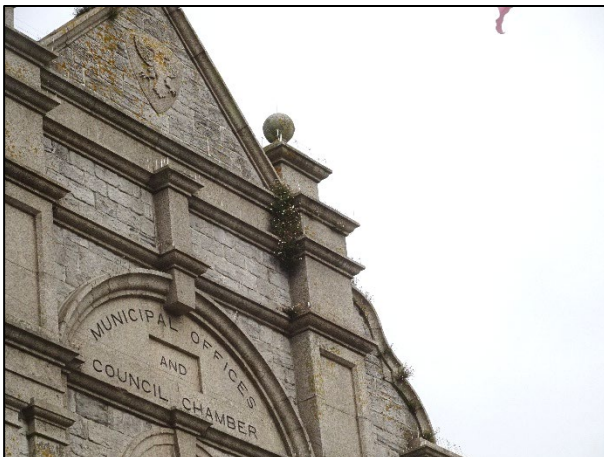
Whilst the building is sound, the most significant issue is that there is quite notable dampness affecting internal finishes - primarily to the front of the building and particularly at high level. This is the result of penetrating dampness and almost certainly due to deterioration of the various mortar joints between the stonework and detailing.

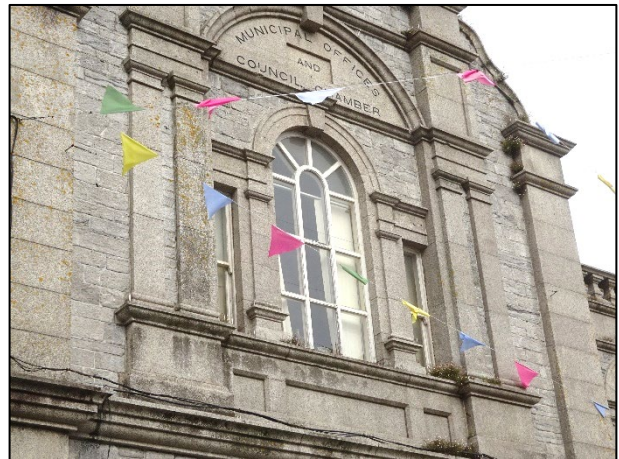
The quality of the stonework to the principal front elevations is very good and, from a distance, all appears in good order. However, upon closer inspection, it can be seen that there is now extensive vegetation growth from the various joints between stones and detailing, which is a clear indicator of deterioration to the various mortar joints and weakness for water ingress.

It would be very difficult to entirely resolve all penetrating dampness, without significant upgrading of external finishes and detailing, much of which would not be permitted given its Listed status. However, careful raking out and repointing of the various mortar joints would certainly help matters significantly and we advise a programme of extensive careful repair and maintenance to the stonework across the principal elevations at the earliest opportunity. A significant but necessary task.

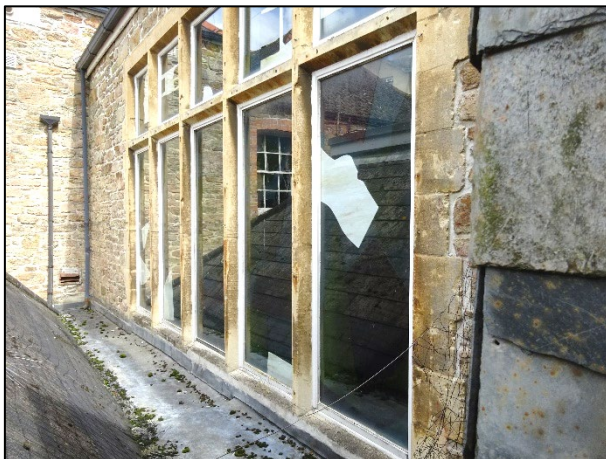
In addition, the individual timber framed casement units are starting to show signs of some decay. In particular, the central lower casement is missing a timber lower rail supporting the glazing.

We advise allowance for some overhauling and repair of the individual timber glazing units and some repair of the stonework.

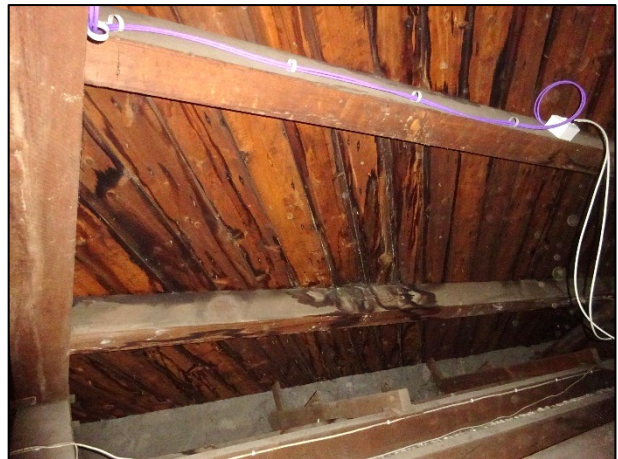
There is quite a lot of water staining evident to the timber sarking boards in various areas – particularly beneath the rear fibre cement slate roof coverings. Not all of the water staining is necessarily indicative of current water ingress but certainly a proportion is.

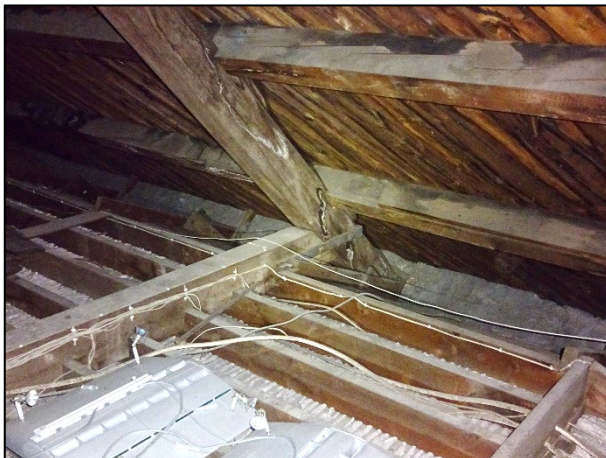
Most notable, there is virtually no insulation within this main roof void, or within the built-up roof covering as far as we can establish. There is certainly potential to introduce insulation over the ceilings. However, as identified below, there are not accessible void spaces beneath all of the roof structure and coverings across the building. This, combined with obvious water staining to the sarking boards, we feel is reasonable justification to strip and replace the roof

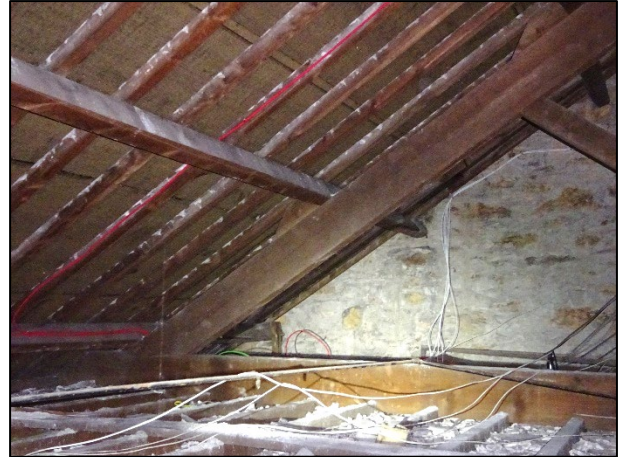
The roof structure is sound where visible but sarking felt now certainly tired and there is evidence of some water staining to a number of timbers in localised areas. Some timber repair has been carried out in the past and we advise allowance for some further localised repair alongside replacement roof covering. Generally, the roof structure is sound here.

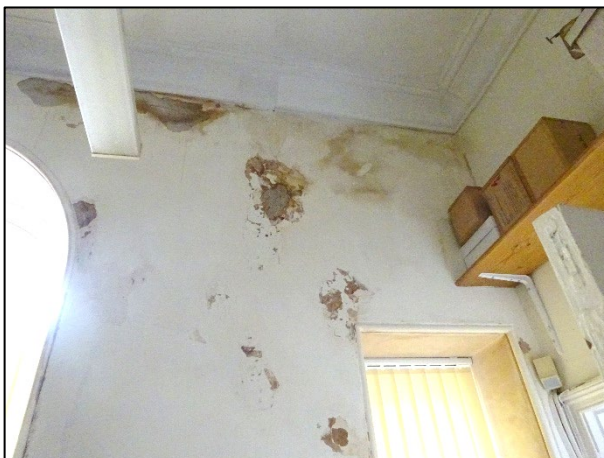
The wall surfaces are considered sound but it is clear that plaster finishes have suffered notable deterioration owing to prolonged penetrating dampness over the years. This is particularly the case to the inside face of the principal front and right hand side elevations.

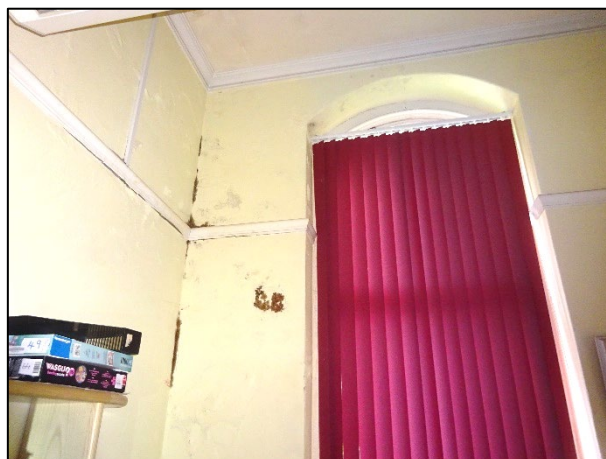
Externally, there is a raised flower bed in this area with quite notable plant growth up against the wall. It would certainly be of benefit if the vegetation were to be cut back and planting soil reduced from the face of the wall. Whilst this is not helping matters, we are of the opinion that the primary reason for the dampness is water ingress through the external stonework.

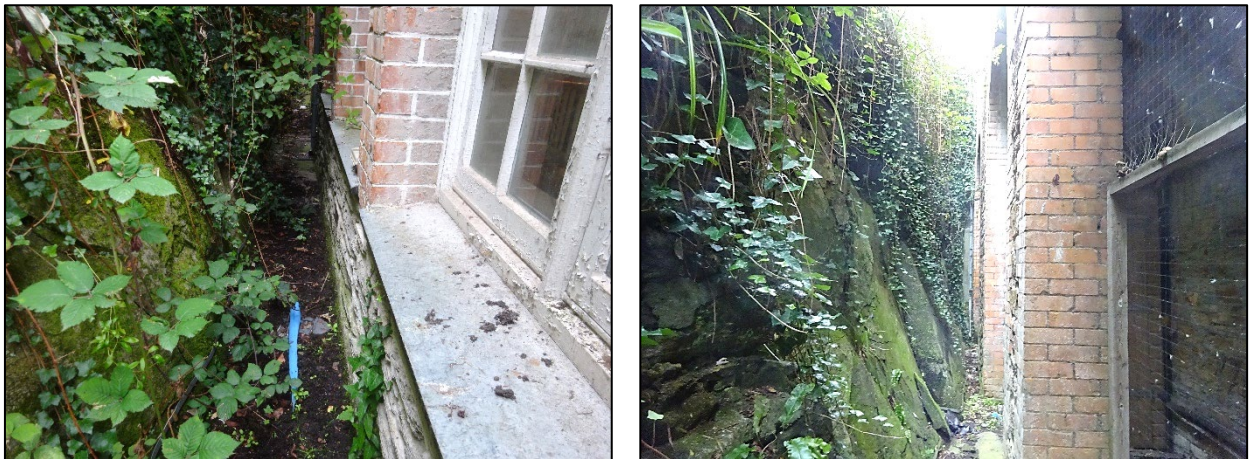
This area is quite heavily overgrown. There is a build-up of general detritus to the ground and a notable pigeon infestation to the undercroft area.

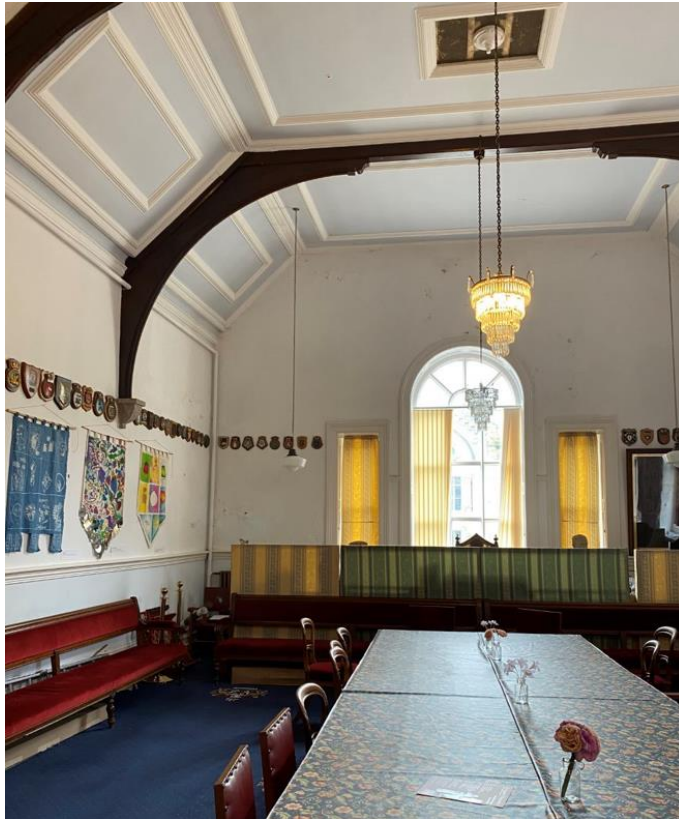
Photo 9.2.1 Non-LED lighting in council chamber

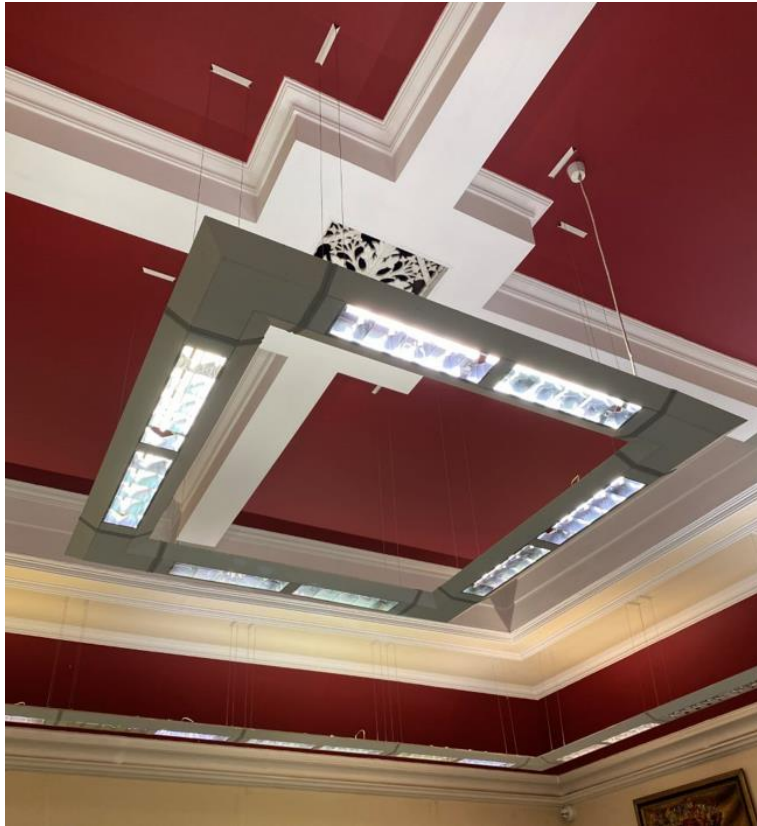
Photo 9.2.3 Library lighting predominantly fluorescent tubes
