EDWINSTOWE VILLAGE HALL

BUILDING CONDITION SURVEY

THURSDAY 20TH JULY 2023

Smith and Roper
Architects and Surveyors
65-67 Church Street
Sutton in Ashfield, NG17 1FE

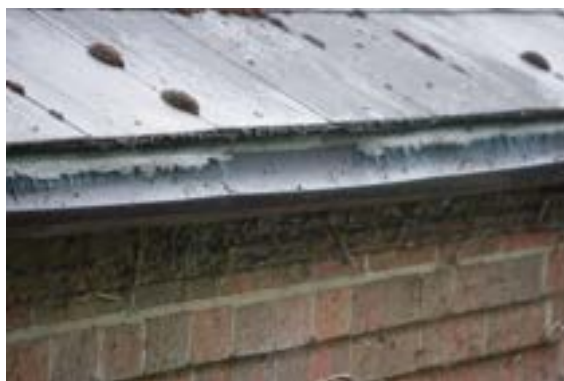
4.1.5 The most recent extension is the locker room with its hipped roof falling to a valley gutter abutting the east slope of the kitchen roof. The roof coverings to the locker room roof appear to be Eternit or similar, with matching overlapping ridge and hip tiles, possibly post-dating the use of asbestos. Some slates have however weathered noticeably better than others. The roof is provided with an underslating membrane, possibly breathable, which appears to have been installed without an eaves carrier and consequently the exposed edge of the membrane is fraying, and a short section at the northern eaves appears to be missing.

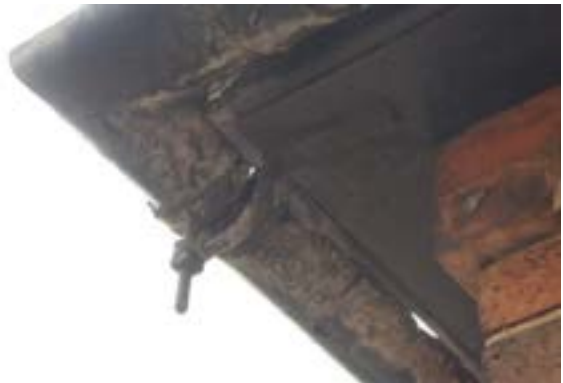
- 4.2.1 The western entrance porch has a half round cast iron gutter, mounted on rise and fall brackets fixed to the eaves soffit. There is extensive flaking of the paint finish to the gutter and rusting and staining suggests that numerous joints are leaking. The western gutter is heavily corroded, and daylight is visible through the southern gutter joints. The rainwater goods are now appropriate for replacement. The gutter discharges at its north-eastern end over the lead channel at the western end of the north-western valley gutter.

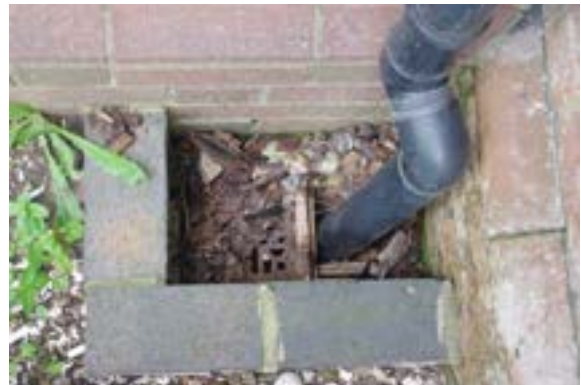
- 4.2.2 The hipped roof above the toilets drains to a half round black pvc gutter mounted on fascia brackets to the projecting eaves. There is staining to gutter joints on both the western and northern gutter runs, indicative of leakage. The gutter discharges at the southern end of the western run, into a 2½" diameter downpipe, in turn discharging into the back inlet of a grated gully with blue brick surround. The surround to the foot of the pipe is dislodged and required reforming, debris is in need of clearance from the gully grating. The paint finish to the timber fascia is flaking generally and early redecoration is recommended.

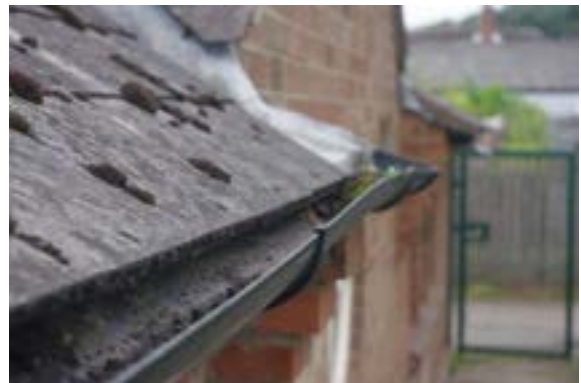
- 4.2.3 The hipped roof above the northern stores, drains to half round pvc gutters mounted on fascia brackets to the projecting painted timber eaves. The gutters are black finished but have subsequently been painted. There is twisting evident to the western end of the northern gutter, at the foot of the lead valley, and a bracket approximately central to the eastern gutter has broken. The gutter discharges at the southern end of the eastern run into the hopper head on the downpipe from the northern roof slopes of the main hall.

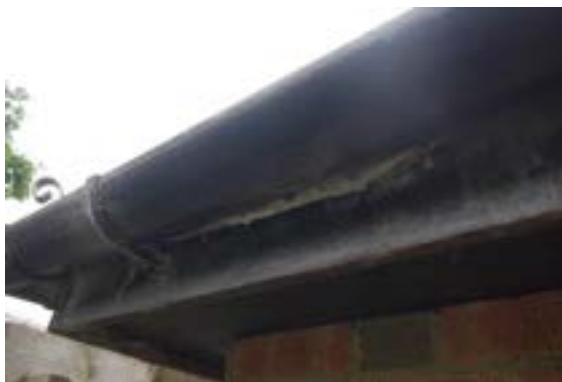
- 4.2.4 There is water staining to the painted timber fascia of the roof to the northern stores which is presumed to relate to a spillage from the gutter. There is a good overhang at the foot of the slates, however moss and other debris from the roof coverings is noted to build up within the gutter and there is a need for regular routine clearance. At the eastern end of the northern gutter, there is evidence that the underslating felt was incorrectly dressed down behind the guttering, although much of the foot of the felt appears to have been lost.

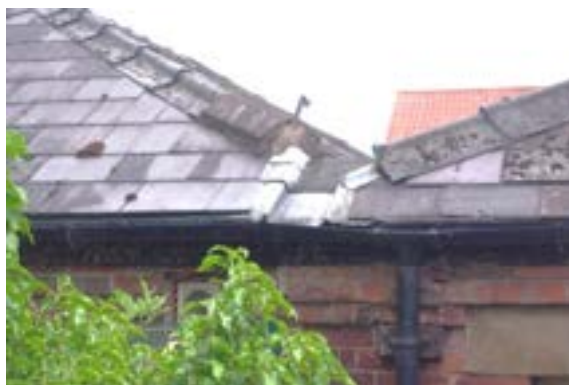
- 4.2.8 The northern slopes of the kitchen and locker room roofs, drain to a black half round pvc gutter, the gutter discharges at the eastern end of the kitchen, i.e. at the northern end of the valley gutter, into a 2½" diameter downpipe. There is a good fall on the gutter, however the brackets on the locker room section are very widely spaced and the rear of the gutter appears to have sprung out of the central bracket. The junction bracket to the immediate east of the downpipe appears high in relation to the outlet, refixing of this section of gutter is recommended. The kitchen and locker room northern rainwater pipe is fixed to timber blocks, the bracket to the lower block is broken but the pipe remains firm. The rainwater pipe, together with the kitchen wastes, discharge into the back inlet of a gully with blue brick surround. The gully is provided with a purpose-made cover; however, it is not possible to remove the cover to inspect or clear the gully without removing the lower section of downpipe.

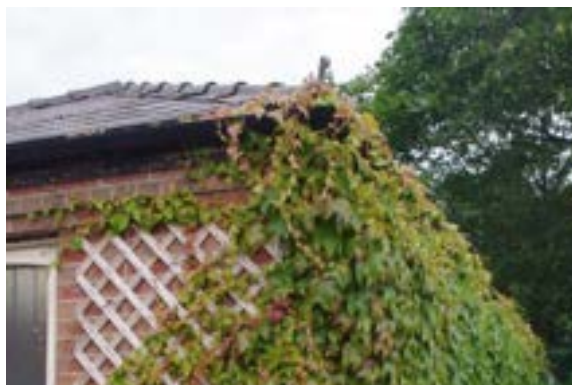
- 4.2.9 The eastern and southern slopes of the locker room and eastern entrance lobby roofs discharge to a half round black pvc gutter, continuous with that to the north slope. There is Virginia creeper to the east wall of the locker room and this is now enveloping the rainwater gutter for the entire length of the eastern run and also encroaching into the southern gutter. The need for regular routine trimming of the creeper should be noted in order to maintain it clear of the gutter. The gutter is mounted on fascia brackets to a painted timber fascia. The paint finish to the fascia is flaking in places and early redecoration is recommended.

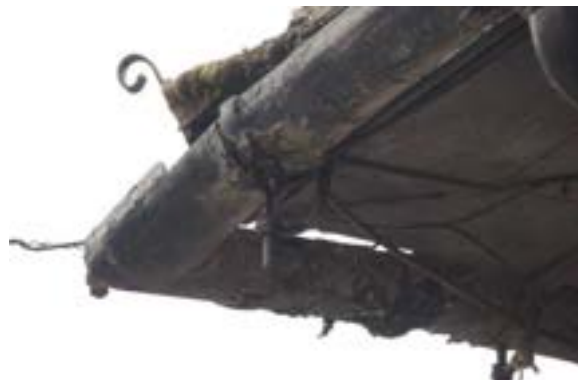
4.2.11 The roof to the original roadside section of the hall and Parish Council Office, drains to a large section half round cast iron gutter, mounted on substantial rise and fall brackets, fixed to the soffit of the projecting eaves. There is one bracket for each length of guttering. Rust and water staining is evident to gutter joints. The south eastern corner section has subsided, and spillage is likely to be occurring in this location. The roof coverings appear to incorporate some form of underslating membrane which is noted to be fraying at the south east corner. An electrical cable is threaded beneath the southern rise and fall brackets.

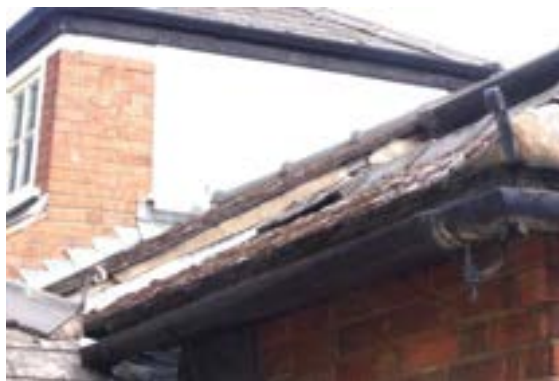
- 4.4.2 The gable walls to the northern section of the main hall extend up above roof level to form the corners of the lantern light. There is some loss of mortar pointing to the section of gable wall beneath the northern lean-to roof and a general check and making good is recommended. This will apply to both gabled walls together with a check that blown rain cannot find its way into the roof structure at the top of the verges.

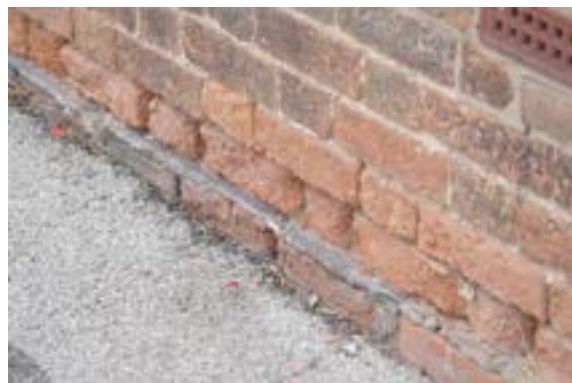
- 4.5.2 The south wall of the hall and the Parish Council office is generally as the east wall. At the eastern end of the wall is an applied mosaic to the Golden Jubilee of Queen Elizabeth II. There is evidence of historic settlement from the eastern side of the head to the eastern window extending up to eaves level and extending downwards to the plinth from the western side of the cill. The pointing to the main walling remains satisfactory for the time being. There is more extensive erosion to the plinth brickwork, particularly at low level, together with evidence of previously brick replacement. Further brick replacement together with repointing of the affected areas is recommended together with the repointing of open joints which are developing between the plinth bricks. The plinth brickwork contains an injection damp proof course and four clayware airbricks. At high level to the western section of the south wall to the Parish Council office, there are two metal ventilation grilles which would benefit from early redecoration.

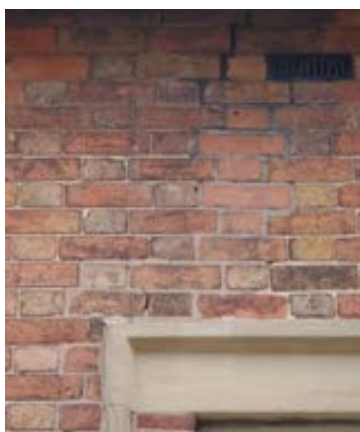
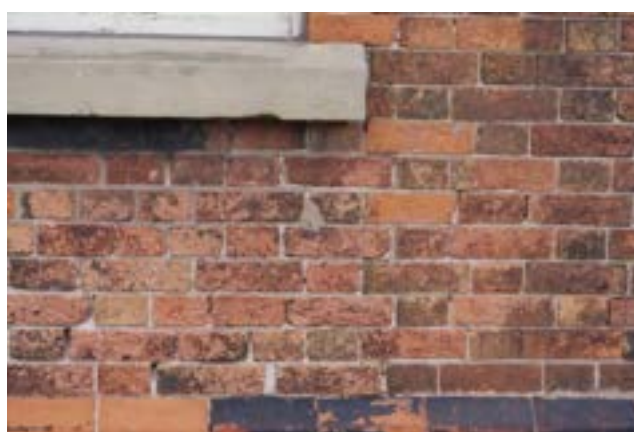
- 4.5.3 The west wall of the Parish Council office is as the east and south walls of the roadside block. There is evidence of previous settlement above and below the northern seatings of the lintel and cill to the southern window. There has only been slight reopening of the crack since last repointed. Isolated open joints are however developing within the vicinity of the cracking and beneath the southern side of the southern window; patch pointing is now recommended.

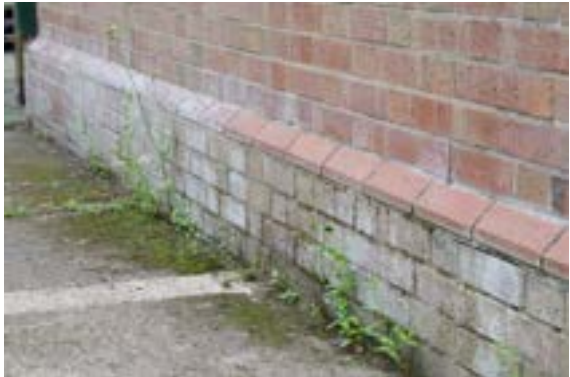
- 4.5.8 The north wall of the northern extension is as the west wall. Whilst the general walling remains in good order, there is staining from overflow pipes located beneath the central and eastern lights of the toilet window. Whilst the wall appeared dry and the source of the moisture is presumed to have been addressed, we recommend that the affected brickwork should be cleaned. All three plastic overflow pipes have been snapped off and we recommend that these should be replaced with something more substantial discharging clear of the wall face. Damp staining is evident to the north wall plinth, possibly associated with spillage from rainwater goods above and weed growth is developing from the foot of the wall. There are also open joints within the plinth. We recommend that weed growth should be treated and removed, plinth brickwork cleaned and open joints repointed.

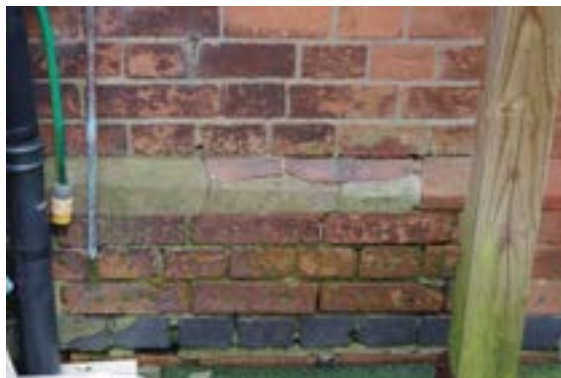
4.5.11 The north wall of the hall, eastern end, and kitchen is constructed in English bond brickwork, with a matching projecting plinth. Open and deeply recessed joints are developing within the western and eastern sections of the wall and associated plinth, repointing of these areas is now recommended. The plinth contains by an injection, dpc. There is a decorative clayware air grate within the central section of the wall.

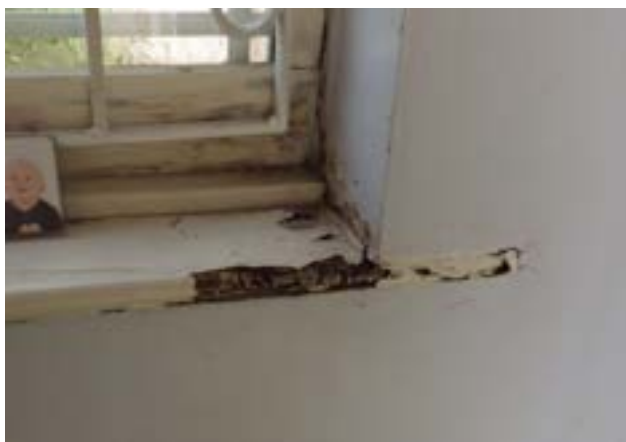
- 4.7.1 Within the north wall of the west porch is a single light painted timber window, incorporating double glazing with applied leading within the glazing unit. The external leaf of the glass is obscured. Internally the window is provided with painted decorative metal security grilles. There is extensive rot noted internally to the window board and evidence of water ingress to the reveal and around the foot of the window. Failure of the plasterwork is also noted to the lower eastern bracket to the security grille. A joinery repair in this area is now deemed appropriate. Externally a brick replacement is noted in this area, and this is presumed to have rectified the cause of the water ingress. Some repointing around the cill externally is however still required

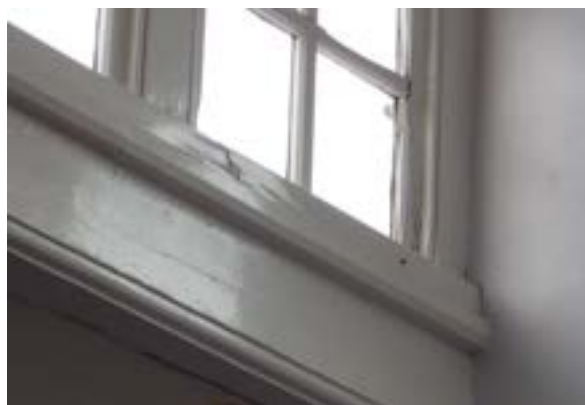
- 4.7.10 The lantern above the northern section of the main hall consists of twelve 4-pane timber framed windows, single glazed, within its north and south walls. There are two further windows within the east and west walls, the northern windows having 4-panes, whilst the southern windows have just a large single pane. The eastern, southern and western windows are provided with twin wall polycarbonate protection externally. Extensive rot is evident internally to the western southern window and adjoining timber cill, urgent remedial measures are clearly required.

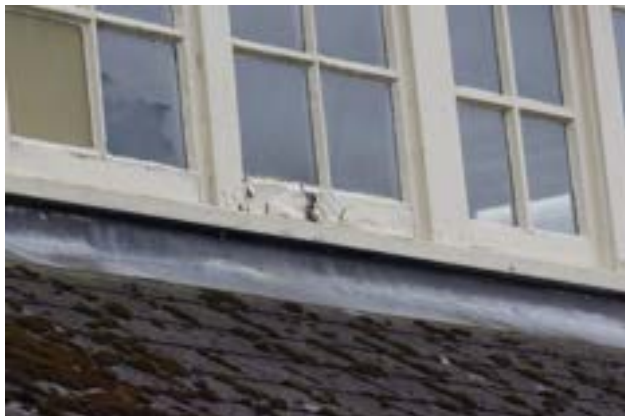
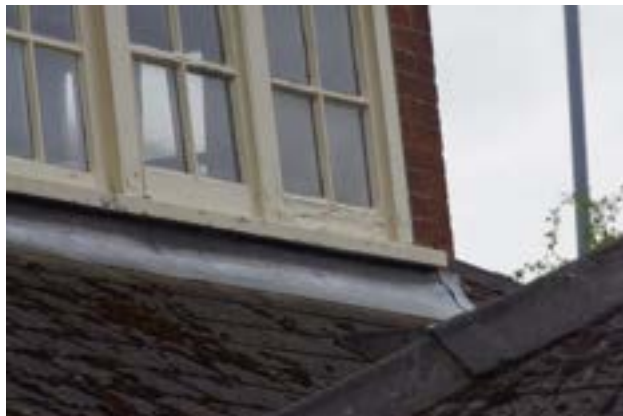
- 4.7.11 The northern windows of the lantern have five replacement panes which are obscure glazed, possibly polycarbonate which has yellowed through age. Northern window 3 from the west appears to be a replacement using different depth top and bottom rails; as a consequence the glazing does not line through with that in the adjoining windows. Northern windows 2 from the east and west ends are pivot opening lights which are no longer operable. Flaking of paint finish is evident externally at low level throughout the length of the northern windows and in particular to the bottom rails of windows 1 and 5 from the west, where rot is likely to be present.

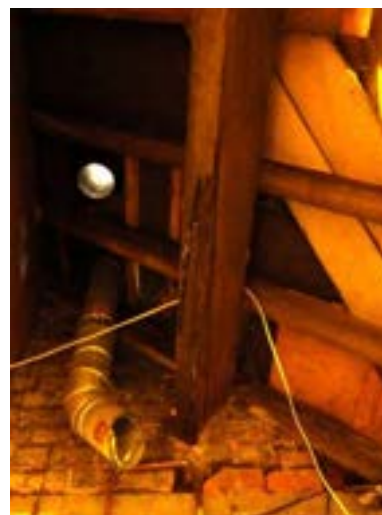
- 5.1.2 Above the boiler room the roof construction is exposed. Exposed rafters and valley beams are visible to the west of the area. The roof is provided with a bitumen based sarking felt. Redundant boiler flues rise through the southern end of the west slope; we recommend that, unless providing combustion air, these should be removed and the roof made good over. A purlin spans north to south, water damage is evident at the southern end to the underside of the purlin, although this appears to be of long standing. Daylight is visible above the felt towards the southern end of the the western side of the roof and a closer inspection on the roof finishes in this area is recommended.

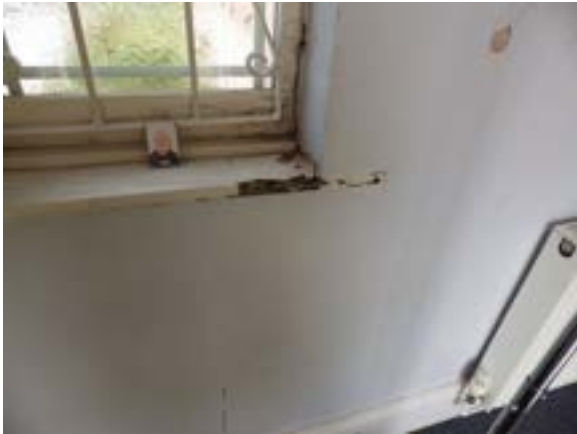
- 5.2.3 Walls to the entrance foyer are painted plaster and provided with tall torus skirtings. Damage together with paint failure is noted towards the western end of the north wall to the east of the window. It is unclear as to the cause and may be the result of water penetration through open joints at the cill of the window and at the junction between the wall of the foyer and the west wall of the male toilet. There may also be an issue with rainwater goods in this area, and we recommend they be checked under rainfall conditions. Plaster repairs and redecoration are recommended for this area.

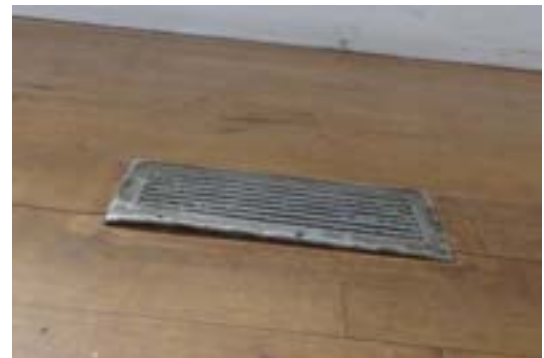
5.9.12 Within the southern section of the main hall floor there are six metal ventilators. These sit slightly proud of the floor finish and could cause trip hazards, particularly the northern edge of the eastern of the three northern grilles. It is noted that most of the grille fixings are missing, and they are currently secured with adhesive. Consideration could be given to the removal of the grilles and setting of new grilles into the floor.

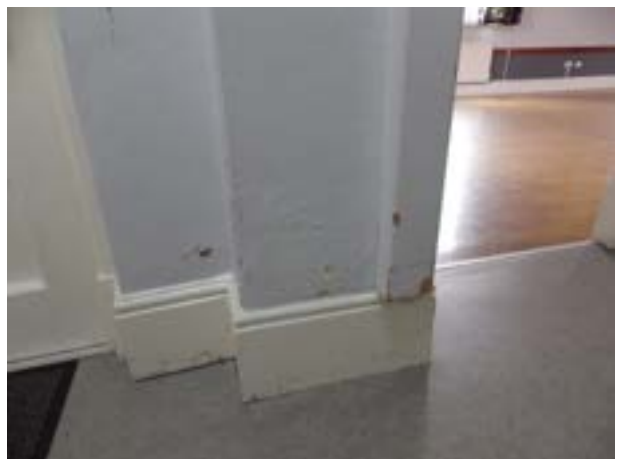
- 5.14.2 The lobby has a painted plaster ceiling which remains in good condition.
- 5.14.3 The lobby has painted plaster walls with a tall painted torus timber skirting. Paint and plaster damage indicative of rising damp is noted at low level to the south wall to the west of the external doorway. It is noted that the rainwater pipe in this area discharges directly over the ground which is formed in brick pavers. The brick pavers shows signs of settlement and one has been replaced with a mortar infill. We recommend consideration be given to the discharging of the surface water to a formal drain, possibly connected to a soakaway located beneath the Thoresby Colliery Garden area. Whilst the wall is provided with a chemical injection DPC which has been inserted into bricks, and could therefore allow damp to rise through mortar joints.

- 5.14.4 Following works to the rainwater goods and gully and a period of drying out, we recommend removal of the low level plaster, replacement possibly in a lime render and redecoration with a breathable paint. The walls of the entrance porch remain sound, although some damage is noted around the light fitting and at the foot of the eastern reveal to the external door where the plaster beading is beginning to rust.

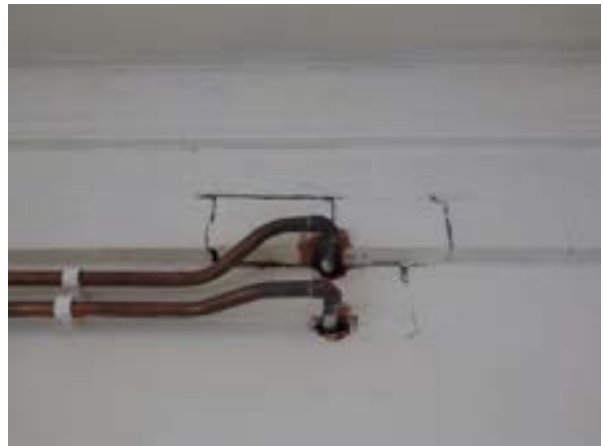
- 5.15.3 The locker room has painted plaster walls with exposed painted high level corbelled brickwork to the west wall, presumably the original eaves of the kitchen area. At low level to this wall is a plastered plinth. Damage is noted to the plasterwork to the plinth to the northern reveal of the entrance door and repairs could be considered. A high level boxing is evident within the north west corner, the reason for which is unclear, however may have previously been a water tank. There is pointing failure and what appears to be loose brickwork towards the southern end of the west wall associated with the heating pipes. Some re-bedding of the bricks and redecoration in this area is recommended.
