**Asbestos Inspection Report (HSG 264)**  
*Refurbishment Survey*  
Swanspool Pavillion  
Swanspool Parade, Wellingborough NN8 2BZ, UK

Surveyed by Nye Phillips on 11 Jun 2025

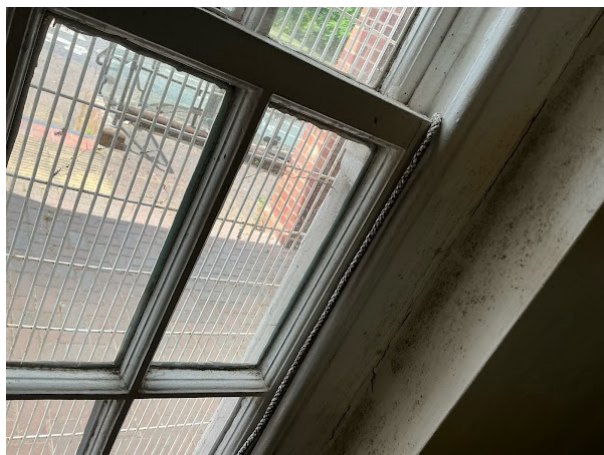
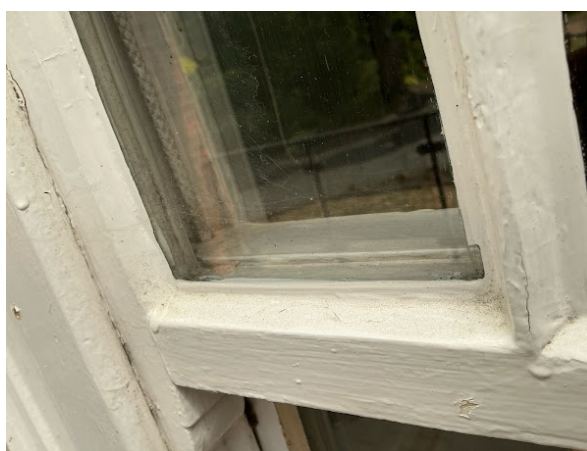
| [Sash windows, sporadic use of putty and limited use of DPC] Ground floor > Throughout the property > Rope, DPC, Putty. > Rope and bitumen | |
|---|---|
| Notes | <i>If the windows are to be disposed of, they should be disposed of as asbestos waste, as they may contain Asbestos in the sash and putty</i> |

### Material Assessment Score 7

| Asbestos Type | Presumed | 3 | Product Type | Reinforced Composites | 1 |
| Condition | High Damage | 3 | Treatment | Composite Materials | 0 |

| Asbestos Item | Asbestos Results | Recommendation | Risk |
|---|---|---|---|
| [Sash windows, sporadic use of putty and limited use of DPC] Ground floor > Throughout the property<br>Rope, DPC, Putty.<br>Rope and bitumen | <b>Type:</b><br><i>Presumed</i><br><b>Condition:</b><br><i>High Damage</i><br><b>Product:</b><br><i>Reinforced Composites</i><br><b>Surface Treatment:</b><br><i>Composite Materials</i> | <b>Action B</b><br>Encapsulation<br><br><i>If the windows are to be disposed of, they should be disposed of as asbestos waste, as they may contain Asbestos in the sash and putty</i> | <b>Fibre Release</b><br><br><i>Medium</i> |

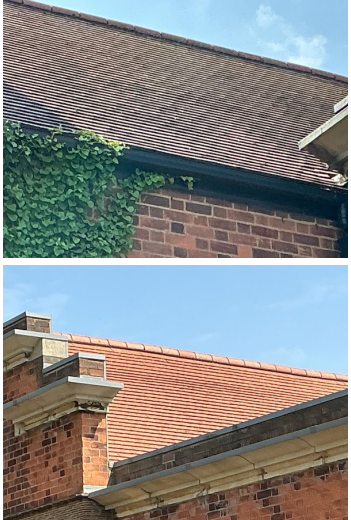
| Excluded Area | Photo |
|---|---|
| <p>External &gt; Roofs<br/>Area</p> <p><i>No access due to height limitations but all roofs appear to be concrete tiles.</i></p> | |

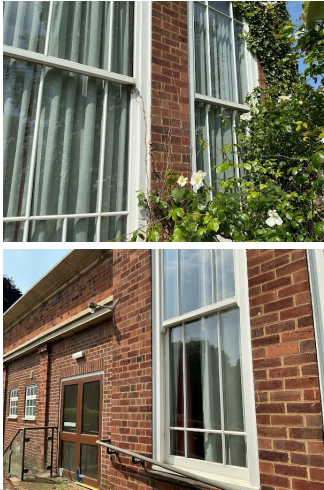
| Non Asbestos Area/Item | Justification | Photo |
|---|---|---|
| External > All walls, windows, doors and water goods<br>Area | <i>No Asbestos Detected</i><br>Area inspected in detail and no suspected asbestos containing materials identified. | |

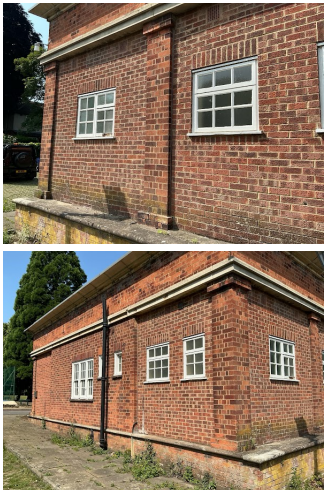
| Non Asbestos Area/Item | Justification | Photo |
|---|---|---|
| External > All walls, windows, doors and water goods<br>Area | <i>No Asbestos Detected</i><br>Area inspected in detail and no suspected asbestos containing materials identified. | |

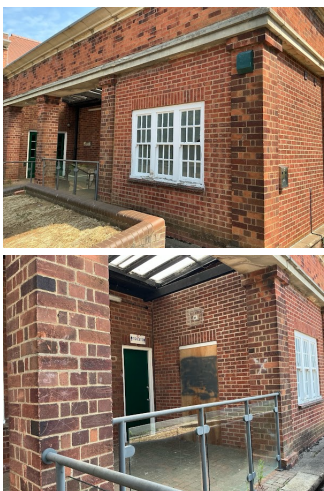
| Non Asbestos Area/Item | Justification | Photo |
|---|---|---|
| External > All walls, windows, doors and water goods<br>Area | <i>No Asbestos Detected</i><br>Area inspected in detail and no suspected asbestos containing materials identified. | |

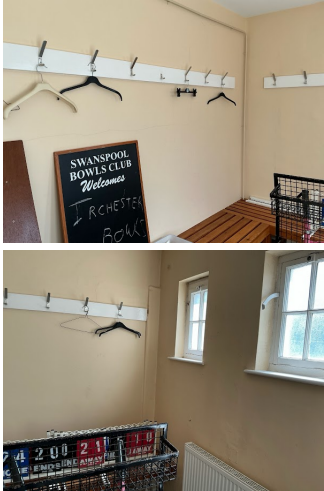
| <p>[All walls, ceilings and floors]<br/>Ground floor &gt; Area 1<br/>Area<br/><i>Limited access to roof space and tiled walls in the toilets.</i></p> | <p><i>No Asbestos Detected</i><br/>Area inspected in detail and no suspected asbestos containing materials identified.</p> | |

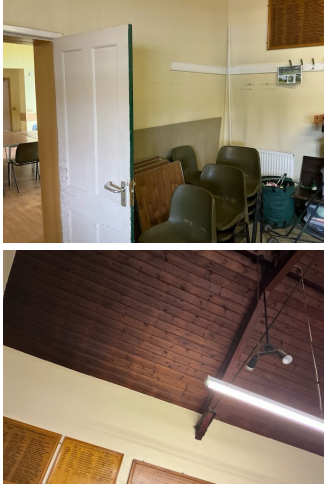
| <p>[All the walls and ceilings]<br/>Ground floor &gt; Store room<br/>Area</p> <p><i>Limited access behind wall plaques and noticeboards to include storage cupboards.</i></p> | <p><i>No Asbestos Detected</i><br/>Area inspected in detail and no suspected asbestos containing materials identified.</p> | |

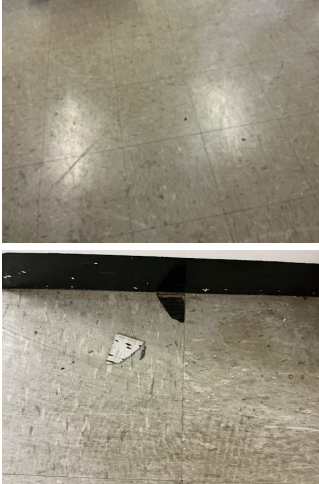
| <p>[Flooring] Ground floor &gt; Hall<br/>Area<br/>Store</p> | <p><i>No Asbestos Detected</i><br/>Lab Results</p> | |

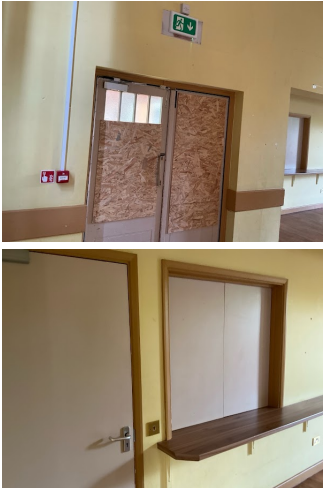
| <p>[All walls suspended ceilings and flooring] Ground floor &gt; Hall Area</p> <p><i>*Due to height restriction a limited access behind suspended ceiling caution advised*</i></p> | <p><i>No Asbestos Detected</i></p> <p>Area inspected in detail and no suspected asbestos containing materials identified.</p> | |

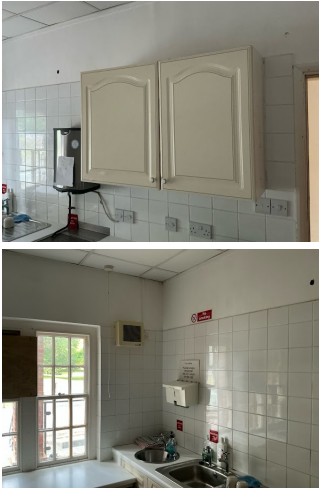
| <p>[All walls suspended ceilings and flooring] Ground floor &gt; Kitchen Area</p> <p><i>*Due to height restriction a limited access behind suspended ceiling caution advised*</i></p> | <p><b>No Asbestos Detected</b></p> <p>Area inspected in detail and no suspected asbestos containing materials identified.</p> | |

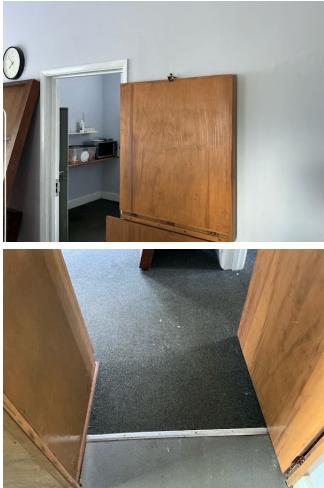
| <p>[All walls ceilings and flooring]<br/>Ground floor &gt; Area 2<br/>Area</p> <p><i>*Due to height restriction a limited access behind suspended ceiling caution advised*</i></p> | <p><b>No Asbestos Detected</b><br/>Area inspected in detail and no suspected asbestos containing materials identified.</p> | |

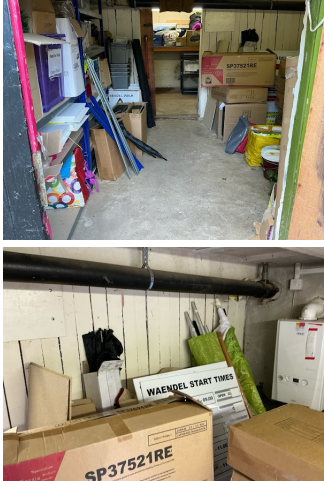
| <p>[All walls ceilings and flooring]<br/>Basement &gt; Area A<br/>Area</p> <p><i>Ceilings aligned with a material called Supalux, which looks very similar to Asbestos but contains no asbestos fibres.<br/>Limited access due to storage items.</i></p> | <p><i>No Asbestos Detected</i><br/>Area inspected in detail and no suspected asbestos containing materials identified.</p> | |

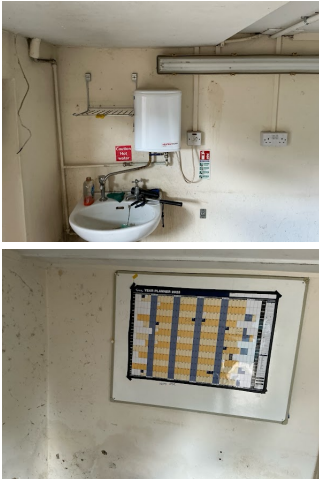
| <p>[All walls ceilings and flooring]<br/>Basement &gt; Area B<br/>Area</p> <p><i>Ceilings are lined with a material called Supalux, which looks very similar to Asbestos but contains no asbestos fibres.</i></p> | <p><i>No Asbestos Detected</i><br/>Area inspected in detail and no suspected asbestos containing materials identified.</p> | |

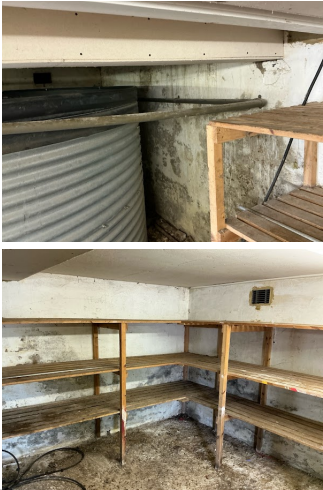
| <p>[All walls ceilings and flooring]<br/>Basement &gt; Area C<br/>Area</p> <p><i>Ceilings are lined with a material called Supalux, which looks very similar to Asbestos but contains no asbestos fibres.</i></p> | <p><i>No Asbestos Detected</i><br/>Area inspected in detail and no suspected asbestos containing materials identified.</p> | |
