**Asbestos Re-Inspection for
Wokingham Town Council**

**The Town Hall (V2)
Market Place
Wokingham
RG40 1AS**

Amicus Environmental Limited	Project Number:	S14069_2025
	Survey Date:	21 January 2025
	Printed On:	28 January 2025
	Page:	Page 1 of 1

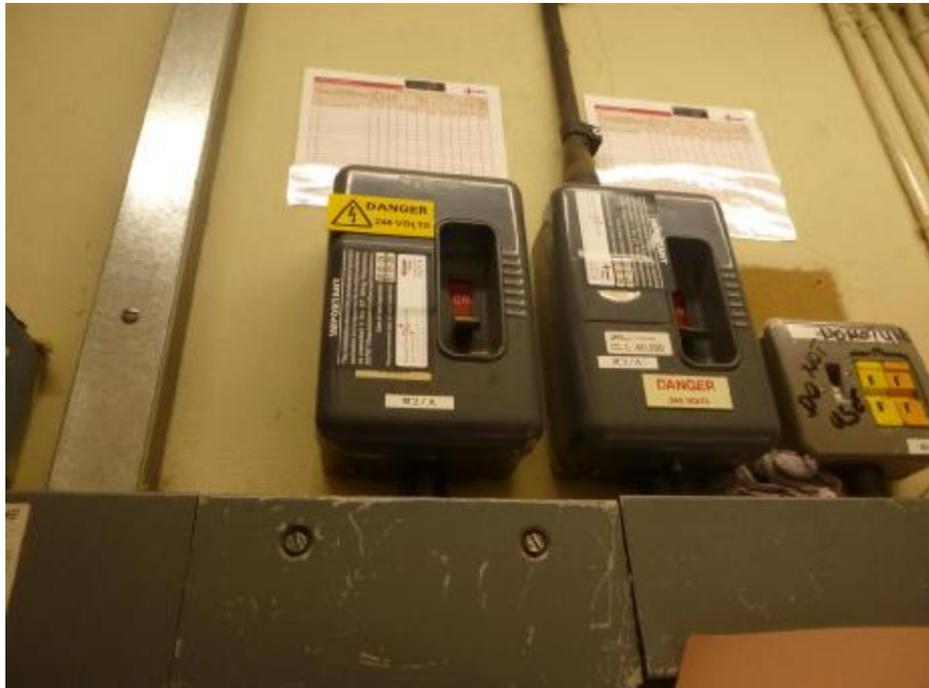
Location ID:	<input type="text" value="41365"/>	Survey Type:	<input type="text" value="RI"/>
Location Ref:	<input type="text" value="05"/>	Product Type:	<input type="text" value="Ropes and woven textiles"/>
Product:	<input type="text" value="Flashguard"/>	Damage:	<input type="text" value="Low damage"/>
Area:	<input type="text" value="Piccolo Arco Restaurant"/>	Treatment:	<input type="text" value="Composite asbestos materials"/>
Floor:	<input type="text" value="Ground floor"/>	Asbestos Type:	<input type="text" value="Chrysotile"/>
Room:	<input type="text" value="G.04"/>	Identification:	<input type="text" value="Presumed"/>
Surveyor Name:	<input type="text" value="D.Jeffs"/>	Quantity:	<input type="text" value="2No. Boxes"/>

Material Risk Score:	<input type="text" value="4"/>
Material Risk Band:	<input type="text" value="Very Low Risk"/>
Priority Risk Score:	<input type="text" value="2"/>

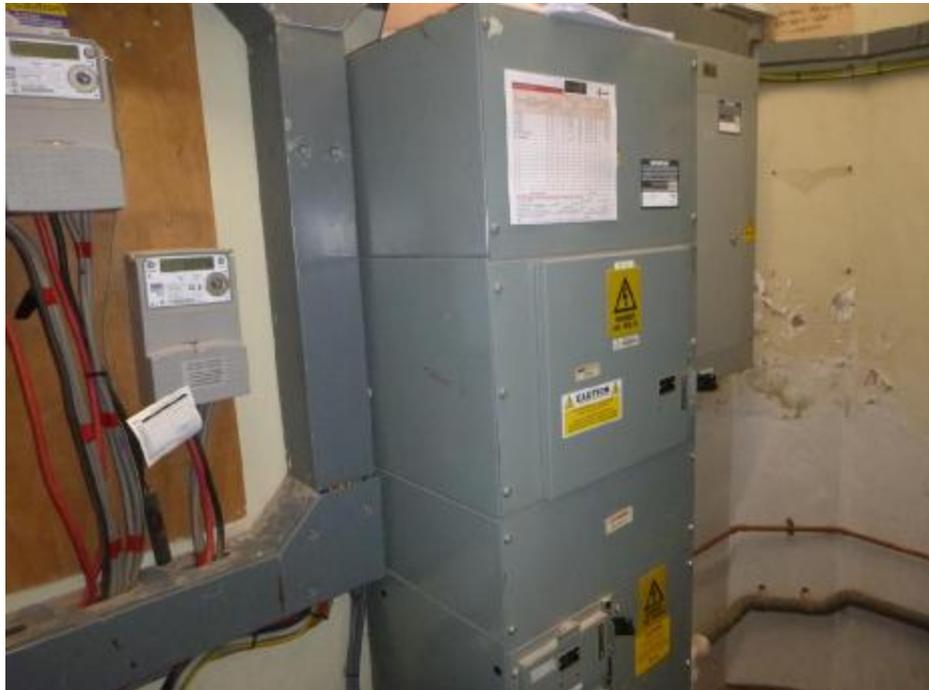
Location ID:	<input type="text" value="41366"/>	Survey Type:	<input type="text" value="RI"/>
Location Ref:	<input type="text" value="06"/>	Product Type:	<input type="text" value="Ropes and woven textiles"/>
Product:	<input type="text" value="Flashguard"/>	Damage:	<input type="text" value="Low damage"/>
Area:	<input type="text" value="Piccolo Arco Restaurant"/>	Treatment:	<input type="text" value="Composite asbestos materials"/>
Floor:	<input type="text" value="Ground floor"/>	Asbestos Type:	<input type="text" value="Chrysotile"/>
Room:	<input type="text" value="G.04"/>	Identification:	<input type="text" value="Presumed"/>
Surveyor Name:	<input type="text" value="D.Jeffs"/>	Quantity:	<input type="text" value="1No. Unit"/>

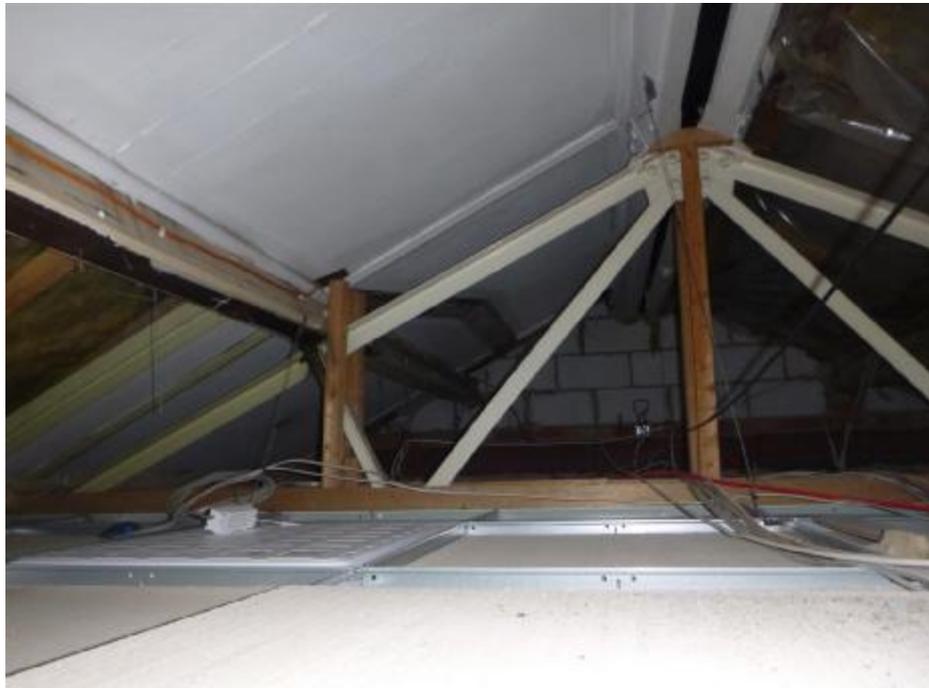
Location ID:	<input type="text" value="41381"/>	Survey Type:	<input type="text" value="RI"/>
Location Ref:	<input type="text" value="21"/>	Product Type:	<input type="text" value="Asbestos cement"/>
Product:	<input type="text" value="Ceiling panel"/>	Damage:	<input type="text" value="Medium damage"/>
Area:	<input type="text" value="Town Hall"/>	Treatment:	<input type="text" value="Asbestos cement sheets etc"/>
Floor:	<input type="text" value="First floor"/>	Asbestos Type:	<input type="text" value="Chrysotile"/>
Room:	<input type="text" value="1.07"/>	Identification:	<input type="text" value="Identified"/>
Surveyor Name:	<input type="text" value="D.Jeffs"/>	Quantity:	<input type="text" value="approx 30m<sup>2</sup>"/>

Material Risk Score:	<input type="text" value="5"/>
Material Risk Band:	<input type="text" value="Low Risk"/>
Priority Risk Score:	<input type="text" value="1"/>

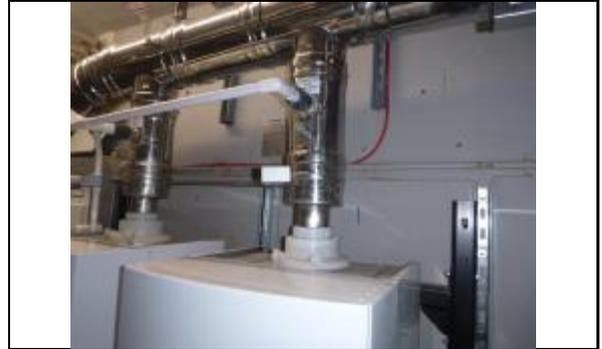
Sample Date	Location Ref	Location ID	Drawing Reference	Area	Floor	Room	Asbestos Type	Product Name	Material Risk Score	Priority Risk Score	Comments	Action	Survey Type
21/01/25	02	41362	As location ref	Piccolo Arco Restaurant	Ground floor	G.03	Anthophyllite/Chrysotile	Residue to Wall	9	4	Lagging residues to walls previously identified by Vintec J040087. No record of removal or remedial works. 3no. Walls sealed & 1no. Wall has been over boarded with ply. Residues assumed to be present behind paint/ply. No change in material condition 2025.	Apply warning labels and manage	RI

Location ID:	41362
Location Ref:	02
Product:	Residue to Wall
Area:	Piccolo Arco Restaurant
Floor:	Ground floor
Room:	G.03
Surveyor Name:	D.Jeffs
Drawing Ref:	As location ref
Asbestos ?	Yes
Date:	21 January 2025

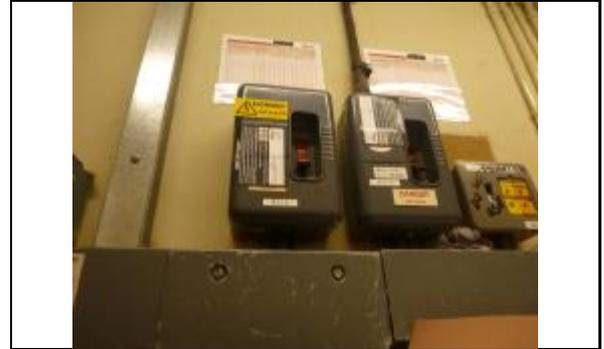
Sample Date	Location Ref	Location ID	Drawing Reference	Area	Floor	Room	Asbestos Type	Product Name	Material Risk Score	Priority Risk Score	Comments	Action	Survey Type
21/01/25	05	41365	As location ref	Piccolo Arco Restaurant	Ground floor	G.04	Chrysotile	Flashguard	4	2	Presumed to be present within 2 live fuseboxes. No change in material condition 2025.	Apply warning labels and manage	RI
21/01/25	06	41366	As location ref	Piccolo Arco Restaurant	Ground floor	G.04	Chrysotile	Flashguard	4	2	Presumed to be present within live switch gear. No change in material condition 2025.	Apply warning labels and manage	RI

Location ID:	41365
Location Ref:	05
Product:	Flashguard
Area:	Piccolo Arco Restaurant
Floor:	Ground floor
Room:	G.04
Surveyor Name:	D.Jeffs
Drawing Ref:	As location ref
Asbestos ?	Yes
Date:	21 January 2025

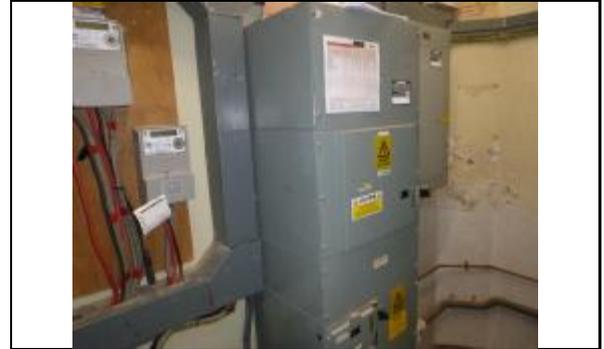
Location ID:	41366
Location Ref:	06
Product:	Flashguard
Area:	Piccolo Arco Restaurant
Floor:	Ground floor
Room:	G.04
Surveyor Name:	D.Jeffs
Drawing Ref:	As location ref
Asbestos ?	Yes
Date:	21 January 2025

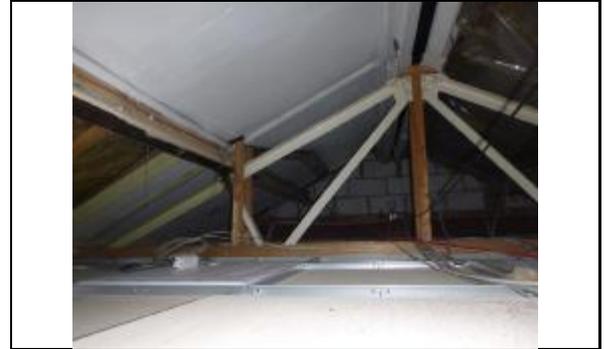
Sample Date	Location Ref	Location ID	Drawing Reference	Area	Floor	Room	Asbestos Type	Product Name	Material Risk Score	Priority Risk Score	Comments	Action	Survey Type
21/01/25	21	41381	As location ref	Town Hall	First floor	1.07	Chrysotile	Ceiling panel	5	1	To pitched roof in ceiling void. No change in material condition 2025.	Apply warning labels and manage	RI

Location ID:	41381
Location Ref:	21
Product:	Ceiling panel
Area:	Town Hall
Floor:	First floor
Room:	1.07
Surveyor Name:	D.Jeffs
Drawing Ref:	As location ref
Asbestos ?	Yes
Date:	21 January 2025
