Asbestos Survey

NMSI Wroughton

Building 5 Hanger L2 & Annexes Type 2
Science Museum
Hackpen Lane
Wroughton
Wiltshire
SN4 9NS

Project Number: NMSI-207b
Survey Date: 13 June 2007
Printed On: 14 July 2007
Page: Page 1 of 1

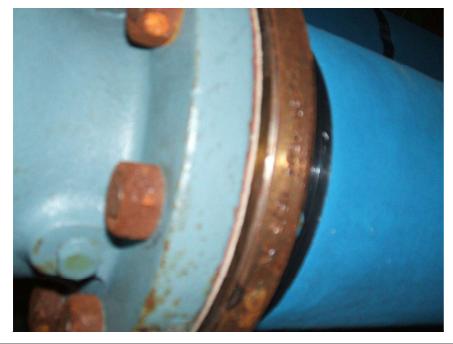
Sample ID:	300967	Survey Type:	Т 2	
Sample Number:	Item 1	Product Type:	Gaskets	
Product:	Gasket	Damage:	Low damage	
Area:	(5) Hanger L2 & Annexes	Treatment:	Composite asbestos materials	
Floor:	Roof level	Asbestos Type:	Chrysotile	
Room:	S05.G-1	Identification:	ion: Identified	
Surveyor Name:	M.Allen	Quantity:	1m2	
Drawing Ref:	Item 1	Accessibility:	: Difficult Accessibility	
Asbestos ?	Yes			
Date:	12 June 2007		Material Risk Score: 4	
Next Inspection:	11 June 2008		Material Risk Band: Very Low Ris	
Analysis:			Priority Risk Score: 2	
Action:		Encapsulate, Label and	Inspect

Asbestos high level pipework flange gaskets above sliding doors.

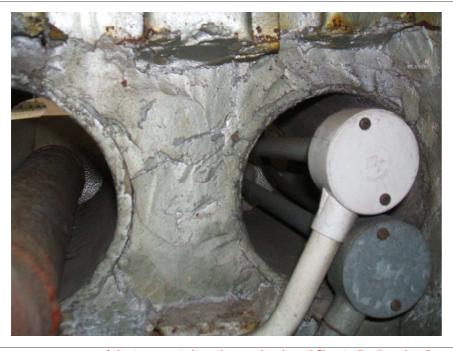
Sample ID:	300968	Survey Type:	T 2	
Sample Number:	Item 2	Product Type:	Asbestos cemen	t
Product:	Cement sleeve	Damage:	Low damage: Scratches	or marks
Area:	(5) Hanger L2 & Annexes	Treatment:	Asbestos cement shee	ets etc
Floor:	Ground floor	Asbestos Type:	Chrysotile	
Room:	S05.G-1	Identification:	Identified	
Surveyor Name:	M.Allen	Quantity:	1 Linear Metre	
Drawing Ref:	Item 2	Accessibility:	Difficult Accessibility	
Asbestos ?	Yes			
Date:	12 June 2007		Material Risk Score:	4
Next Inspection:	11 June 2008		Material Risk Band:	Very Low Risk
Analysis:			Priority Risk Score:	3
Action:		Remove by a licenced co	ontractor

Asbestos cement pipework expansion sleeve (x2) protruding through wall

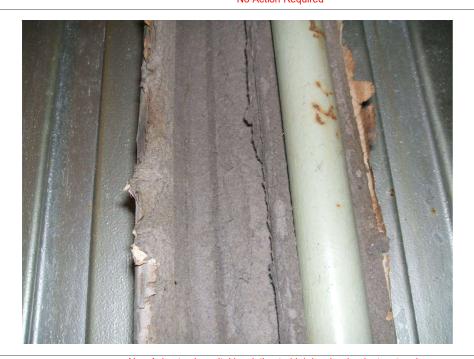
Sample ID:	300969	Survey Type:	T 2	
Sample Number:	Item 3	Product Type:	NADIS	
Product:	Insulation	Damage:	NADIS	
Area:	(5) Hanger L2 & Annexes	Treatment:	NADIS	
Floor:	High Level	Asbestos Type:	NADIS	
Room:	S05.G-1	Identification:	Identified	
Surveyor Name:	M.Allen	Quantity:		
Drawing Ref:	Item 3	Accessibility:	Difficult Accessibility	
Asbestos ?	No			
Date:	12 June 2007		Material Risk Score: 0	
L	Nick Americanists	 	Material Risk Band: NADIS	
Next Inspection:	Not Applicable		Priority Risk Score: N/A	
Analysis:			1 Honey Nak Ocore. 14/A	
Action:		No Action Requ	ired

Non-Asbestos 'econite' insulation to high level redundant water pipe

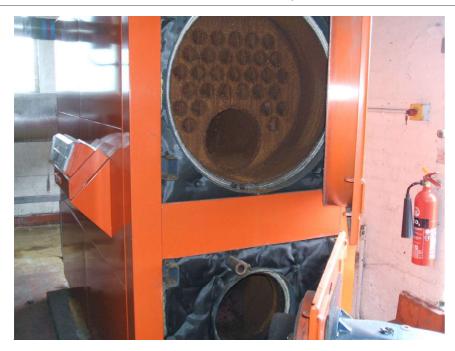
Sample ID:	300970	Survey Type:	T 2		
Sample Number:	Item 4	Product Type:	NADIS		
Product:	Rope	Damage:	NADIS		
Area:	(5) Hanger L2 & Annexes	Treatment:	NADIS		
Floor:	Ground floor	Asbestos Type:	NADIS		
Room:	S05.G-2	Identification:	Identified		
Surveyor Name:	M.Allen	Quantity:	10 Linear Metre		
Drawing Ref:	Item 4	Accessibility:	Medium Accessibility		
Asbestos ?	No				
Date:	13 June 2007		Material Risk Score: 0		
Next Inspection:	Not Applicable		Material Risk Band: NADIS		
Analysis:	· · · · · · · · · · · · · · · · · · ·		Priority Risk Score: N/A		
Action:		 No Action Req	uired

Non-Asbestos fibreglass rope seals to boiler access doors

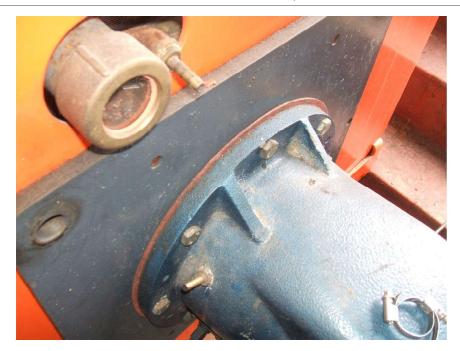
Sample ID:	300971	Survey Type:	T 2	
Sample Number:	Item 5	Product Type:	luct Type: NADIS	
Product:	Gasket	Damage:	NADIS	
Area:	(5) Hanger L2 & Annexes	Treatment:	NADIS	
Floor:	Ground floor	Asbestos Type:	NADIS	
Room:	S05.G-2	Identification:	Identified	
Surveyor Name:	M.Allen	Quantity:	1m2	
Drawing Ref:	Item 5	Accessibility:	Easy Accessibility	
Asbestos ?	No			
Date:	13 June 2007		Material Risk Score: 0	
Next Inspection:	Not Applicable		Material Risk Band: NADIS	
Analysis:			Priority Risk Score: N/A	
Action:		No Action Requir	ed

Material Comments: Non-Asbestos gasket seal to boiler burner flange

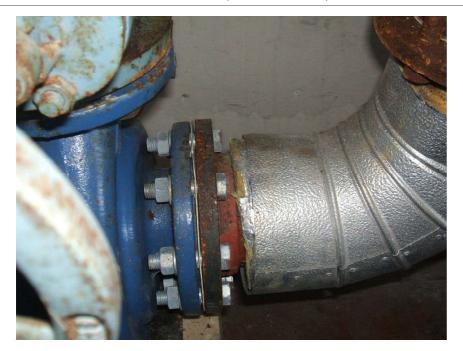
Sample ID:	300972	Survey Type:	T 2	
Sample Number:	Item 6	Product Type:	Gaskets	
Product:	Gasket	Damage:	No visible damage	
Area:	(5) Hanger L2 & Annexes	Treatment:	Composite asbestos materials	
Floor:	Ground floor	Asbestos Type:	Chrysotile	
Room:	S05.G-2	Identification:	Identified	
Surveyor Name:	M.Allen	Quantity:	1m2	
Drawing Ref:	Item 6	Accessibility:	Difficult Accessibility	
Asbestos ?	Yes			
Date:	13 June 2007		Material Risk Score: 3	
Next Inspection:	12 June 2008		Material Risk Band: Very Low Risk	
Analysis:			Priority Risk Score: 2	
Alialysis.				
Action:		Encapsulate, Label and	Inspect

asbestos gaskets to various pipe and valve flanges (x12)

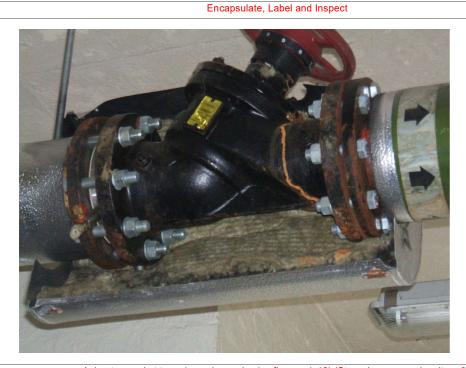
Sample ID:	300973	Survey Type:	ırvey Type: T 2	
Sample Number:	Item 7	Product Type:	Gaskets	
Product:	Gasket	Damage:	Low damage	
Area:	(5) Hanger L2 & Annexes	Treatment:	Composite asbestos materials	
Floor:	Ground floor	Asbestos Type:	Chrysotile	
Room:	S05.G-2	Identification:	Strongly Presumed as previous sample	
Surveyor Name:	M.Allen	Quantity:	1m2	
Drawing Ref:	Item 7	Accessibility:	Difficult Accessibility	
Asbestos ?	Yes			
Date:	13 June 2007		Material Risk Score: 4	
Next Inspection:	12 June 2008		Material Risk Band: Very Low Risk	
Analysis:			Priority Risk Score: 2

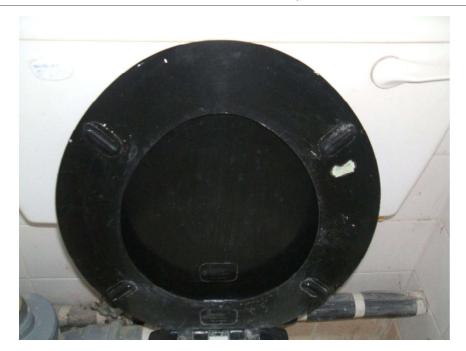
Sample ID:	300974	Survey Type:	T 2	
Sample Number:	Item 8	Product Type:	NADIS	
Product:	Toilet Seat	Damage:	NADIS	
Area:	(5) Hanger L2 & Annexes	Treatment:	NADIS	
Floor:	Ground floor	Asbestos Type:	NADIS	
Room:	S05.G-7	Identification:	on: Identified	
Surveyor Name:	M.Allen	Quantity:	1m2	
Drawing Ref:	Item 8	Accessibility:	Easy Accessibility	
Asbestos ?	No			
Date:	13 June 2007		Material Risk Score: 0	
Next Inspection:	Not Applicable		Material Risk Band: NADIS	
Analysis:	<u>``</u>		Priority Risk Score: N/A	
Action:		No Action Regu	uired

Material Comments: Non-Asbestos toilet seat
