## CCTV REPORT

Singlegate Primary School  
Ian Williams

09/03/2024

**Site: SINGLEGATE PRIMARY SCHOOL**

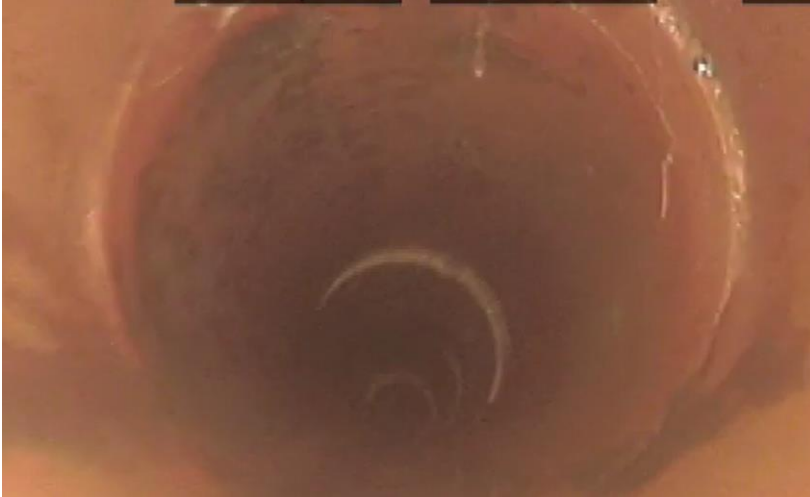
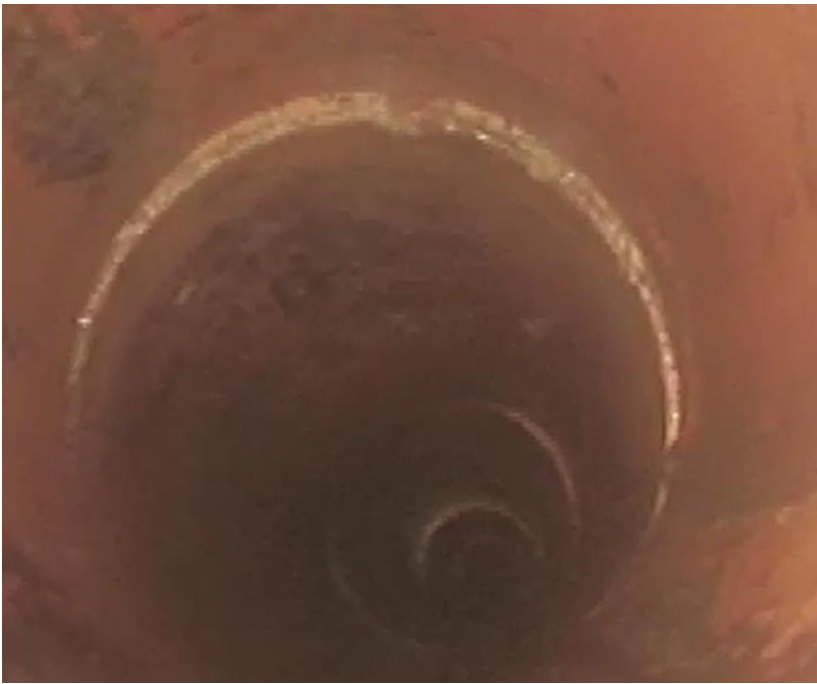
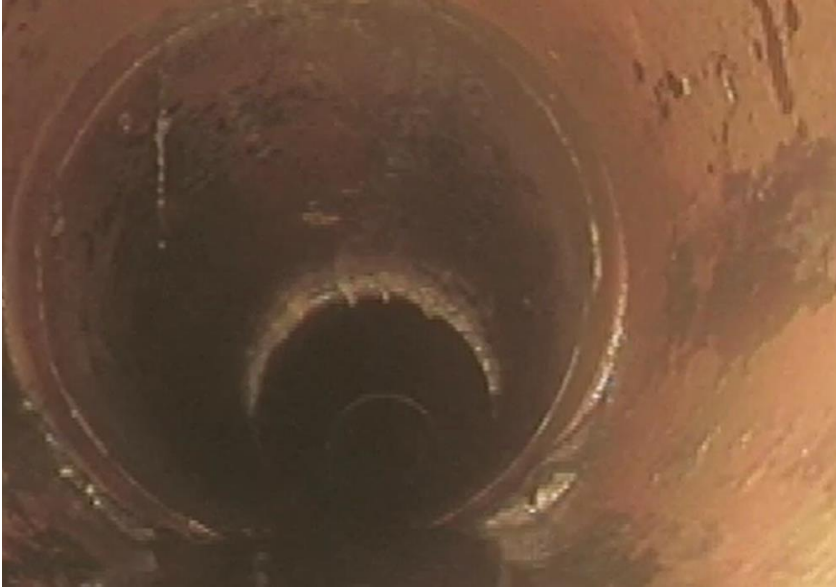
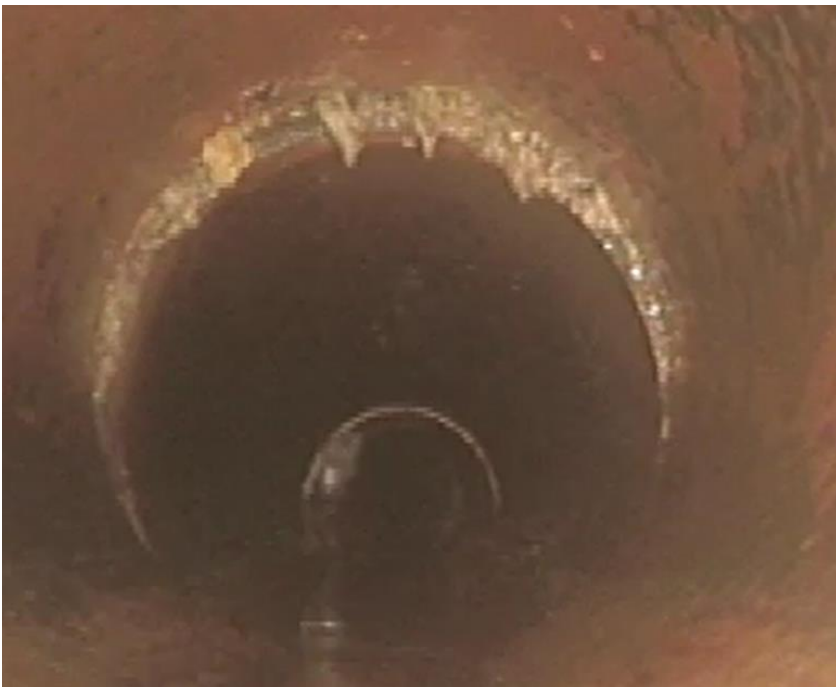
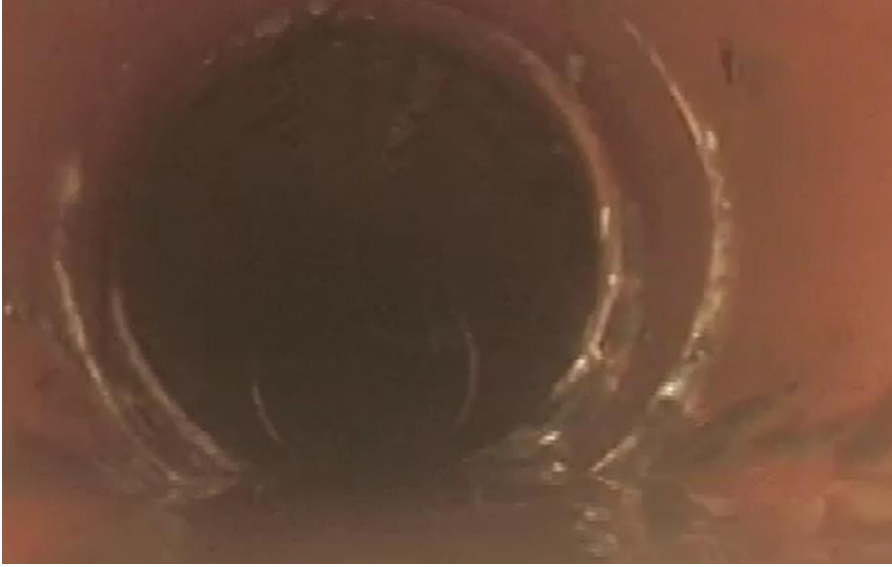
Run 1	Heads downstream from MH/1 across the front of the school. The run is in a poor state throughout its length with fractures, displacement, and cracks. On arrival MH/2 was 100% blocked due to grease, toilet paper and a metal rod (see pictures). This has blocked the hole system. 3 hours was spent trying to clear, this was eventually achieved. The run is combined and takes RWG'S 1 & 2. There may also be another unknown junction at approx. 14.66m. We would advise the run is HPWJ and the poss junction investigated further. If there is no junction at 14.66m we would advise the run is lined downstream to the junction serving RWG's 1&2. Then a lined inverted upstream from MH/2 to the junction with RWG's 1 & 2. If the poss junction at 14.66 then our drainage team will need to advise on a solution from site.	£4,475.90
Run 2	Heads upstream through the playground to MH/8 located in the car park. The run has numerous defects throughout including cracks, displacement, and root ingress. We would advise the run id HPWJ, and a continuous liner inverted to MH/7.	£4,336.40

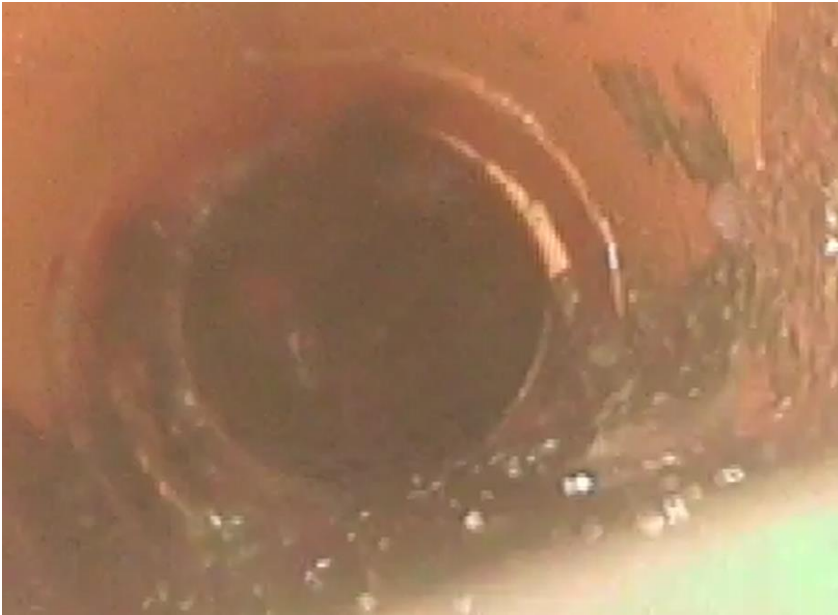
Run 7	Heads downstream from a break in that was carried out on SVP/1. The run has a displacement then becomes blocked. We cannot advise where the run may terminate as there doesn't appear to be any further foul drains in the area. We would assume it must enter the foul system somewhere, but we cannot advise. We would advise the displacement is SOND located, and an excavation carried out. The run can be HPWJ and our finding reported. he displacement then the run can be HPWJ and our findings reported.	£565.99
Run 8	Heads upstream from MH/6. The run is PVC and is serviceable with no visible defects. The run appears to head internally but we cannot advise what its servers.	£0
Run 9	Heads downstream and turns left and heads along the side elevation. The run is PVC and is serviceable with no visible defects.	£0
Run 10	Heads upstream from MH/3 to RWG/6. The run is PVC and appears serviceable with no visible defects.	£0

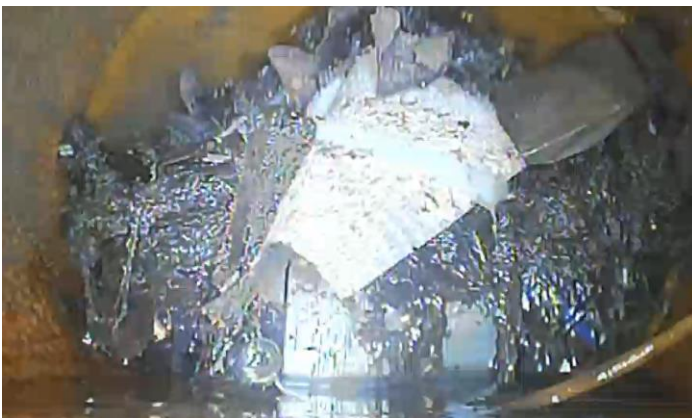
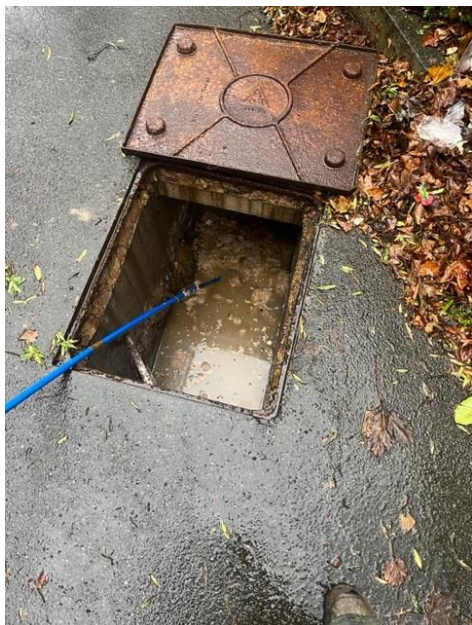
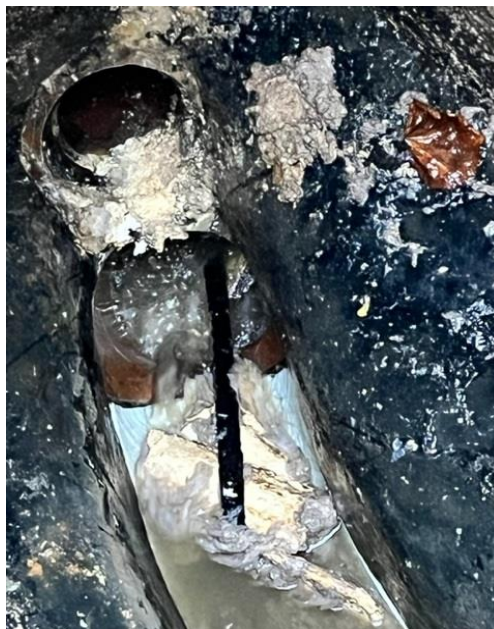
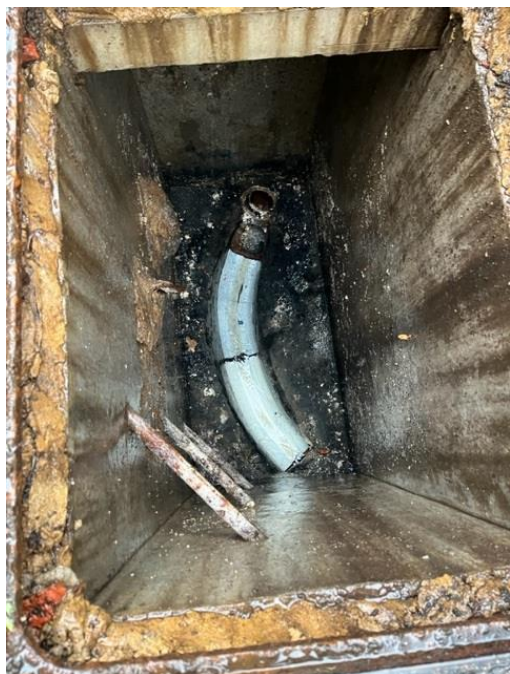
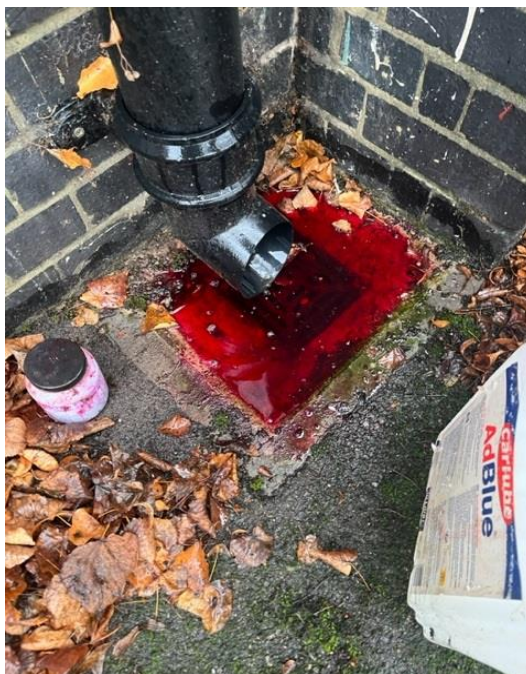
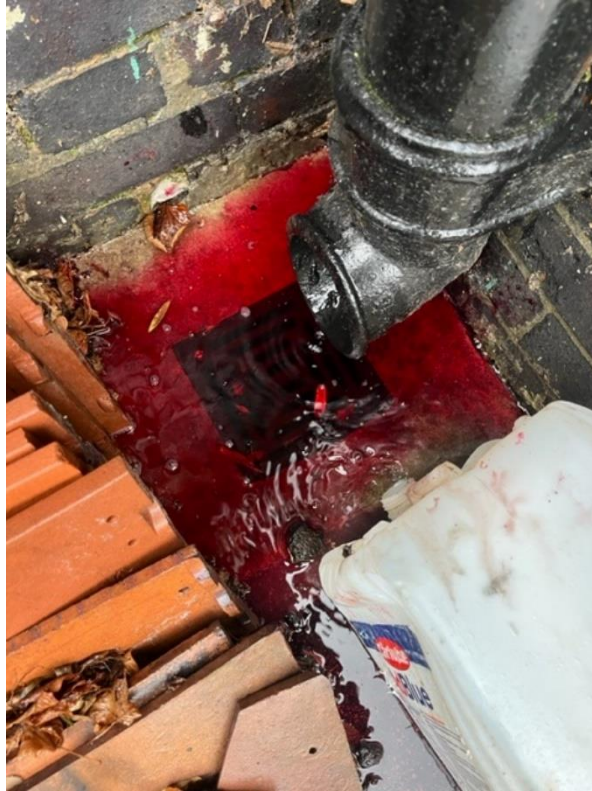
Run 11	Heads downstream from RWG/8 and joins run 5. The run is PVC and appears serviceable with no visible defects.	£0
Run 12	Heads upstream under the astroturf. The run is 225mm until 1.42m approx. where it changes to 150mm. There is a blockage at 15.90 which we could not pass. We would advise the run is HPWJ.	£115.00
Total + VAT		£10,693.29
