**CONDITION REPORT**

**OSWALDTWISTLE CIVIC THEATRE**

**26<sup>th</sup> JANUARY 2024**

**Job Reference Number: BS 1250**

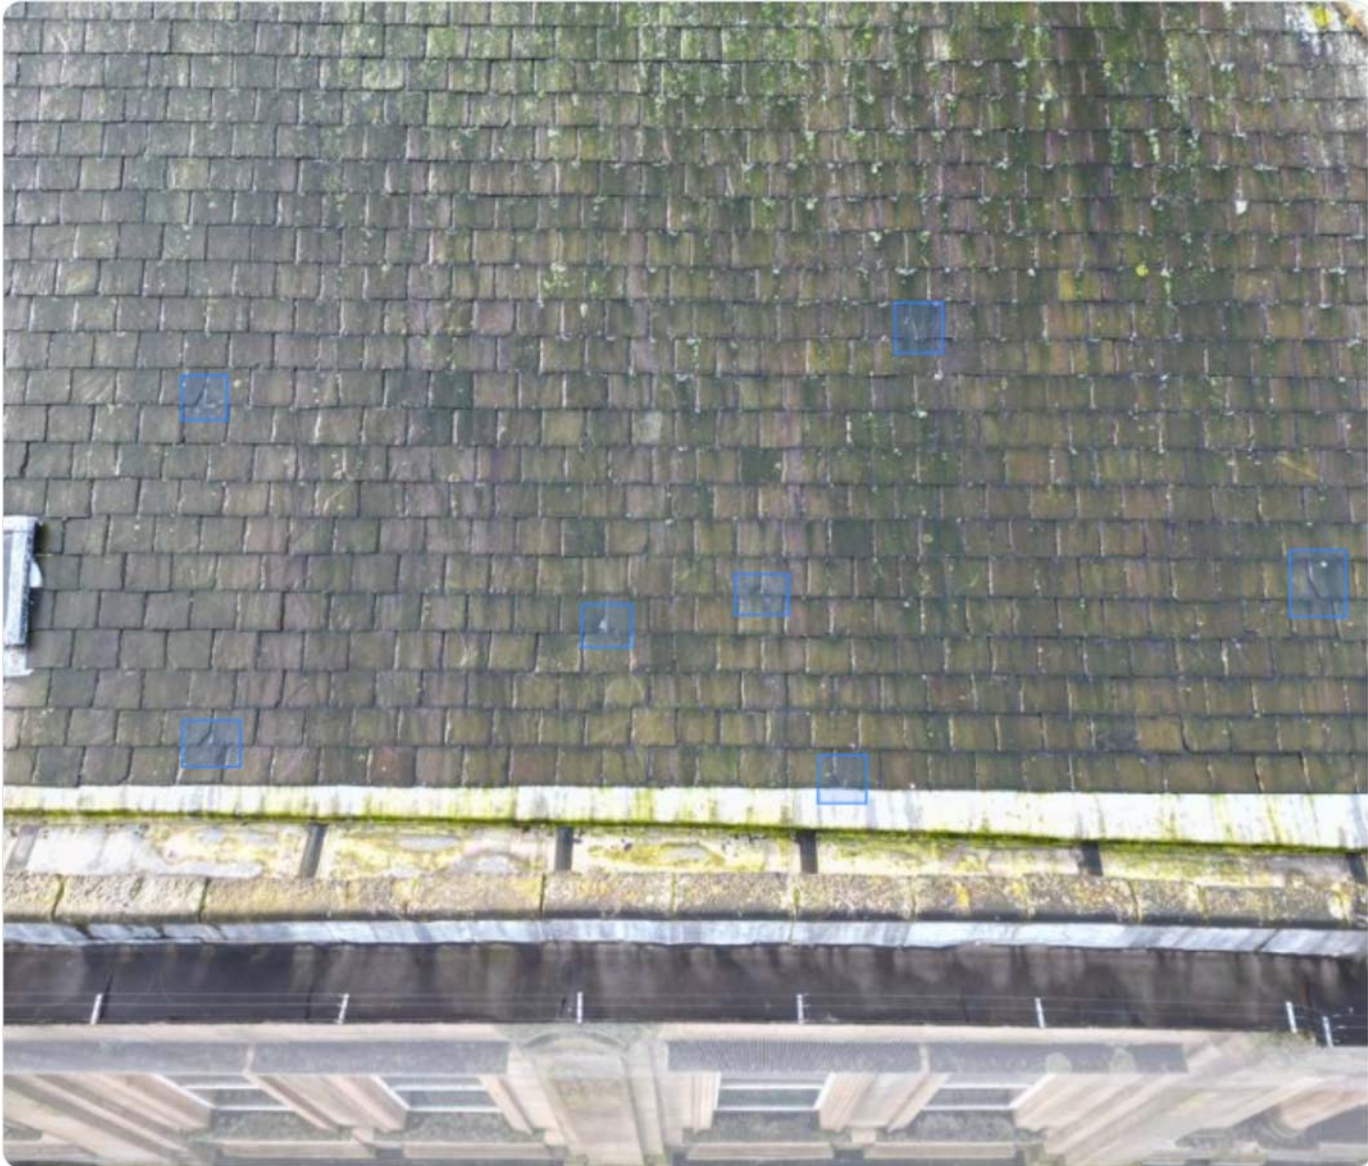
Broken slate

Description: corner only

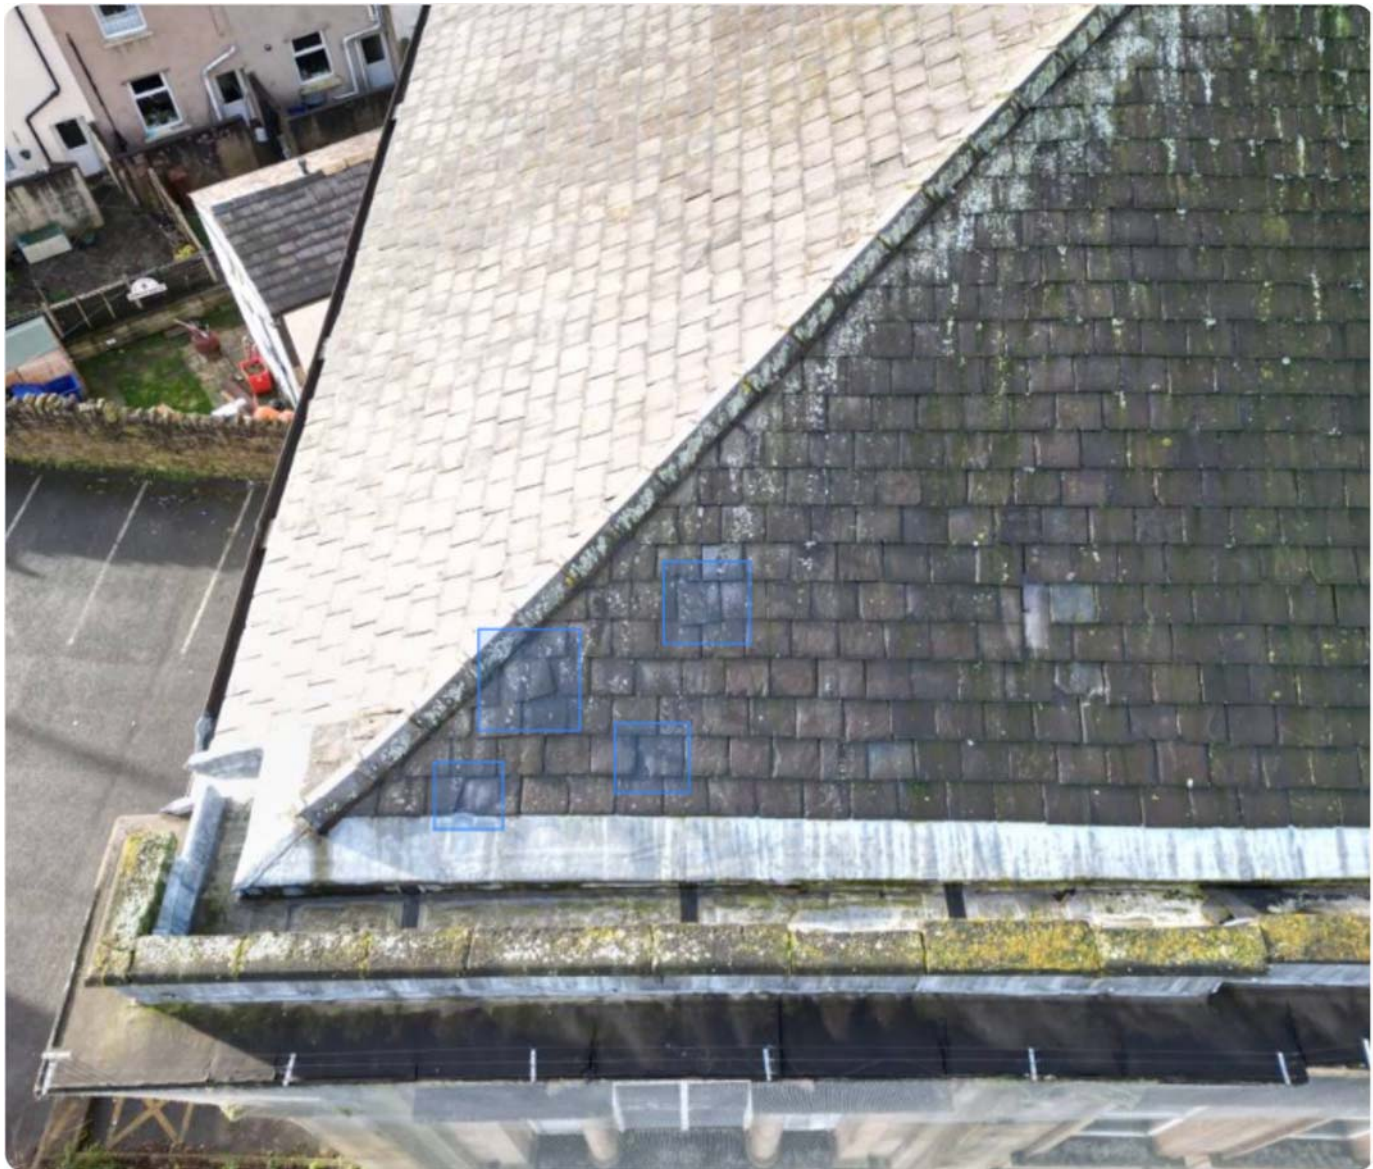
Slipped slate

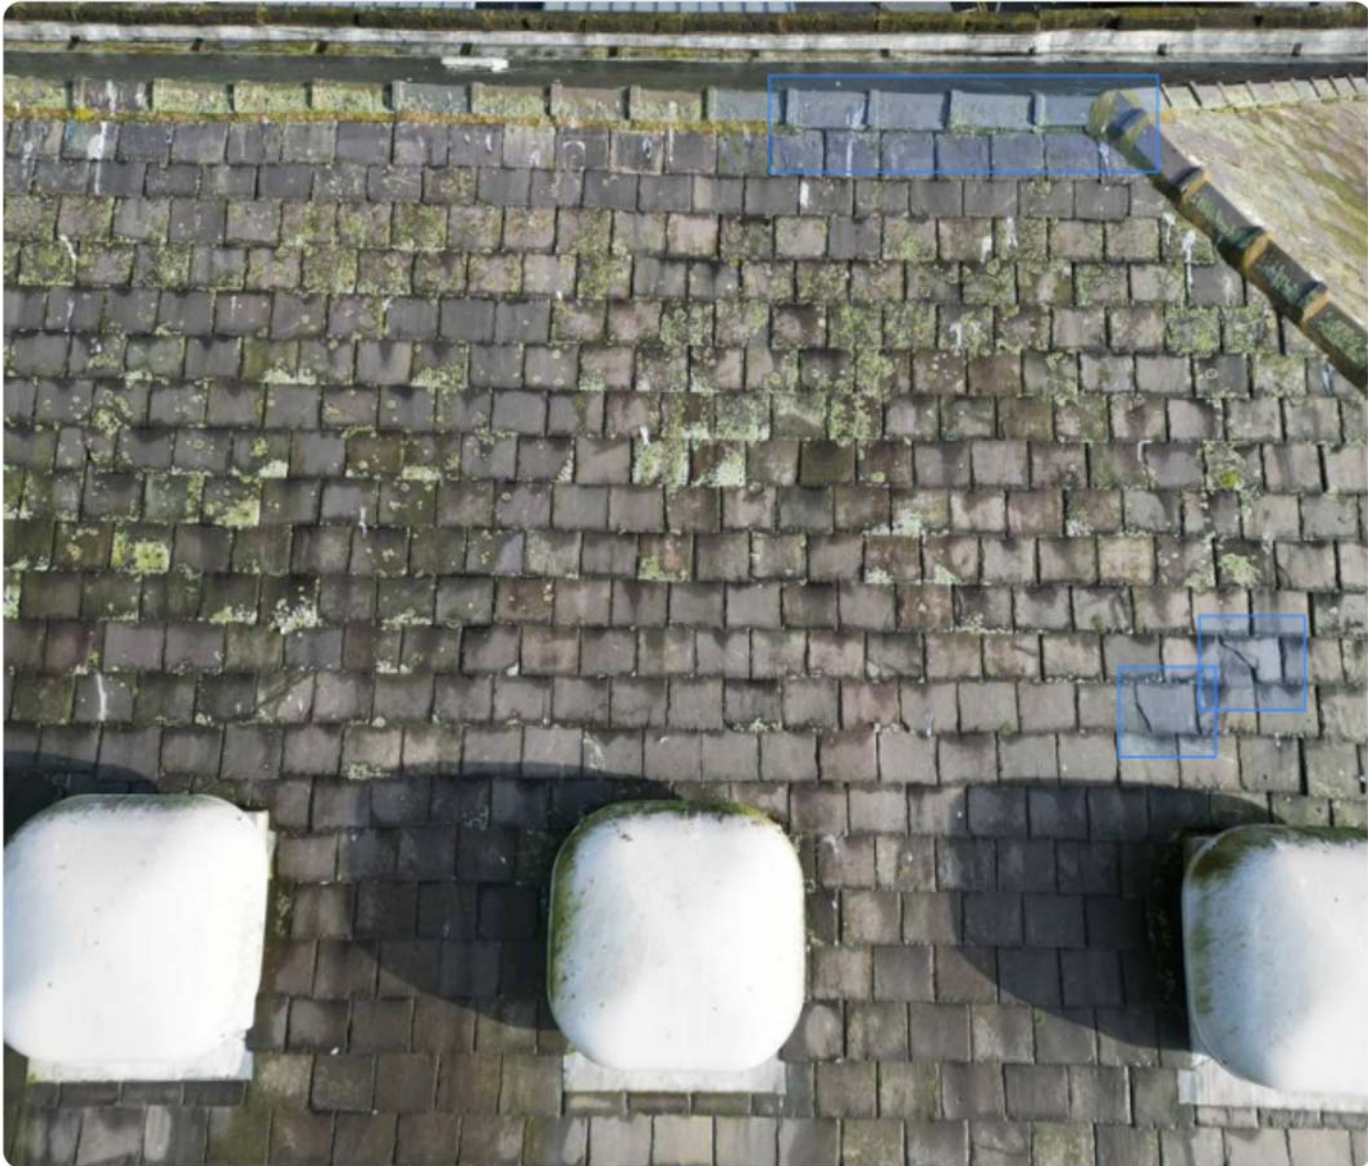
Defective pointing

Description: defective pointing to ridge tiles

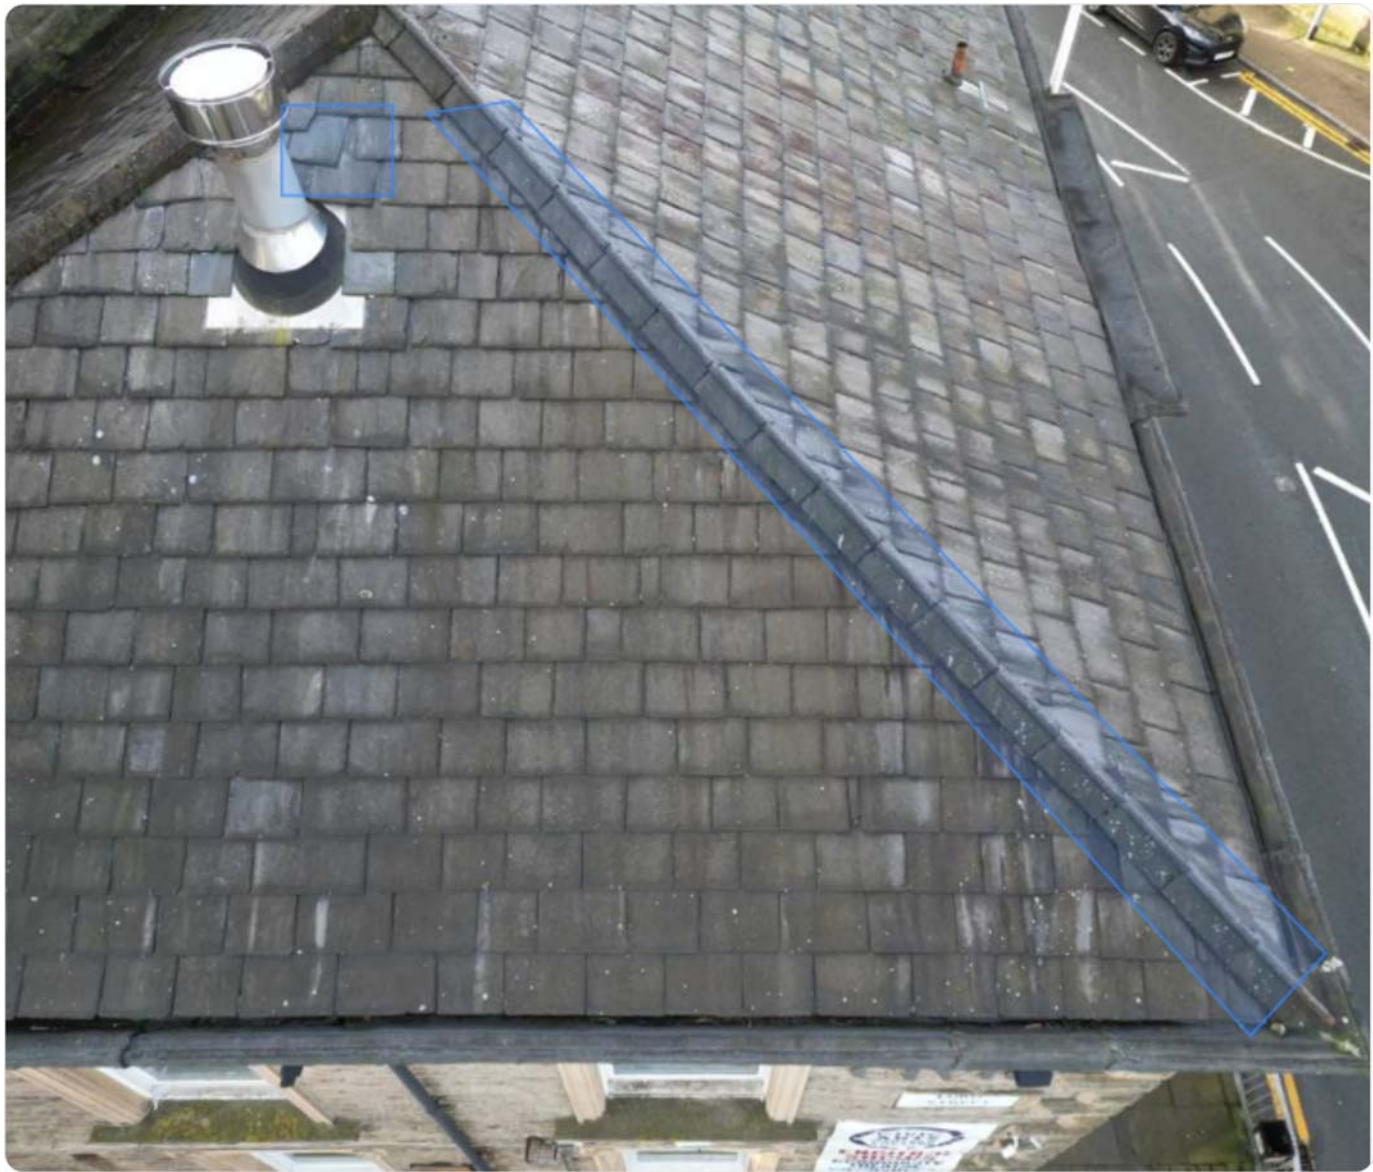
Slipped slate

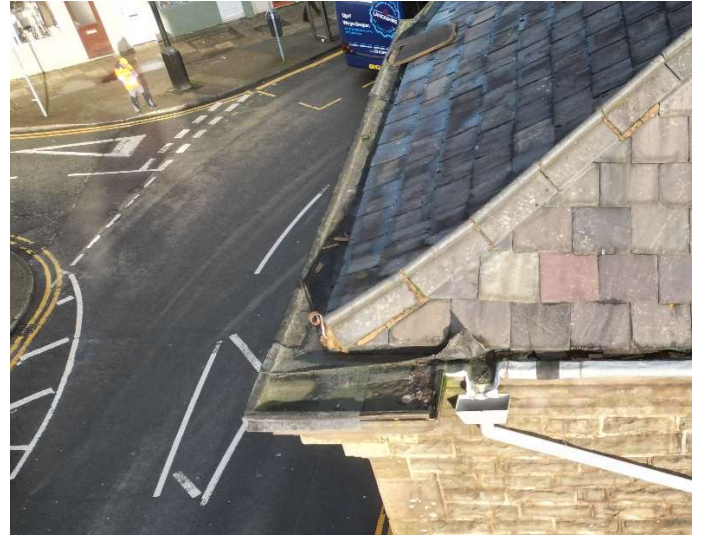
At the front the property is believed to comprise of stone trough gutters formed within the top cornice of the stone external walls which would originally have been lined with leadwork. The stonework has been lined with bitumen roofing felt which appears to be performing adequately **[Photo 1]** although we did note that the down stand to the face of the wall is not fully adhered and lifting up in places. At the right-hand end there appears to be some remnants of a cast iron gutter which can be seen where the roofing felt is lifted up. The cast iron appeared heavily corroded **[Photo 2]**.

Photo2 – Corroded cast iron visible underneath bitumen roofing felt

Ideally when the bitumen felt lining requires replacement the gutters should be lined with leadwork. The cast iron rainwater pipes require redecoration. The uPVC downpipes will require replacement in the long term.

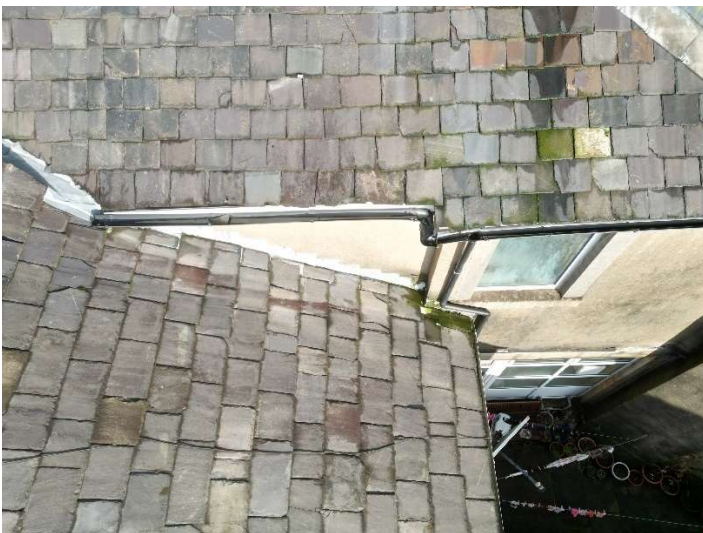
At the rear of the adjoining dwelling the gutters are uPVC and relatively modern **[Photo 5]**. The gutters appear to be in fair condition although we found a failed joint at the small return which is leaking partly saturating the base of the wall below. The gutter is served by a uPVC rainwater pipe which presented without defect.

Photo 5 – uPVC gutter with failed joint

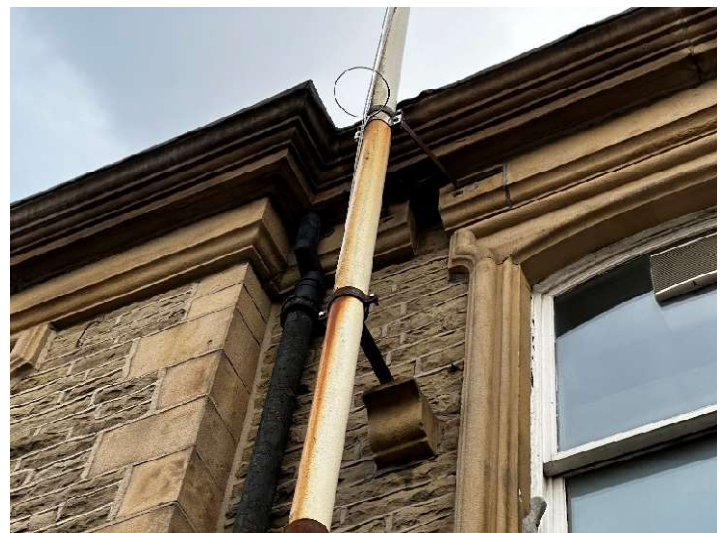
The stone troughs have running outlets which connect to a mixture of cast iron and uPVC rainwater pipes. The cast iron is in poor decorative condition although the metal itself presented without defect **[Photo 6]**. The uPVC is showing its age having discoloured due to solar depredation.

Photo 6 – Paintwork to cast iron rainwater pipe in poor condition

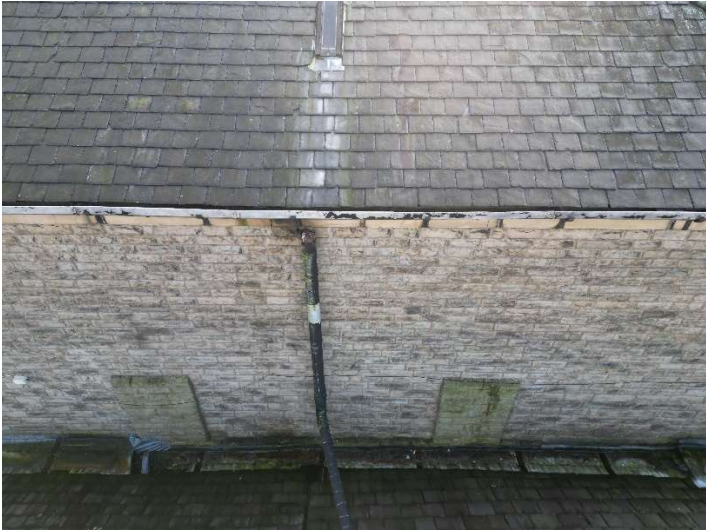
At the front is a painted aluminium box gutter supported by stonework at the top of the wall **[Photo 7]**. The paintwork itself is in poor decorative condition but we could see no signs of leaks to the gutter. There are three downpipes serving the gutter at the left side a hopper receives water from the Lord Street elevation and a uPVC downpipe discharges onto the lead lined gutter below. The downpipe appeared to be free from defect although of some age. The central downpipe appears to be large diameter uPVC pipe which returns at 90° and penetrates the rear pitch of the L shaped hipped roof **[Photo 8]**. The downpipe appears serviceable although of some age. At the right-hand end is a uPVC downpipe which returns to the right-side elevation before connecting directly into the outlet for the flat roof. The downpipe is of some similar condition.

Photo 7 – Paintwork to aluminium gutter in poor condition

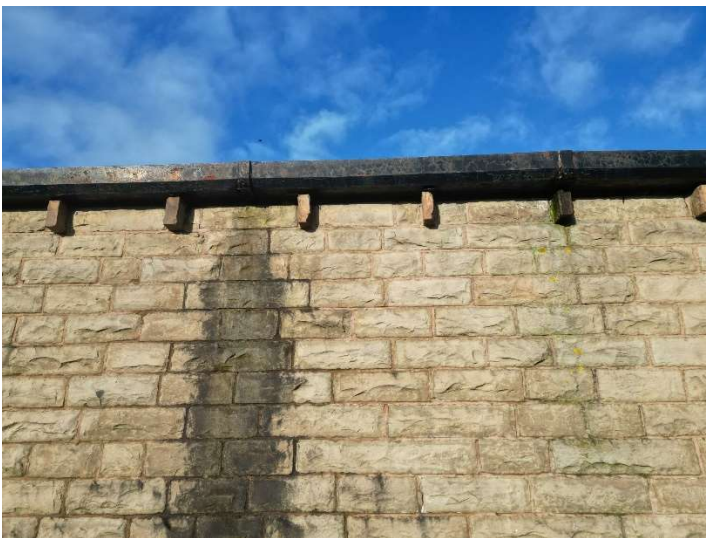
At the rear the original cast iron gutters remain and are in poor condition **[Photo 10]** with some leaks having been ongoing for a considerable period of time **[Photo 11]**. We would advise that the guttering be replaced with a seamless aluminium gutter. There is a single cast iron downpipe with a hopper that receives water from the cast iron gutter and from

Photo 11 – Painted cast iron gutter leaking

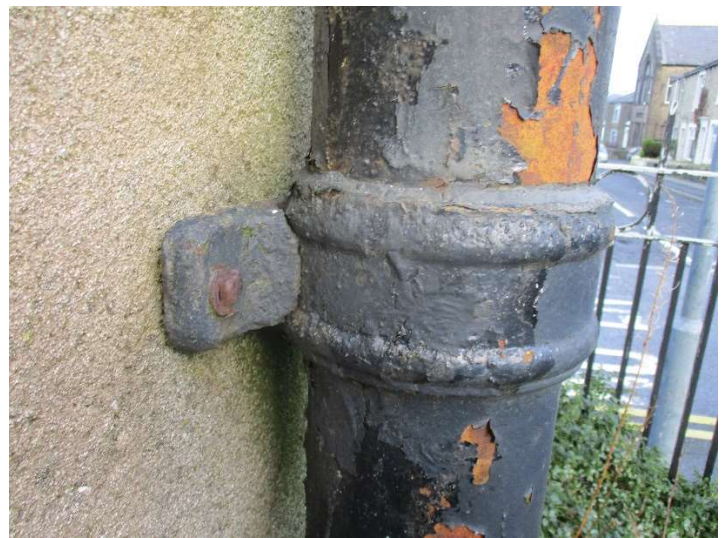
the lead lined gutter to the main frontage. The downpipe itself is in satisfactory condition although requires redecoration. We did note that some of the fixings were defective, and the security of the pipe should be checked **[Photo 12]**.

Photo 12 – Defective fixing for cast iron rainwater pipe

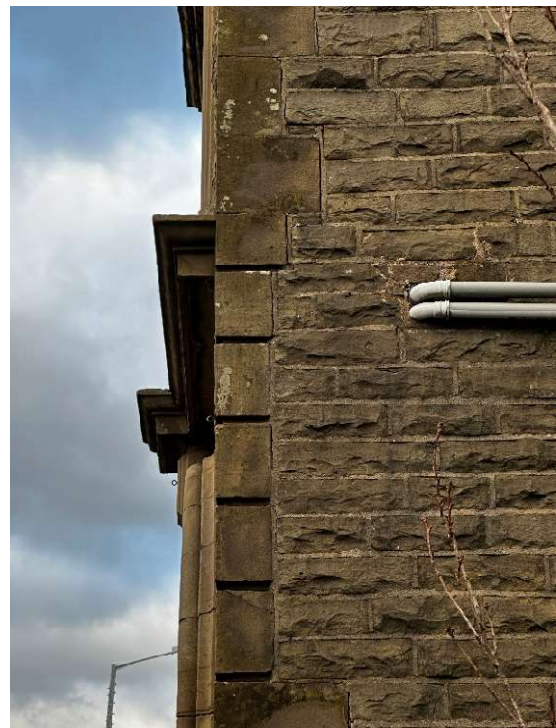
We noted that the front elevation appears to be leaning outwards slightly from vertical when viewed from this side **[Photo 29]**. A vertical crack is visible where a gap has opened up between the stone quoins and the coursed stonework to the top half of the wall **[Photo 30]**. We would advise that the cracking be monitored to determine if it is progressive.

Photo 30 – Vertical crack between quoins and coursed stone

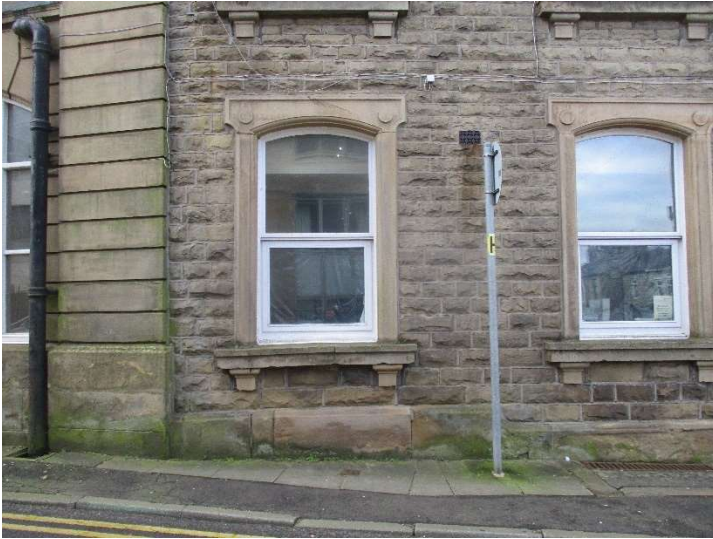
We noted some damage to the stone which appears to be as a result of movement of the structure. The stone sill to the left-hand ground floor window is cracked and the stone head that makes up the window surround is also exhibiting shear cracking. The masonry below the window is clearly sloping downwards towards the rear block and a degree of movement has occurred to the wall although we would suggest that it appears longstanding **[Photos 31-32]**. We would advise however, that the cracking be monitored to determine if it is progressive.

Photo 31 – Structural movement at junction between front block and rear block stone window sill and head cracked

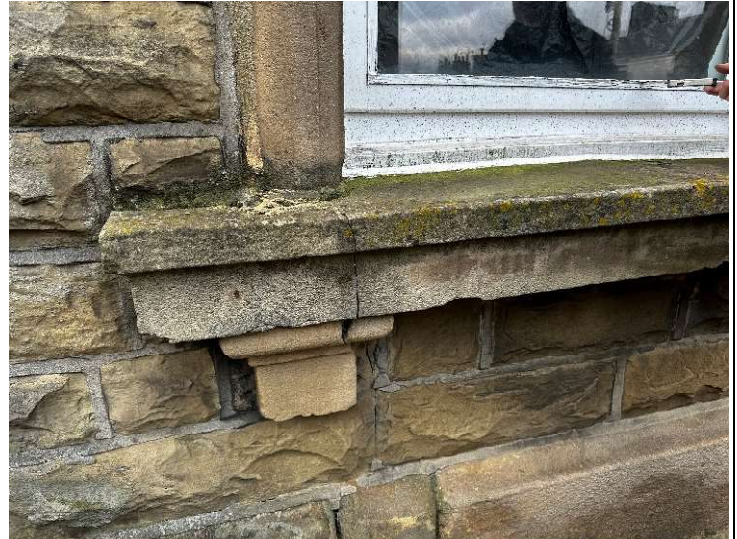
Photo 32 – Stone window sill cracked

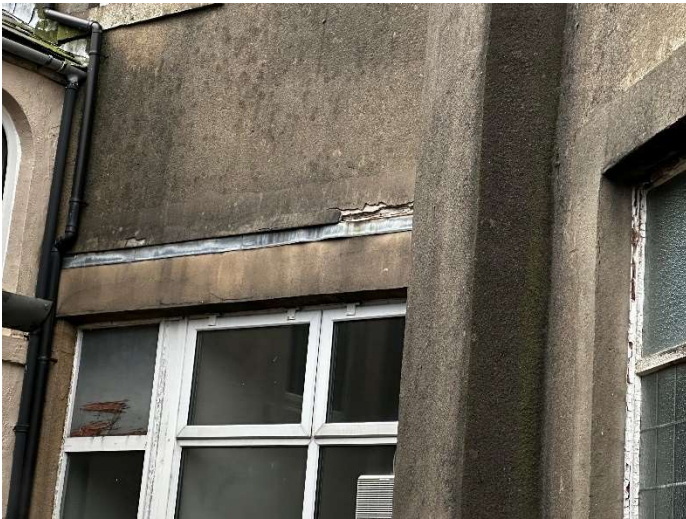
There is a small section of wall which is within the rear yard of the adjoining dwelling. The masonry has a cement render finish which is in poor condition with a section of render missing to the bell cast detail above the kitchen window and cracked/damp render below the leadwork flashing. We would advise that ideally this render should be replaced **[Photo 33]**.

Photo 33 – Defective render to rear of front block

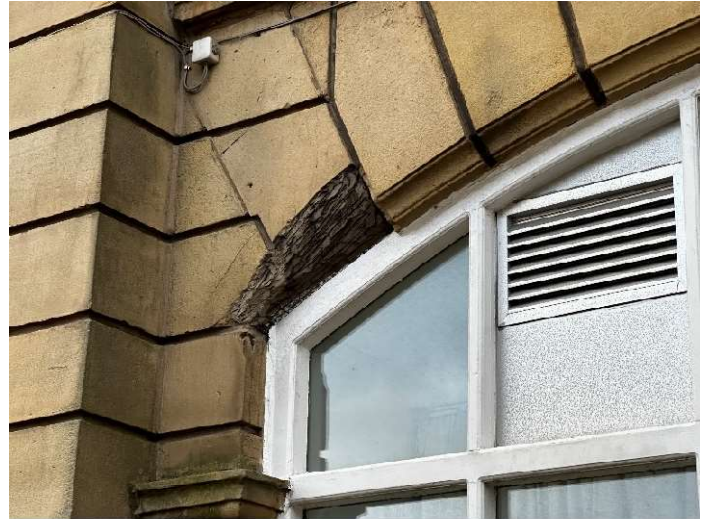
The stonework on this side of the building is in poor condition and exhibiting widespread dampness and deterioration of the stonework **[Photos 38-47]**.

Photo 46 – Damaged section of stone

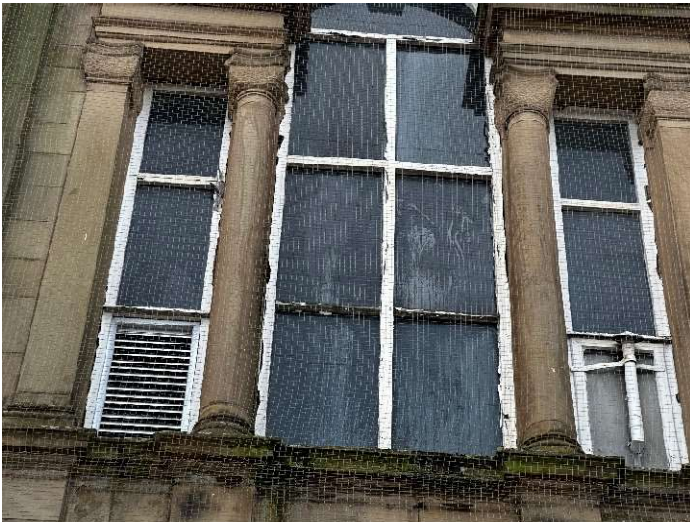
Photo 47 - Dampness and weathering to stone

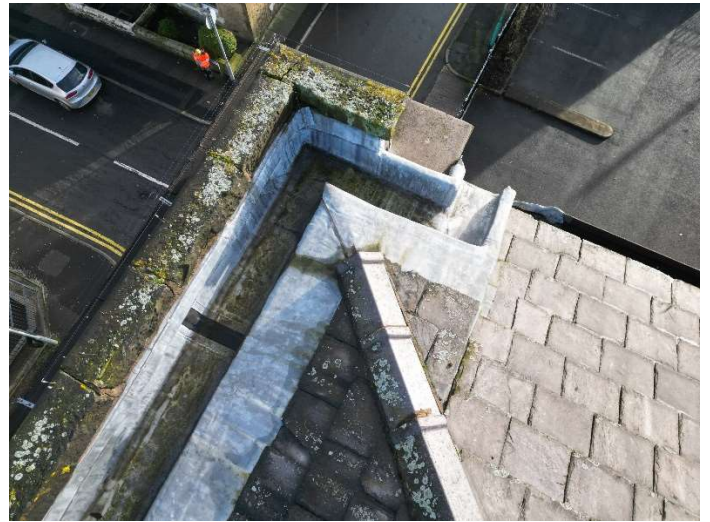
At the top of the wall is a parapet with stone copings with both sides of the parapet lined with lead. The joints to the coping stones are pointed with mortar which is in poor condition and will likely be allowing penetrating dampness to occur and we also noted isolated damage to the copings themselves. The copings should be checked to ensure they are securely and firmly bedded, and all of the joints should be raked out and resealed. The top surface of the projecting stone cornice and the upstand to the parapet wall has had a layer of asphalt applied some time ago as a waterproofing measure. The asphalt is now in poor condition and no longer watertight with numerous cracks and deterioration of the material at the exposed edge **[Photos 48 -49]**. We would advise that the asphalt be removed and replaced with leadwork. Due to the defects to the coping stones and asphalt

Photo 48 – Damaged coping stone and eroded joints

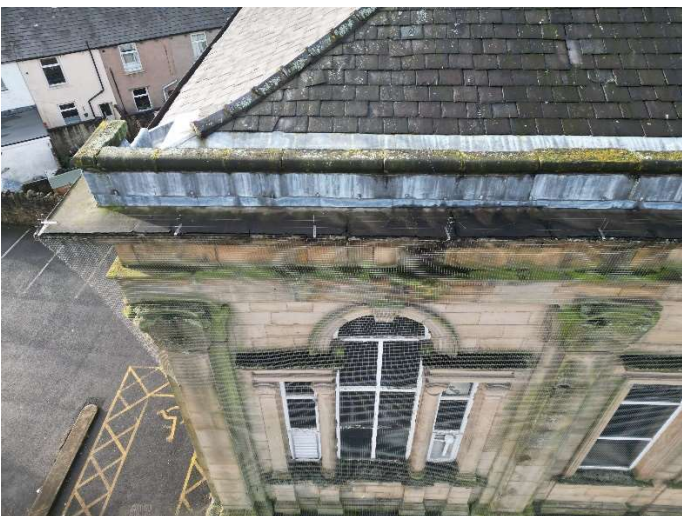
Photo 49 – Failed asphalt capping to stone cornice

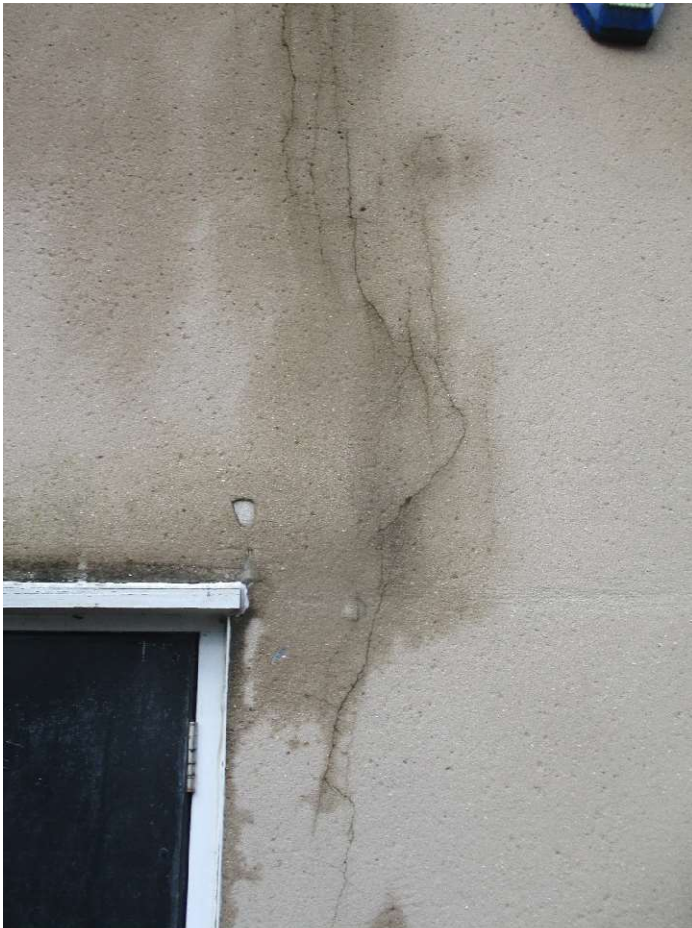
Photo 53 – Cracking to render

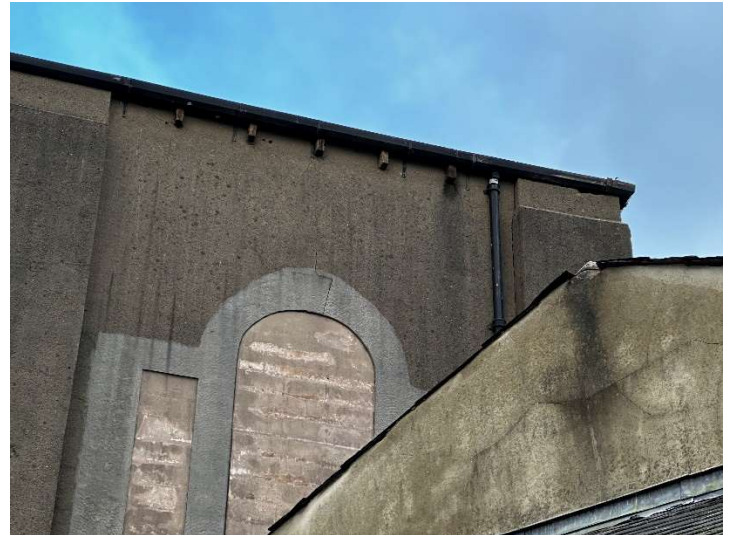
Photo 54 - Cracking to render

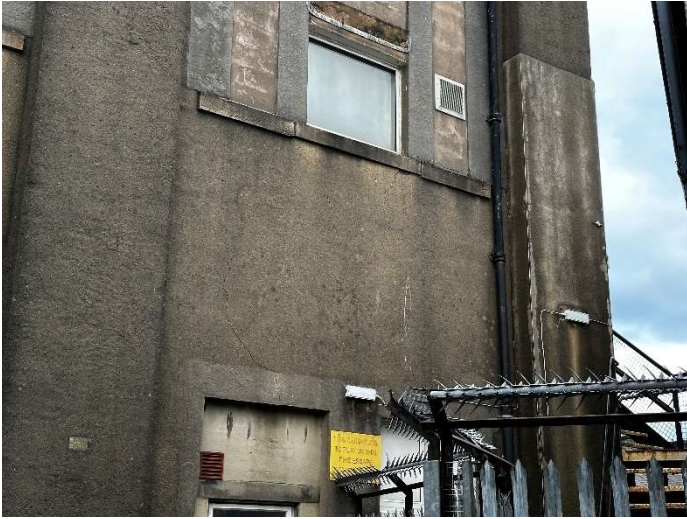
Photo 55 – Cracking to render

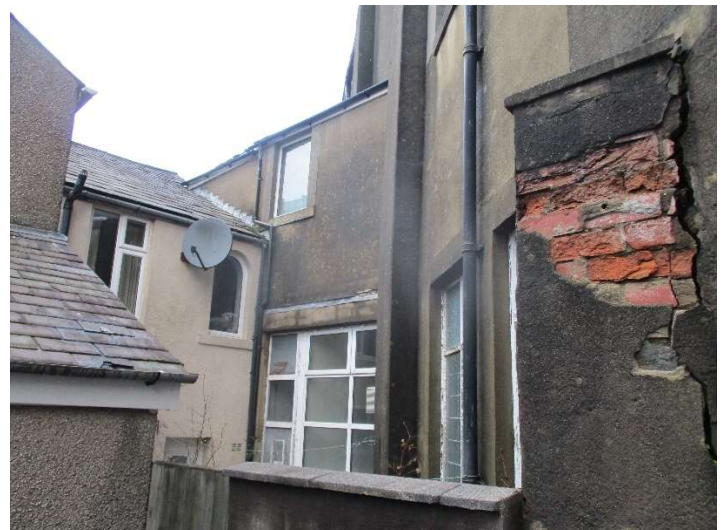
Photo 58 – Buttresses to boundary wall potentially unsafe

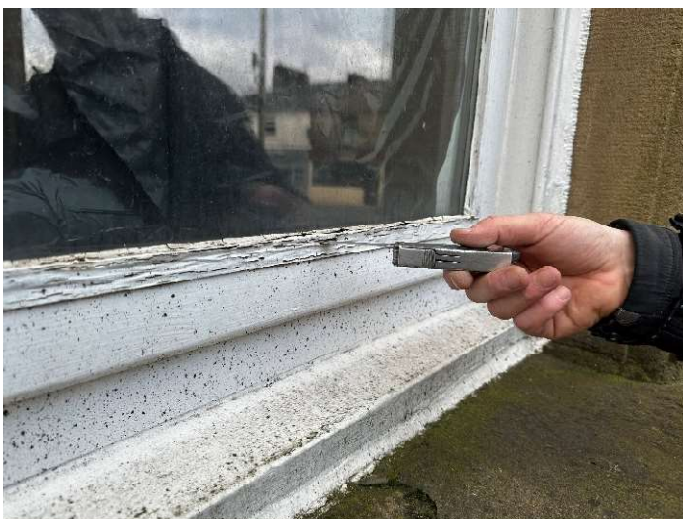
Photo 59 – Wet rot timber decay to beading

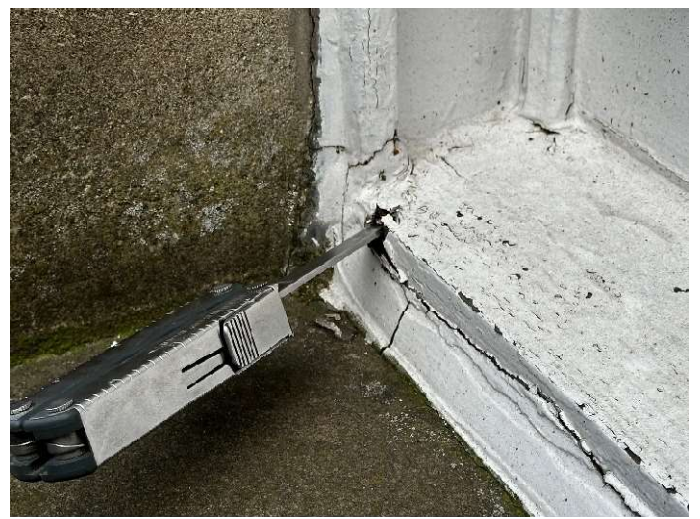
Photo 60 – Wet rot timber decay to window frame

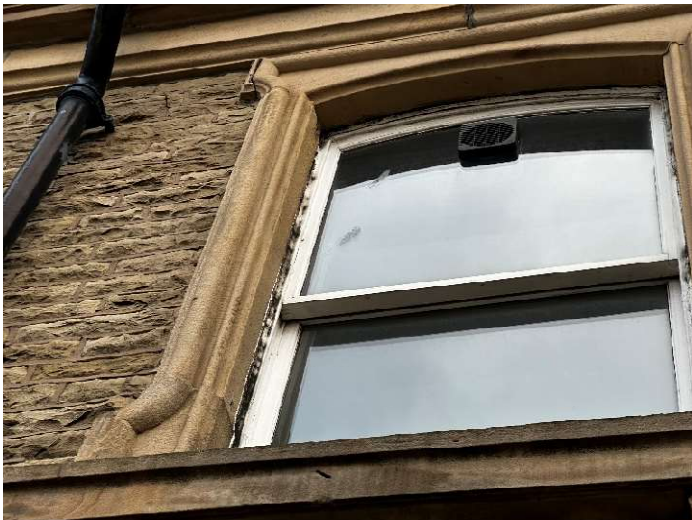
Photo 61 – Failed sealant to window perimeter

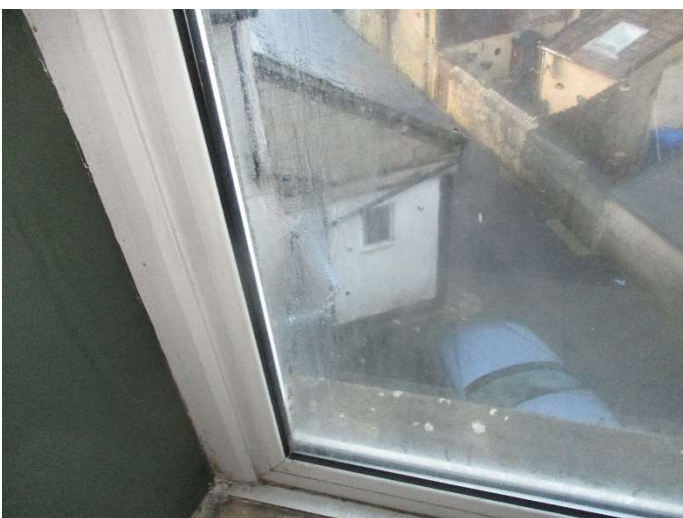
Photo 65 – uPVC double glazed units within theatre have failed to right side elevation with condensation between the panes

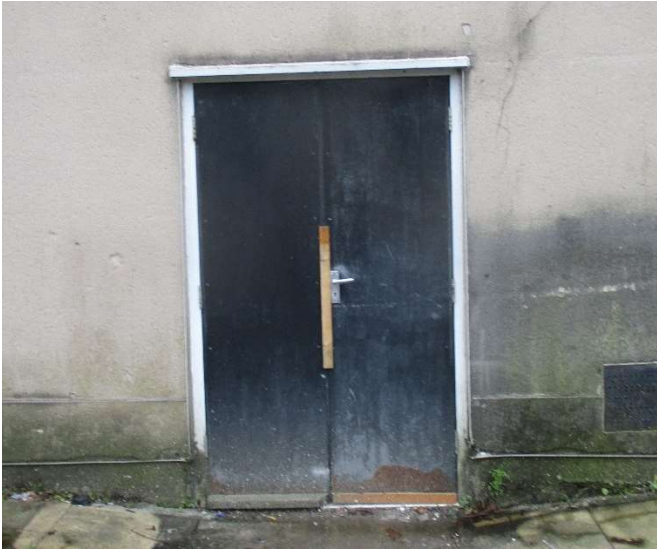
Photo 67 – Painted timber double doors in poor condition

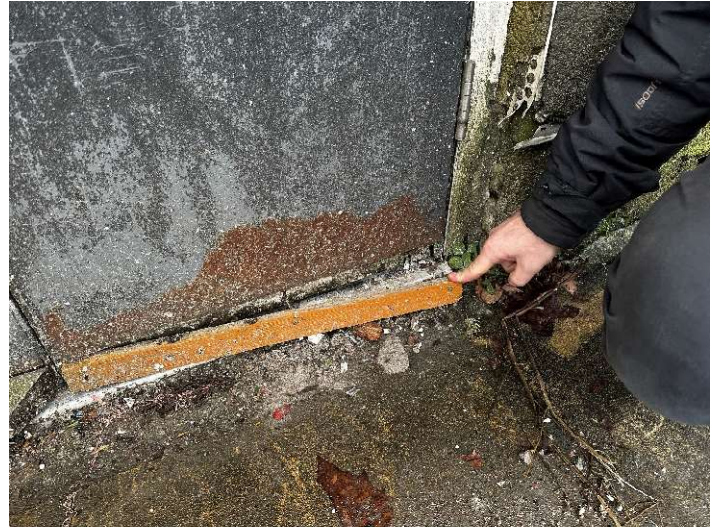
Photo 68 – Doors rotten at low level

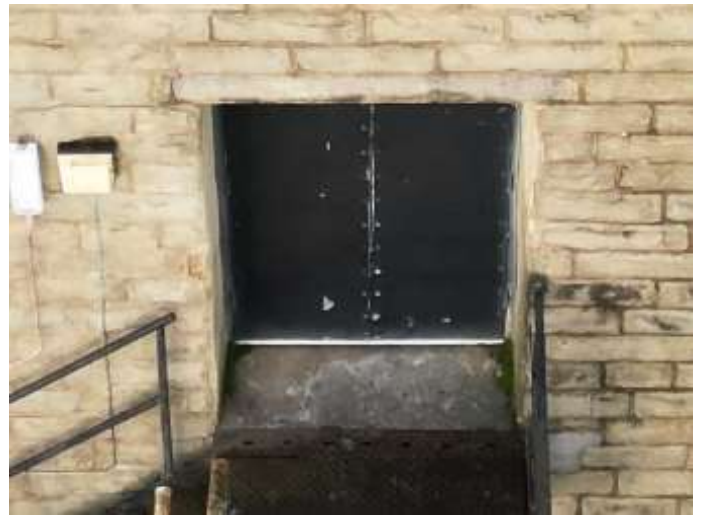
Photo 70 – Fire escape doors require redecoration

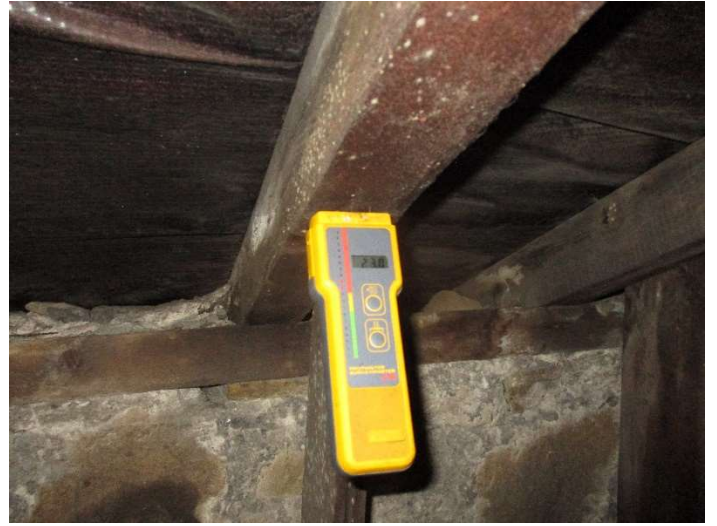
Photo 80 – Moisture content of timber 23%

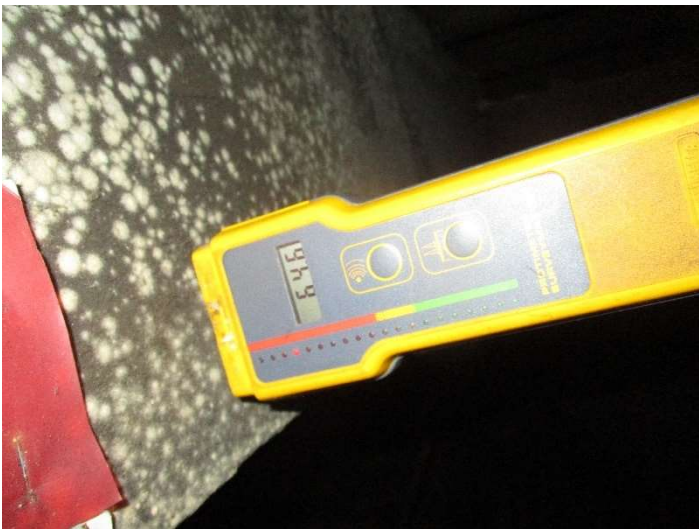
Photo 81 – Moisture content of timber 64%

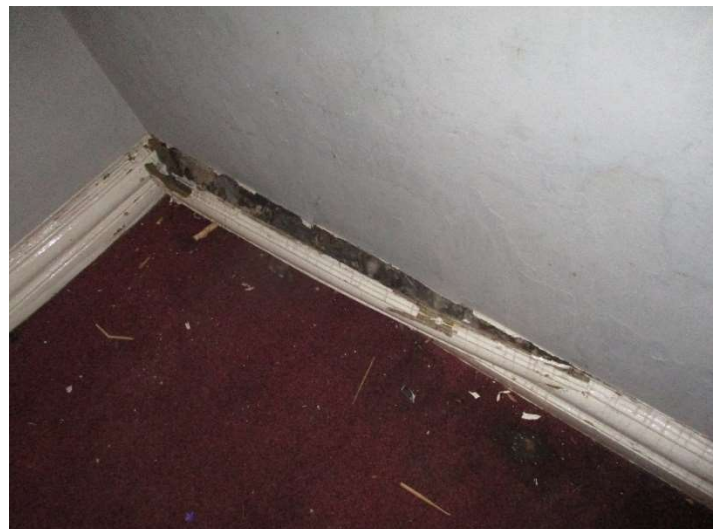
Photo 90 – Rear block – dampness to wall to left side elevation and wet rot timber decay to skirting board

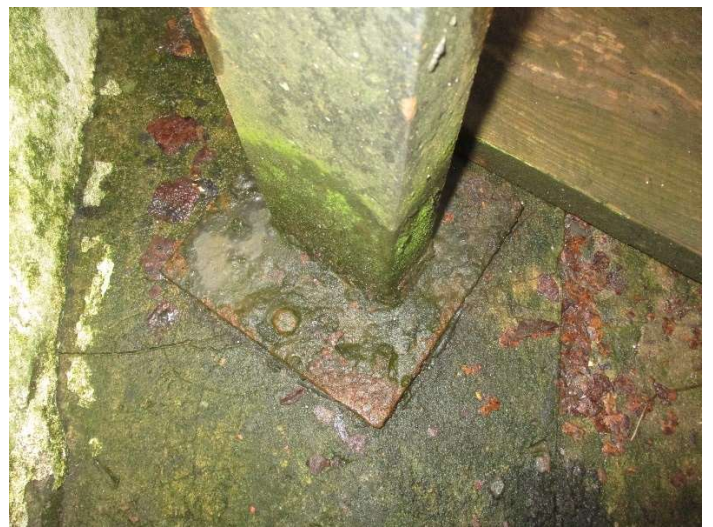
Photo 96 - External staircase corrosion to base plate

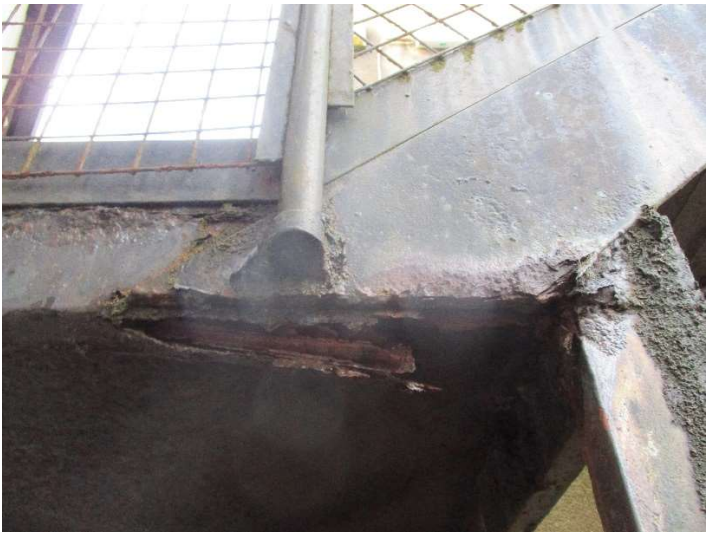
Photo 97 – External staircase corrosion to landing

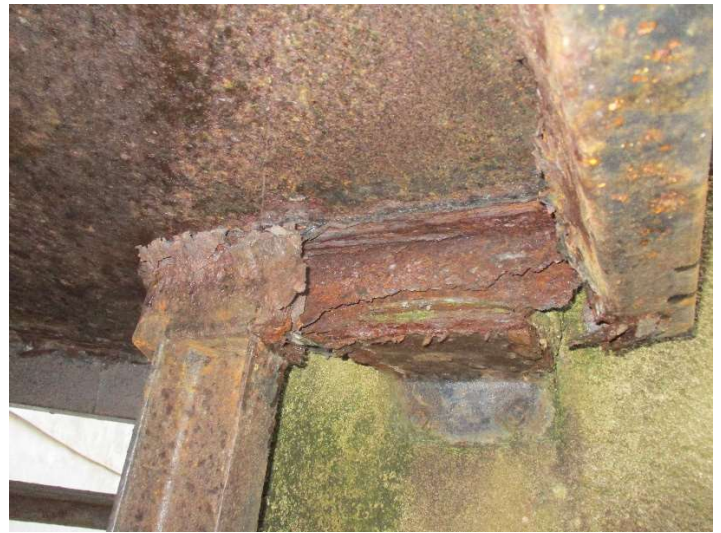
Photo 98 – External staircase corrosion to framework

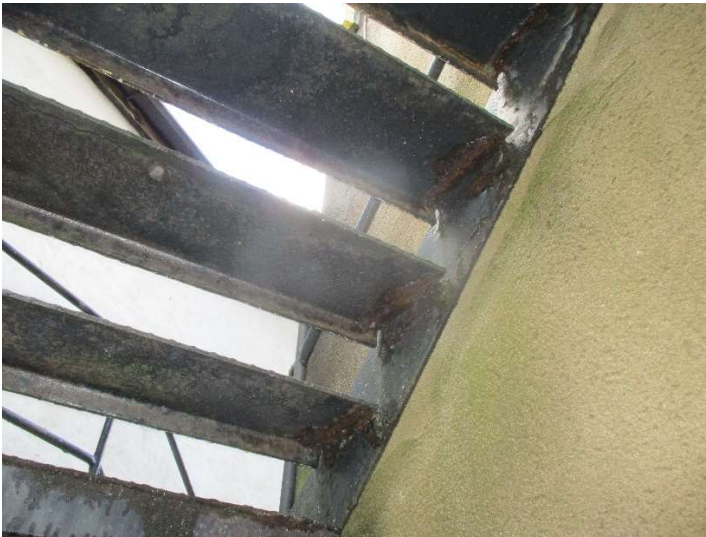
Photo 98 – External staircase corrosion to treads

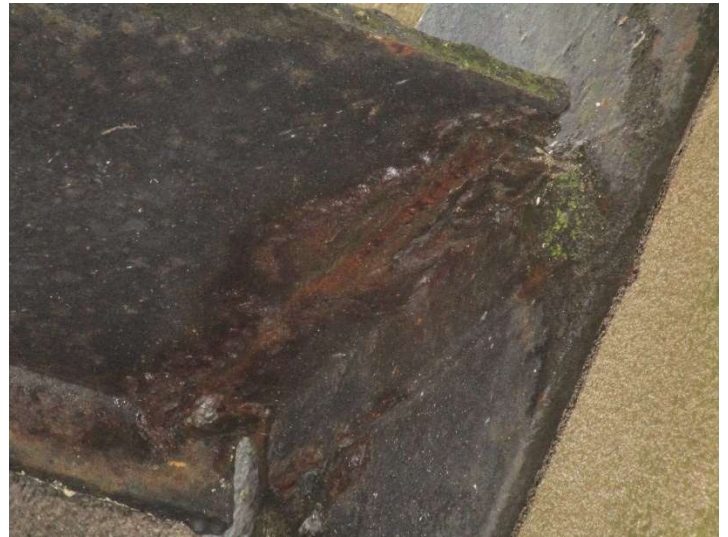
Photo 99 – External staircase corrosion to treads
