# **BUILDING SURVEY REPORT**

**THE GUIDE HUT, OFF THE HIGH STREET, CORSHAM SN13 0EZ**

13<sup>th</sup>, 14<sup>th</sup> April 2022

## **HEXTALLS Surveyors Ltd**

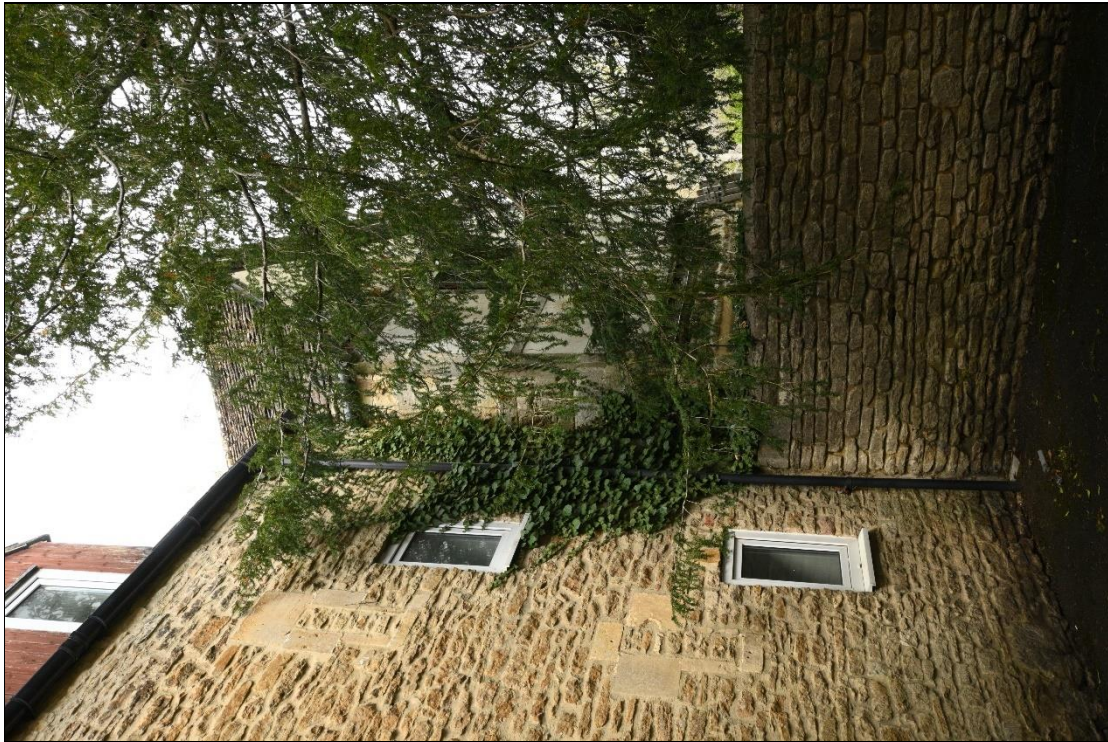
View towards the back right corner hidden by trees and building.

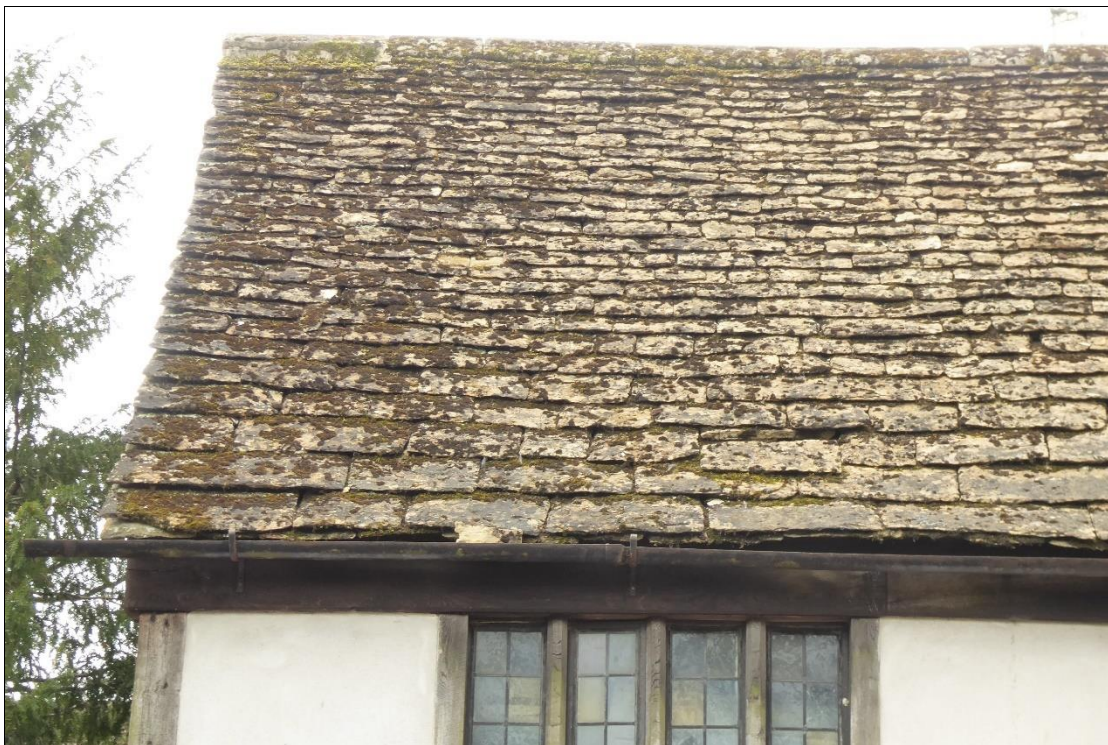
There are signs that the stone ridge tiles are loose with missing mortar in joints between tiles and missing mortar bed. On the front slope and mainly in the left half there are a few broken and missing tiles, with debris lying also in the gutter below. If the moss were to be cleaned off you would probably find other damage as moss traps moisture encouraging frost damage in wintry conditions.

Moss will cause frost damage to the tiles. The roof has not been overhauled for many years judging by the age of the roof lining.

1.       The roof cladding is partly covered with moss with signs of consequential frost damage to some of the stone tiles. Removal of moss is advised but not essential. Replacing the few slipped and damaged tiles should be carried out. The ridge should be checked and tiles re-bedded in mortar as necessary.

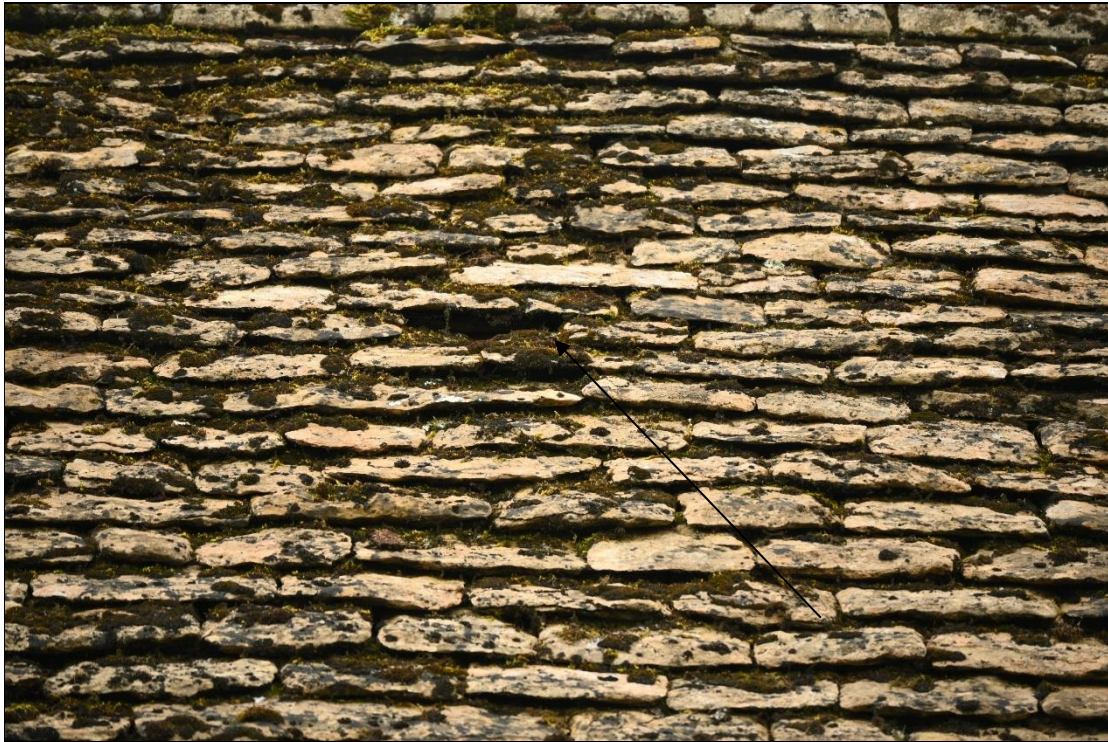
There are a couple of damaged or missing tiles.

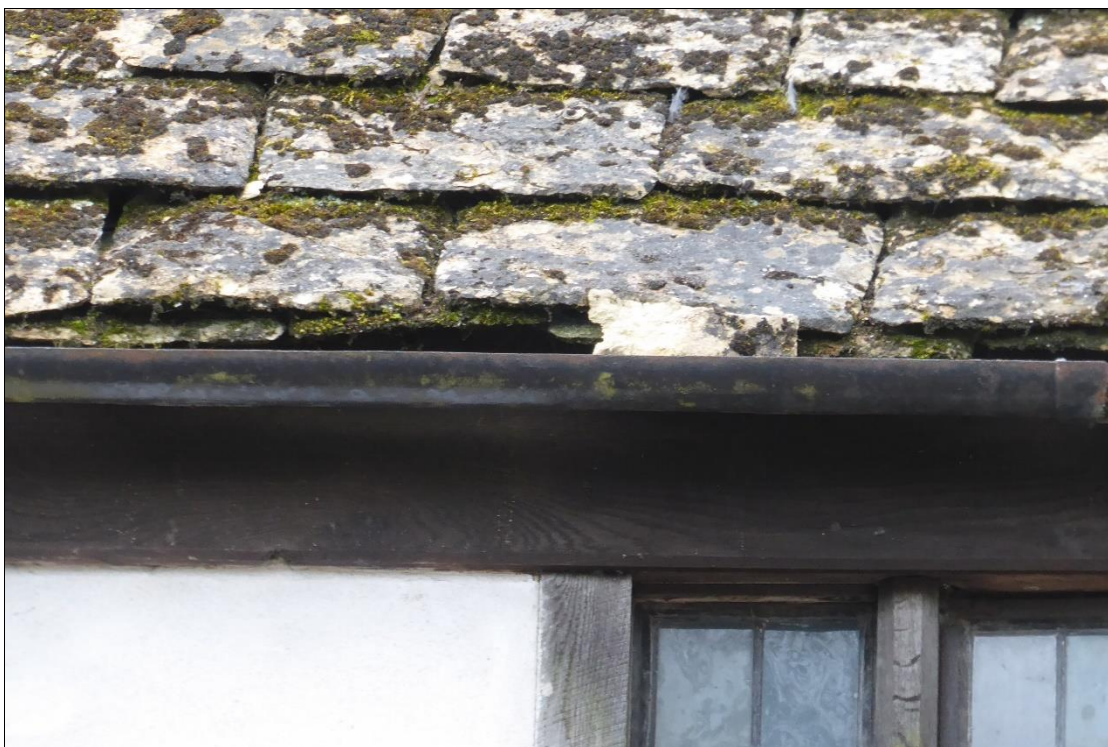
Tile debris.

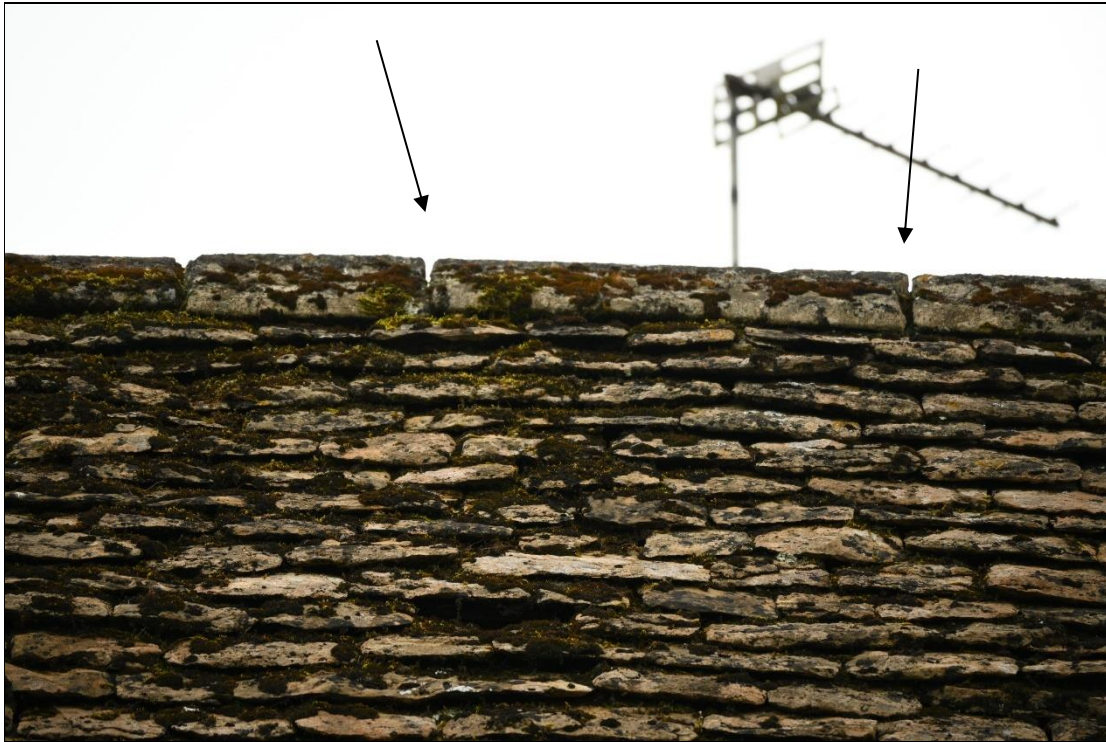
Pointing to the ridge needs overhaul.

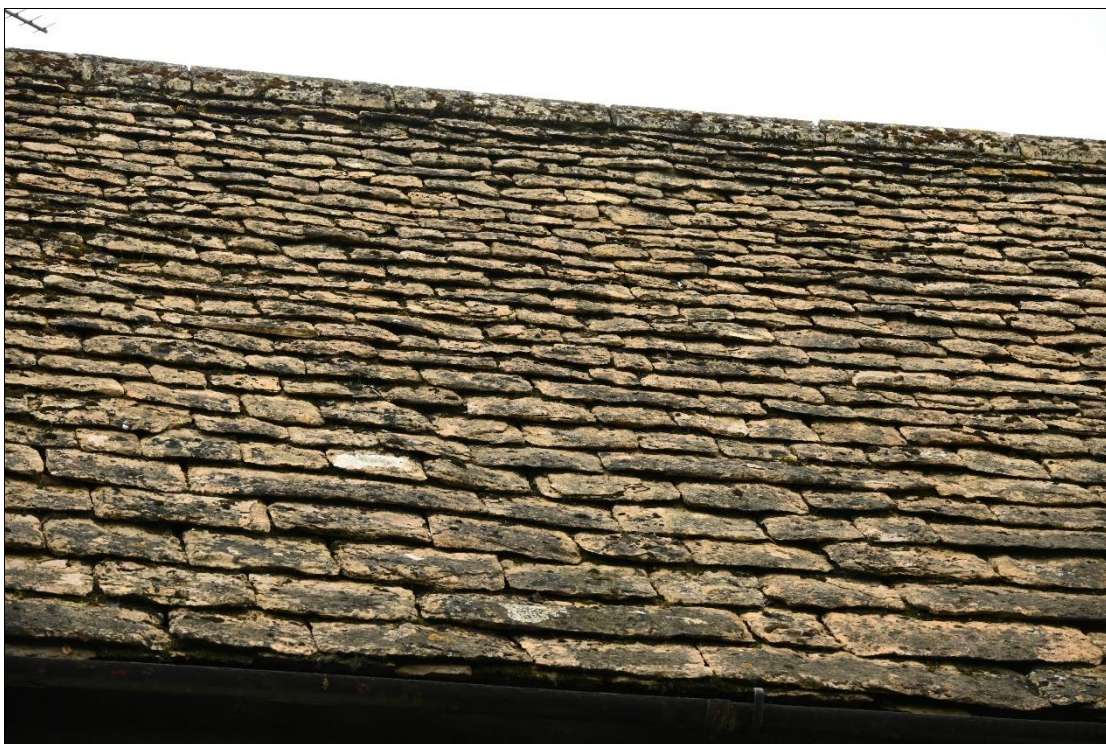
Middle part of the slope looks in reasonable condition.

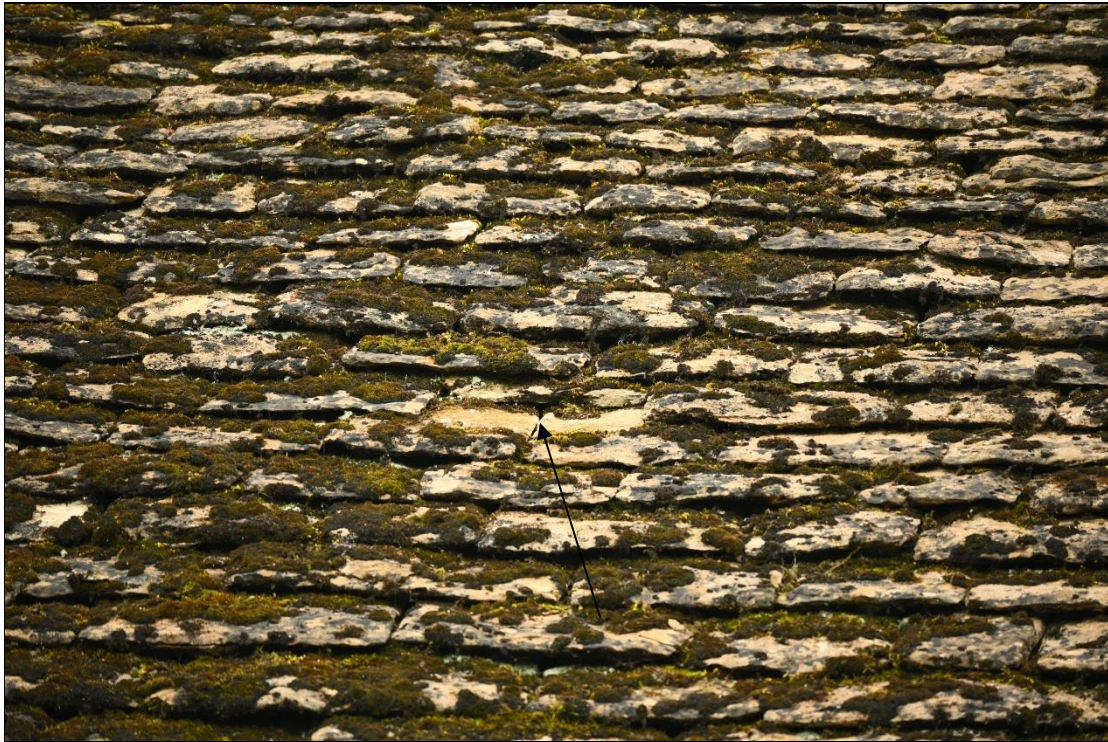
Further example of missing tile.

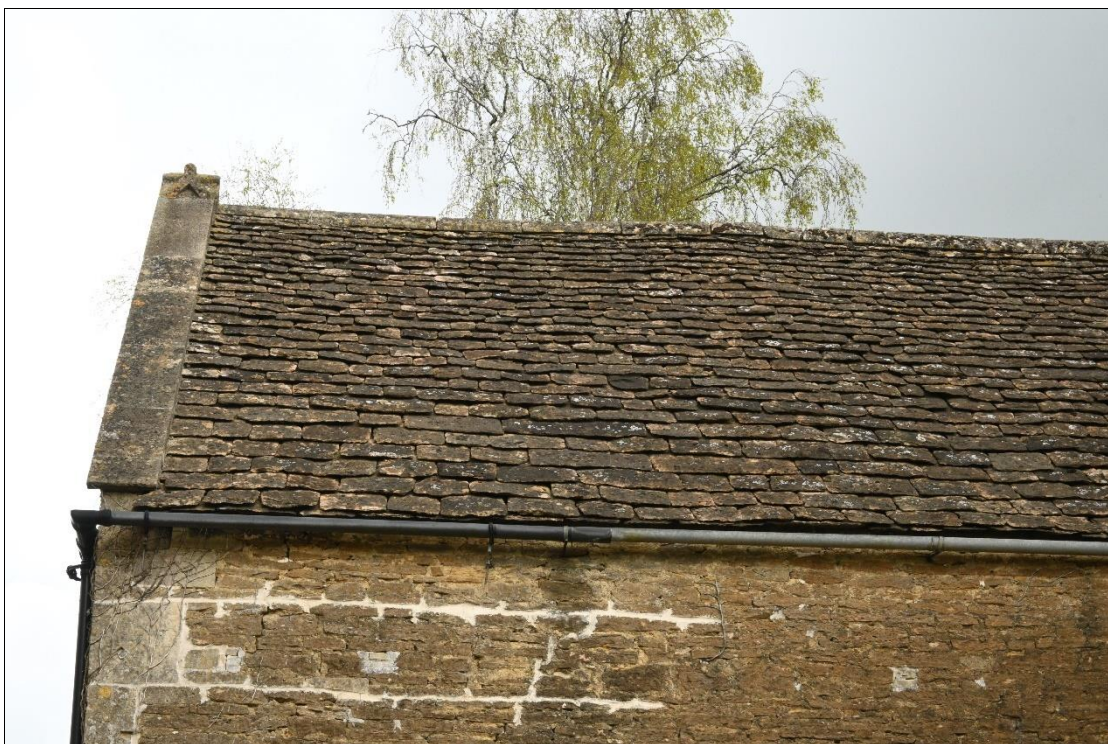
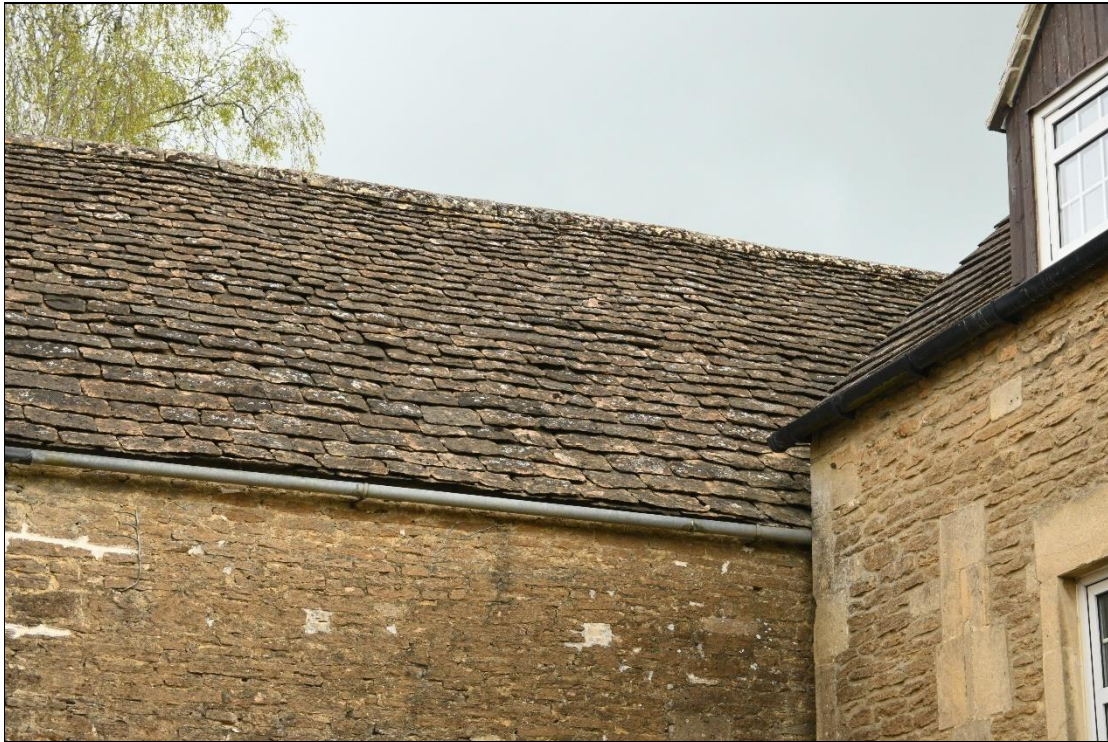
Rear slope looks quite reasonable.

As above.

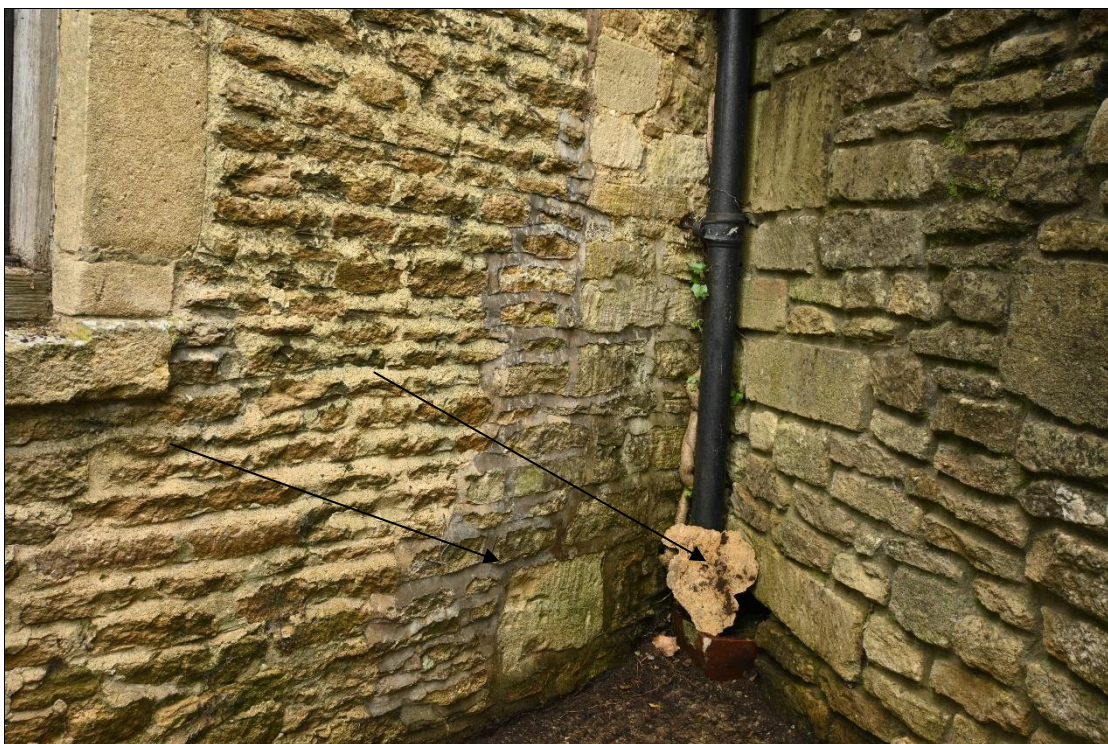
Front right downpipe arrangement should be checked. Cement repointing not ideal.

4. There is scope for minor pointing of stone walls. There has been cement used to repair in places such as the front right bottom corner. Replacing with lime mortar is advised.

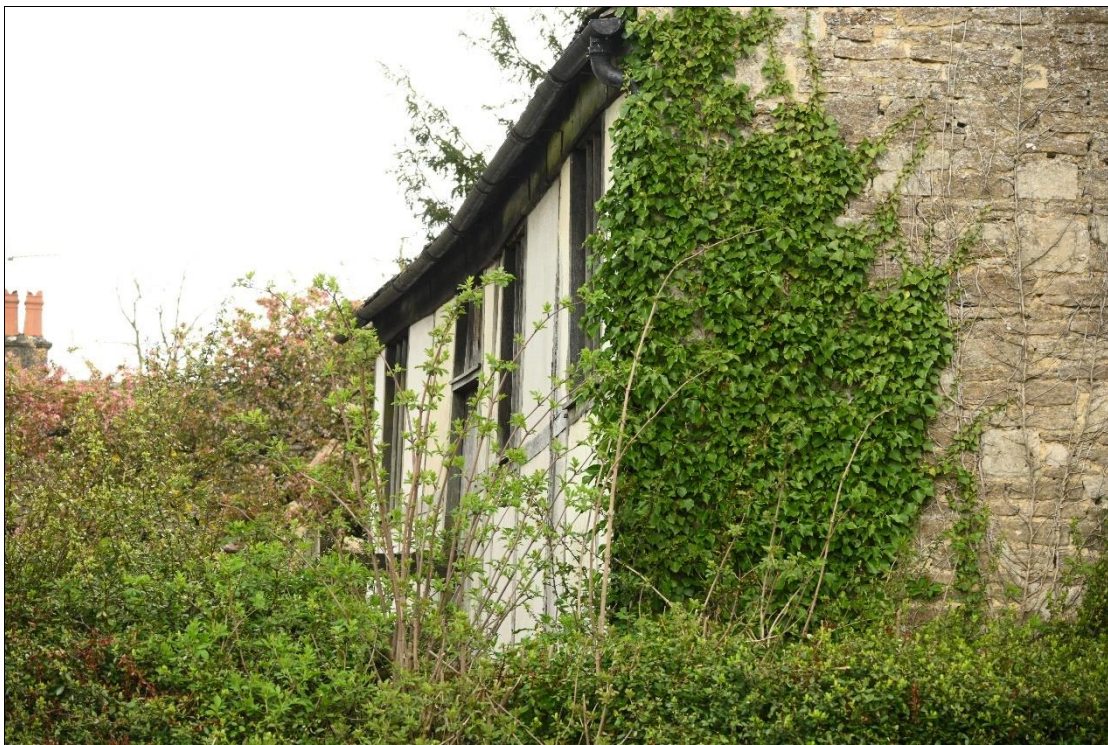
Suffers from an inward lean or bow. All historic.

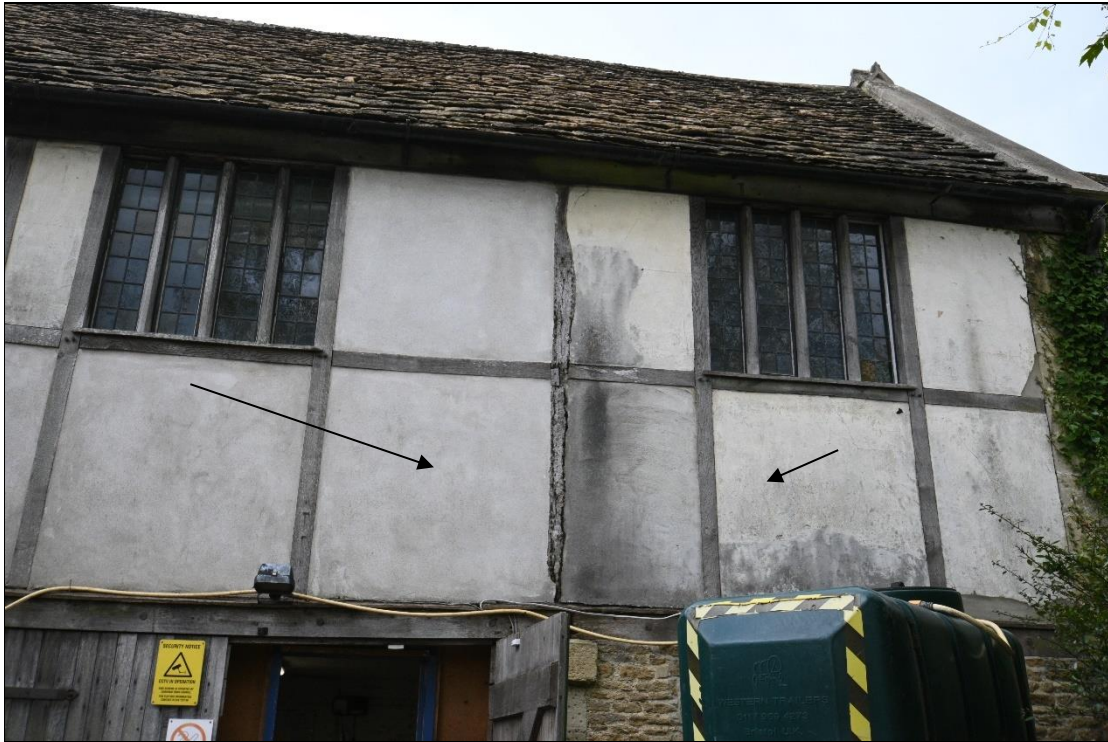
It is possible cement rather than lime was used so not a sympathetic repair.

The panels don't appear to be lime render - more cement render but this is not certain.

2. Gutters should be cleaned of moss and checked for leaks at joints.
3. Rendered panels need minor work replacing render which doesn't match and sealing carefully cracks and holes.

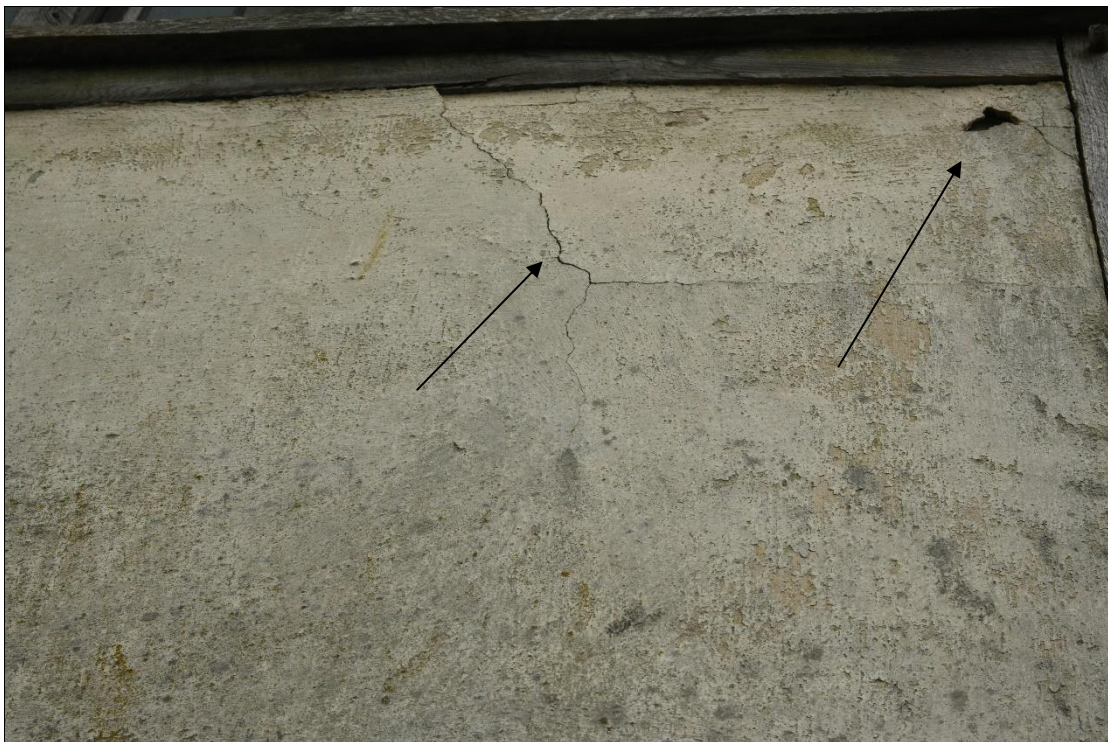
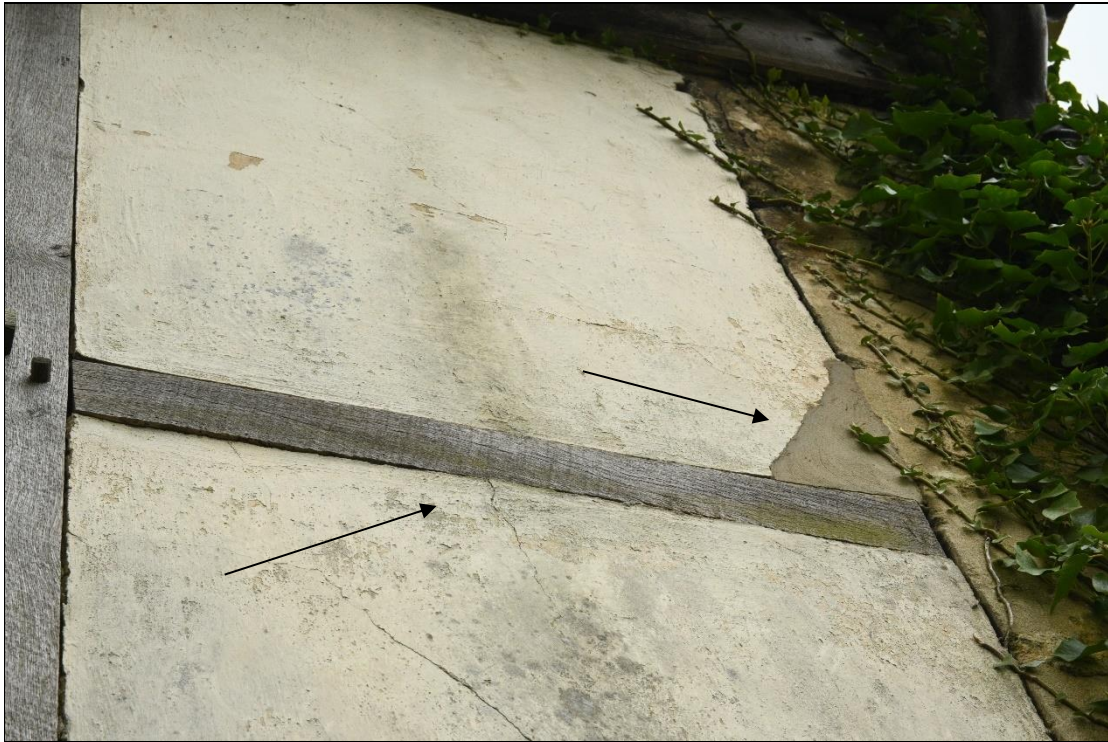
They suffer hairline cracks and holes.

As above.

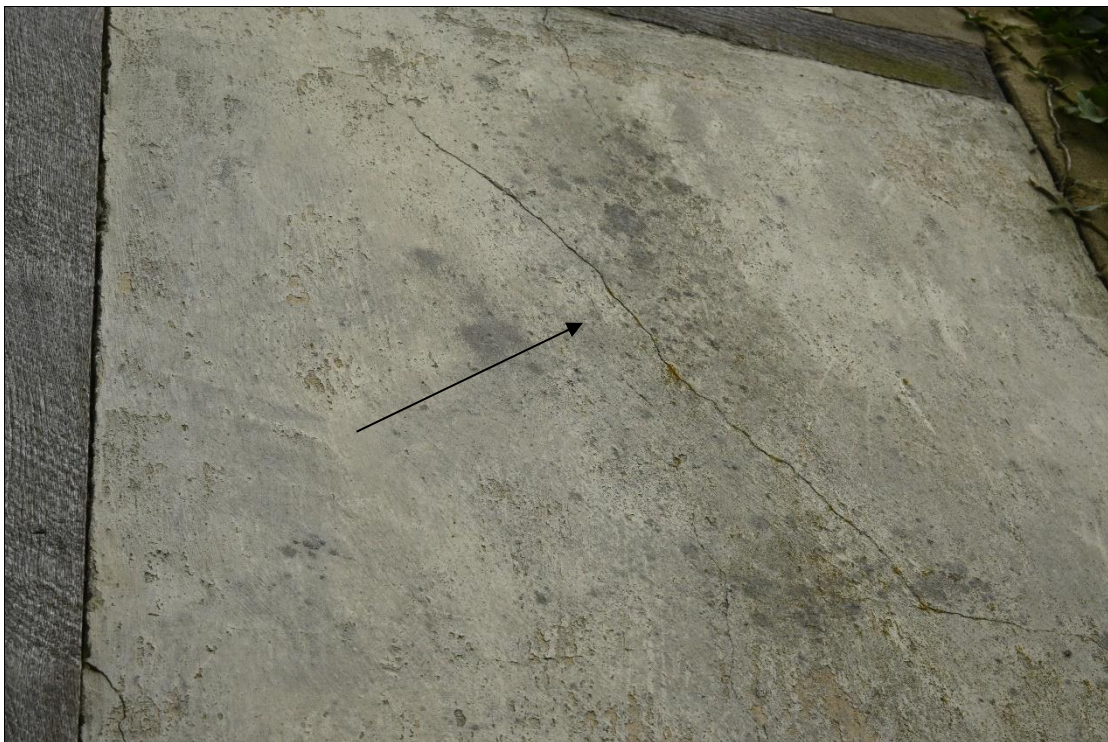
And here. Close inspection is advised to check the render is still firmly attached.

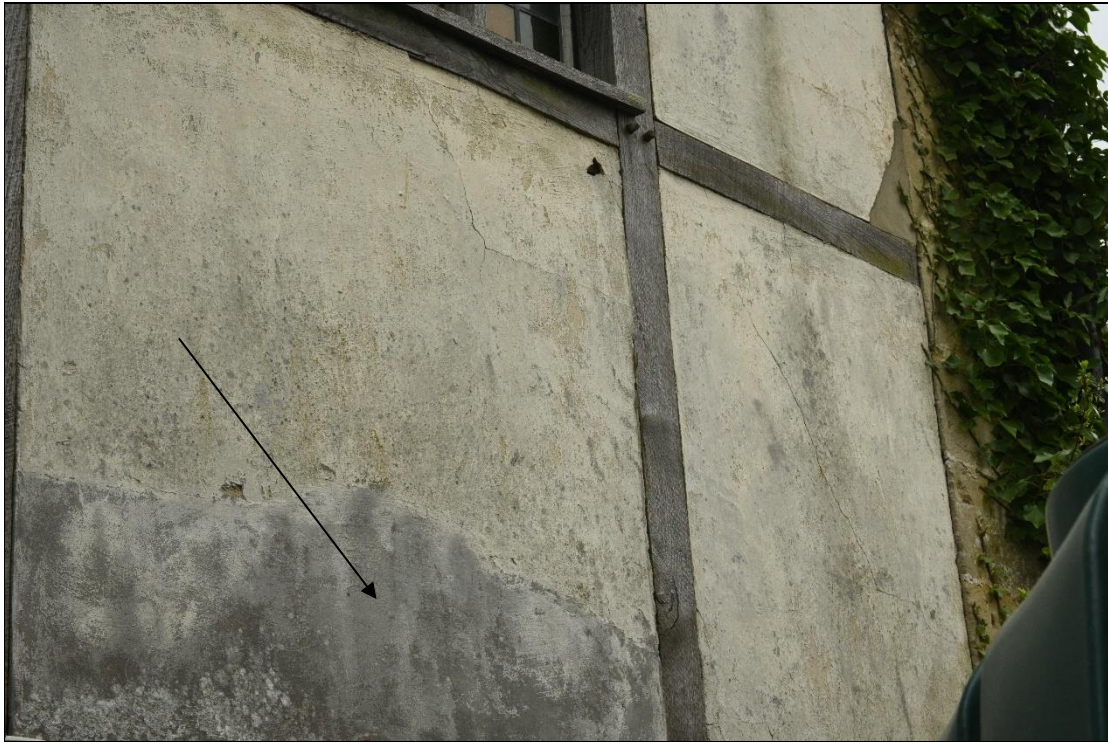
Repairs perhaps made using cement.

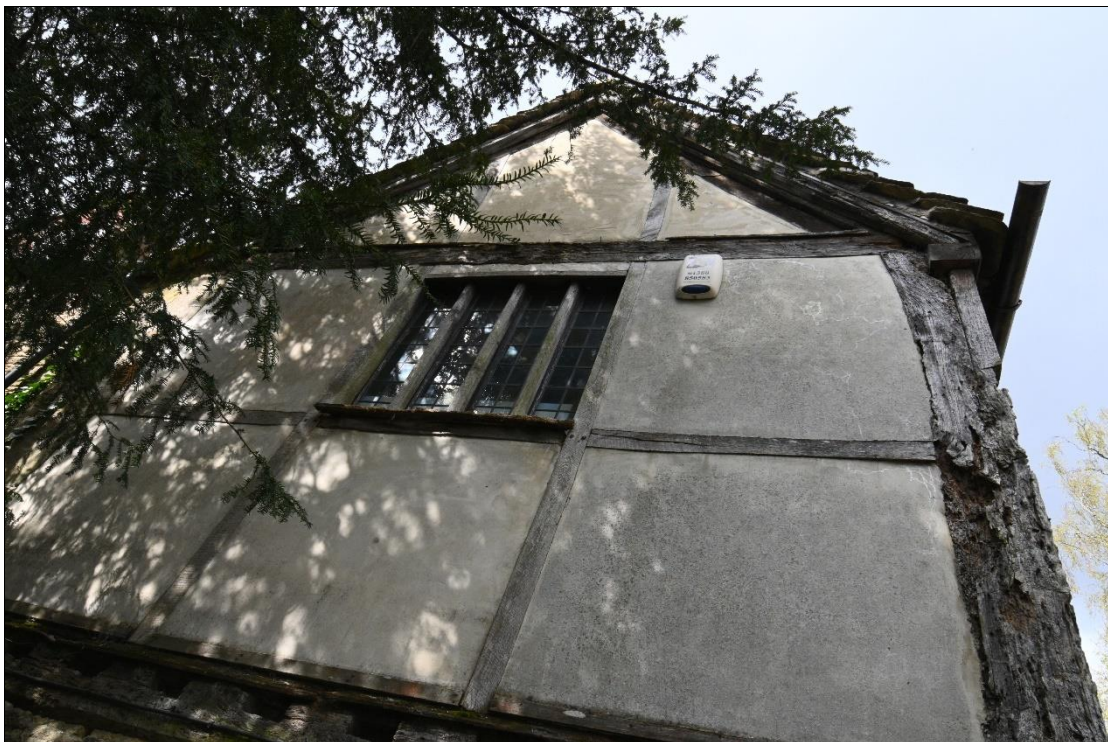
Left gable end elevation render looks okay.

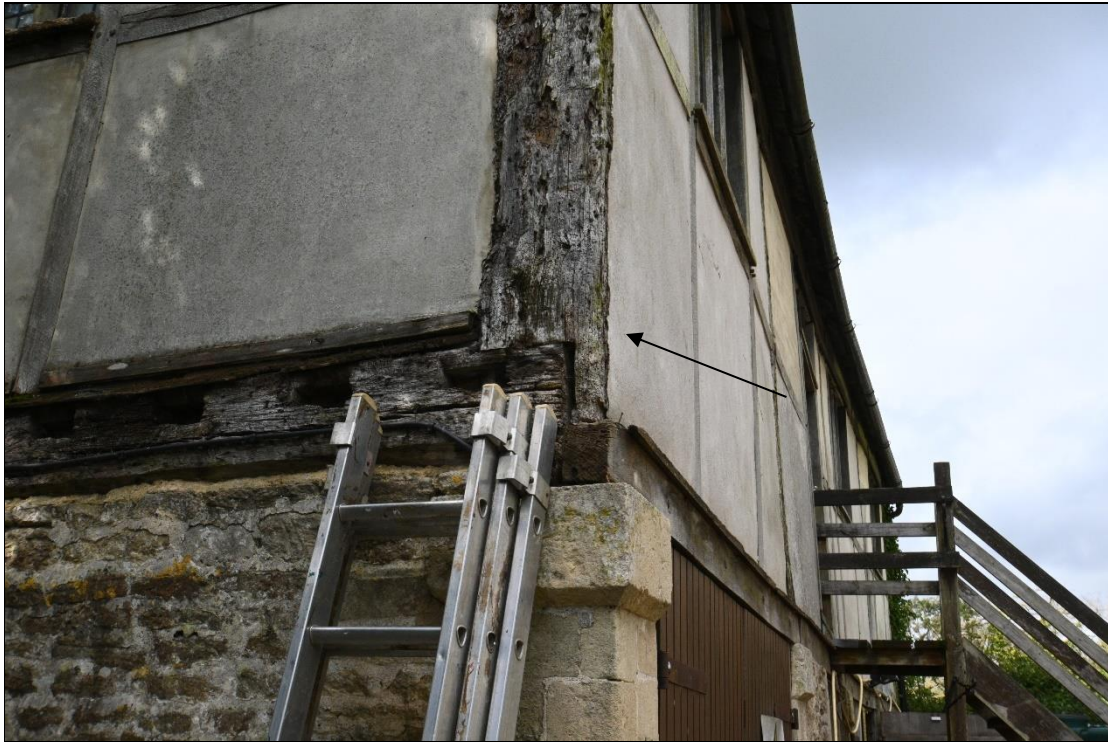
On the front elevation the first floor timber frame looks generally satisfactory but the face of the jowl post at the left corner is particularly worn but the upper part remains with a new section of oak let in as a repair.

Foot of the jowl post.

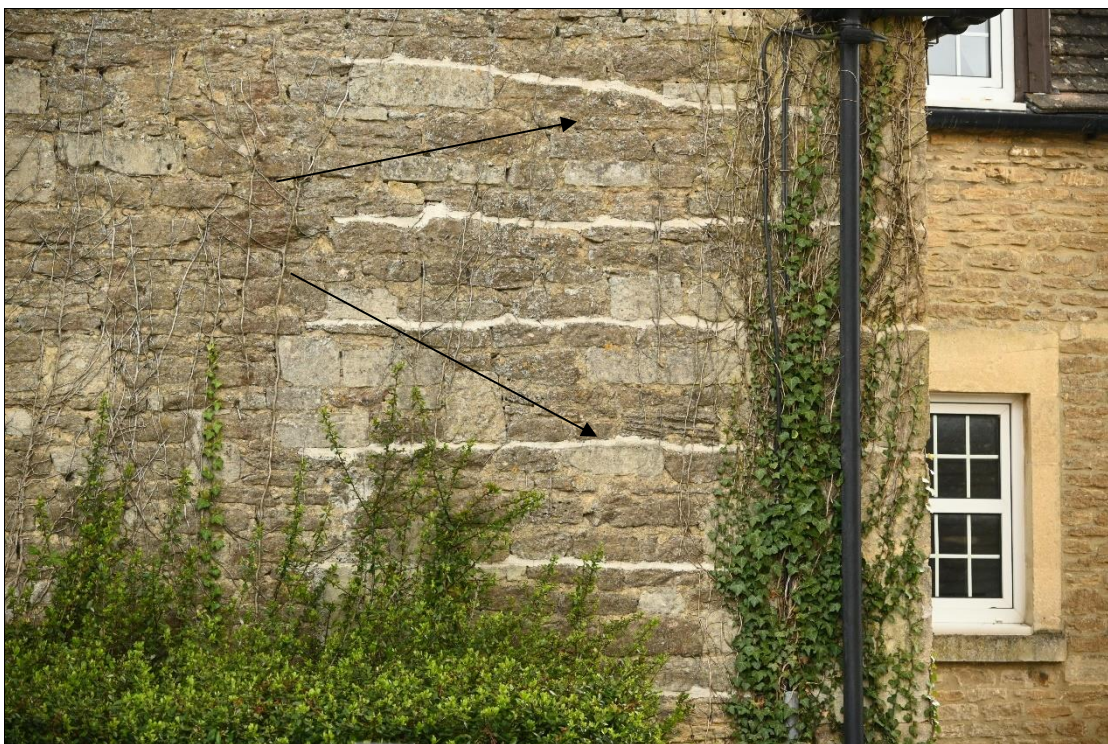
The regularly spaced horizontal lines at the corners of the building suggest that stainless steel straps or ties have been fitted to strengthen the corner of the building. If so, there should be an engineers report detailing what was wrong and why the repair was required.

Light lines where joints repointed following, I think, the fitting of steel straps, to brace the building corners.

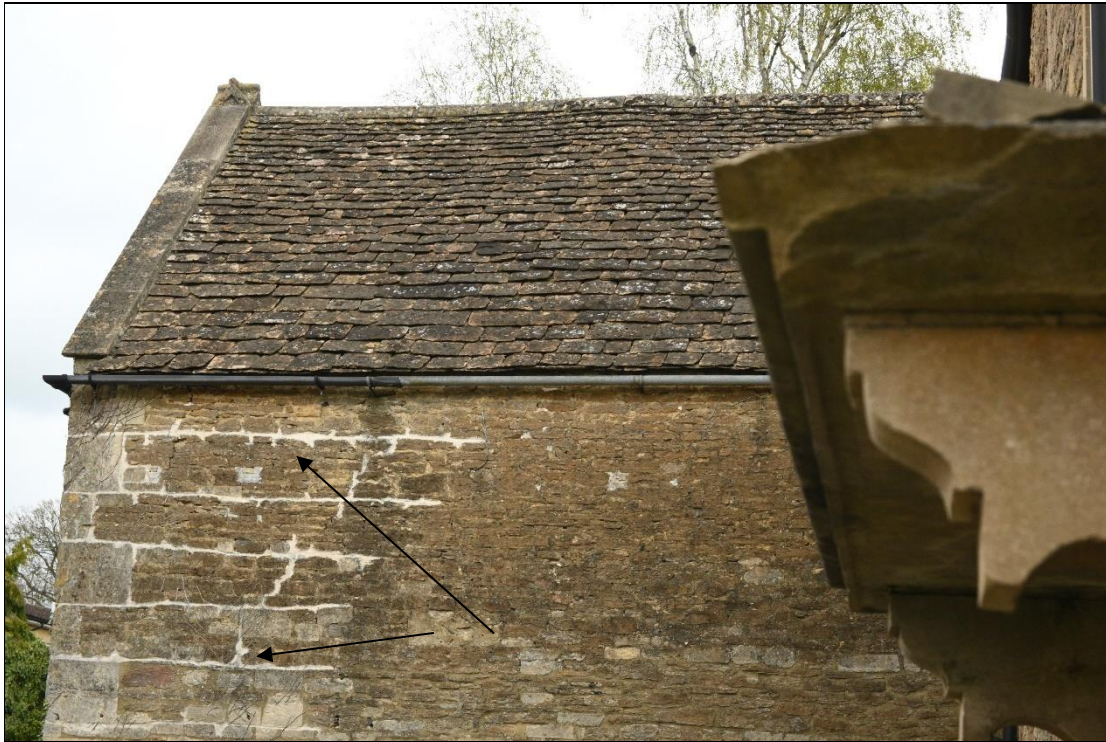
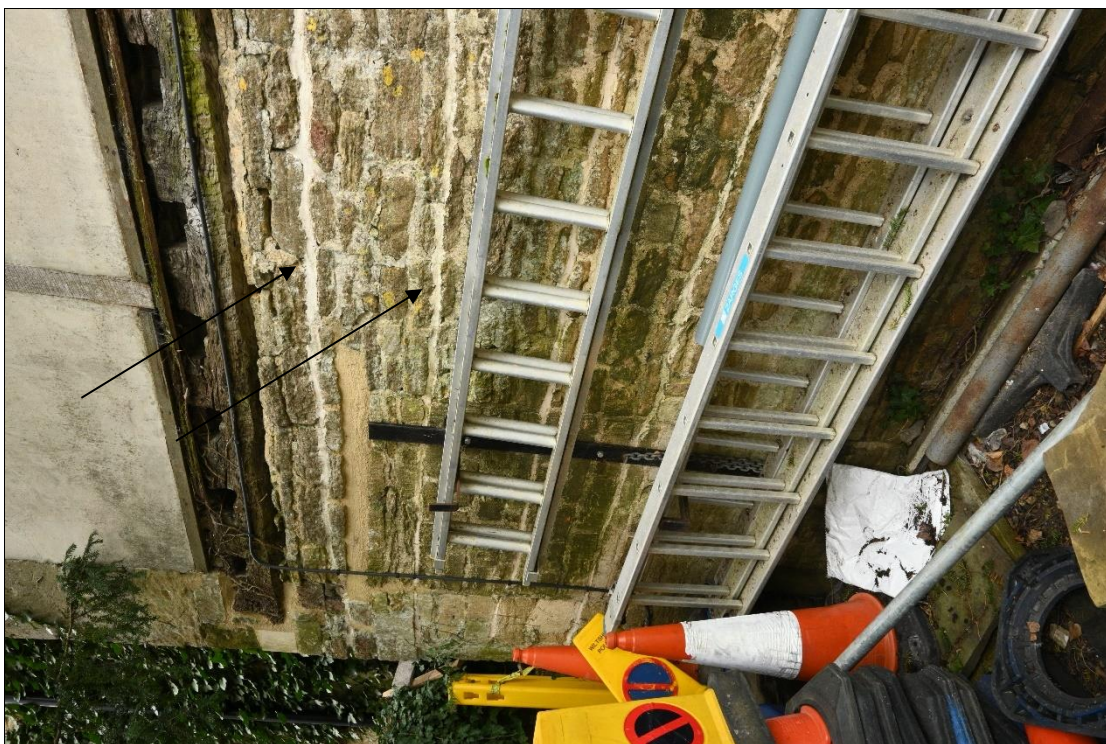
Further on the back elevation.

And left gable back corner.

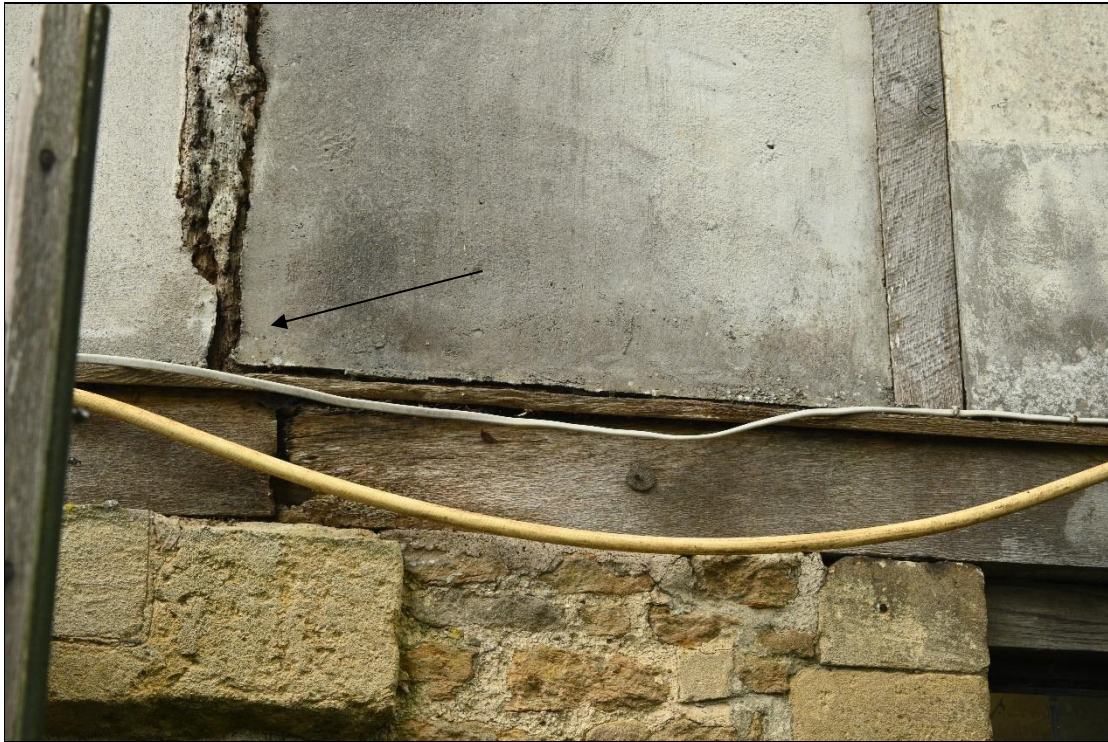
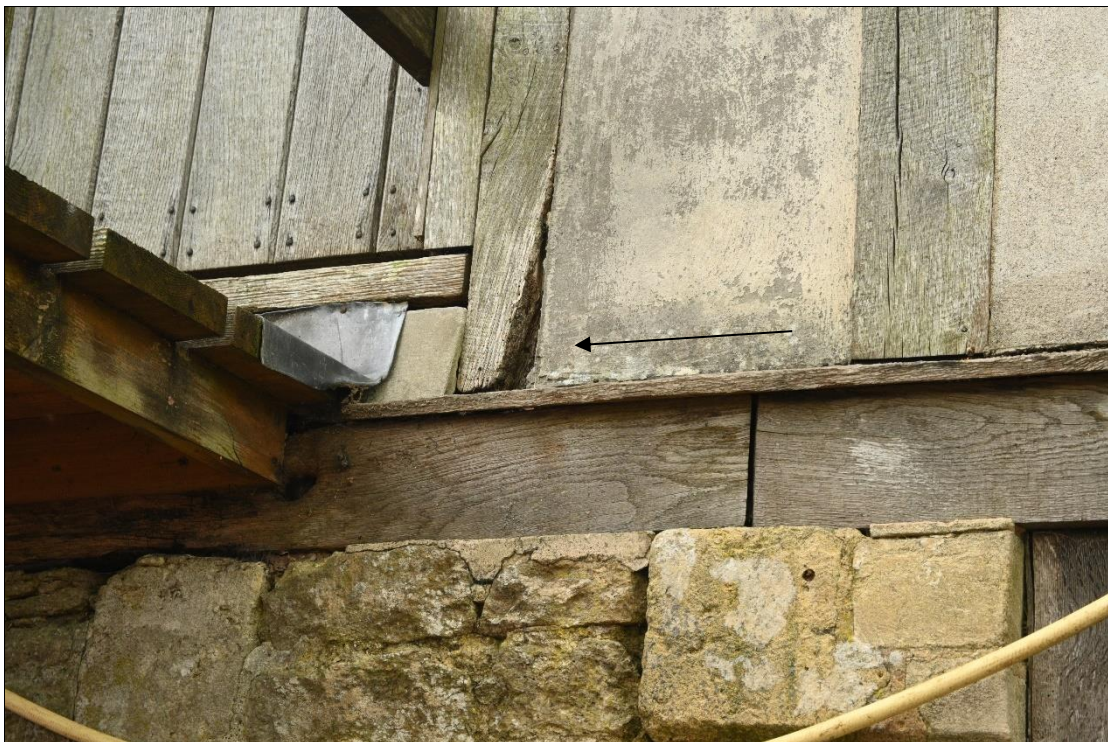
The old post suffered past damage and is now largely protected by render. Bit of gap at the base of the render where it meets the wooden drip.

Asa above.

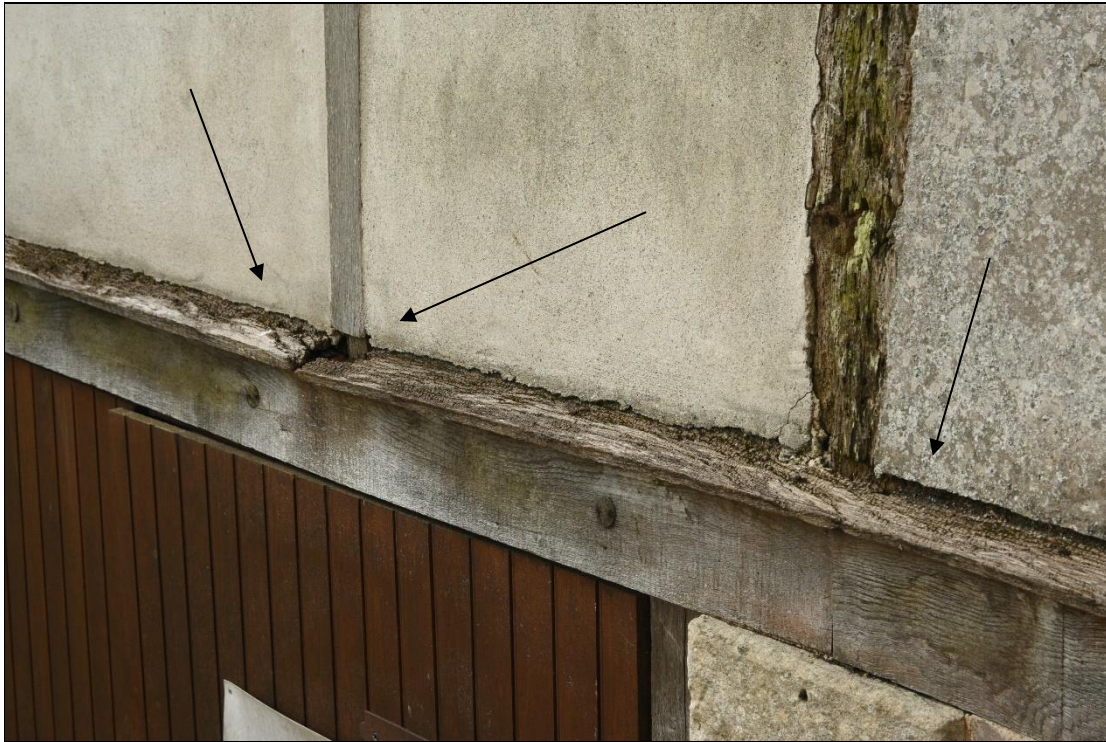
At the base of the rendered panels the oak shelf or drip fitted above the fascia is showing signs of weather damage with joints also visible to the rendered panels. There is particular weather damage to the drip above the left Garage doors and at the base of the old post to the right of the doors. Whilst the drip should be replaced when done it would be sensible to seal joints with lime mortar to prevent direct water ingress.

The wooden drip or shelf shows some wear particularly where arrowed.

5. The timber framed walls need further repair replacing rotten elements such as replacing the drip at the base of the frame, and making sure the feet of vertical elements are sound and protected from future decay.

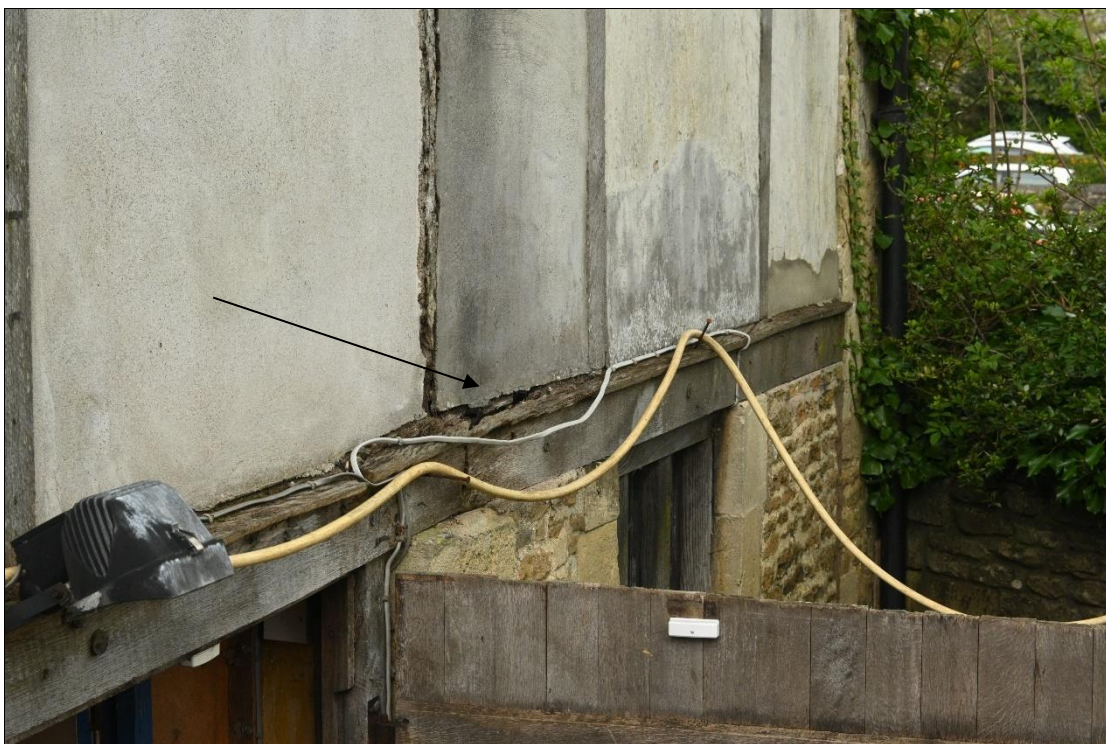
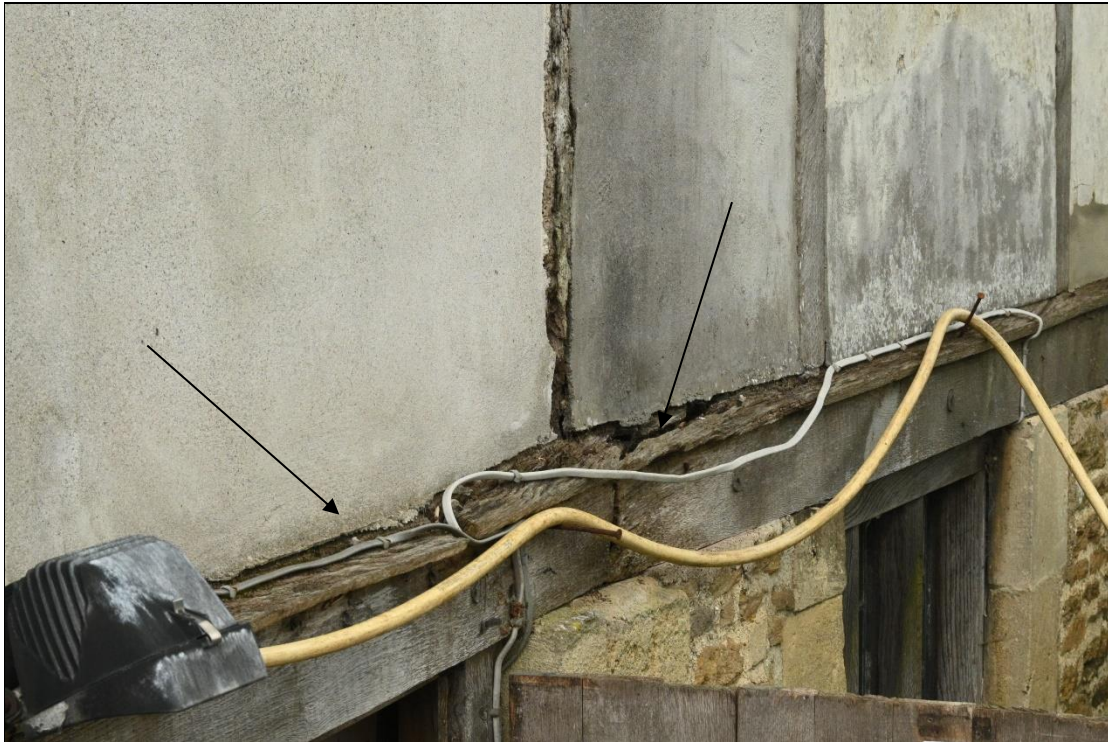
Here the drip certainly needs replacing.

Close up.

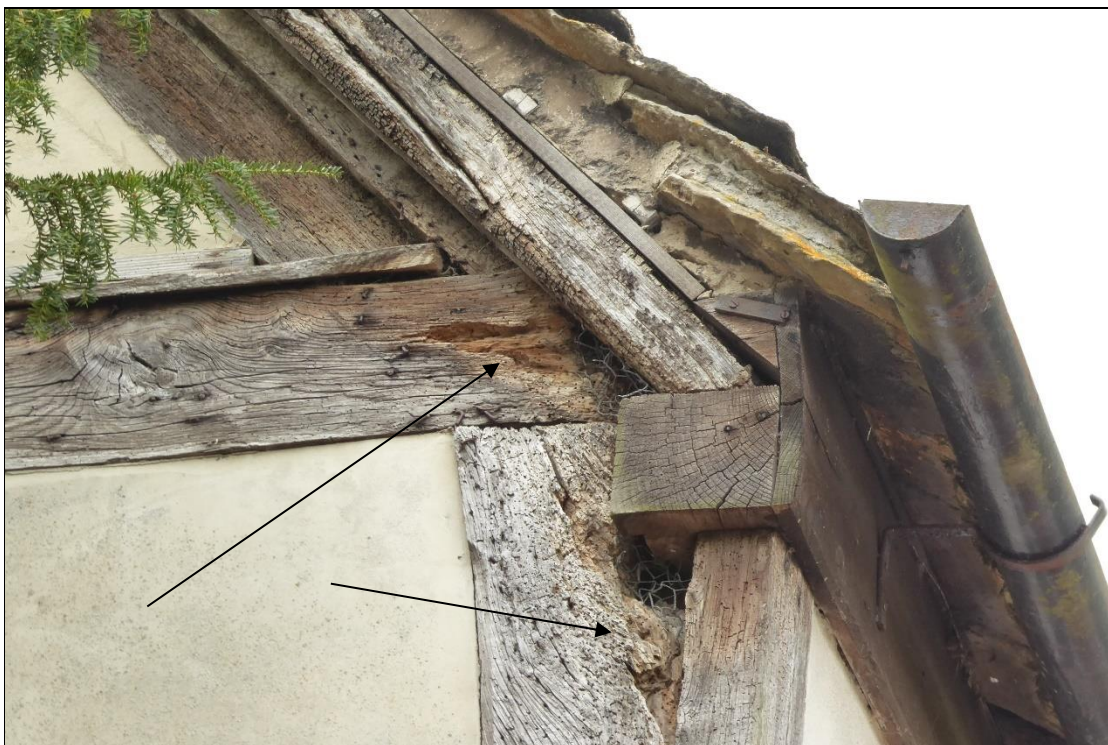
Old timbers are moisture damaged and show signs of historic and possibly recent woodworm infestation but there is no suggestion of failure or a need for structural repair.
