# **BUILDING SURVEY REPORT**

**THE GUIDE HUT, OFF THE HIGH STREET, CORSHAM SN13 0EZ**

13<sup>th</sup>, 14<sup>th</sup> April 2022

## **HEXTALLS Surveyors Ltd**

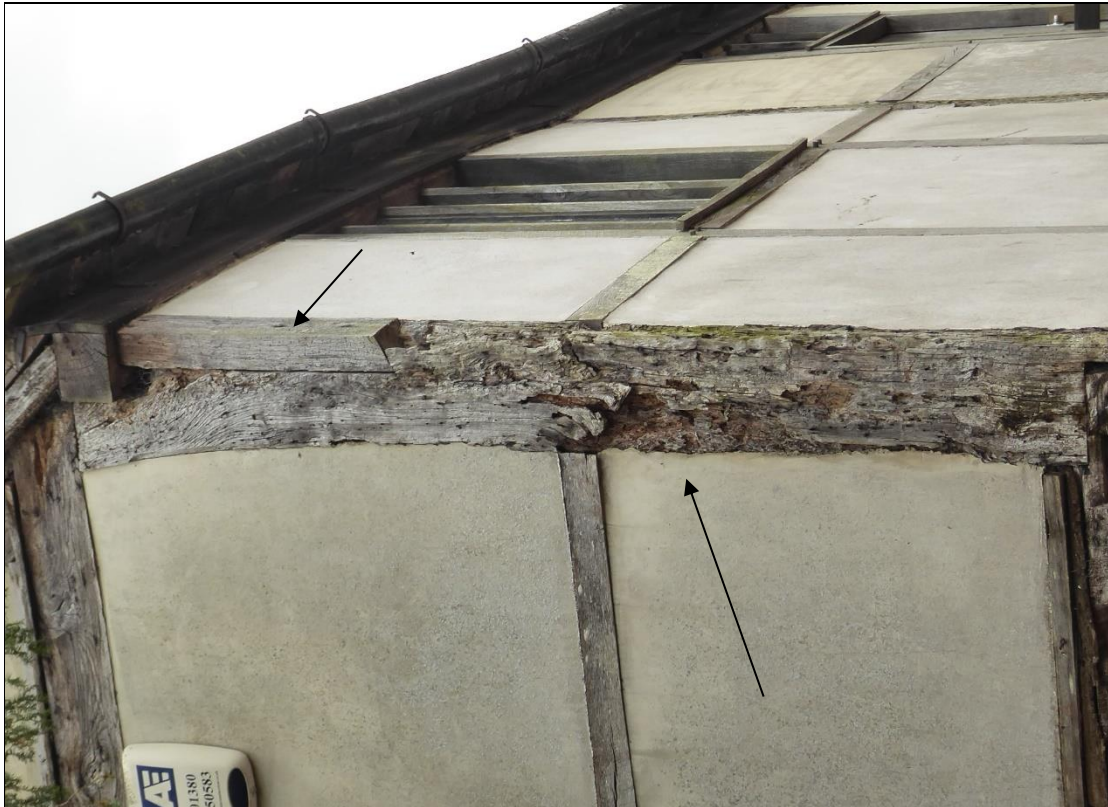
The top corner was repaired when other work was done but there is perhaps a case for repair where arrowed.

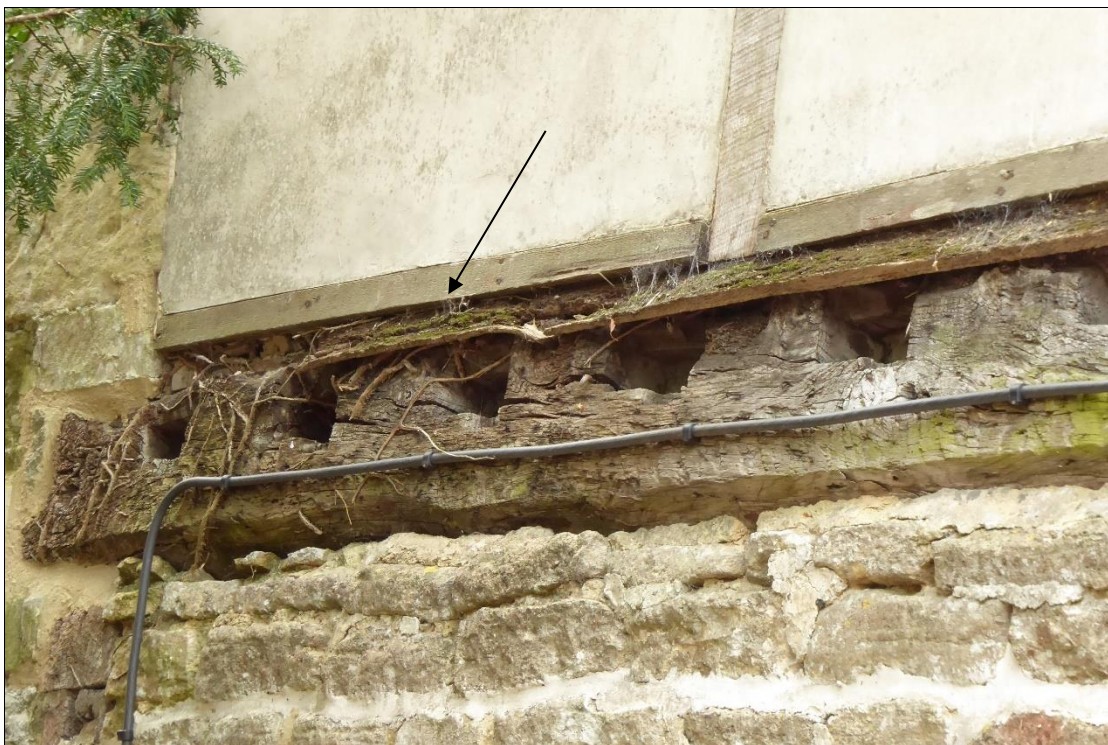
On the left elevation there is significant damage to the base of the first floor window frame and its cill as well as similar damage to the the drip over the old beam. The old beam is of course somewhat damaged where sockets were cut to support joists.

Drip above the beam poor condition. I wonder whether there should be a wooden cover fitted to hide the joist holes.

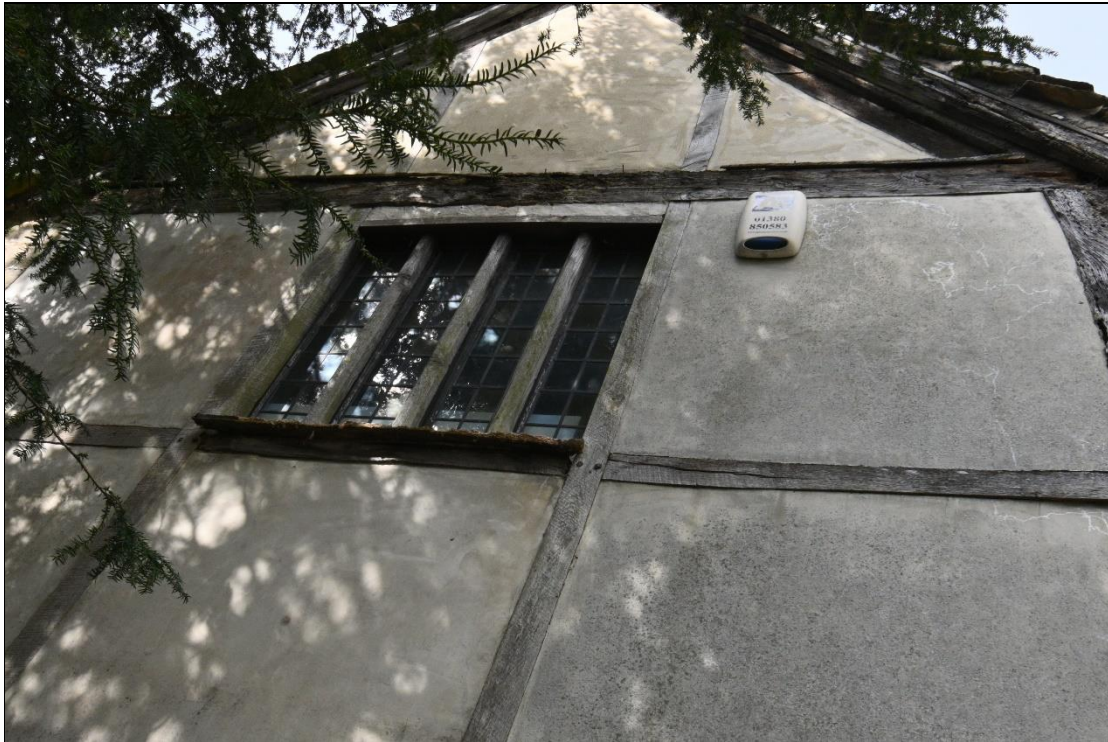
On the first floor the base of the frame to the window in the left end gable has failed and is almost detached from the feet of the side frames and mullions. There are signs of woodworm, so significant repair is required to the frame there.

This window is in poor condition.

6. The first floor window in the left gable requires significant repair. Close inspection of the other first floor windows will probably reveal other areas where repair should be done to make sure they remain useful for some years to come.

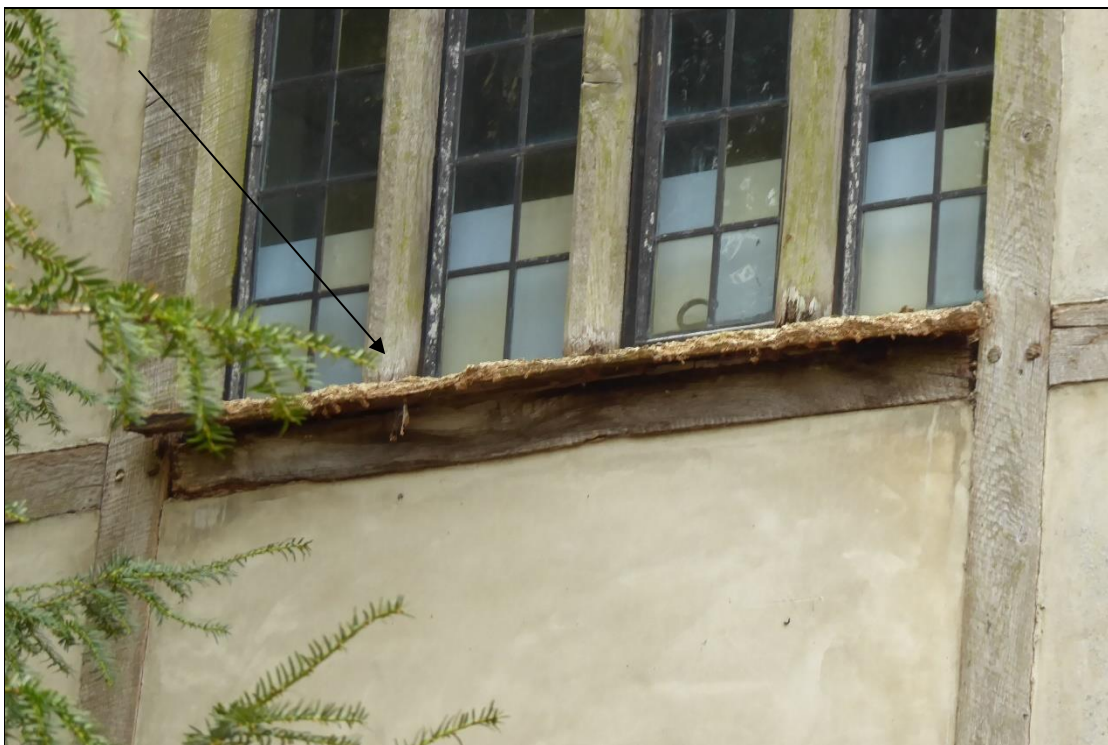
Close up of rotten drip outside.

5. The timber framed walls need further repair replacing rotten elements such as replacing the drip at the base of the frame, and making sure the feet of vertical elements are sound and protected from future decay.

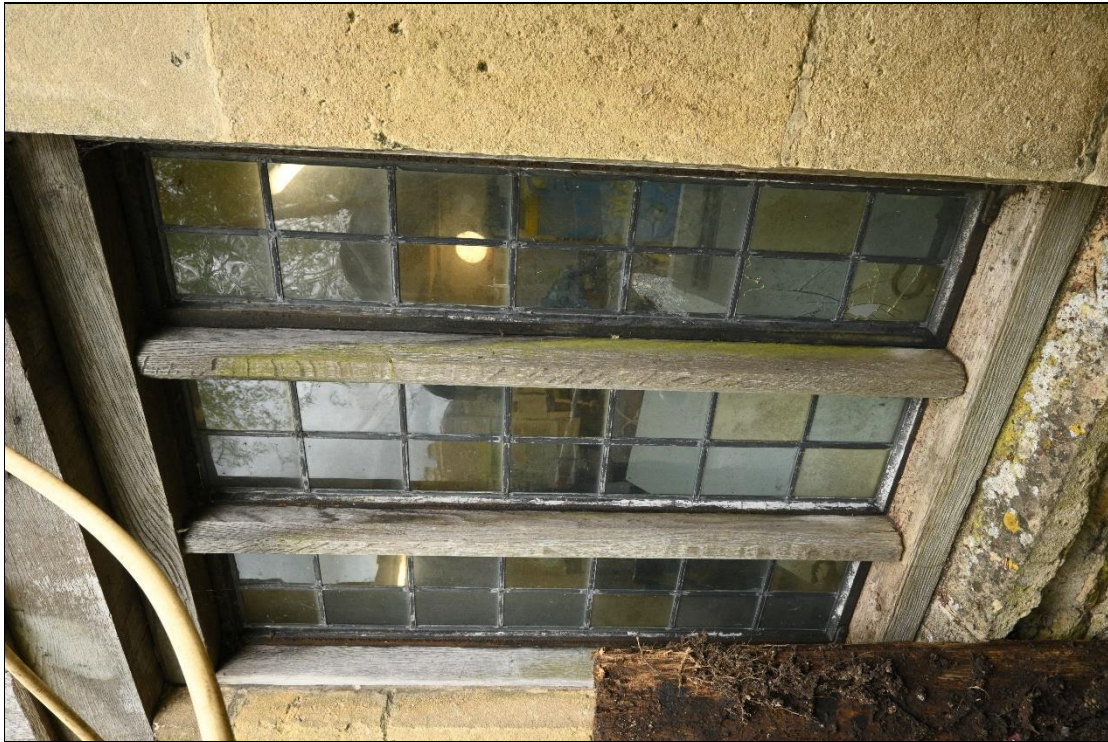
Some window frames are in quite good condition as are the metal framed casements.

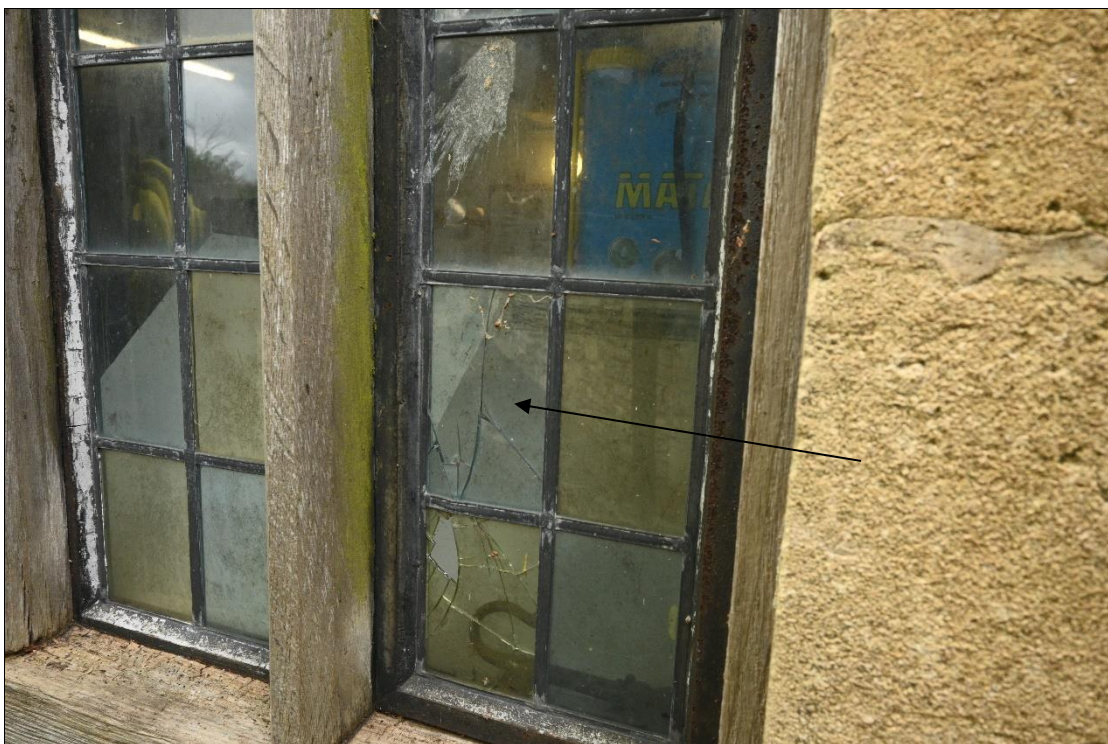
Regarding the glazing then some appears slightly coloured and there are a few cracked panes.

But the glass is broken in several. It looks as if coloured glass has been used.

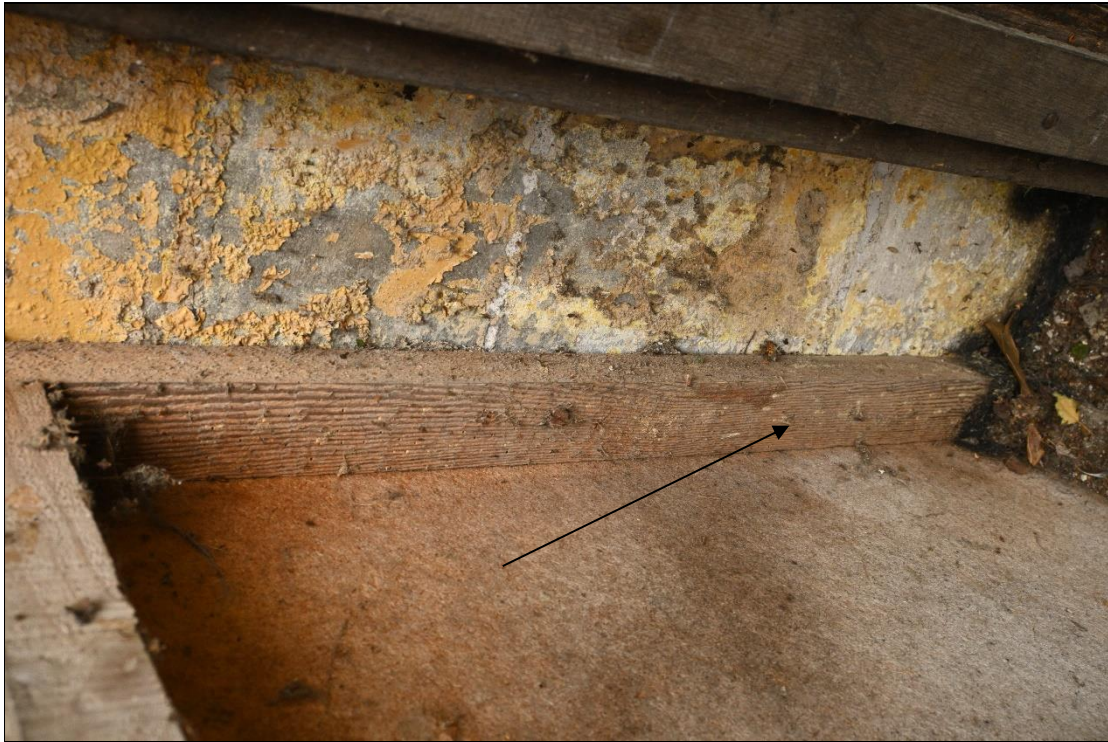
This frame is by the main door. Signs of recent woodworm activity.

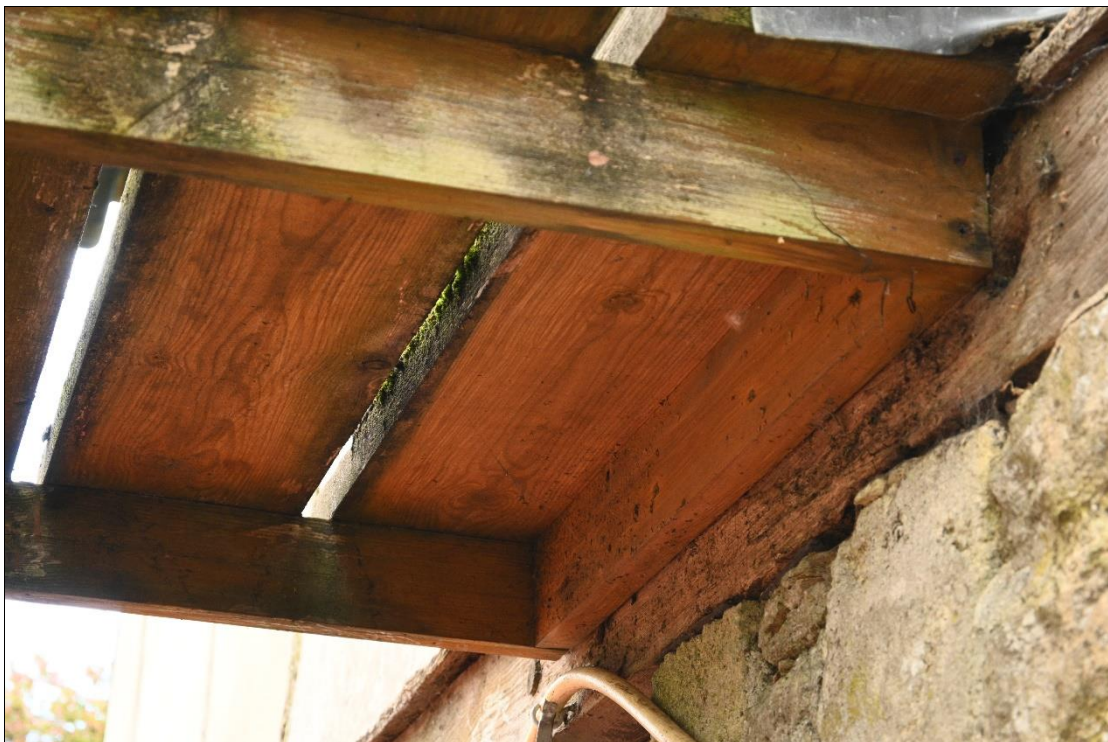
Underside of stairs to first floor looks sound.

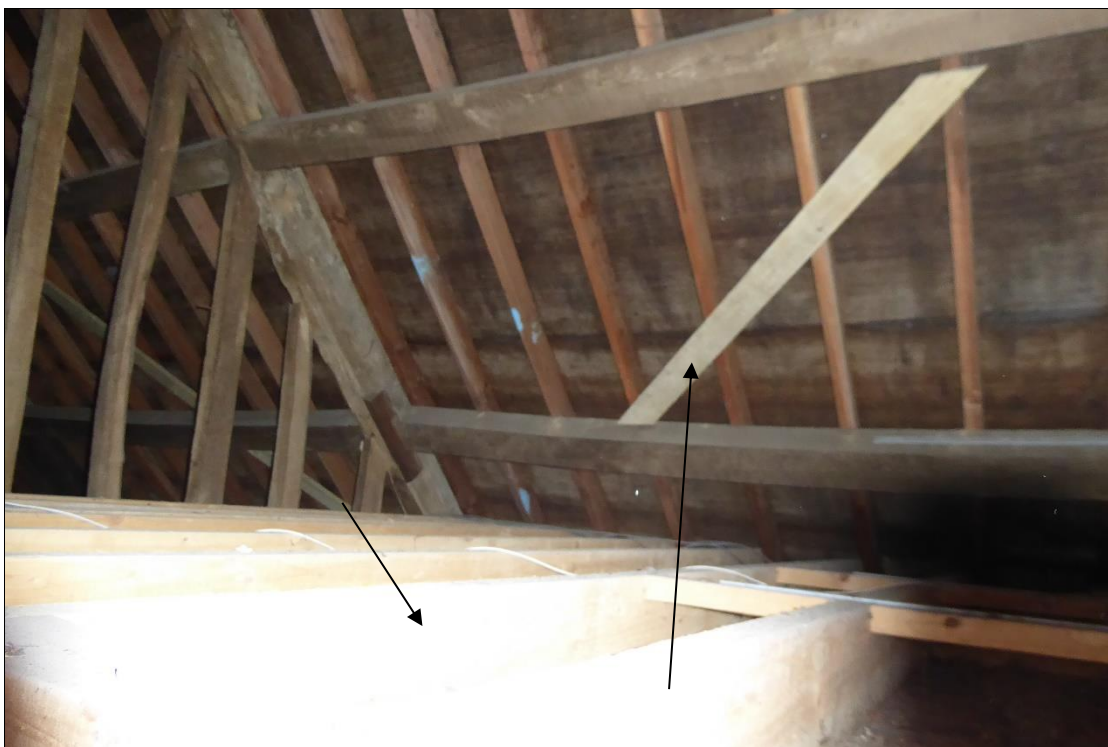
The diagonal wind bracing timbers were fitted from the inside so the roof hasn't been stripped and reclad to enable these repairs and the age of the felt suggests the roof was last completely overhauled 50 plus years ago.

Modern ceiling joists and diagonal wind bracing timber which was fitted inside.  
No insulation. Old felt lining.

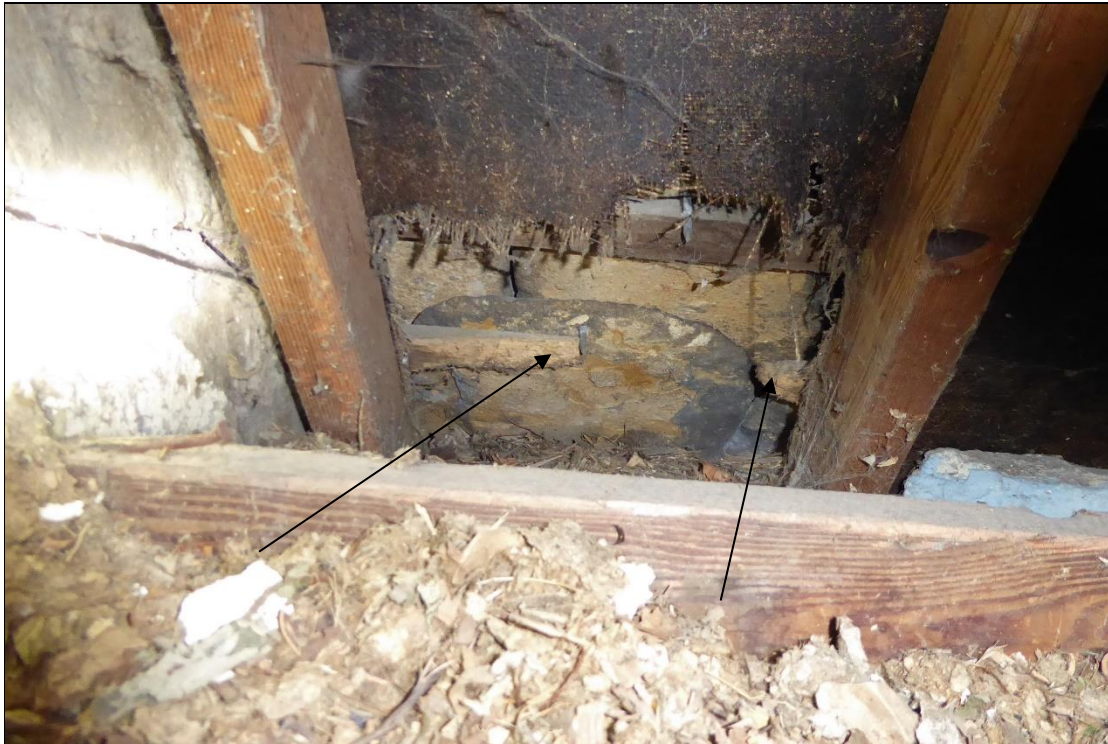
Example of perished felt and also missing horizontal timber batten so limiting tile support.

7. The roof frame was strengthened but this work was done from the inside without stripping the tiles so the roof lining is old and suffers expected age defects with sections missing.

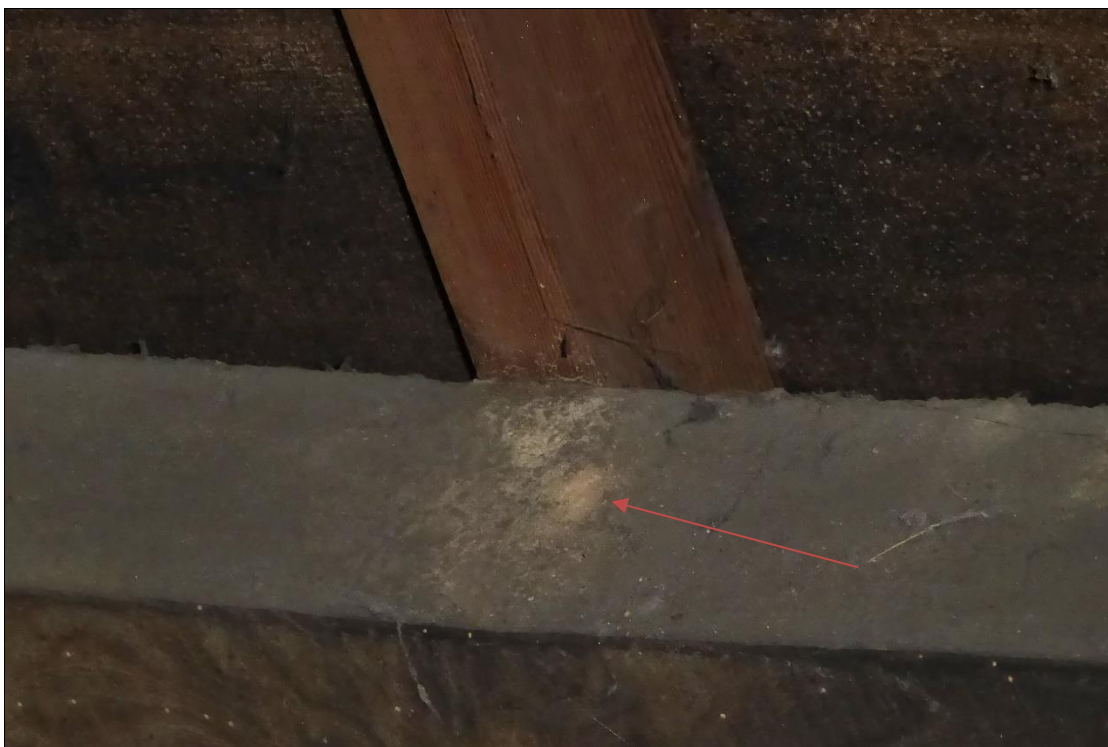
There is plenty of evidence of woodworm infestation. There is no insulation but clearly the roof structure has been repaired.

Signs there could be active woodworm infestation.

The condition of the roof tiles outside and felt lining inside suggest that this roof could do with overhaul but clearly the roof frame itself has relatively recently been strengthened. As a work shop/store the roof is fine at present but if the building were to serve another purpose the roof should be stripped and reclad, the timbers treated against woodworm infestation and insulation provided.

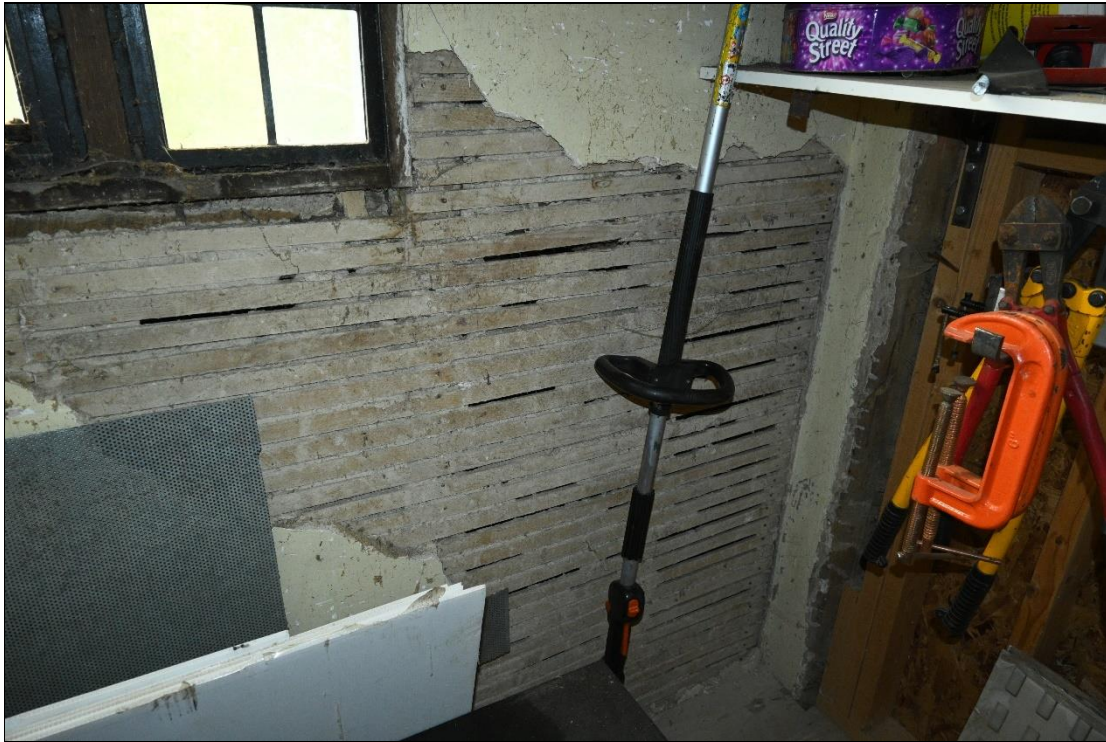
Lath and plaster wall lining inside. There is no insulation in the wall which would need to be fitted if the building use were to change to offices or residential.

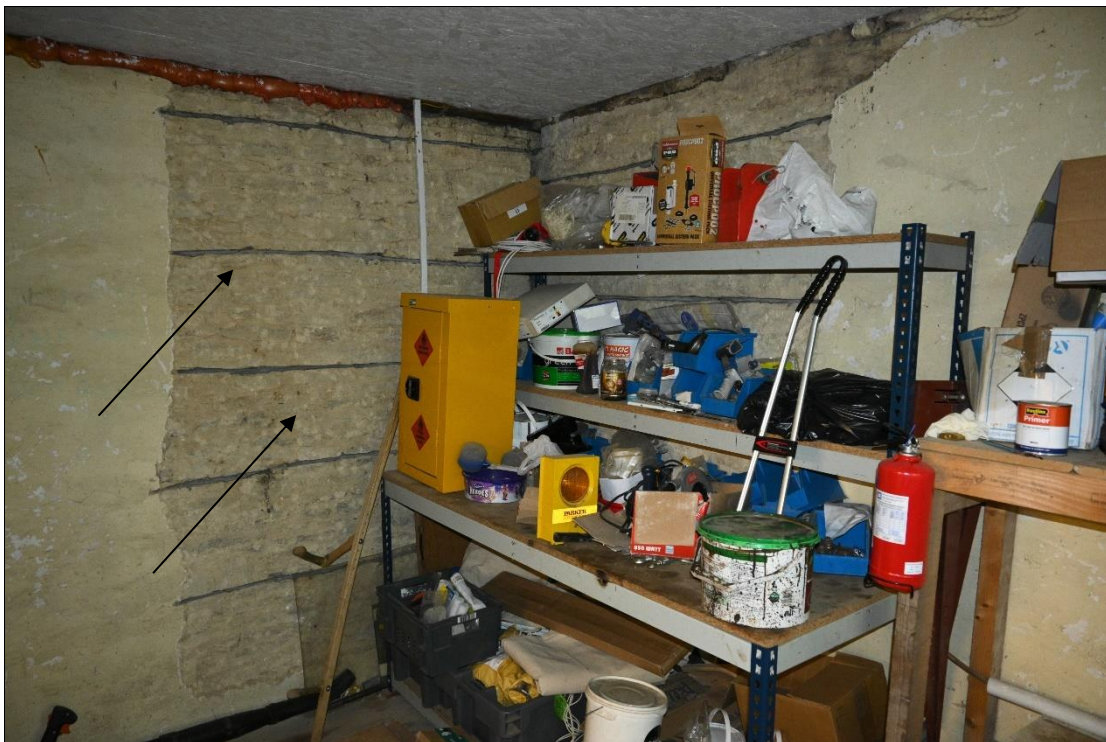
- The exterior walls have been considered above. Inside there is evidence of historic vertical cracking at the back left corner with evidence this corner has been strapped.

The same lines on the back corner where we think straps have been fitted.

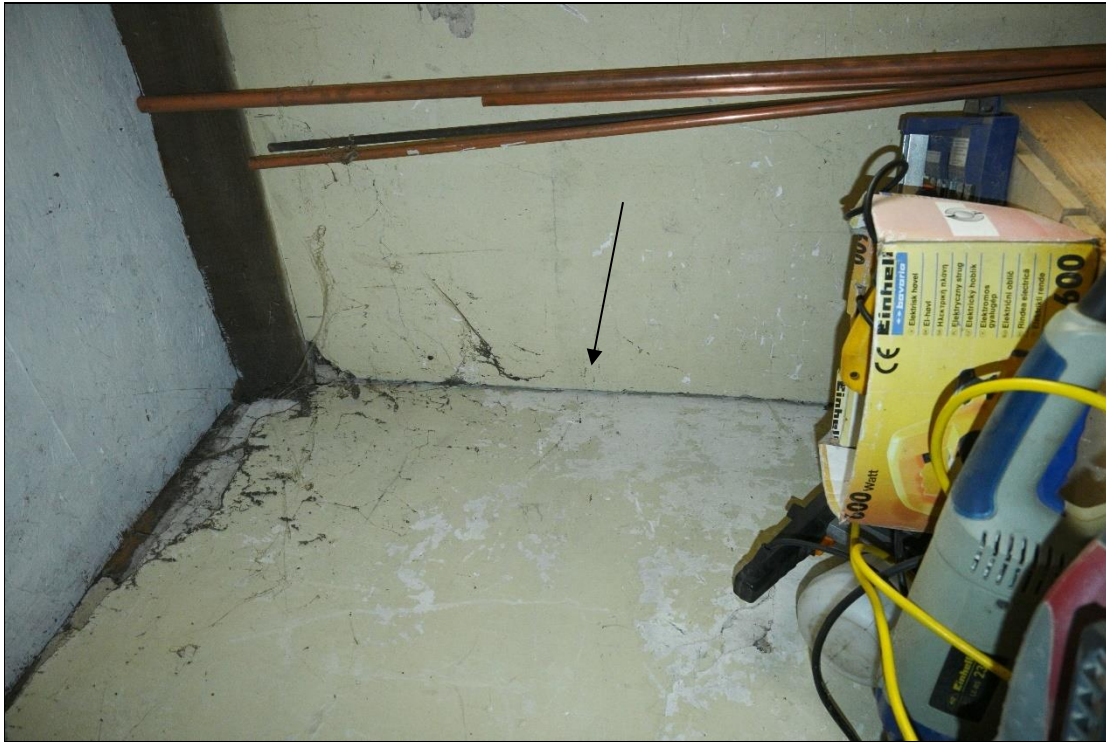
Slight cracking at this corner not of concern.

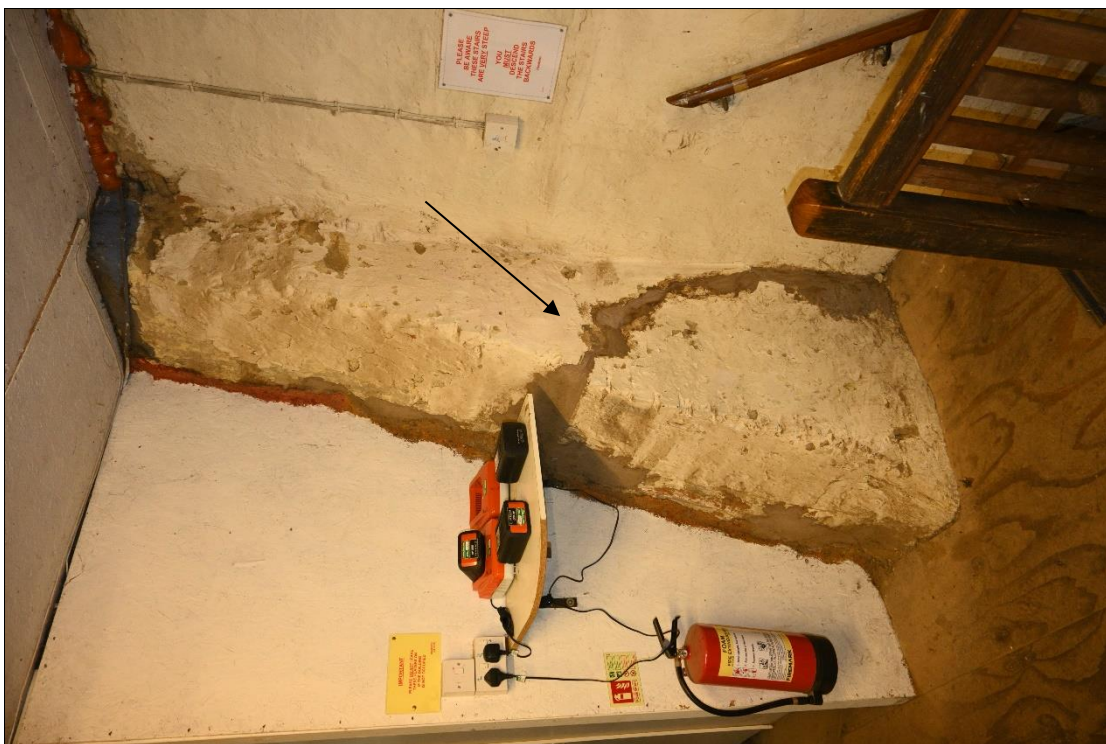
At the left corner there is what we believe is a chimney breast although no external chimney remains. The upper part of the chimney breast has shifted slightly to the rear at some time but the crack which developed has been repaired with cement. This cracking ties in with the outward bow seen in the rear wall. It is not known when this repair was made but there was no suggestion of further cracking or movement.

Cracked first floor chimney breast repaired with cement. There was no suggestion of any further cracks since the repair.

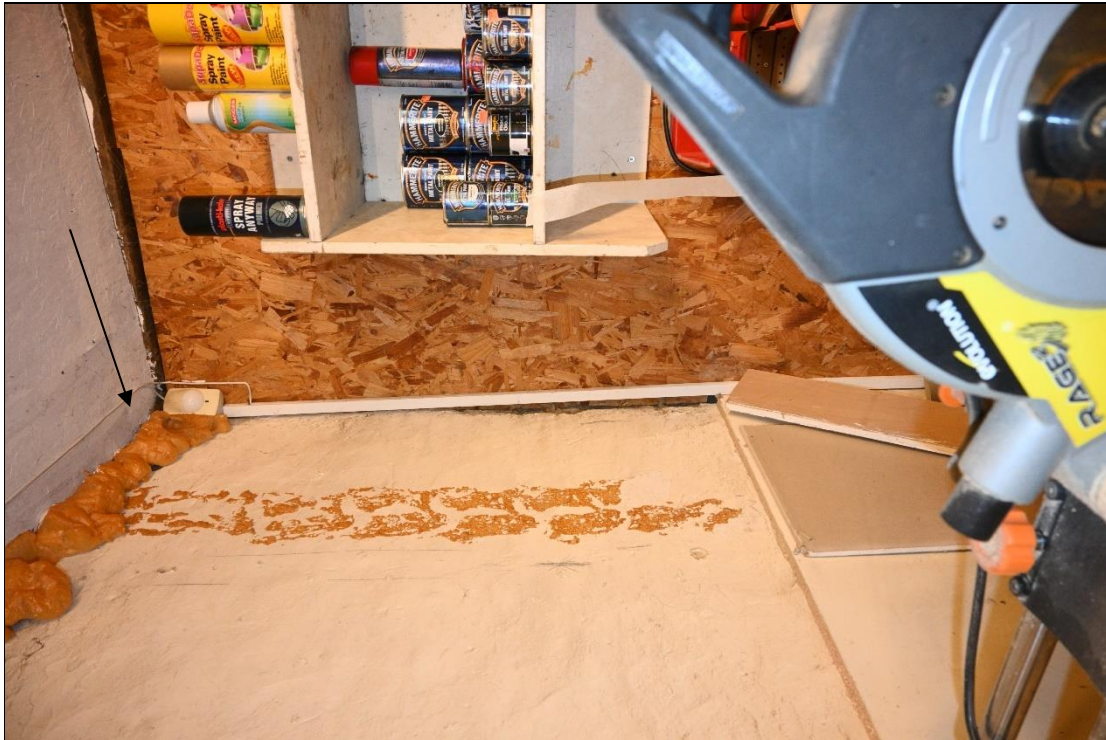
Foam used presumably to limit draughts. Not ideal.

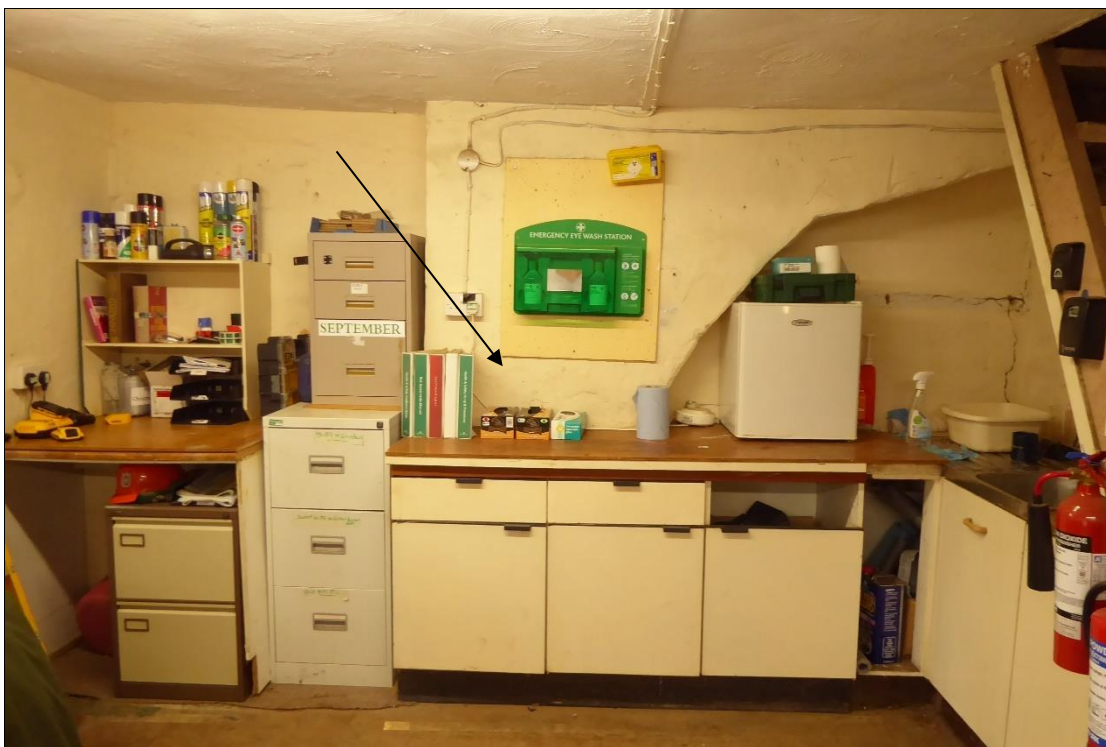
Chimney breast probably to serve a fireplace.

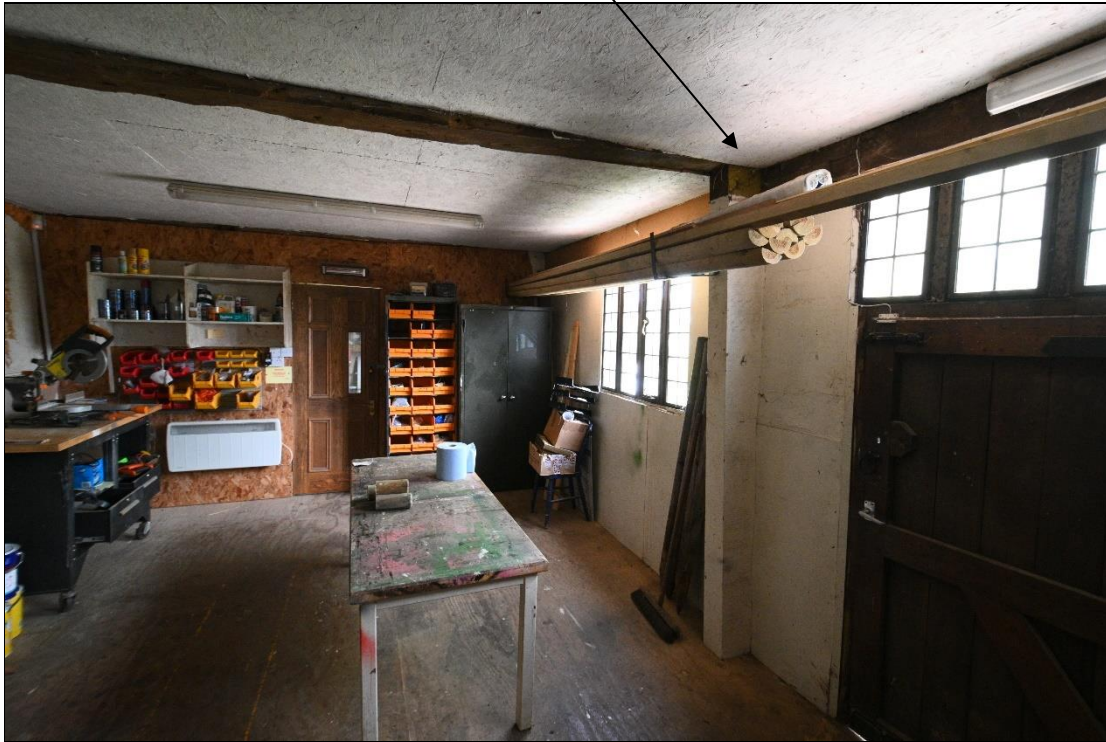
First floor room with post inside front wall support main beam to a roof truss because the lightweight timber framed front wall wouldn't provide that support.

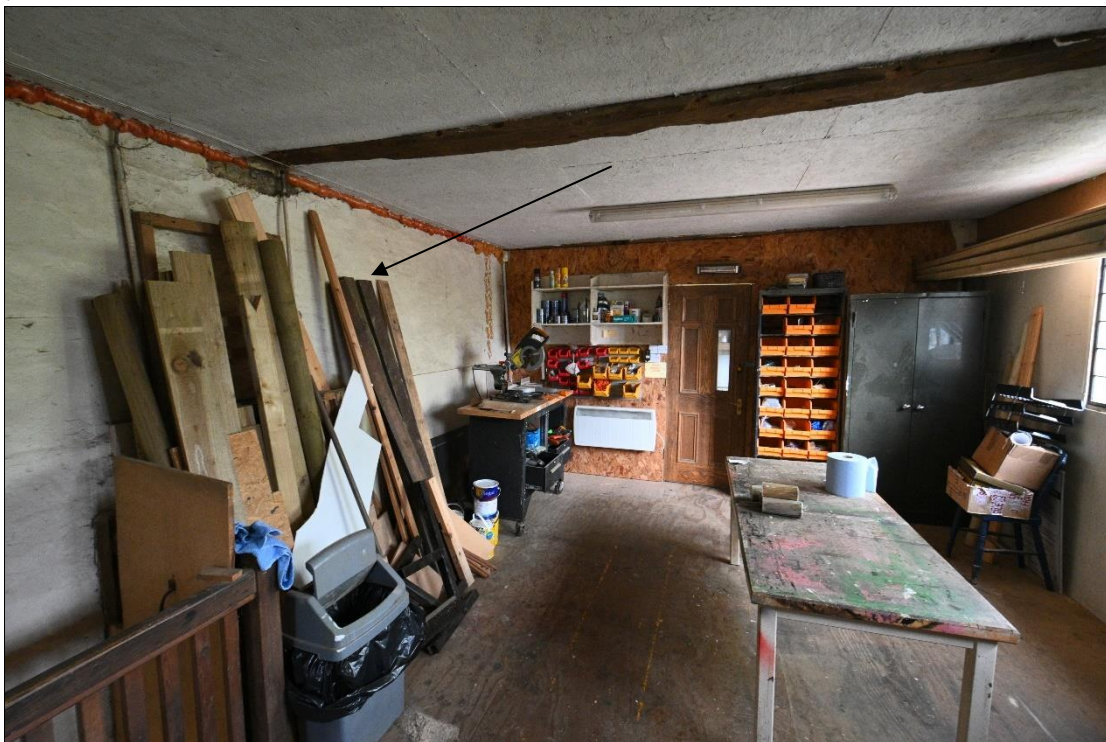
Rear elevation with outward lean.

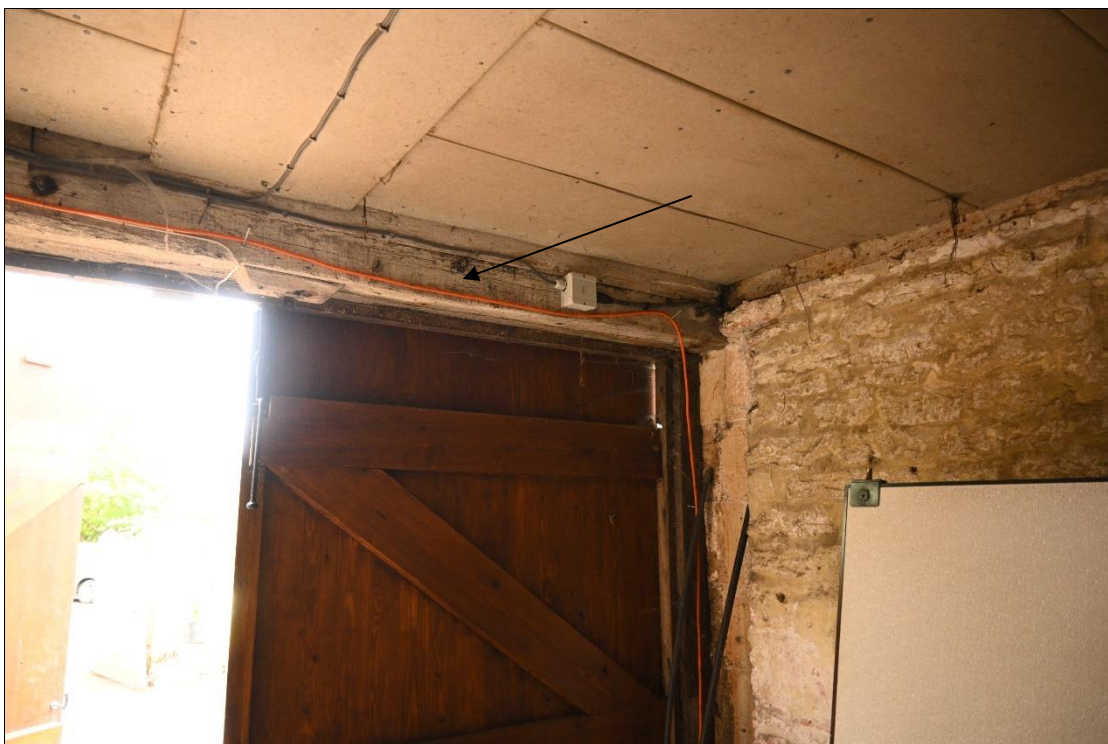
Beam over the front garage doors looks okay.

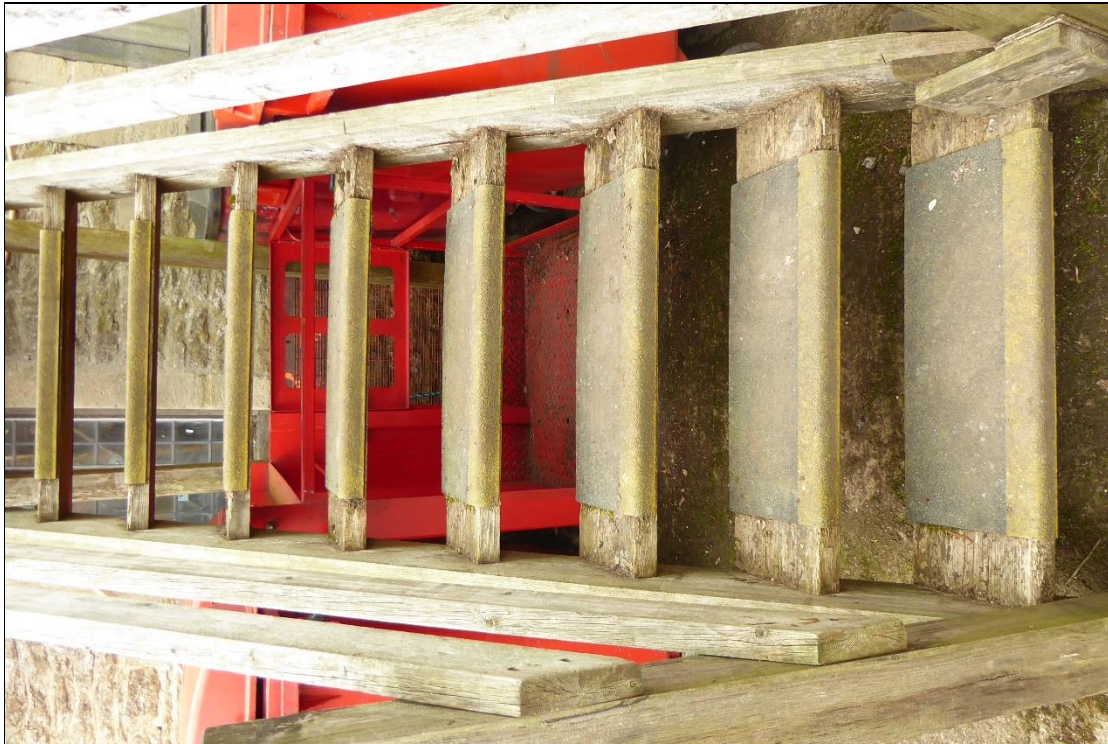
Basic steps which wouldn't meet safety standards no with deep gaps between treads.

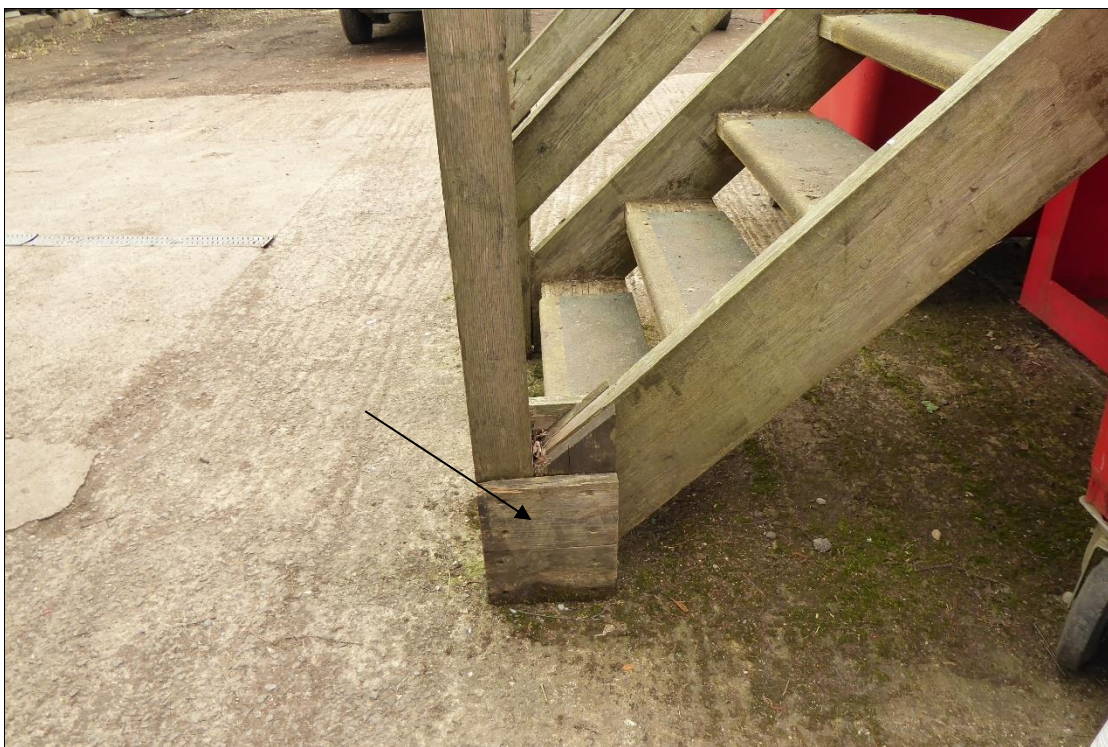
Repaired foot of the string where suffering rot.

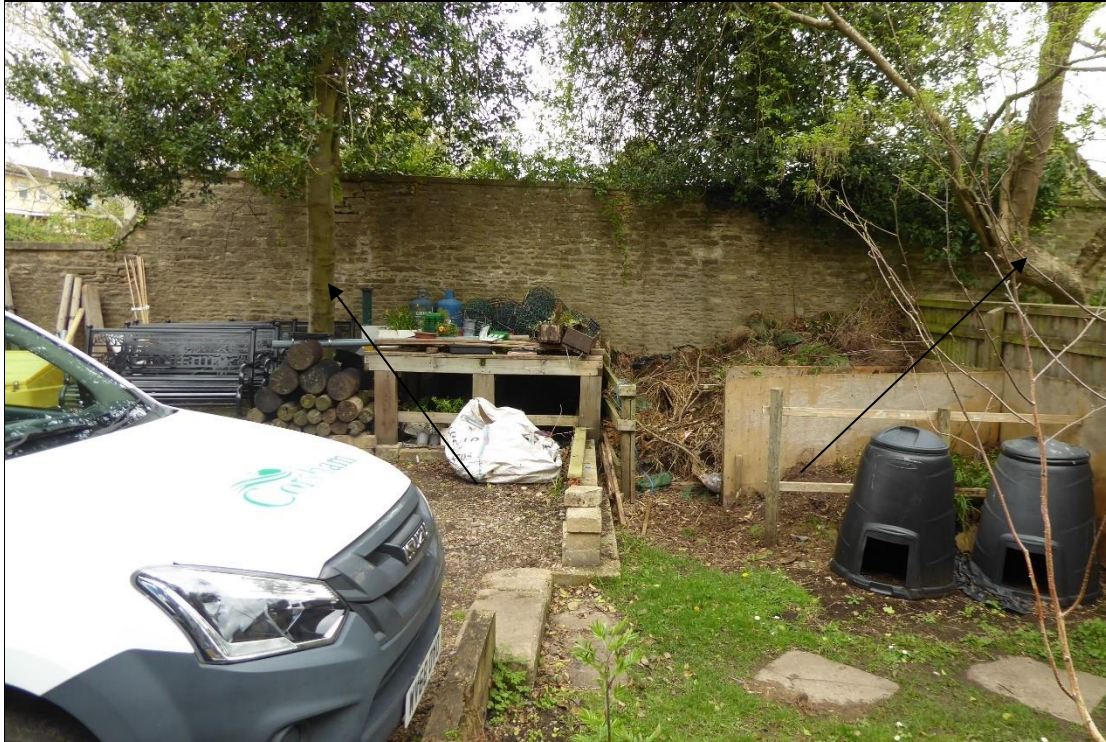
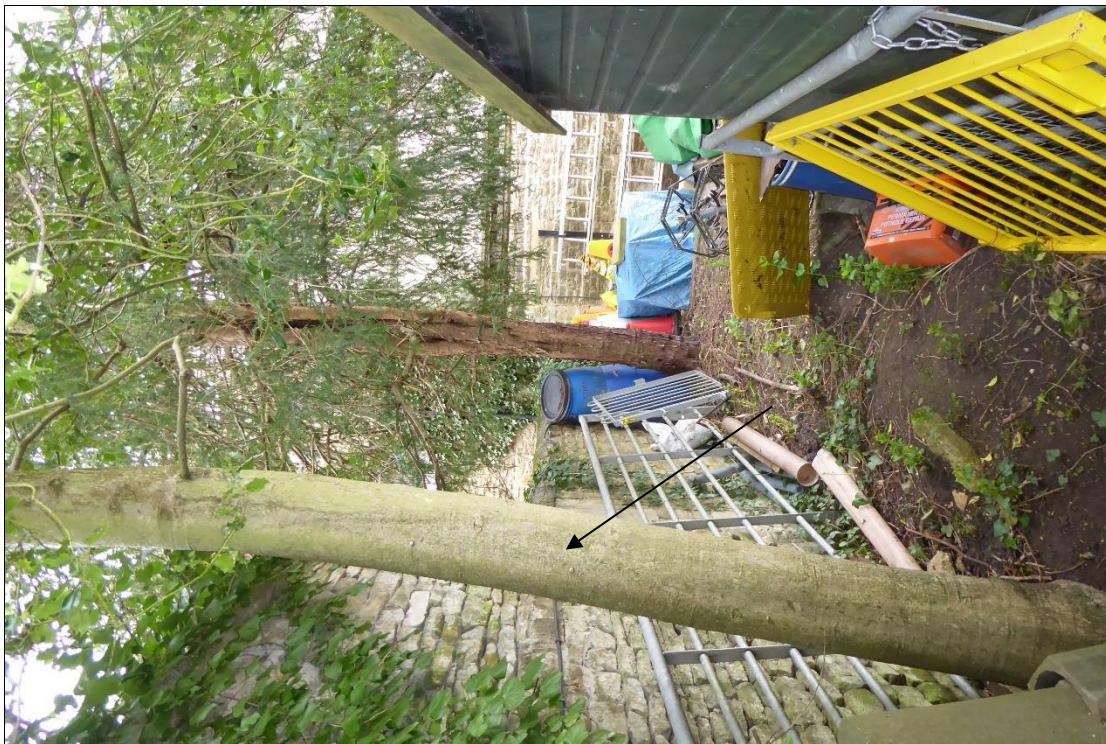
34.     **The Site**                     The site wasn't really inspected but stone boundary walls appear okay. The main point to appreciate is that there are mature trees close to boundaries and these should be checked by an arboriculturist and work done as required to make sure the trees don't cause damage to adjoining structures. There didn't seem to be any damage currently.

Mature trees close to boundary walls and structures need to be checked by arboriculturist and managed to ensure they don't cause damage to walls and buildings. Not damage was noted.
