BUILDING SURVEY REPORT

ARNOLD HOUSE, 31 HIGH STREET, CORSHAM, SN13 0EZ

29th March 2022

HEXTALLS Surveyors Ltd

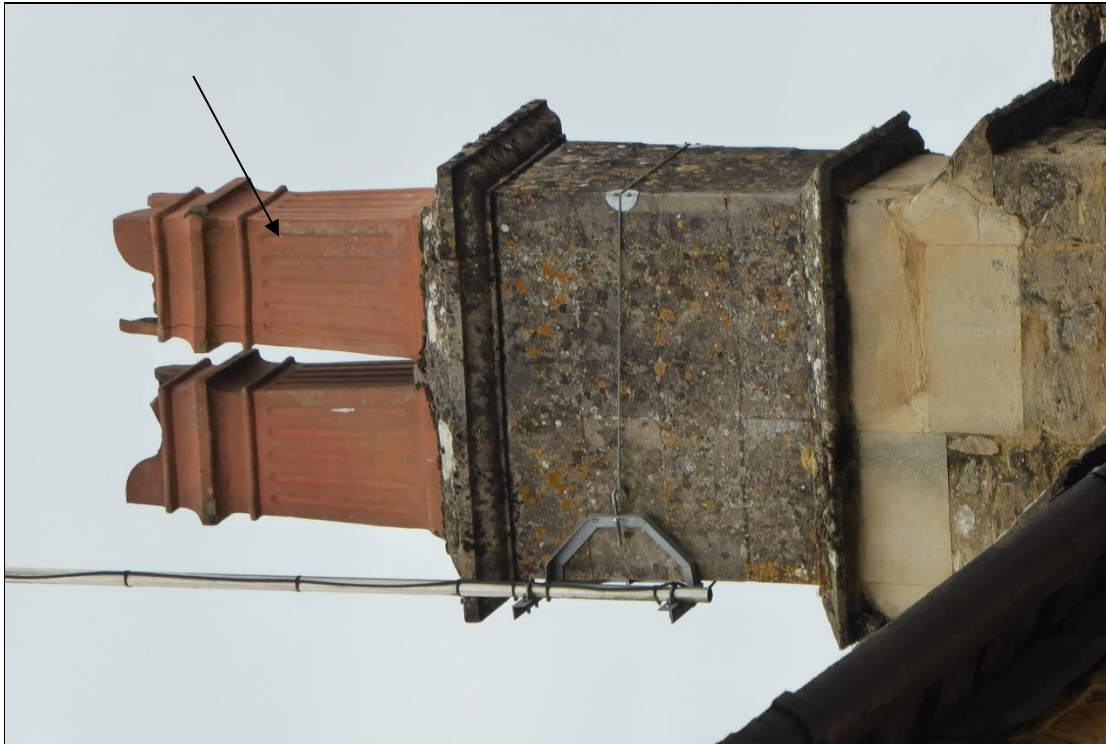
Both pots have suffered slight damage with sections of the clay pot missing and hairline cracks visible. Replacement is recommended but not essential as the hairline cracks may worsen with successive frosts. Some distance below the upper part of the chimney there is a lead flashing to the right of the rear stack which overlaps a lead lined valley between converging slopes. Not all the flashing was visible.

Damaged and cracked pots.

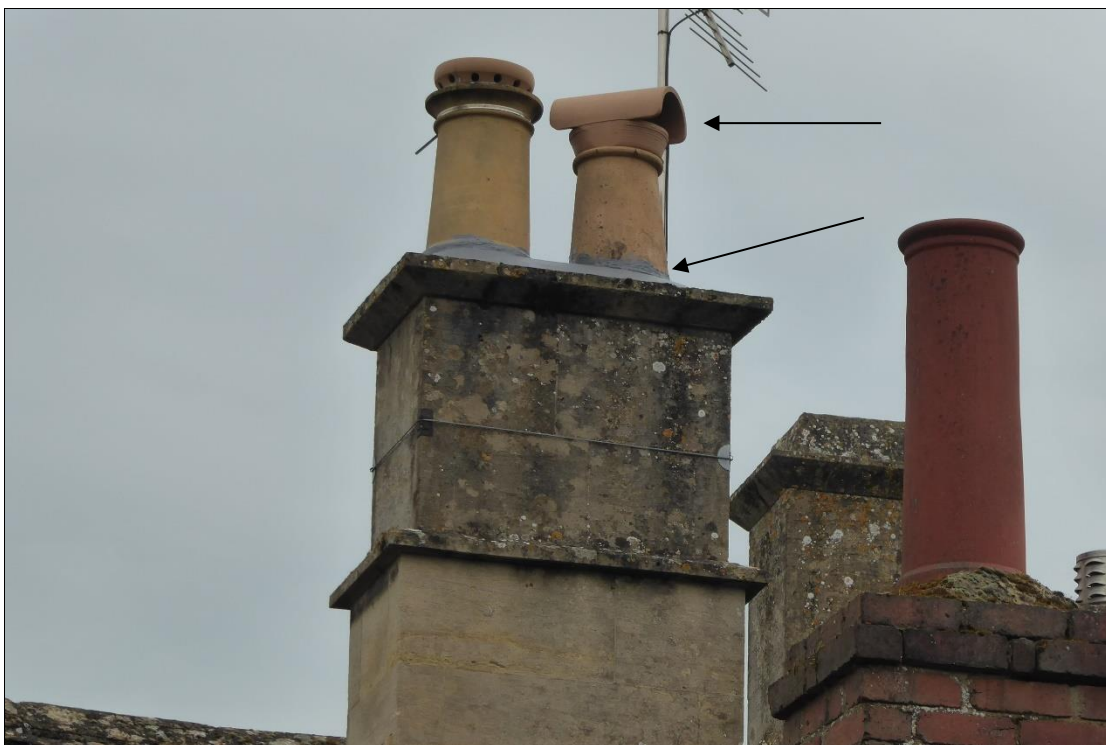
At the right side at the rear there is a twin ashlar chimney with cornice and drip stone rising off a broad mainly rubble stone stack. The chimney supports a TV aerial. The stack supports two 2 modern clay pots, one with ventilation spigot and the other with bonnet. The flaunching around the clay pots has been repaired using a rubberoid solution. We understand there was concern there was moisture ingress so the caps to the chimney pots were fitted and a water proofing paint applied between the pots and flaunching to prevent water ingress. See notes on 'Dampness' for further comment. We are slightly surprised the rubberoid paint was used as this may not be effective and only a short term fix if so.

Rubber paint to seal against damp not an ideal repair on a listed building. Water ingress still arises despite the fitting of the caps. Therefore the bonnet might be better placed to shield against the westerly weather.

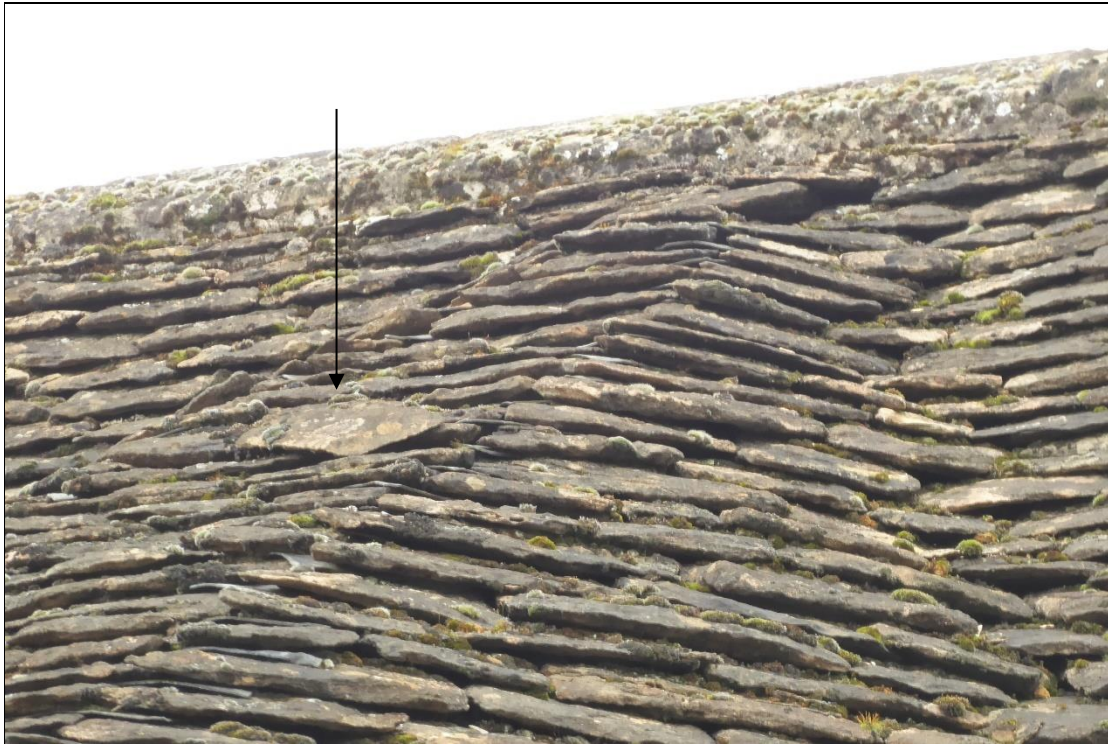
Slipped tile.

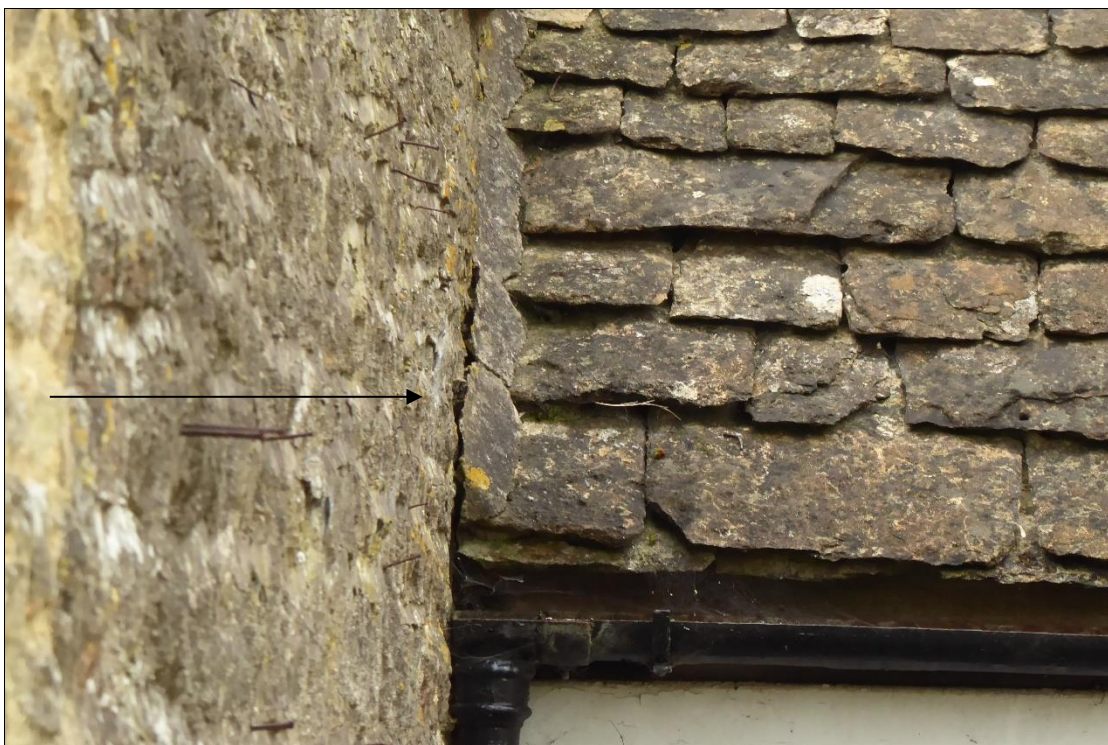
The single-storey rear wing behind the Tourism Office has a mono pitched roof clad with Cotswold stone tiles. Cement flashings left side to garden wall are cracked and we recommend close inspection and repair as necessary. Lead flashings right hand side look satisfactory. Cement flashing head of roof slope intact but minimal.

Cracked flashings single storey rear wing.

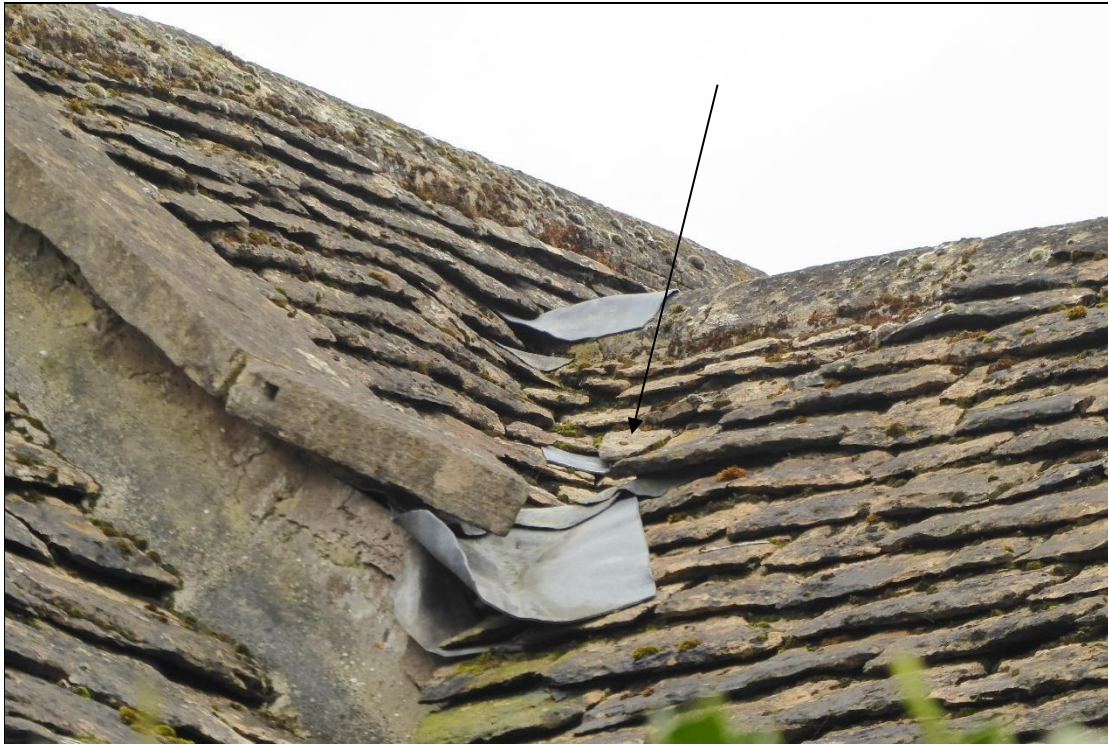
Loose tiles.

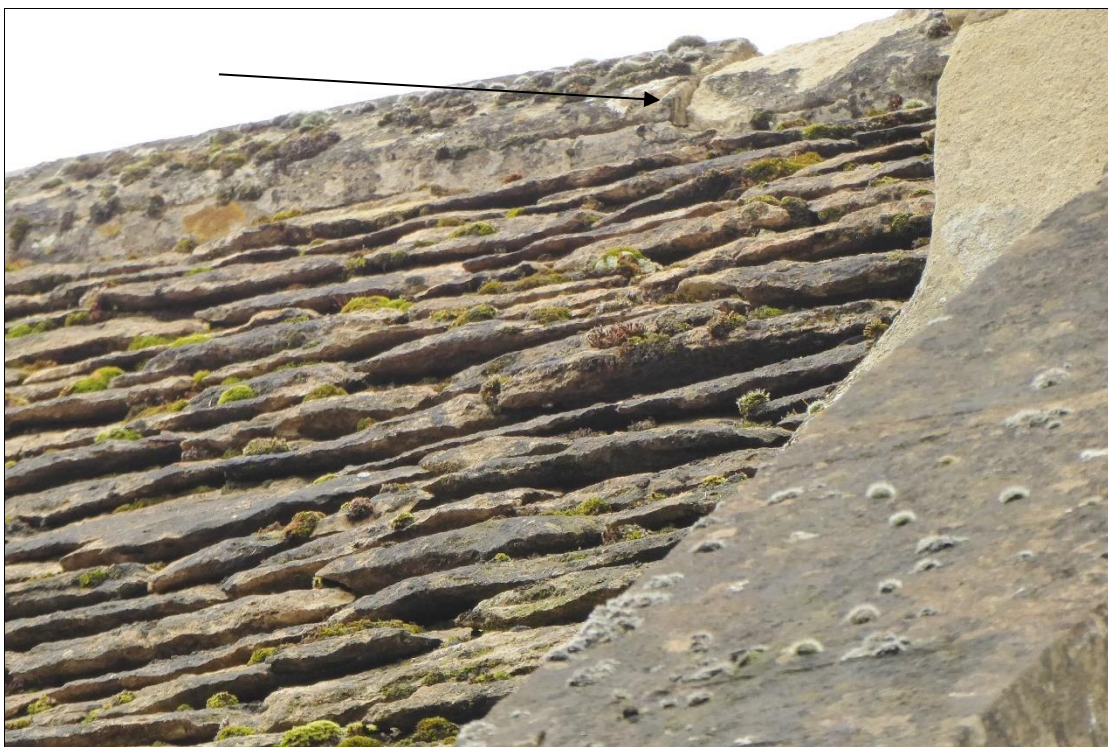
Minor damage to the ridge.

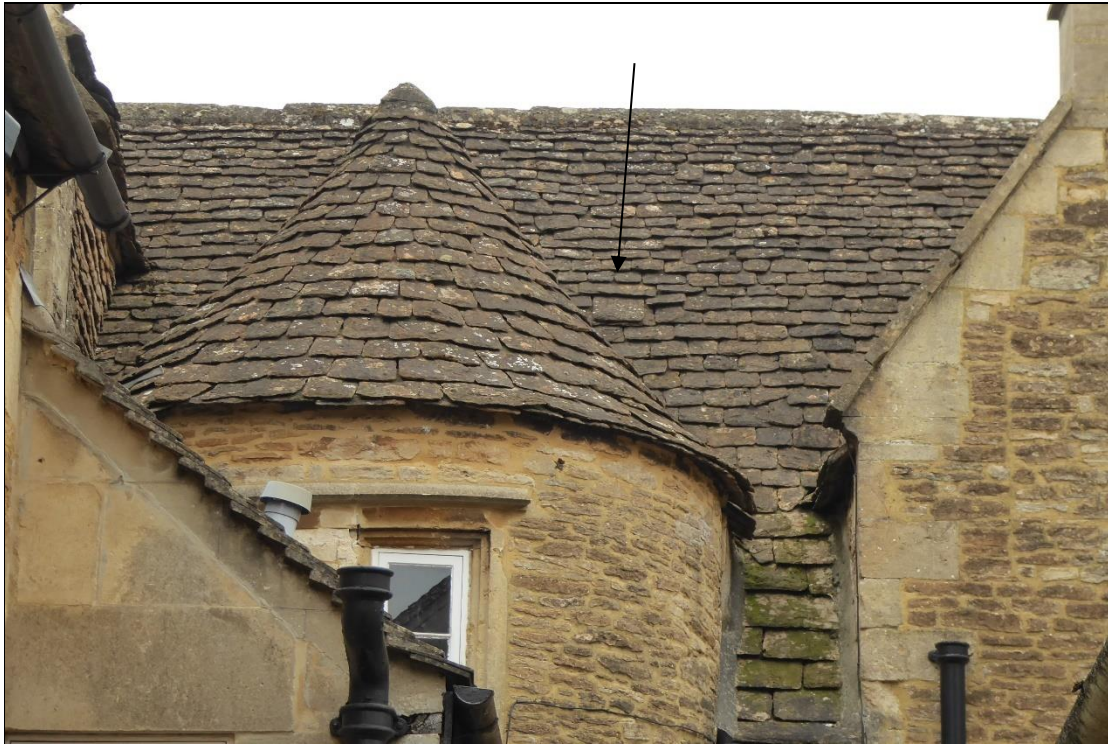
Slipped tile.

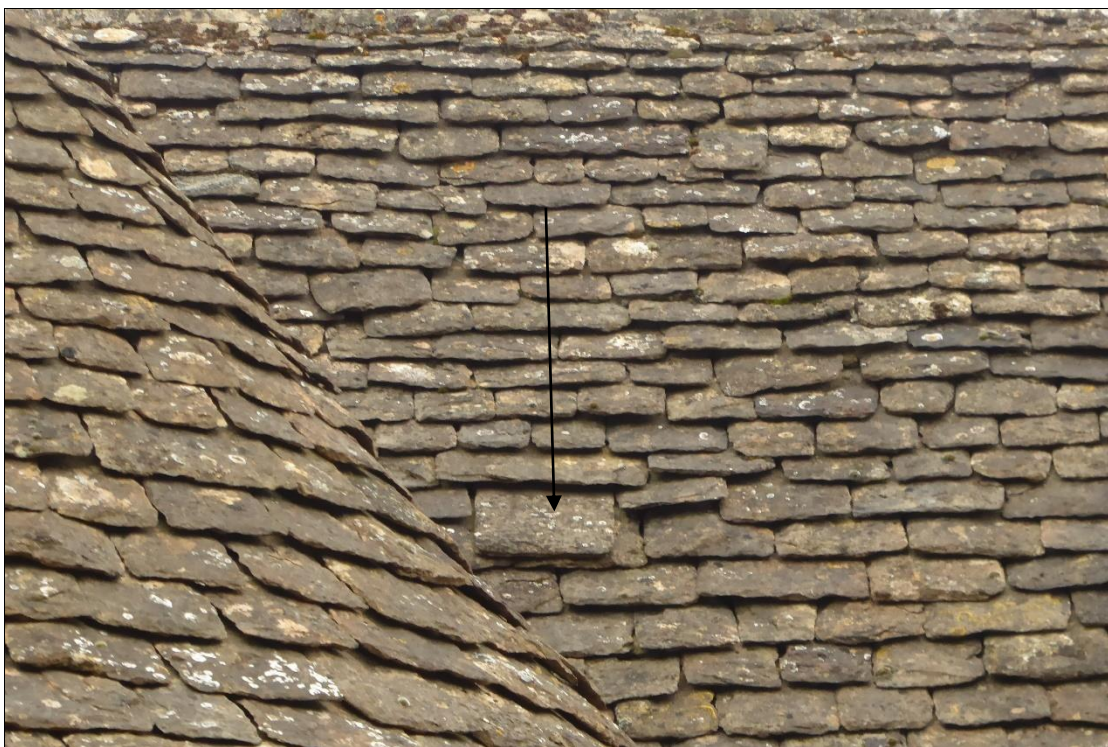
Close up.

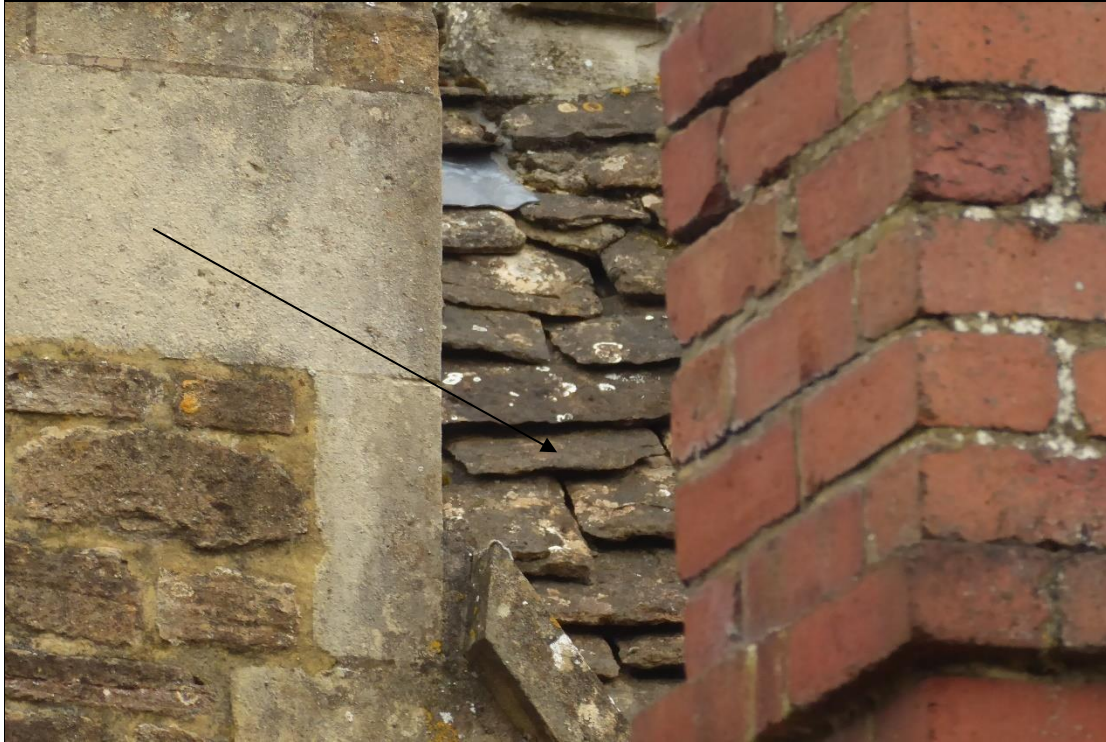
Possible slippage in this area.

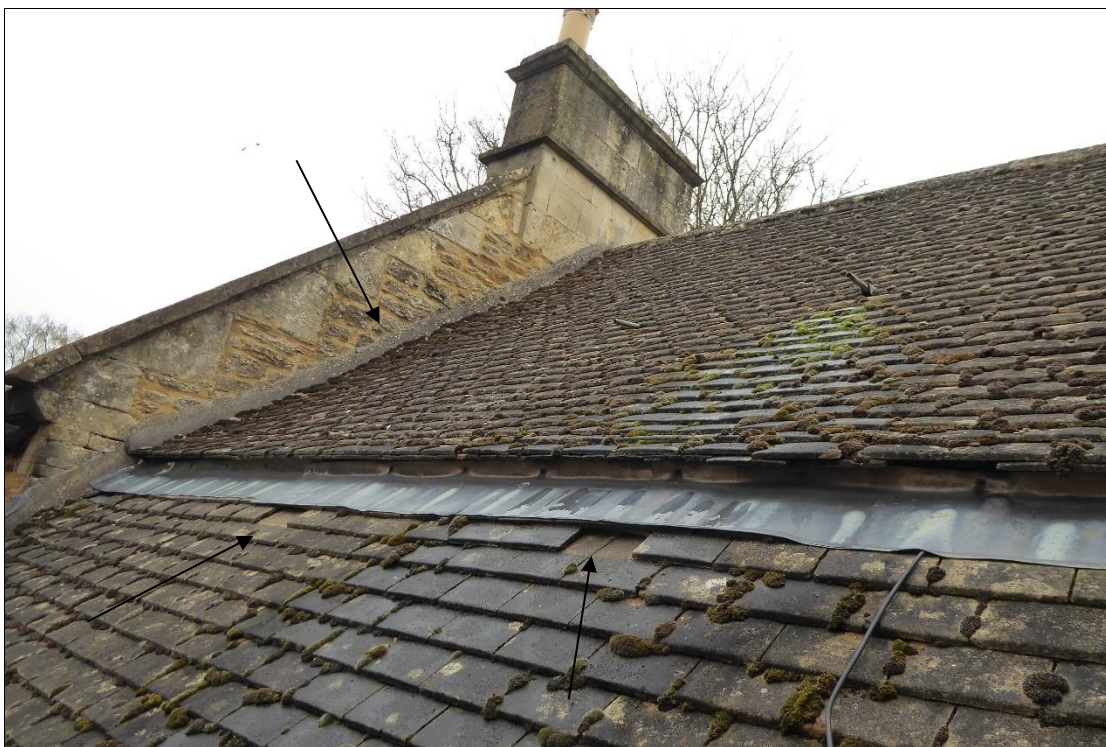
Roof slope west facing over Flat 2. A couple of missing tiles. There is damp in the chimney breast so the cement flashings may need work. Inspection advised.

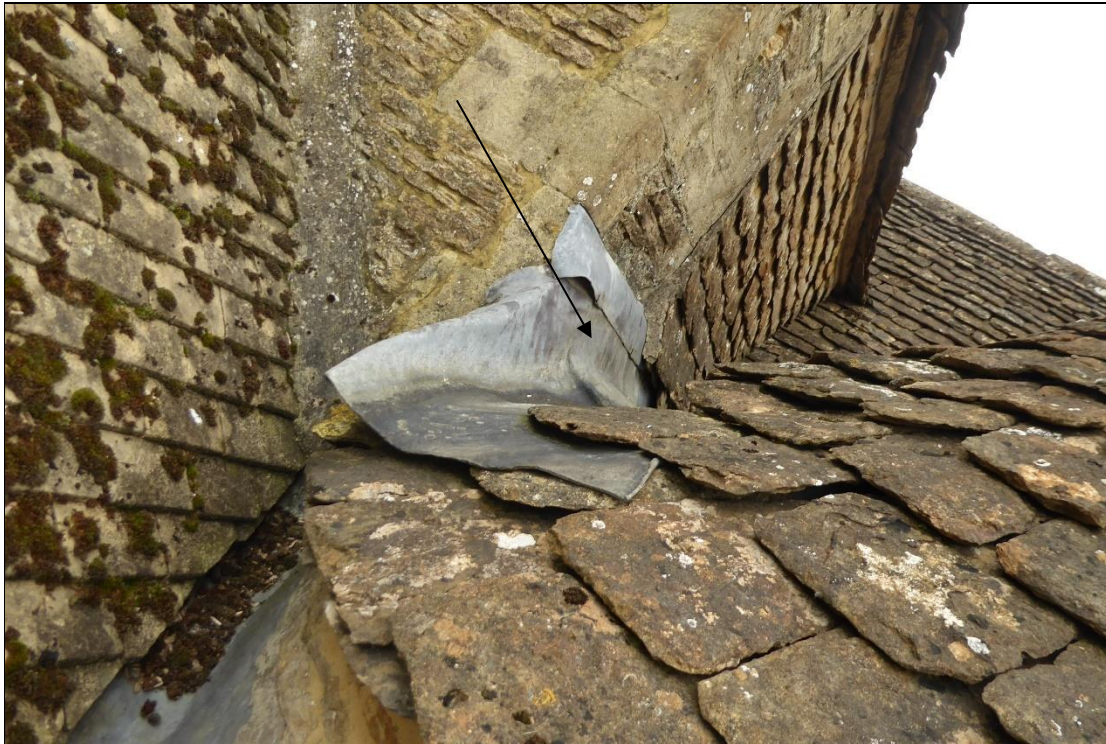
Staircase tower roof, where visible, satisfactory draining to the left side to a lead lined valley which could not be inspected. It is in the vicinity of the valley and the left slope to the roof over the staircase that there has been water ingress causing stains inside. See notes on 'Dampness' for further comment.

Location of the source of the roof leak affecting the attic stairs. Couldn't quite extend high enough to see the valley gutter. Roof contractor should make inspection.

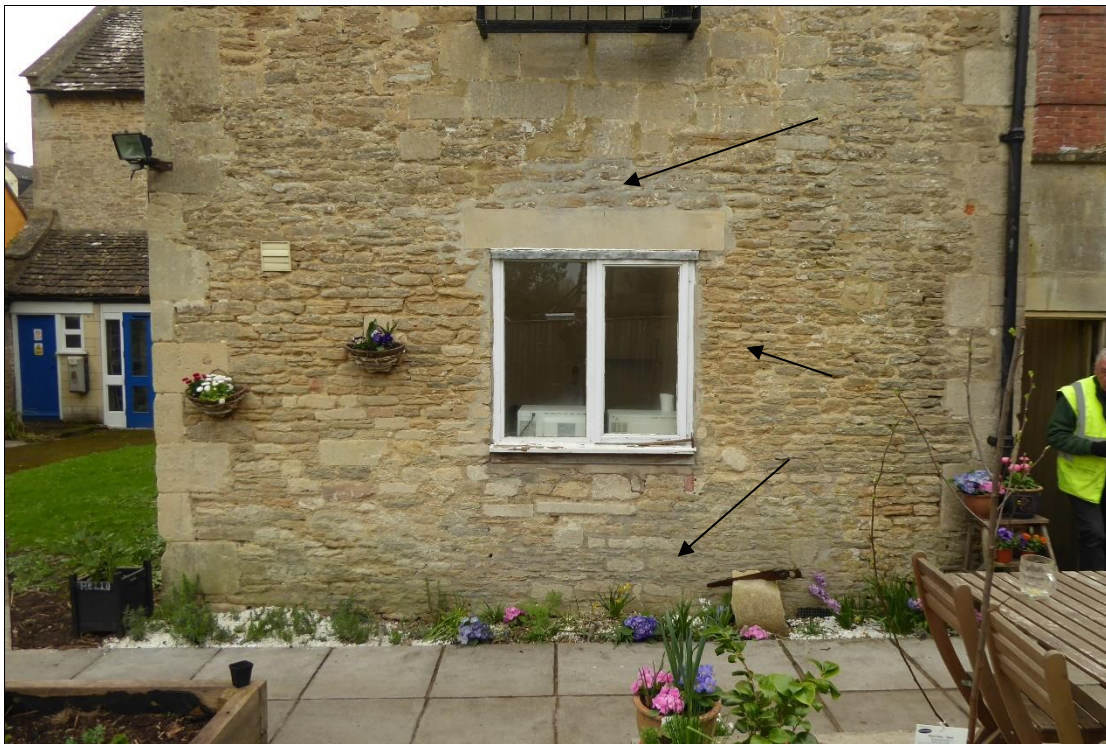
Cement pointing on rear elevation not appropriate with stone or with this being a listed building.

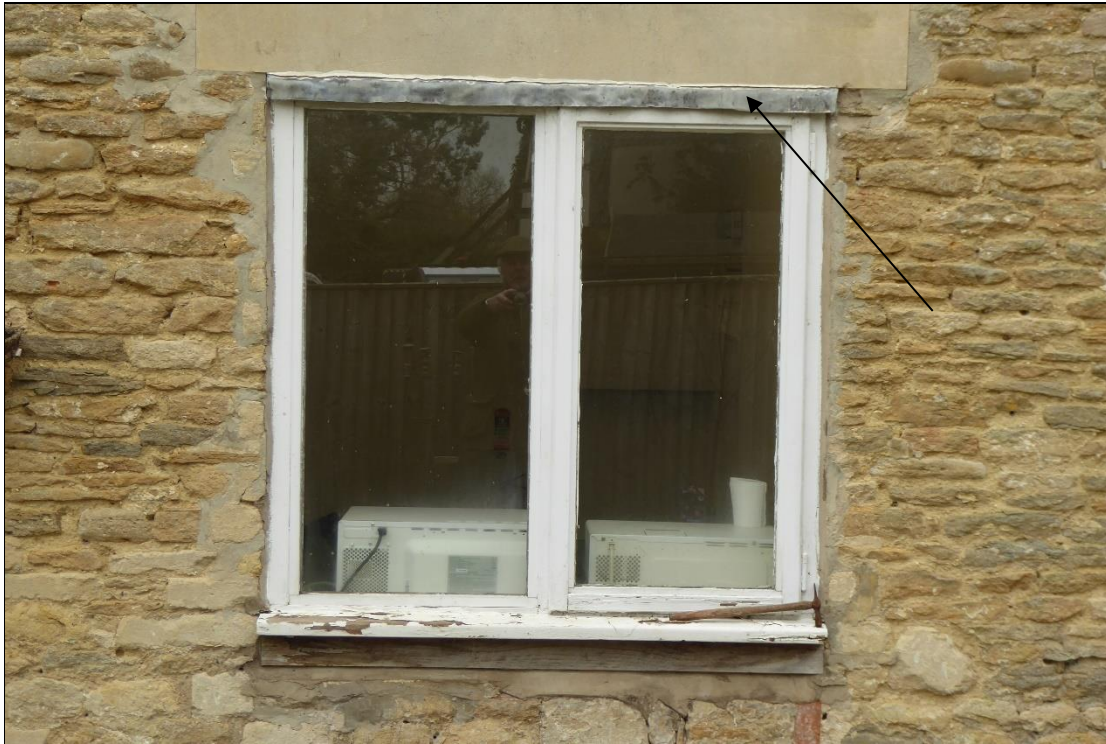
At the rear there is a metal balconette quite old with old lead medallions, some missing. Sash window first floor level looks satisfactory. The ground floor casement window suffers rot in the sill and bottom rail to the opening window, which cannot be opened because lead flashings fitted to stop water ingress at the head of the window obstruct its operation.

Poor quality rear staff kitchen window. Lead flashing stops the casement from opening.

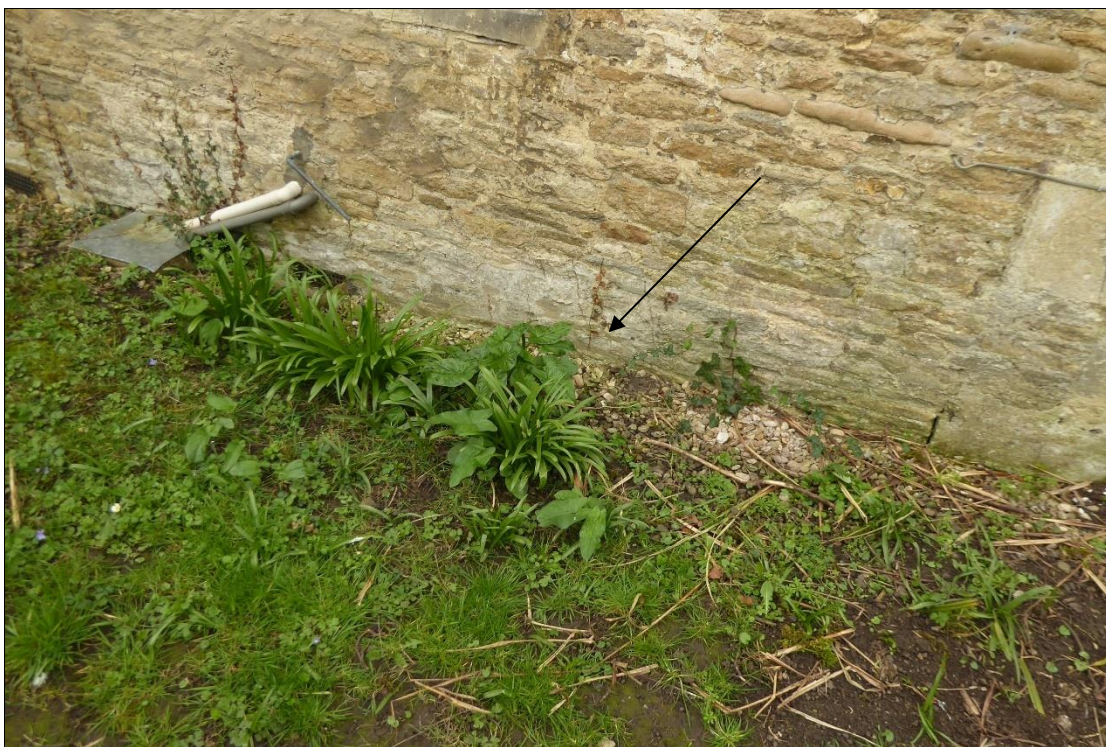
| Damp courses. | 7. High ground levels around the back of the building and in particular the rear wing are causing damp problems. Reducing levels is advised but the position of underground drainage may prevent this. Further investigation by drainage specialist is recommended to check on levels. |

Ground levels higher than internal floor levels particularly in the rear wings.

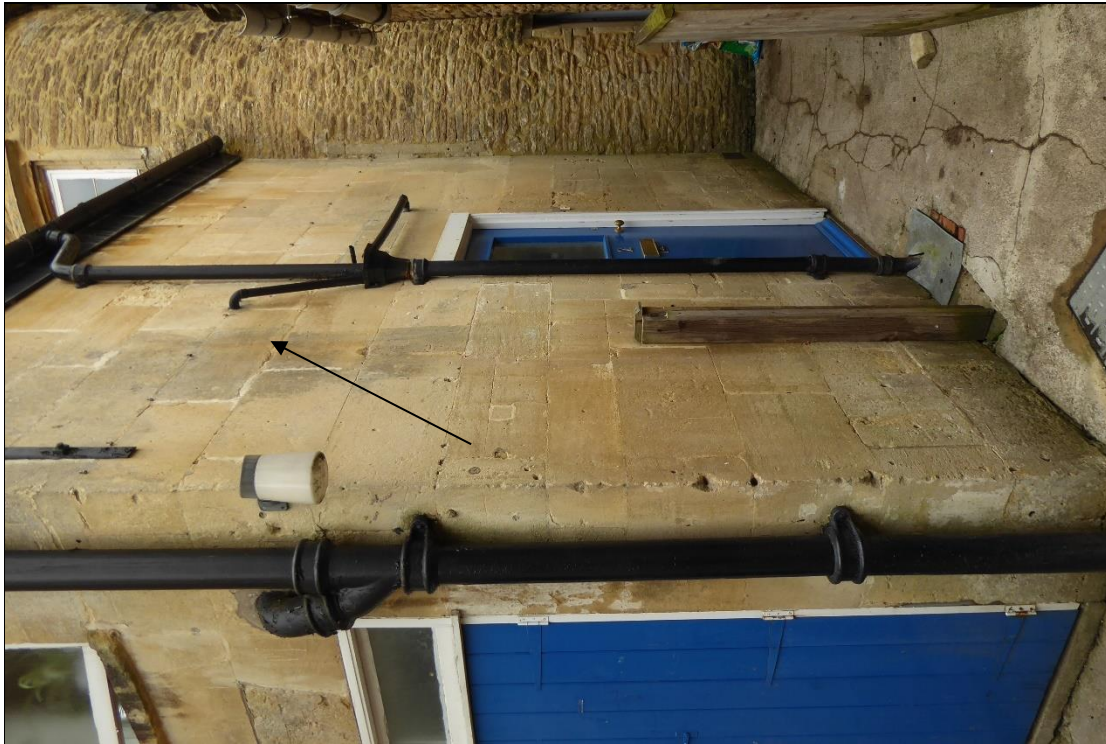
The side wall is damp inside. This structure is built with thin ashlar blocks which will tend to draw moisture in and will also be cold and limited insulation.

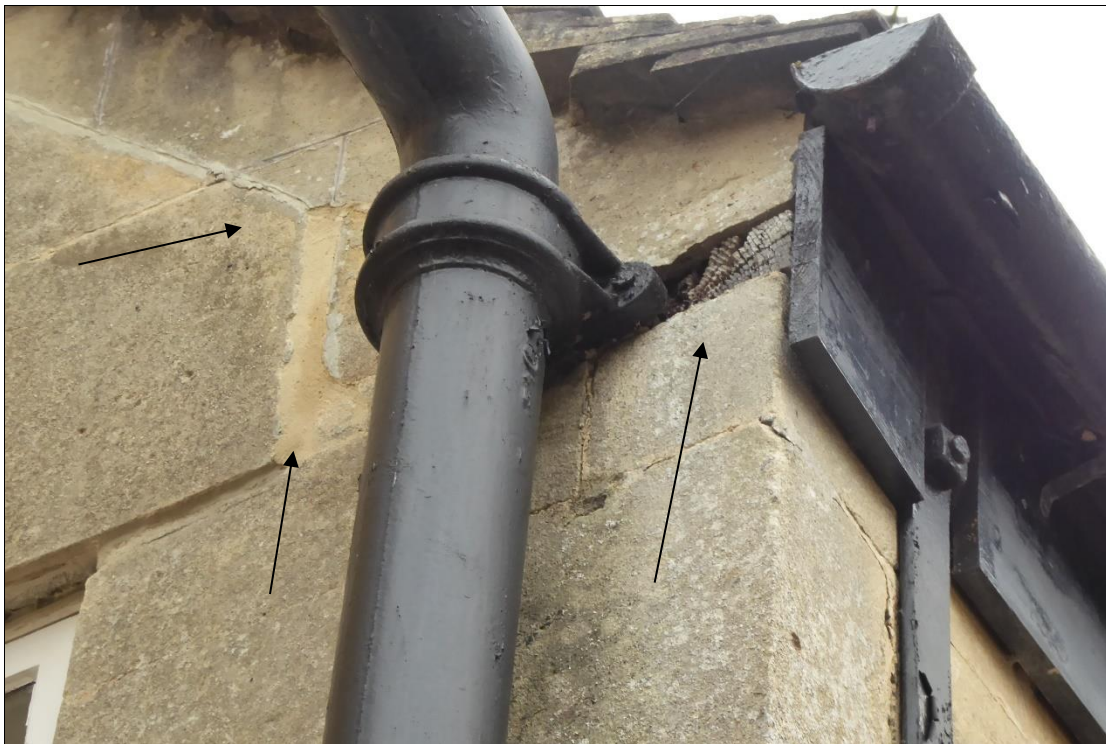
The end of the timber wall plate has been affected by rot and woodworm. Not an important issue. However the end is exposed so will suffer further decay, and the downpipe bracket fixing may be loose. Repointing around the window lintel to the Bathroom in Flat 2 shows slight movement. Again the wall is single skin ashlar so susceptible to movement and cracking.

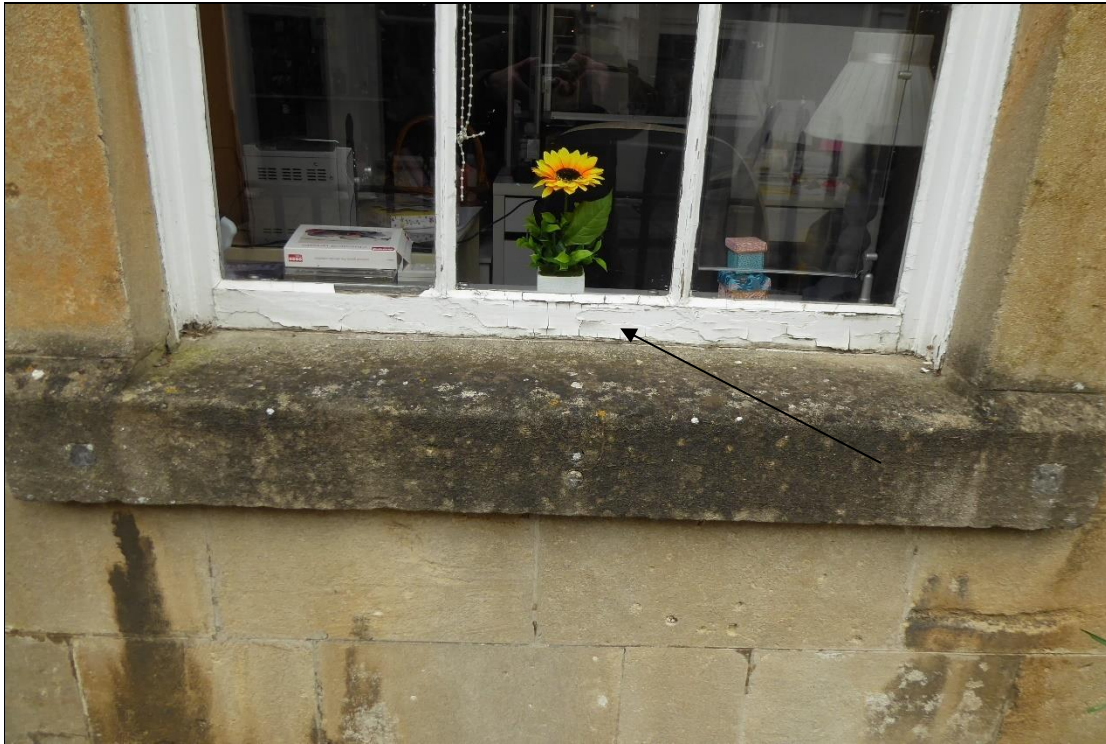
Need for external redecoration.

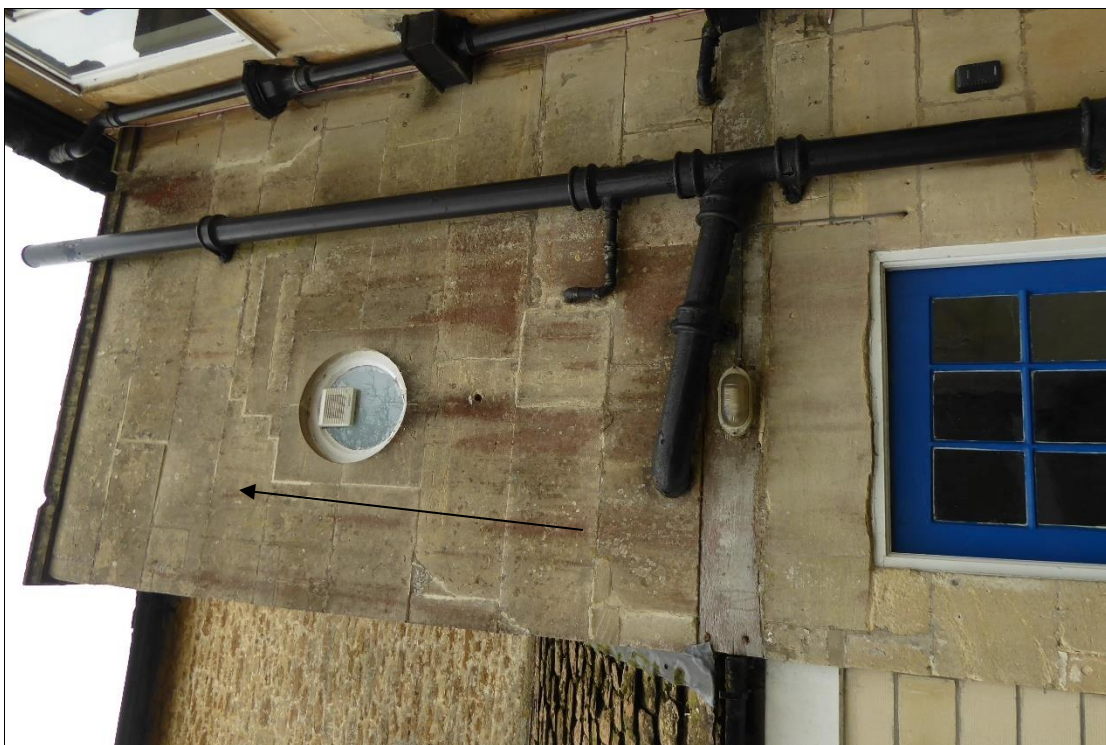
There are signs of past movement in the ashlar blocks which from the Bathroom wing to Flat 1. This type of movement is typical with single skin thin stone walls.

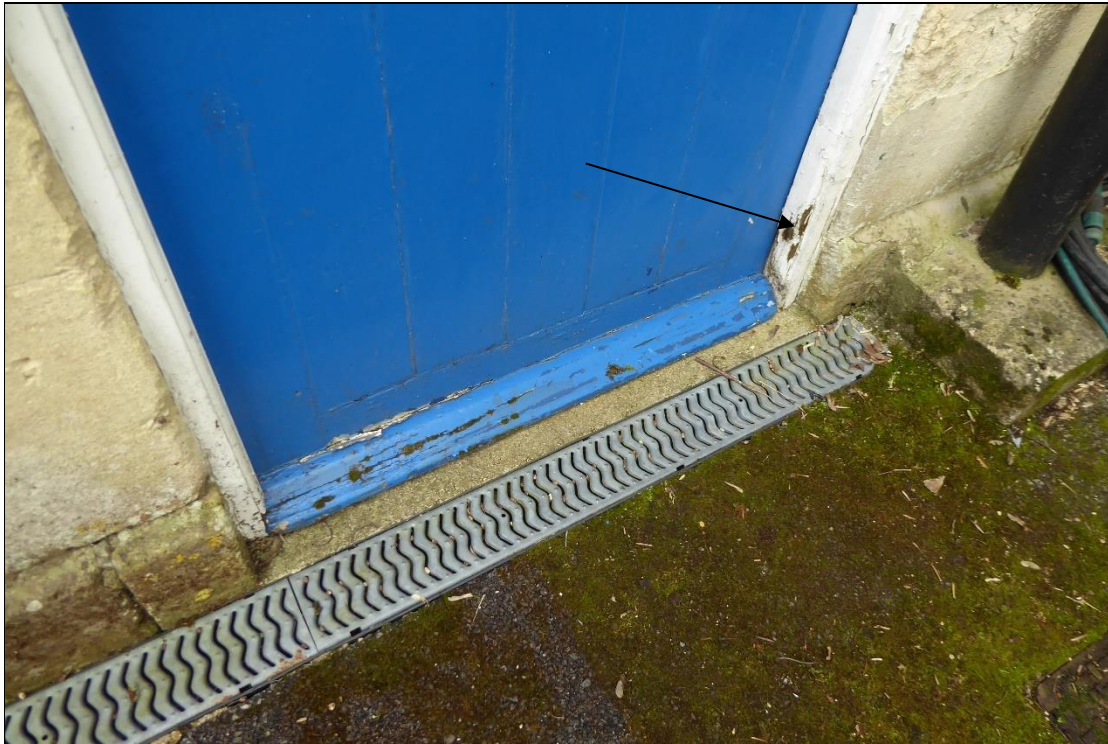
Slight rot door frame to entrance door to Flat 2.

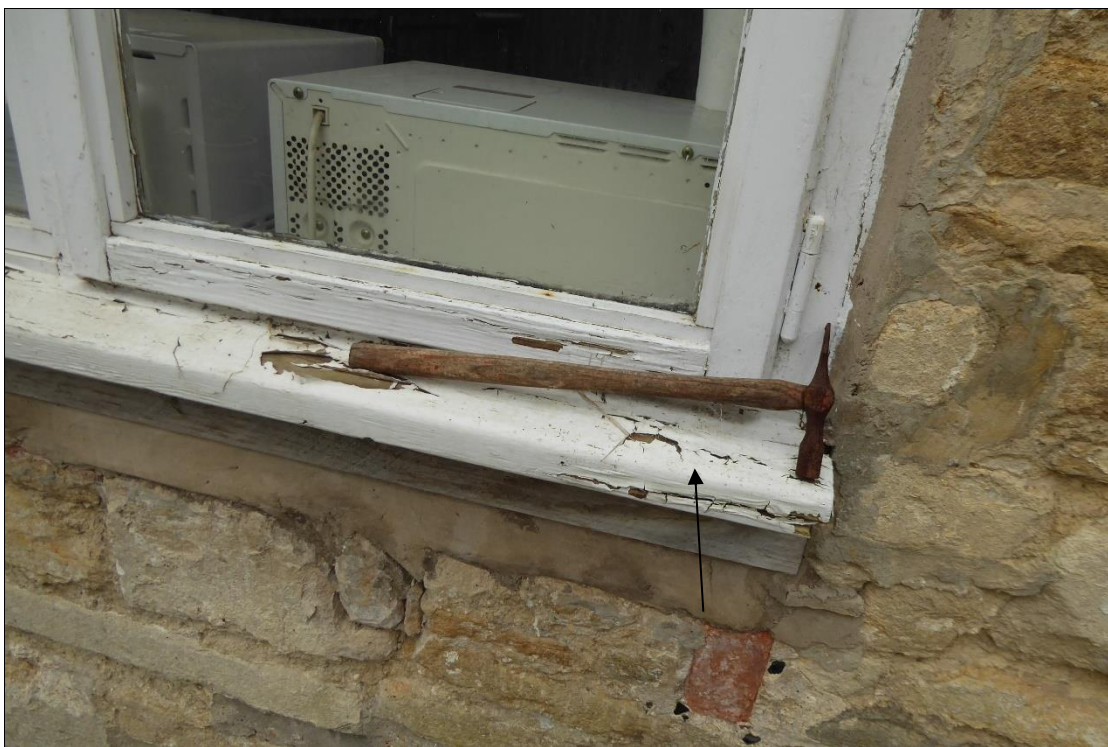
Rot in window cill.

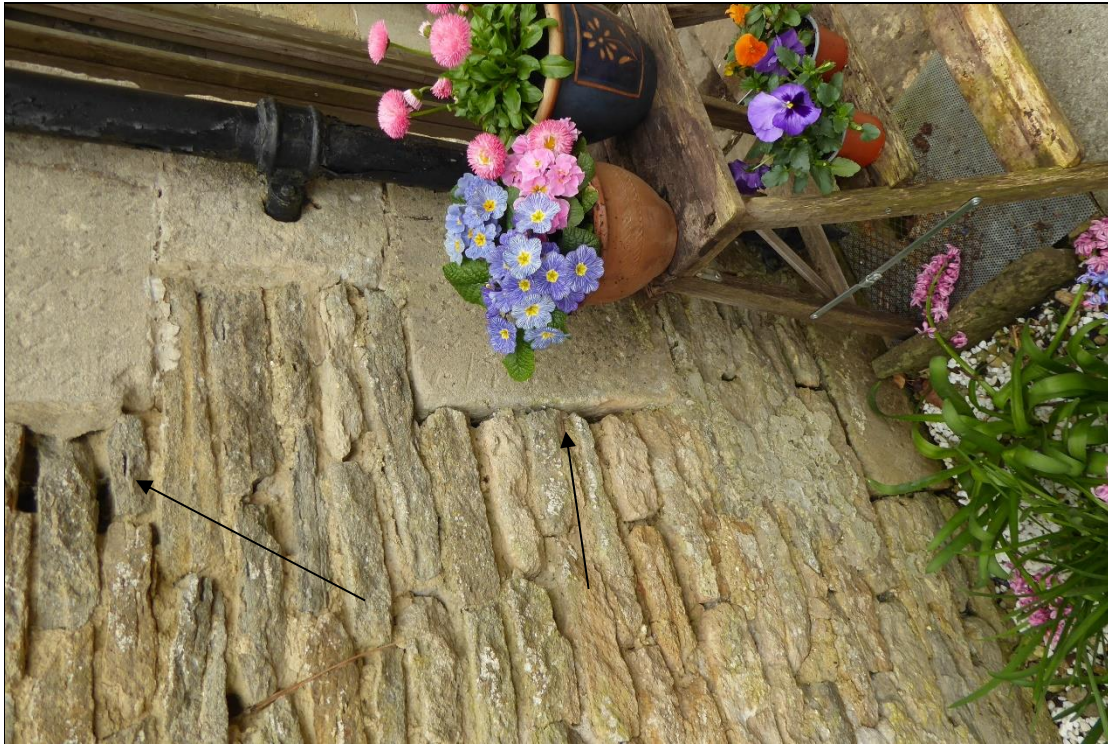
Scope for minor repointing rear right corner of the rear wing.

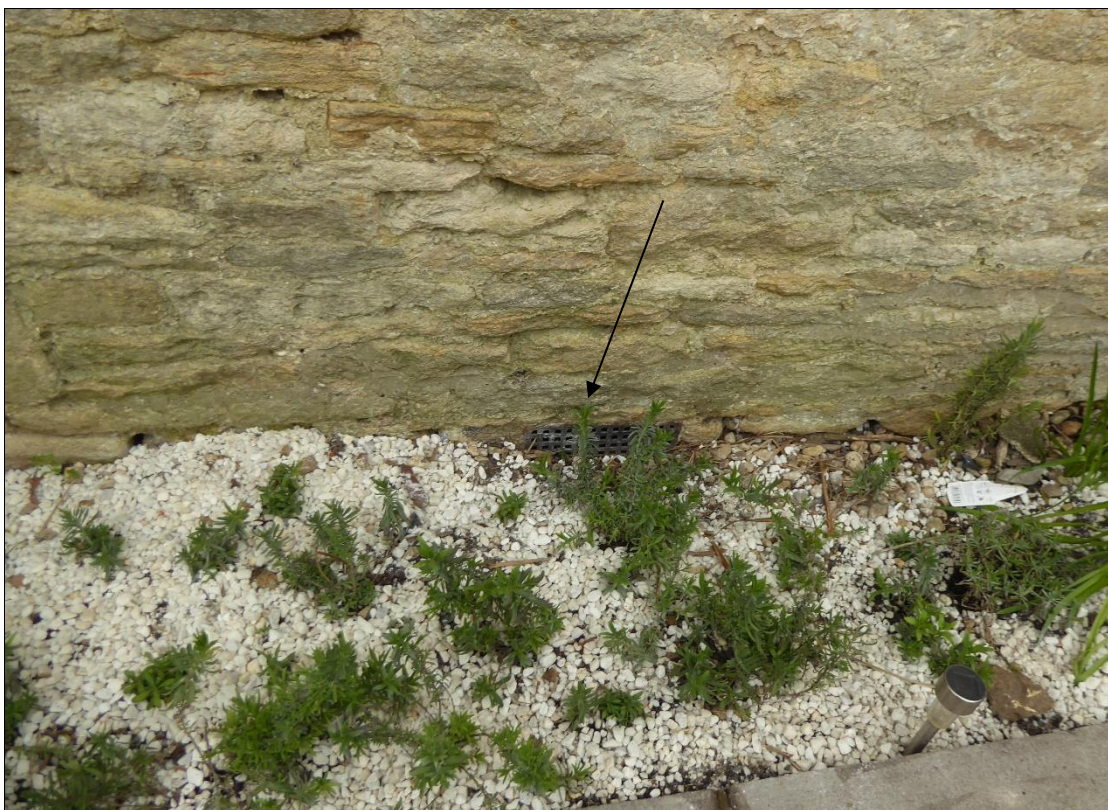
Air vents are close to ground levels or below.

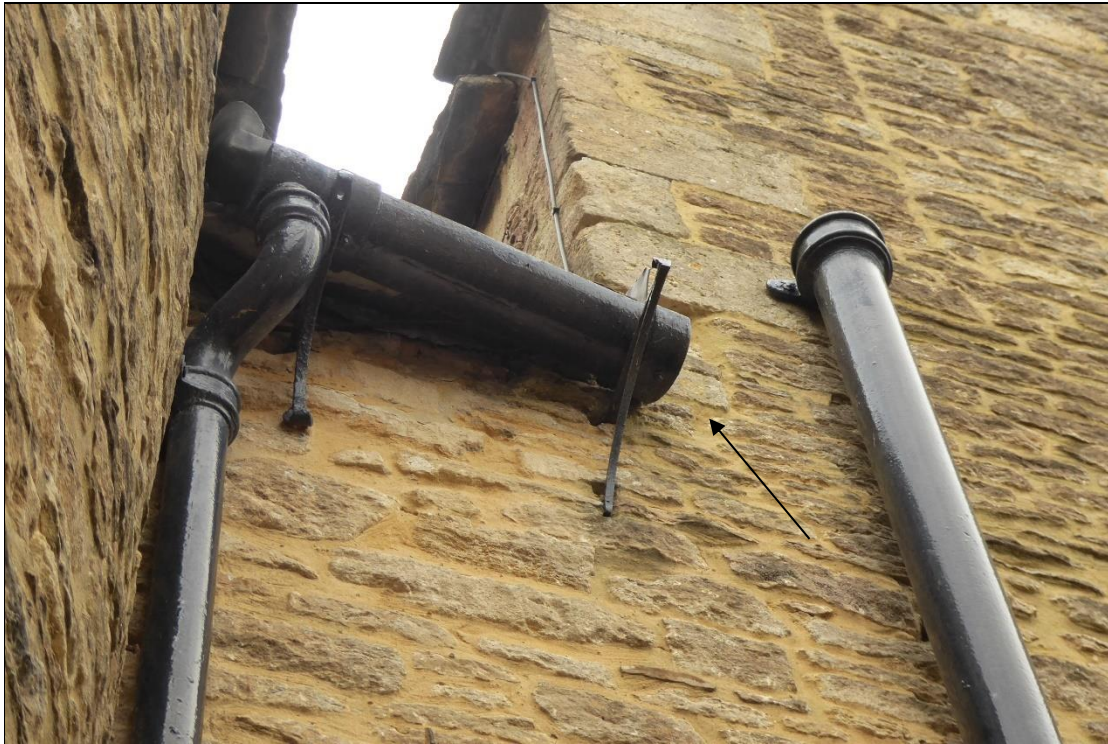
The gutter may need to be re-aligned.

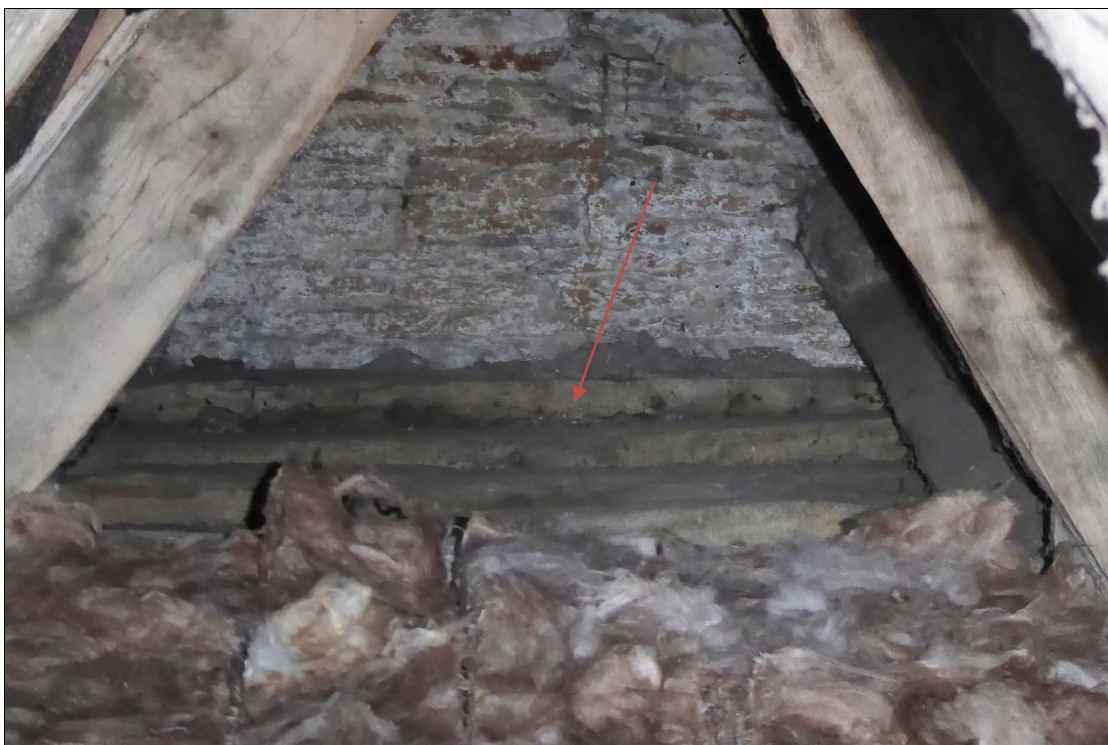
Far end roof space over the attic rooms was not insulated when other insulation was installed.

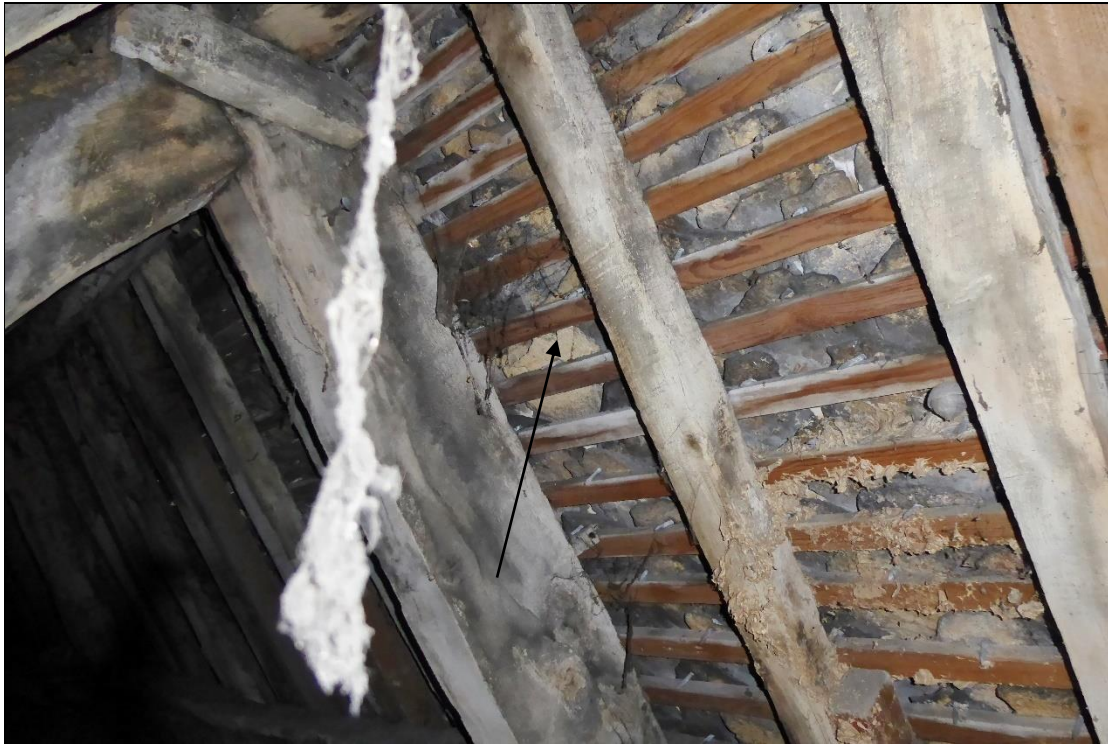
| Roof spaces. | 8. The front roofs either have an old roof lining which is starting to fail or no lining at all such as in Arnold House. Generally the roofs don't appear to be leaking but will be susceptible to wind driven snow being blown in both where the roof is not lined and where there are holes in the old roof lining. |

Unlined inside of the front roof slope over Arnold House.

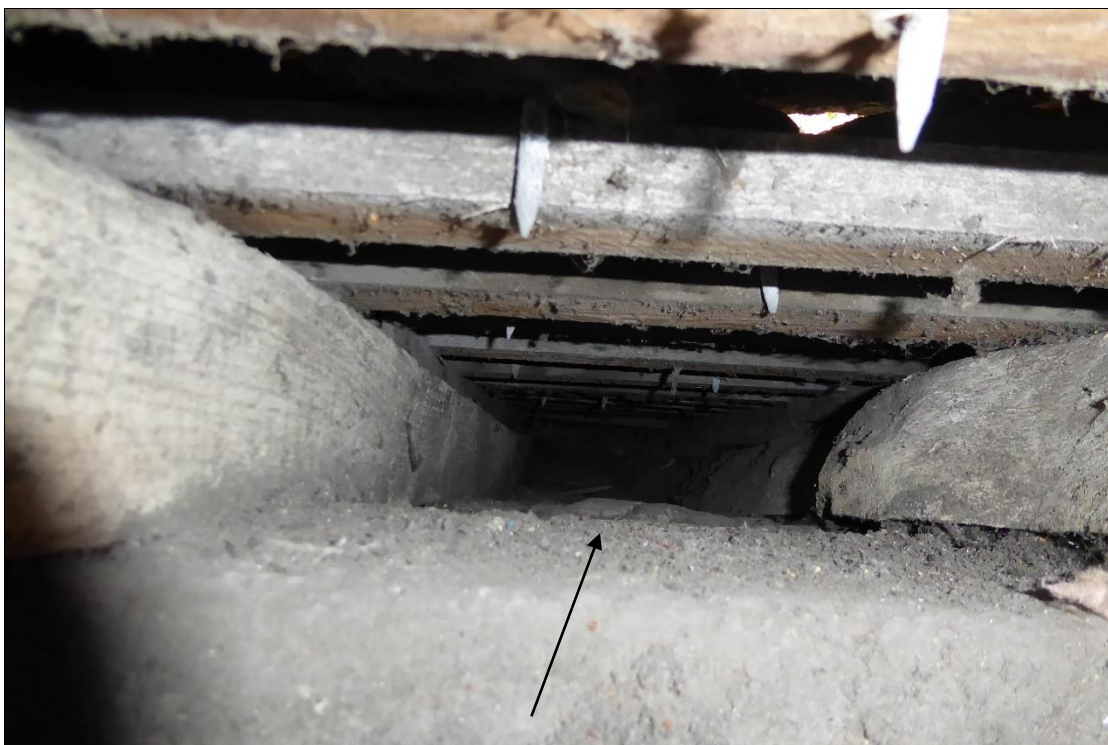
| Insulation | 16. | Roof space insulation within the front roofs needs improvement with missing insulation over Arnold House particularly over sloping ceilings and with limited insulation fitted over Flat 1.

No insulation over sloping ceilings.
