BUILDING SURVEY REPORT

ARNOLD HOUSE, 31 HIGH STREET, CORSHAM, SN13 0EZ

29th March 2022

HEXTALLS Surveyors Ltd

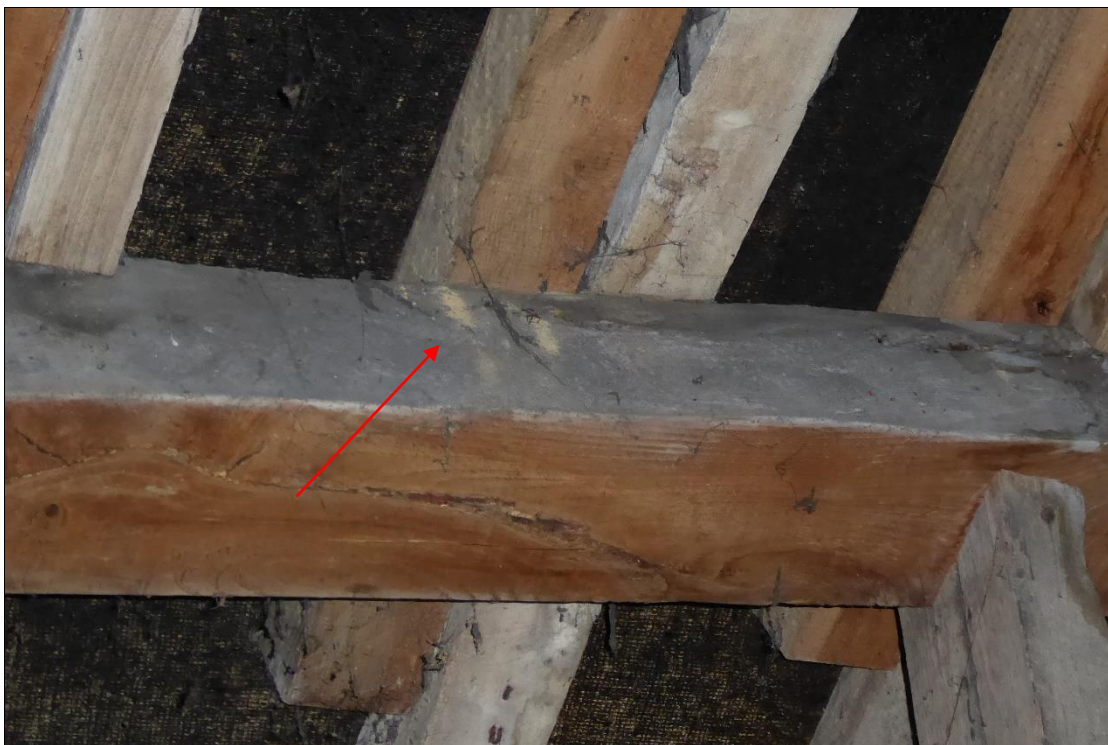
Timber defects 19. There are signs of active woodworm in the roof over 31 High Street and in the cupboard below the front left window Arnold House.

Dust indicates recent woodworm activity although this could still be quite old.

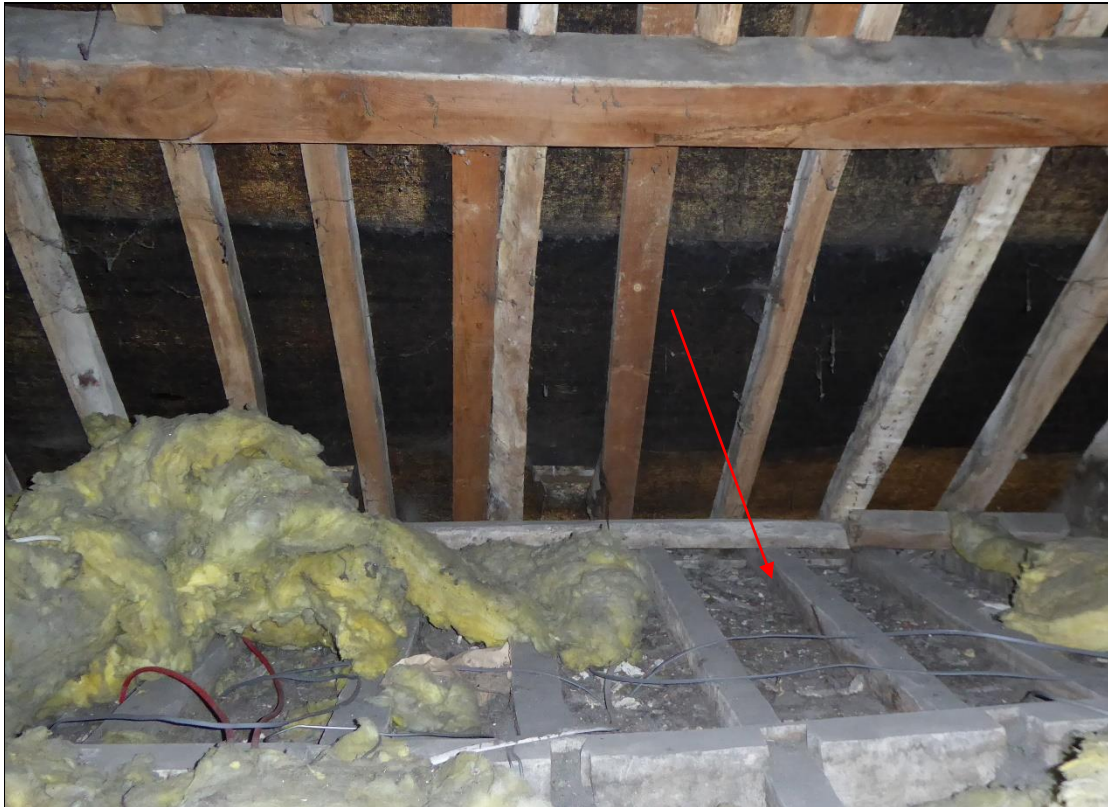
Torn felt base of roof and lack of insulation.

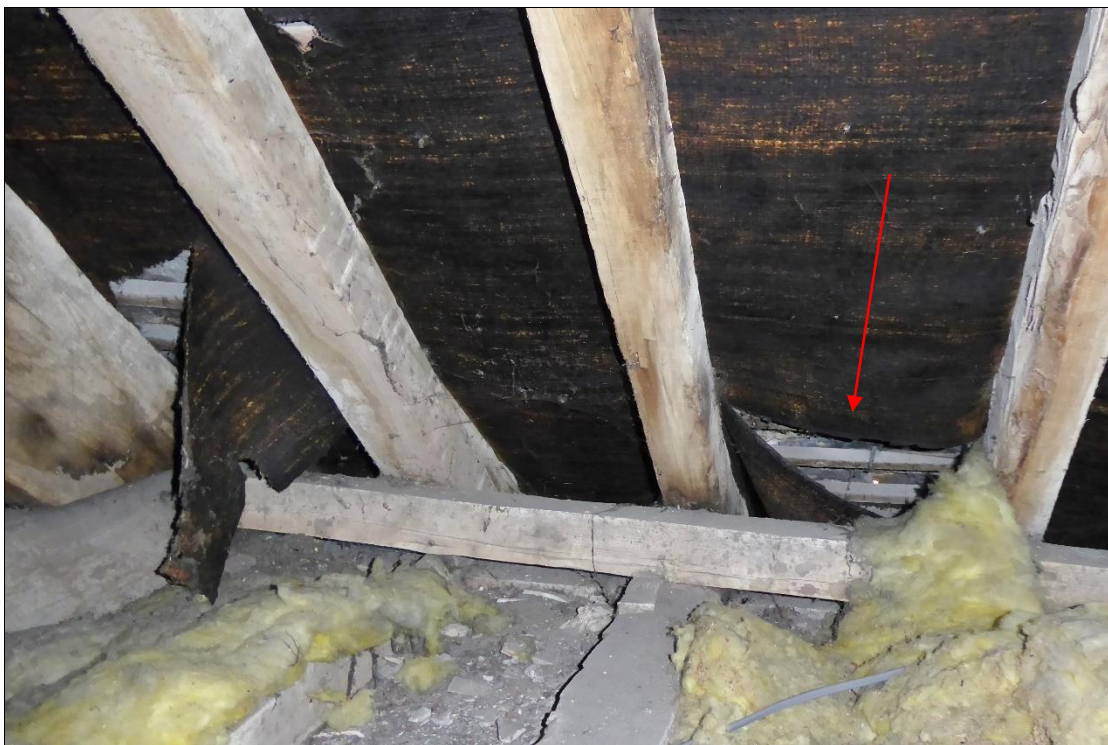
The old bituminous felt lining is torn and has collapsed in places.

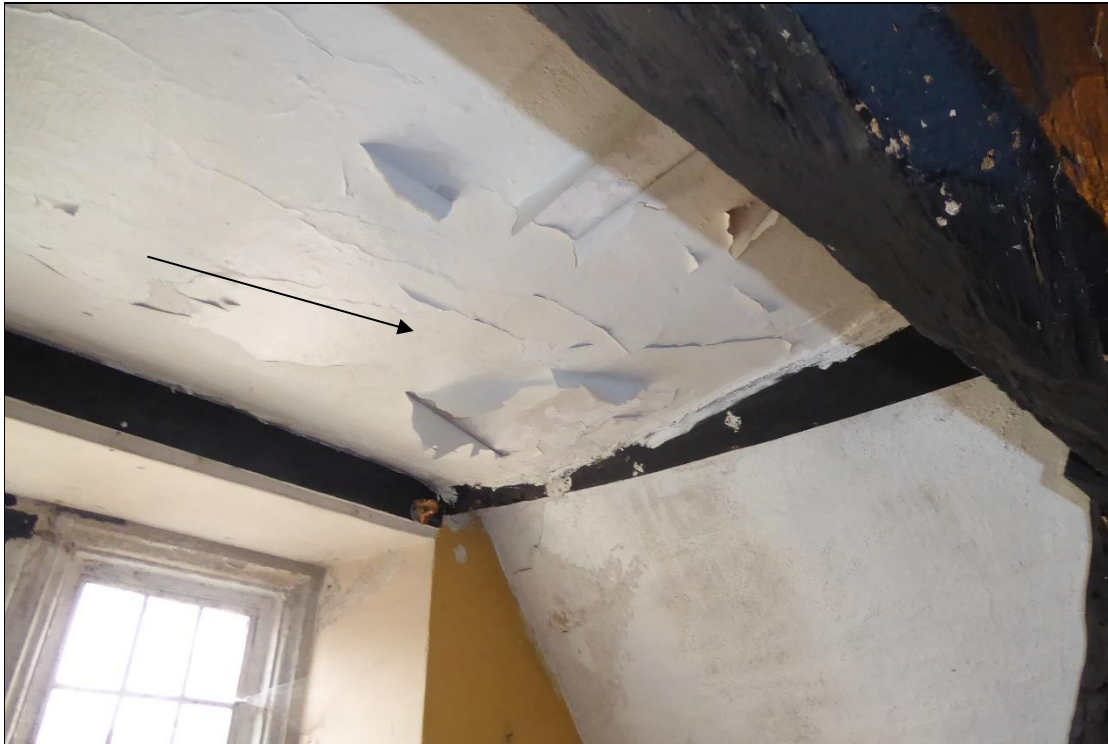
| Decoration. | 15. | There are several areas, commonly ceilings but also some walls, where old lime paints lie under modern paints. As a result of the lack of adhesion between the two the modern paints peel. Affected surfaces need to be cleaned of loose paint and surfaces stabilised. Decorator to advise. |

Peeling paint here and elsewhere in the building often caused by application of modern paints over old lime paints which don't have a stable surface to which the modern paints can adhere to.

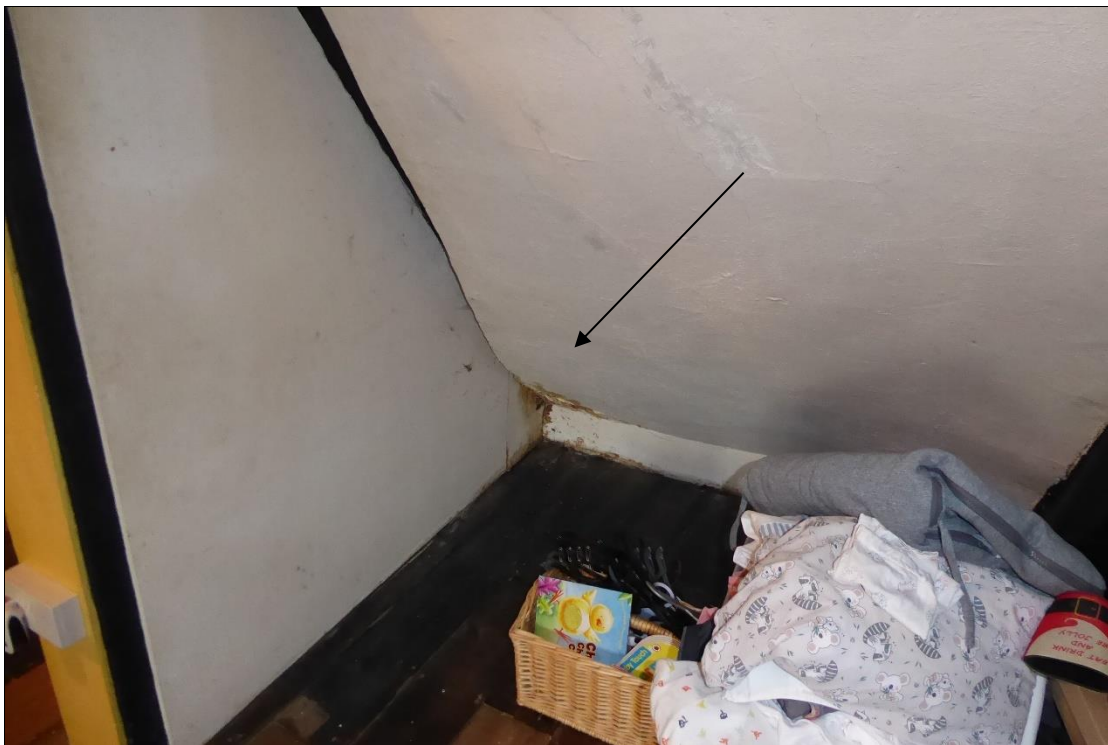
Collapsed sloping ceiling adjacent to the top of the attic stairs.

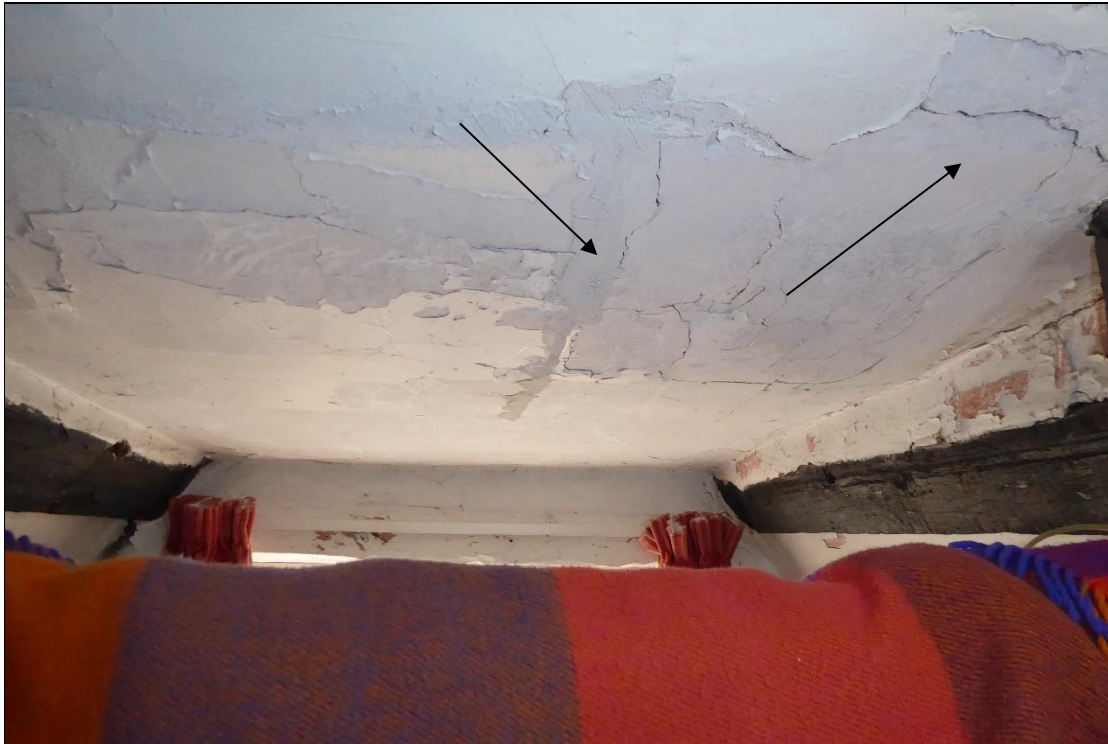
| Ceilings. | 9. | Attic ceilings are in poor condition. |

Weak lath and plaster ceilings in the attic rooms.

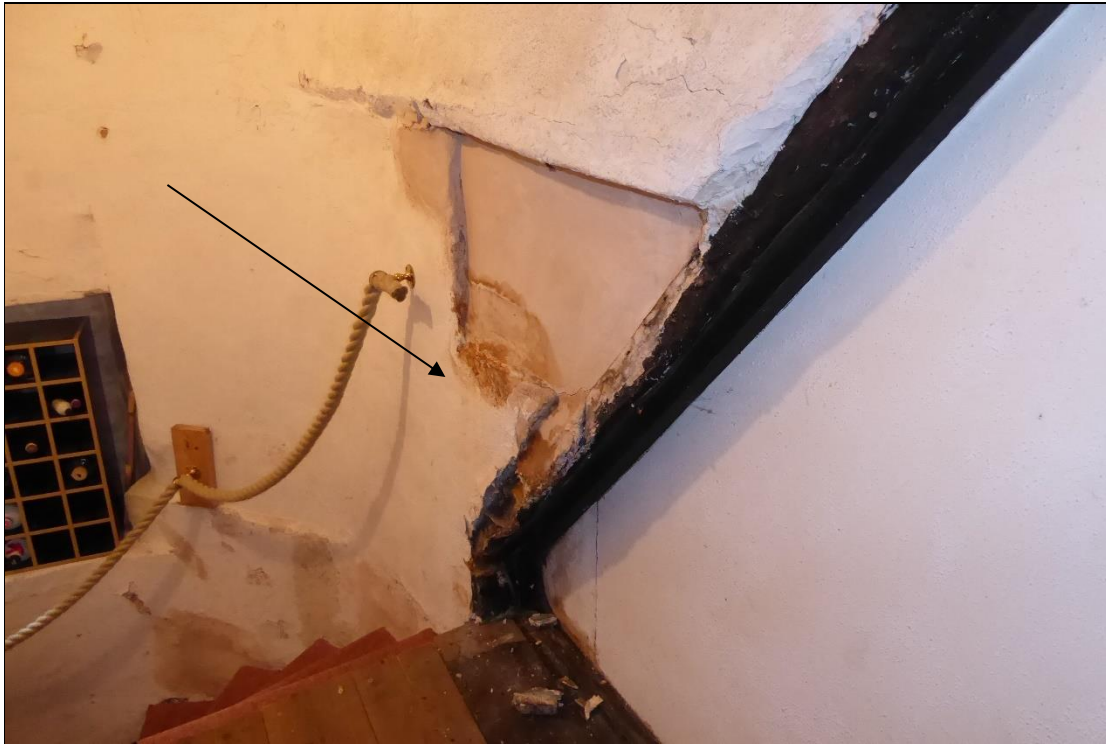
Damp in the wall and ceiling top of the attic stairs.

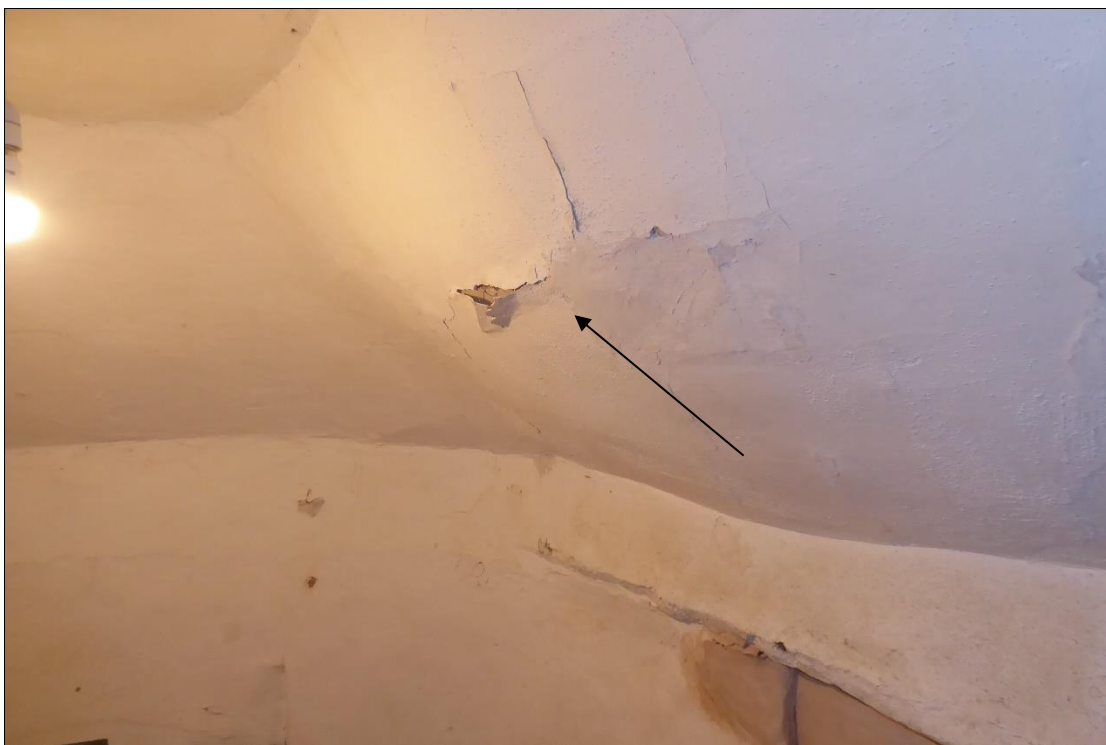
Another example of damaged ceiling top of the stairs to the attic rooms.

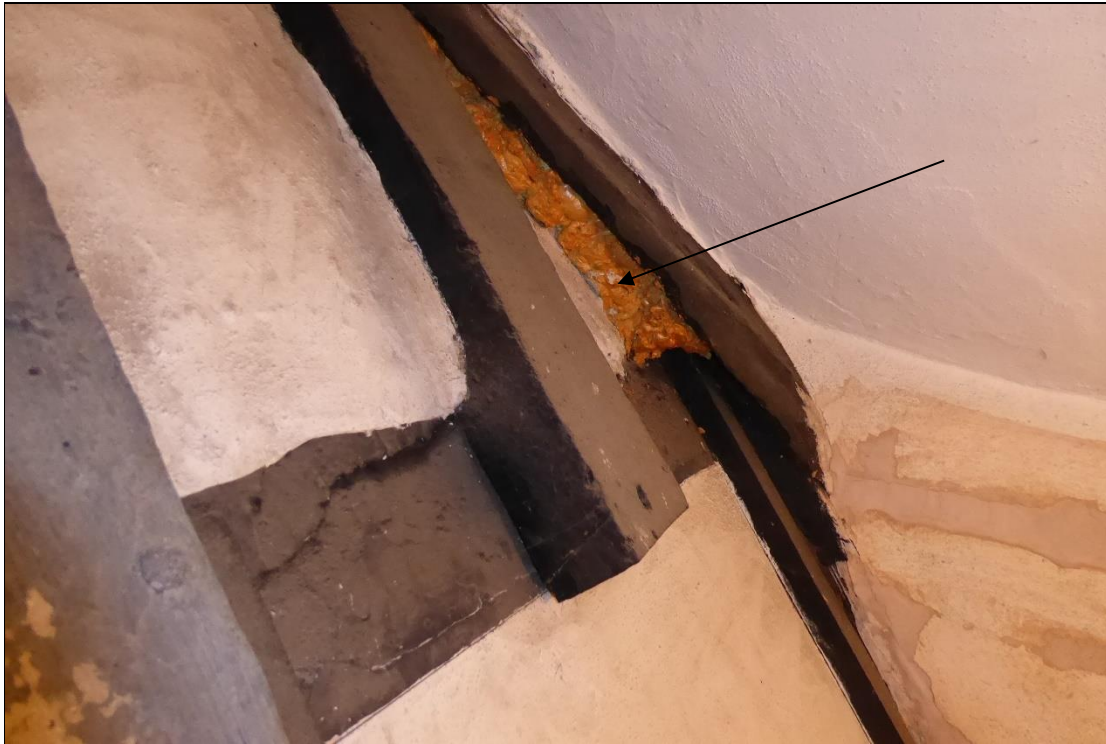
Expanded foam used to seal a gap in the ceiling at the top of the staircase to attic rooms in flat 2. Not best practice.

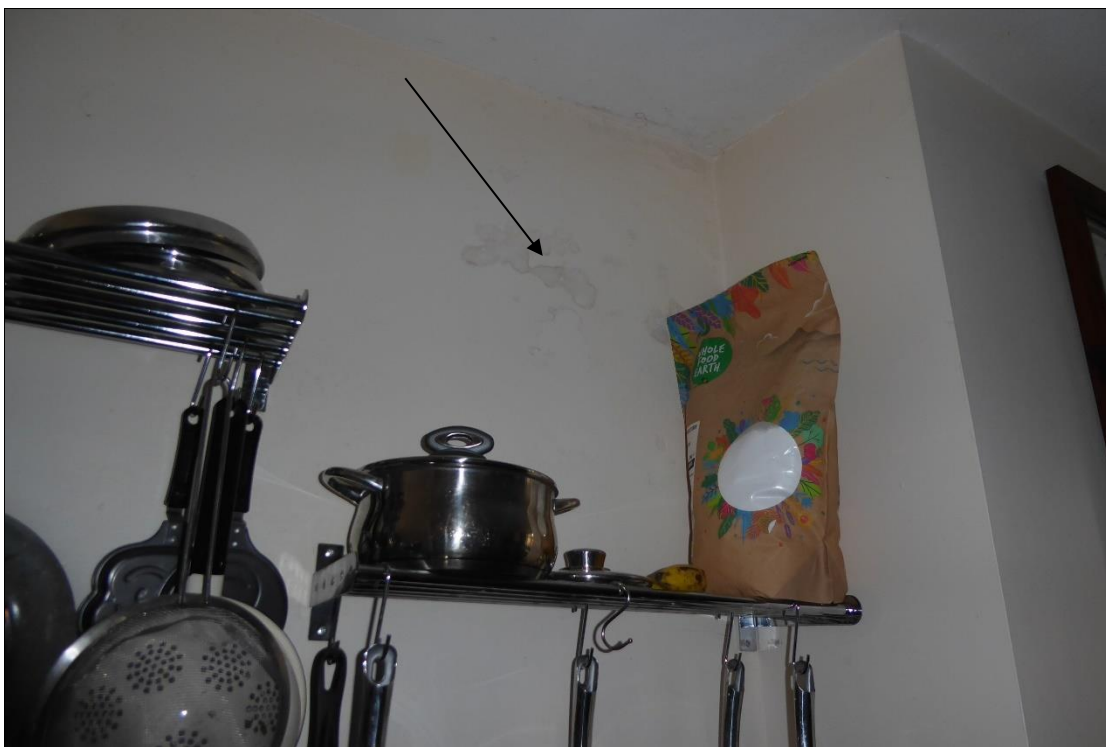
Damp in the recess to the left of the chimney breast in the kitchen of flat 2.

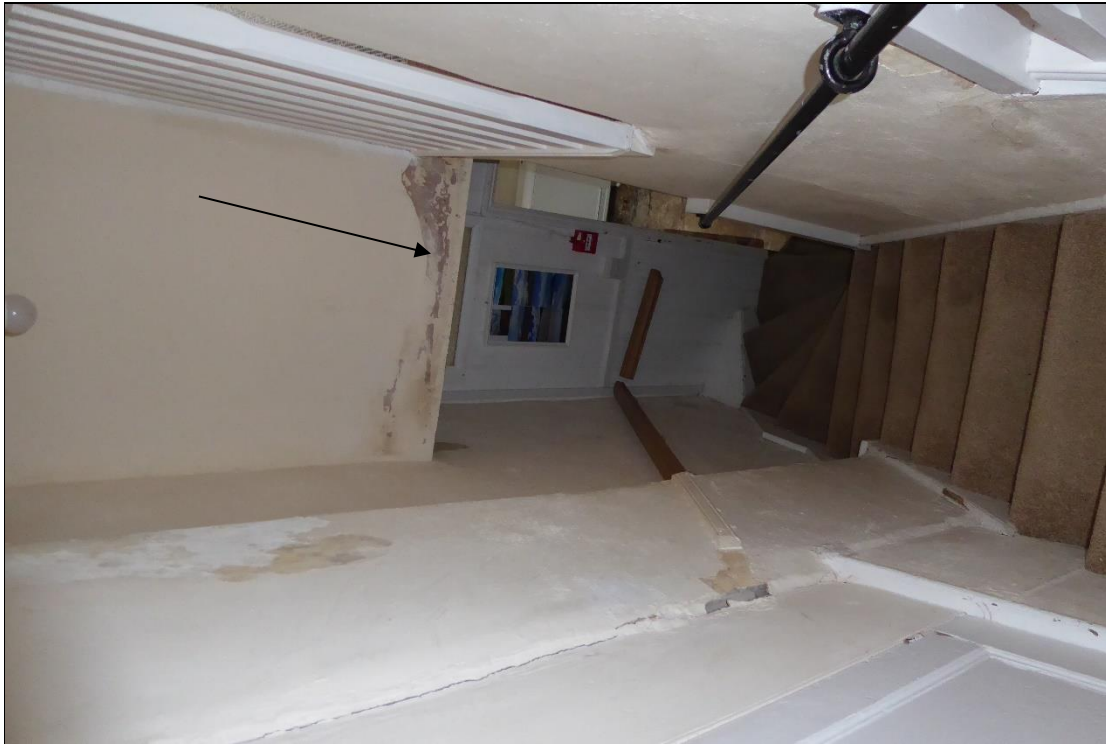
The shower fitting in Flat 2 was leaking when checked.

Damp stains where the shower in the bathroom flat 2 has leaked.

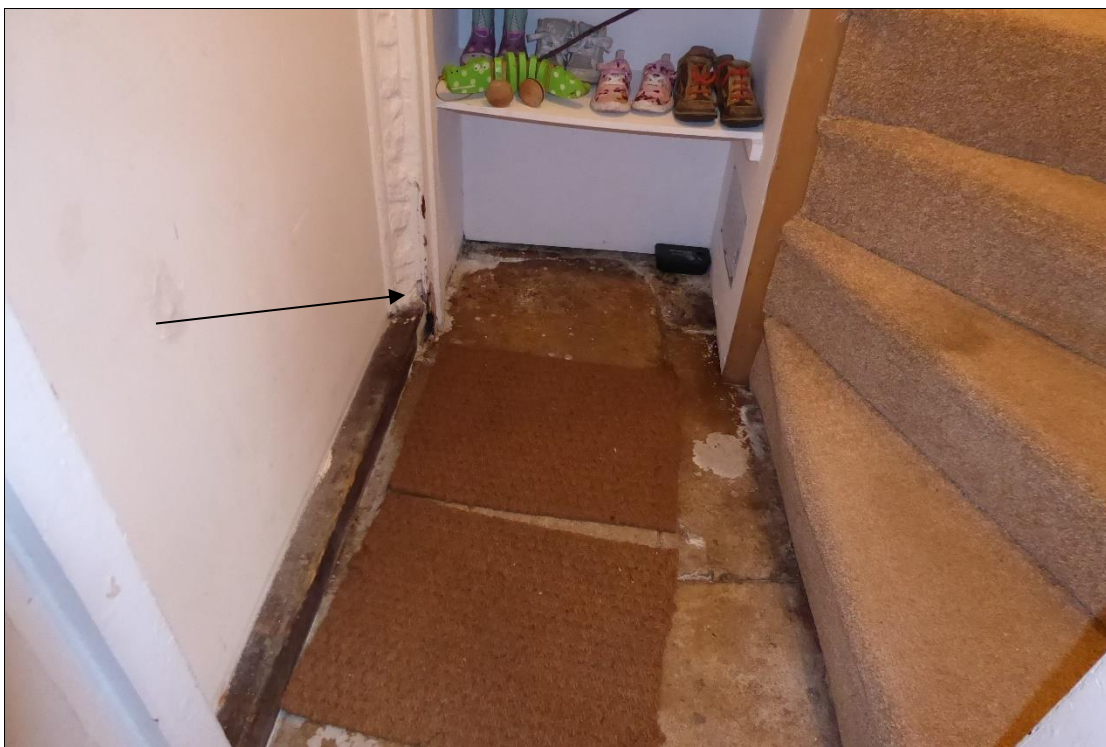
Rot affects the edge of the frame by the not close off doorway to the Kitchen.

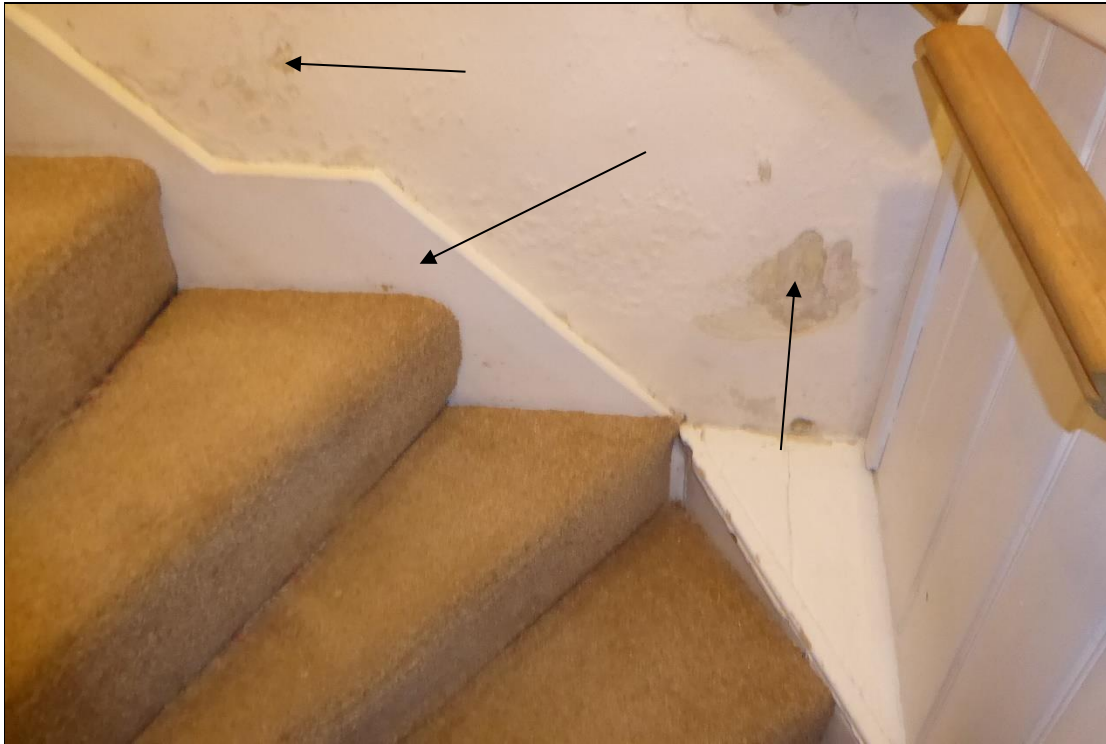
There is damp in the wall at the base of the stairs. The string or side of the stairs has been replaced suggesting rot caused by contact with damp had caused problems.

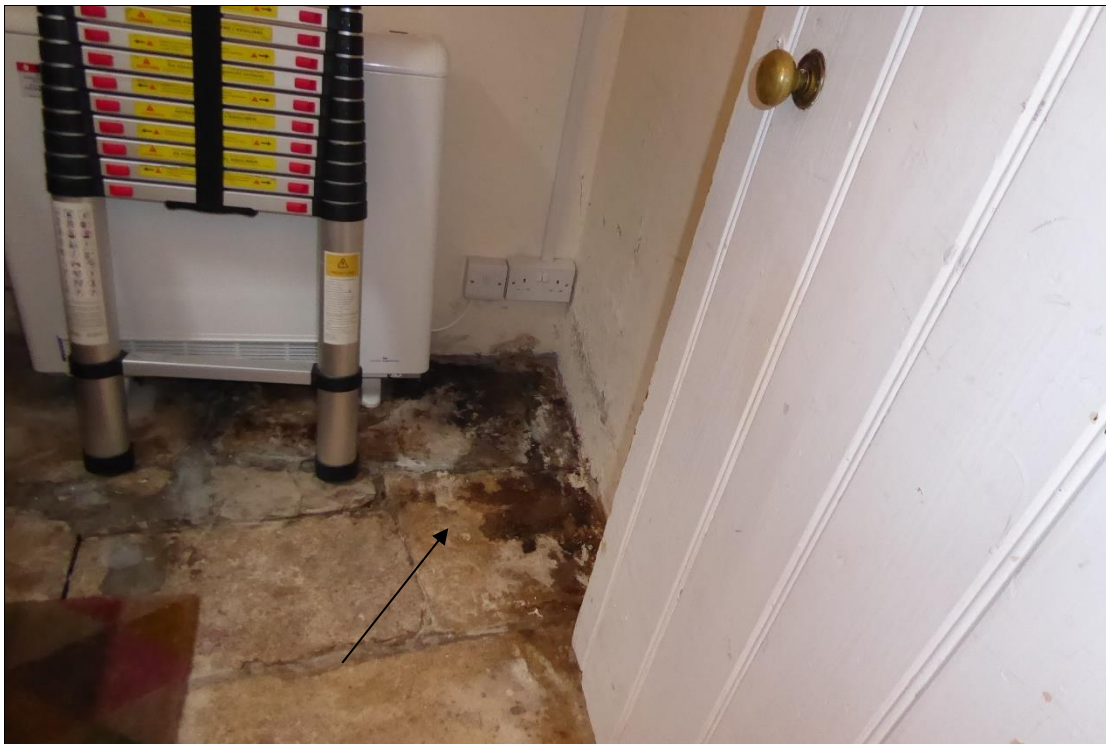
Flagstone floors damp. – Lobby entrance to Flat 2.

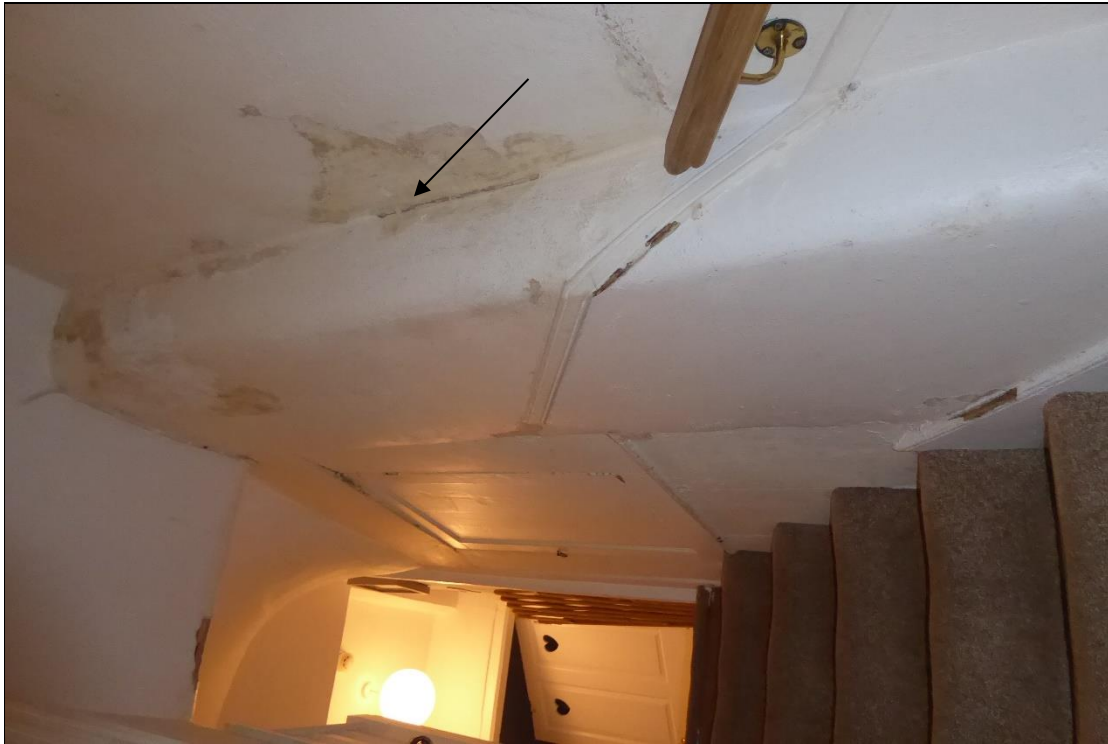
Damp causing issues in the staircase wall to flat 2.

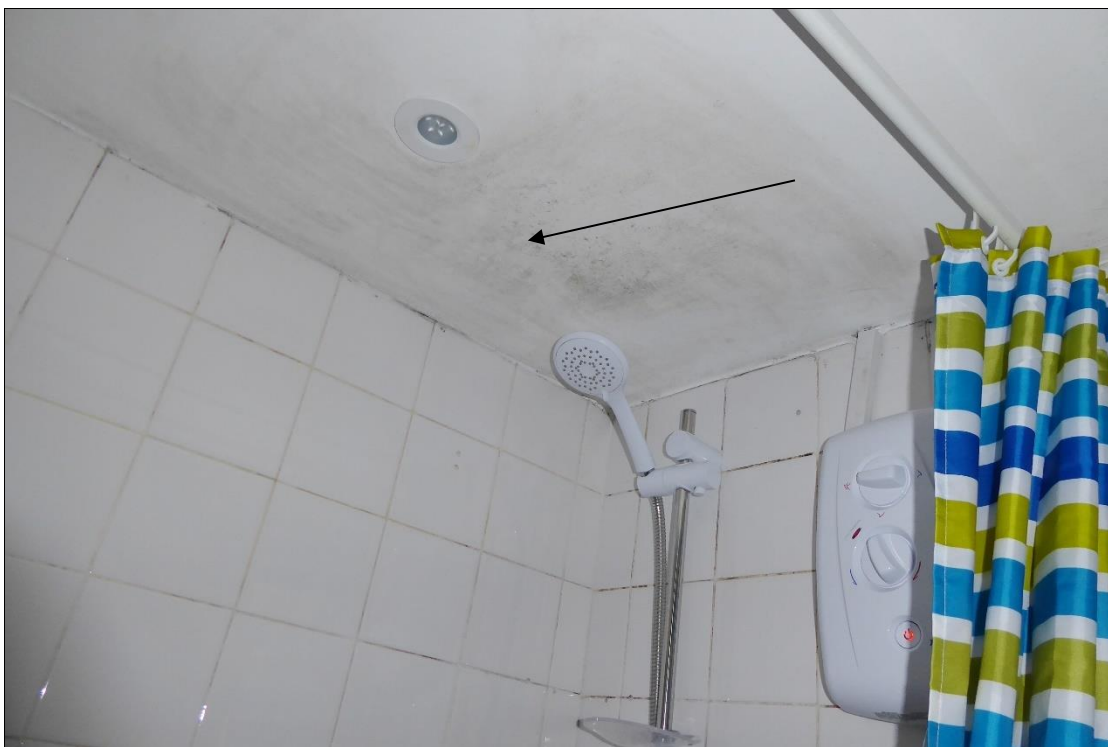
Mold stains indicate condensation issues in the bathroom to flat 1.

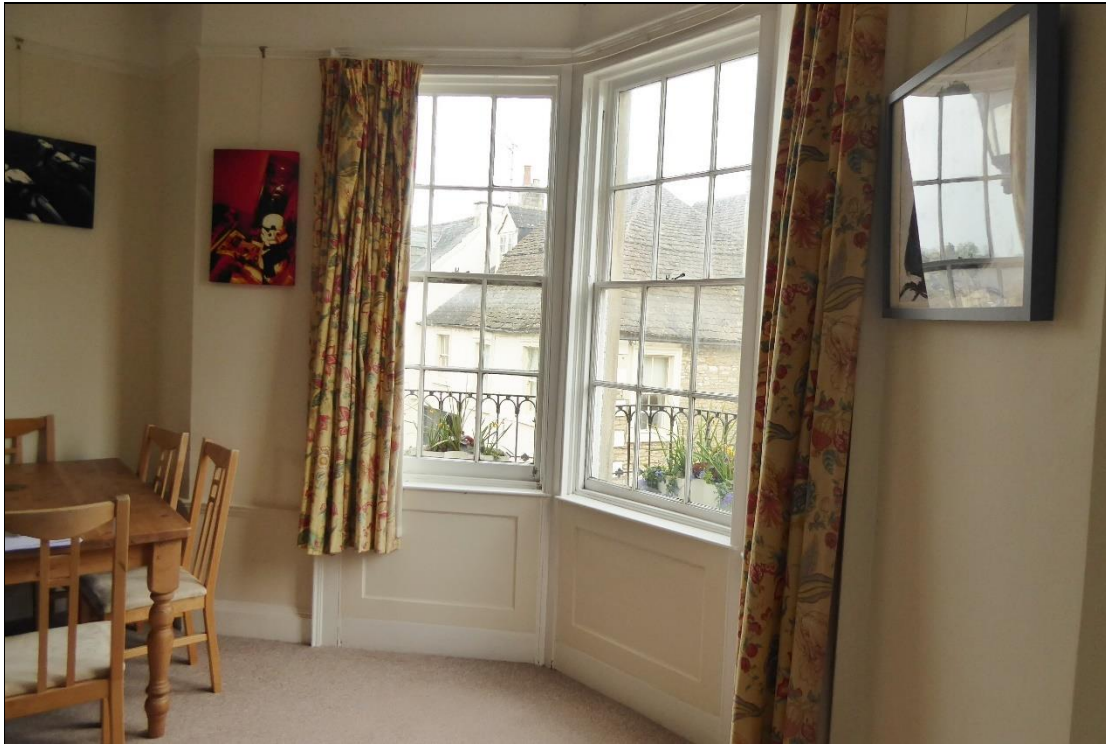
Windows have been draught seals but some time ago we suspect an effectiveness limited.

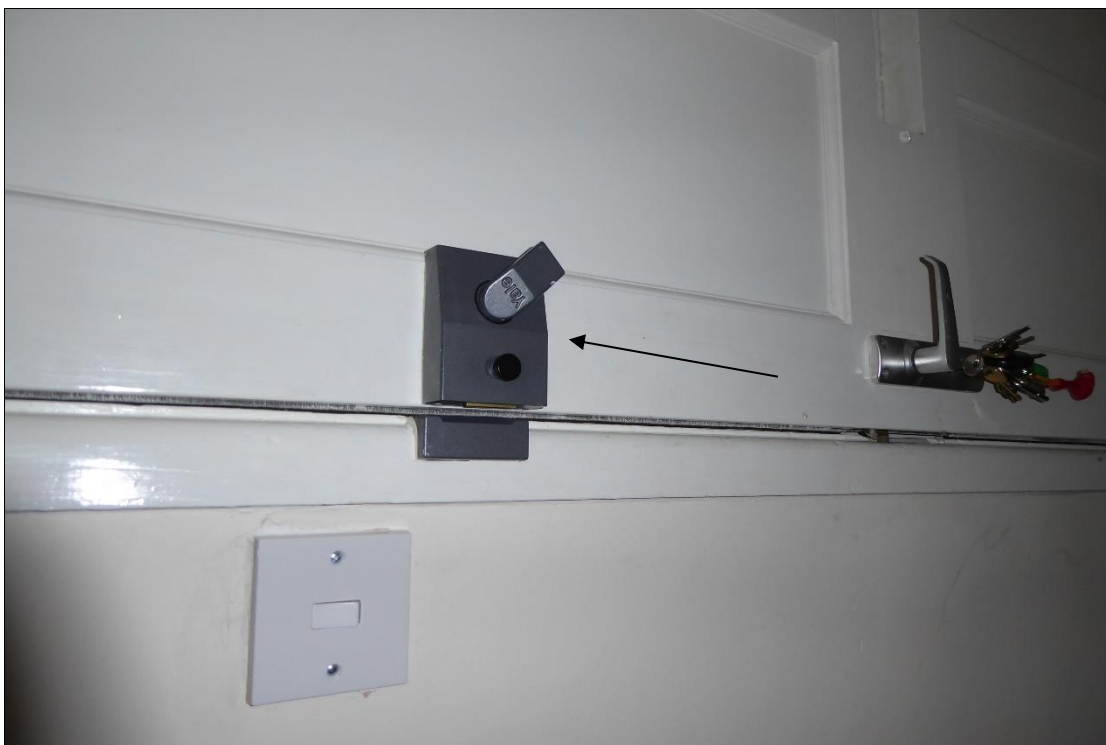
Entrance doors to flats should be fitted with thumb locks.

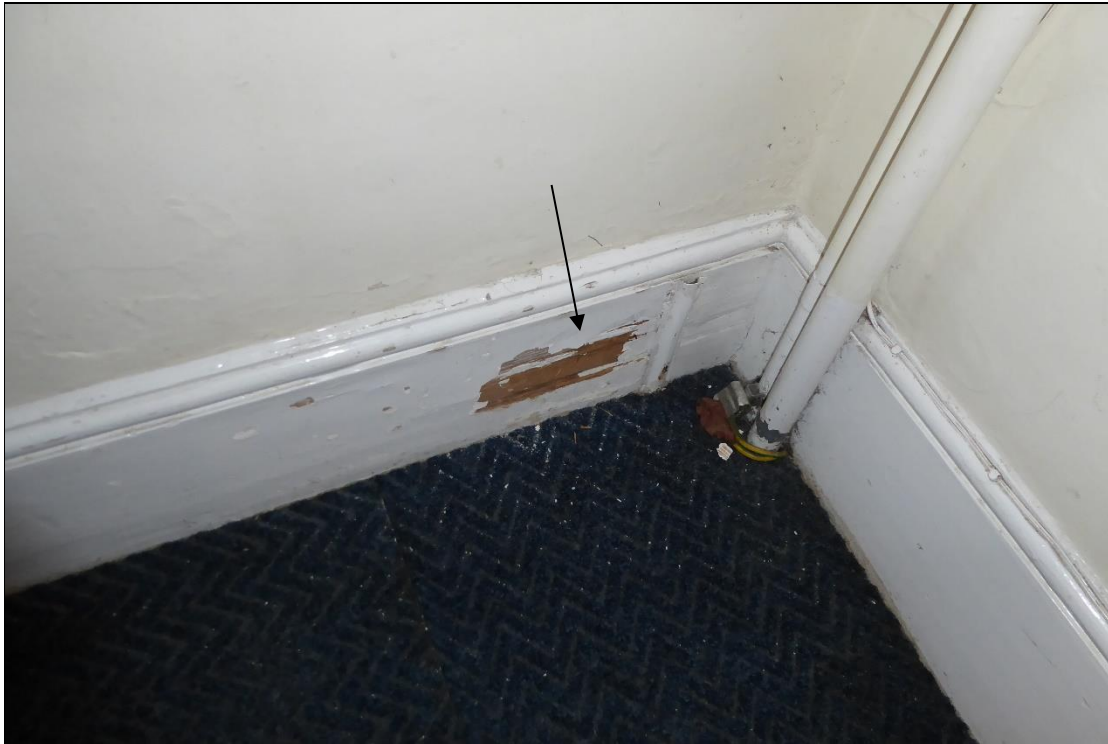
| Joinery. | 14. | There signs of rot affecting some skirting boards on the ground floor. This will be caused by contact with damp such as in wall and floor surfaces. |

Rotten skirting boards front of the Hall.

Rot affects some skirting boards. This should be checked and affected timber replaced.

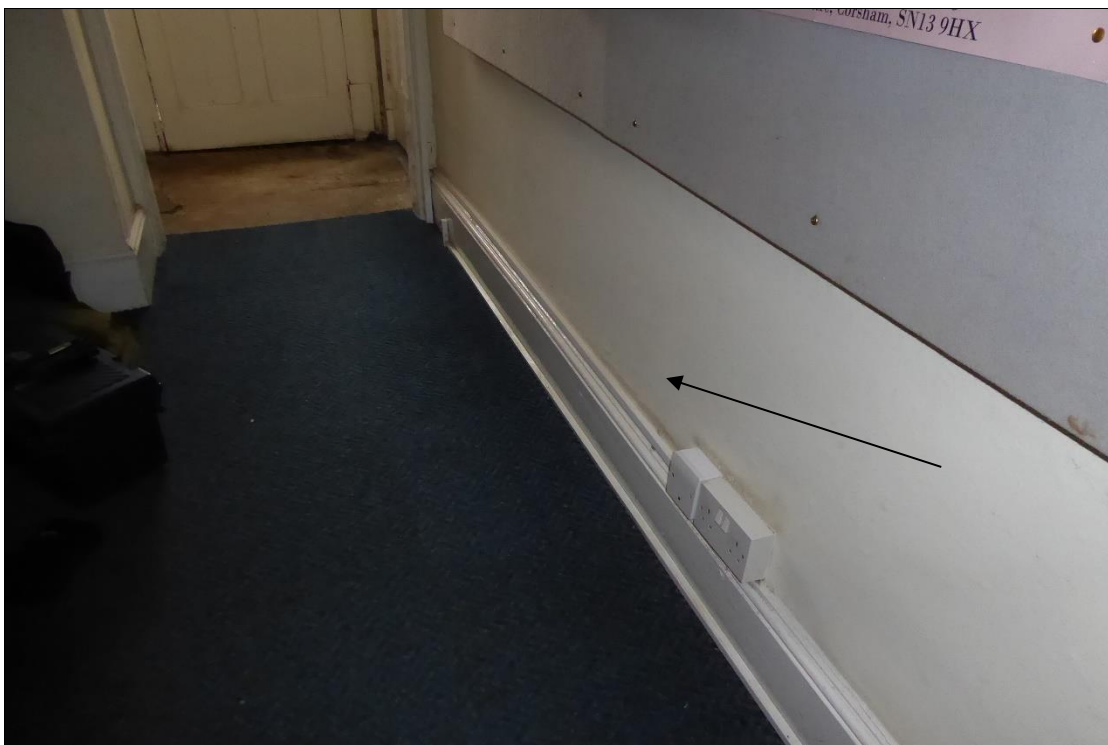
Signs of damp in this Hall wall.

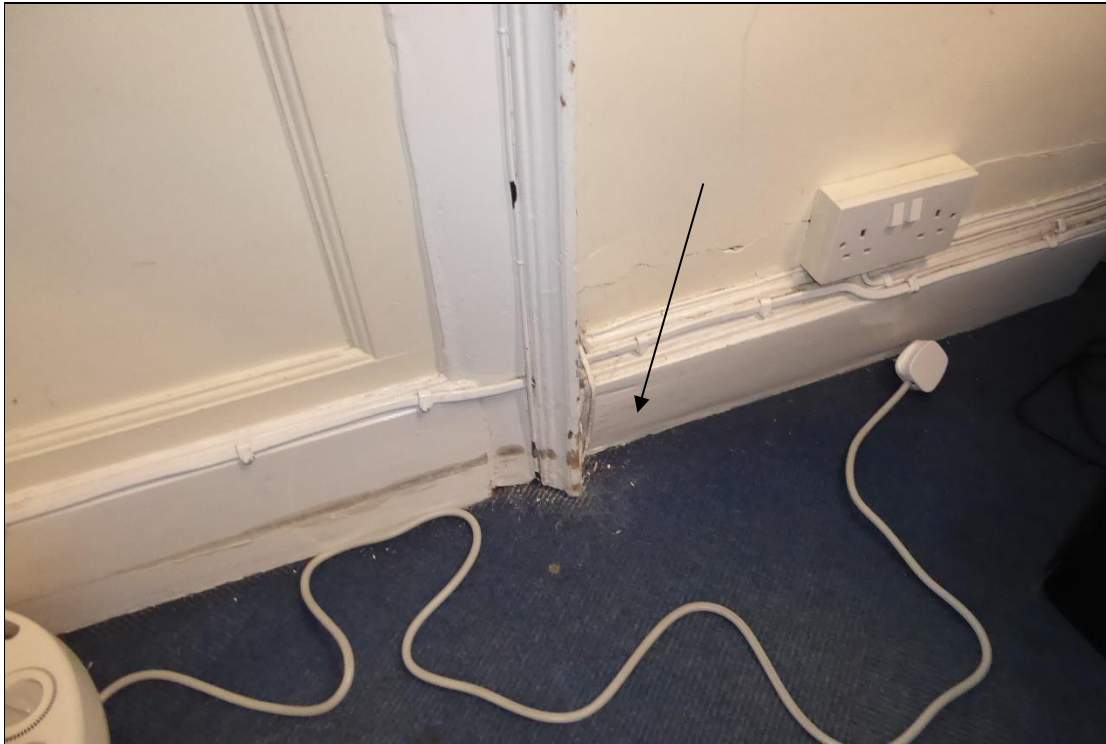
Rot affects the skirting boards in the Tourism office.

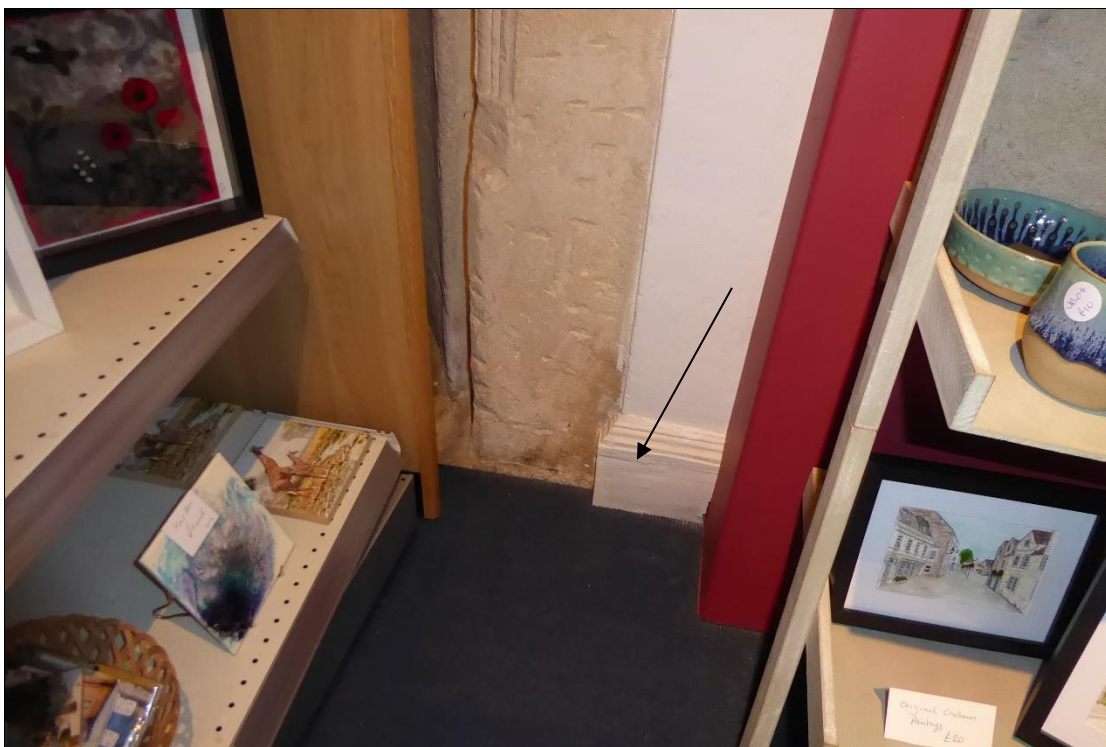
Signs of rot in the skirting board to the right of the fireplace at the back of the shop.

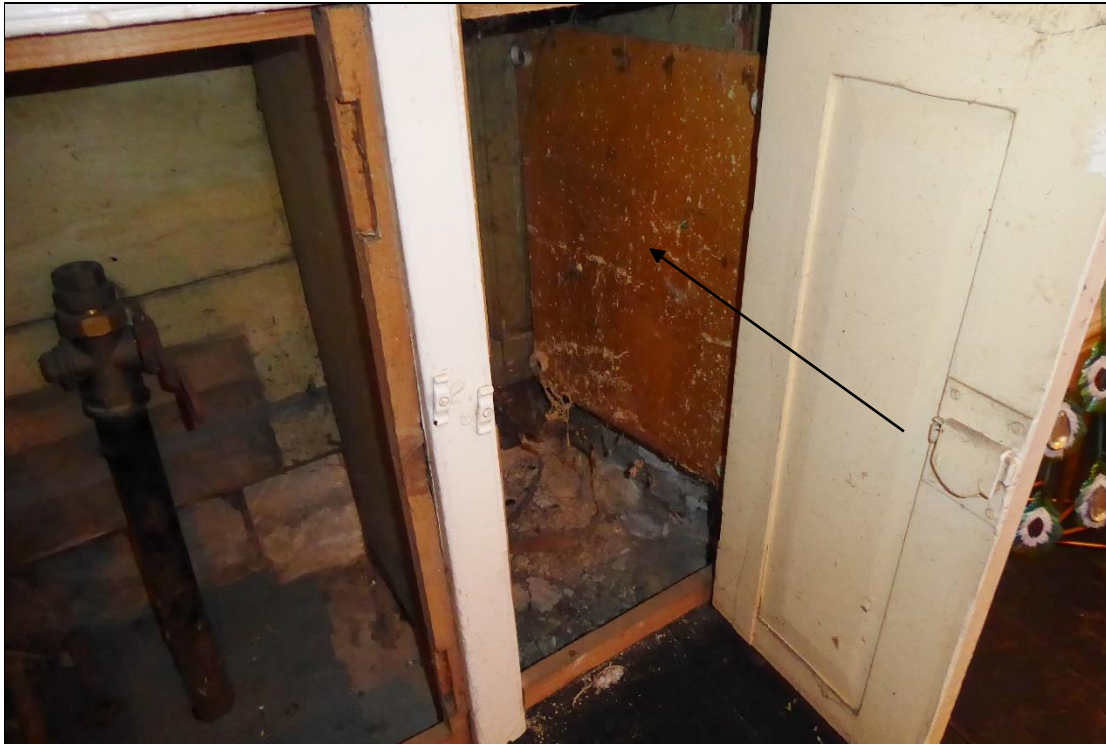
This is the cupboard into the recess below the left Store/shop below the front left window. There are signs of woodworm in the board to the right. Old gas main pipe.

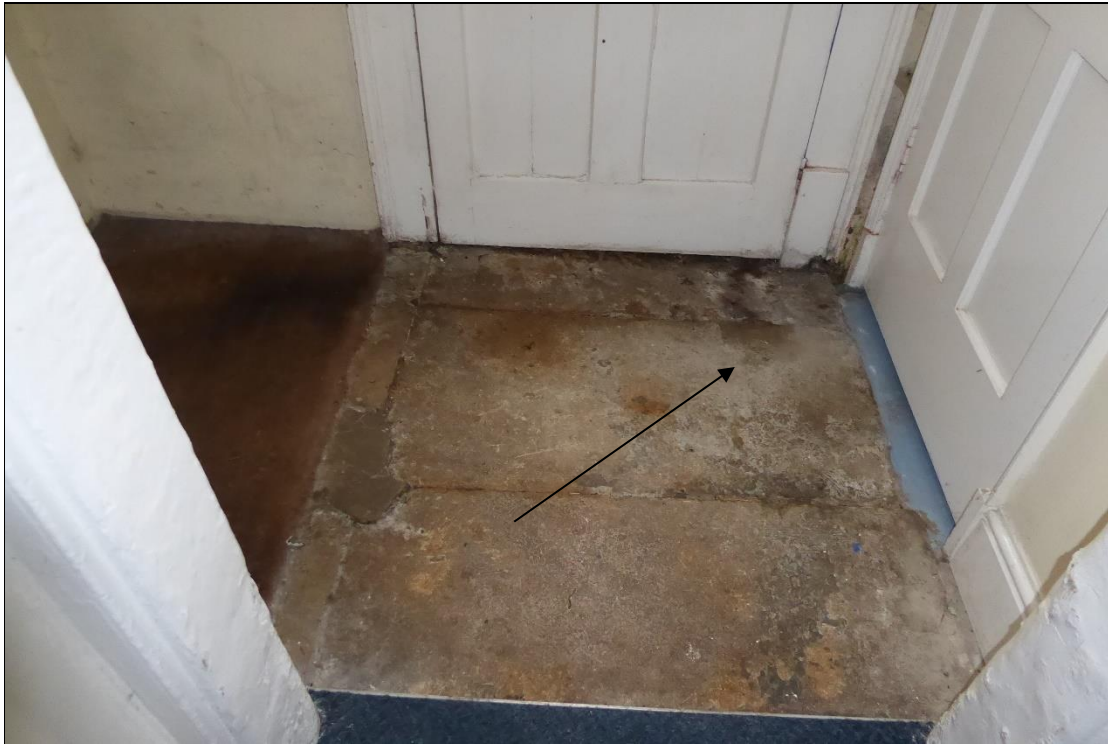
Old flagstones will be damp so should not be covered.

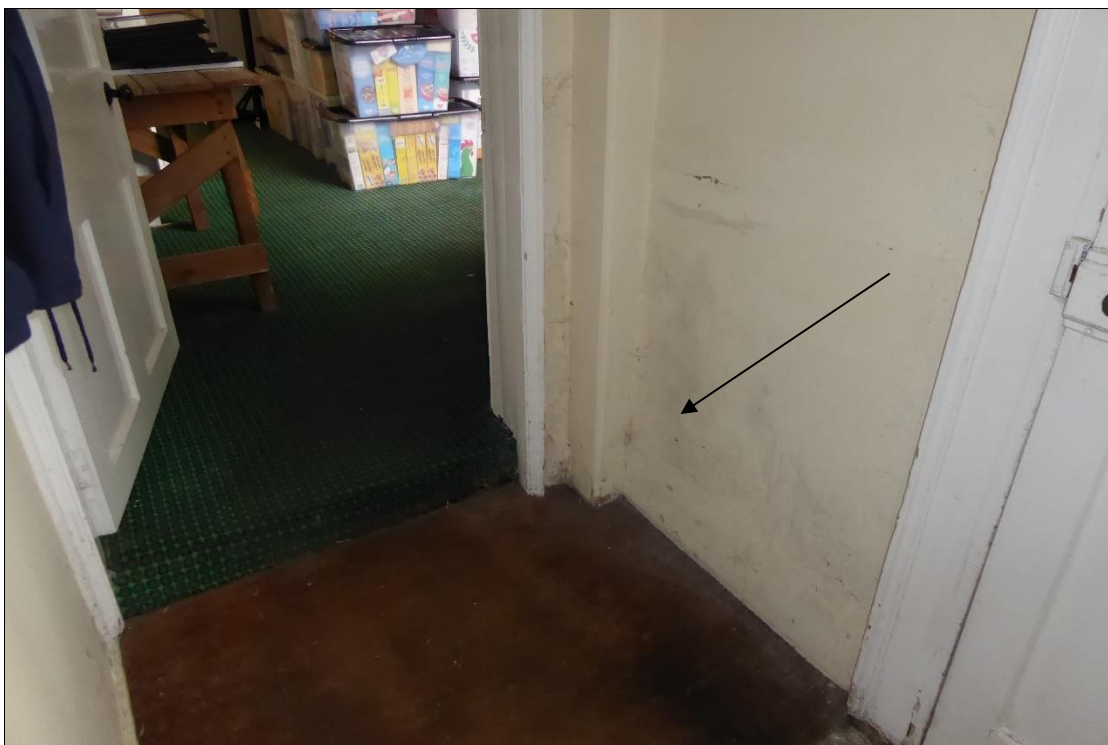
Damp in the rear Lobby before the Kitchen.

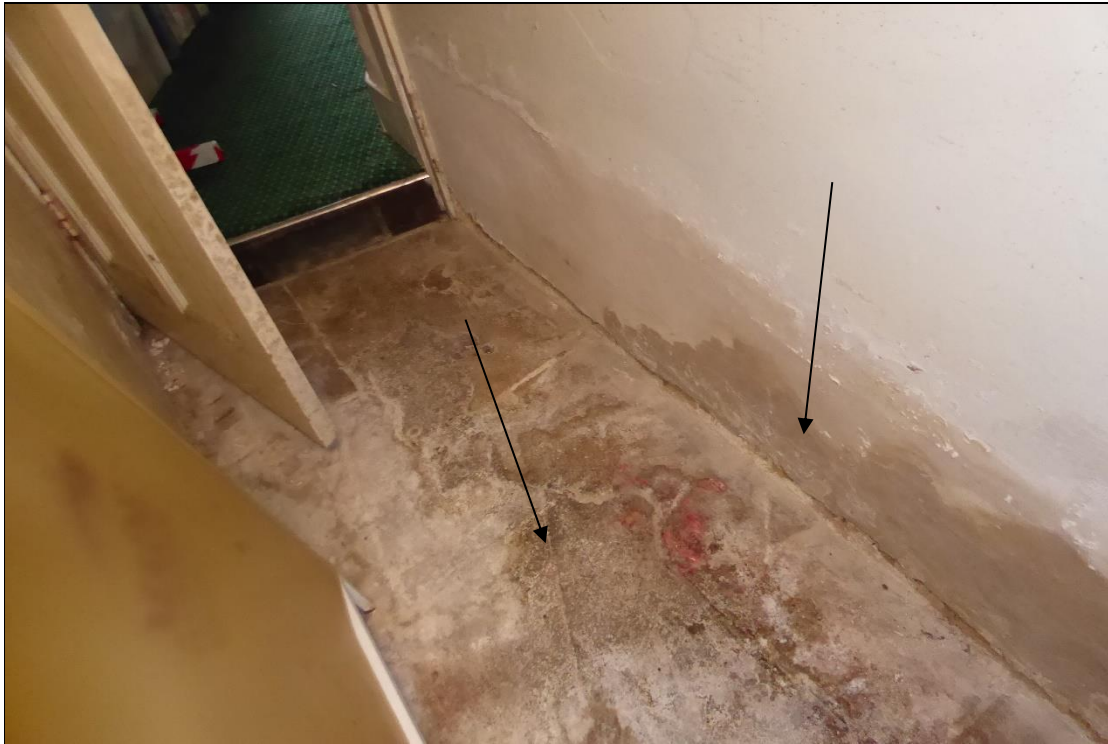
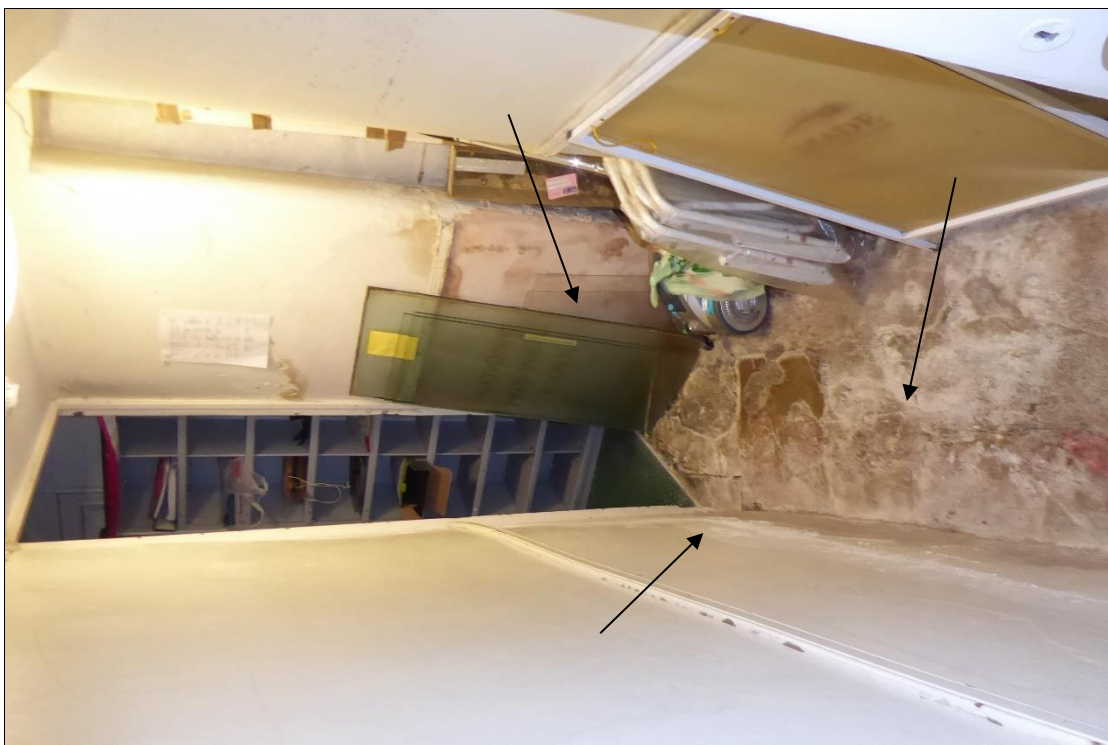
Damp a general issue in the floor and walls in the passage between the left Hall and Kitchen,

As above,
