BUILDING SURVEY REPORT

ARNOLD HOUSE, 31 HIGH STREET, CORSHAM, SN13 0EZ

29th March 2022

HEXTALLS Surveyors Ltd

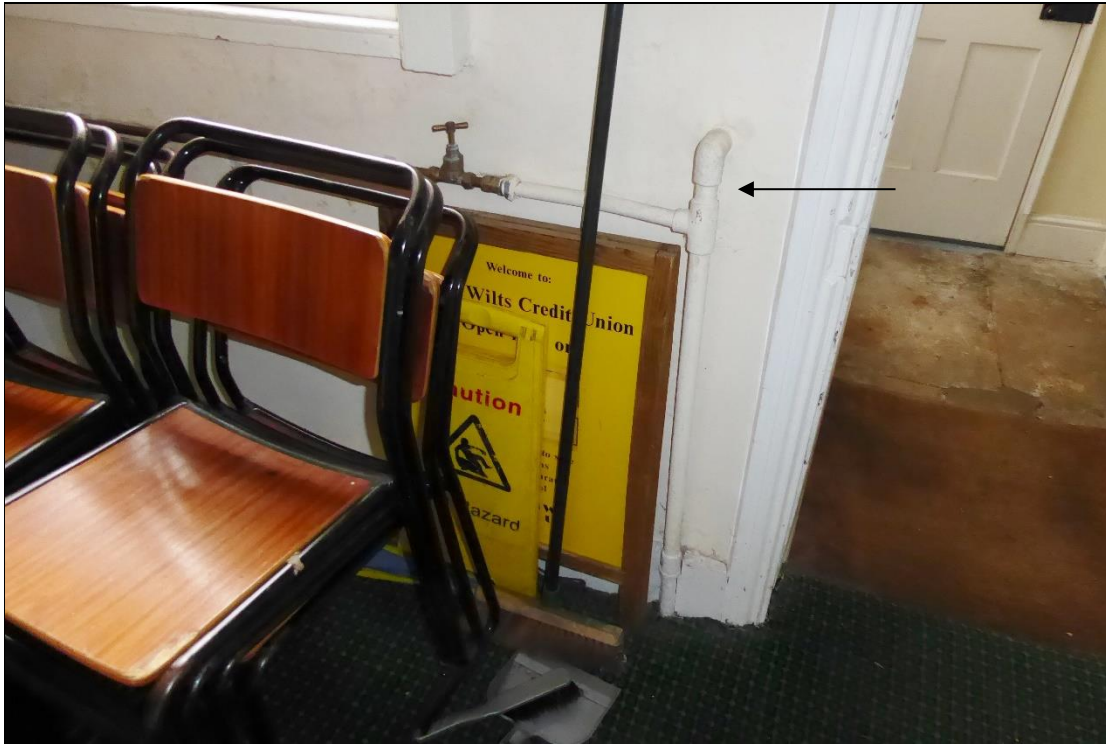
Is this the incoming main? Old metal pipes such as this tend to corrode particularly if the pipe is the one laid under ground to the public water main.

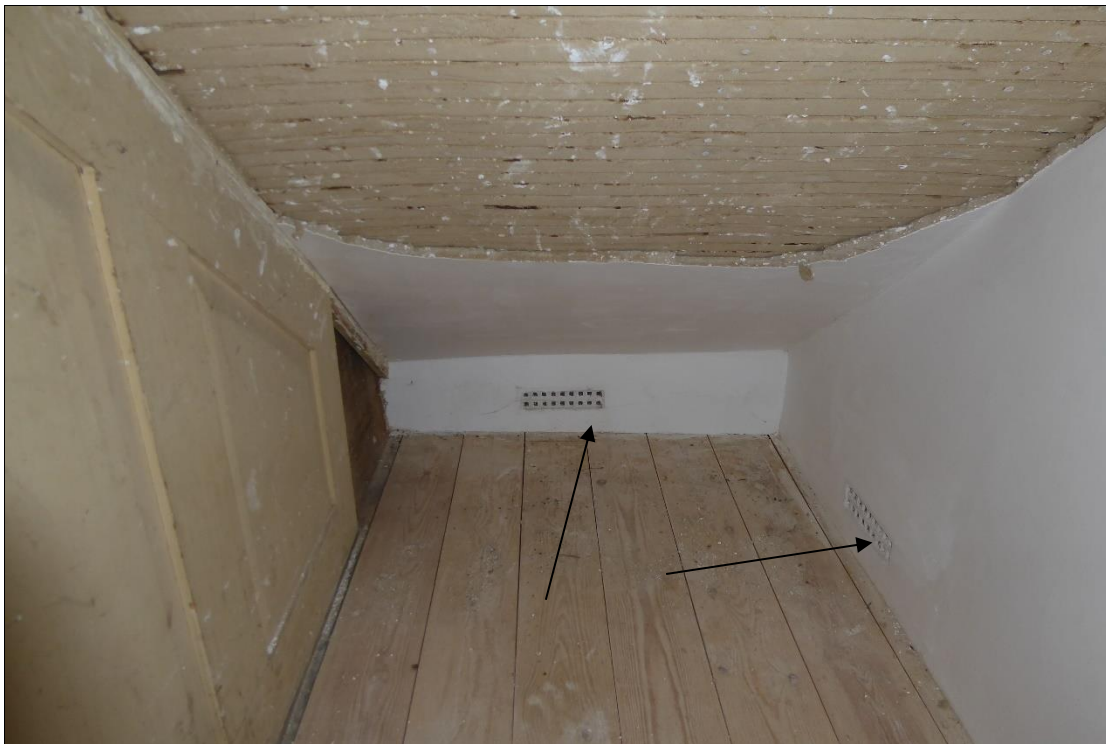
Ceiling collapse under the stairs not important. The vents are modern and serve the Shop floor void. The flooring looks modern.
