# ASBESTOS RE-INSPECTION SURVEY REPORT 2023

Grange Leisure Centre  
Grange Drive, Swindon, SN3 4JY

Merit Report J3102

Issue Date: 30<sup>th</sup> March 2023

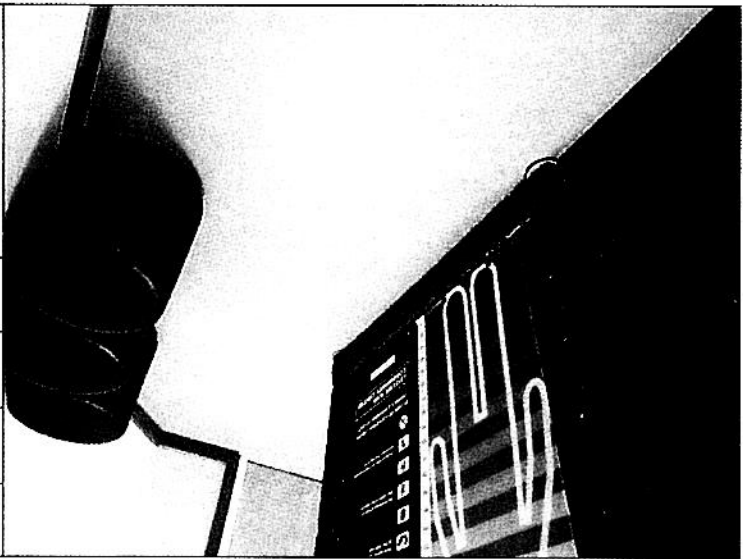
| Plan ref | Location | Position / Description | Product type | Sample number / AWS / SP / P | Sample Identification No Access or N.A.V.D. | Extent | Product type (1-3) | Damage / Deterioration (0-3) | Surface Treatment (0-3) | Asbestos Type (1-3) | Risk Rating (2-12) | Comments / Recommendation | Photo No. |
|---|---|---|---|---|---|---|---|---|---|---|---|---|---|
| GF03a | Soft Play (previously Bar) | Adhesive below vinyl and on concrete floor | Adhesive | SP | Chrysotile | 8 m2 | 1 | 0 | 0 | 1 | 2 | Manage and re-inspect on a regular basis | 1 |

| | | Photo Number | 1 | Sample Reference | Strongly Presumed | |
| | | Plan Ref | | GF03a | | |
| | | Location | Soft Play (previously Bar) | | | |
| | | Position / | Adhesive below vinyl and on concrete floor | | | |
| | | Comments / Recommendation | Manage and regularly re-inspect on a regular basis | | | |

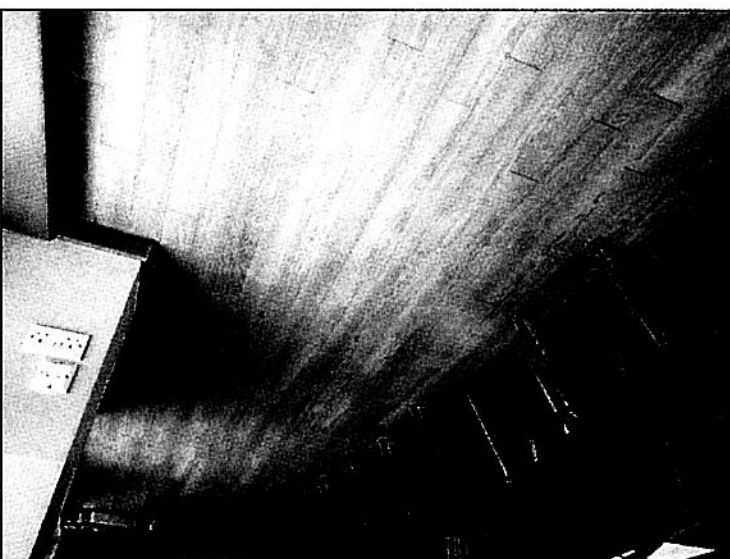
| Plan ref | Location | Position / Description | Product type | Sample number / AWS / SP / P | Sample Identification No Access or N.A.V.D. | Extent | Product type (1-3) | Damage / Deterioration (0-3) | Surface Treatment (0-3) | Asbestos Type (1-3) | Risk Rating (2-12) | Comments / Recommendation | Photo No. |
|---|---|---|---|---|---|---|---|---|---|---|---|---|---|
| GF14 | Meeting room (previously Office) | Adhesive below vinyl and on concrete floor | Adhesive | AWS22 | Chrysotile | 50 m2 | 1 | 0 | 0 | 1 | 2 | Manage and re-inspect on a regular basis | 4 |

| <div> <div>Photo Number</div> <div>4</div> </div> <div> <div>Sample Reference</div> <div>AWS22</div> </div> | <div>Plan Ref</div> <div>GF14</div> | <div>Location</div> <div>Meeting Room (previously Office)</div> | <div>Position / Description</div> <div>Adhesive below vinyl and on concrete floor</div> | <div>Comments / Recommendation</div> <div>Manage and regularly re-inspect on a regular basis</div> | |

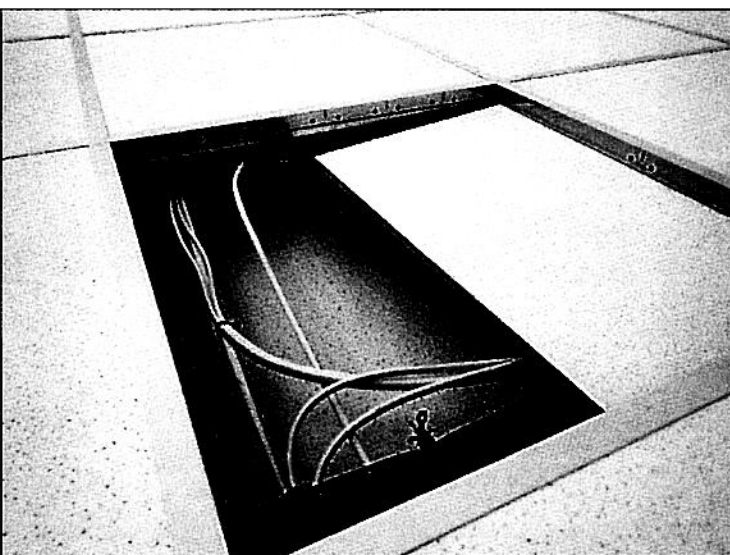
| Plan ref | Location | Position / Description | Product type | Sample number / AWS / SP / P | Sample Identification No Access or N.A.V.D. | Extent | Product type (1-3) | Damage / Deterioration (0-3) | Surface Treatment (0-3) | Asbestos Type (1-3) | Risk Rating (2-12) | Comments / Recommendation | Photo No. |
|---|---|---|---|---|---|---|---|---|---|---|---|---|---|
| GF14 | Meeting room (previously Office) | Above suspended ceiling on concrete | Textured Coating | AWS20 | Chrysotile | 50 m2 | 1 | 1 | 0 | 1 | 3 | Manage and re-inspect on a regular basis | 5 |

| <div> <div>Photo Number</div> <div>5</div> </div> <div> <div>Sample Reference</div> <div>AWS20</div> </div> | <div>Plan Ref</div> <div>GF14</div> | <div>Location</div> <div>Meeting Room (previously Office)</div> | <div>Position / Description</div> <div>Textured Coating on concrete to ceiling above suspended ceiling</div> | <div>Comments / Recommendation</div> <div>Manage and regularly re-inspect on a regular basis</div> | |

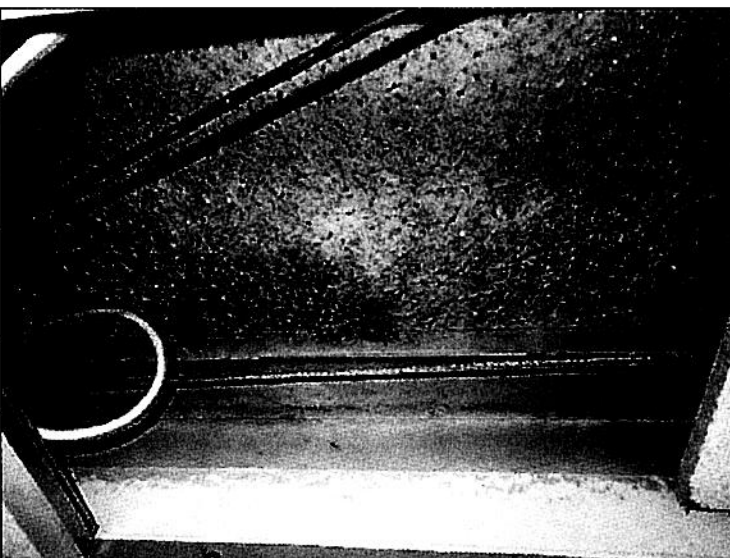
| Plan ref | Location | Position / Description | Product type | Sample number / AWS / SP / P | Sample Identification No Access or N.A.V.D. | Extent | Product type (1-3) | Damage / Deterioration (0-3) | Surface Treatment (0-3) | Asbestos Type (1-3) | Risk Rating (2-12) | Comments / Recommendation | Photo No. |
|---|---|---|---|---|---|---|---|---|---|---|---|---|---|
| GF15 | Server Room | Above suspended ceiling on concrete | Textured Coating | S20 | Chrysotile | | 1 | 1 | 0 | 1 | 3 | Manage and re-inspect on a regular basis | 6, 7 |

| <div> <div>Photo Number</div> <div>6</div> </div> <div> <div>Sample Reference</div> <div>S20</div> </div> | <div>Plan Ref</div> <div>GF15</div> | <div>Location</div> <div>Server Room</div> | <div>Position / Description</div> <div>Textured Coating on concrete to ceiling above suspended ceiling</div> | <div>Comments / Recommendation</div> <div>Manage and regularly re-inspect on a regular basis</div> | |

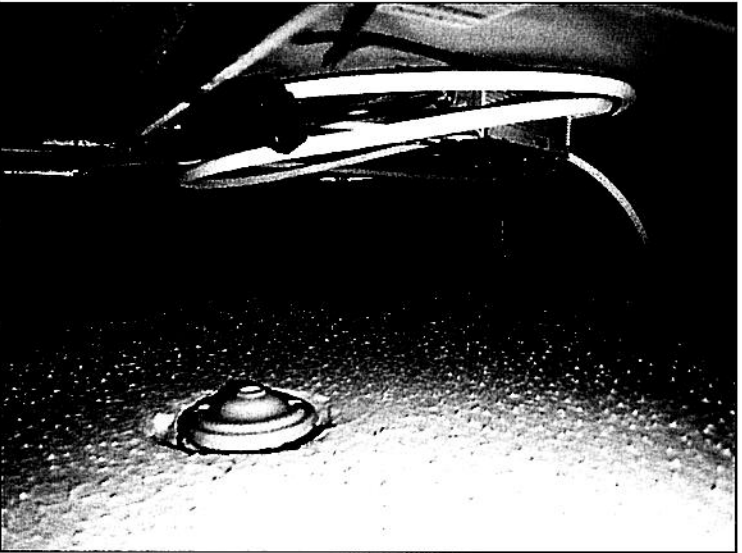
| Plan ref | Location | Position / Description | Product type | Sample number / AWS / SP / P | Sample Identification No Access or N.A.V.D. | Extent | Product type (1-3) | Damage / Deterioration (0-3) | Surface Treatment (0-3) | Asbestos Type (1-3) | Risk Rating (2-12) | Comments / Recommendation | Photo No. |
|---|---|---|---|---|---|---|---|---|---|---|---|---|---|
| GF16 | Meeting room (previously) | Above suspended ceiling on | Textured Coating | AWS20 | Chrysotile | | 1 | 1 | 0 | 1 | 3 | Manage and re-inspect on a regular | 8 |

| | Photo Number | 8 | Sample Reference | AWS20 |
| | Plan Ref | GF16 | | |
| | Location | Meeting Room (previously Office) | | |
| | Position / Description | Textured Coating on concrete to ceiling above suspended ceiling | | |
| | Comments / Recommendation | Manage and regularly re-inspect on a regular basis | | |

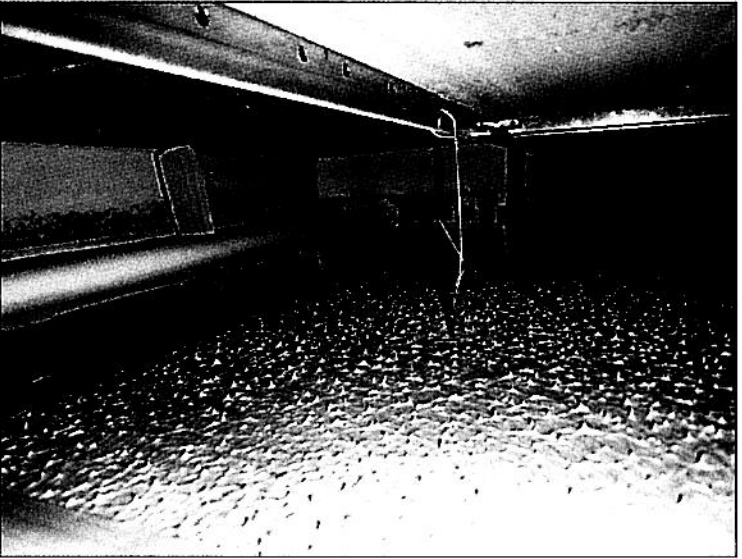
| Plan ref | Location | Position / Description | Product type | Sample number / AWS / SP / P | Sample Identification No Access or N.A.V.D. | Extent | Product type (1-3) | Damage / Deterioration (0-3) | Surface Treatment (0-3) | Asbestos Type (1-3) | Risk Rating (2-12) | Comments / Recommendation | Photo No. |
|---|---|---|---|---|---|---|---|---|---|---|---|---|---|
| GF17 | Meeting room (previously Office) | Above suspended ceiling on concrete | Textured Coating | AWS10 | Chrysotile | | 1 | 1 | 0 | 1 | 3 | Manage and re-inspect on a regular basis | 9 |

| | Photo Number | 9 | Sample Reference | AWS10 |
| | Plan Ref | GF17 | | |
| | Location | Meeting Room (previously Office) | | |
| | Position / Description | Textured Coating on concrete to ceiling above suspended ceiling | | |
| | Comments / Recommendation | Manage and regularly re-inspect on a regular basis | | |

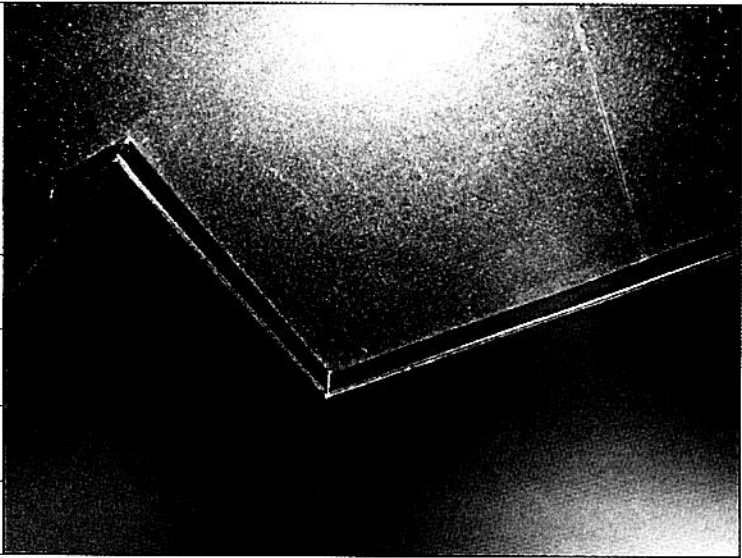
| Plan ref | Location | Position / Description | Product type | Sample number / AWS / SP / P | Sample Identification No Access or N.A.V.D. | Extent | Product type (1-3) | Damage / Deterioration (0-3) | Surface Treatment (0-3) | Asbestos Type (1-3) | Risk Rating (2-12) | Comments / Recommendation | Photo No. |
|---|---|---|---|---|---|---|---|---|---|---|---|---|---|
| GF26 | Spinning Room (previously Store) | Adhesive to vinyl tiles and on concrete floor below vinyl | Adhesive | S16 | Chrysotile | 30 m2 | 1 | 0 | 0 | 1 | 2 | Manage and re-inspect on a regular basis | 13 |

| | Photo Number | 13 | Sample Reference | S16 |
| | Plan Ref | GF26 | | |
| | Location | Spinning Room (Previously Store) | | |
| | Position / Description | Adhesive below vinyl and on concrete floor | | |
| | Comments / Recommendation | Manage and regularly re-inspect on a regular basis | | |

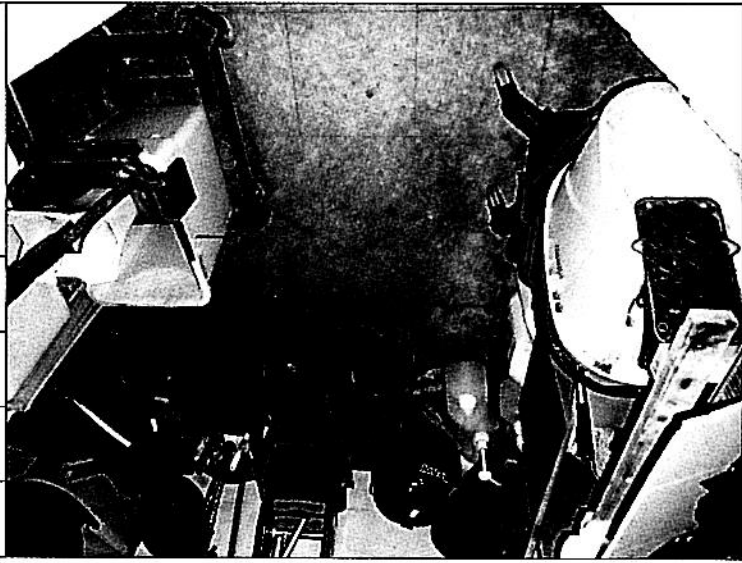
| plan ref | Location | Position / Description | Product type | Sample number / AWS / SP / P | Sample Identification No Access or N.A.V.D. | Extent | Product type (1-3) | Damage / Deterioration (0-3) | Surface Treatment (0-3) | Asbestos Type (1-3) | Risk Rating (2-12) | Comments / Recommendation | Photo No. |
|---|---|---|---|---|---|---|---|---|---|---|---|---|---|
| GF28 | Store | Adhesive to vinyl tiles and on concrete floor | Adhesive | AWS16 | Chrysotile | 2 m2 | 1 | 0 | 0 | 1 | 2 | Manage and re-inspect on a regular basis | 15 |

| | Photo Number | 15 | Sample Reference | AWS16 |
| | Plan Ref | GF28 | | |
| | Location | Store | | |
| | Position / Description | Adhesive below vinyl and on concrete floor | | |
| | Comments / Recommendation | Manage and regularly re-inspect on a regular basis | | |

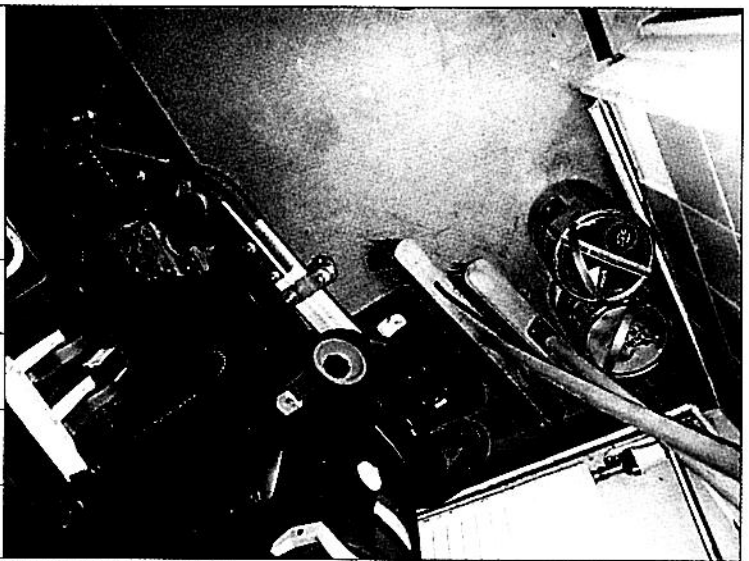
| plan ref | Location | Position / Description | Product type | Sample number / AWS / SP / P | Sample Identification No Access or N.A.V.D. | Extent | Product type (1-3) | Damage / Deterioration (0-3) | Surface Treatment (0-3) | Asbestos Type (1-3) | Risk Rating (2-12) | Comments / Recommendation | Photo No. |
|---|---|---|---|---|---|---|---|---|---|---|---|---|---|
| GF29 | Store | Adhesive to vinyl tiles and on concrete floor | Adhesive | AWS16 | Chrysotile | 2 m2 | 1 | 0 | 0 | 1 | 2 | Manage and re-inspect on a regular basis | 16 |

| Photo Number | | 16 | Sample Reference | AWS16 |
| Plan Ref | | GF29 | | |
| Location | | Store | | |
| Position / Description | | Adhesive below vinyl and on concrete floor | | |
| Comments / Recommendation | | Manage and regularly re-inspect on a regular basis | | |
