Our Ref: 18258/EO/RPT/01  
Date: 06 October 2025

**Re: 18258 – Cherry Lodge Farm, Shrewton, Wiltshire, SP3 4ET**

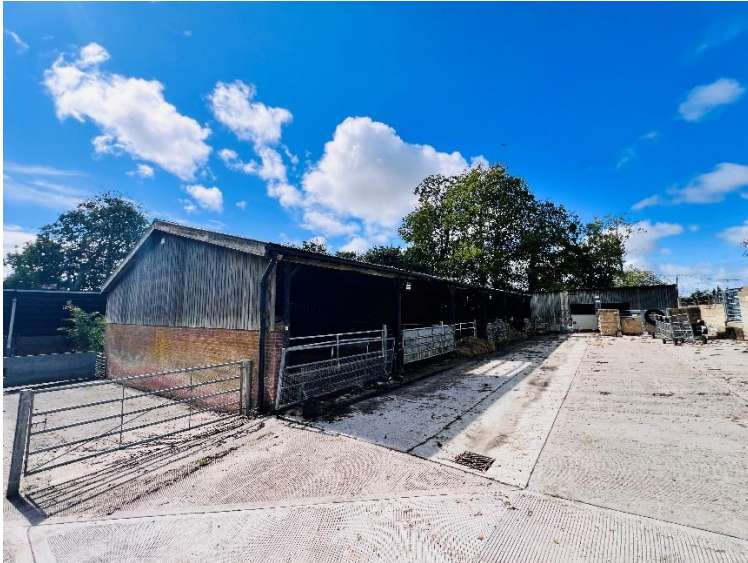
Photograph 01

The purlins in the penultimate bay adjacent to the front elevation of the building could be seen to have sustained significant damage and were visibly distorted; these are likely no longer providing any restraint to the principal rafters of the steel portal frames on either side of the affected bay.

The cladding in the affected bay was missing, leaving the internal building envelope and structural steelwork of the portal frames exposed to the elements.

Cherry Lodge Farm, Shrewton, Wiltshire, SP3 4ET  
Damaged Roof

- ***Replaced the damaged purlins with like-for-like cold-formed metal purlins; these should be adequately bolted with metal cleats to the top of the principal rafters of the steel portal frame.***
- ***The missing cladding in the affected bay should be replaced with like-for-like cladding panels and/or lightweight corrugated plastic covering.***

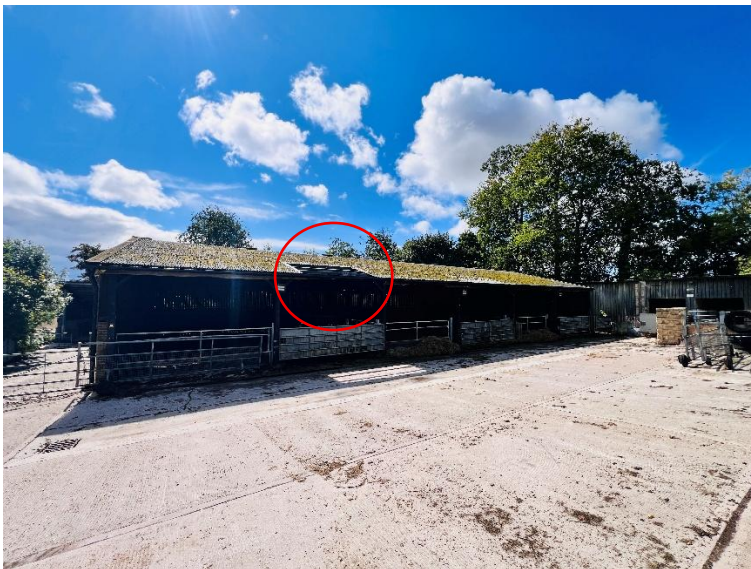
Photograph 02

Cherry Lodge Farm, Shrewton, Wiltshire, SP3 4ET  
Damaged Roof

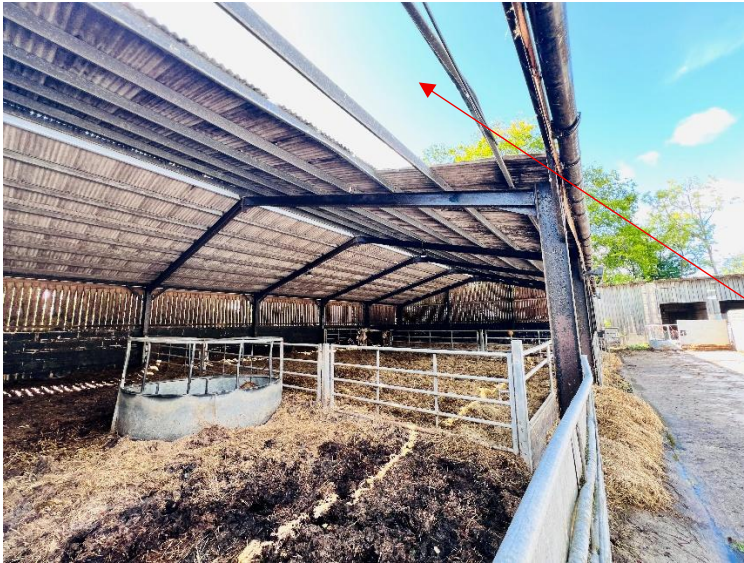
Photograph 03

Cherry Lodge Farm, Shrewton, Wiltshire, SP3 4ET  
Damaged Roof

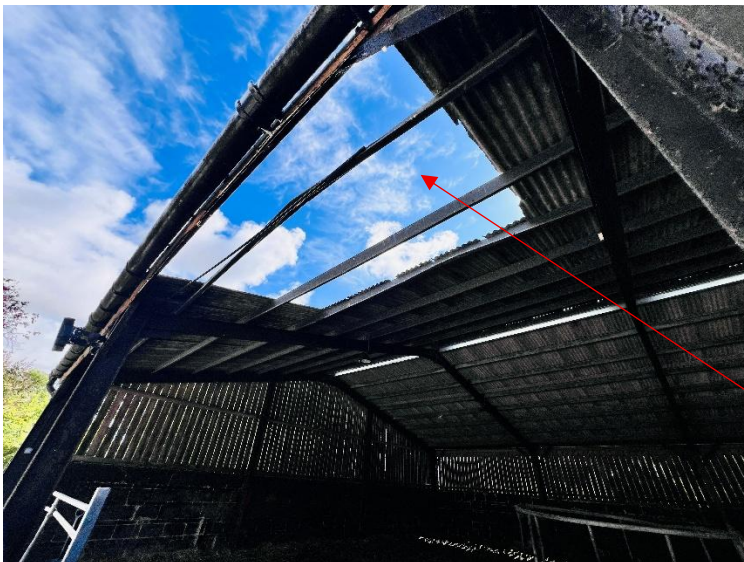
Photograph 05

Cherry Lodge Farm, Shrewton, Wiltshire, SP3 4ET  
Damaged Roof
