Asbestos Refurbishment Survey Report

Environment Agency Unit A
Halfords Park Halfords Lane
Smethwick B66 1EL

Name and address of site:	Environment Agency Unit A, Halfords Park Halfords Lane, Smethwick B66 1EL		
Name and address of client:	McAndrew Martin Ltd, Trafalgar House, 11 Acorn Business Centre, Northarbour Road, Portsmouth,		
Client contact:	Yamin Ahmed		
Type of survey:	Asbestos Refurbishment Survey (with MA only)		
Date of survey:	18 Dec 2023		
Report Revision Number:	1		
TEAMS internal job number:	J003778		
Lead surveyor[s]:	Cleaveland Calixte	Signature:

Service Type	Asbestos Refurbishment Survey		
Report Revision Number	1	Surveyors	Cleaveland Calixte
TEAMS Job Number	J003778	Survey Date	18 Dec 2023 to 20 Dec 2023
Site Address:	Environment Agency Unit A Halfords Park Halfords Lane Smethwick B66 1EL	Bulk Analysis Laboratory	N/A
		Sample Analysis Date	2 Jan 2024

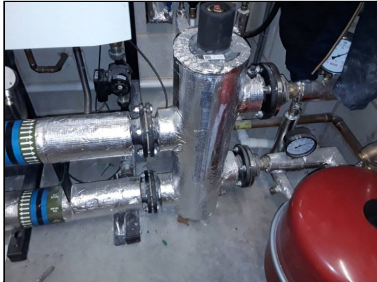
Survey Date:	Lead Surveyor	Survey Type	Floor	Analysis
	18 Dec 2023 to 20 Dec 2023	Cleaveland Calixte	Refurbishment Survey	Ground Floor	No Asbestos Detected
	Building	Room	Item	Quantity	
	Environmental Agencie, Unit A, Halfords Lane	Boiler room 001	Gaskets To pipework	6no.	
	Sample No (S,SP,P,As)	Product Type	Surface Treatment	Condition	Accessibility
	JR007088 (S)	N/A	N/A	N/A	N/A
	Material Risk Score				
	N/A				
Recommended action	No further action required				
Surveyor comments	N/A
