# Asbestos Management Survey Report

Pembroke Gardens Recreation Ground, Moredon, Swindon, SN25 3EN

| Date of Survey: | 11 Mar 2015 |

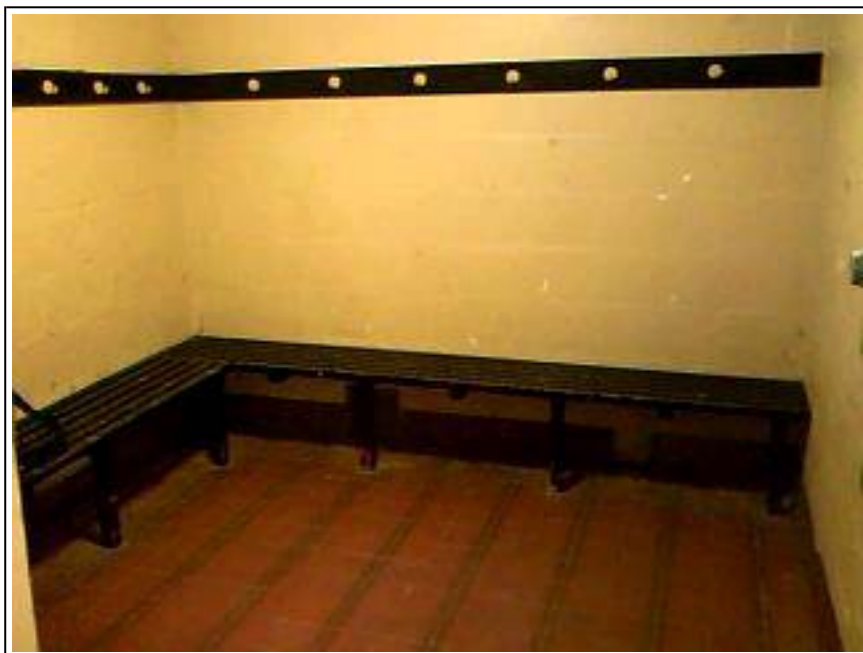
Survey Data Sheet: Conclusions & Recommendations  
 Site Location: Pembroke Gardens Recreation Ground, Moredon, Swindon, SN25 3EN  
 Unique item Number: 1

| Sample Ref | Fl | Location | Description | Qty | Analysis Result | Total M.A.S | Licensed Material Y/N |
|---|---|---|---|---|---|---|---|
| Surveyed | Ground Floor | Changing Room. 001 | No asbestos detected - | | N/A | | N |

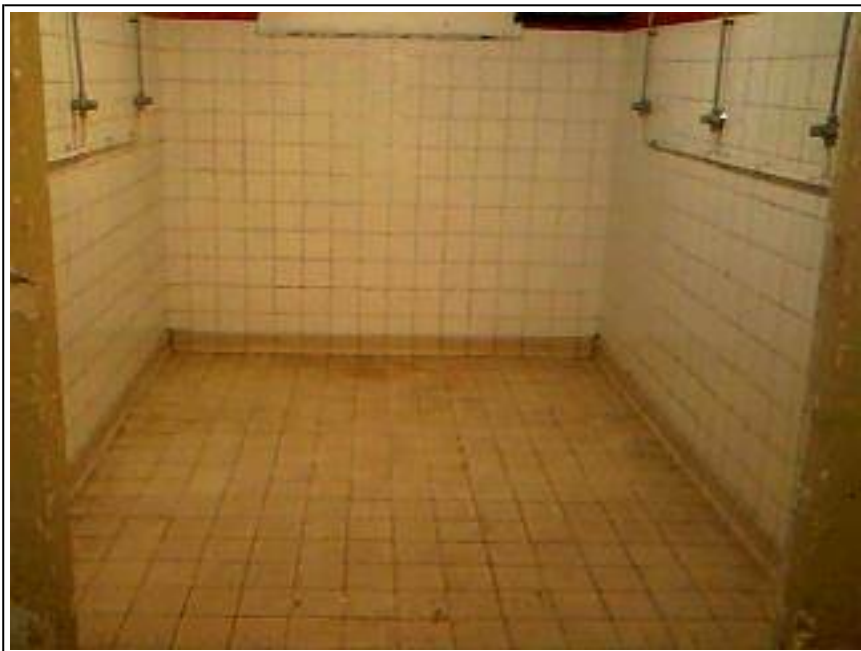
Survey Data Sheet: Conclusions & Recommendations  
 Site Location: Pembroke Gardens Recreation Ground, Moredon, Swindon, SN25 3EN  
 Unique item Number: 2

| Sample Ref | Fl | Location | Description | Qty | Analysis Result | Total M.A.S | Licensed Material Y/N |
|---|---|---|---|---|---|---|---|
| Surveyed | Ground Floor | Showers. 002 | No asbestos detected - | | N/A | | N |

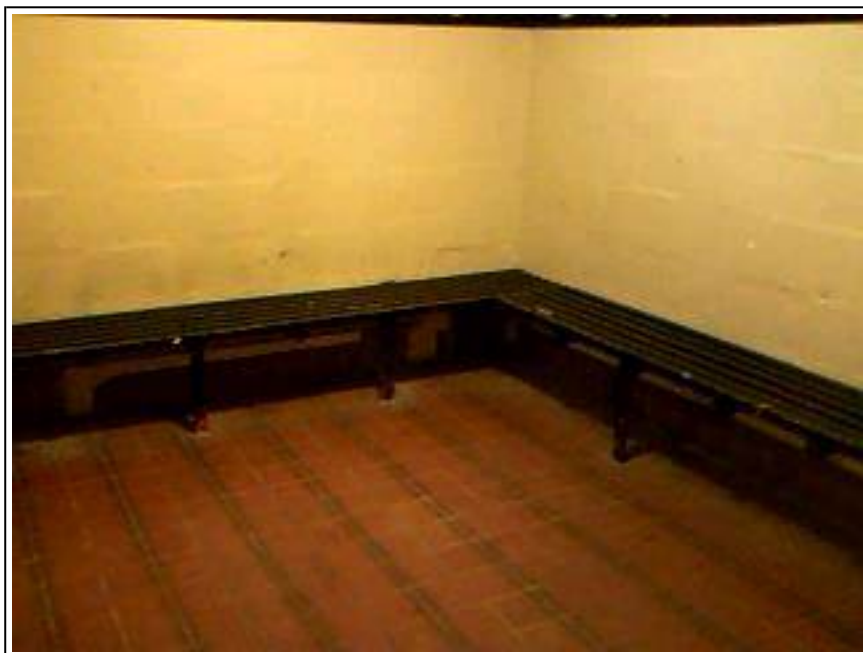
Survey Data Sheet: Conclusions & Recommendations  
 Site Location: Pembroke Gardens Recreation Ground, Moredon, Swindon, SN25 3EN  
 Unique item Number: 3

| Sample Ref | FI | Location | Description | Qty | Analysis Result | Total M.A.S | Licensed Material Y/N |
|---|---|---|---|---|---|---|---|
| Surveyed | Ground Floor | Changing Room. 003 | No asbestos detected - | | N/A | | N |

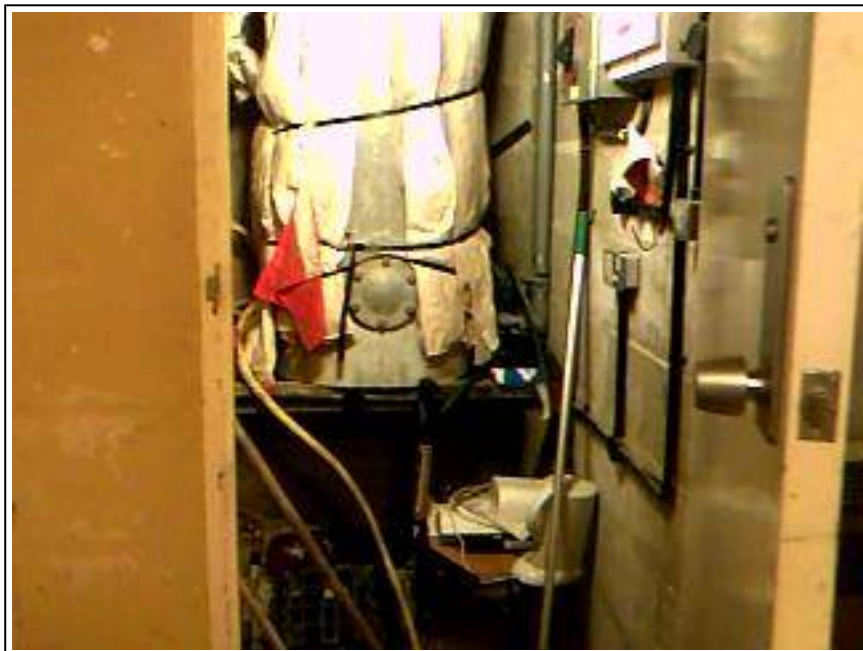
Survey Data Sheet: Conclusions & Recommendations  
 Site Location: Pembroke Gardens Recreation Ground, Moredon, Swindon, SN25 3EN  
 Unique item Number: 4

| Sample Ref | FI | Location | Description | Qty | Analysis Result | Total M.A.S | Licensed Material Y/N |
|---|---|---|---|---|---|---|---|
| Surveyed | Ground Floor | Boiler Cupboard. 004 | No asbestos detected - | | N/A | | N |

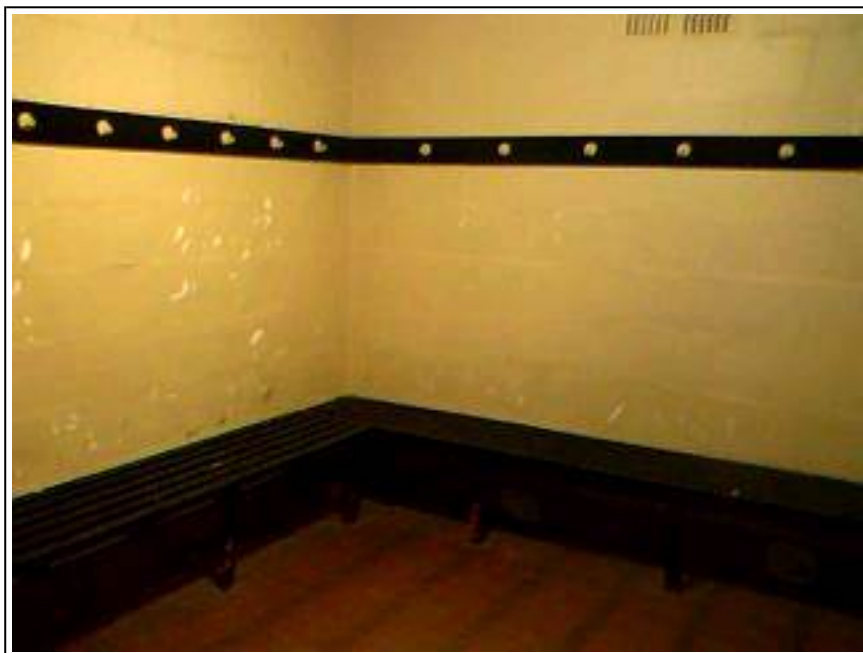
Survey Data Sheet: Conclusions & Recommendations  
 Site Location: Pembroke Gardens Recreation Ground, Moredon, Swindon, SN25 3EN  
 Unique item Number: 5

| Sample Ref | Fl | Location | Description | Qty | Analysis Result | Total M.A.S | Licensed Material Y/N |
|---|---|---|---|---|---|---|---|
| Surveyed | Ground Floor | Changing Room. 005 | No asbestos detected - | | N/A | | N |

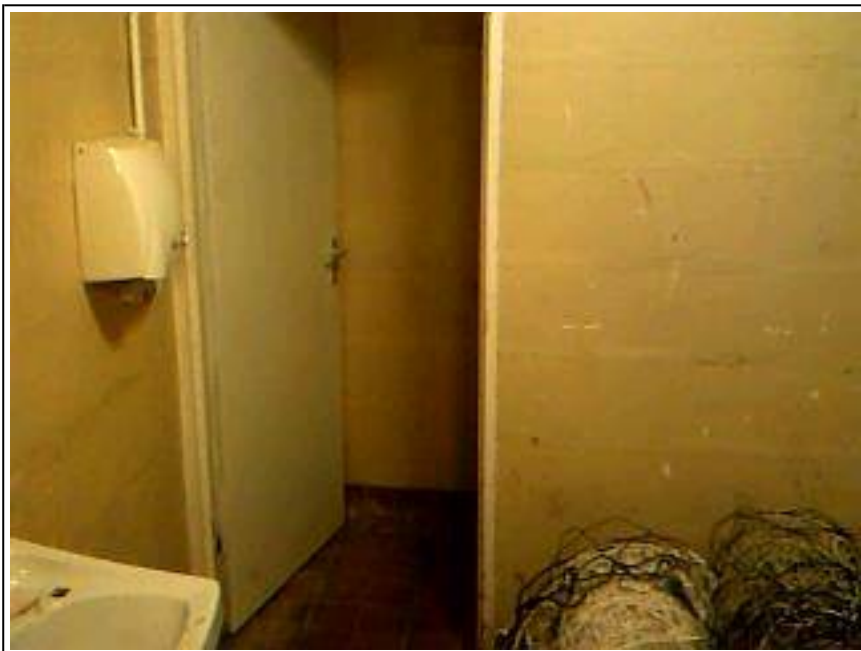
Survey Data Sheet: Conclusions & Recommendations  
 Site Location: Pembroke Gardens Recreation Ground, Moredon, Swindon, SN25 3EN  
 Unique item Number: 6

| Sample Ref | Fl | Location | Description | Qty | Analysis Result | Total M.A.S | Licensed Material Y/N |
|---|---|---|---|---|---|---|---|
| Surveyed | Ground Floor | WC. 006 | No asbestos detected - | | N/A | | N |

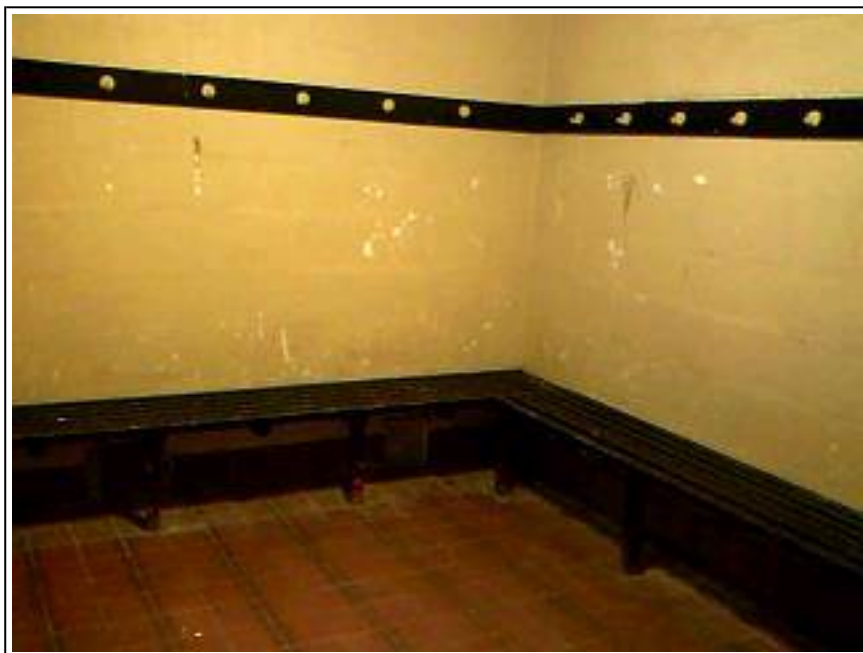
Survey Data Sheet: Conclusions & Recommendations  
 Site Location: Pembroke Gardens Recreation Ground, Moredon, Swindon, SN25 3EN  
 Unique item Number: 7

| Sample Ref | Fl | Location | Description | Qty | Analysis Result | Total M.A.S | Licensed Material Y/N |
|---|---|---|---|---|---|---|---|
| Surveyed | Ground Floor | Changing Room. 007 | No asbestos detected - | | N/A | | N |

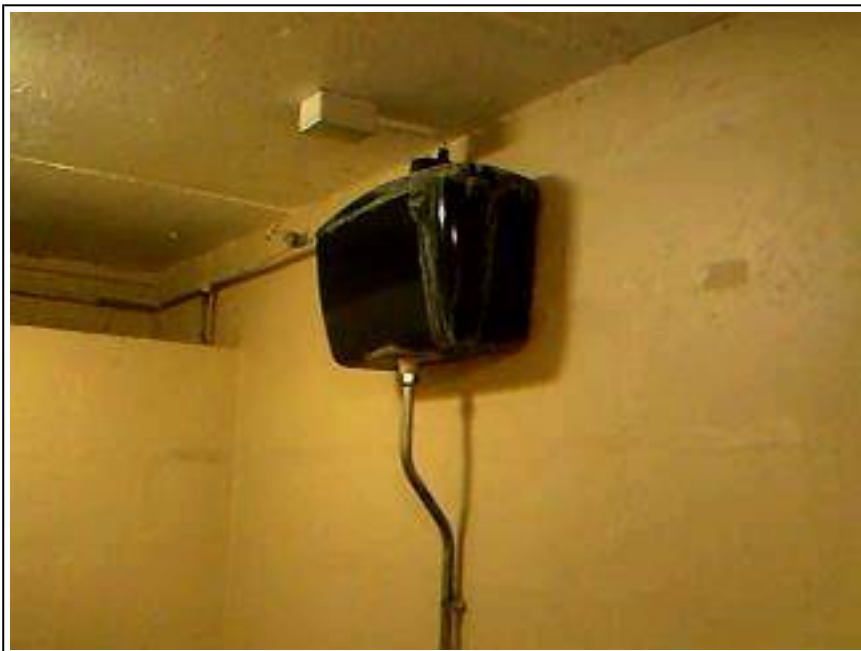
Survey Data Sheet: Conclusions & Recommendations  
 Site Location: Pembroke Gardens Recreation Ground, Moredon, Swindon, SN25 3EN  
 Unique item Number: 8

| Location | FI | Asbestos Containing Material | M.A.S | Recommended Action |
|---|---|---|---|---|
| Circulation. 008 | Gr | Wall - Cistern REFER PREVIOUSLY SAMPLED (ENSB01) - Reinforced Composite | 3 | Leave & Manage |

| Sample Ref | FI | Location | Description | Qty | Analysis Result | Total M.A.S | Licensed Material Y/N |
|---|---|---|---|---|---|---|---|
| ENSB01 | Ground Floor | Circulation. 008 | Wall - Cistern - Reinforced Composite | 1no. | Amosite | 3 | N |

This material may remain in situ and be managed accordingly. Undertake continued regular recorded inspections on the condition of the material as dictated in the asbestos register and management plan. No drilling, cutting or any abrasive actions should take place on this material.

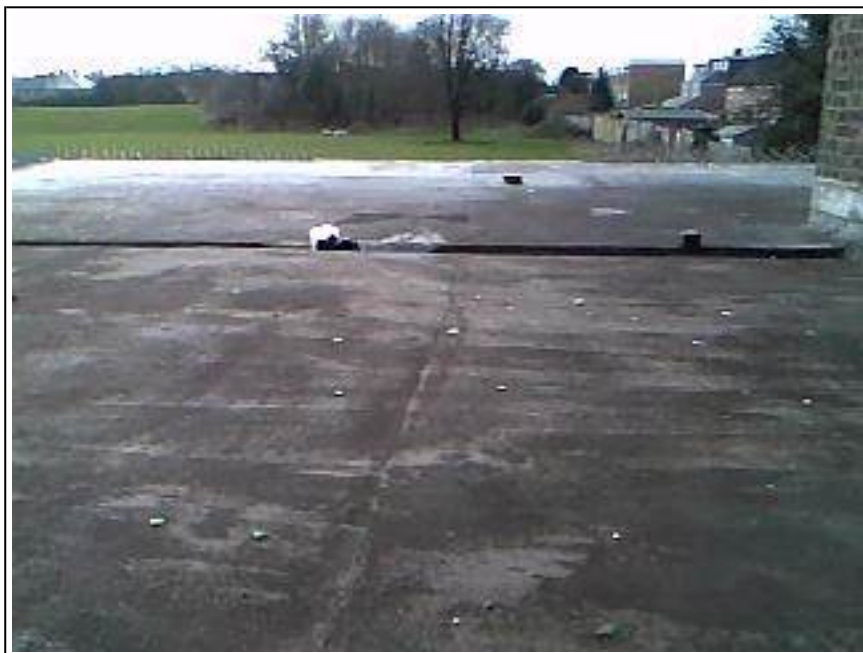
Survey Data Sheet: Conclusions & Recommendations  
 Site Location: Pembroke Gardens Recreation Ground, Moredon, Swindon, SN25 3EN  
 Unique item Number: 9

| Sample Ref | FI | Location | Description | Qty | Analysis Result | Total M.A.S | Licensed Material Y/N |
|---|---|---|---|---|---|---|---|
| AD005531 | External | External | Roof - Felt - Well Bound Material | 50m <sup>2</sup> | NADIS | | N |
