## ASBESTOS REINSPECTION SURVEY REPORT

**Customer:** Swindon Borough Council  
**Site:** Moredon Recreation Ground Changing Room & Pavilion  
Akers Way  
Moredon  
Swindon  
Wiltshire, SN2 2NF  
**Date:** 21st November 2018  
**Report No:** J024539

Project: Asbestos Reinspection Survey

Report Reference: J024539

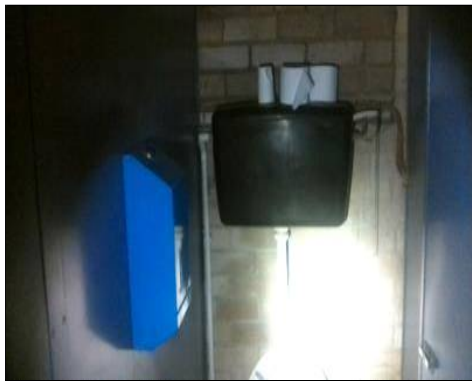
| Location: | Ground Floor - Shower Area 002 | | | |
| Description: | Toilet cistern to wall | | | |
| Asbestos Type: | Amosite (2) | | | |
| Condition: | Unknown (1) | | | |
| Risk Assessment (H/M/L/VL) | High | Recommendations: | Manage and arrange access | |
| General findings since the last survey/re-inspection. | | | | Unable to Access –Locked at the time of inspection presumed it be the same. |

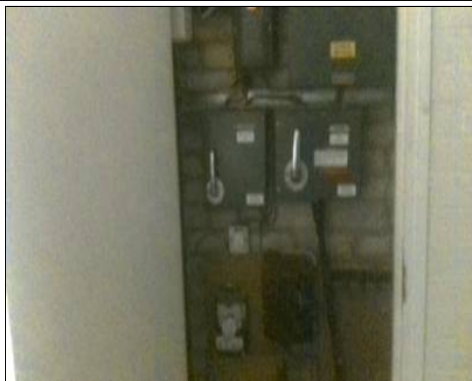
| Location: | Ground Floor - Electrical cupboard 006 | | | |
| Description: | Flashguards to electrical switchgear | | | |
| Asbestos Type: | Chrysotile (1) | | | |
| Risk Assessment (H/M/L/VL) | High | Recommendations: | Manage and arrange access | |
| General findings since the last survey/re-inspection. | | | | Unable to Access |

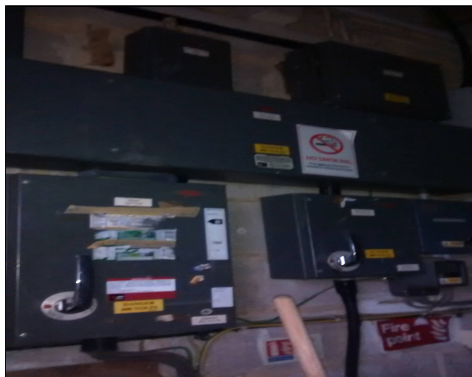
| Location: | Ground Floor - Plant room 010 | | | |
| Description: | Electrical switchgear boxes to wall | | | |
| Asbestos Type: | P Chrysotile (1) | | | |
| Condition: | Low Damage (1) | | | |
| Risk Assessment (H/M/L/VL) | Low | Recommendations: | Manage and inspect periodically | |
| General findings since the last survey/re-inspection. | | | | No Change –Recommended action has been updated. It is presumed flash guards are present but further ACM may be present upon further investigation. |
| Comments | No access due to live electrics - presume ACMs within - exercise caution | | | |

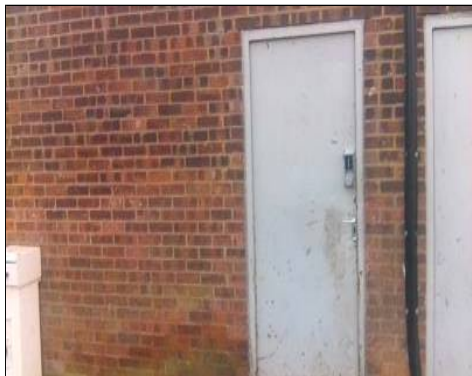
| Location: | | Ground Floor - Store 015 | | |
| Description: | | No access - presumed ACMs to stores | | |
| Risk Assessment (H/M/L/VL) | | High | Recommendations: | Manage and arrange access |
| General findings since the last survey/re-inspection. | | | | Unable to Access |
| Comments | | No access within stores - no key available - presumed ACMs within - exercise caution | | |

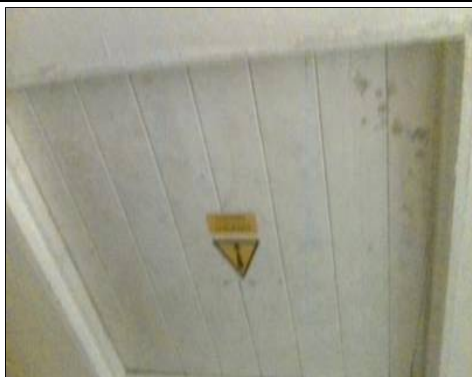
| Location: | Roof Void - Attic | | | |
| Description: | Loft hatch to ceiling | | | |
| Risk Assessment (H/M/L/VL) | High | Recommendations: | Manage and arrange access | |
| General findings since the last survey/re-inspection. | | | | Unable to Access |
| Comments | No access due to safety restrictions - presumed ACMs within - exercise caution | | | |
