Ground Floor Layout - Services - Changing 2 1:25

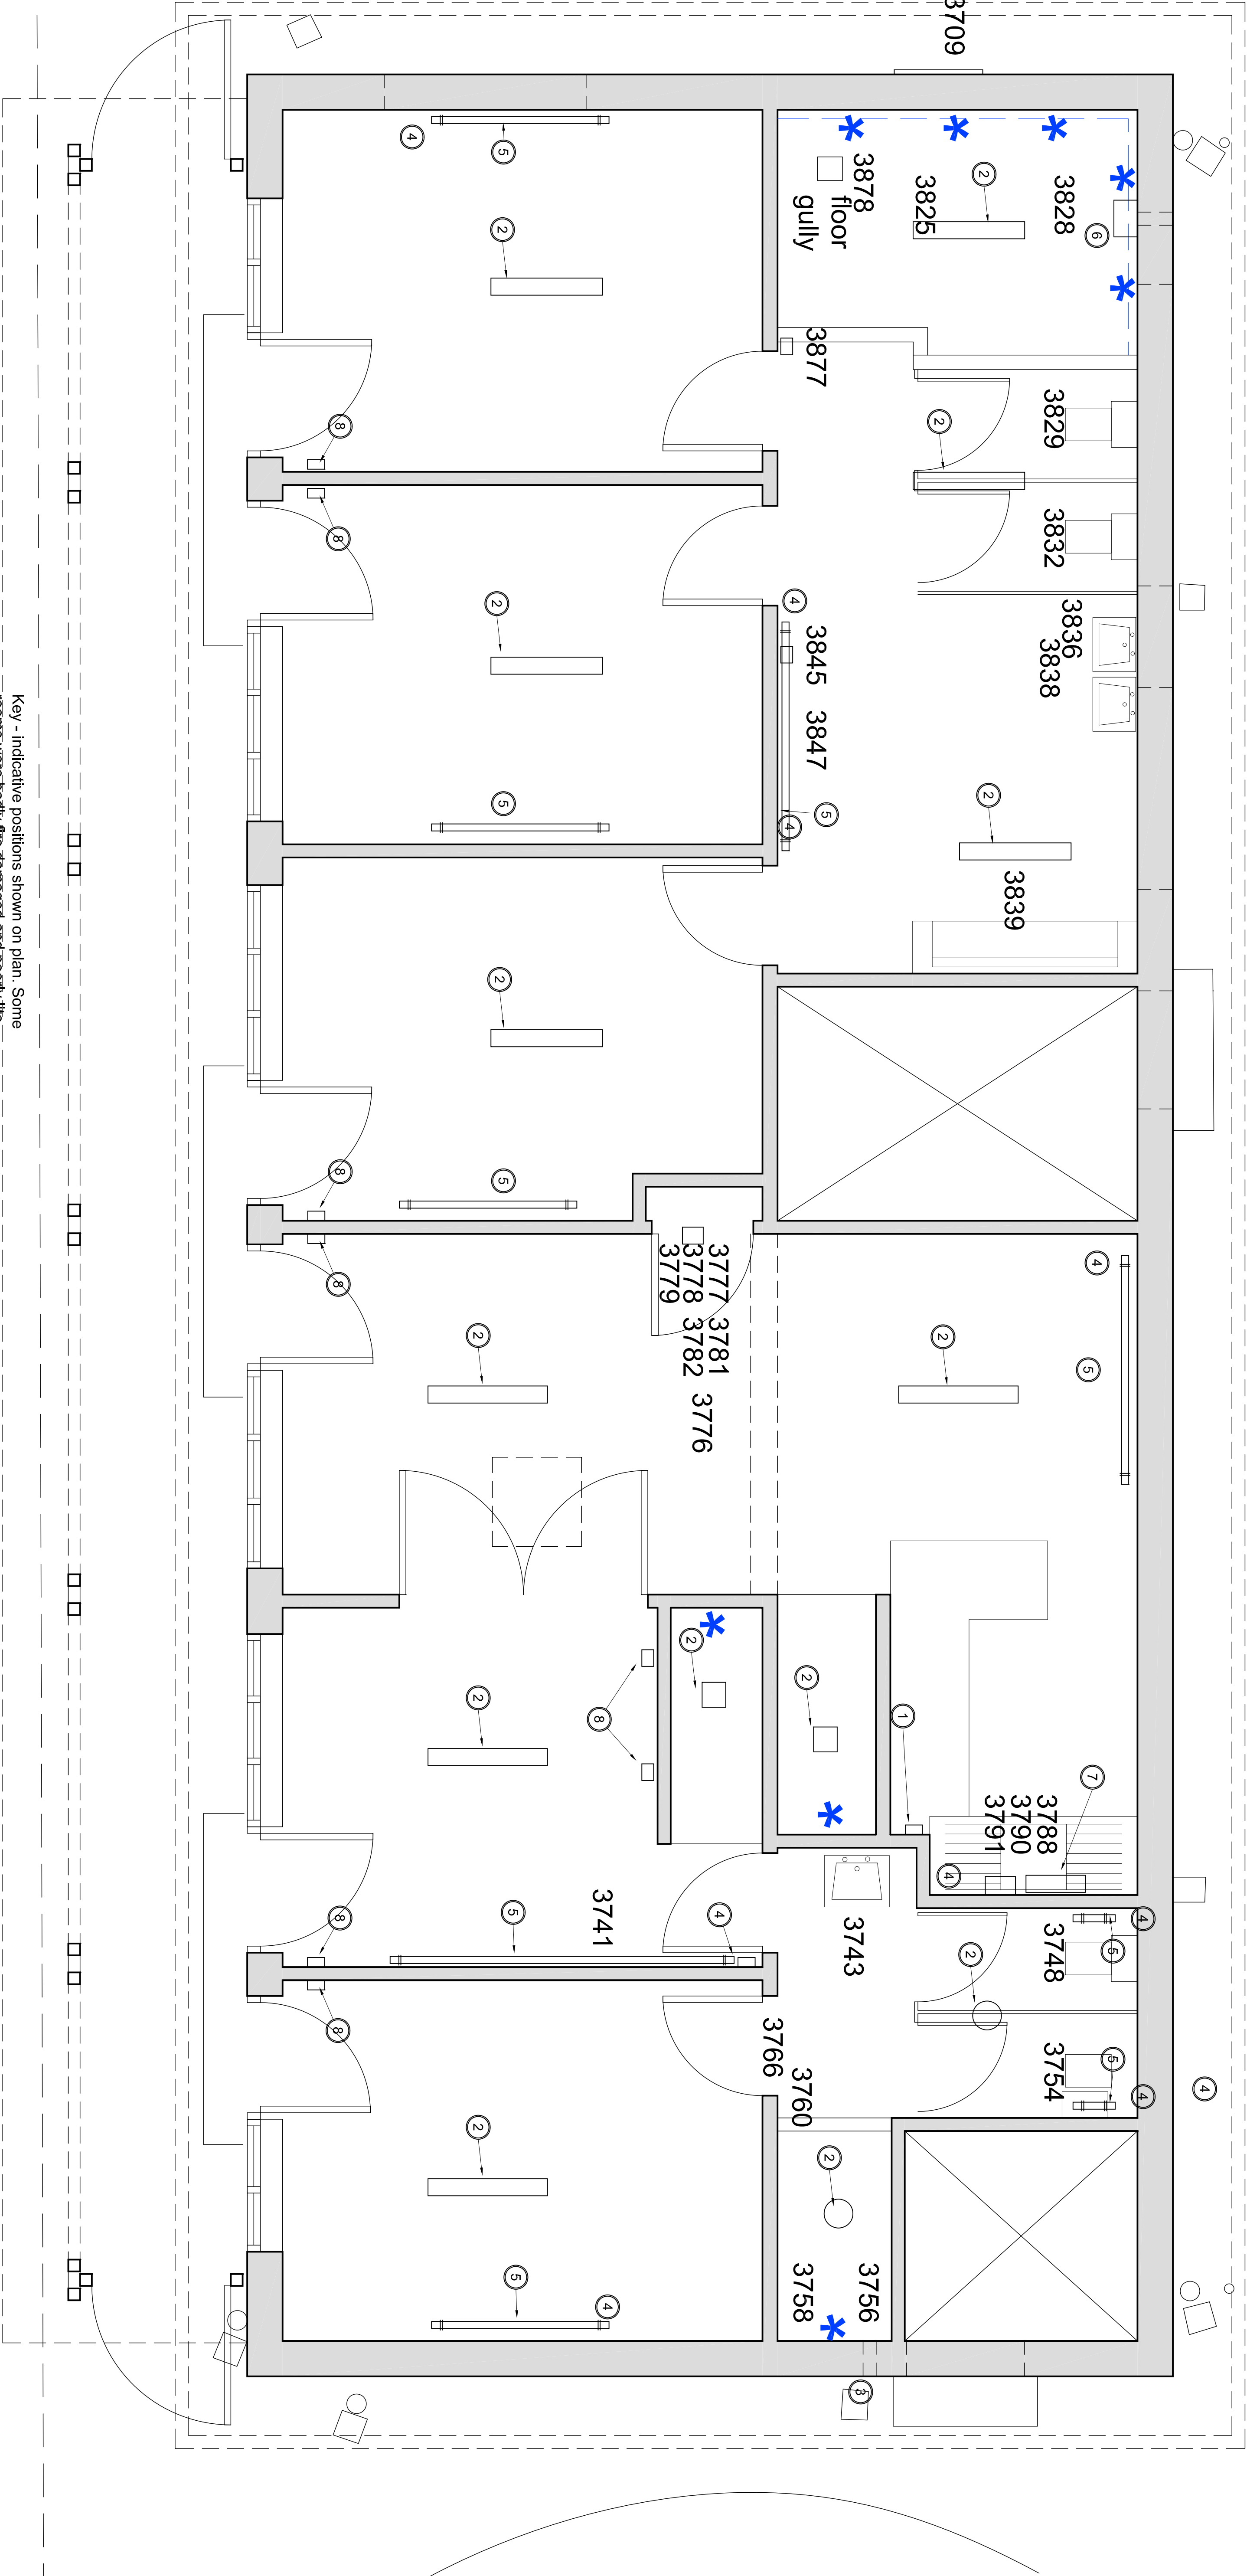
Key - Indicative positions shown on plan. Some rooms were badly fire damaged and poorly fit.

- 1 Double Socket  
see photo 3677
- 2 Light fitting  
see photo 3839
- 3 Vent  
see photo 3756
- 4 Spur outlet  
see photo 3847
- 5 Heater  
see photo 3741, 3847
- 6 Extractor  
see photo 3828
- 7 Water Heater  
see photo 3788
- 8 Light switch
