<b>Project:</b>	Chippenham Town Hall and Neeld Hall Decarbonisation	Queen Square House
<b>Subject:</b>	Neeld Hall Heating Condition Survey Findings	18-21 Queen Square
<b>Document Ref:</b>	4887 DSN02	Bristol
<b>Date:</b>	12 Nov 25	BS1 4NH
		0117 238 0909

## 2.2 Survey Pictures

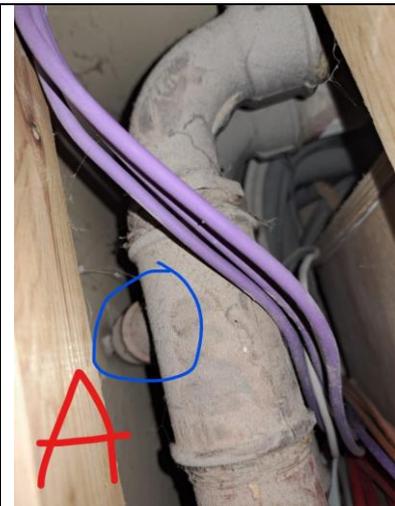
<p>A, shows the pipework running around the Tech Deck with a tee dropping to feed a radiator in the store area. Sizes are 1 1/2 with a 1/2 drop to low level and carrying on round in 1 1/4.</p>

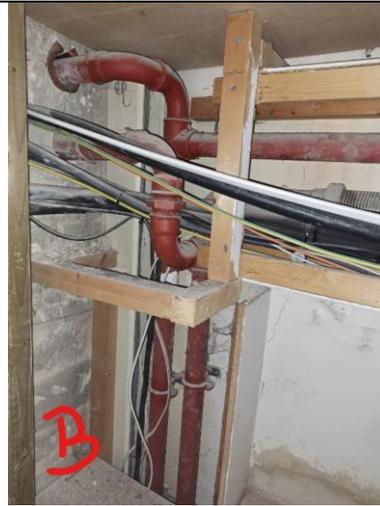
B, shows what is behind the boxing in the corner of the Tech Deck area. 2 x 1 1/2 carrying on along at high level and dropping to low level to feed the radiators.

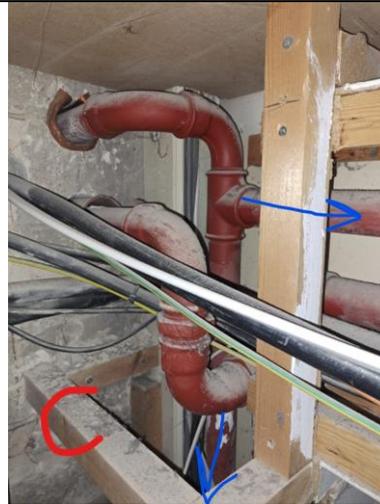
C, as above

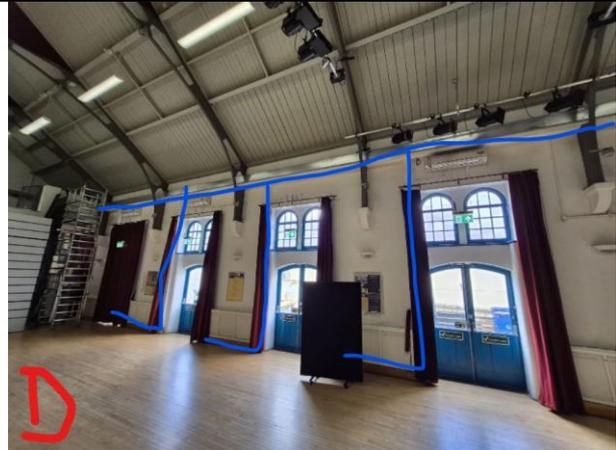
D, shows the existing routes of the pipework for radiators on the wall (outside wall).

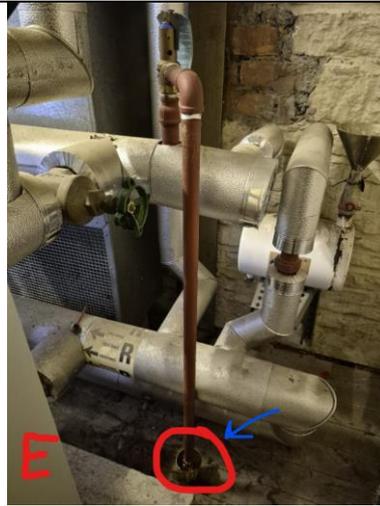
"We started to investigate the pipework starting at the plant room exploring through the floors and ceilings. Safety valve attached to the back of the boiler was passing and had water in a drip tray that had been previously placed there by others.

E, shows the passing safety valve and cup filled with water.

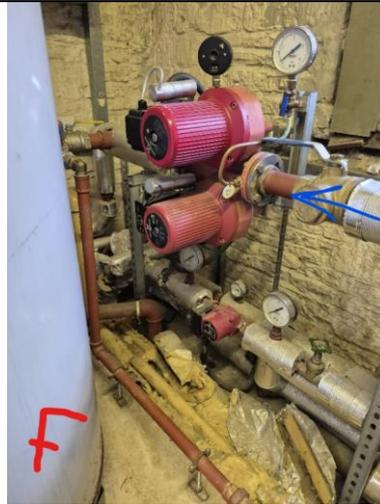
We couldn't find any other commissioning sets, reg valves, orifice plates or binder points on the job to take any flow rates from. We were unable to take any flow rates on the whole job due to none being installed. It would be possible to find out flow rates. However, this would mean extra work and extra costs to install them.

F, shows pump set up, with no binder/test points or commissioning sets in the plant room.

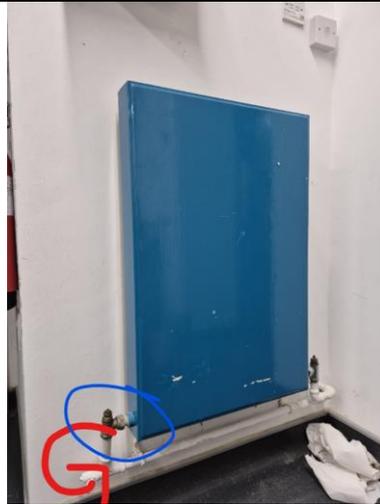
G, faulty radiator in kitchen.
