## **Asbestos Refurbishment Survey Report**

Neeld Hall, Borough Parade, Chippenham, SN15 3WL

### **SWINDON ASBESTOS SURVEYING LTD**

| Job No: | J004955 |

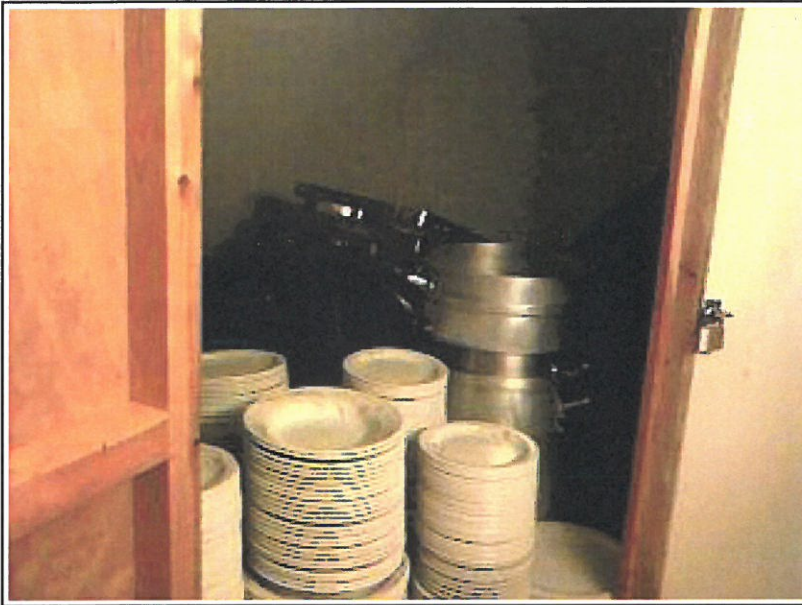
**Survey Data Sheet:** Conclusions & Recommendations  
**Site Location:** Neeld Hall, Borough Parade, Chippenham, SN15 3WL  
**Building Designation:** Building 01  
**Unique item Number:** 1

| Sample Ref | FI | Location | Description | Qty | Analysis Result | Total M.A.S | Licensed Material Y/N |
|---|---|---|---|---|---|---|---|
| Surveyed | Z-Sub Level 1 | Understairs Cupboard. B01 | No asbestos detected - | | N/A | | N |

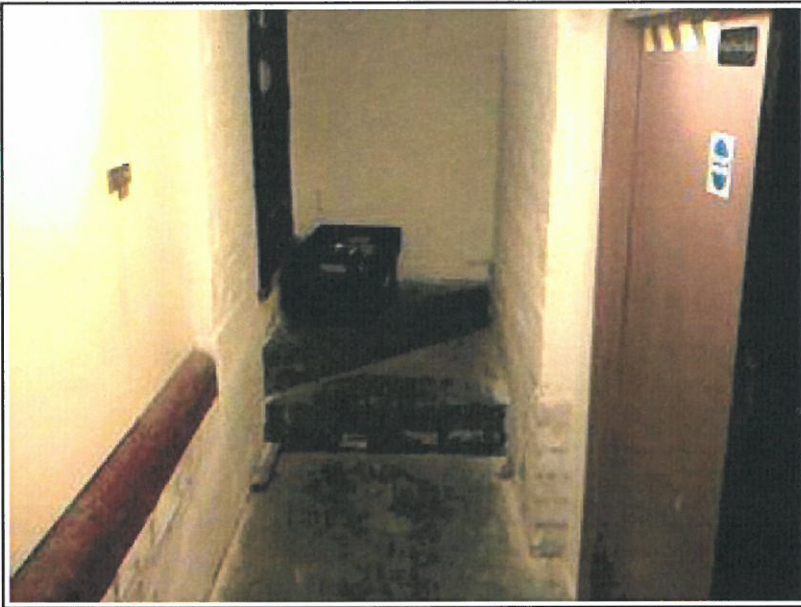
**Survey Data Sheet:** Conclusions & Recommendations  
**Site Location:** Neeld Hall, Borough Parade, Chippenham, SN15 3WL  
**Building Designation:** Building 01  
**Unique item Number:** 2

| Sample Ref | FI | Location | Description | Qty | Analysis Result | Total M.A.S | Licensed Material Y/N |
|---|---|---|---|---|---|---|---|
| Surveyed | Z-Sub Level 1 | Circulation. B02 | No asbestos detected - | | N/A | | N |

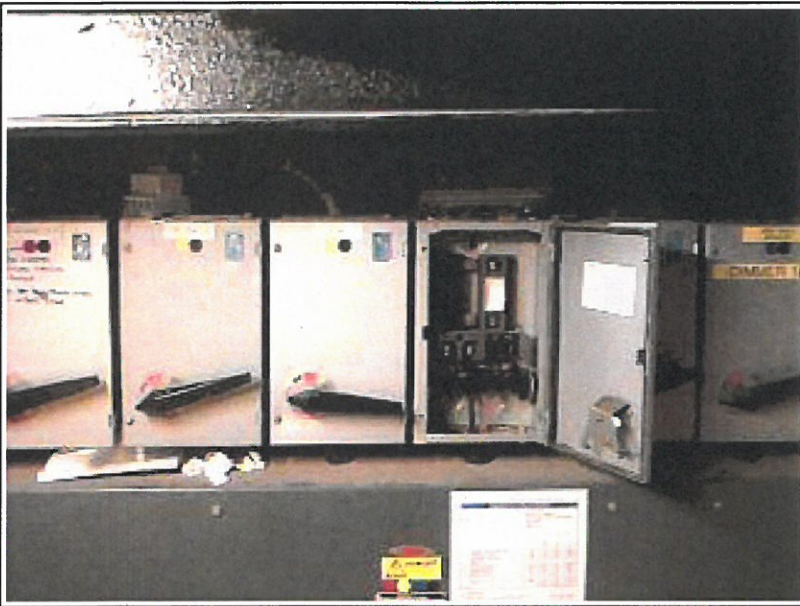
**Survey Data Sheet:** Conclusions & Recommendations  
**Site Location:** Neeld Hall, Borough Parade, Chippenham, SN15 3WL  
**Building Designation:** Building 01  
**Unique item Number:** 3

| Sample Ref | FI | Location | Description | Qty | Analysis Result | Total M.A.S | Licensed Material Y/N |
|---|---|---|---|---|---|---|---|
| AD006175 | Z-Sub Level 1 | Under Stage Area. B03 | Within switchgear - Flashguards - Asbestos Textiles/Paper | <1m <sup>2</sup> | Chrysotile | 5 | N |

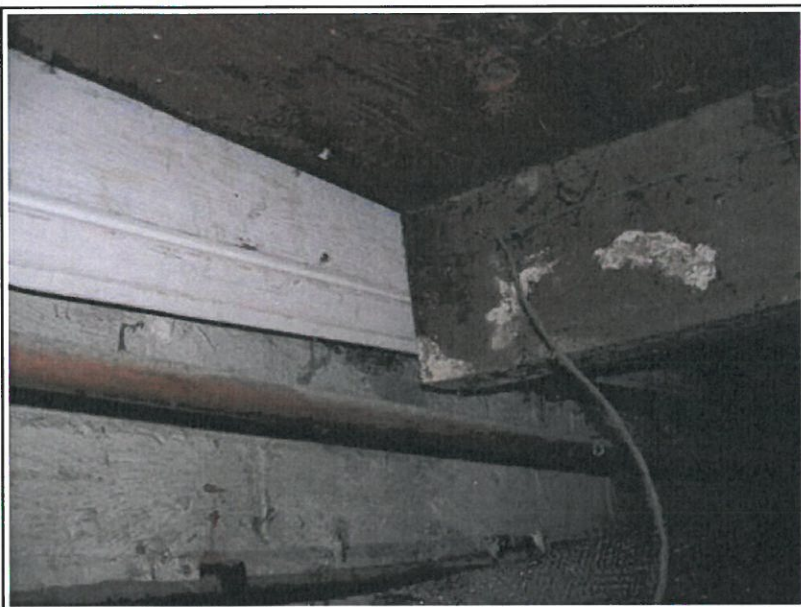
**Survey Data Sheet:** Conclusions & Recommendations  
**Site Location:** Neeld Hall, Borough Parade, Chippenham, SN15 3WL  
**Building Designation:** Building 01  
**Unique item Number:** 4

| Sample Ref | Fl | Location | Description | Qty | Analysis Result | Total M.A.S | Licensed Material Y/N |
|---|---|---|---|---|---|---|---|
| AD006176 | Z-Sub Level 1 | Under Stage Area. B03 | Wall and beam - Insulation residue - Asbestos Insulation/Coating | <1m <sup>2</sup> | Chrysotile + Amosite | 10 | Y |

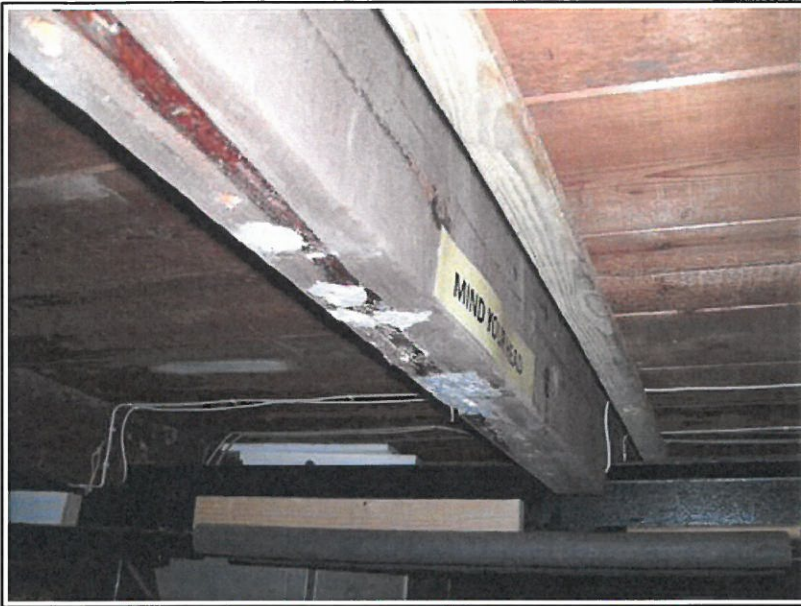
**Survey Data Sheet:** Conclusions & Recommendations  
**Site Location:** Neeld Hall, Borough Parade, Chippenham, SN15 3WL  
**Building Designation:** Building 01  
**Unique item Number:** 5

| Sample Ref | FI | Location | Description | Qty | Analysis Result | Total M.A.S | Licensed Material Y/N |
|---|---|---|---|---|---|---|---|
| AD006177 | Z-Sub Level 1 | Under Stage Area. B03 | Ceiling beam - Insulation board residue - Asbestos Insulating Board | <1m <sup>2</sup> | Chrysotile | 8 | Y |

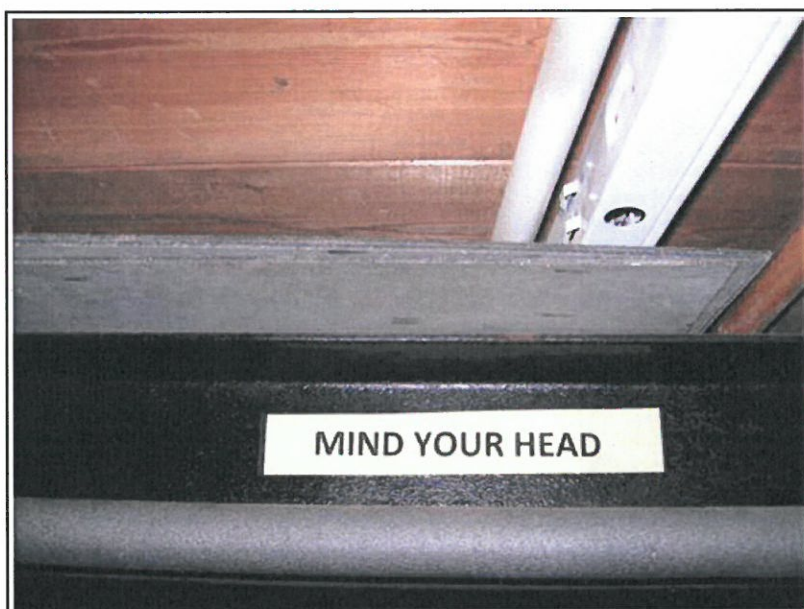
**Survey Data Sheet:** Conclusions & Recommendations  
**Site Location:** Neeld Hall, Borough Parade, Chippenham, SN15 3WL  
**Building Designation:** Buildng 01  
**Unique item Number:** 6

| Sample Ref | Fl | Location | Description | Qty | Analysis Result | Total M.A.S | Licensed Material Y/N |
|---|---|---|---|---|---|---|---|
| AD006178 | Z-Sub Level 1 | Under Stage Area. B03 | Loose to ceiling - Cement tiles - Asbestos Cement | 3no. | Chrysotile | 3 | N |

| FI | Building Designation | Location | Asbestos Containing Material | M.A.S | Recommended Action |
|---|---|---|---|---|---|
| Z- | Buildng 01 | Under Stage Area. B03 | Loose to ceiling - Cement tiles - Asbestos Cement | 3 | Remove |

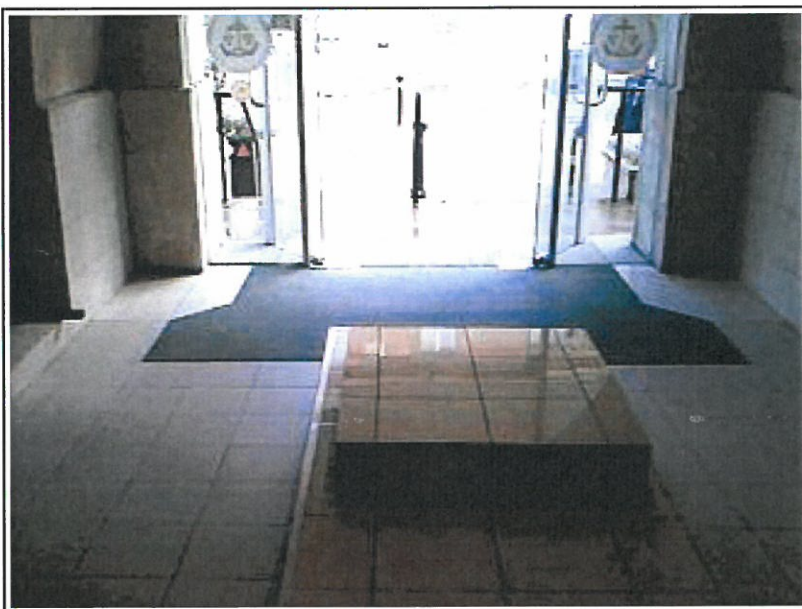
**Survey Data Sheet:** Conclusions & Recommendations  
**Site Location:** Neeld Hall, Borough Parade, Chippenham, SN15 3WL  
**Building Designation:** Building 01  
**Unique item Number:** 10

| Sample Ref | Fl | Location | Description | Qty | Analysis Result | Total M.A.S | Licensed Material Y/N |
|---|---|---|---|---|---|---|---|
| Surveyed | Ground Floor | Lobby. 002 | No asbestos detected - | | N/A | | N |
