## Asbestos Inspection Report Refurbishment Survey

The Neeld Theatre  
High Street  
Chippenham  
SN15 3ER

Project No: G-11485  
Report Issue: 1  
Date: Feb 2023

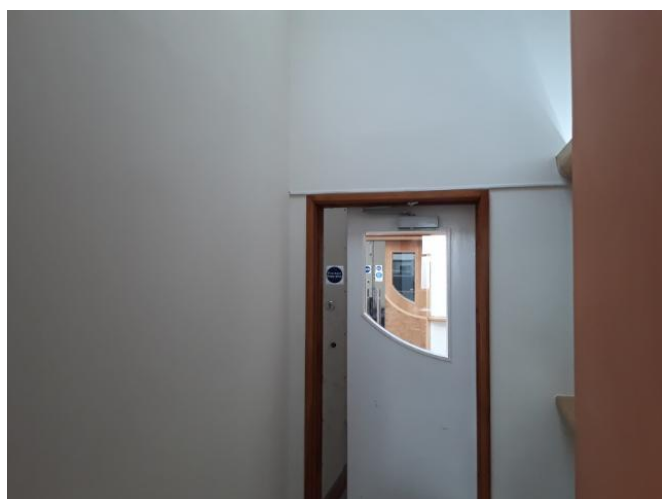
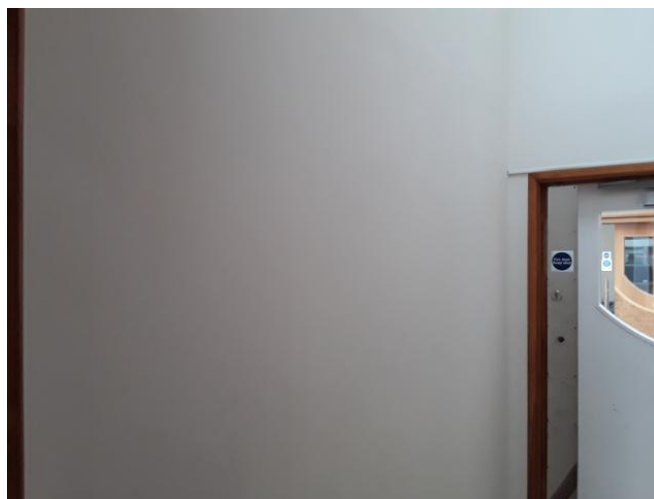
| Product: | Wall lining | Asbestos Type: | NADIS 0 |
| Asbestos: | No | Accessibility: | N/A |

Comments: Insulating board (Plasterboard) wall lining

| Action: | No further action required | | |

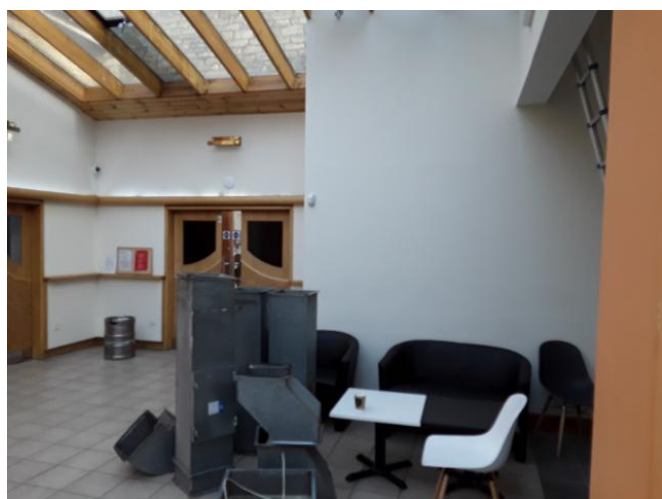
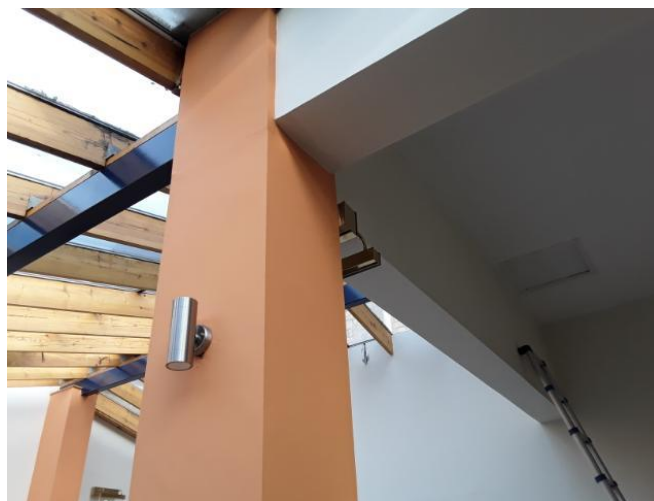
| Product: | Cladding | Asbestos Type: | NADIS 0 |
| Asbestos: | No | Accessibility: | N/A |

Comments: Insulating board cladding to steel

| Action: | No further action required | | |

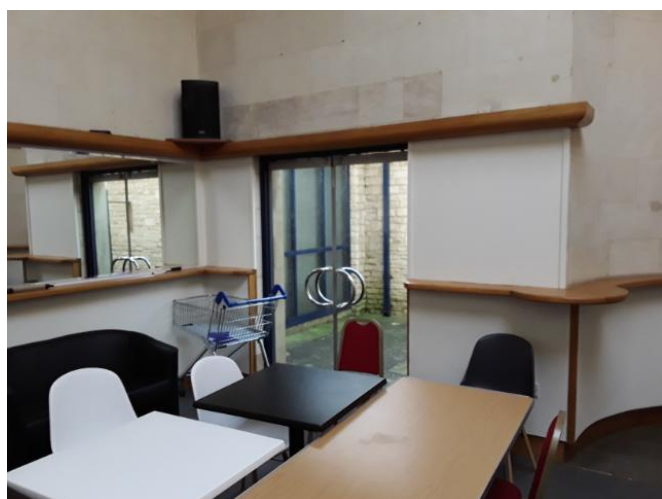
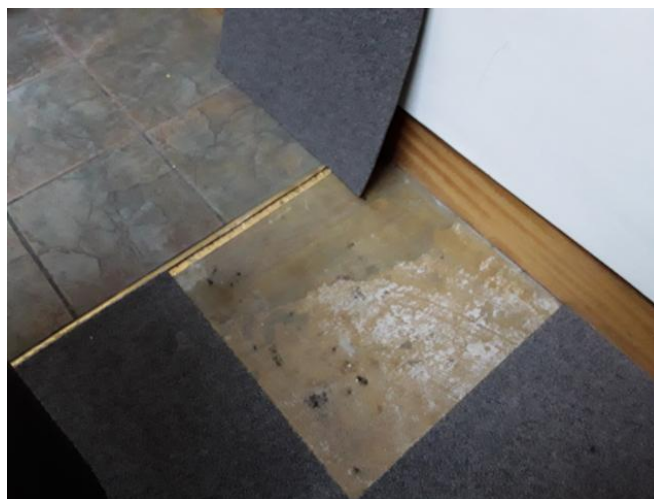
| Product: | Floor screed | Asbestos Type: | NADIS 0 |
| Asbestos: | No | Accessibility: | N/A |

Comments: Floor screed beneath carpet tiles and ceramic floor tiles

| Action: | No further action required | | |

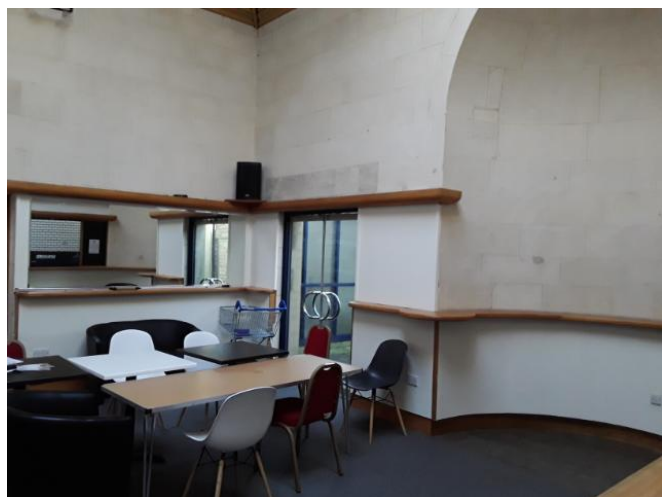
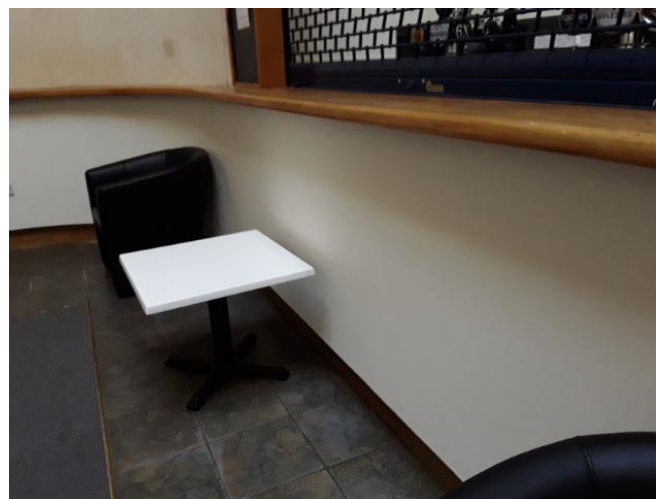
| Product: | Lining | Asbestos Type: | NADIS 0 |
| Asbestos: | No | Accessibility: | N/A |

Comments: Insulating board lining below bar serving area

| Action: | No further action required | | |

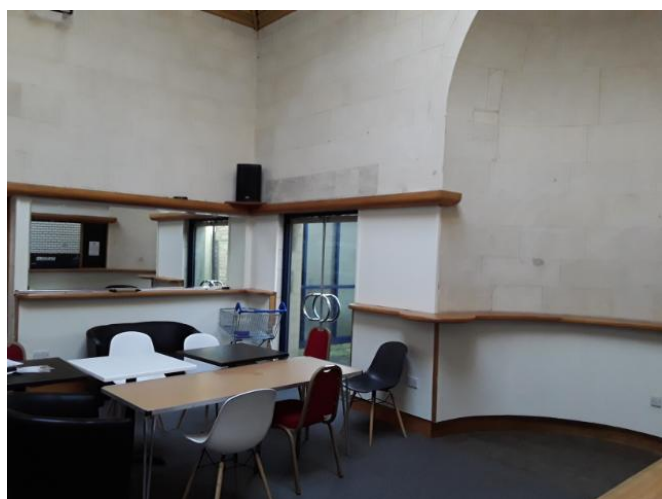
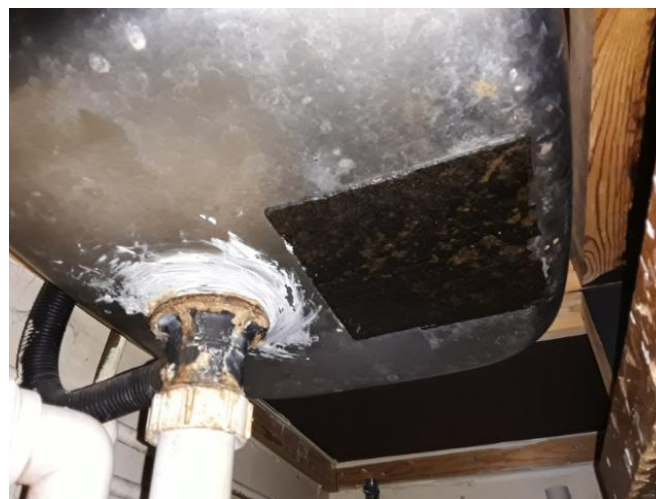
| Product: | Sink pad | Asbestos Type: | NADIS 0 |
| Asbestos: | No | Accessibility: | N/A |

Comments: Bitumen pad to underside of sink

| Action: | No further action required | | |

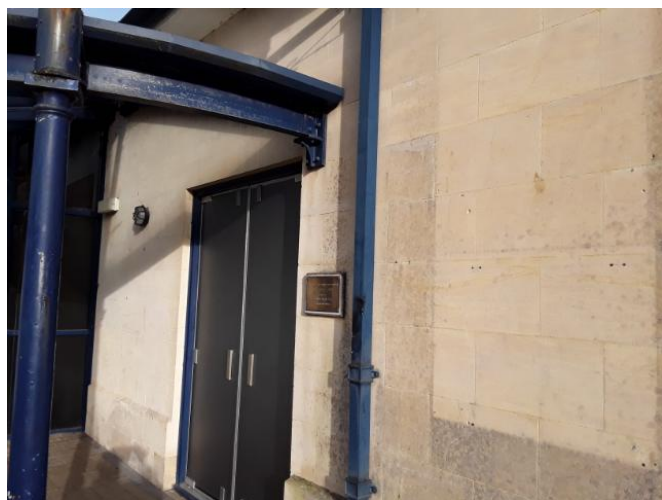
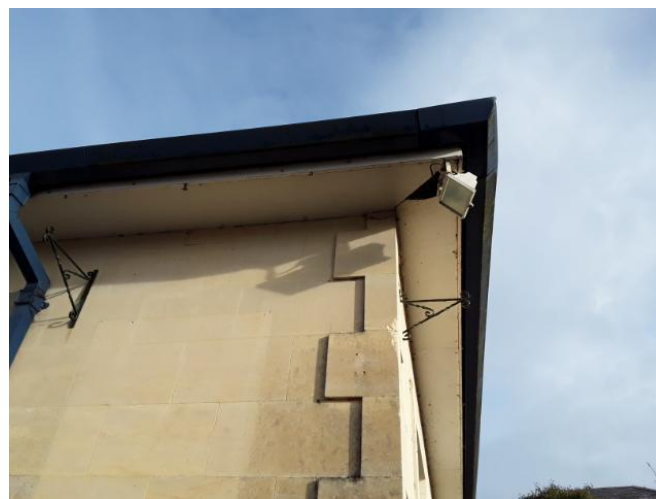
| Product: | Soffits | Asbestos Type: | NADIS 0 |
| Asbestos: | No | Accessibility: | N/A |

Comments: Insulating board (Supalux) soffits

| Action: | No further action required | | |

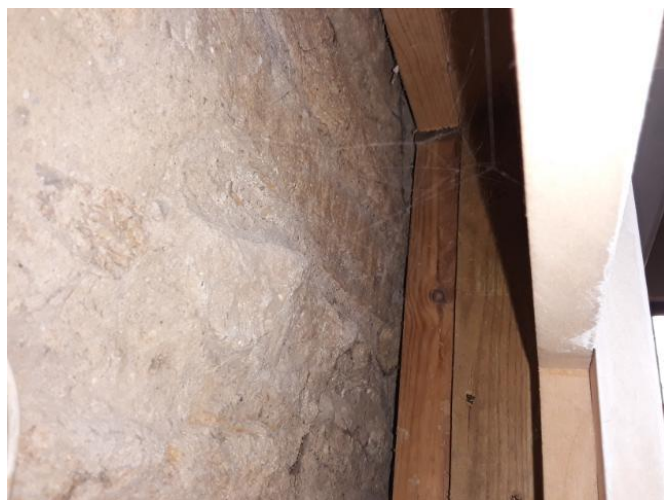
Comments: View beyond timber panelling (no asbestos detected)

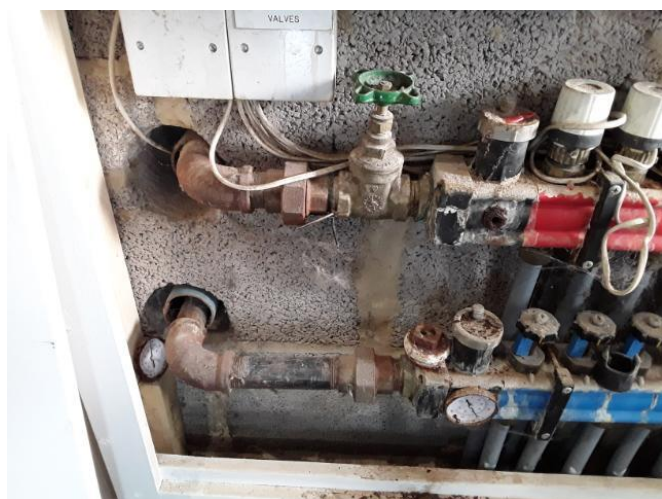
Comments: View of metal pipework collars penetrating wall (no asbestos detected)

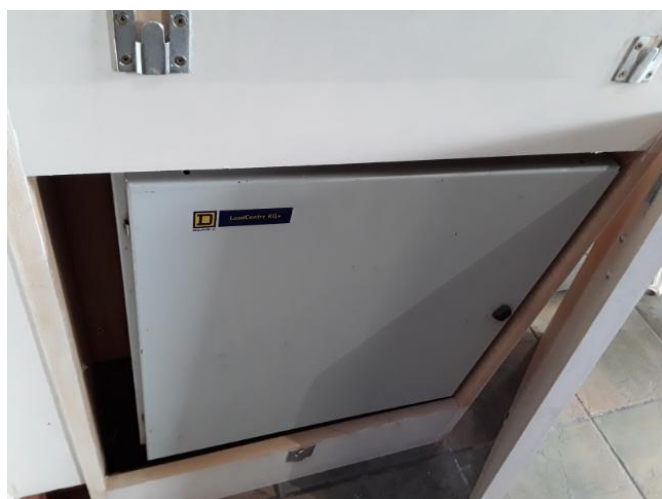
Comments: View of modern electrics within timber wall lining (no asbestos detected)
