## **ASBESTOS REFURBISHMENT SURVEY REPORT**

**SITE SURVEYED:**  
**Client Specified Areas**  
**Need Hall**  
**Borough Parade**  
**Chippenham**  
**SN15 3WL**

**SURVEYED ON:**  
**4<sup>th</sup> August 2016**

REFERENCE NUMBER - 16/S11348

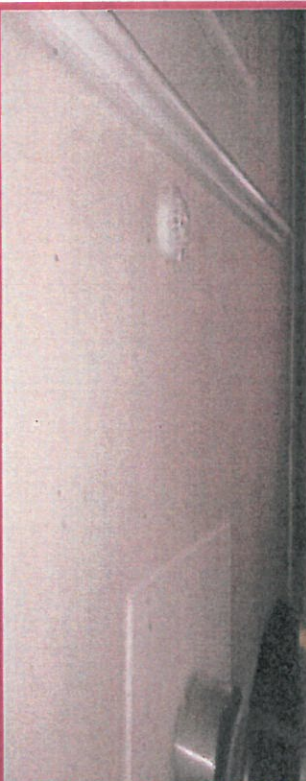
| Incident Reference | Sample Number | Level | Material Location | | | Quantity | | |
|---|---|---|---|---|---|---|---|---|
| 1 | 16/S11348/001 | Second floor | 201 Plant Room | | | 9m <sup>2</sup> | | |

| Incident Reference | Sample Number | Level | Material Location | | | Quantity | | |
|---|---|---|---|---|---|---|---|---|
| N/A | N/A | N/A | N/A | N/A | N/A | N/A | No Action | Material was found not to contain asbestos. |

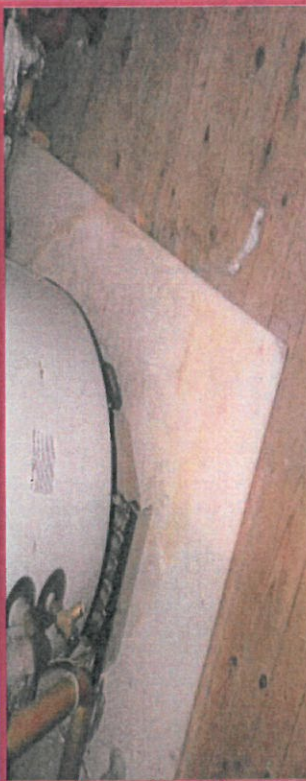
| Incident Reference | Sample Number | Level | Material Location | | | | Quantity | | |
|---|---|---|---|---|---|---|---|---|--|
| 2 | 16/S11348/002 | Second floor | 201 Plant Room | | | | 2m <sup>2</sup> x 2 | | |

| Incident Reference | Sample Number | Level | Material Location | | | | Quantity | | |
|---|---|---|---|---|---|---|---|---|--|
| N/A | N/A | N/A | N/A | N/A | N/A | N/A | No Action | Material was found not to contain asbestos. | |

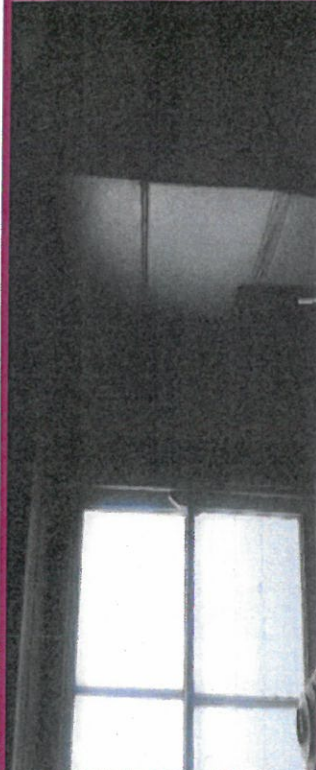
| Incident Reference | Sample Number | Level | Material Location | | | | Quantity | | Comments |
|---|---|---|---|---|---|---|---|---|---|
| 3 | 16/S11348/003 | Second floor | 201 Plant Room | | | | 1m <sup>2</sup> | | |

| Incident Reference | Sample Number | Level | Material Location | | | | Quantity | | Comments |
|---|---|---|---|---|---|---|---|---|---|
| NAD | Insulating Board Firebreak Panel to Air Conditioning Vent | | N/A | | N/A | | | | |
| N/A | N/A | N/A | N/A | N/A | N/A | N/A | No Action | Material was found not to contain asbestos. | |

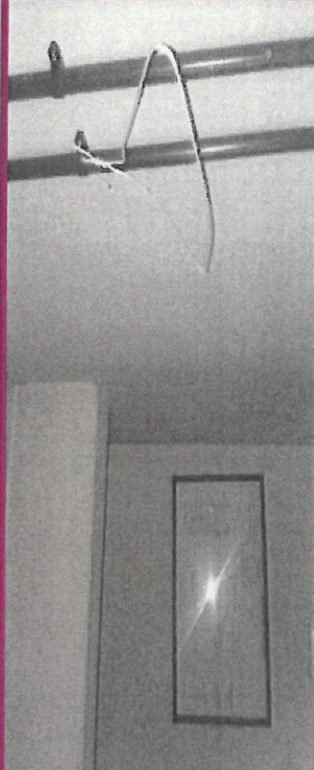
| Incident Reference | Sample Number | Level | Material Location | | | | Quantity | | Comments |
|---|---|---|---|---|---|---|---|---|---|
| 4 | 16/S11348/004 | Second floor | 201 Plant Room | | | | 10m <sup>2</sup> | | |

| Incident Reference | Sample Number | Level | Material Location | | | | Quantity | | Comments |
|---|---|---|---|---|---|---|---|---|---|
| N/A | N/A | N/A | N/A | N/A | N/A | N/A | No Action | Material was found not to contain asbestos. | |

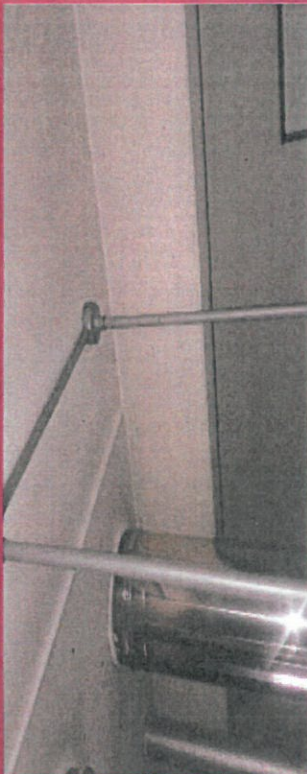
| Incident Reference | Sample Number | Level | Material Location | | | Quantity | | | | | | Comments |
|---|---|---|---|---|---|---|---|---|--|--|--|---|
| 5 | 16/S11348/005 | Second floor | 201 Plant Room | | | 3 lm | | | | | | |

| Incident Reference | Sample Number | Level | Material Location | | | Quantity | | | | | | Comments |
|---|---|---|---|---|---|---|---|---|--|--|--|---|
| Accessibility | Product Type | Extent of Damage | Surface Treatment | Asbestos Type | Total | Priority | Recommendation | Material was found not to contain asbestos. | | | | |

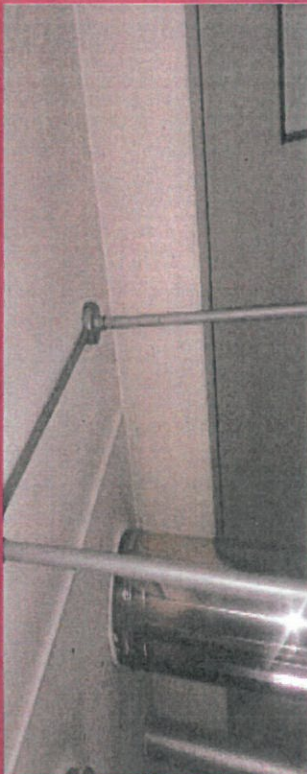
| Incident Reference | Sample Number | Level | Material Location | | | | Quantity | |
|---|---|---|---|---|---|---|---|---|
| 5 | 16/S11348/005 | Second floor | 201 Plant Room | | | | 3 lm | |

| Incident Reference | Sample Number | Level | Material Location | | | | Quantity | |
|---|---|---|---|---|---|---|---|---|
| N/A | N/A | N/A | N/A | N/A | N/A | N/A | No Action | Material was found not to contain asbestos. |

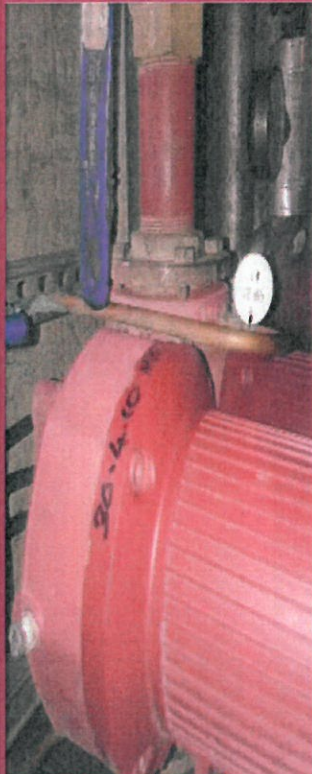
| Incident Reference | Sample Number | Level | Material Location | | | | Quantity | |
|---|---|---|---|---|---|---|---|---|
| 6 | 16/S11348/006 | Second floor | 201 Plant Room | | | | Throughout | |

| Incident Reference | Sample Number | Level | Material Location | | | | Quantity | |
|---|---|---|---|---|---|---|---|---|
| N/A | N/A | N/A | N/A | N/A | N/A | N/A | No Action | Material was found not to contain asbestos. |

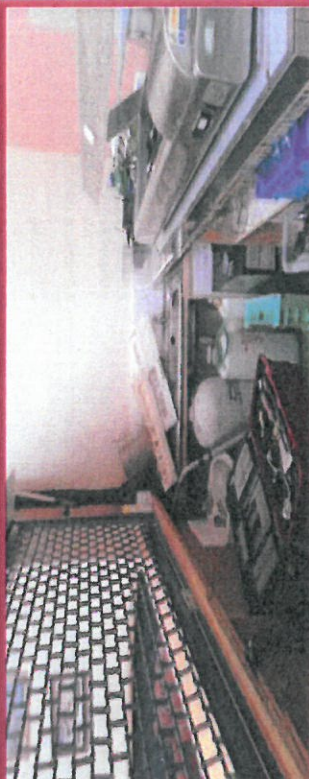
| Incident Reference | Sample Number | Level | Material Location | | | | Quantity | |
|---|---|---|---|---|---|---|---|---|
| 14 | 16/S11348/012 | Ground floor | 009 Cheese Hall | | | | 1 No. Unit | |

| Incident Reference | Sample Number | Level | Material Location | | | | Quantity | |
|---|---|---|---|---|---|---|---|---|
| N/A | N/A | N/A | N/A | N/A | N/A | N/A | No Action | Material was found not to contain asbestos. |

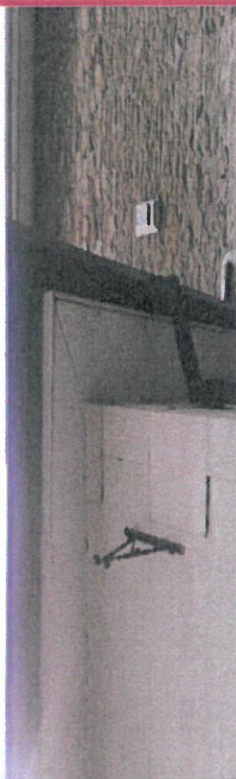
| Incident Reference | Sample Number | Level | Material Location | | | | Quantity | |
|---|---|---|---|---|---|---|---|---|
| 16 | S11348/013 | External | 008 Café Roof | | | | 16 lm | |

| Incident Reference | Sample Number | Level | Material Location | | | | Quantity | |
|---|---|---|---|---|---|---|---|---|
| N/A | N/A | N/A | N/A | N/A | N/A | N/A | No Action | Material was found not to contain asbestos. |
