Tree work specification: Trowbridge Town Council sites, Trowbridge, Wiltshire. BA14

Introduction

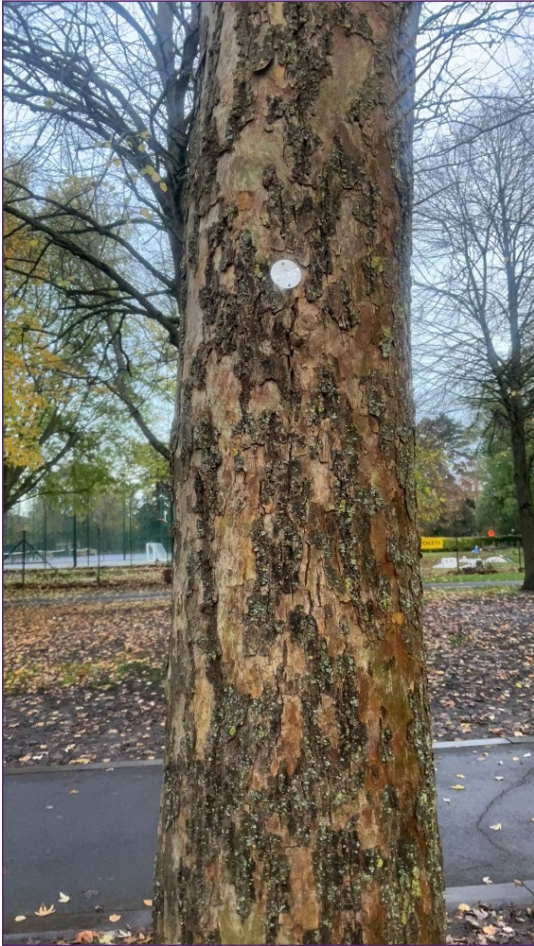
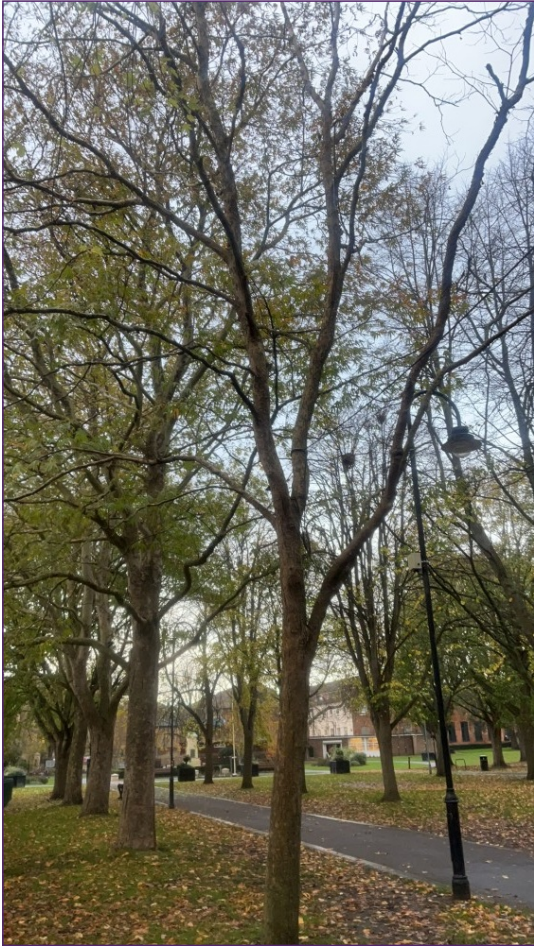
Item	Species	Comments	Recommendations	Price
T-101	Maple	Dead	Fell

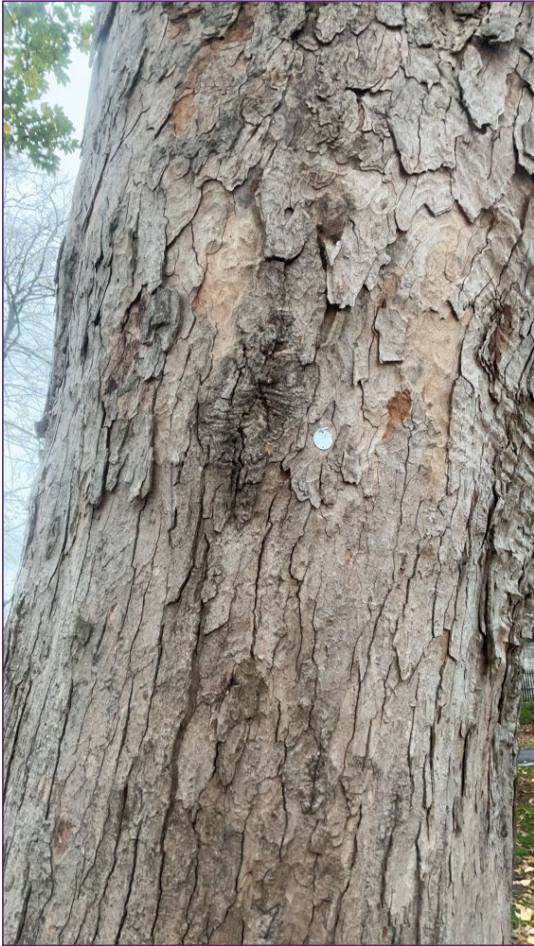
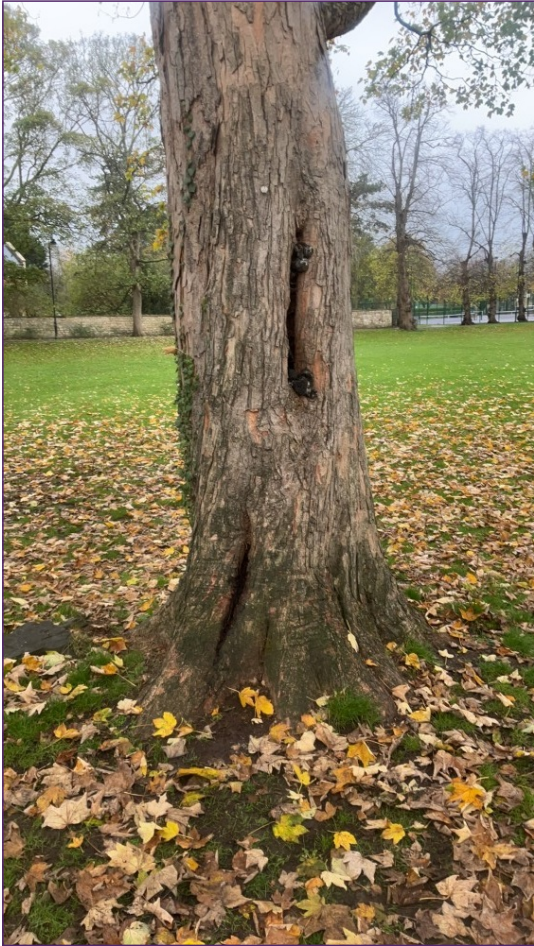
Item	Species	Comments	Recommendations	Price
T-102	Sycamore	Decay in trunk at 1 m, dieback to central stem	Fell

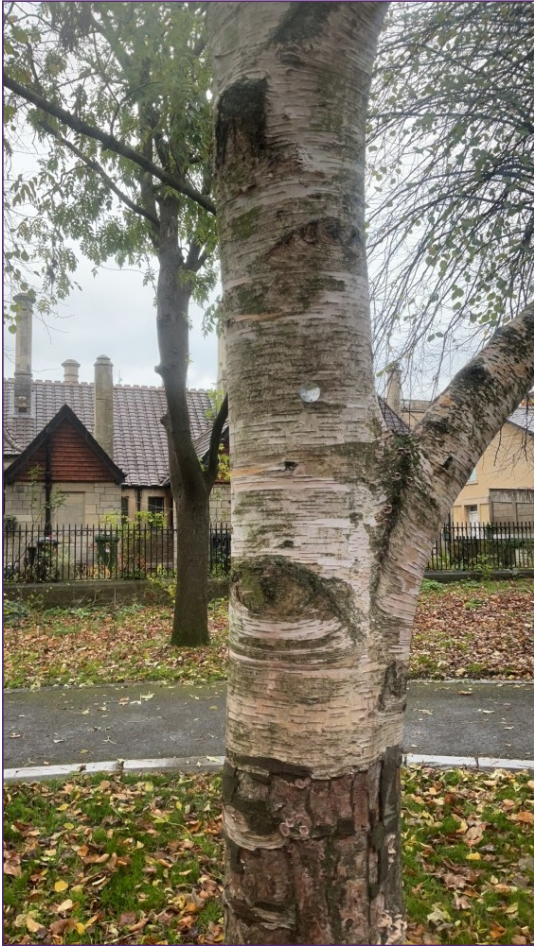
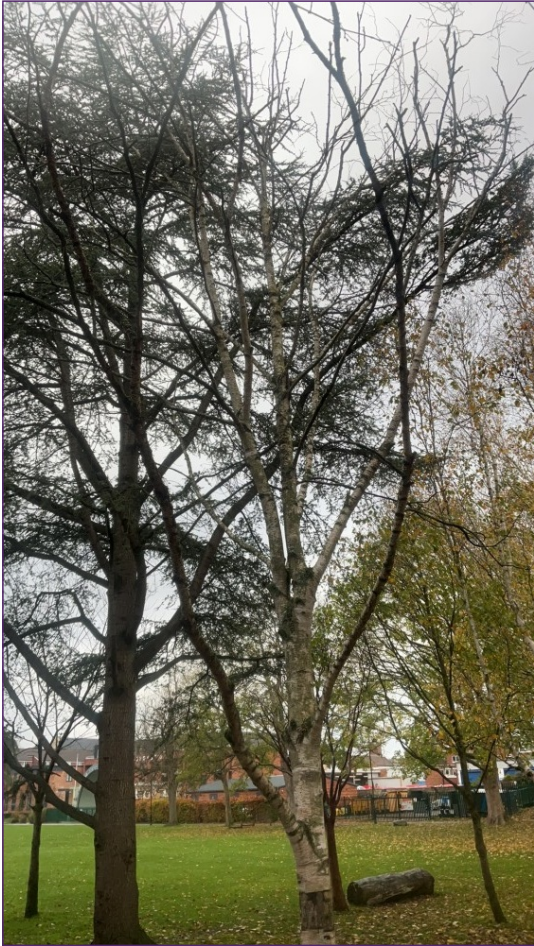
Item	Species	Comments	Recommendations	Price
T-103	Birch	Dead	Fell

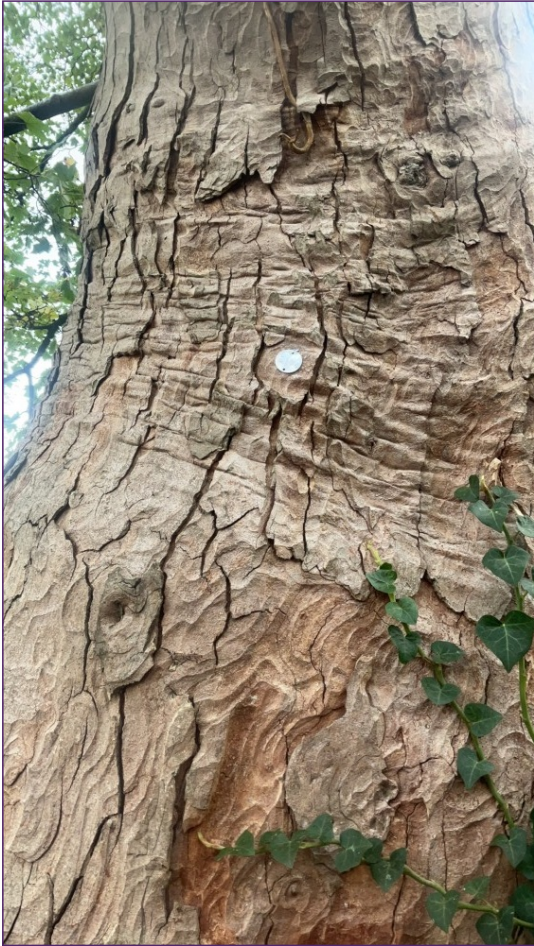
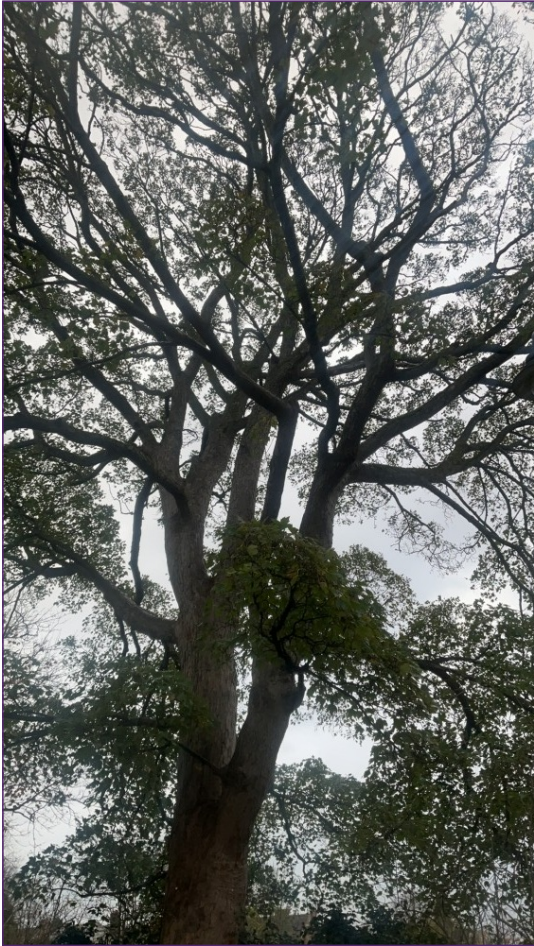
Item	Species	Comments	Recommendations	Price
T-104	Sycamore	Significant deadwood over path and light	Stabilise dead wood

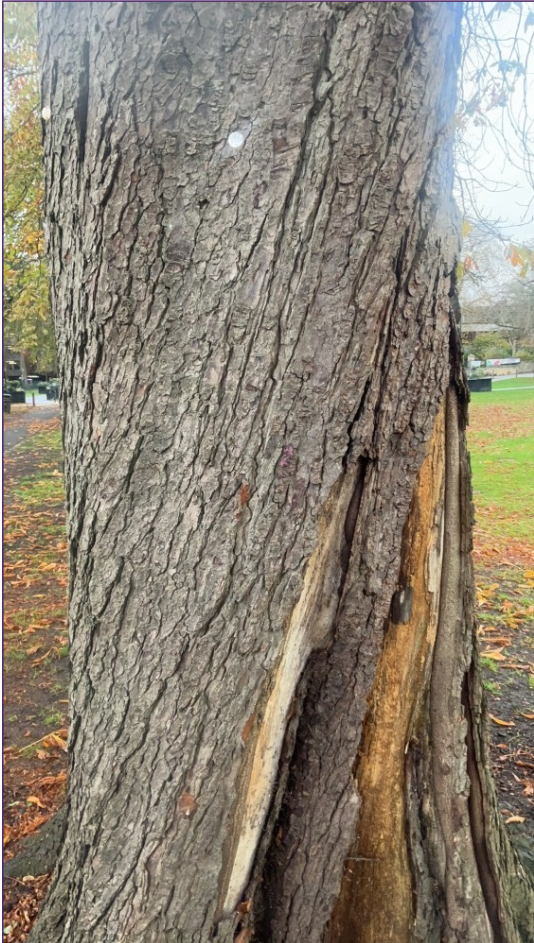
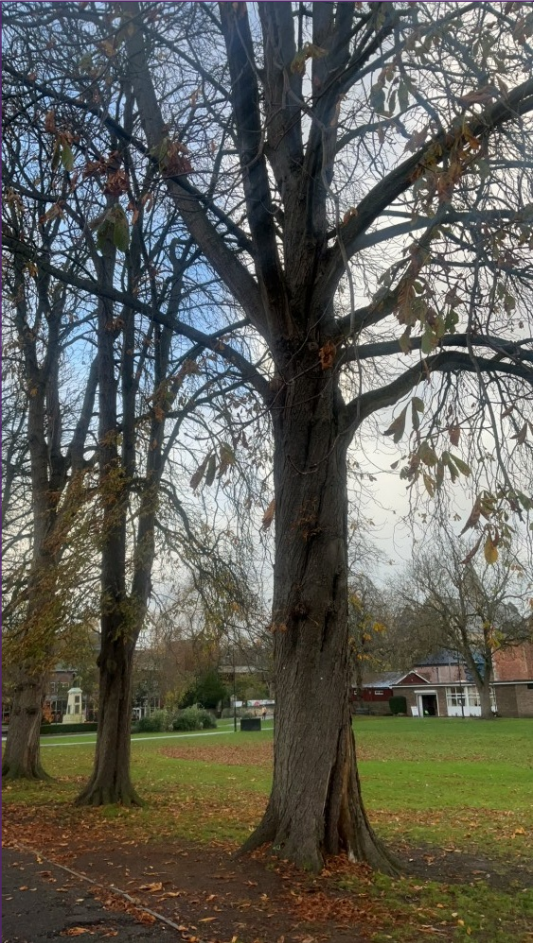
Item	Species	Comments	Recommendations	Price
T-105	Horse chestnut	Decay through stem, spiral crack up to crown break at 5 m	Fell

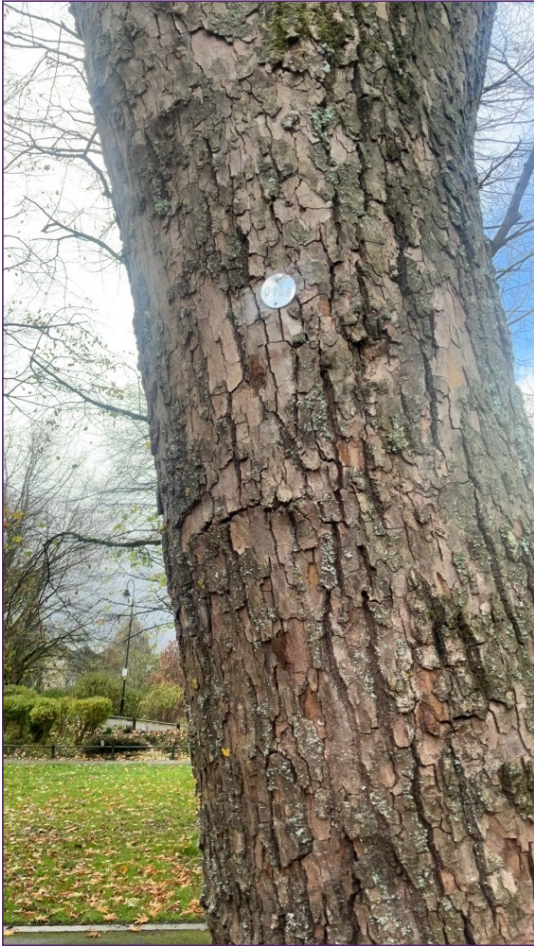
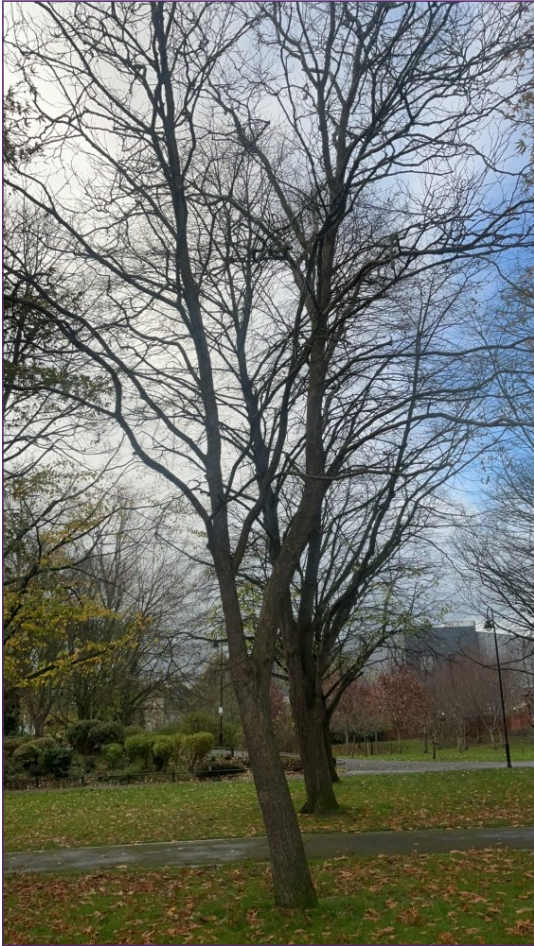
Item	Species	Comments	Recommendations	Price
T-106	Plane	Dead	Fell

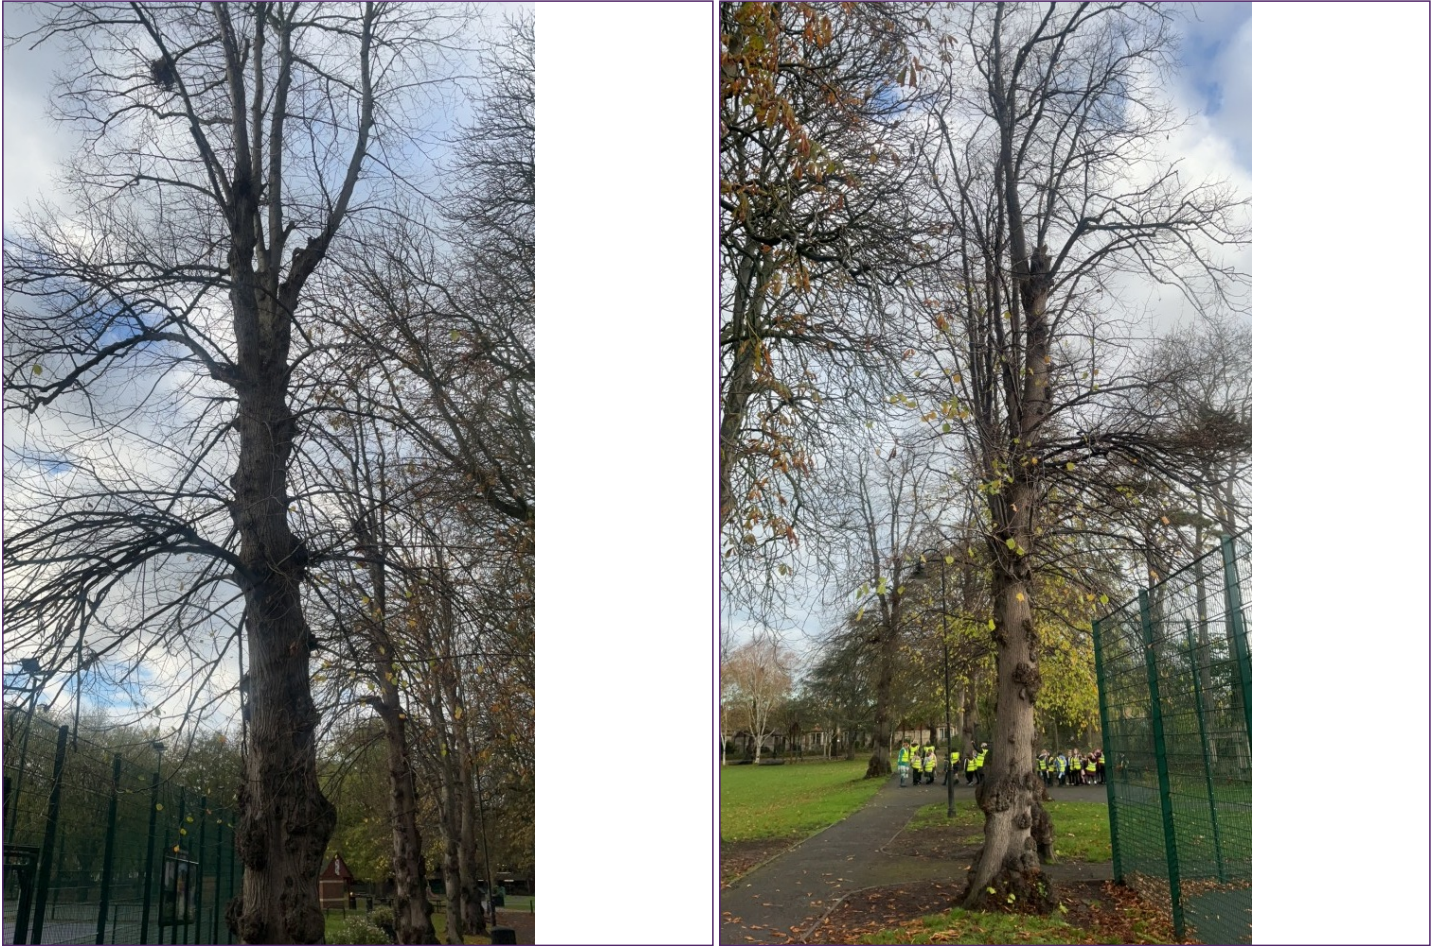
Item	Species	Comments	Recommendations	Price
G-107	Lime	Line of 12 trees, lapsed pollards, poor upper branch structure, overhanging courts	Re-pollard

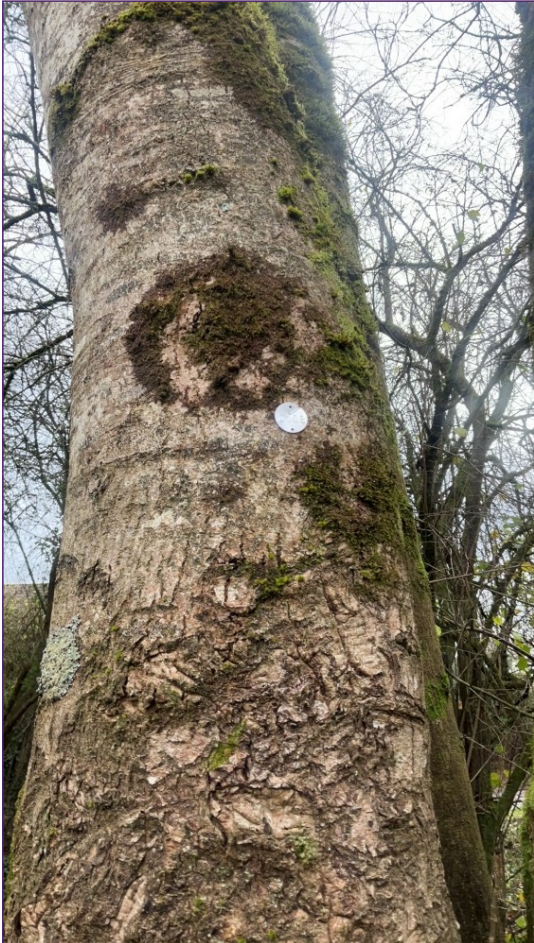
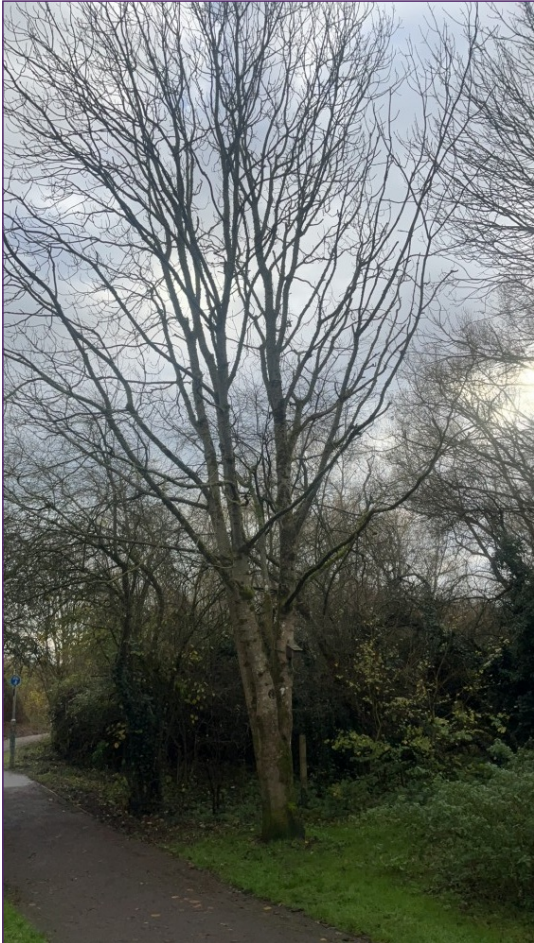
Item	Species	Comments	Recommendations	Price
T-108	Ash	Ash dieback disease (>75% defoliation)	Habitat to 4 m

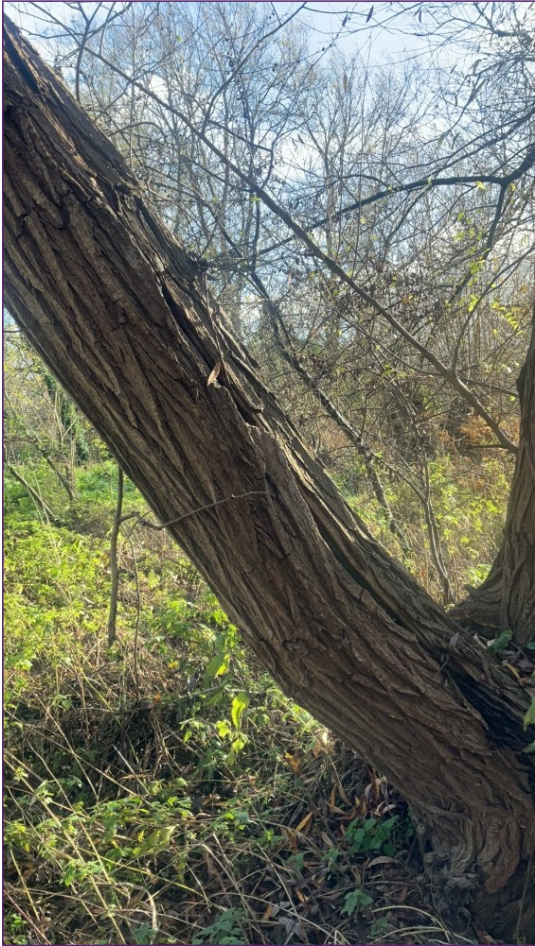
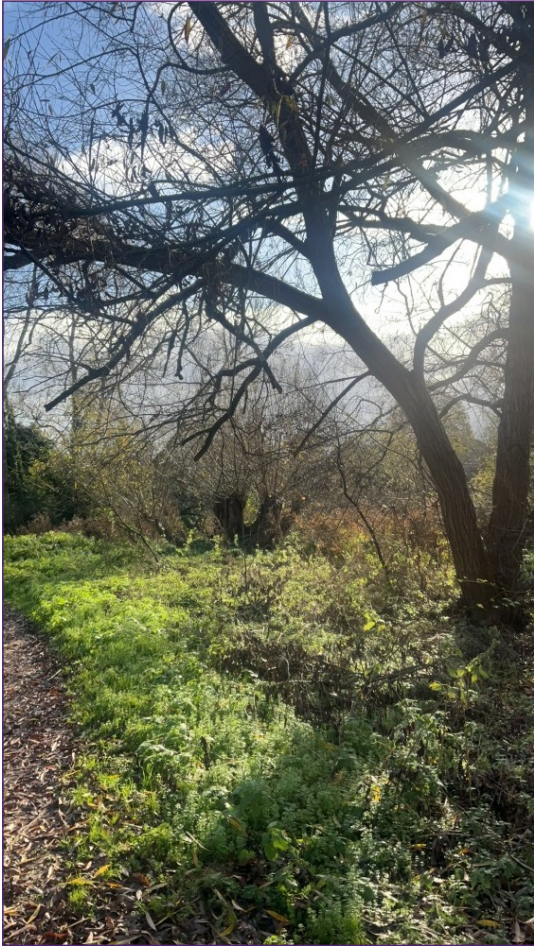
Item	Species	Comments	Recommendations	Price
T-109	Willow	Hazard beam crack through stem over footpath	Reduce defective stem to leave 4 m

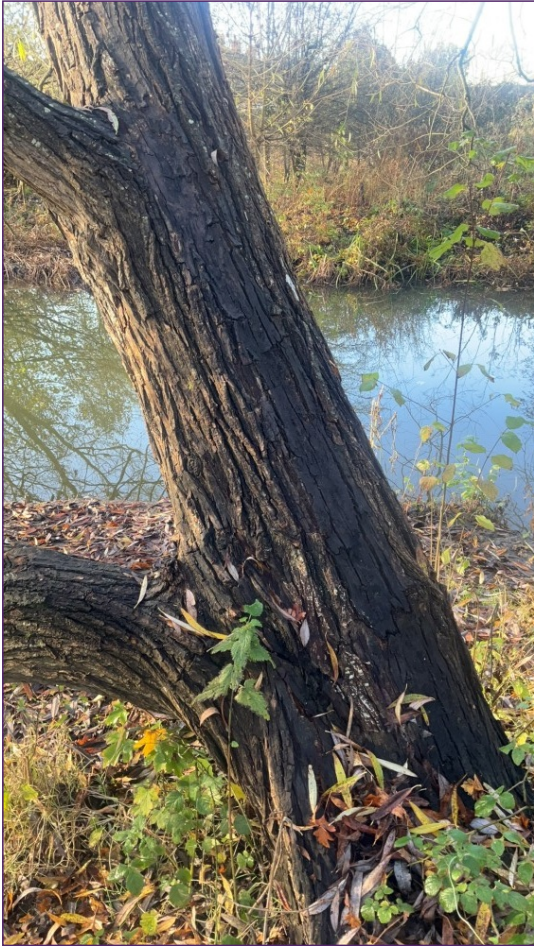
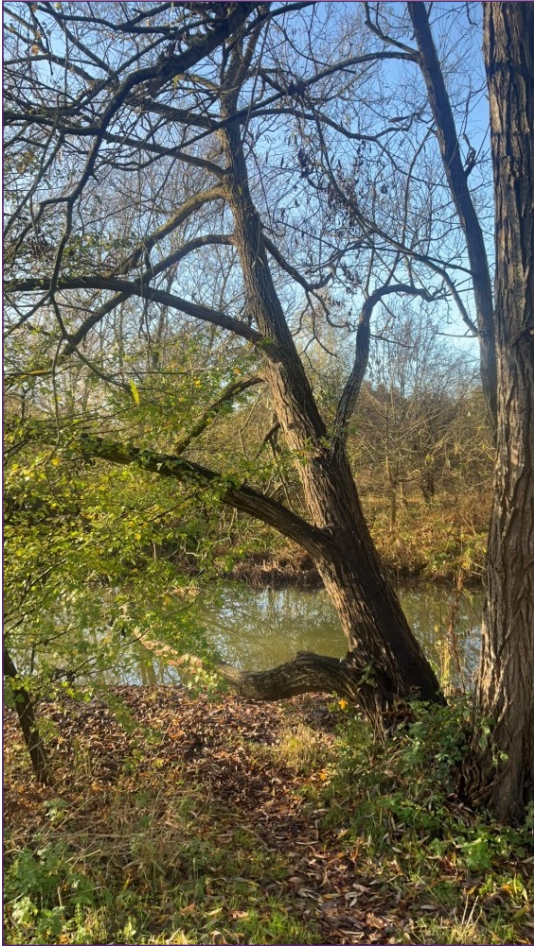
Item	Species	Comments	Recommendations	Price
T-110	Willow	Stem over river cracked at 0.5 m	Reduce stem over river to leave 4 m

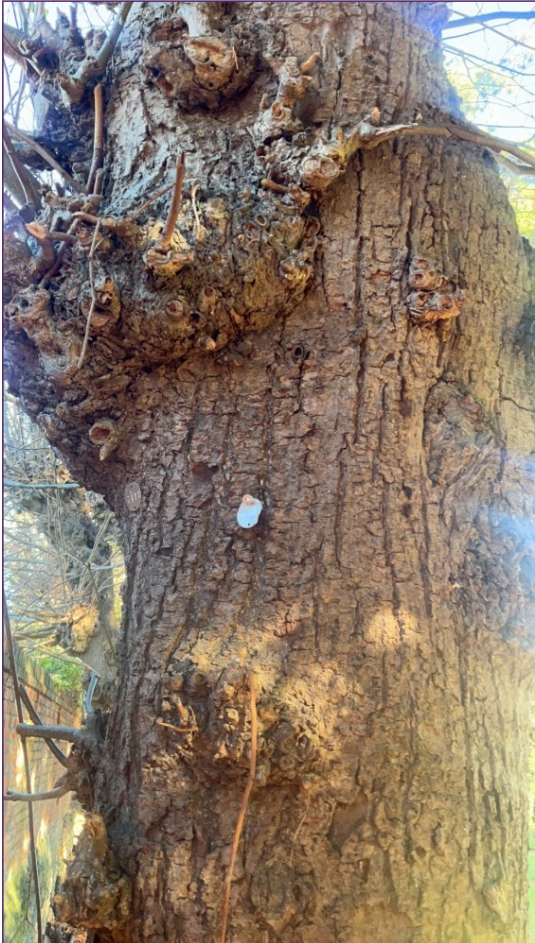
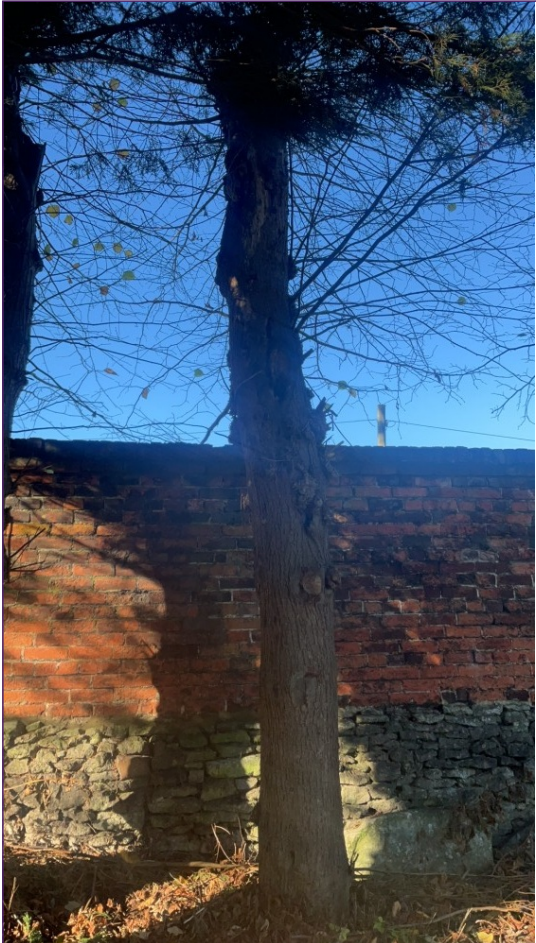
Item	Species	Comments	Recommendations	Price
G-111	Lime	5 no. pollarded trees up against boundary wall. Significant decay through stem of tagged tree.	Pollard 4 trees, fell tagged tree

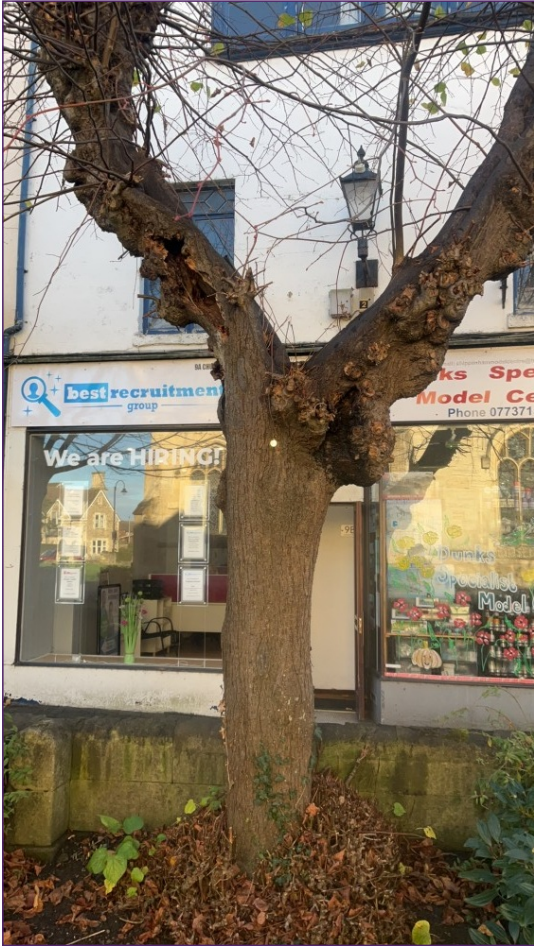
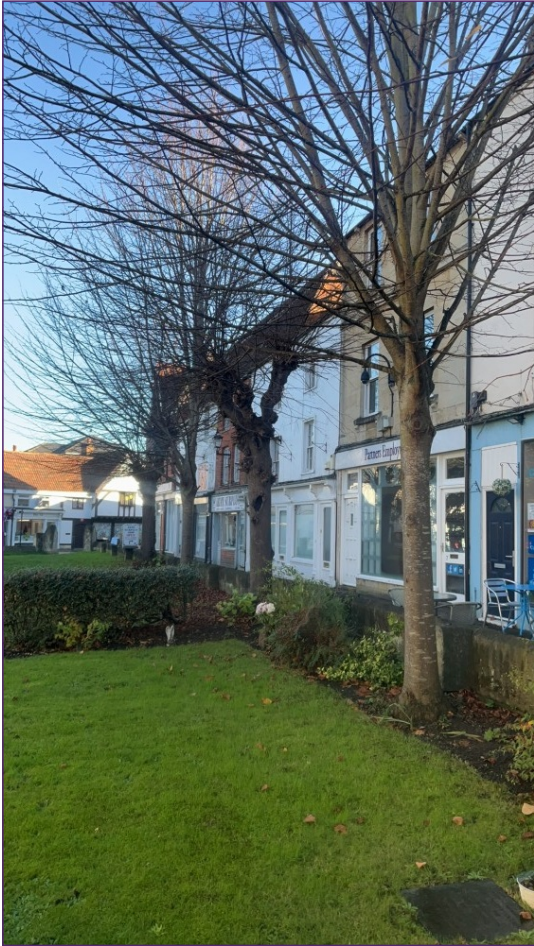
Item	Species	Comments	Recommendations	Price
G-112	Lime, Variegated maple	6 no pollarded trees, significant decay through all trees. Replacements have been initiated, and consideration should be given to replacing all of them.	Re-pollard

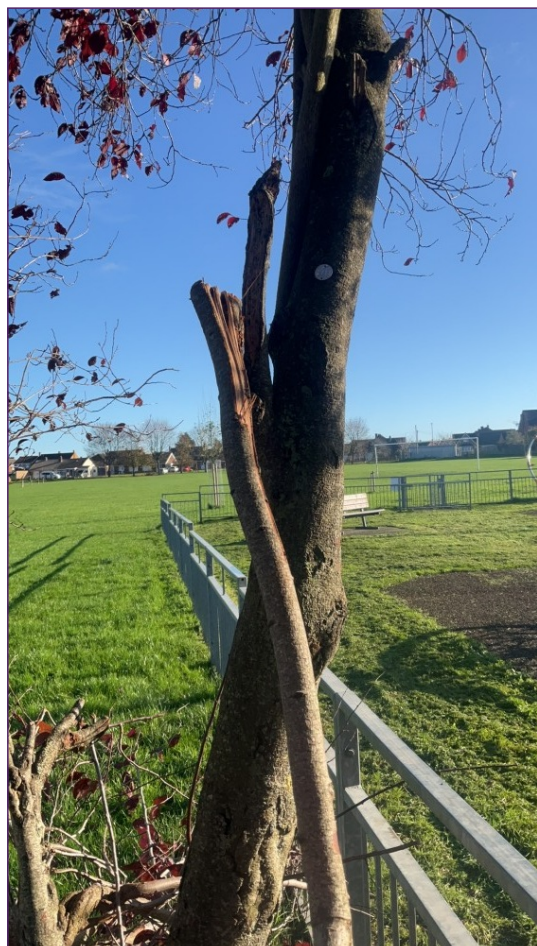
Item	Species	Comments	Recommendations	Price
G-113	Purple plum, hawthorn	Broken limbs over playground boundary	Remove broken limbs

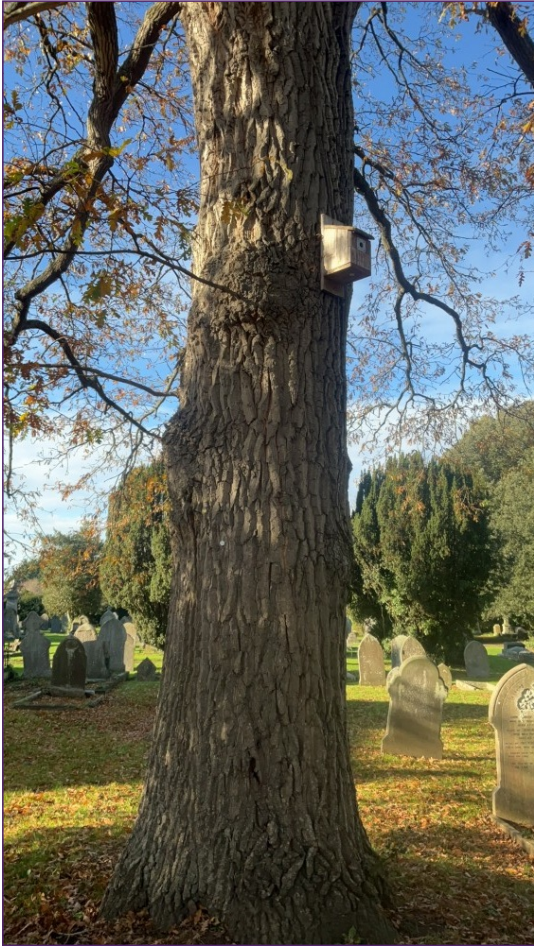
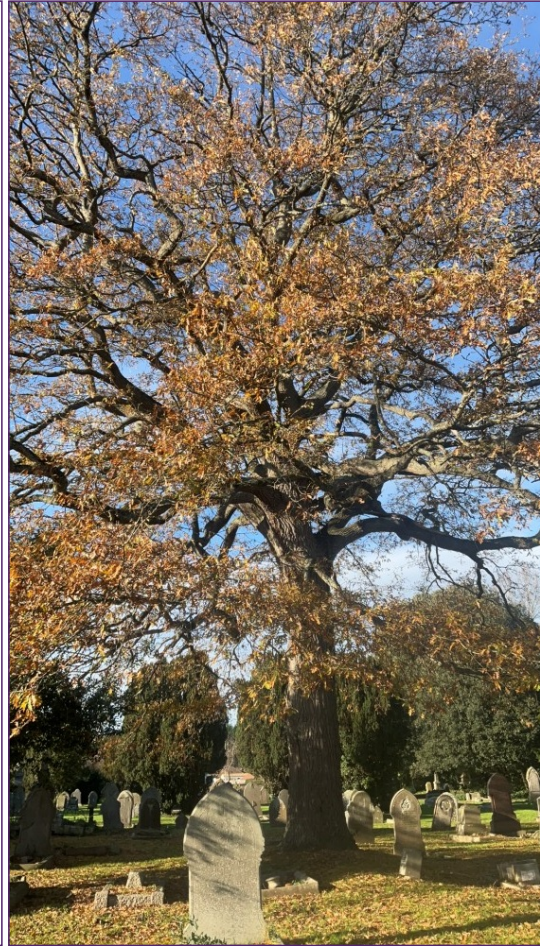
Item	Species	Comments	Recommendations	Price
T-114	Turkey oak	Dead wood (throughout crown)	Stabilise dead wood

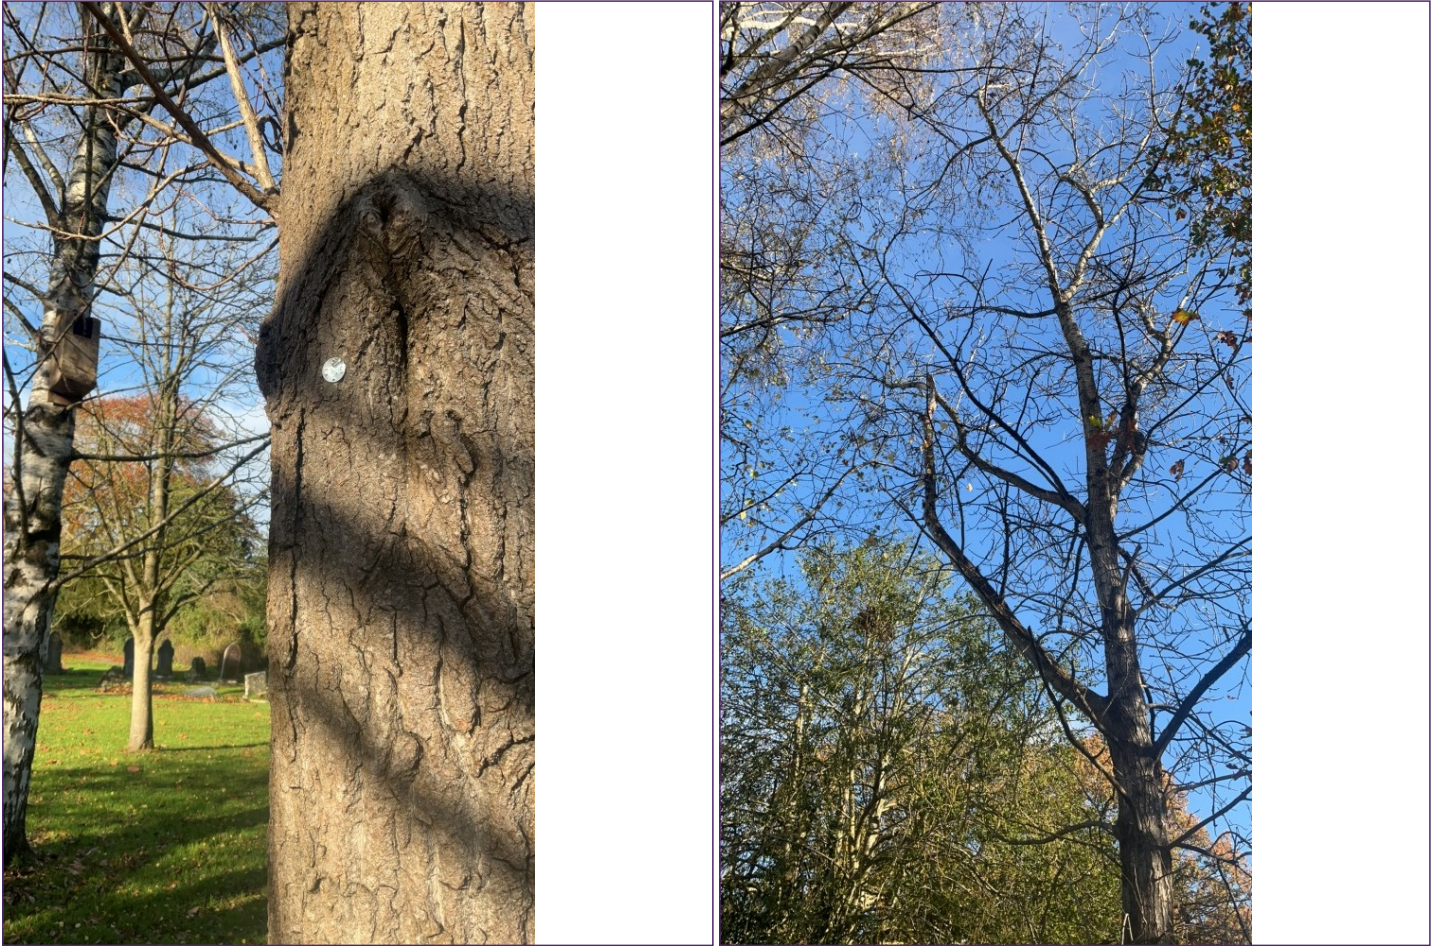
Item	Species	Comments	Recommendations	Price
T-115	Poplar	Storm damage (in upper crown), broken branches	Stabilise deadwood, and remove broken branches

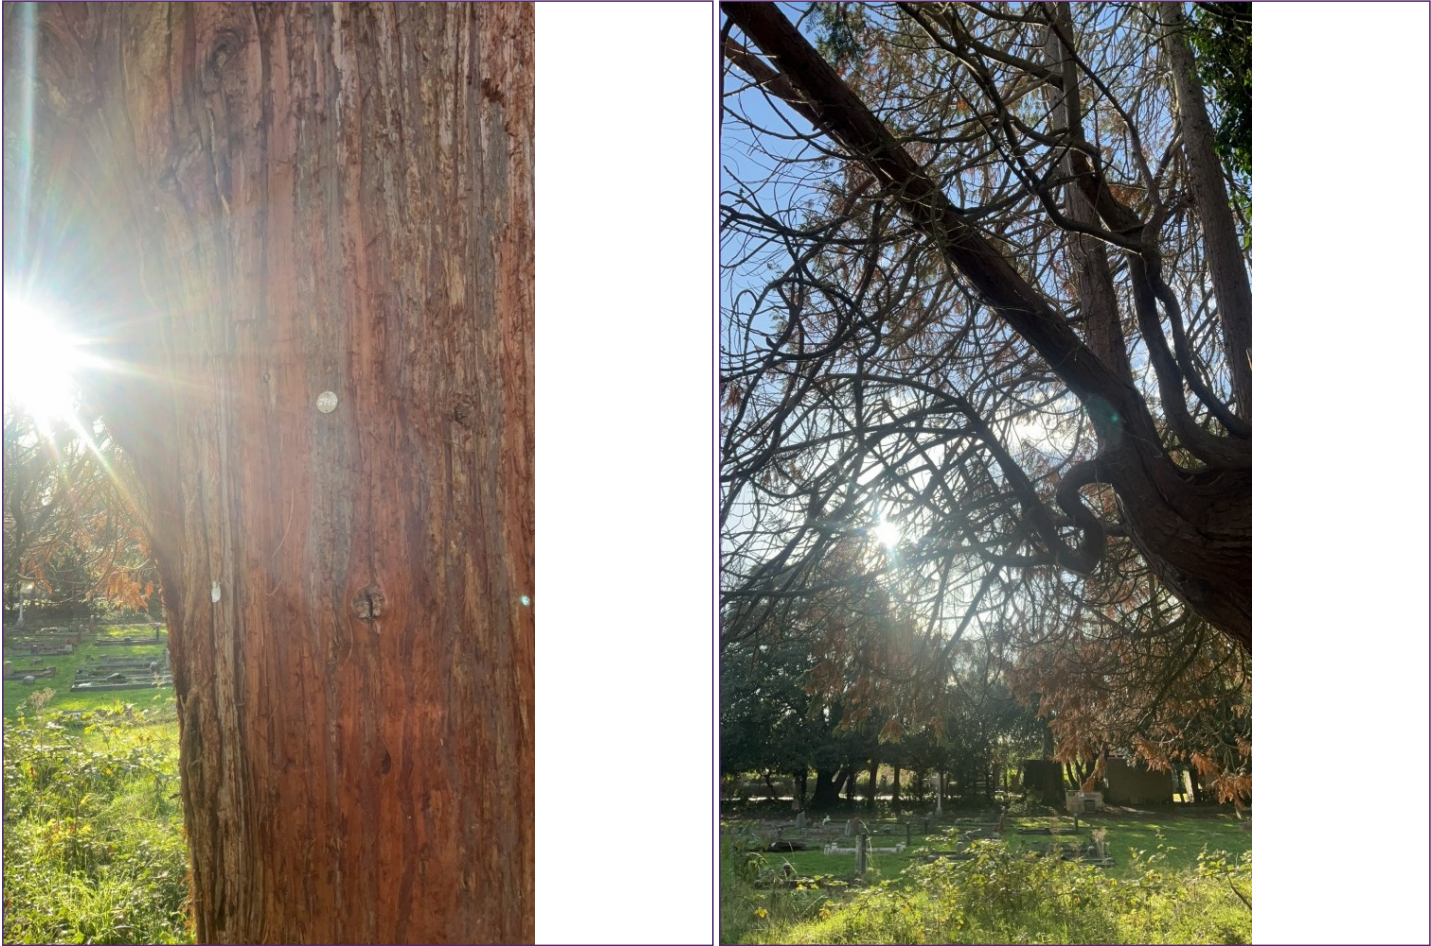
Item	Species	Comments	Recommendations	Price
T-116	Lawson cypress	Storm damage (severe in need of remedial works)	Stabilise vulnerable branches

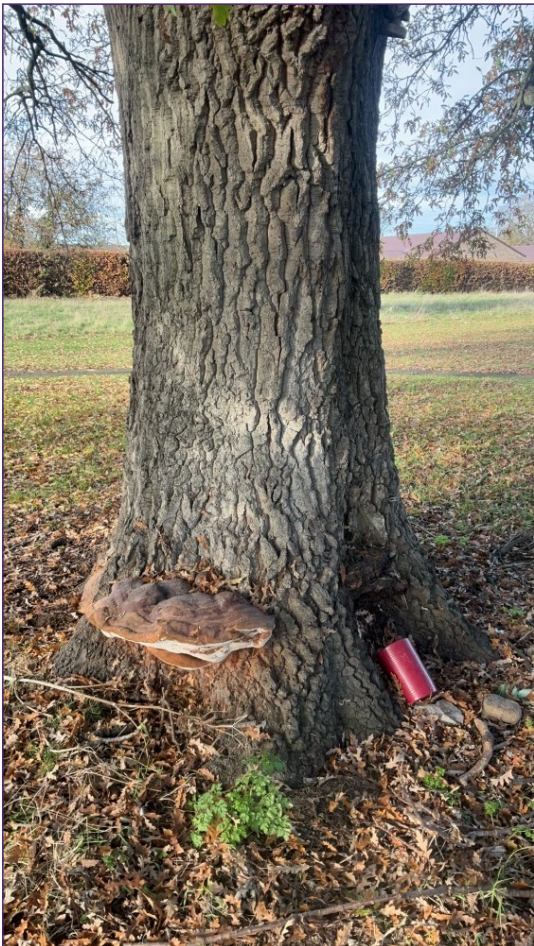
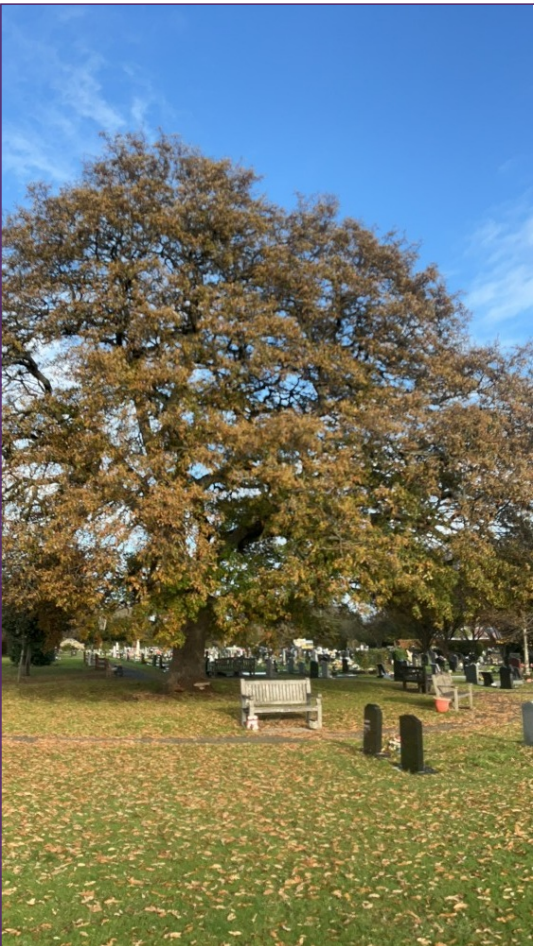
Item	Species	Comments	Recommendations	Price
T-117	Turkey oak	Significant, large and mature fungal brackets present at base. Wide, squat crown, but exposed. Important landscape tree, benches and graves beneath. Retention only possible if tree is fenced off to prevent access beneath. Replacement essential if felled.	Fell

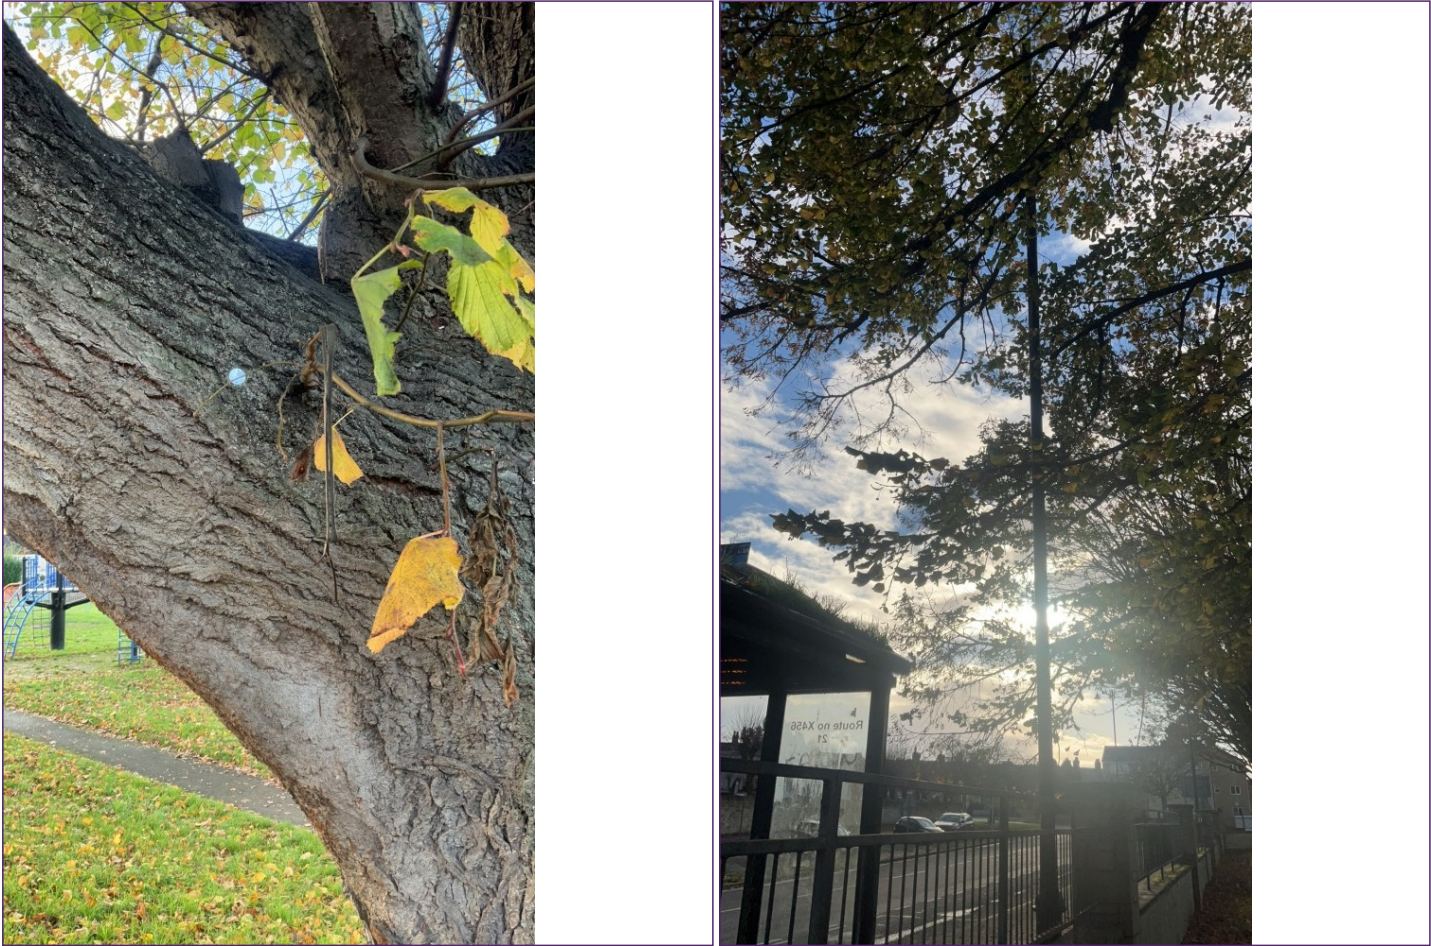
Item	Species	Comments	Recommendations	Price
T-119	Lime	Interference with light column	Prune branches interfering with light column to give a clearance of 2 m

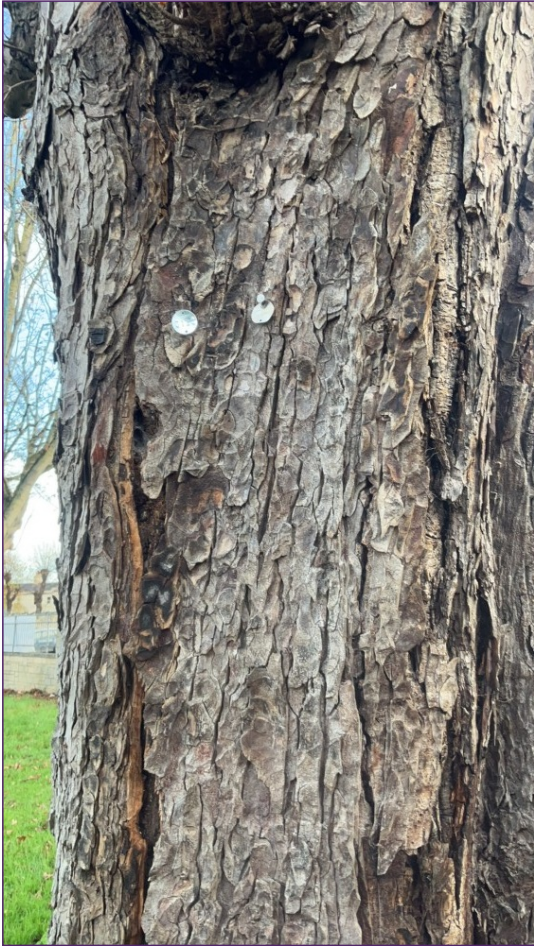
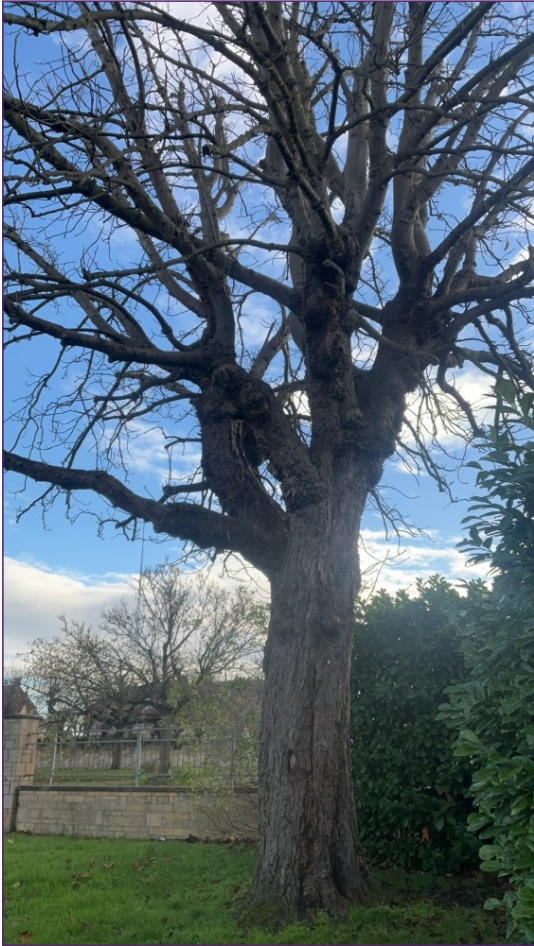
Item	Species	Comments	Recommendations	Price
T-120	Horse chestnut	Decay in trunk at 1 m	Fell

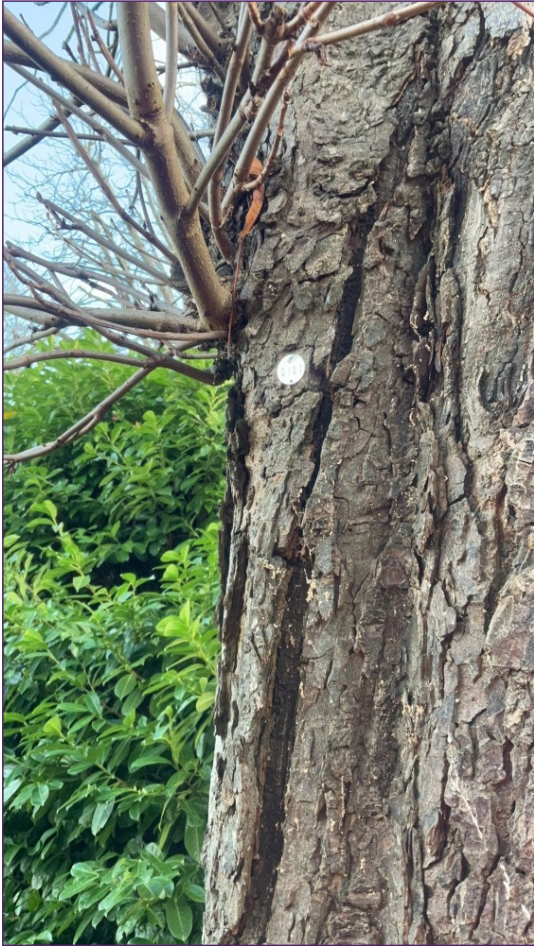
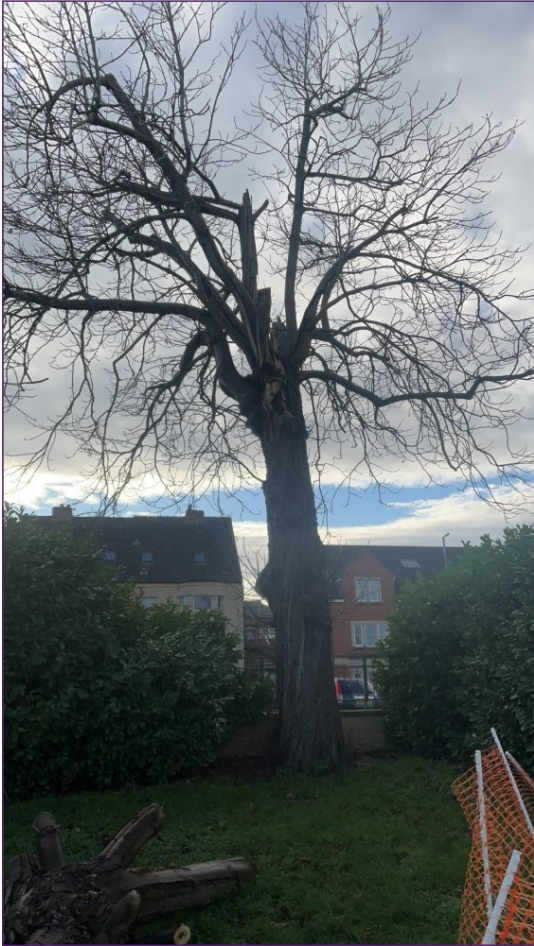
Item	Species	Comments	Recommendations	Price
T-121	Horse chestnut	Failed limbs, significant decay in stem	Fell

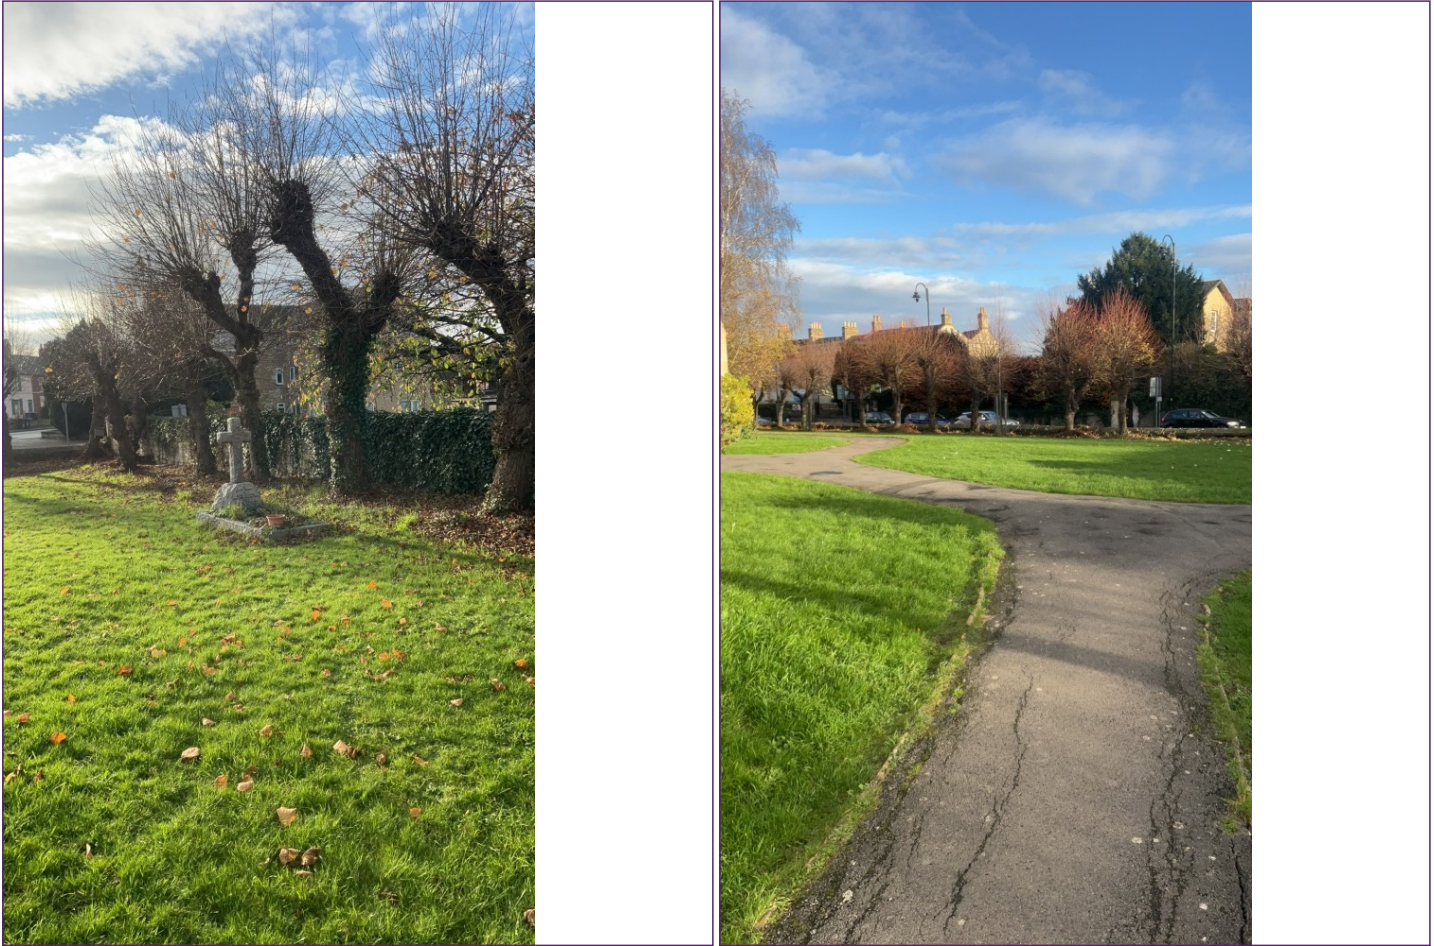
Item	Species	Comments	Recommendations	Price
G-122	Lime	Line of pollarded trees around churchyard.	Re-pollard
