Tree work specification: Trowbridge Town Council sites, Trowbridge, Wiltshire. BA14

Introduction

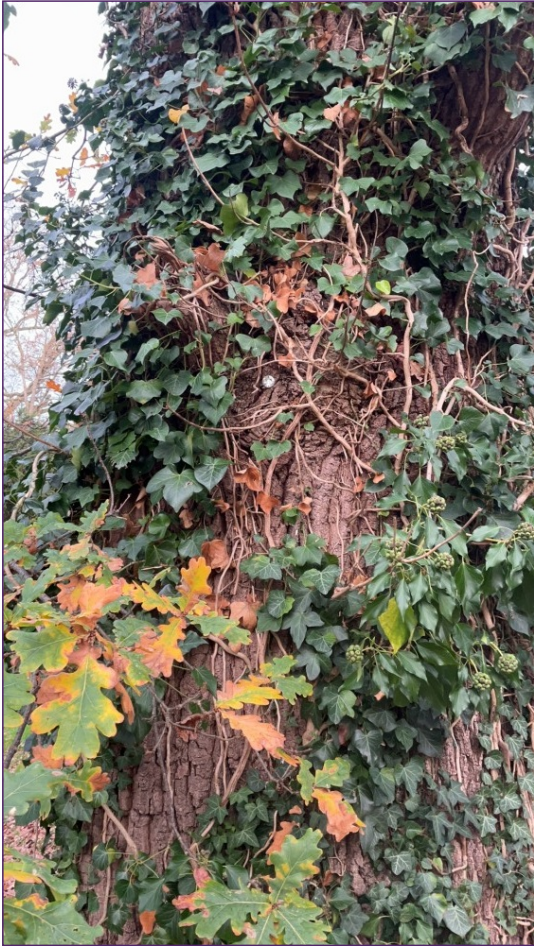
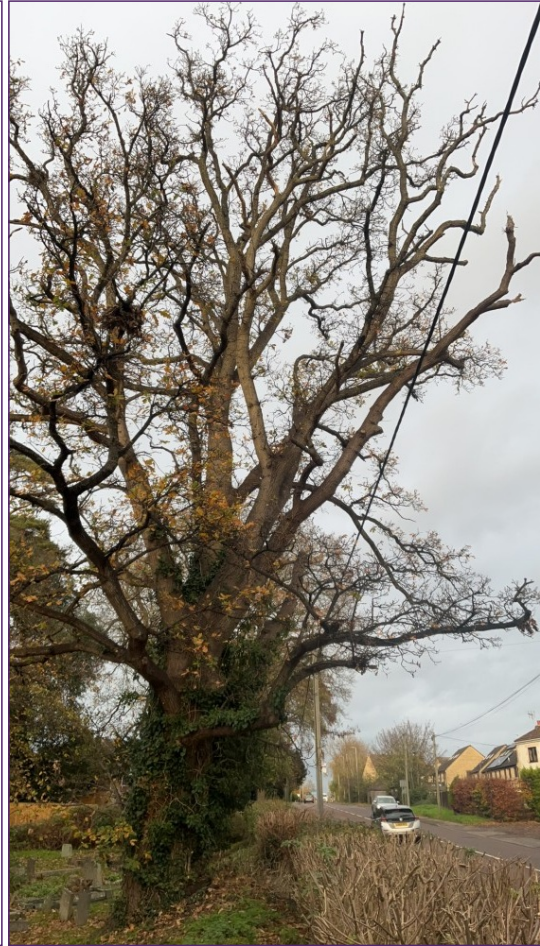
Item	Species	Comments	Recommendations	Price
T-123	Oak	Declining condition, deadwood over road, dieback	Reduce/shape whole tree by 5 m

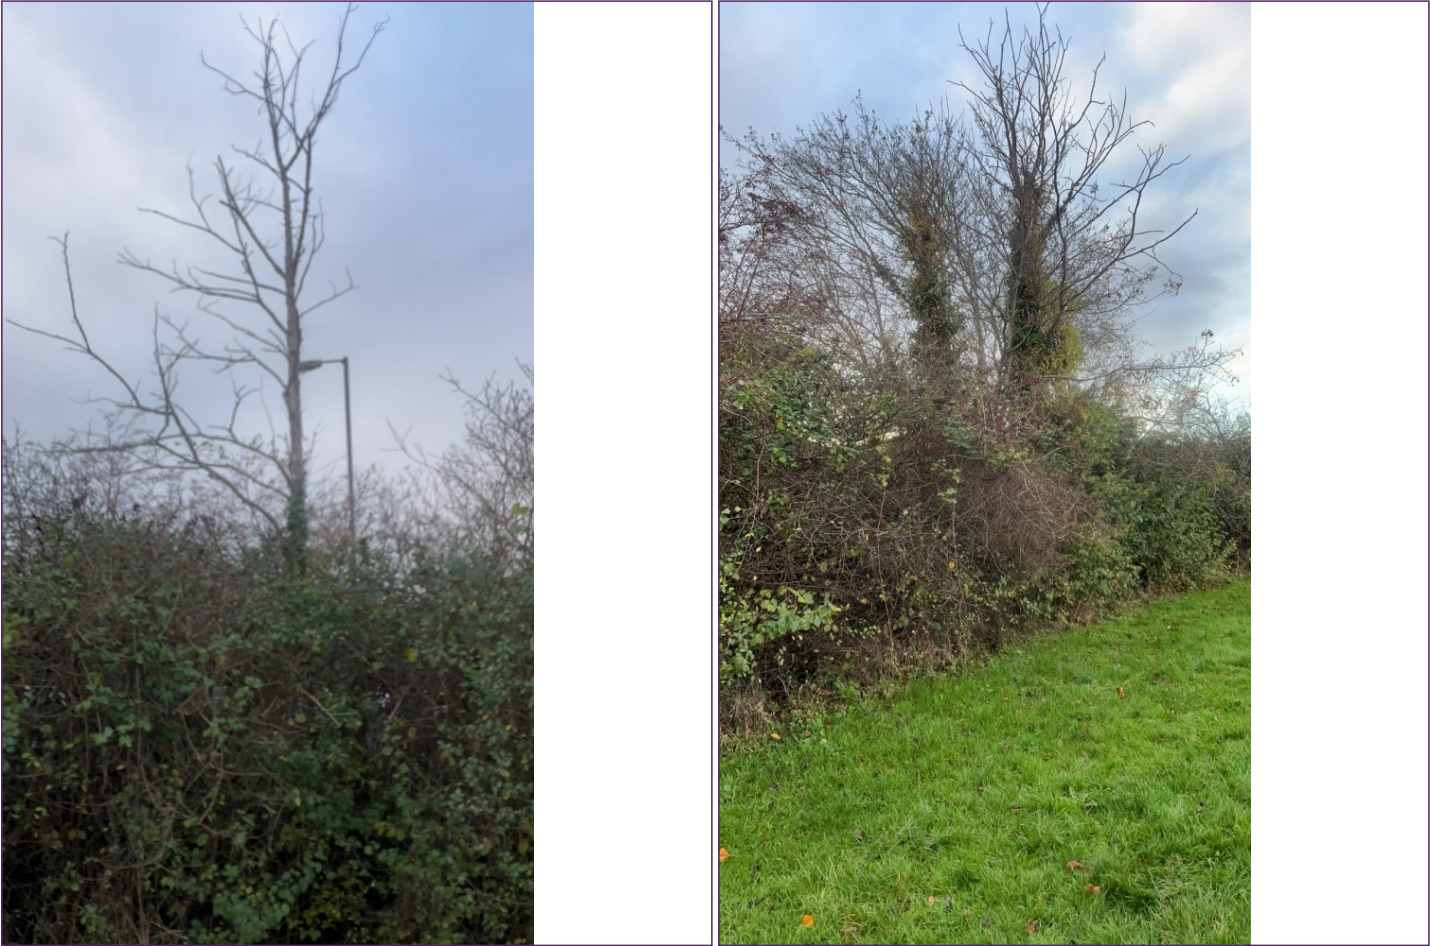
Item	Species	Comments	Recommendations	Price
G-124	Elm	3 dead stems	Fell

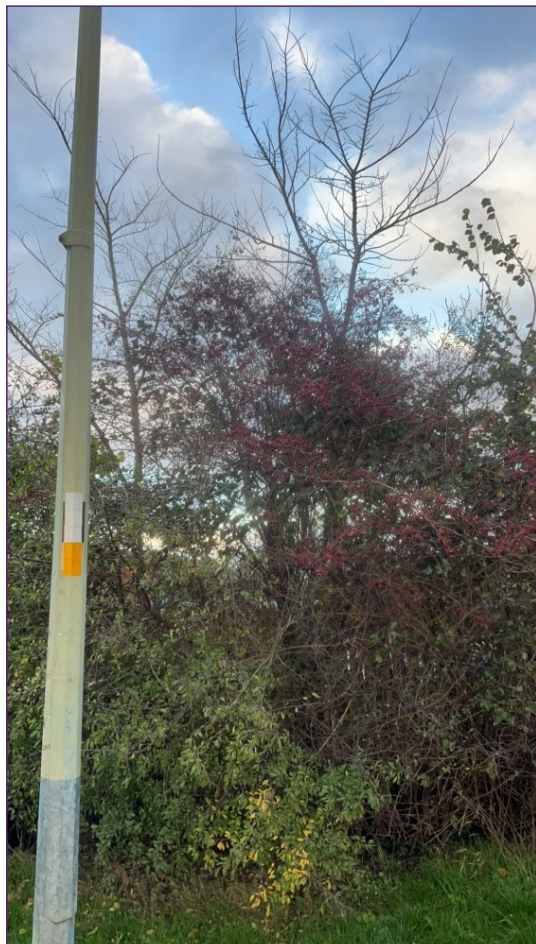
Item	Species	Comments	Recommendations	Price
G-125	Elm	Multiple dead stems	Fell

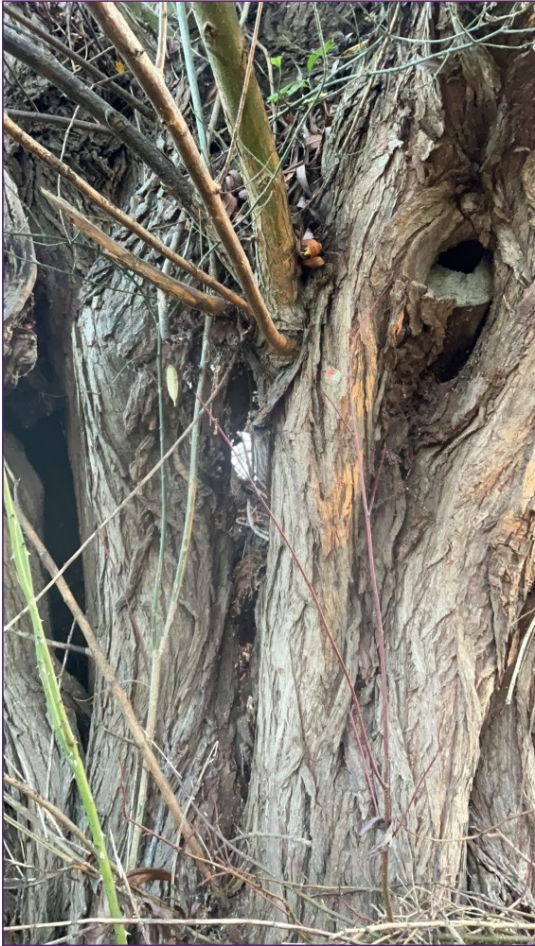
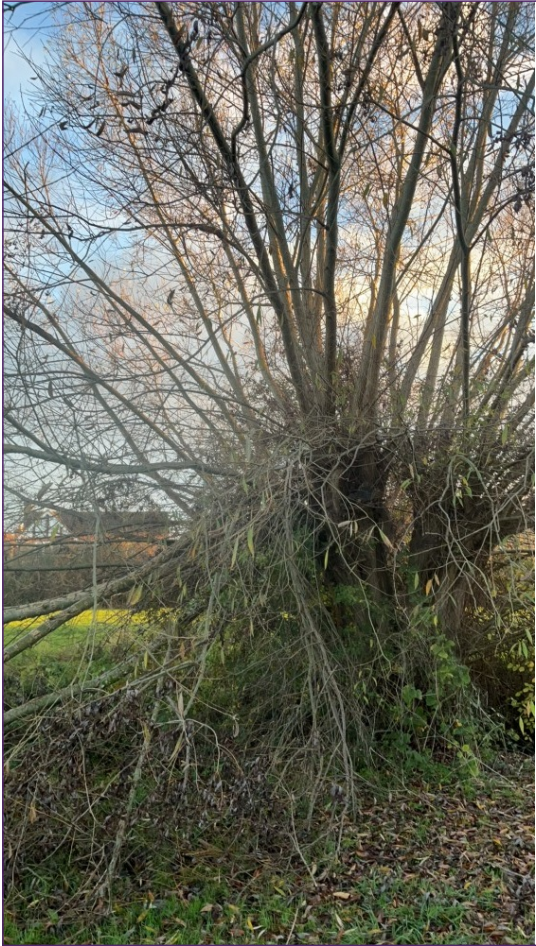
Item	Species	Comments	Recommendations	Price
T-126	Crack willow	Old pollard, several failed limbs, hollow stem	Re-pollard

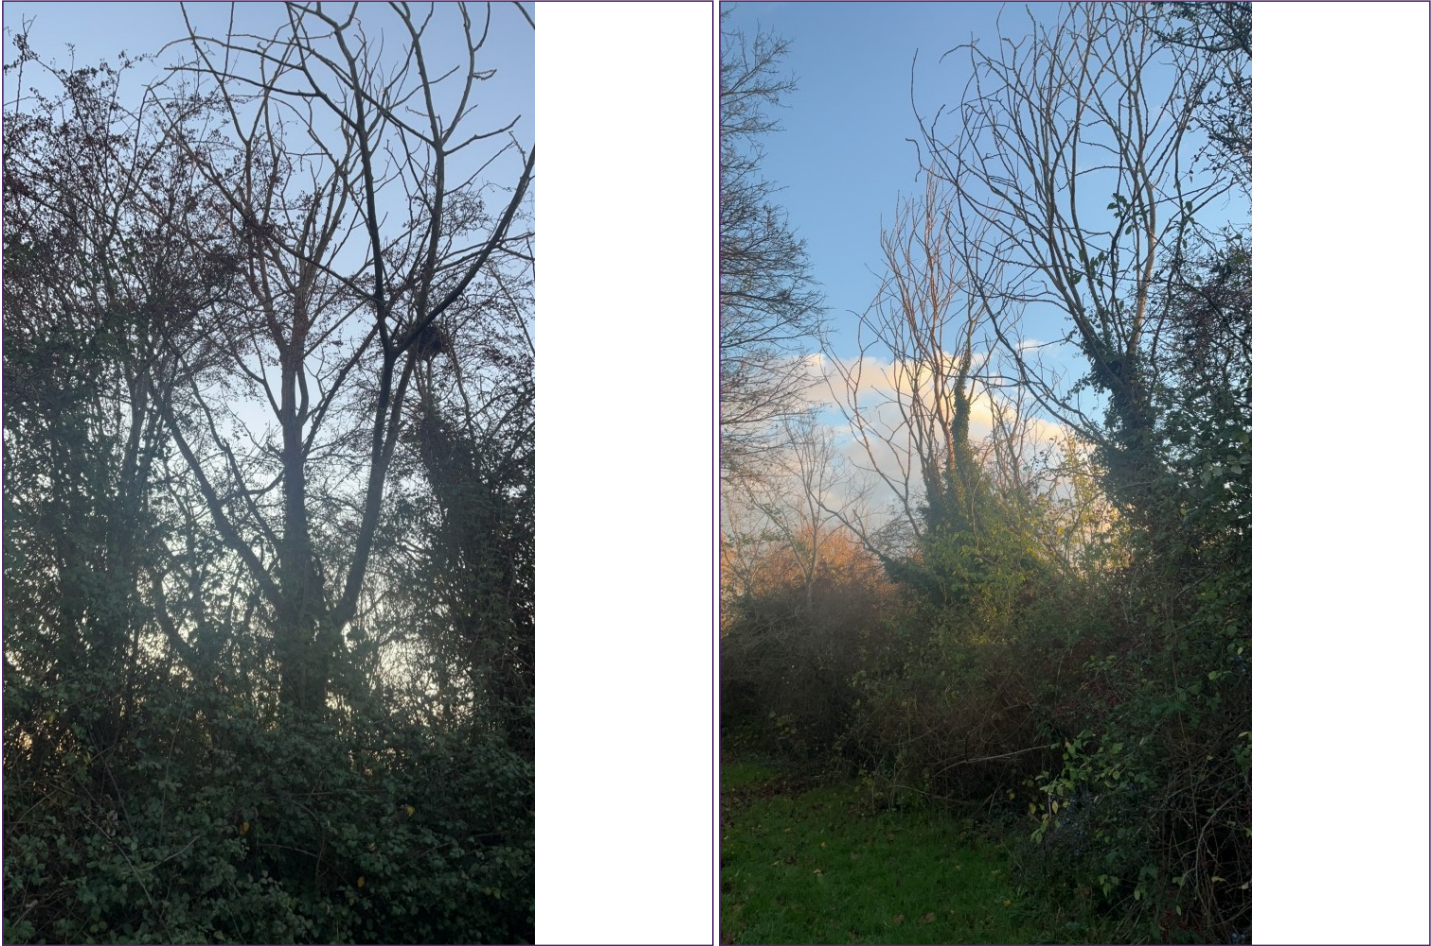
Item	Species	Comments	Recommendations	Price
G-127	Elm	3 dead stems	Habitat to 3 m
